## Home Inspection Report

**4541 Patria Dr**

**San Diego, CA 92115**

Inspected On: Tue, Sep 29 2026 at 1:00PM

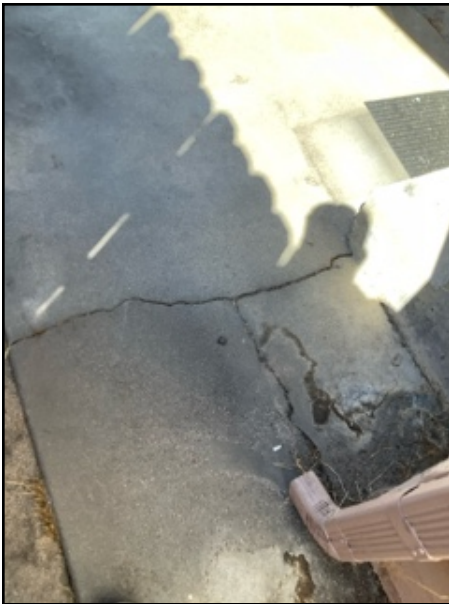
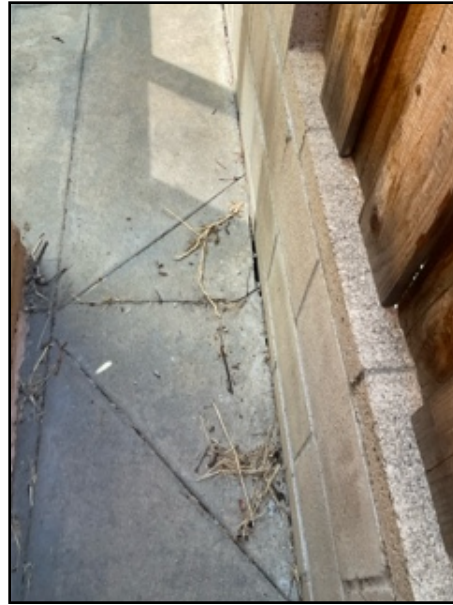
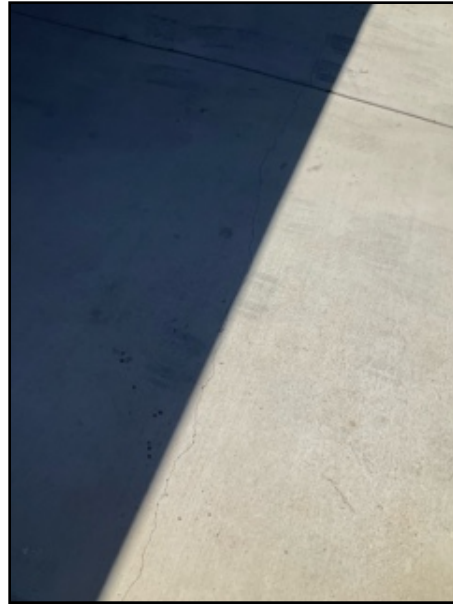
Cracks, stains and uneven surfaces noted at driveway, walkways and patio.

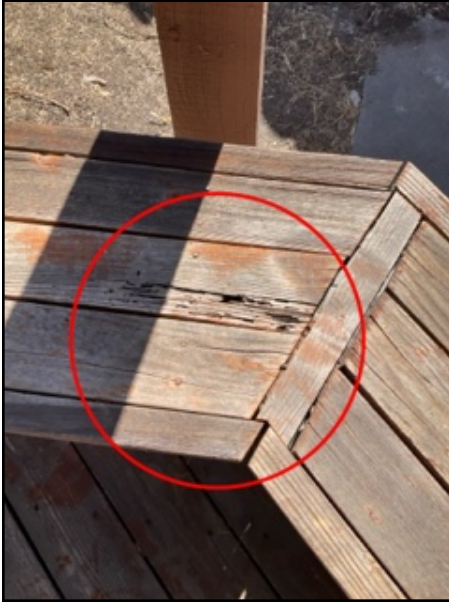
Figure 6-1

**Comment 6:**  
**FURTHER EVALUATION REQUIRED:** Evidence of possible wood, destroying organisms noted on wood deck and backyard.

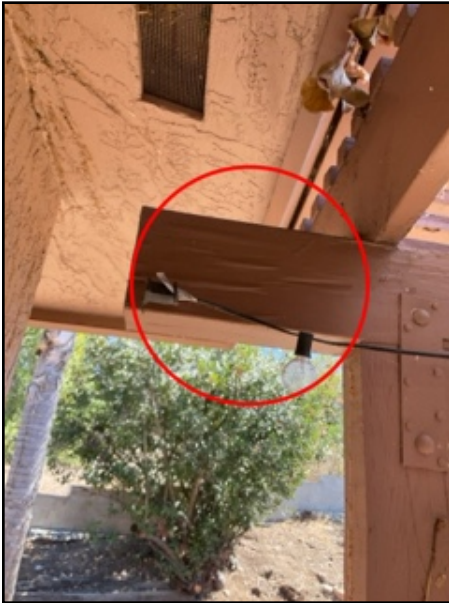
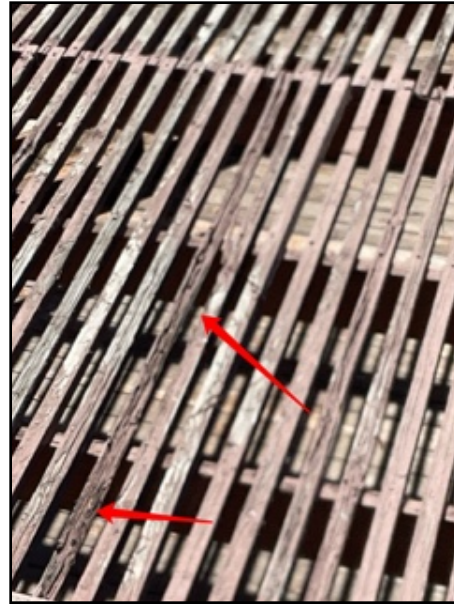
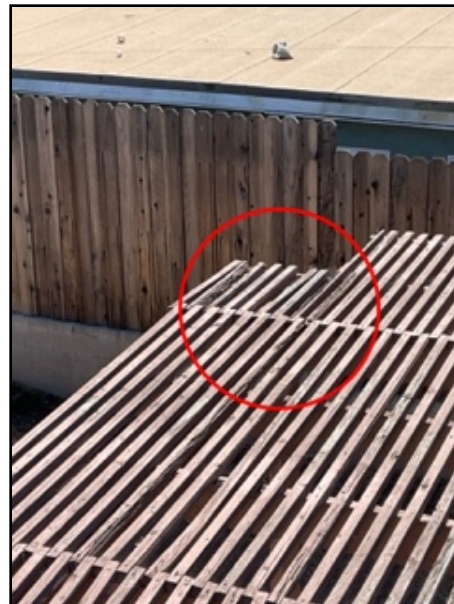
**Comment 7:**  
**FURTHER EVALUATION REQUIRED:**  
Evidence of possible wood destroying organisms / dry rot noted at various locations throughout patio cover.

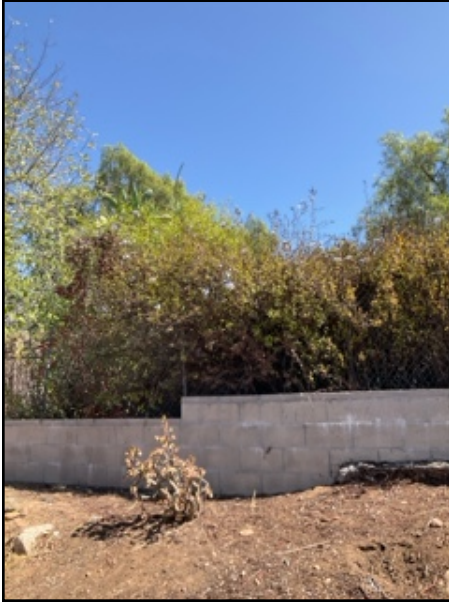
Figure 8-1

REPAIR OR REPLACE: Vegetation noted as growing over and through metal fence in backyard.

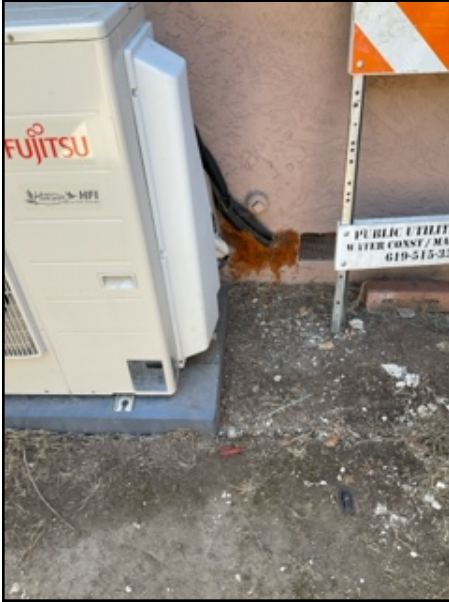
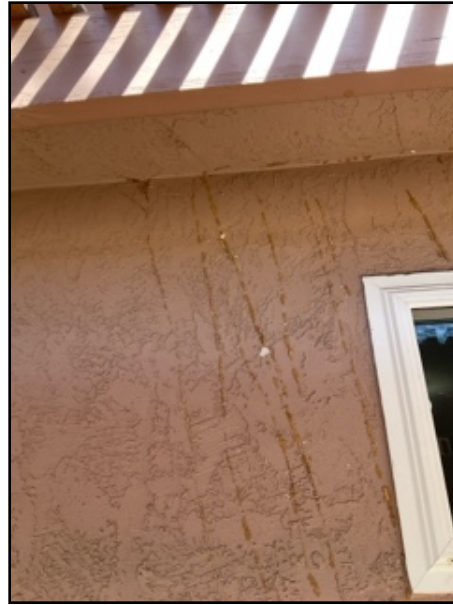
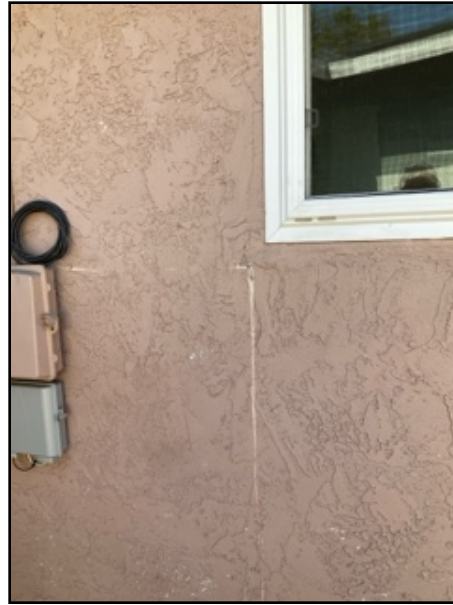
REPAIR OR REPLACE: Old vegetation noted as growing on stucco at front and back of home. Stucco noted as peeling from removal.

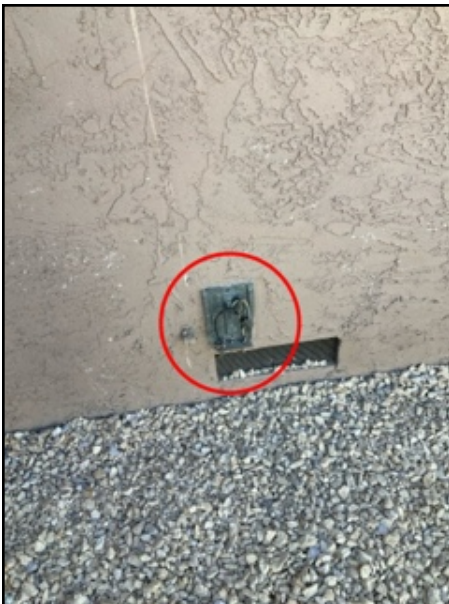
Figure 10-1

REPAIR OR REPLACE: Cover for low-voltage telephone wiring noted as missing.

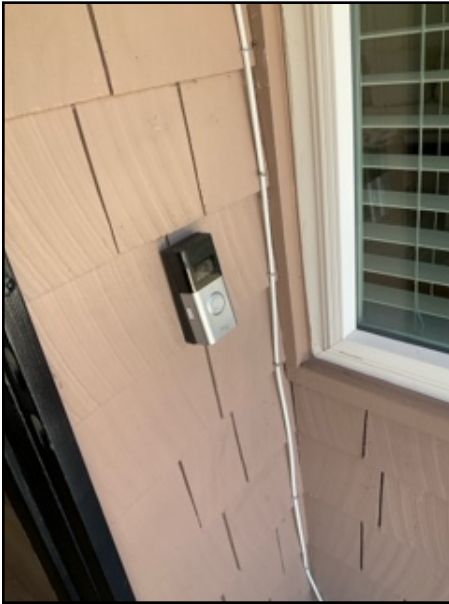
Figure 11-1

Inspector notes smart doorbell is present at the home. Throughout this report, smart devices will be noted as 'further evaluation required' due to the accompaniment of usernames and passwords often associated with smart devices.

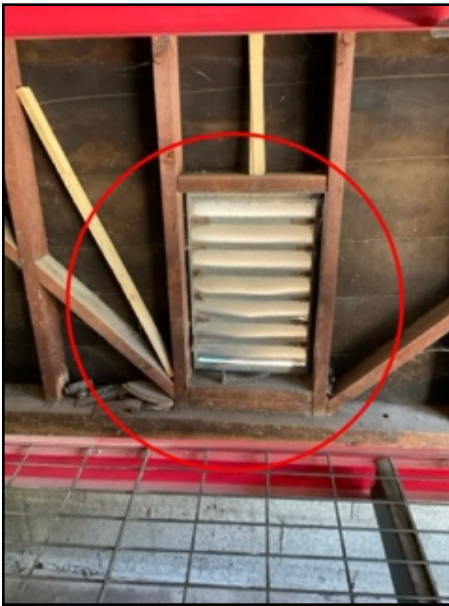
Figure 12-1

REPAIR OR REPLACE: Screen for vent and garage noted as deteriorated and torn.

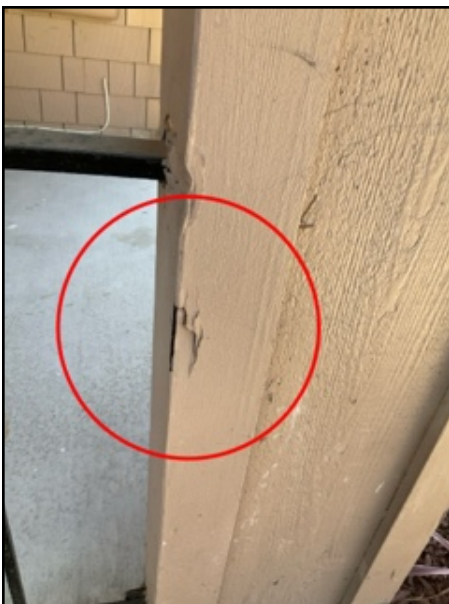
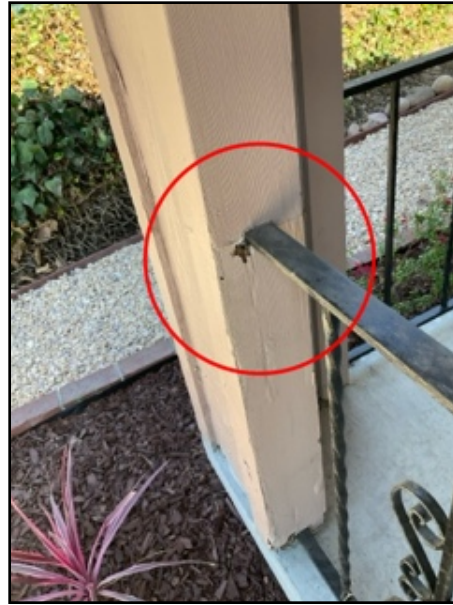
Evidence of possible wood destroying organisms / dry rot noted at the front porch posts.

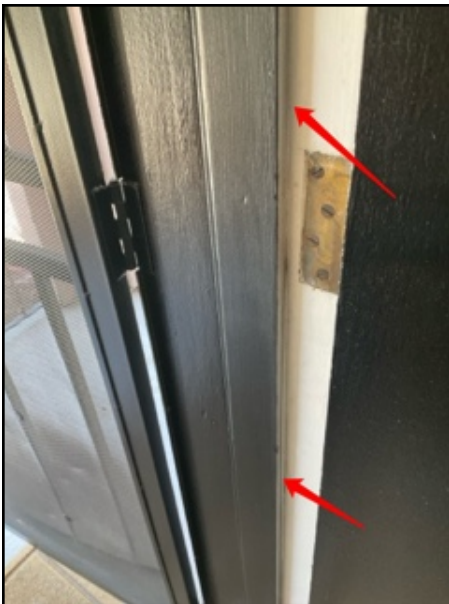
Figure 14-1

REPAIR OR REPLACE: Weatherstripping noted as not installed on exterior doors.

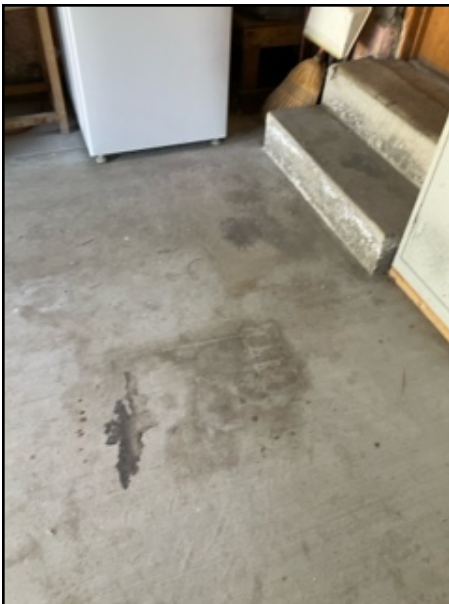
Figure 16-1

Comment 16:  
Cracks and stains noted at garage floor.

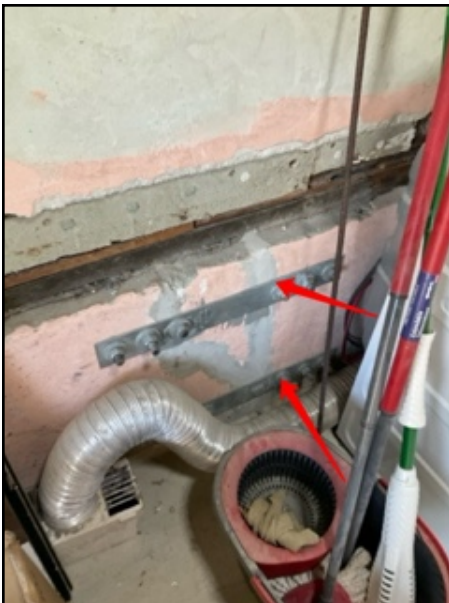
Figure 17-1

**FURTHER EVALUATION REQUIRED:** Previous repair noted as made on concrete foundation, wall and garage.

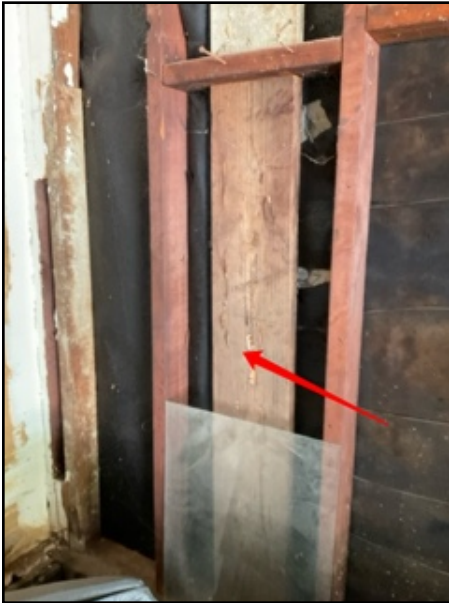
Figure 18-1

**FURTHER EVALUATION REQUIRED:** Evidence of possible wood destroying organisms noted on garage, wood framing. Cracks noted on concrete interior wall near water heater.

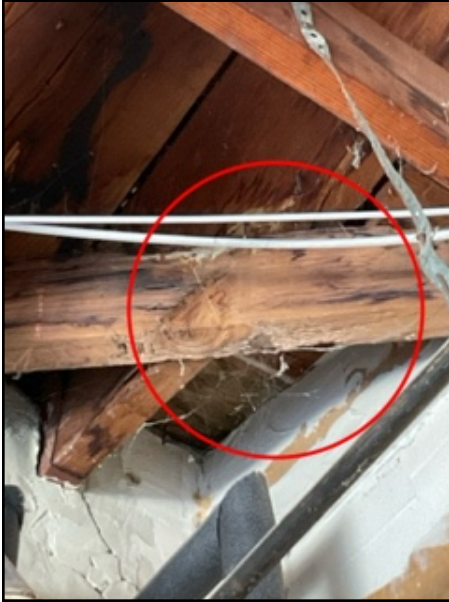
Figure 19-1

**Comment 19:**  
**FURTHER EVALUATION REQUIRED:** Evidence of possible wood, destroying organisms/dry rot noted on roof framing.

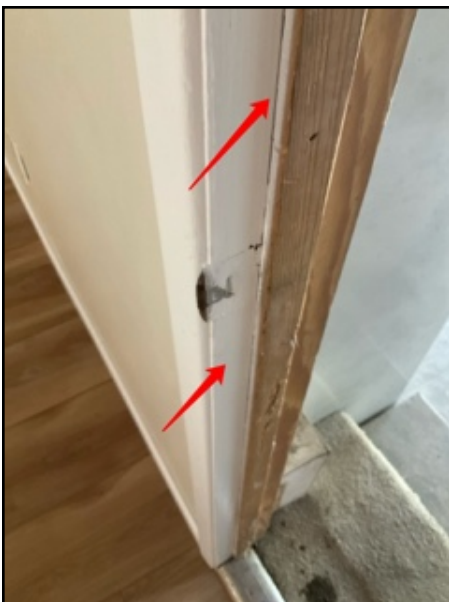
Figure 20-1

**Comment 20:**  
**REPAIR OR REPLACE:** Weatherstripping noted as not installed on garage entry door.

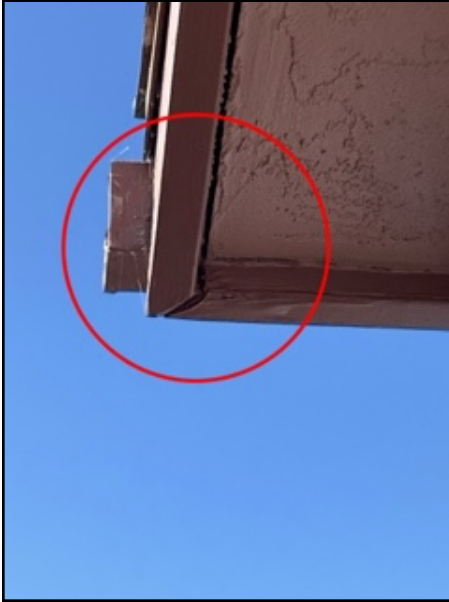
Figure 23-1

**Comment 23:**  
**FURTHER EVALUATION REQUIRED:** Evidence of possible wood destroying organisms / dry rot noted on soffit and/or fascia.

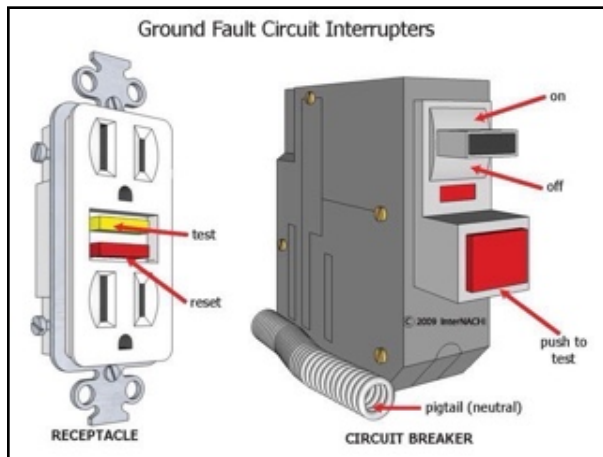
Figure 24-1

Although it may not have been required when this home was originally built, whenever outlets are replaced it is required to have GFCI outlets installed near water/ high humidity sources such as exterior, bathrooms and kitchens. It is beyond the scope of this report to check building code requirements for GFCI installation at each location. Client may choose to upgrade any non-protected outlets for additional safety.

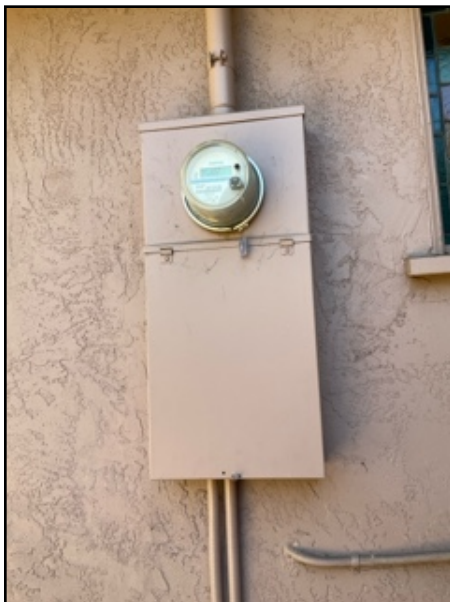
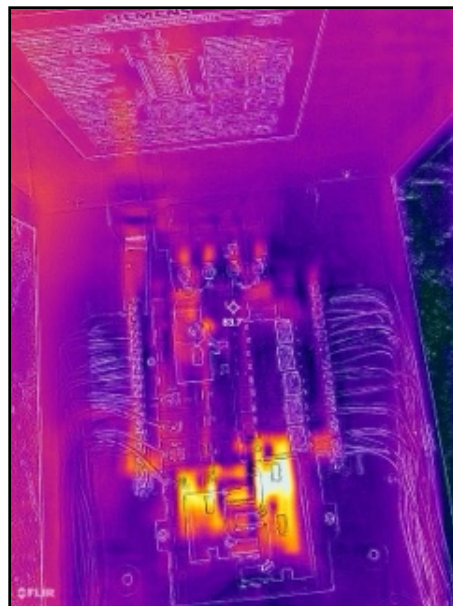
Service panel inspection pictures. A thermal scan was conducted and no significant hot spots were noted.

Several electric components appear to be the original configuration. Several advances in safety have been made since the original design was installed. The service panel appears to be functioning as designed.

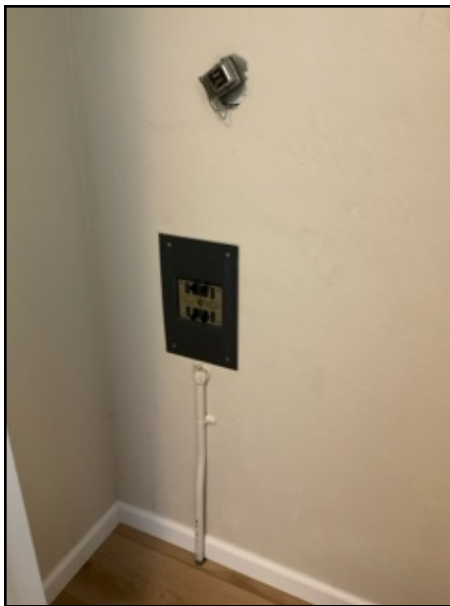
Figure 28-1

A thermal scan was conducted and no significant hot spots were noted.

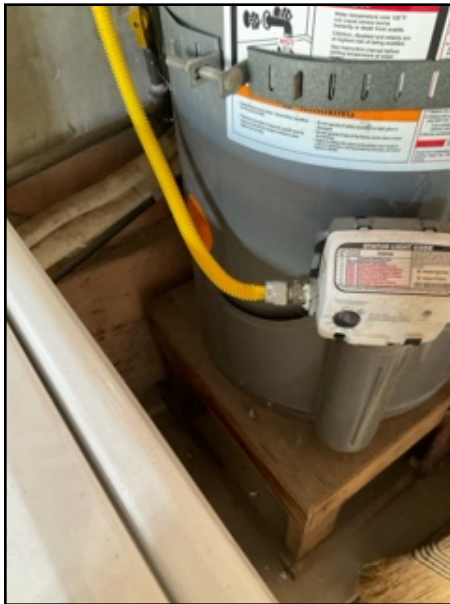
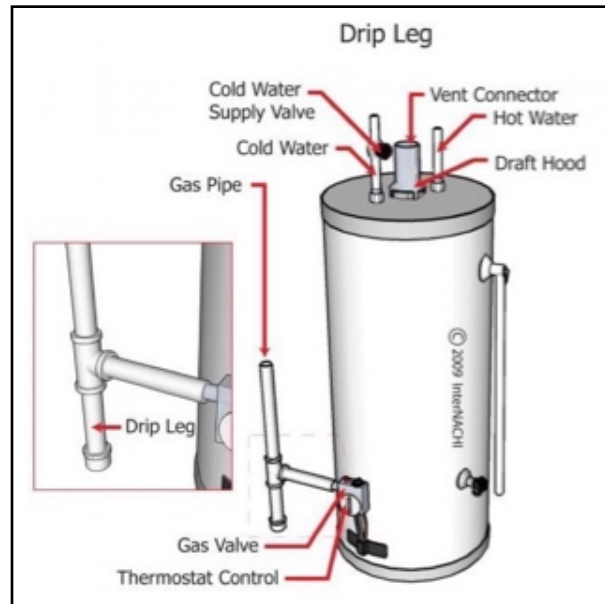
**REPAIR OR REPLACE:** Gas sediment trap noted not present or installed improperly at time of inspection. Sediment trap is designed to catch debris, rust, and moisture and gas line to help prevent clogging and/or damage to appliance burners and valves. Sediment trap should be installed as close as possible to the appliance inlet as possible.

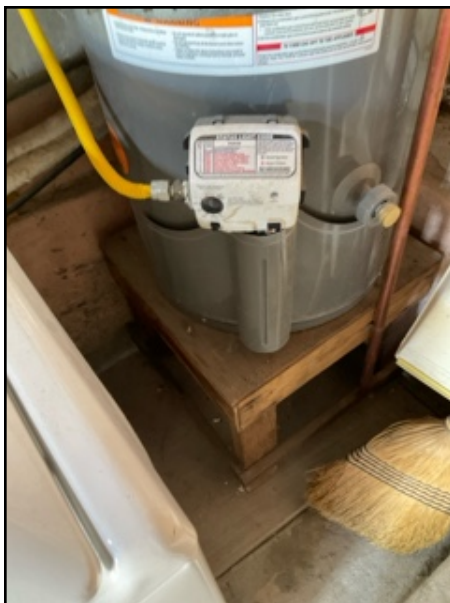
Figure 45-1

REPAIR OR REPLACE: Auxiliary catch pan noted as not installed on 2021 water heater.

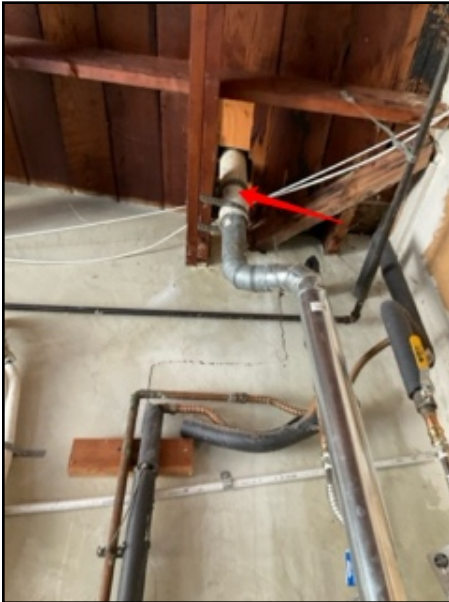
Figure 46-1

FURTHER EVALUATION REQUIRED: Apparent Transite exhaust ducting noted at water heater. This type of pipe is common in older homes and when intact and undisturbed generally does not pose an immediate health risk. Recommend leaving the material undisturbed and monitoring for damage. If removal, repair or invasive work is planned, engage in more qualified professional for further evaluation.

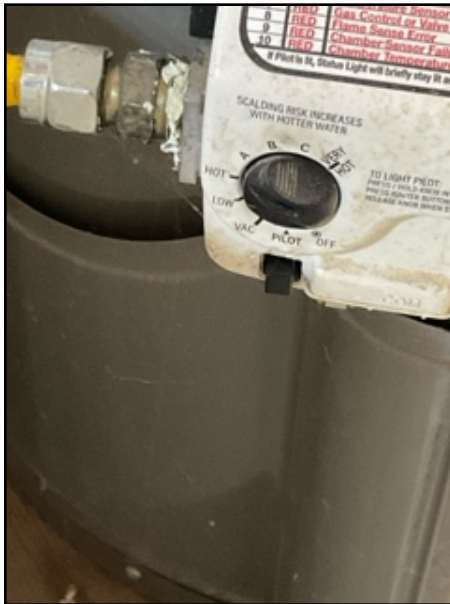
Figure 47-1

Water temperature was 136°F. Most appliance manufacturers recommend a temperature of around 120°F. Generally temperatures above 130°F are considered unsafe.

FURTHER EVALUATION REQUIRED: Thermostat on water heater noted as set to the A setting at time of inspection. Water temperature reach 136°F. Inspector recommends turning down thermostat to recommended manufactured setting.

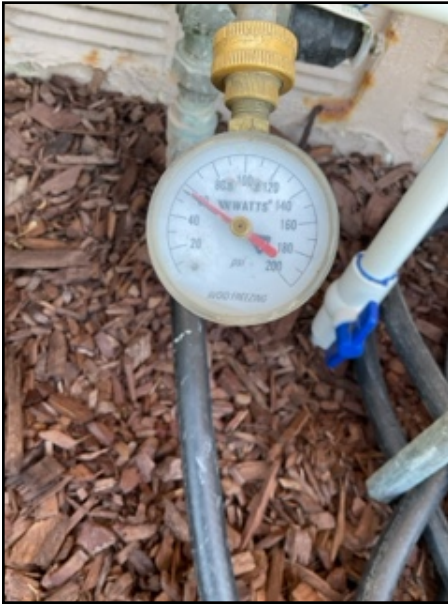
Figure 48-1

Water pressure is 60 psi. Most appliance manufacturers recommend pressure to be set between 50 and 80 psi.

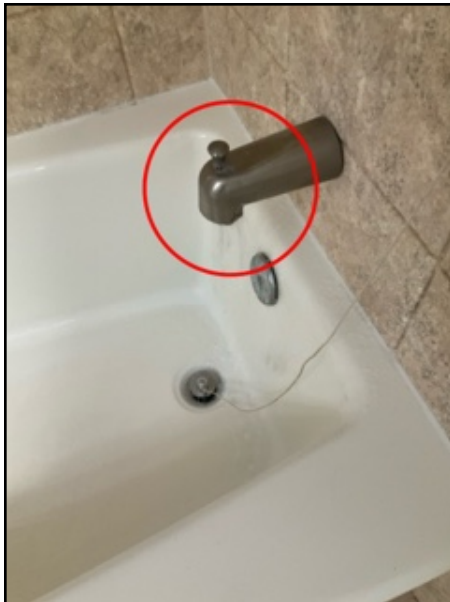
Figure 49-1

REPAIR OR REPLACE: Shower diverter allows water to leak by.

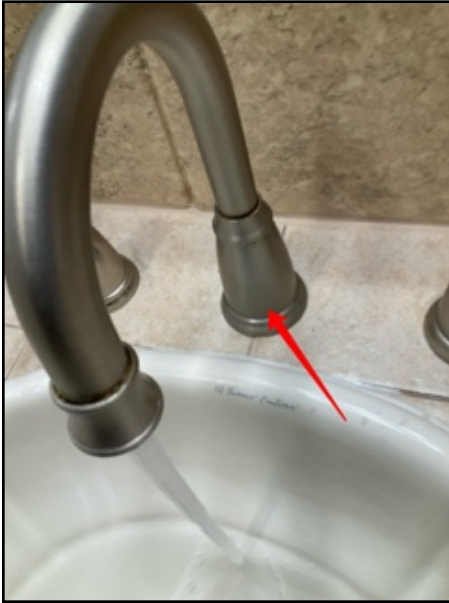
Figure 50-1

REPAIR OR REPLACE: Sink faucet noted as loose.

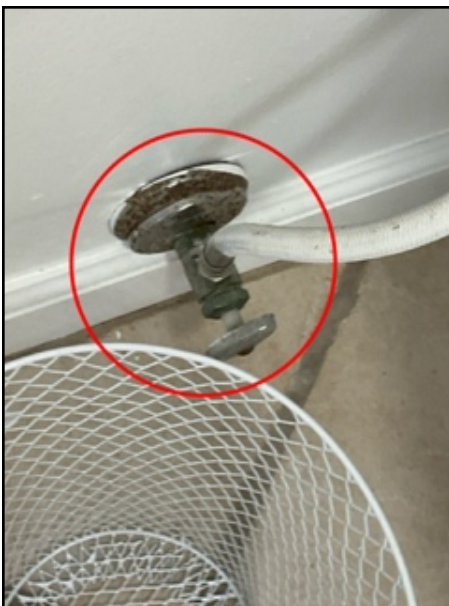
Figure 51-1

REPAIR OR REPLACE: Angle stop behind toilet noted as rusted and corroded.

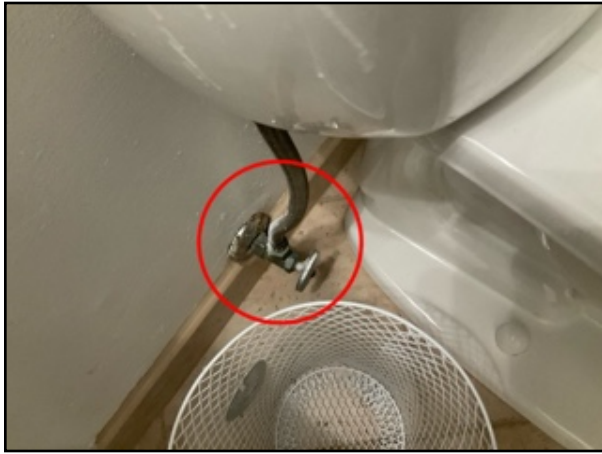
Figure 52-1

REPAIR OR REPLACE: Angle stop behind toilet noted as rusted and corroded.

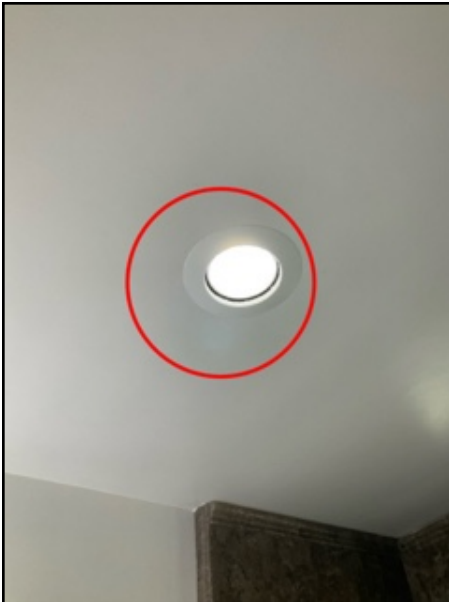
Figure 53-1

REPAIR OR REPLACE: Ventilator is loud and potentially nearing the end of its serviceable life.

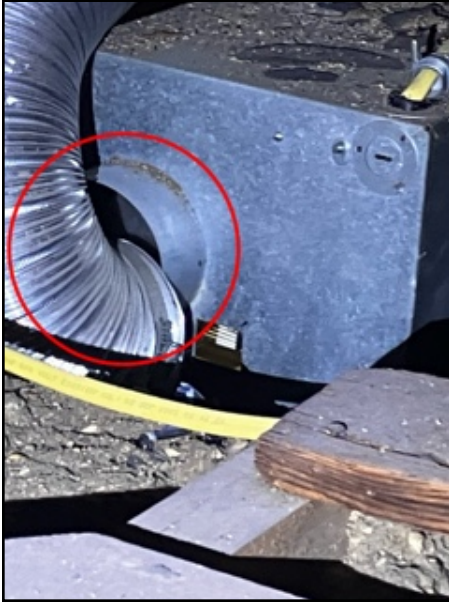
Figure 54-1

REPAIR OR REPLACE: Ducting for ventilator over hallway bathroom in attic noted as disconnected.

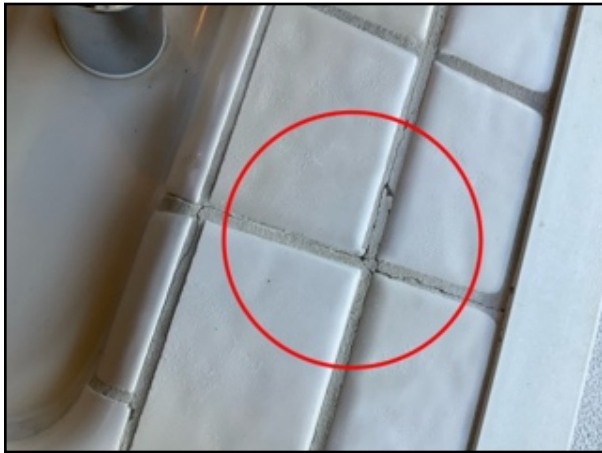
Figure 55-1

REPAIR OR REPLACE: Tile countertop noted as cracked. Grout between tile noted as deteriorated.

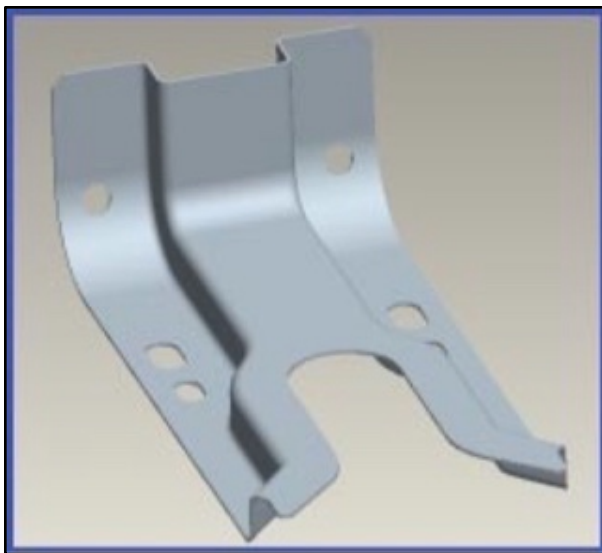
Figure 56-1

As of 2012 anti-tip devices are required to be installed on all new range installations. Age of range is unknown. Anti tip device not installed at range.

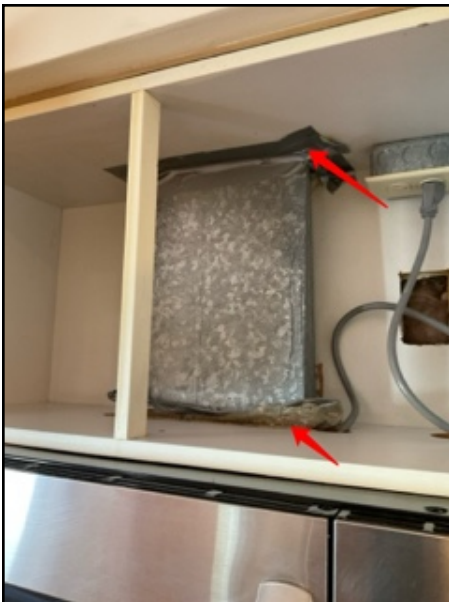
Figure 58-1

Comment 58:  
**REPAIR OR REPLACE:** Ducting for microwave noted as sealed with duct tape. Duct tape is delaminating.

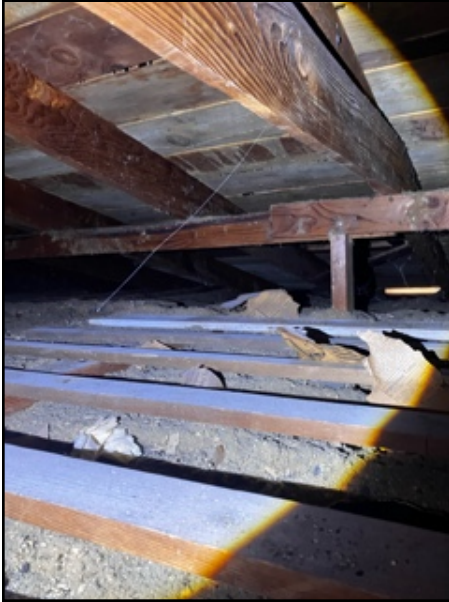
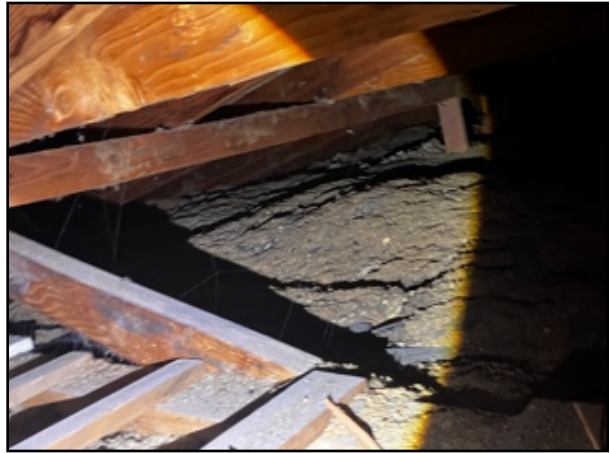
**FURTHER EVALUATION REQUIRED:** Previous water stains noted on roof sheeting around vent pipe. Inspector notes new roof has been installed.

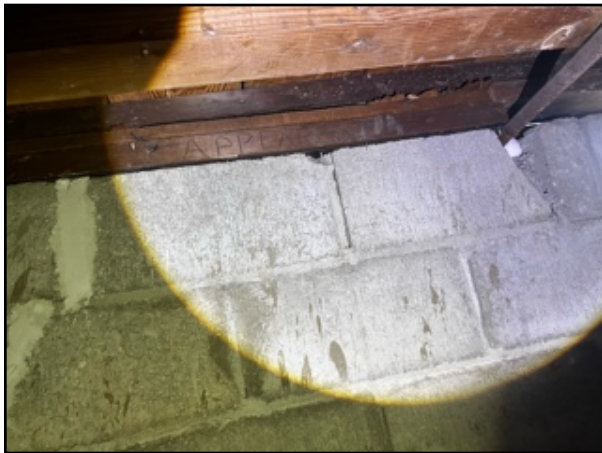
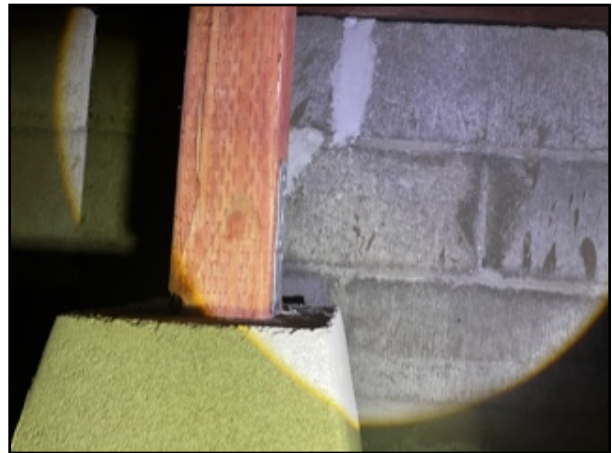
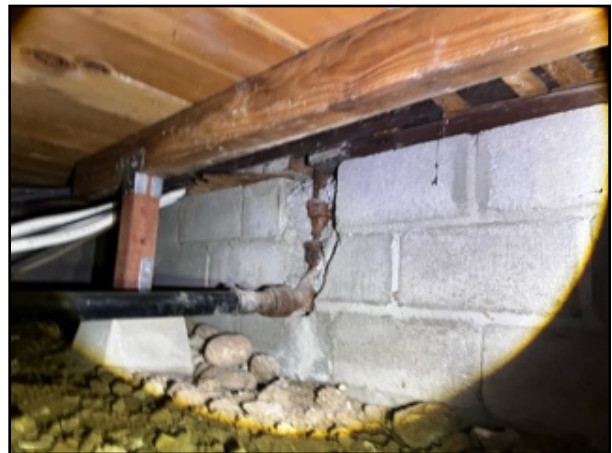
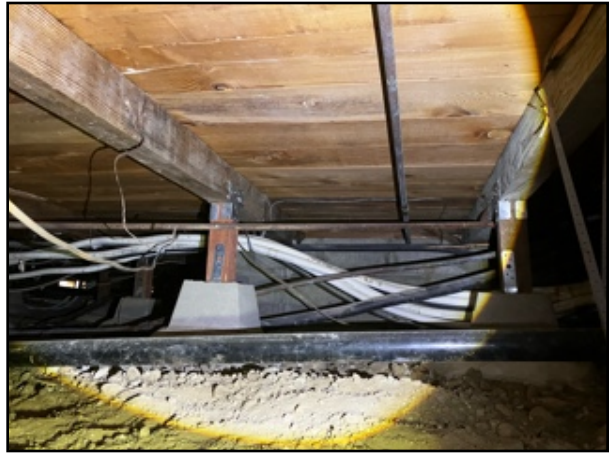
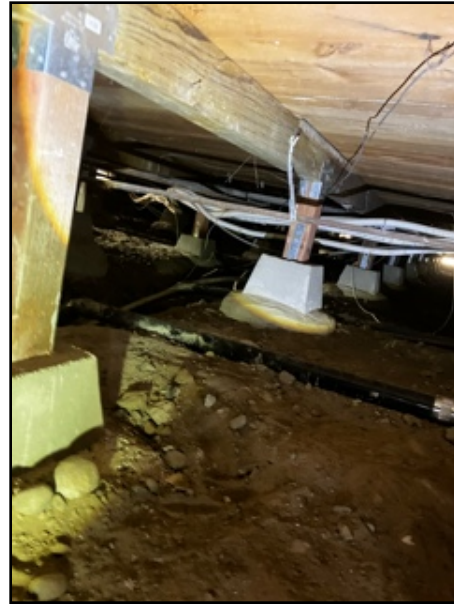
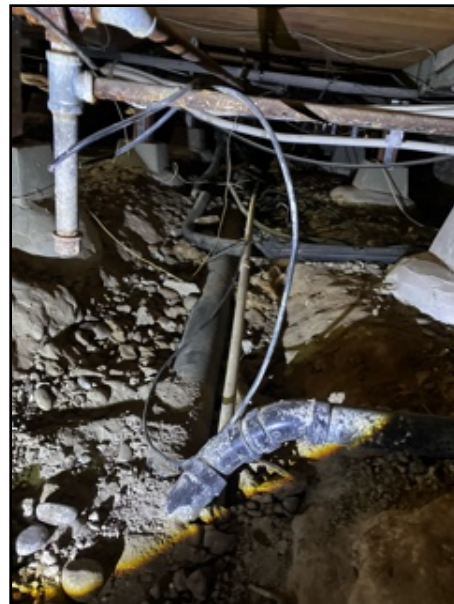
Post and peers have been strapped and secured. New concrete has been poured underneath post. Foundation work has been made at various locations. ABS plumbing noted underneath bathrooms and kitchen. Laundry has small section of cast-iron connecting to ABS pipe.

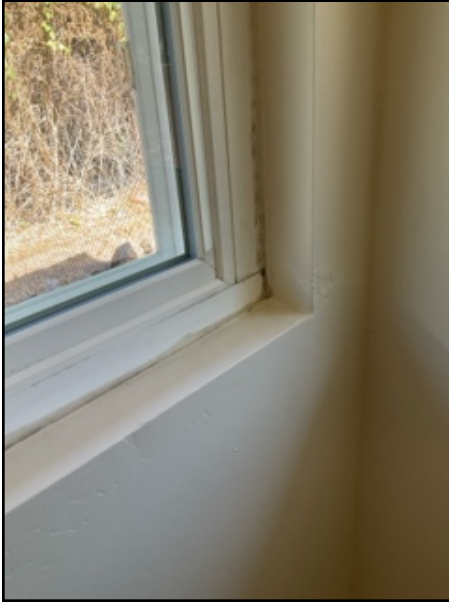
Figure 64-1

Minor paint, drywall damage, burned out bulbs, broken/missing covers and other minor cosmetic defects noted at various locations throughout the home.

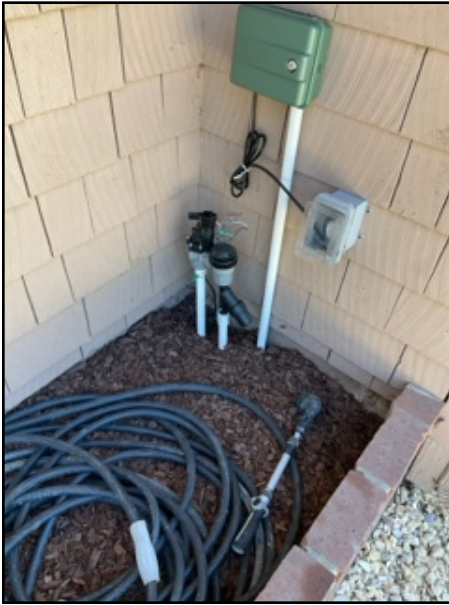
Figure 67-1

Lawn sprinklers were manually operated at valves. No apparent leaks or broken sprinkler heads were noted. It is beyond the scope of this inspection to inspect timers or non-visible electronic components.

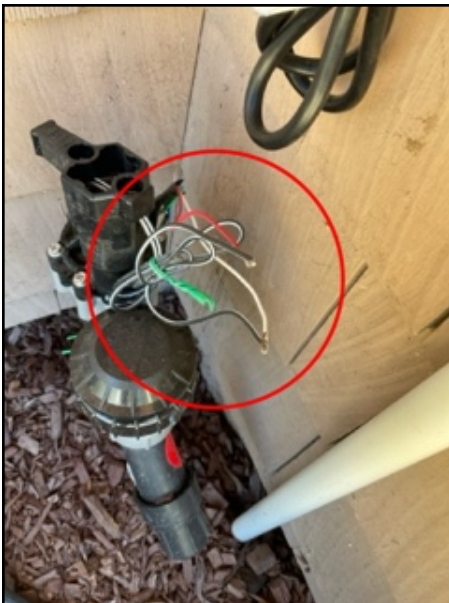
Figure 68-1

**Comment 68:**  
**REPAIR OR REPLACE:** Connection wires noted as not capped or taped off irrigation valve.
