# PROPERTY INSPECTION REPORT

**FOUR POINT**  
HOME INSPECTION INC.

**4158 Quarterhorse Way**

**Date of Inspection: 9/29/2026**

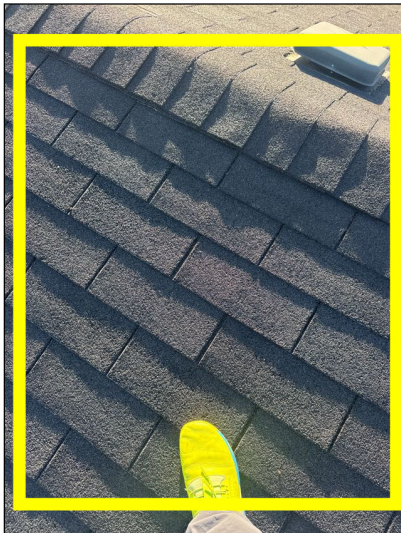
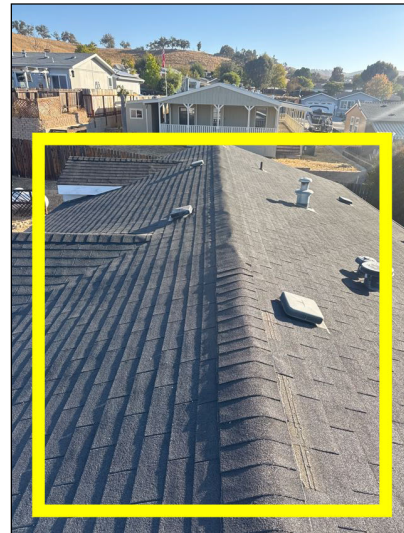
The roof had loose and/or missing shingles. The Inspector recommends replacement of any loose or missing shingles by a qualified roofing contractor to avoid damage from moisture intrusion.

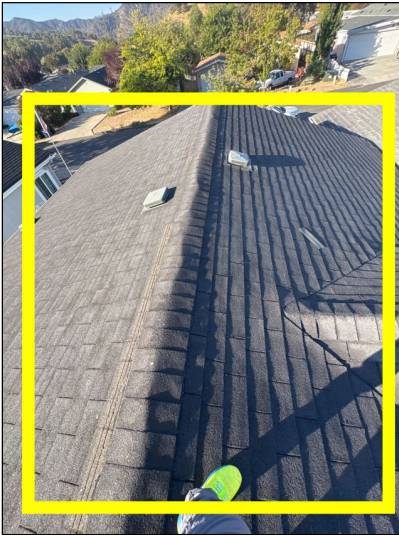
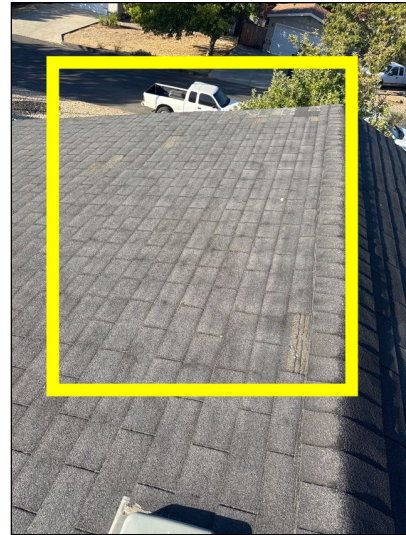
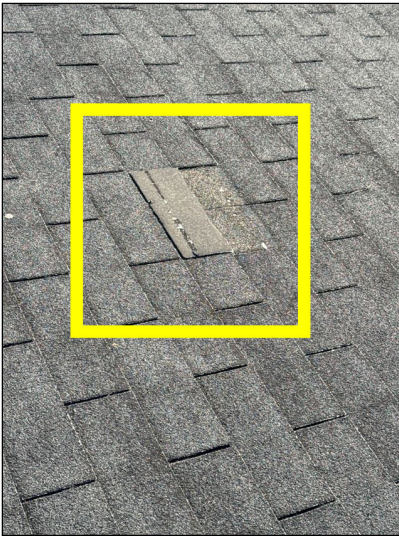
The roof had loose and/or missing shingles.

| Roof | | | |
|---|---|---|---|
| | Page 11 Item: 1 | Roof Condition | The roof had loose and/or missing shingles. The Inspector recommends replacement of any loose or missing shingles by a qualified roofing contractor to avoid damage from moisture intrusion. |

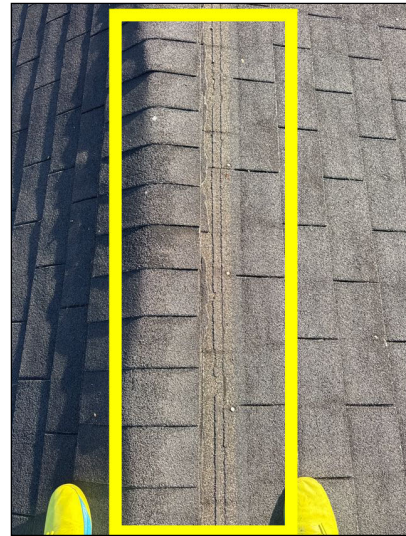
The roof had loose and/or missing shingles.

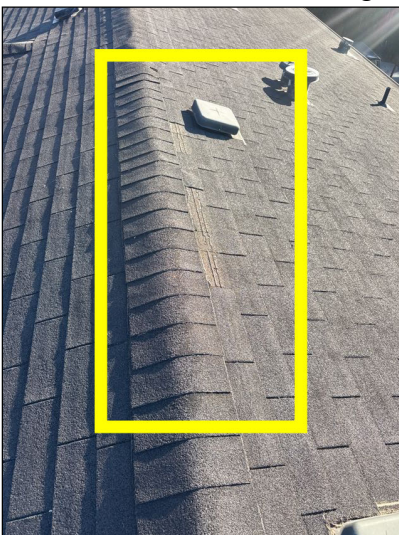
The roof had loose and/or missing shingles.

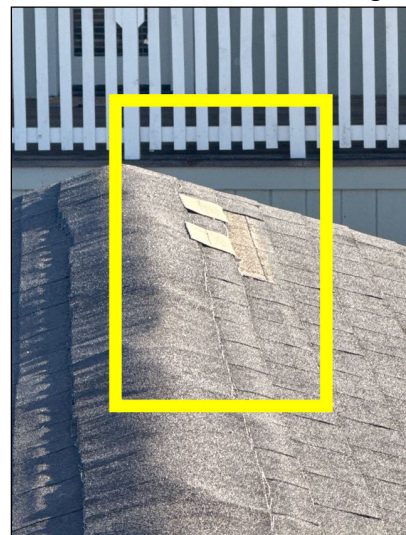
The roof had loose and/or missing shingles.

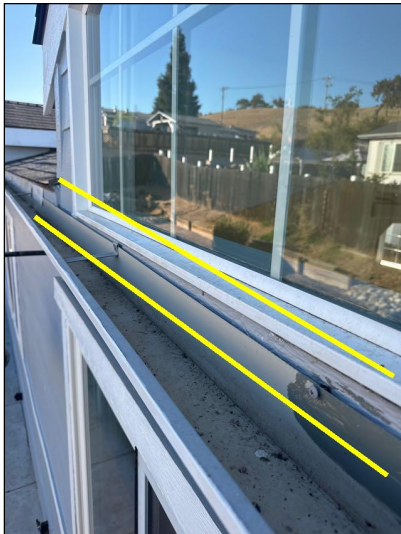
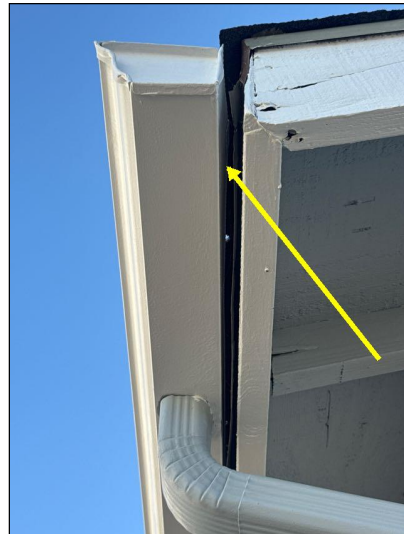
**Gutters in certain areas incorrectly installed. This will result in spillage and runoff draining to the foundation and exterior walls. The Inspector recommends correction to help protect the home structure and occupants. All work should be performed by a qualified contractor.**

| Roof | | | |
|---|---|---|---|
| | Page 14 Item: 5 | Gutters | Gutters in certain areas incorrectly installed. This will result in spillage and runoff draining to the foundation and exterior walls. The Inspector recommends correction to help protect the home structure and occupants. All work should be performed by a qualified contractor. |

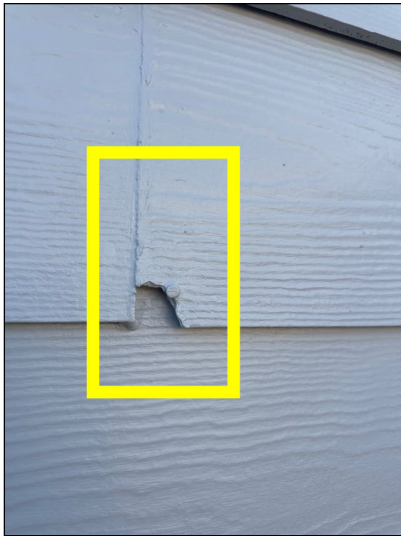
**Maintenance Needed:** All gaps and holes in the siding surface should be sealed to keep unwanted moisture out.

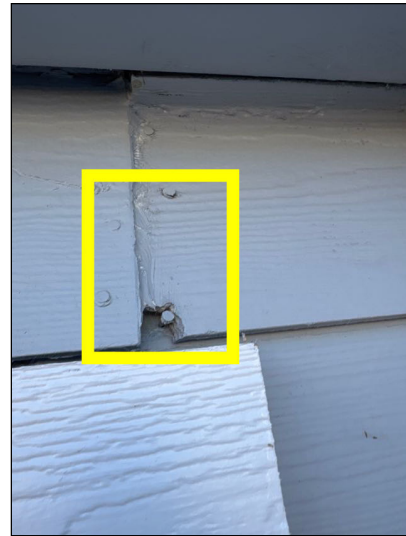
**Maintenance Needed:** All gaps and holes in the siding surface should be sealed to keep unwanted moisture out.

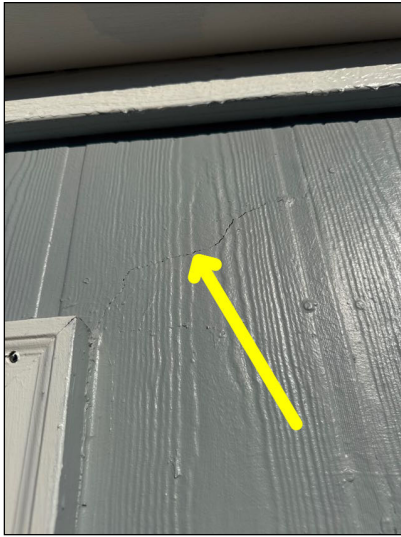
**Monitor:** Normal cracking was visible in siding covering exterior walls of the home at the time of the inspection.

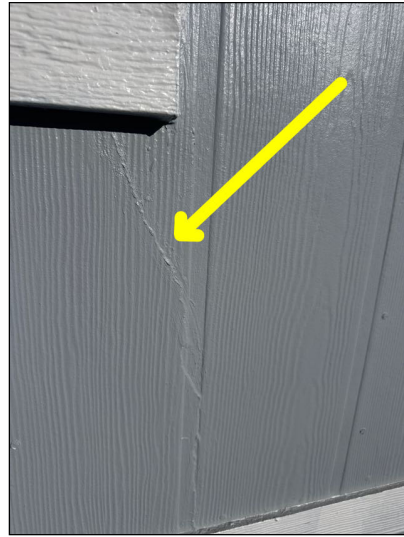
**Monitor:** Normal cracking was visible in siding covering exterior walls of the home at the time of the inspection.

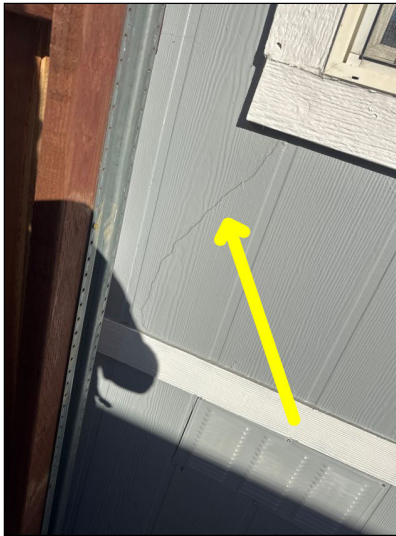
**Monitor:** Normal cracking was visible in siding covering exterior walls of the home at the time of the inspection.

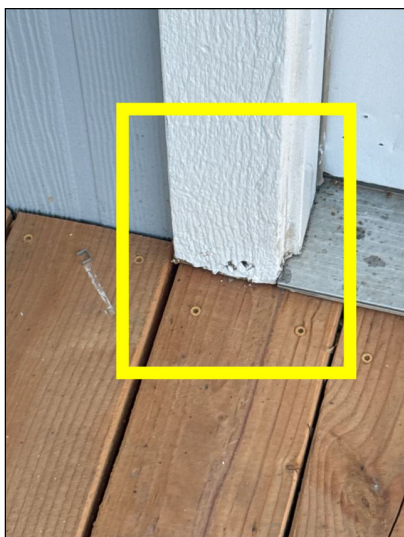
Moisture damage, wood rot, observed.

| Roof | | | |
|---|---|---|---|
| | Page 16 Item: 2 | Trim Condition | <ul style="list-style-type: none"> <li>• Moisture damage, wood rot, observed. Refer to pest report for further details and repair damage as needed.</li> <li>• Missing trim should be replaced by a qualified contractor.</li> </ul> |

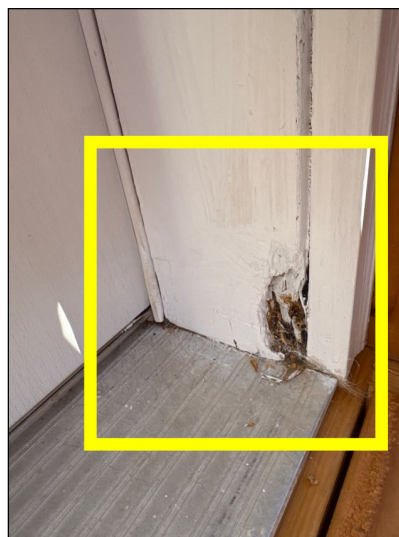
Moisture damage, wood rot, observed.

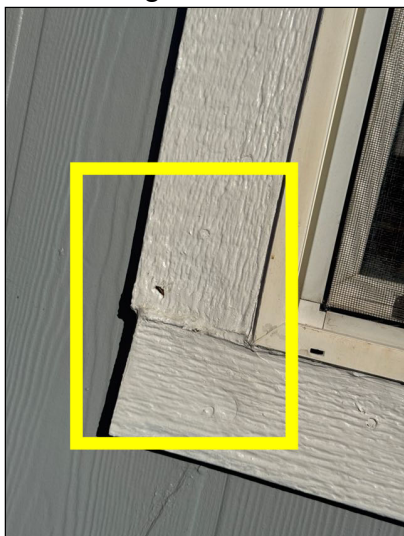
Moisture damage, wood rot, observed.

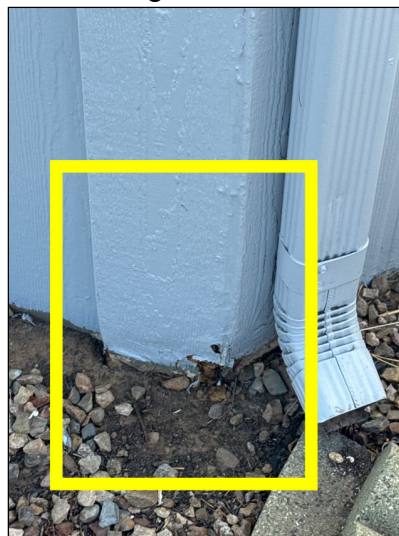
Moisture damage, wood rot, observed.

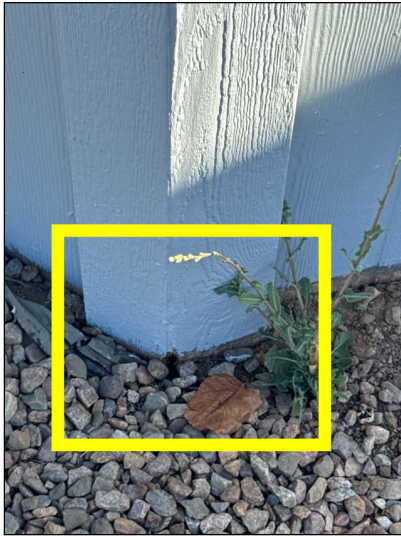
Moisture damage, wood rot, observed.

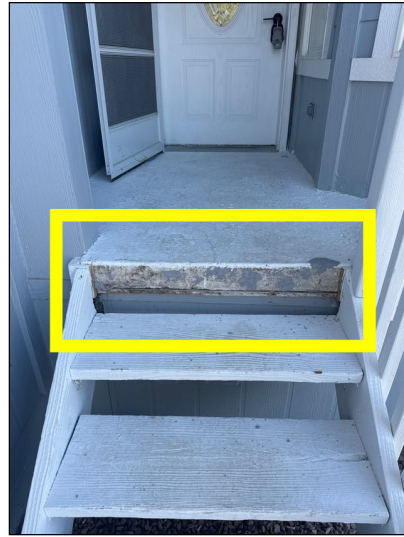
Missing trim should be replaced by a qualified contractor.

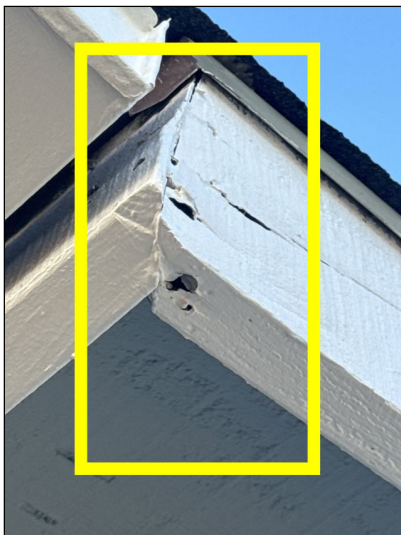
Moisture damage, wood rot, observed.

| Roof | | | |
|---|---|---|---|
| | Page 18 Item: 3 | Soffits & Fascia | Moisture damage, wood rot, observed. Refer to pest report for further details and repair damage as needed. |

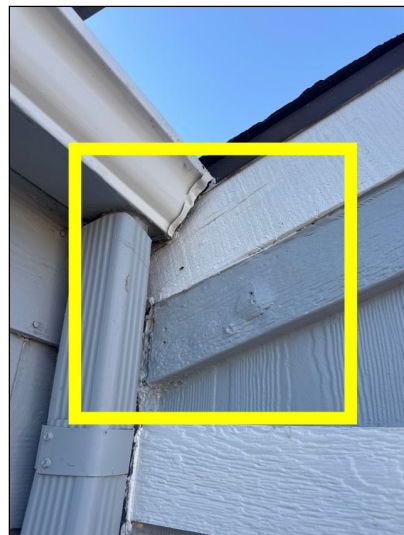
Moisture damage, wood rot, observed.

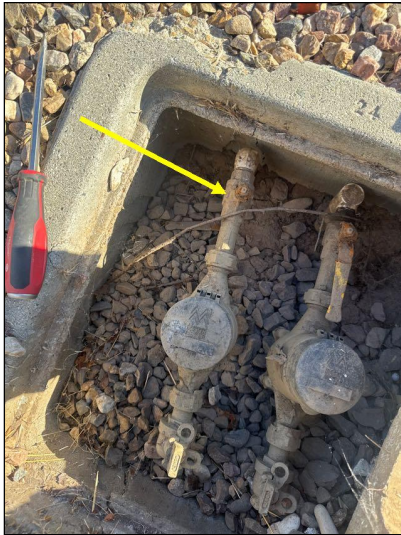
The main water supply shut-off valve had a broken handle.

| Roof | | | |
|---|---|---|---|
| | Page 22 Item: 2 | Main water shut off valve | The main water supply shut-off valve had a broken handle. The Inspector recommends evaluation by a qualified plumbing contractor. |

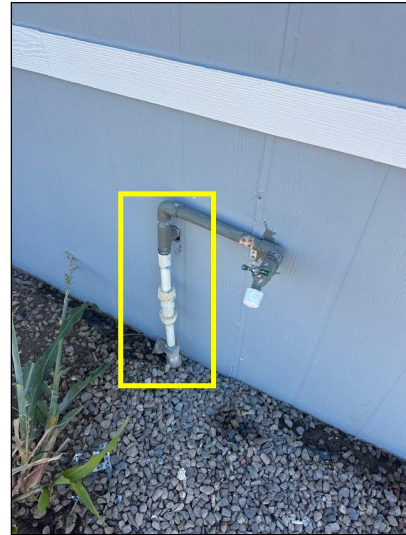
**Safety Improvement:** Consider having a more accessible main water supply shut-off valve installed by a qualified plumbing contractor for use during an emergency.

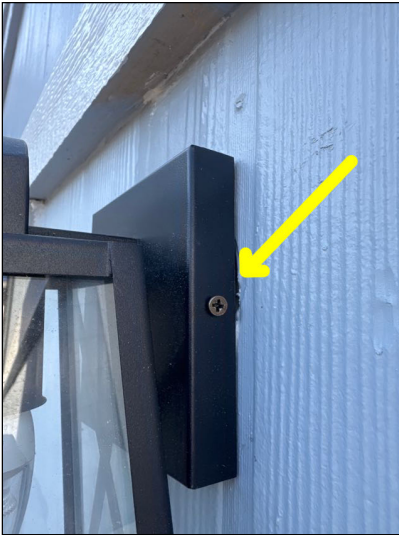
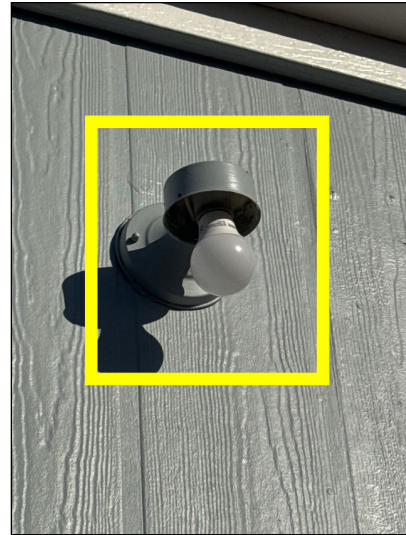
Exterior lighting was installed in a manner that left energized electrical components exposed to moisture intrusion.

**Maintenance:** A light fixture was missing the globe cover leaving the light bulb exposed.

| | Page 25 Item: 7 | Exterior Lighting | Exterior lighting was installed in a manner that left energized electrical components exposed to moisture intrusion. This condition will deteriorate electrical connections and is a potential fire hazard. The inspector recommends correction by a qualified electrical contractor. |

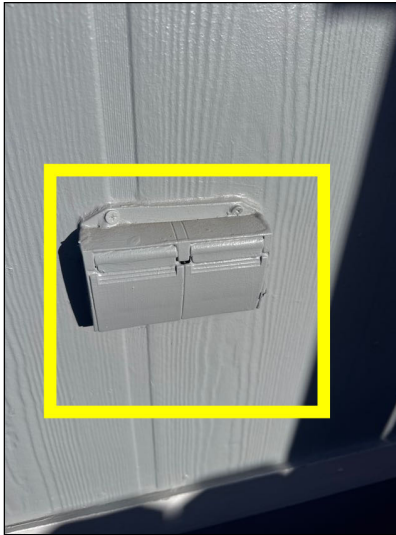
The exterior electrical receptacle was painted shut.

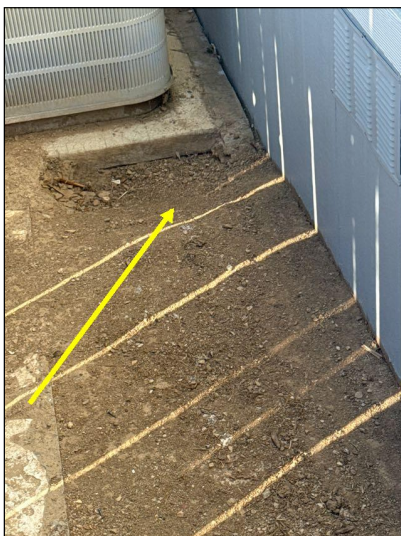
The home had areas of neutral or negative drainage that will route runoff from precipitation toward the foundation.

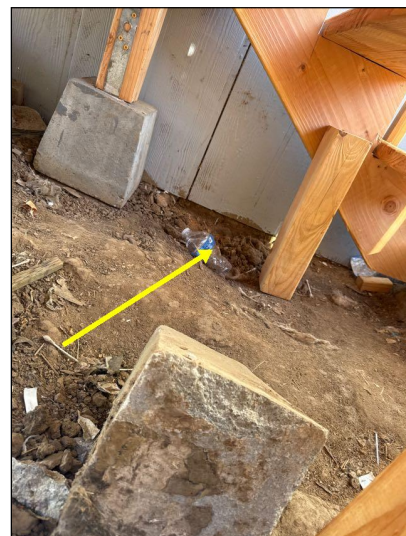
The home had areas of neutral or negative drainage that will route runoff from precipitation toward the foundation.

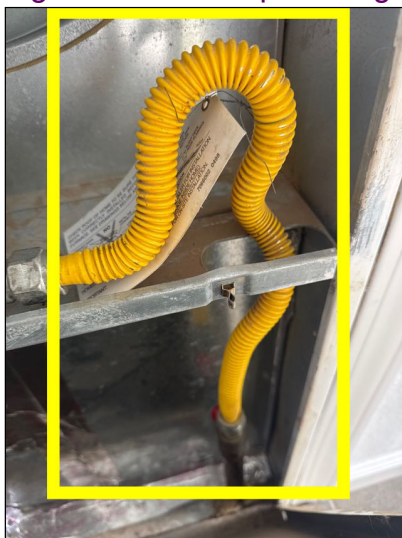
**Improvement:** The gas supply pipe contained no sediment trap.

**Recommended Improvement:** The gas supply pipe contained no sediment trap. A sediment trap is generally recommended but not always required, depending on the local Authority Having Jurisdiction (AHJ). The purpose of a sediment trap is to prevent sediment or debris particulates from entering and clogging the heaters gas valve, which can cause the heater to shut down. You may wish to consult with local contractor concerning the advisability of installing a sediment trap in the gas line.

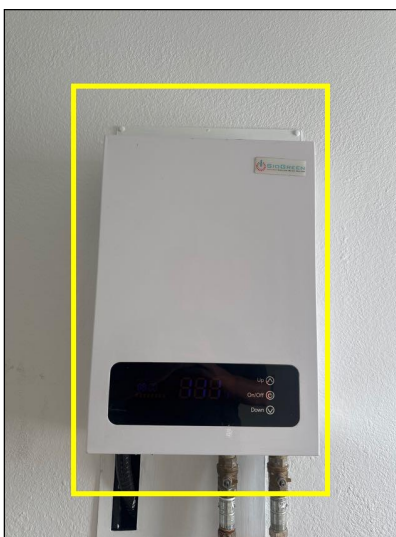
The data plate for this water heater was not accessible.

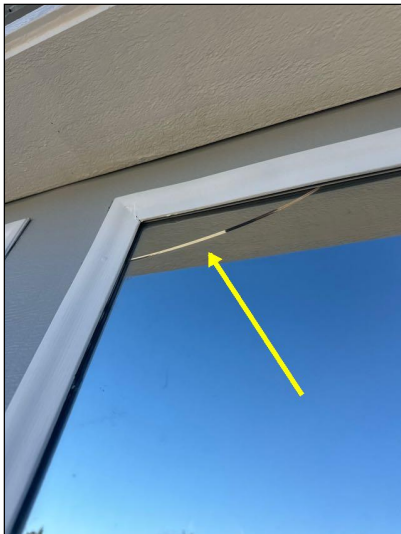
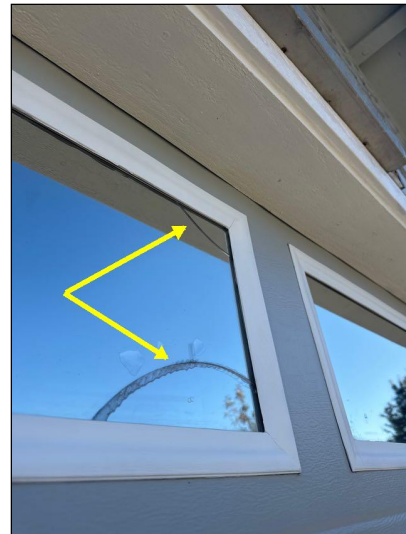
- A garage vehicle door panel glass was cracked. Before the expiration of your inspection objection deadline, you should consult with a garage door contractor to gain an idea of options and costs for repair/replacement.

| | Page 40 Item: 1 | Garage Door Condition | • A garage vehicle door panel glass was cracked. Before the expiration of your inspection objection deadline, you should consult with a garage door contractor to gain an idea of options and costs for repair/replacement. |

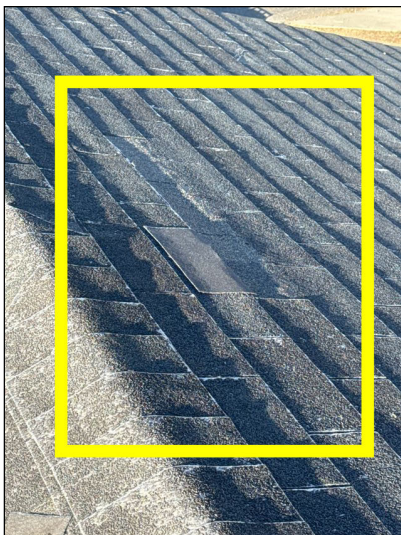
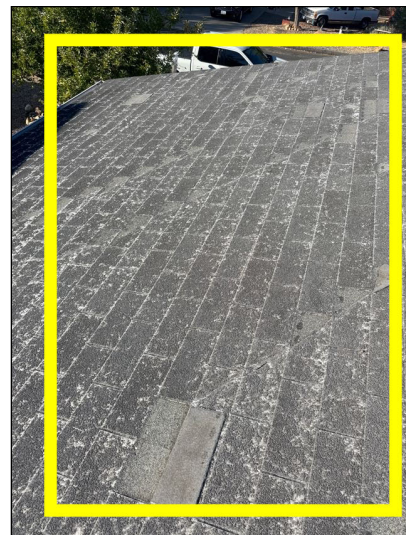
The roof had loose and/or missing shingles. The Inspector recommends replacement of any loose or missing shingles by a qualified roofing contractor to avoid damage from moisture intrusion.

| | Page 43 Item: 14 | Garage Roof | <p>Asphalt shingles covering the roof of this garage were old, exhibited severe general deterioration and may need to be replaced soon. The Inspector recommends that before the expiration of your Inspection Objection Deadline you consult with a qualified roofing contractor to gain an idea of options and costs for replacement.</p> <p>The roof had loose and/or missing shingles. The Inspector recommends replacement of any loose or missing shingles by a qualified roofing contractor to avoid damage from moisture intrusion.</p> |

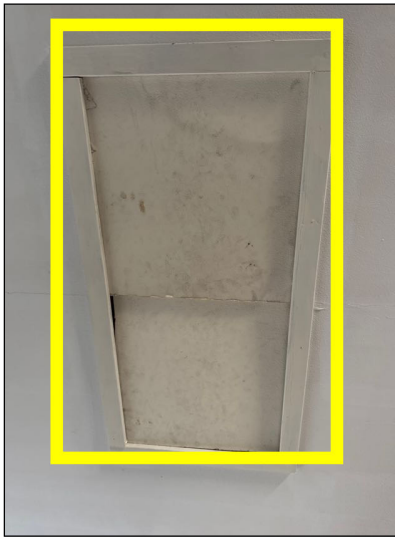
**Monitor:** The attic hatch was damaged prior to the inspectors' entry into the attic space. The Inspector recommends any necessary repairs to the attic hatch be performed by a qualified contractor.

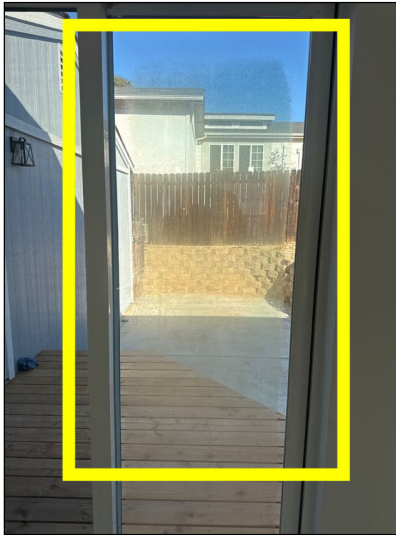
The sliding glass door in the Living Room had double-pane glazing in which condensation was visible at the time of the inspection. This is an indication that the door has lost its thermal integrity. In some situations repair is possible, however if irreparable damage has occurred (glass has been etched), the door will need replacement. The Inspector recommends that before the expiration of your Inspection Objection Deadline you consult with a qualified contractor to discuss options and costs for repair or replacement.

| Interior Areas | | | |
|---|---|---|---|
| | Page 48 Item: 5 | Patio Doors | The sliding glass door in the Living Room had double-pane glazing in which condensation was visible at the time of the inspection. This is an indication that the door has lost its thermal integrity. In some situations repair is possible, however if irreparable damage has occurred (glass has been etched), the door will need replacement. The Inspector recommends that before the expiration of your Inspection Objection Deadline you consult with a qualified contractor to discuss options and costs for repair or replacement. |

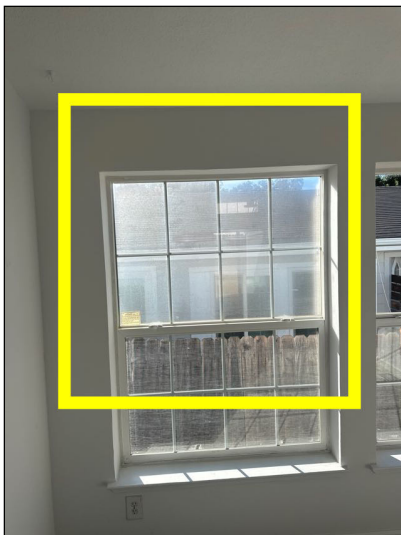
Staining and etching of the glass at the window indicated a loss of thermal integrity.

| Interior Areas | | | |
|---|---|---|---|
| | Page 49 Item: 7 | Window Condition | <p>Although no condensation was visible at the time of the inspection, staining and etching of the glass at a window in the Living Room indicated a loss of thermal integrity. Etching of the glass from long-term exposure to condensation constitutes permanent damage. The Inspector recommends that before the expiration of your Inspection Objection Deadline you consult with a qualified contractor to discuss options and costs for replacement.</p> <p>The lower sash of a single-hung window in the Living Room would not stay up when lifted and released, and fell with enough force to cause significant injury. The Inspector recommends repair or replacement by a qualified contractor.</p> <p>The sash bar has dropped out of place on a single-hung window in the Dining Room. This could affect the ability for the window stay up when lifted and released and or make the window non-functioning. The Inspector recommends repair or replacement by a qualified contractor.</p> |

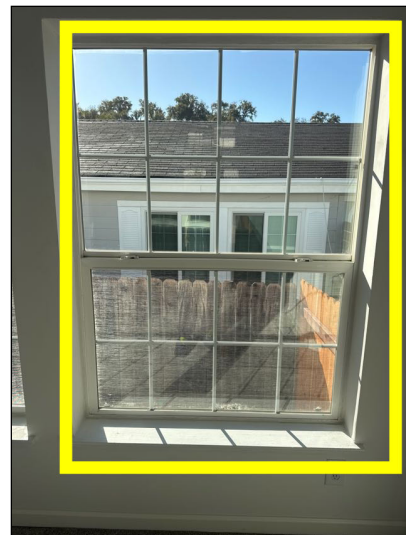
The lower sash of a single-hung window in the Living Room would not stay up when lifted and released, and fell with enough force to cause significant injury.

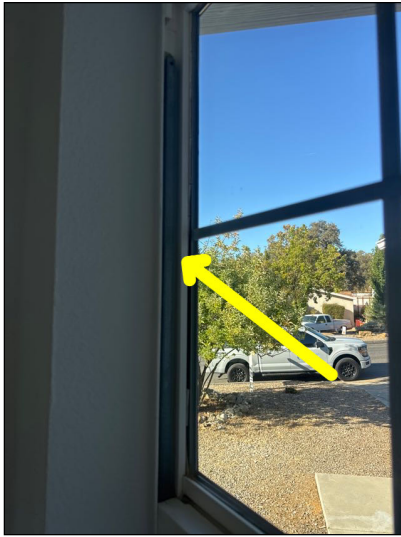
The sash bar has dropped out of place on a single-hung window in the Dining Room. This could affect the ability for the window stay up when lifted and released and or make the window non-functioning. The Inspector recommends repair or replacement by a qualified contractor.

The sash bar has dropped out of place on a single-hung window

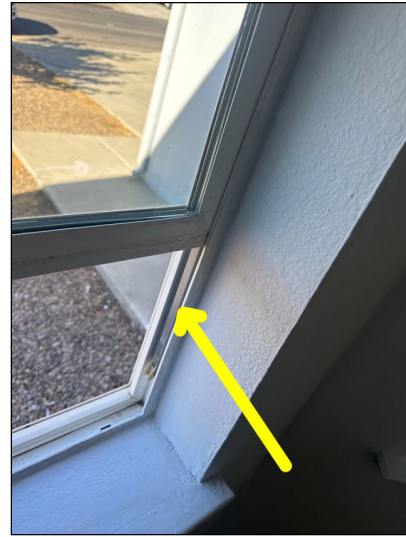
The sash bar has dropped out of place on a single-hung window

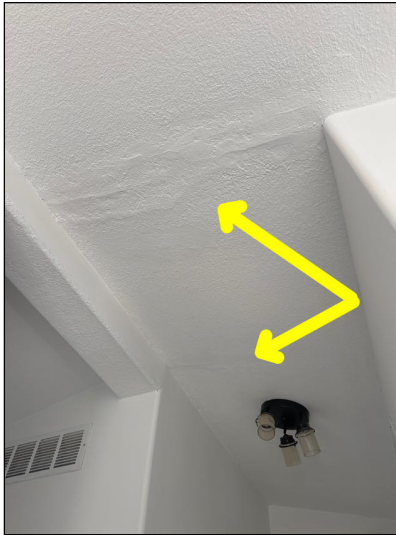
**Monitor:** Normal settlement cracking was visible in interior ceiling of the home at the time of the inspection.

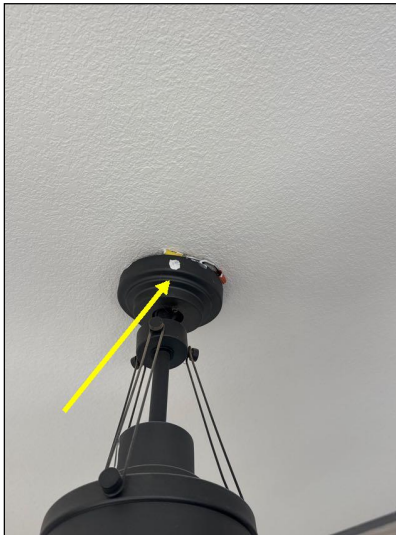
- **Monitor:** The ceiling fan shroud was loose. The Inspector recommends that shroud is properly installed to protect the wires.

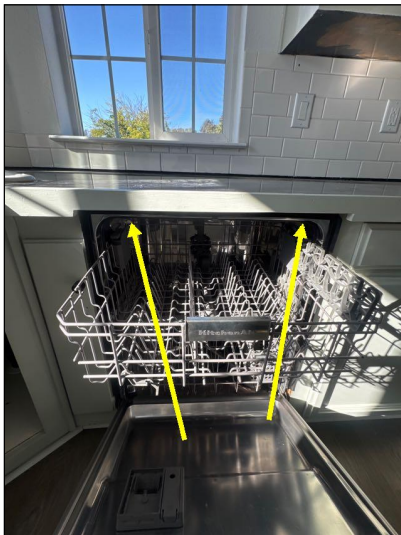
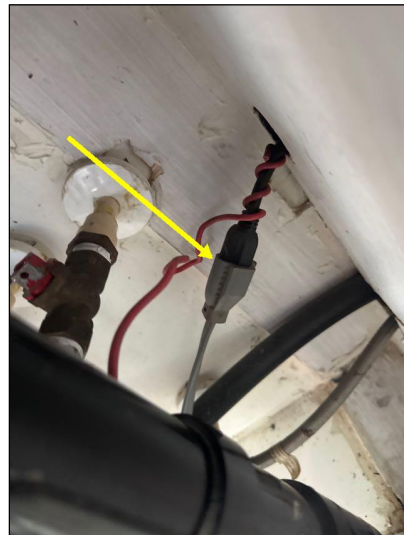
- The dishwasher drain line is kinked. The inspector recommends repair by a qualified contractor.

| | Page 54 Item: 8 | Dishwasher | <ul style="list-style-type: none"> <li>• Dishwasher installation was incomplete (tilts forward when opened), not secured by mounting bracket. The Inspector recommends completion of the installation by a qualified plumbing contractor or technician.</li> <li>• Extension cord used as permanent wiring was visible for the dishwasher. This condition is a potential fire hazard. The Inspector recommends that any such wiring be removed and replaced with properly-installed, approved wiring by a qualified contractor.</li> <li>• The dishwasher drain line is kinked. The inspector recommends repair by a qualified contractor.</li> </ul> |

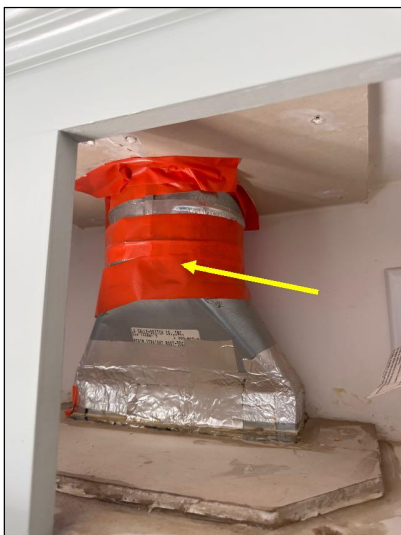
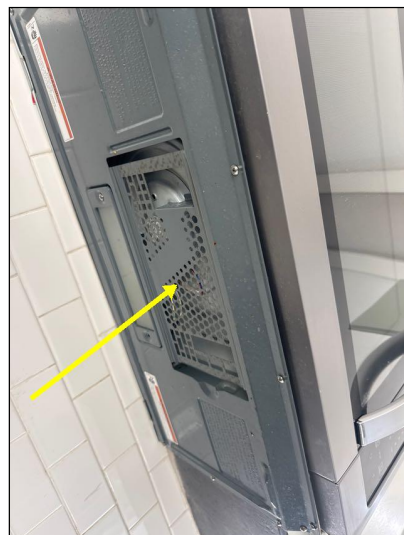
- At the time of the inspection, the Inspector observed no deficiencies in the condition and operation of the range hood exhaust fan and lights.
- **Safety:** Improper cloth backed duct tape utilized on the vent duct connections in the cabinet above the vent hood is considered a fire hazard. Recommend proper metallic foil tape utilized to re-attach the ducting.
- **Safety:** Any range hood is missing the grease screen. The Inspector recommends that before the expiration of your Inspection Objection Deadline you consult with a qualified contractor to discuss options and costs for repair or replacement.

| | Page 55 Item: 10 | Vent Condition | <ul style="list-style-type: none"> <li>• <b>Safety:</b> Improper cloth backed duct tape utilized on the vent duct connections in the cabinet above the vent hood is considered a fire hazard. Recommend proper metallic foil tape utilized to re-attach the ducting.</li> <li>• <b>Safety:</b> Any range hood is missing the grease screen. The Inspector recommends that before the expiration of your Inspection Objection Deadline you consult with a qualified contractor to discuss options and costs for repair or replacement.</li> </ul> |

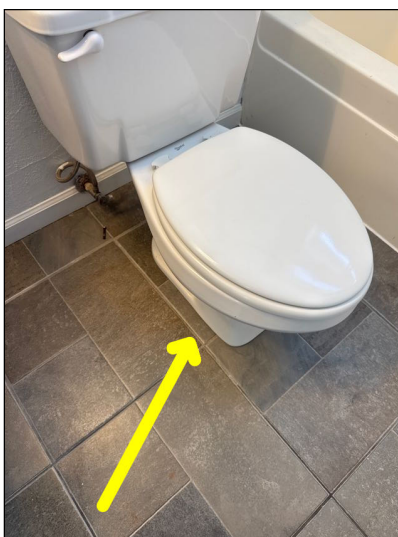
In this bathroom, the toilet was loose at the floor and should be re-attached by a qualified plumbing contractor.

| | Page 64 Item: 3 | Toilets | In this bathroom, the toilet was loose at the floor and should be re-attached by a qualified plumbing contractor. |

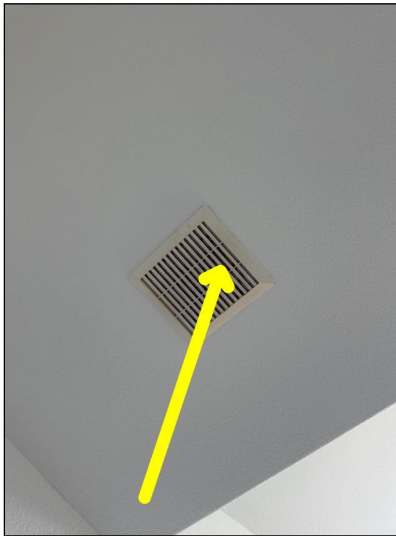
- The bathroom exhaust fan did not operate at the time of the inspection. Recommend review for repair or replacement as necessary.

| | Page 67 Item: 10 | Exhaust Fan | <ul style="list-style-type: none"> <li>• The bathroom exhaust fan did not operate at the time of the inspection. Recommend review for repair or replacement as necessary.</li> </ul> |
