## Inspection Services

### *Inspection Report*

**Address: 1000 Santa Maria Ave Los Osos, CA 93402**

**04/16/2026**

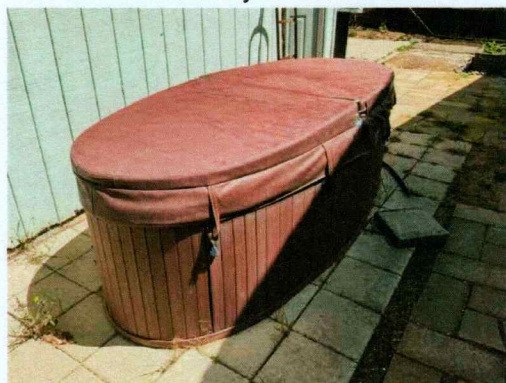
**SU 10: Spa -** *The locking cover on the spa should be locked at all times when not in use. An unlocked spa cover is considered a safety hazard.*

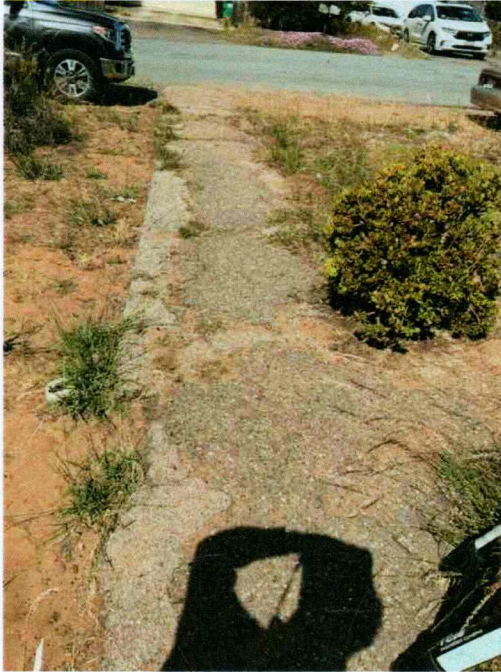
**SU 12:** Areas of the walkways are uneven with potential trip hazards.

**MR UPG 13:** Recommend repairs at the asphalt sidewalk.

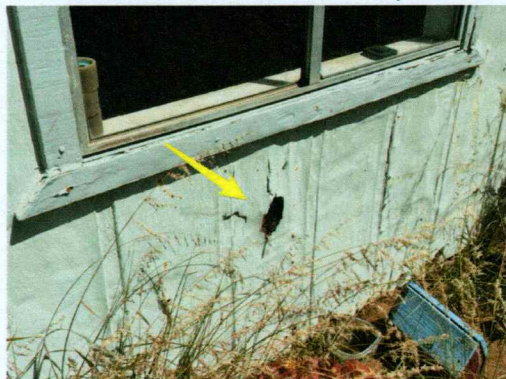
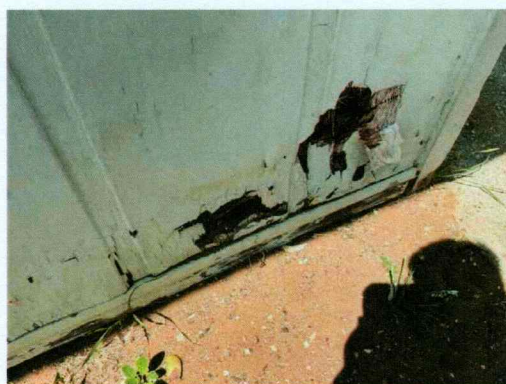
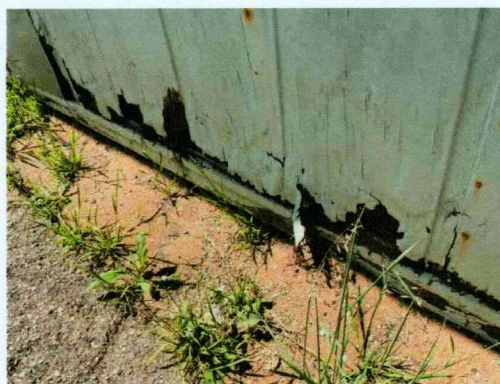
**E&C 20:** Some moisture and/or bug-type damage and deterioration found at areas of the exterior wood siding and/or trim. Refer to the termite report for additional comments, recommendations, locations and extent.

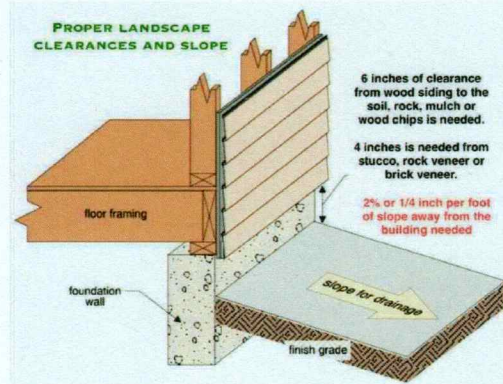
**MR 30:** Soil level found high along areas of the perimeter of the foundation and exterior siding (recommend 6 inches from the bottom of the exterior siding to dirt, rock, mulch or wood chips).

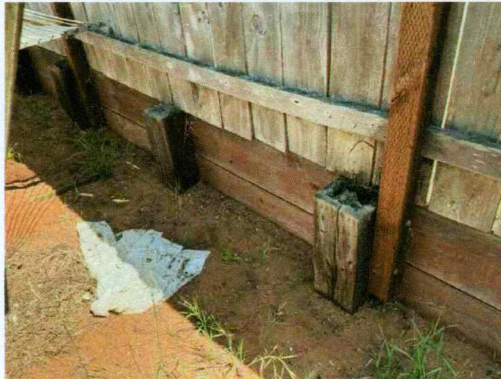
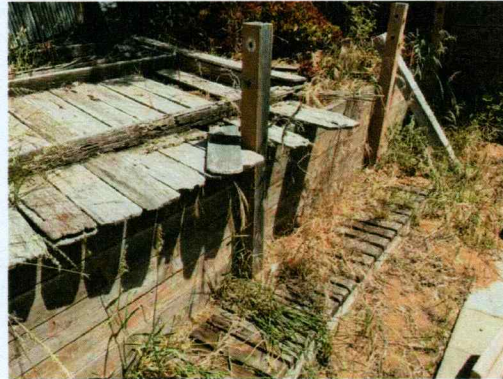
**E&C 35:** Some moisture damage, deterioration, with some leaning of the wood retaining wall(s). Sections of the wood, retaining walls appear to be nearing the end of its structural life. *Be aware that wood retaining walls have a limited lifespan and will warrant eventual replacement. Monitor, replace or repair the wood retaining walls as needed.*

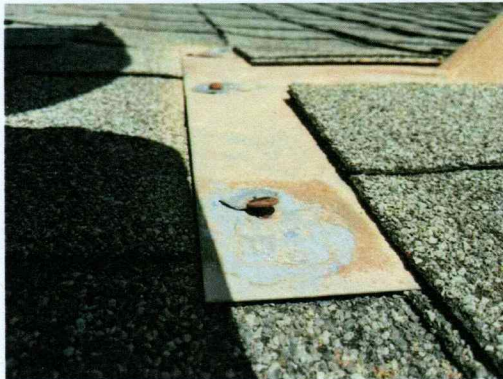
**E&C MR 45:** Exposed, Loose and Lifting nails at flashings at areas of the roof. Recommend tightening or replacing loose nails and sealing all exposed nails at areas of roof flashings.

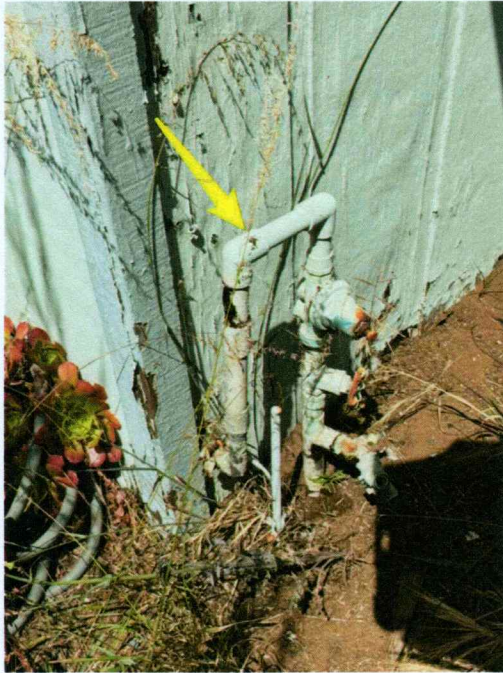
**UPG DS 60: Disclosure:** The White Plastic PVC pipe used above ground for faucet, sprinkler or supply piping is fragile, not UV rated, and can break easily. Upgrades are recommended to help prevent future damage or water leakage.

Example. Off the main water supply

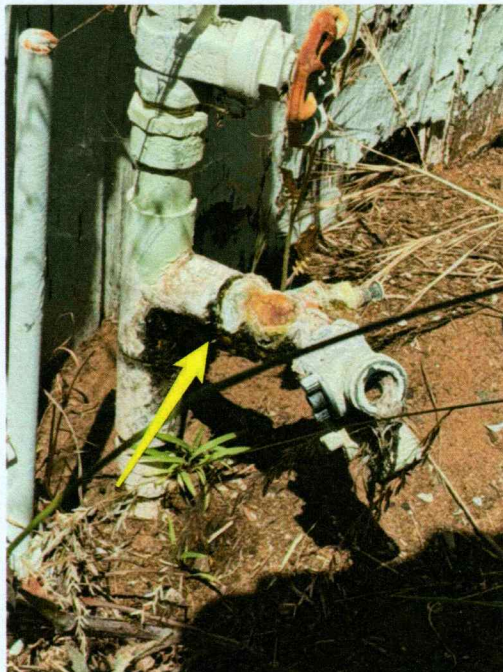
**E&C 62:** The Exterior hose faucet or supply piping is actively leaking / drips continuously AT THE HOSE FAUCET AREA ON THE MAIN WATER SUPPLY SHUT OFF LOCATION AT THE SOUTHEAST CORNER.

Active leaking and dripping

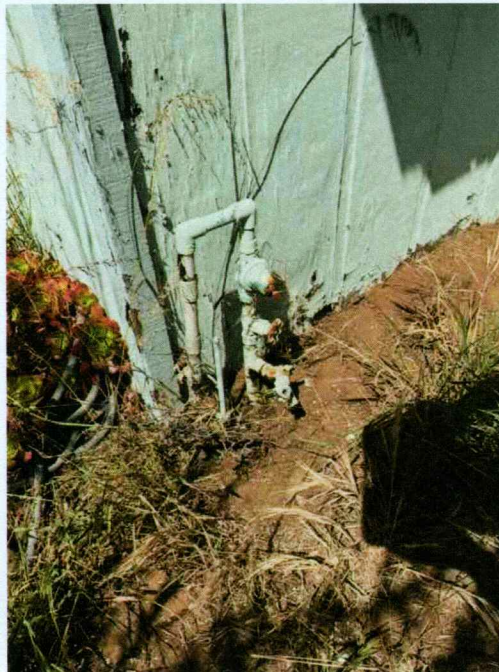
**E&C 63:** Broken or Missing handles at some exterior hose faucets.

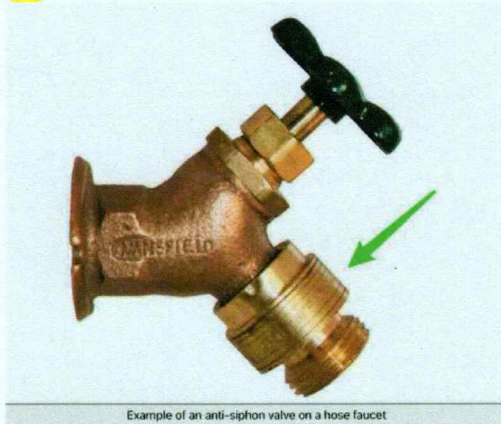
**UPG 64:** Anti-siphon valves recommended on exterior hose faucets where not installed.

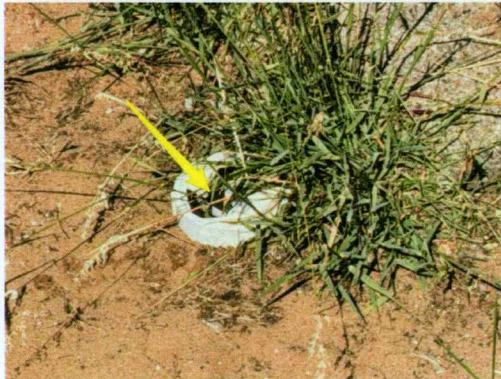
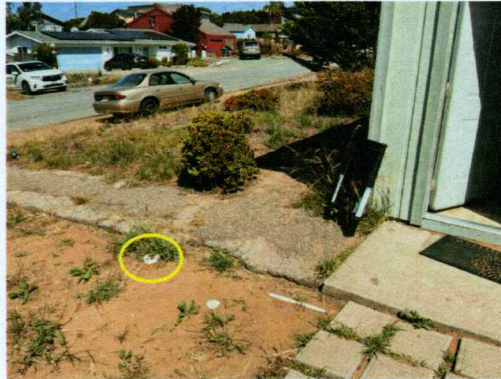
**SC 67:** Sewer clean out cat found broken on the front of the house at the southwest corner. Recommend replacement.

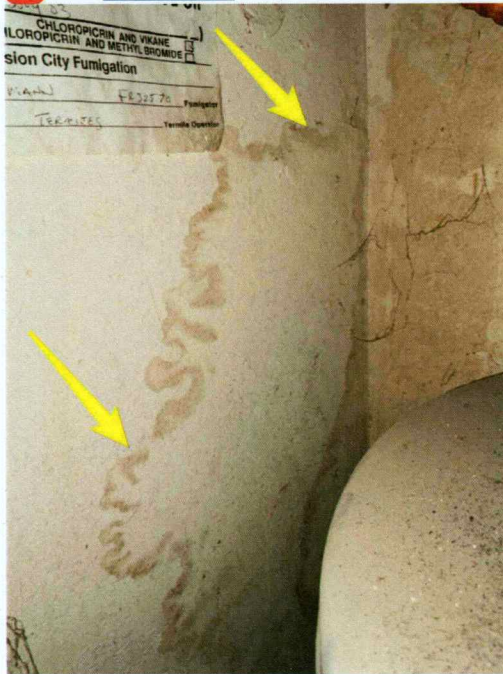
**FI** 76: **Disclosure:** Dry Moisture stains noted at areas around the water heater at the platform and/or enclosure.

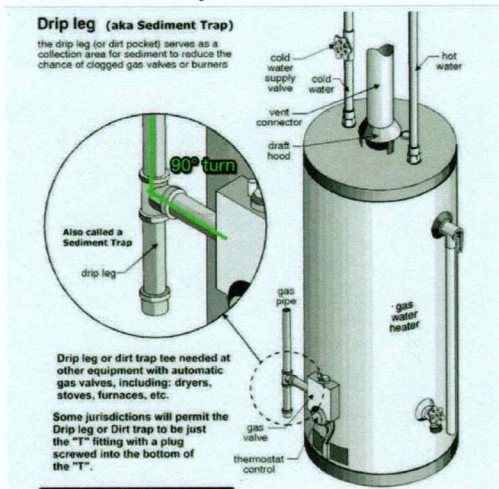
**SU 78:** Recommend the installation of the missing sediment trap / drip leg at the WATER HEATER gas piping at flex connection by a certified or licensed plumbing professional familiar with minimum requirements. [CPC 1212.8]

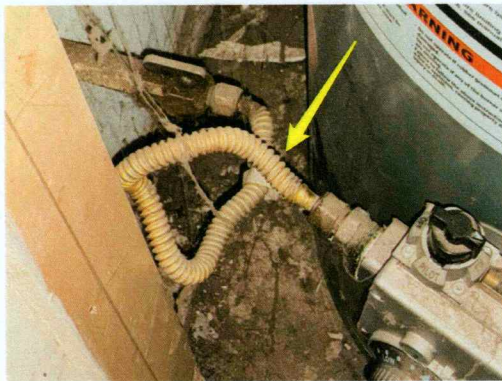
**SC 79:** The GAS CO. has determined that an uncoated brass gas flex connector needs to be replaced for safety at the: WATER HEATER. Replacement needed for safety.

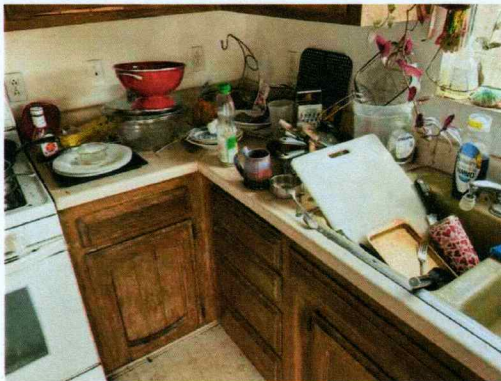
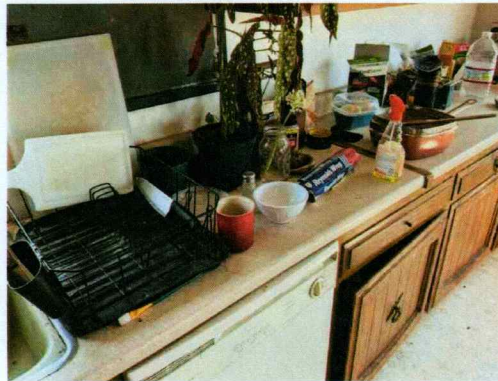
**DS 94: Disclosure:** The areas behind and under the kitchen cabinetry, refrigerator, dishwasher, occupants storage and ovens are not accessible, not visible and not inspected.

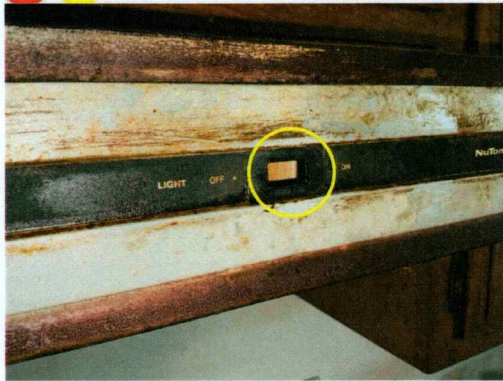
**E&C MR 100:** Kitchen cook top exhaust hood light non-operational / damaged missing switch.

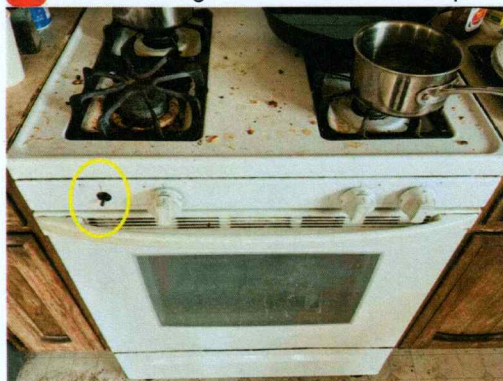
**E&C 101:** Missing a knob at the cook top.

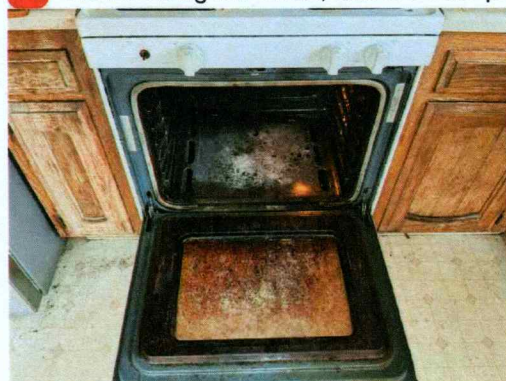
**E&C 105:** Missing the racks, and the floor panel found loose and partially disassembled inside the oven.

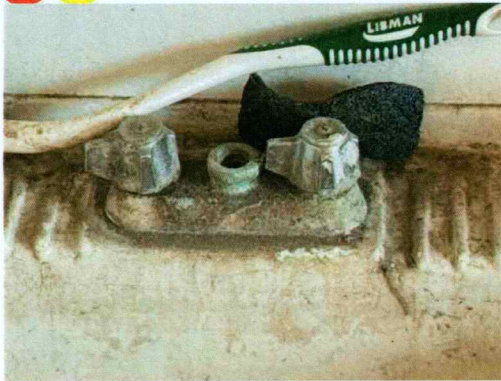
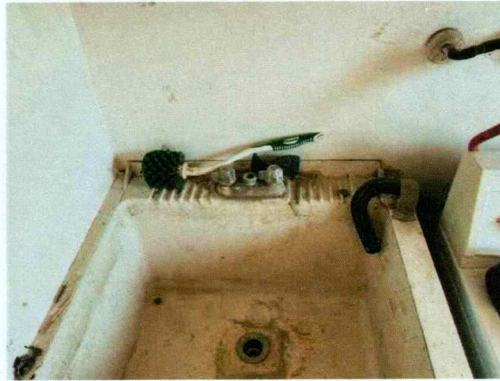
**E&C MR 117:** The laundry sink faucet found damaged, not usable.

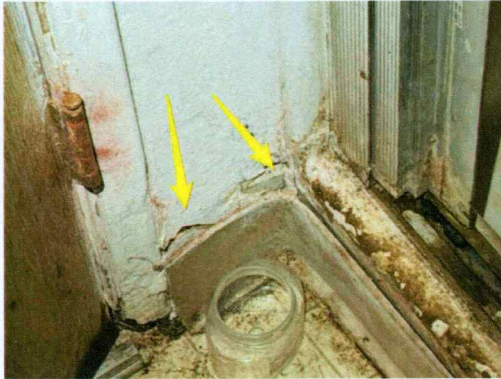
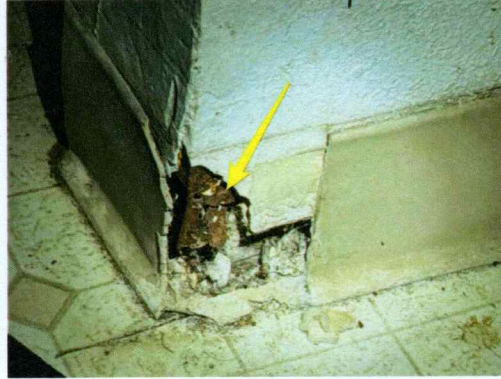
**FI** 126: Moisture stains & damage to walls, baseboards and/or floor outside shower: HALLWAY / LAUNDRY BATHROOM

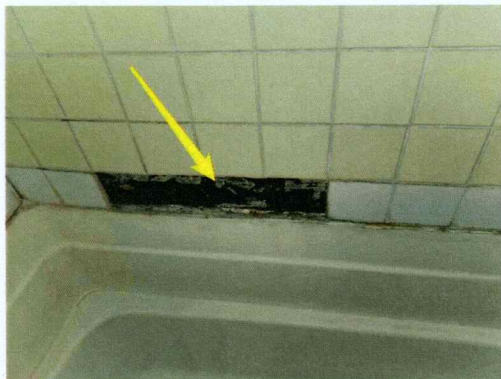
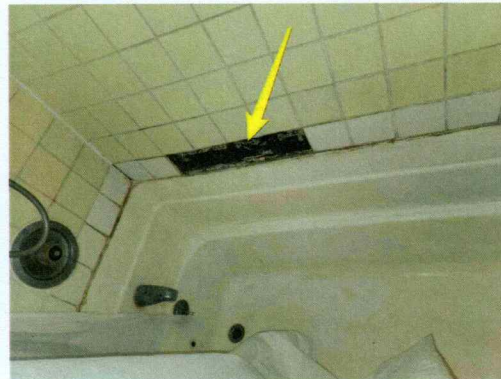
**FI** 127: Some damaged loose missing tiles found at area PRIMARY BEDROOM BATHROOM SHOWER ENCLOSURE

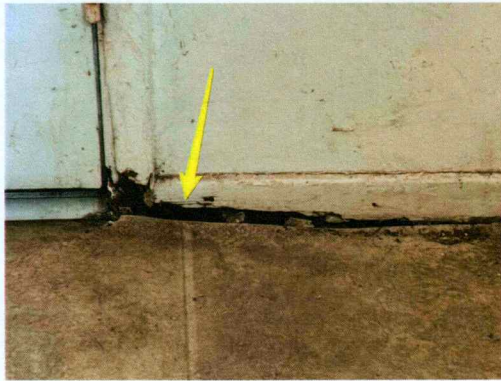
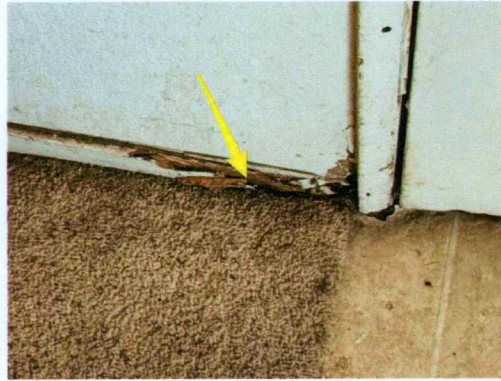
**FI 132:** Evidence of some past or current water intrusion from around the FRONT ENTRY DOOR with water stains and/or damage on the interior.

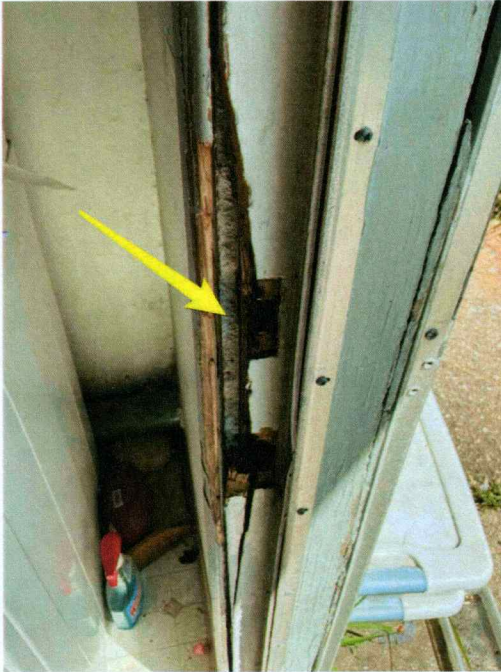
**E&C 134:** Moisture AND Physical damage at exterior wood door: HALLWAY / LAUNDRY BATHROOM. Door no longer latches due to damaged door frame

Damaged door frame

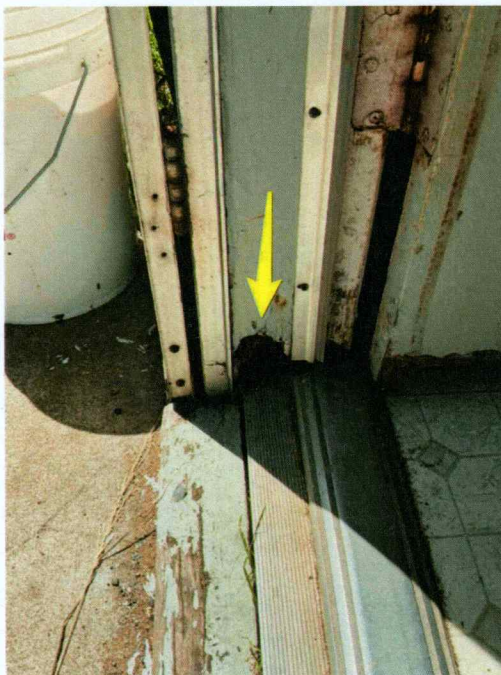
Damaged door jam

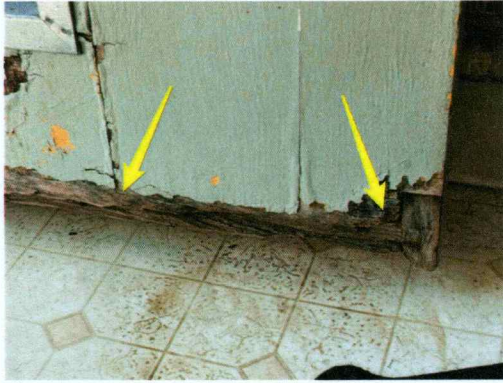
Damaged wood door

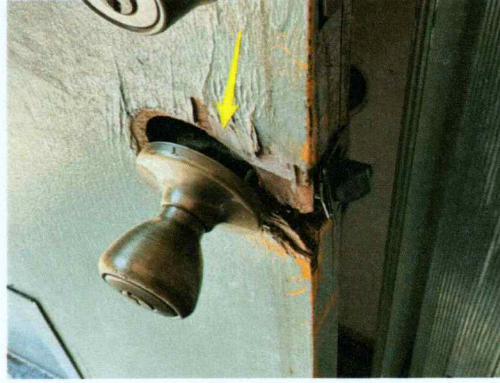
Damaged door knob

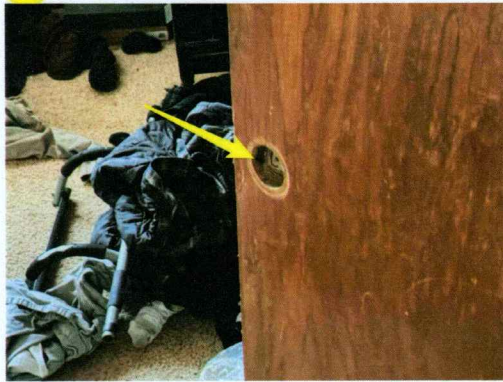
**MR** 138: Interior door knob found missing at: BEDROOM-1

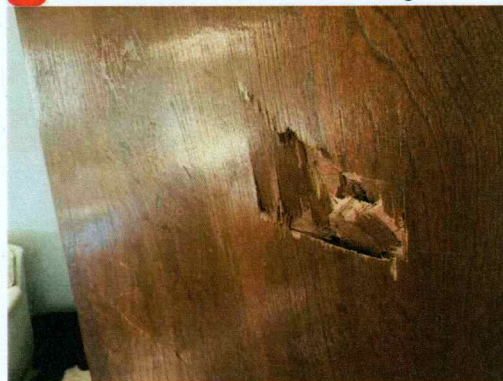
**E&C** 139: Interior door found damaged: BEDROOM-1

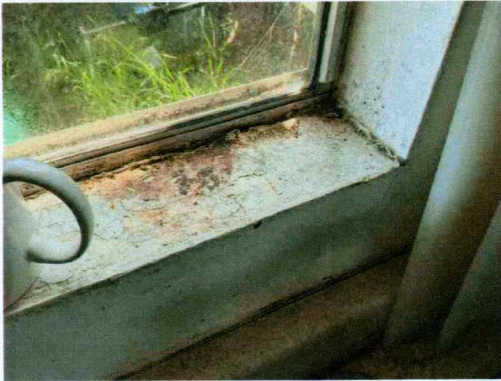
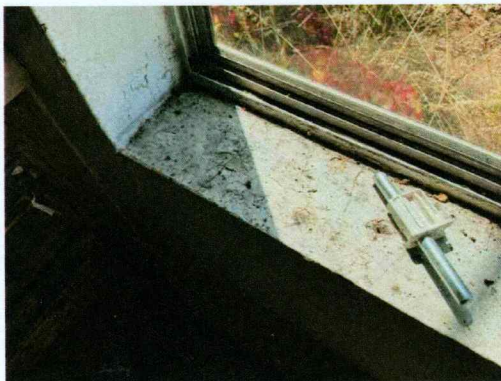
**FI 144:** Moisture stains and/or damage on the inside at some window sills. Refer to the termite report for additional comments and recommendations.

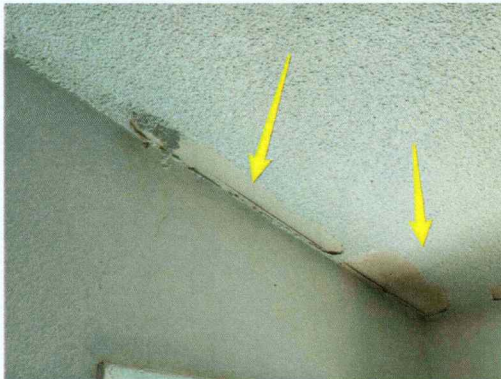
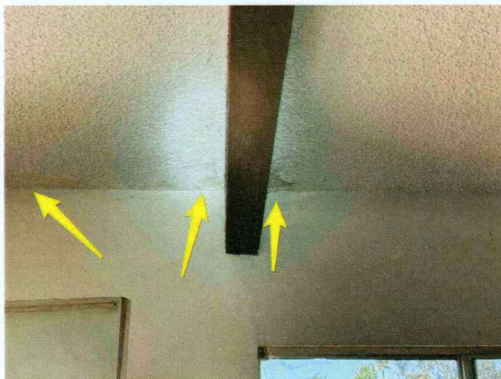
**FI 156:** Evidence of past moisture stains & damage at ceiling area in the ABOVE THE FRONT ENTRY DOOR. Recommend further review of the water stains to determine the cause, the current condition and if repairs are needed.

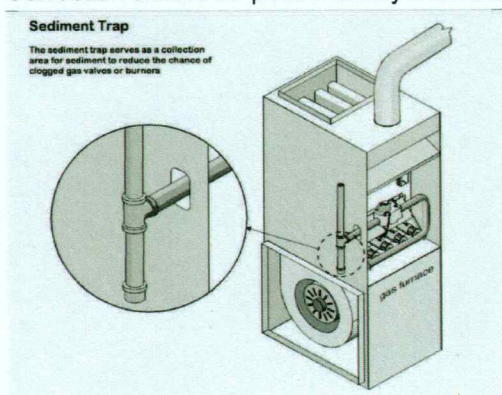
**UPG** 159: Missing the required installation of the sediment trap at the furnace gas piping at flex connection. Correction should be performed by a certified or licensed HVAC professional familiar with minimum requirements.

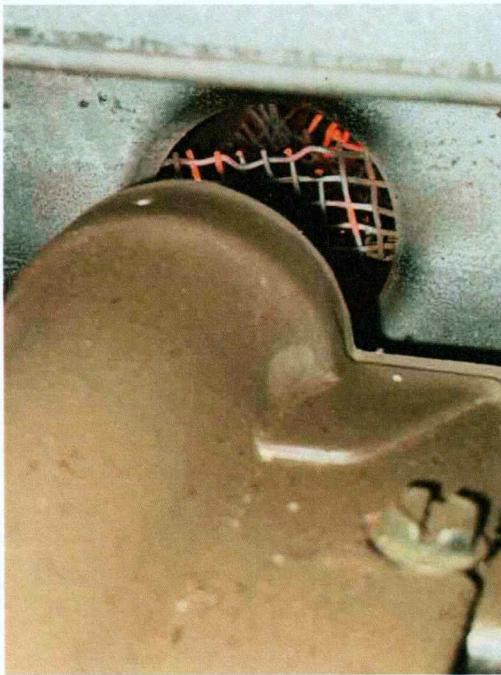
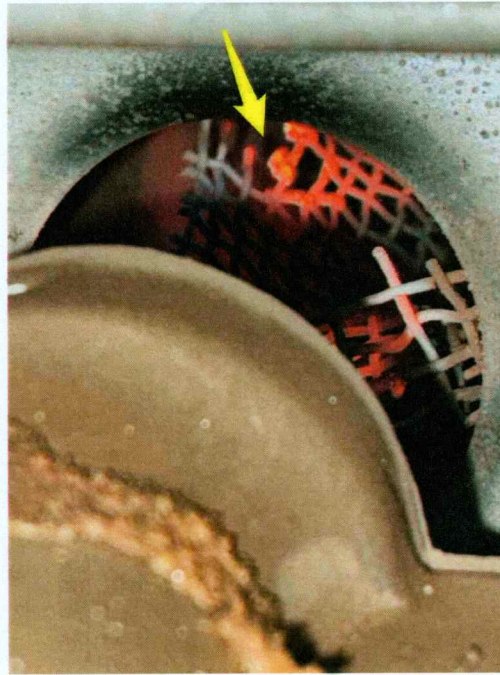
**MR 160:** Damaged or Deteriorated "NOx" SCREENS found inside the furnace burn chamber. Simple removal or replacement is recommended. Recommend further review recommendations by a qualified and licensed HVAC professional familiar with the minimum installation requirements.

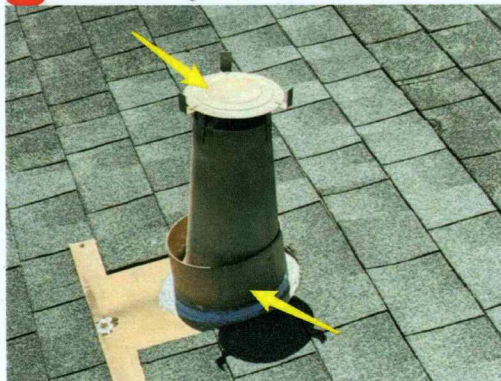
**E&C 161:** Damaged furnace vent termination cap at the roof. Recommend replacement.

Broken furnace vent cap at roof needs replacement

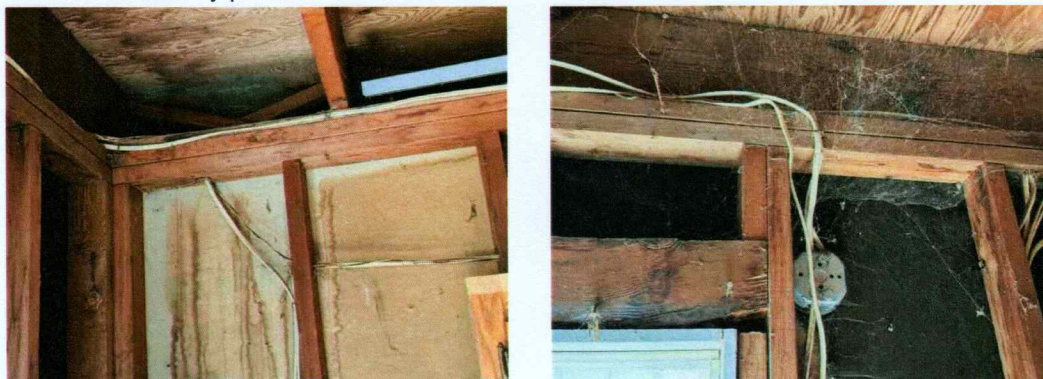
**SC 173:** Improper exposed electrical wiring, "Romex" improperly installed subject to physical damage, not in a conduit or raceway per standards: THROUGHOUT THE GARAGE

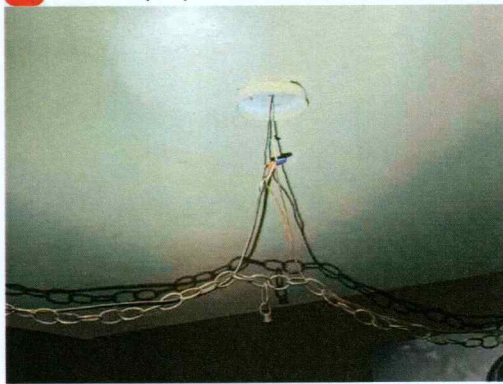
**SC 177:** Improper installation of the light fixture in the garage storage room.

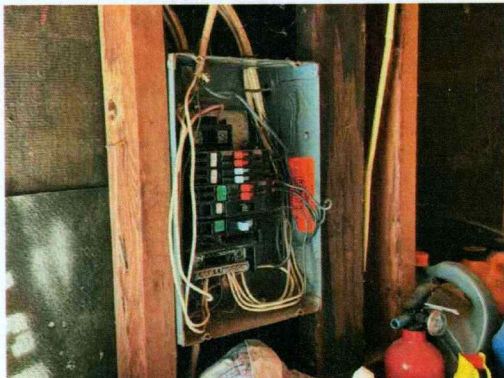
**SC 179:** Many defects found in the GARAGE ELECTRICAL SUB PANEL. Recommend further review the electrical sub panels by a qualified licensed electrical professional and correct as needed.

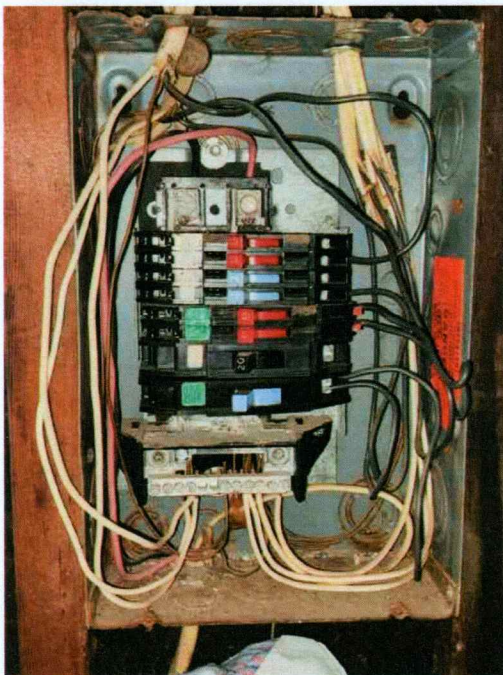
**SC 184:** Inadequate amount of service Ampacity provided for the potential load capacity for the GARAGE ELECTRICAL SUB PANEL. Currently using 30 amp wire. Recommend review and repairs by a licensed electrical contractor.

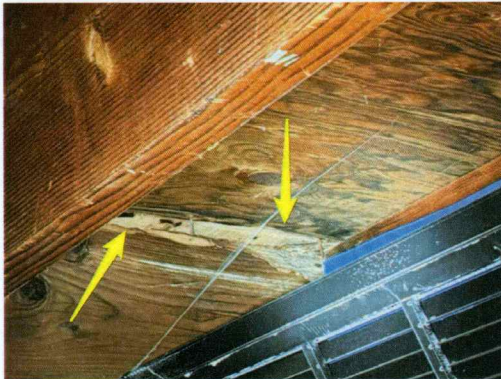
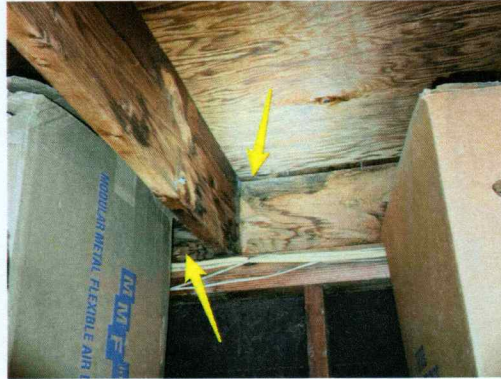
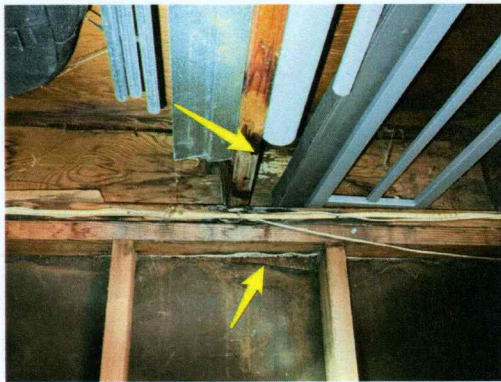
**FI 194:** Moisture stains and/or damage found on areas of the garage ceiling and walls. Recommend further review to determine cause, current condition and if repairs are needed. Areas found dry today.

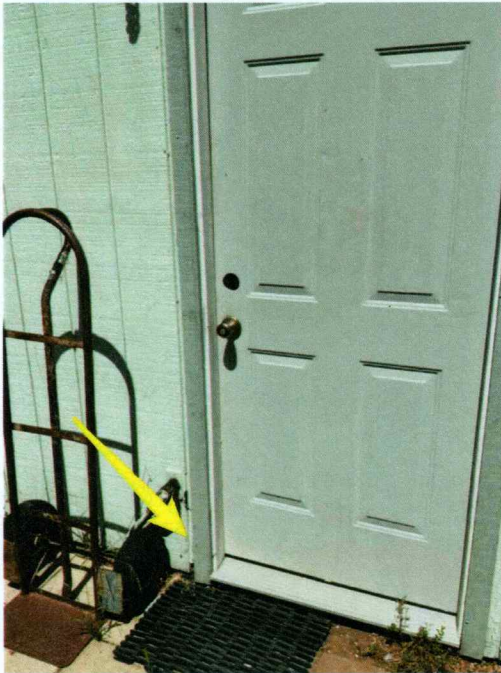
**FI 197:** The door frame and wall framing found loose around the garage pedestrian door. Suspected defect in the wall framing.

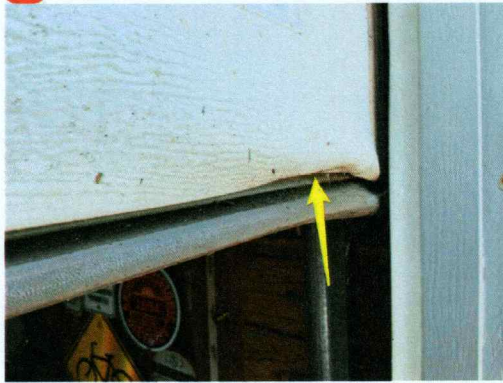
Example

**E&C 202:** Disclosure: Some dented panel(s) at garage vehicle roll-up door.

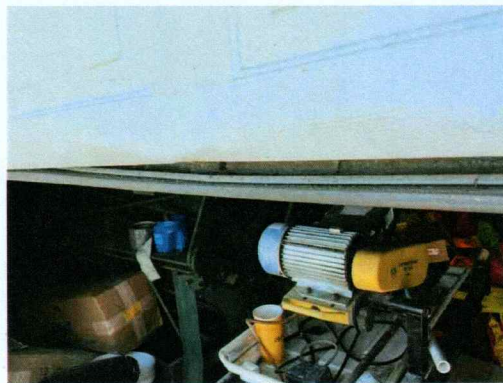
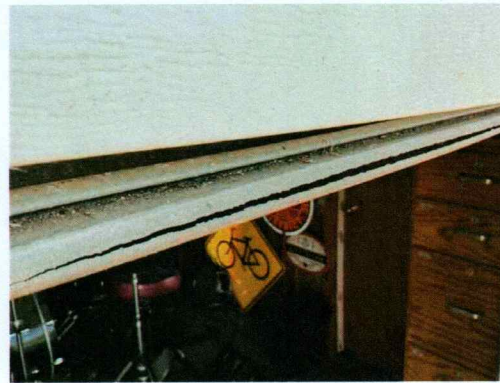
**MR 203:** Deteriorated and/or damaged weatherstripping noted at the bottom of the garage vehicle door. Upgrades or corrections recommended.
