## PROPERTY INSPECTION REPORT

1005 Alexandria Dr  
San Diego, CA 92107

10/01/2026

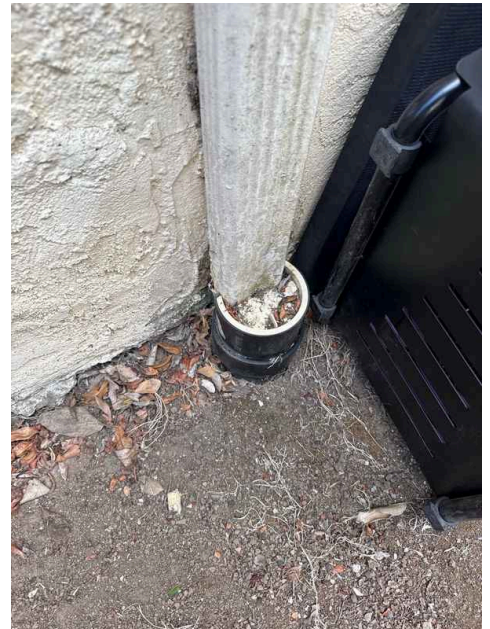
#### SURFACE DRAINS

Surface drains were noted and the inside of the drains could not be evaluated. Inquire with the seller as to the termination point(s) of the surface drains.

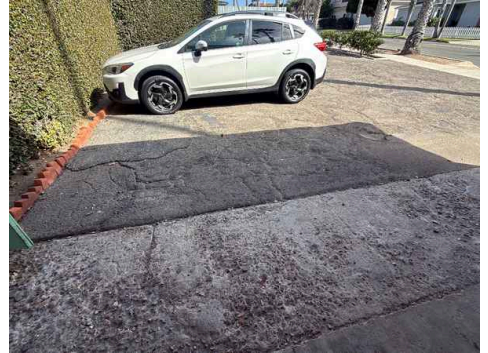
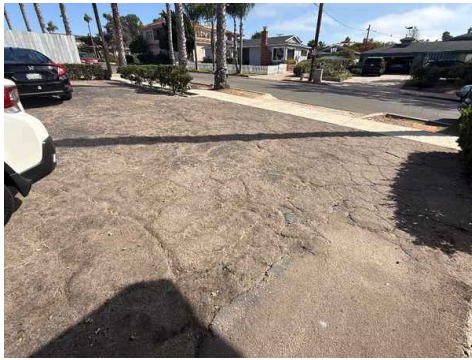
**DAMAGE / DETERIORATION - REPAIR**

Damage and or deterioration was present at one or more areas. Correction is recommended.

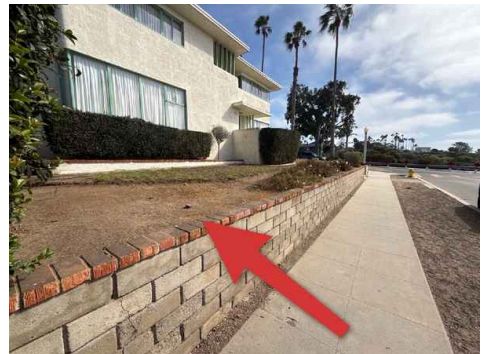
## 4.1.2 Driveways, Sidewalks, Patios

A walk off or drop off hazard was noted in one or more areas. Recommend installing guardrails for added safety. A qualified professional is recommended for further evaluation and/or repairs.

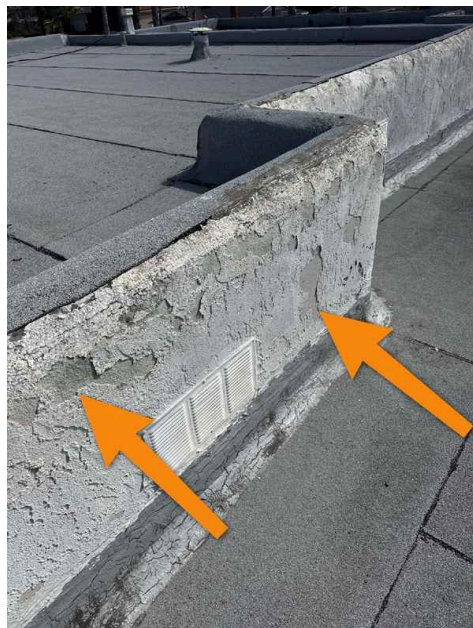
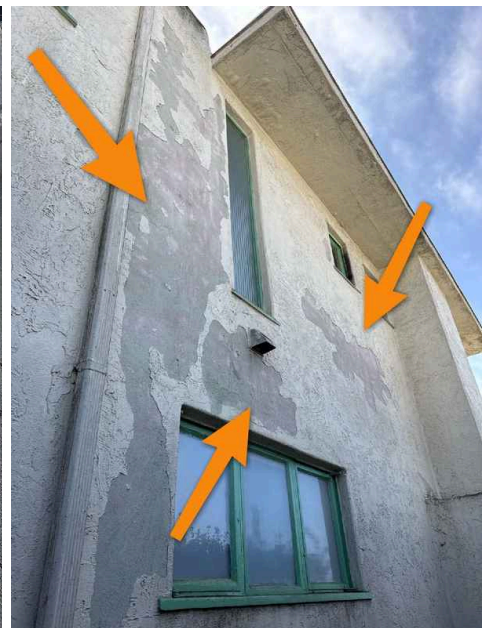
**DAMAGED STUCCO**

Damage was noted at the stucco at one or more areas. Advise further evaluation and repair by a licensed stucco contractor to help prevent moisture intrusion.

Contact a qualified professional.

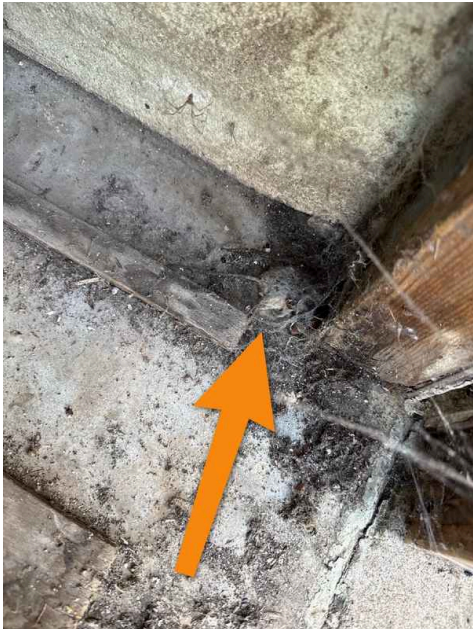
Evidence of possible rodent activity was noted on the exterior of the home in areas. We recommend further evaluation by a licensed pest control technician to determine repairs necessary at this time.

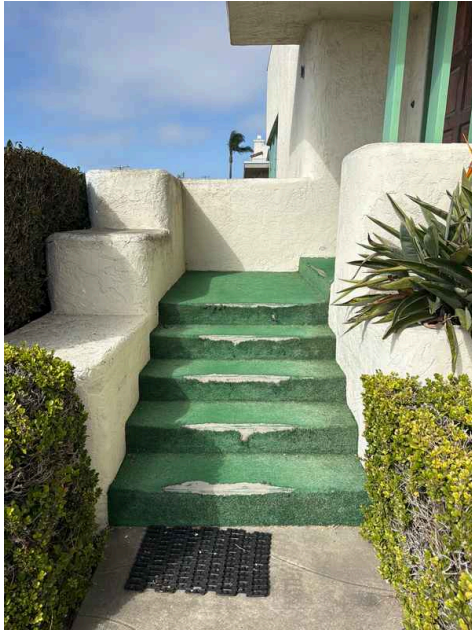
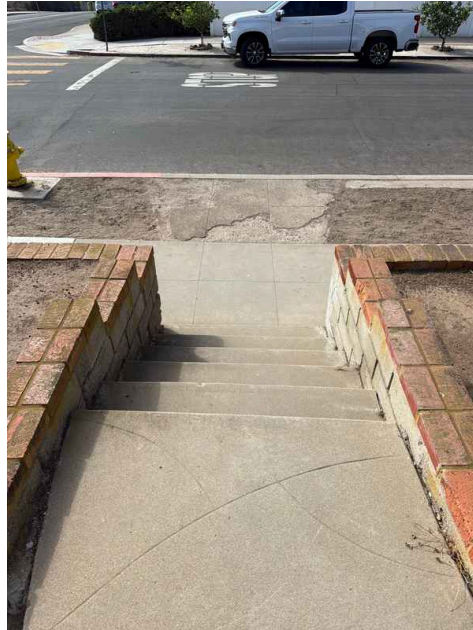
4.6.1 Decks / Balconies / Stairs

**MISSING HANDRAILS NOTED**

Handrails and/or guard rails were missing in one more areas. Corrections are recommended for improved safety.

Contact a qualified professional.

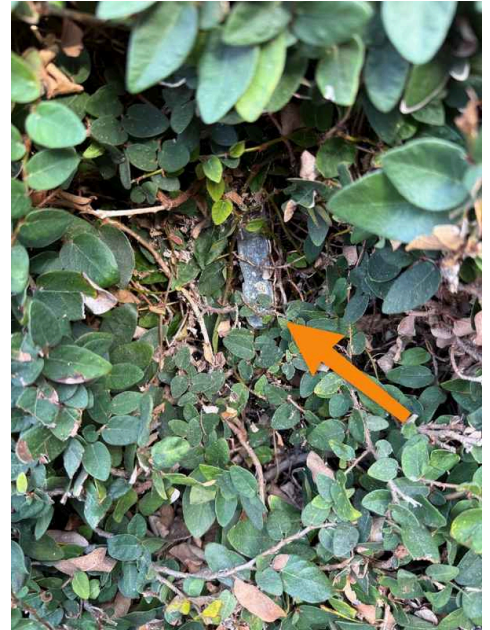
Vegetation was present around the main water shut off. We recommend clearing vegetation for proper access.

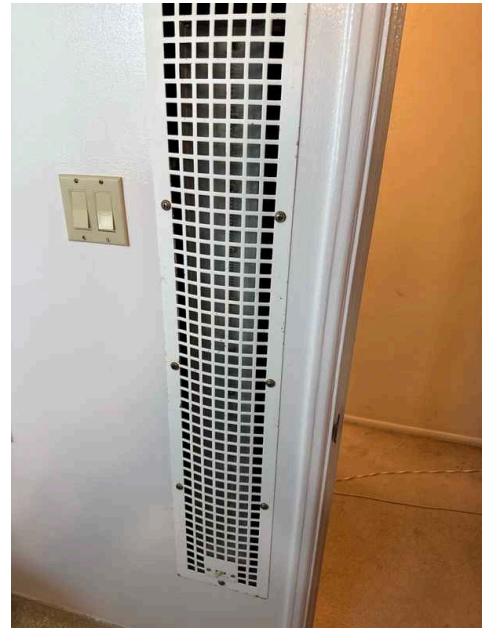
### **ELECTRIC BATHROOM HEATERS**

Electric heat wall units in close proximity of water is not a good idea. Caution is recommended when using these units.

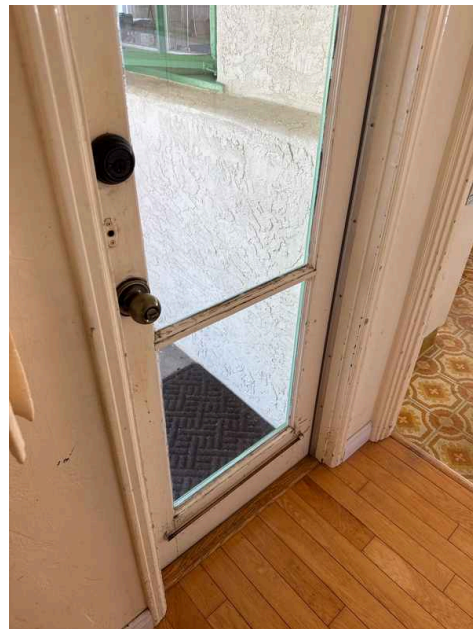
### **SINGLE PANE WINDOWS**

Single pane windows were noted at one or more doors. These windows are not energy efficient and replacement should be considered.

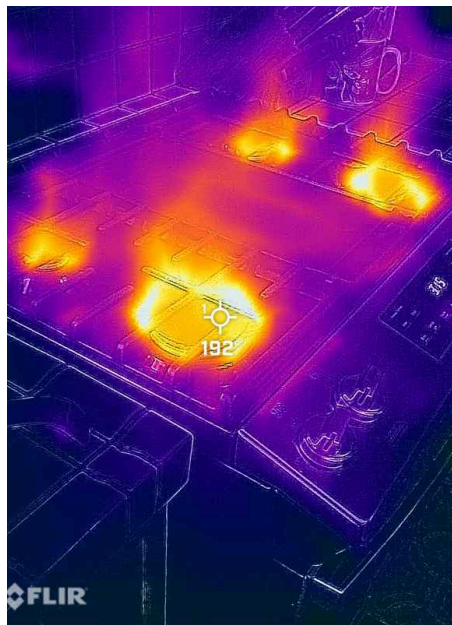
## Range/Oven/Cooktop: Thermal Image of Range Working

Infrared picture of range/cooktop in operation. This unit appeared operational.
