### *Inspection Report*

Address: 2325 Warm Springs Ln Templeton, CA 93465

10/03/2026

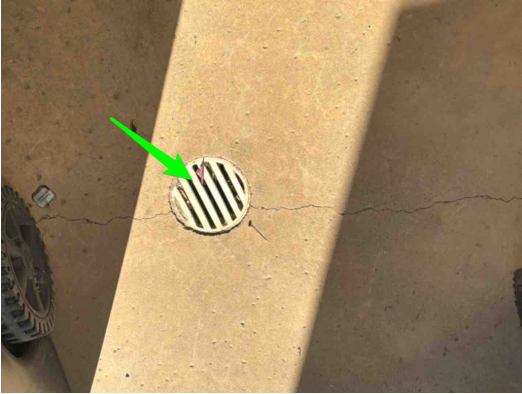
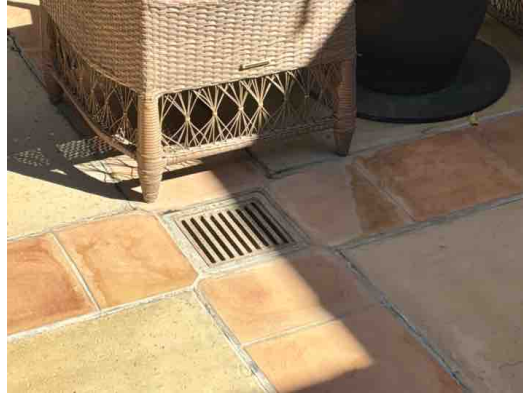
**MR DS 25: Disclosure:** Some surface drains noted in areas of the patio. Drains not tested. The condition of the underground piping and terminations are unknown. Recommend having drains and terminations cleaned, tested and inspected by a qualified landscape contractor to determine the proper flow. Keep drains clean and free of debris regularly.

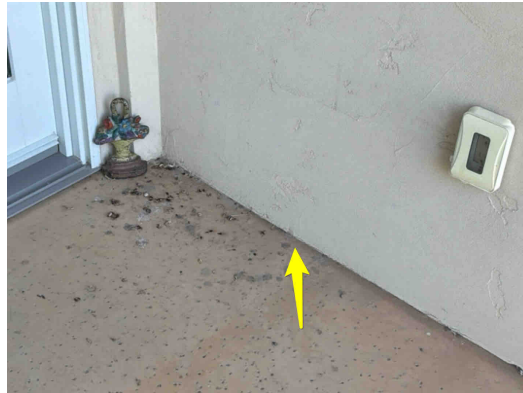
**UPG DS 26: Disclosure:** Areas of some patios were installed high at or above the exterior siding. This can potentially under certain conditions, allow for moisture to accumulate at the base of the siding and can cause deterioration or water intrusion inside the wall cavities.

Example. At a couple of small areas

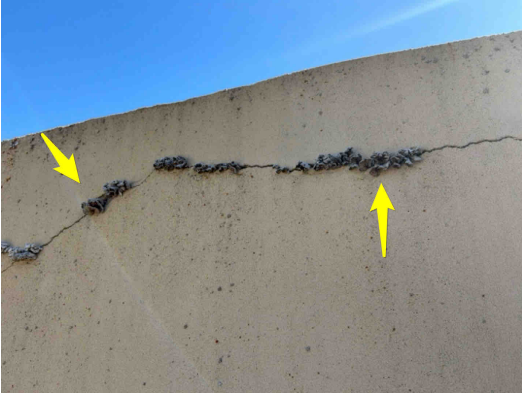
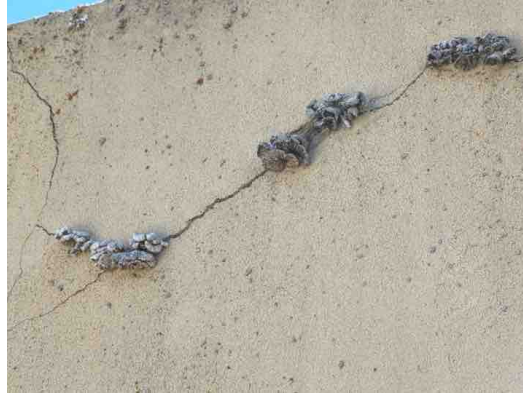
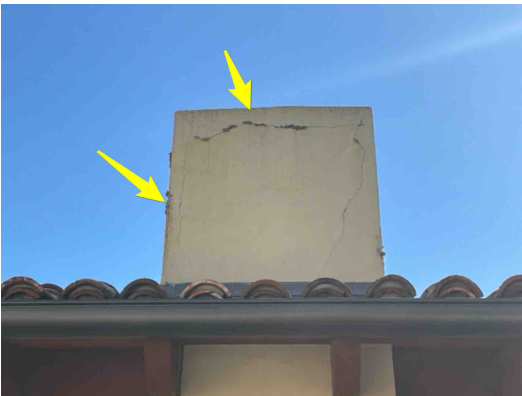
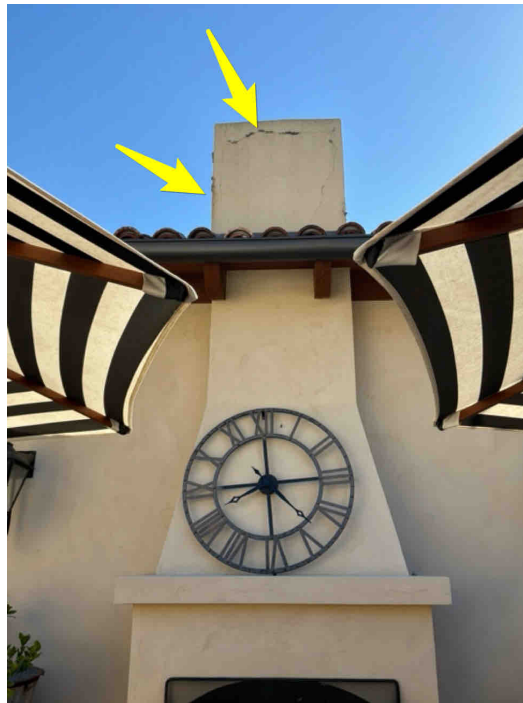
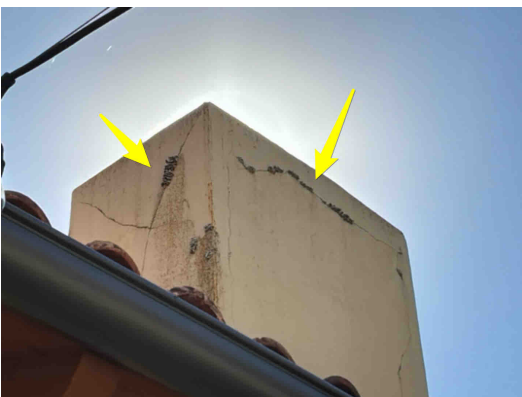
**FI 33:** Some unusual and excessive cracking in areas of the exterior stucco at the EXTERIOR - FRONT ENTRY COURTYARD STUCCOED FIREPLACE CHIMNEY. This type of cracking is generally indicative of a failure of the waterproofing (Tar paper or Tyvex), behind the stucco which is causing swelling, deterioration and damage to the structural wood framing due to the water intrusion. Client should investigate further by having the stucco removed around the cracks to help determine the cause and condition of the wood framing and have properly corrected by a licensed contractor. Refer to termite report for additional comments and recommendations.

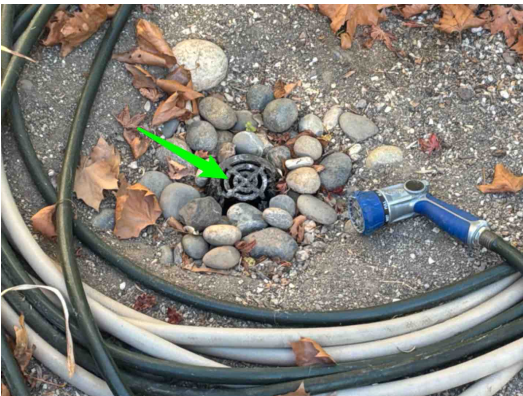
**MR DS 39:** Surface and/or yard drain boxes noted but not tested. The condition of the underground piping and terminations are unknown. Recommend having drains and terminations cleaned, tested and inspected by a qualified landscape contractor to determine the proper flow. Keep drains clean and free of debris regularly.

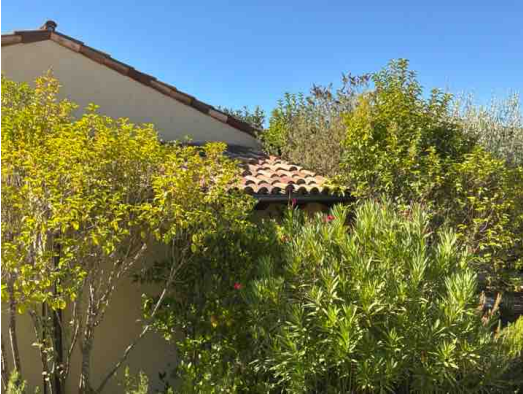
**MR 40:** Plants and/or Trees touch the buildings exterior and/or the roof. Proper landscape maintenance needed.

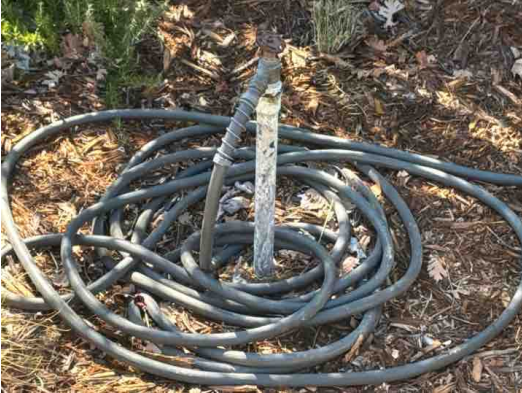
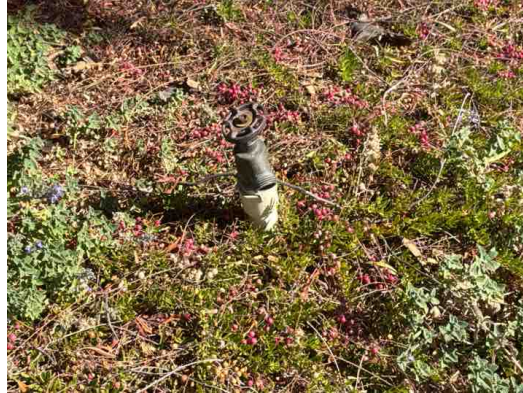
**UPG DS 62: Disclosure:** The White Plastic PVC pipe used above ground for faucet, sprinkler or supply piping is fragile, not UV rated, and can break easily. Upgrades are recommended to help prevent future damage or water leakage.

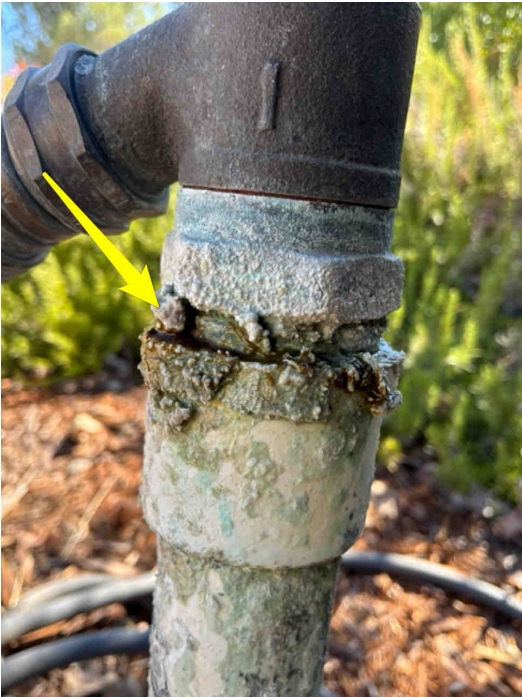
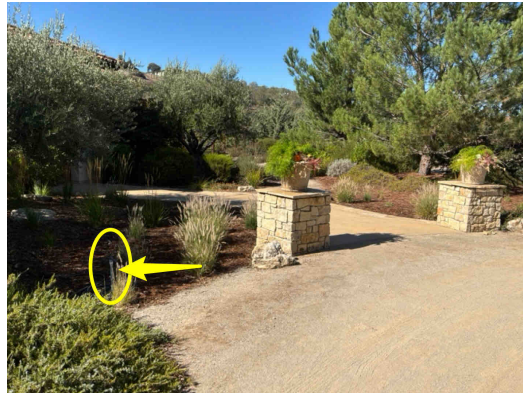
**E&C 65:** Active small water leak found at AN ADDED EXTERIOR PLASTIC GARDEN HOSE FAUCET NEAR THE FRONT ENTRY WALKWAY. Recommend further evaluation and repairs by qualified plumbing professional.

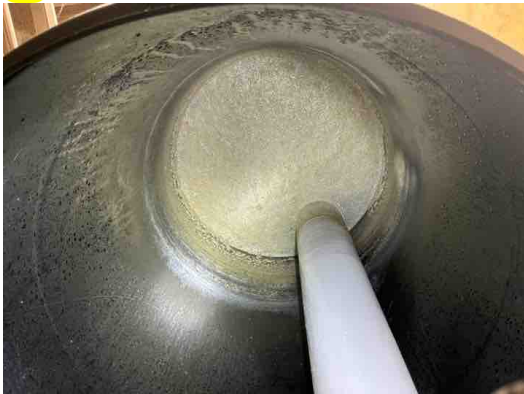
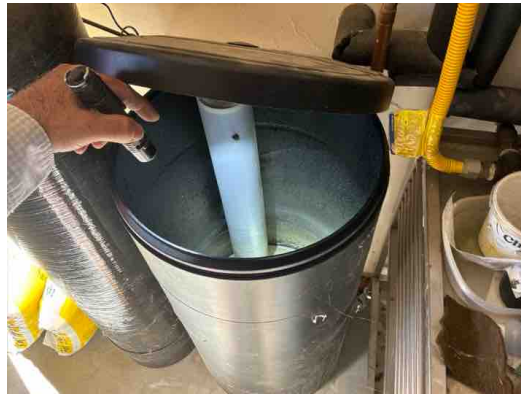
**MR 69:** Recommend servicing water softener. Water softener found low on salt and dirty.

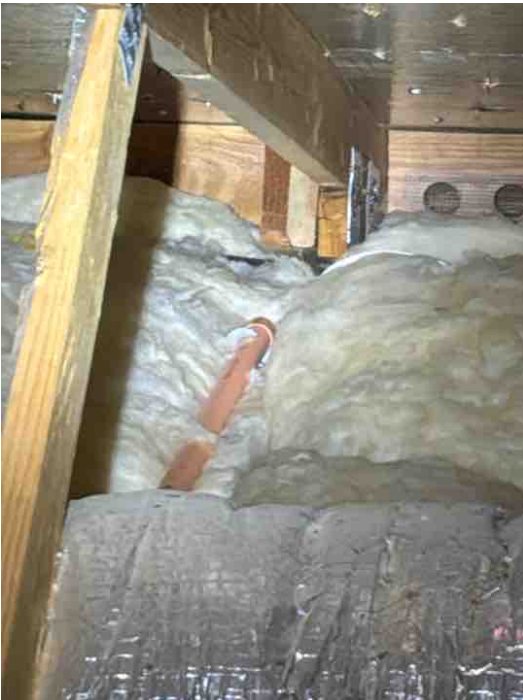
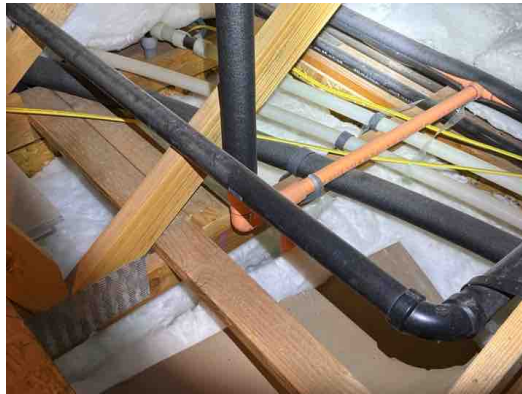
**E&C 74: Missing** freeze protection at some of the exposed fire sprinkler piping in AREAS of the attic. Freeze protection is required and will help prevent freezing and/or breakage of the plastic fire sprinkler piping during unusually cold weather. Have all attics evaluated and the fire sprinkler pipe insulated per standards.

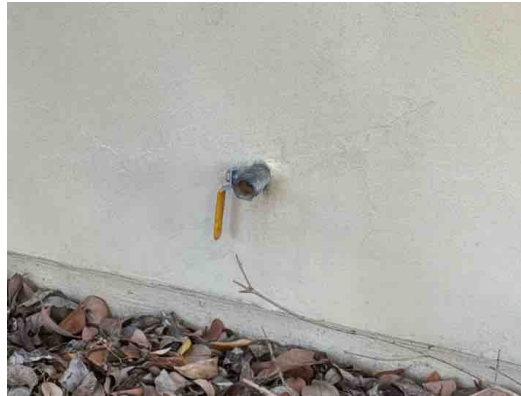
**UPG 75:** Missing the placard at the exterior fire sprinkler "Inspectors Test" valve.

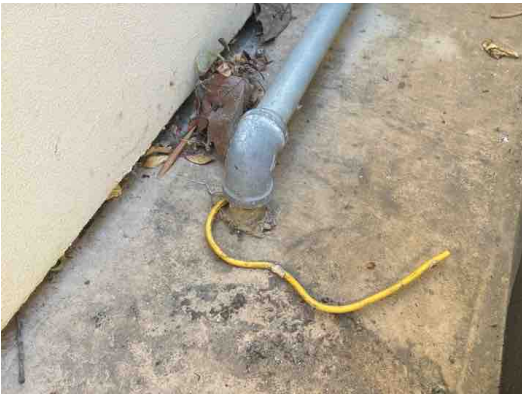
**DS 79: Disclosure:** Gas pipe not protected / sleeved through concrete at GENERAC ELECTRIC GENERATOR GAS SUPPLY LOCATED ON THE NORTH SIDE OF THE GARAGE. No visible deterioration or damage found at this time. Continue to monitor.

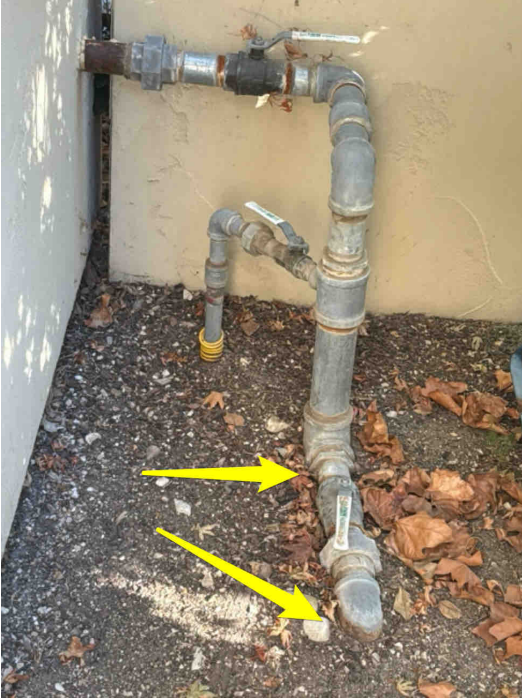
**SU 80:** Improper installation of metal gas piping observed in contact with or too close to soil without the required corrosion protection. Gas piping **installed underground or within 6 inches of grade** should be protected with an approved factory-coated pipe or corrosion-resistant wrapping system to help prevent rust, deterioration, and potential gas leaks. Recommend evaluation of all exposed gas piping and replacement or upgrading of unprotected sections as needed by a qualified licensed plumbing contractor.

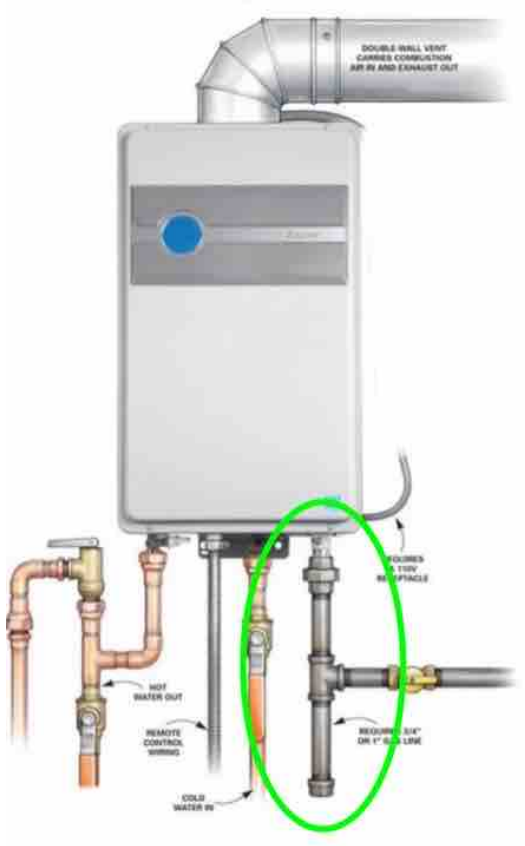
**UPG 90:** Missing the sediment trap / drip leg at the TANKLESS WATER HEATER gas piping at flex connection. Corrections recommended by a certified or licensed plumbing professional familiar with minimum requirements.

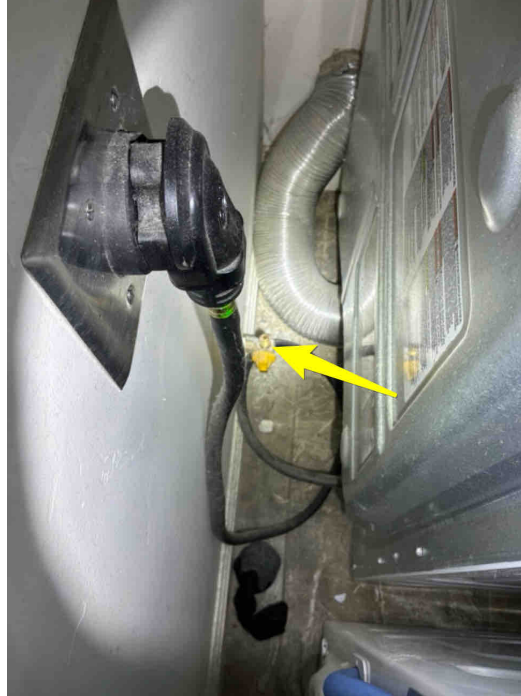
**SC 116:** A proper cap is missing at an unused gas valve per standards at the LAUNDRY. This can allow the gas valve to be accidentally turned on slightly creating a gas leak behind the laundry.

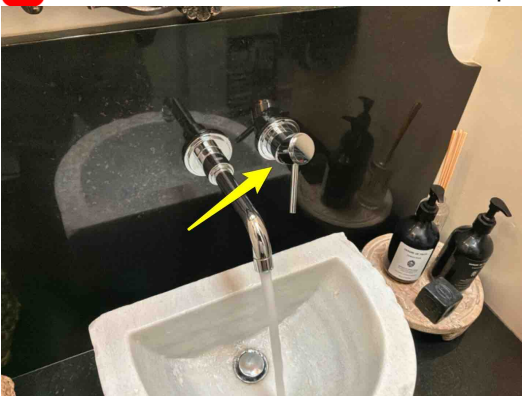
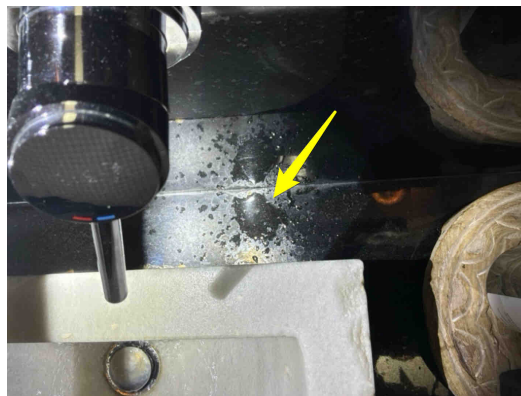
**E&C 135:** Bathroom sink faucet leaks / drips from handle when on: LAUNDRY HALLWAY 1/2 BATHROOM

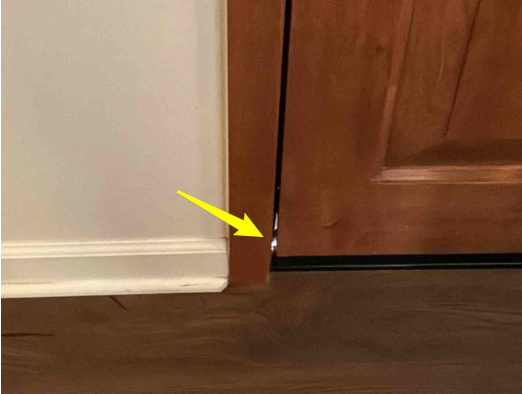
Laundry room hallway exterior door

1. LAUNDRY ROOM HALLWAY EXTERIOR DOOR. Adjustment and/or repair of the weather stripping is recommended to help prevent water and critter intrusion.

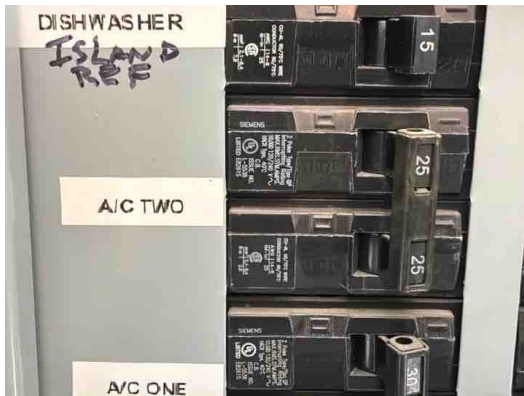
**SC 167:** Improper circuit breaker size installed for the air conditioners condenser in electrical panel per the manufactures placard: Currently at 25-amps. Which is more than the Maximum allowed of 15-amps. Recommend replacement of the current breaker to a new proper 15-amp per requirements.

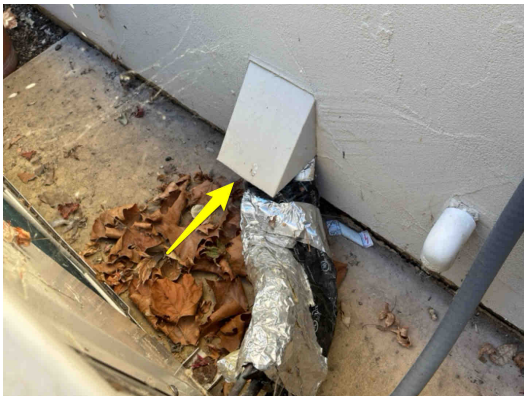
**E&C 168:** Recommend sealing the hole or opening through the exterior wall where the Air Conditioner's refrigeration pipes enter the building. This will help prevent rodent, bug and /or water intrusion through this area as need per standards.

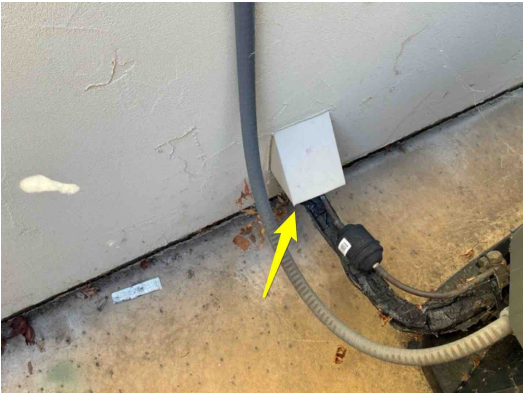
Recommend sealing the wall penetration with an approved material to help prevent moisture, pest intrusion, and air leakage.

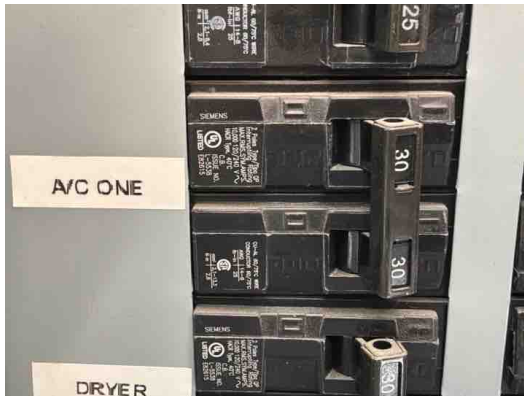
**E&C 207:** Improper circuit breaker size installed for the EAST SIDE air conditioner condenser in electrical panel per the manufacturer's placard: Currently at 30-amps, which is more than the maximum allowed of 25-amps. Recommend replacement of the current breaker to a new proper 25-amp per requirements and warranty retention.

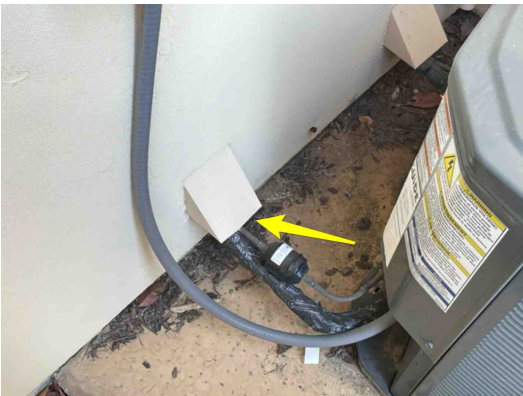
Recommend sealing the wall penetration with an approved material to help prevent moisture, pest intrusion, and air leakage.

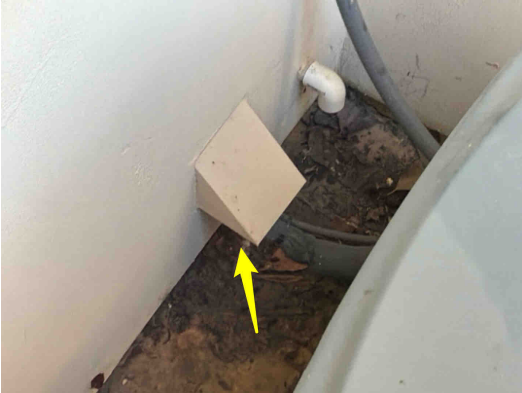
Recommend sealing the wall penetration with an approved material to help prevent moisture, pest intrusion, and air leakage.
