## Inspection Services

### *Inspection Report*

Address: 90 Villa Ct Pismo Beach, CA 93449

07/23/2026

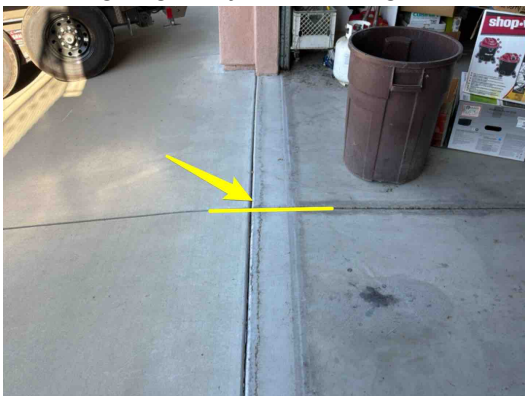
**15:** Typical & common cracks found in areas of the driveway.

**DS 16: Disclosure:** Due to the slope and height of the driveway at the garage connection, some water intrusion into the garage may occur during certain weather.

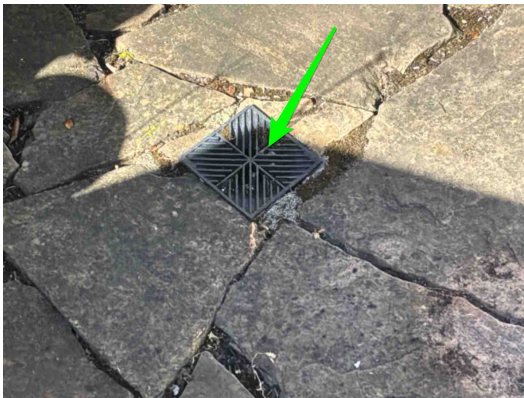
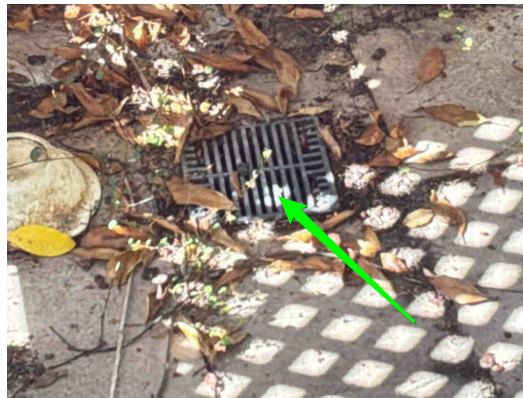
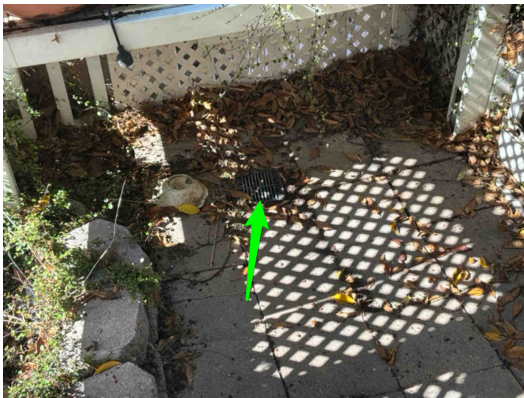
**MR DS** 21: **Disclosure:** Some surface drains noted in areas of the patio. Drains not tested. The condition of the underground piping and terminations are unknown. Recommend having drains and terminations cleaned, tested and inspected by a qualified landscape contractor to determine the proper flow. Keep drains clean and free of debris regularly.

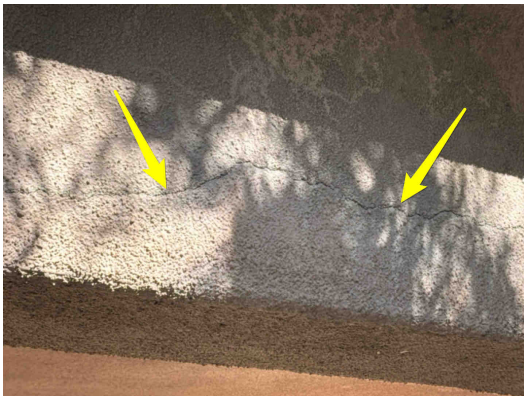
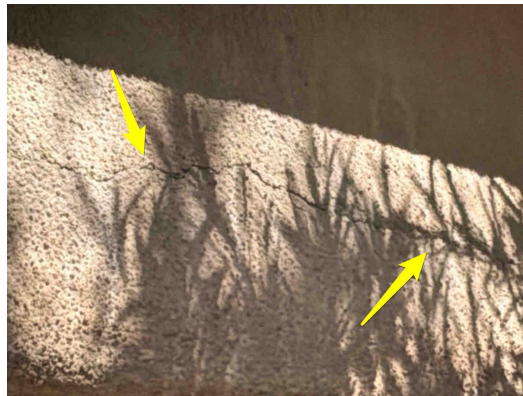
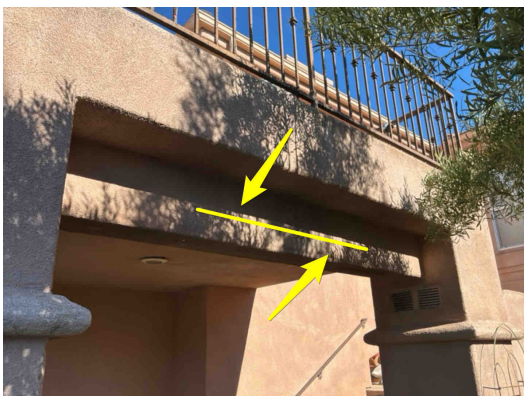
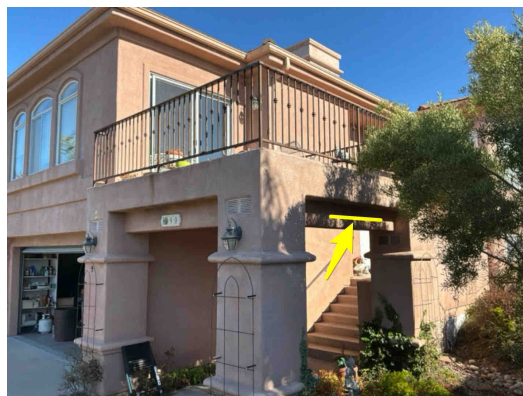
**DS** 28: Some typical-type cracking was observed at areas of the exterior stucco. These types of cracks are common and are often the result of normal shrinkage, thermal expansion, or minor building movement. At the time of inspection, no significant displacement or structural concerns were noted. However, the cracks should be monitored over time for signs of additional movement, widening, displacement, or the development of new cracks, which may indicate a more significant underlying condition requiring further evaluation.

**FI** 29: Some unusual and moderate cracking at areas of the exterior stucco UNDER THE UPSTAIRS WATERPROOF DECK OVER THE FRONT ENTRY. This type of cracking is indicative of a failure of the waterproofing under the stucco which is causing swelling, deterioration and/or damage to the structural wood framing. Client should investigate further by removing the stucco until satisfied as to the cause, condition, potential future issues and correct as needed. Refer to termite report for additional comments and recommendations.

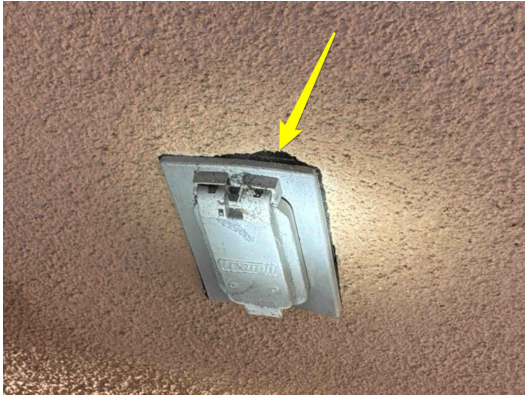
Example

**MR 30:** Recommend sealing holes in exterior walls to prevent water intrusion around areas such as unused open holes in the exterior siding and trim, exterior light fixtures, around exterior electrical boxes and covers, and where utility pipes and/or wires pass through the exterior walls. Have a qualified painter or licensed professional evaluate the entire exterior and seal where needed.

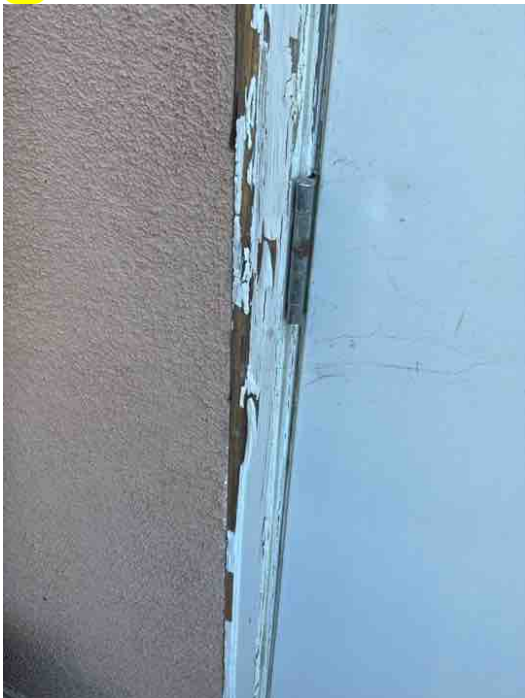
**E&C 33:** Some moisture and/or bug type damage & deterioration found at exterior wood trim areas. Refer to the termite report for locations and extent.

**MR 34:** Deteriorated, cracked, and separated caulking was observed at various exterior trim locations, including around doors, windows, fascia, and other exterior penetrations. Recommend maintenance and replacement of failed sealants to help prevent moisture intrusion.

**MR 35:** Deteriorated paint or finish at areas of the exterior.

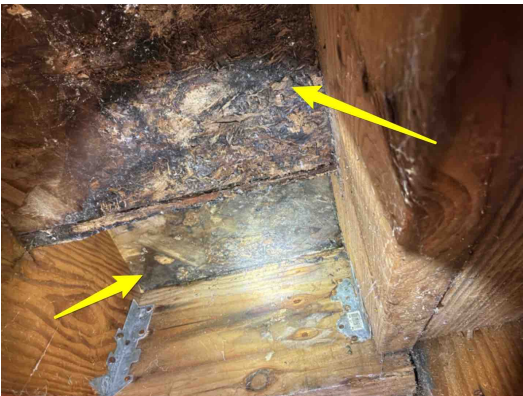
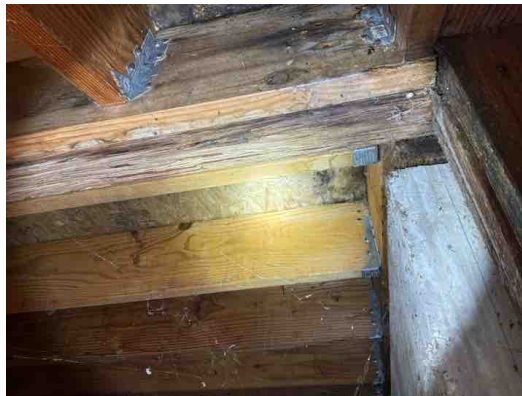
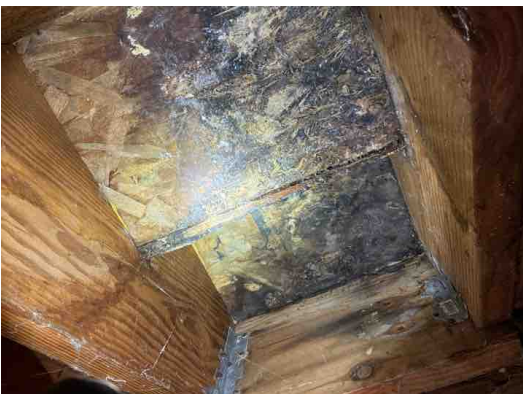
**E&C 37:** Moisture-type damage & deterioration found at areas of the exterior wood frame framed waterproof stairway: OFF THE FRONT ENTRY. Suspected leaking of the waterproofing. Recommend additional review by a licensed waterproof decking contractor. Refer to the Termite report for additional details and recommendations.

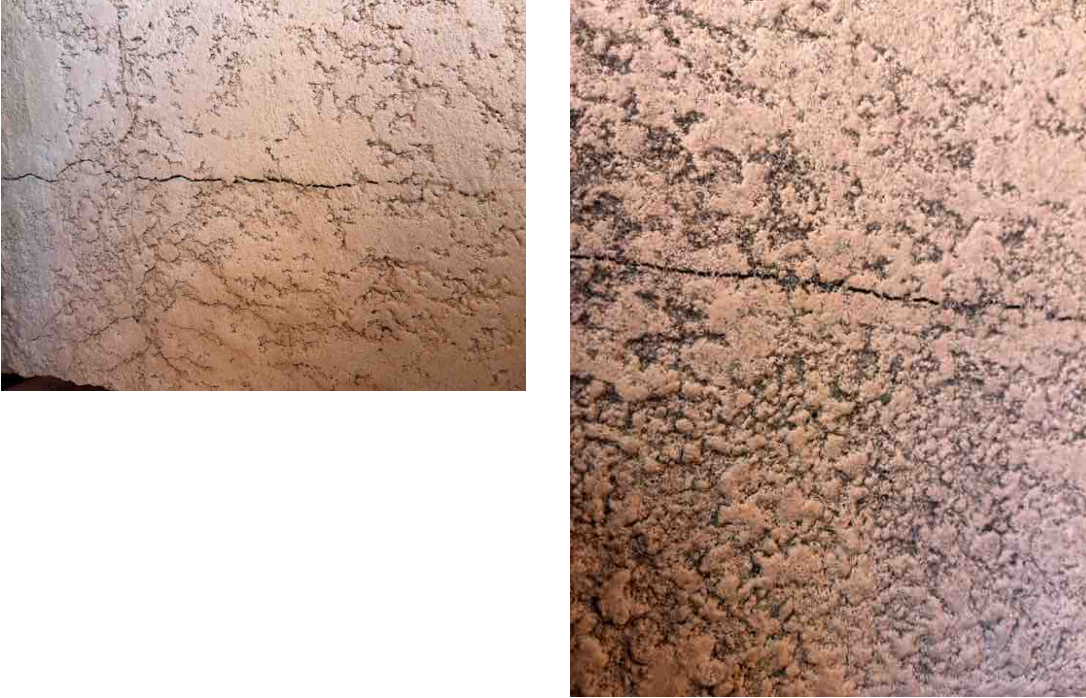
**FI 38:** Some visible cracking and deterioration noted at areas of FRONT ENTRY WATERPROOF STAIRWAY. recommend additional review by waterproof decking specialist as maintenance, upgrades repairs may be needed.

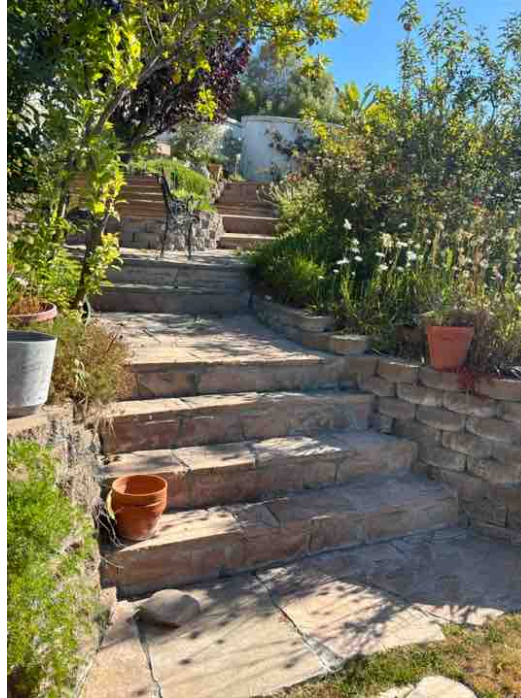
Example

**SU 41:** Recommend a proper graspable handrail at the exterior stairway ALL EXTERIOR LANDSCAPE STAIRS AND STEPS ON THE PROPERTY for safety.

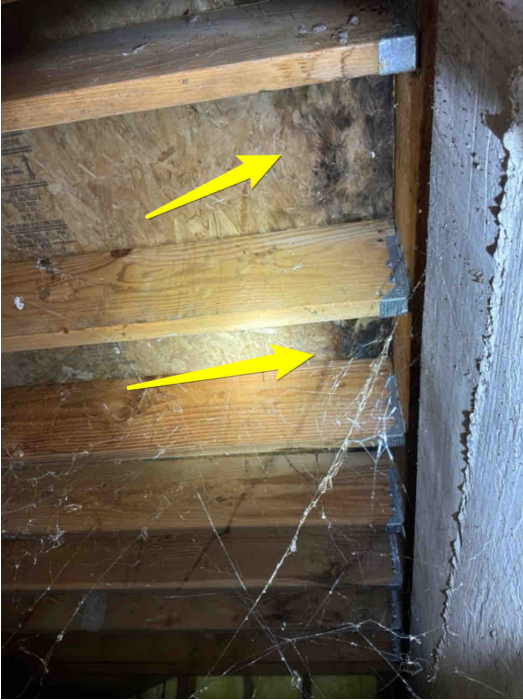
**FI 43:** **WATERPROOF DECK COATING CONDITION:** The FRONT ENTRY waterproof deck appears to be nearing or at the end of its useful life. Visible water stains and damage at the wood framing on the underside of the decking.

**FI 44:** Some moisture-type damage and deterioration found at areas of the wood framing below the FRONT ENTRY WATERPROOF DECK. Suspected past leaking of the waterproofing. Recommend additional review by licensed waterproof deck contractor. *Refer to the termite report for additional comments and recommendations.*

Recommend review a replacement by qualified waterproof decking contractor.

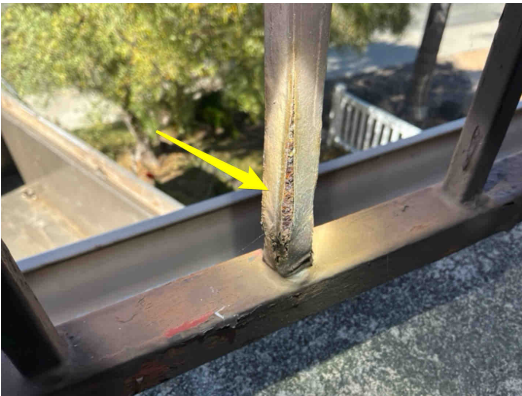
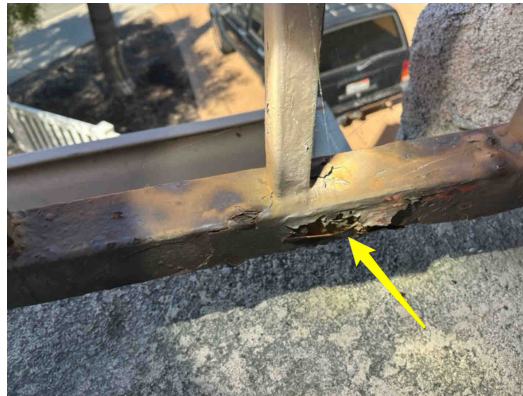
**FI 47:** **WATERPROOF DECK COATING CONDITION:** The WATERPROOF DECK OFF THE DINING ROOM appears to be at the end of its useful life, with some visible damage.

**E&C 48:** Some rust deterioration and/or damage noted at areas of the metal railings at the WATERPROOF DECK OFF THE DINING ROOM. Maintenance repair or upgrades are recommended for safety.

Recommend review a replacement by qualified waterproof decking contractor.

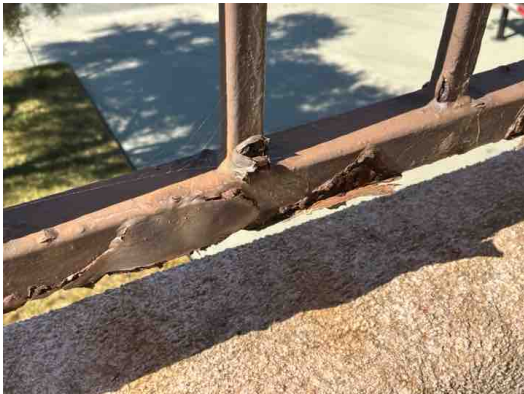
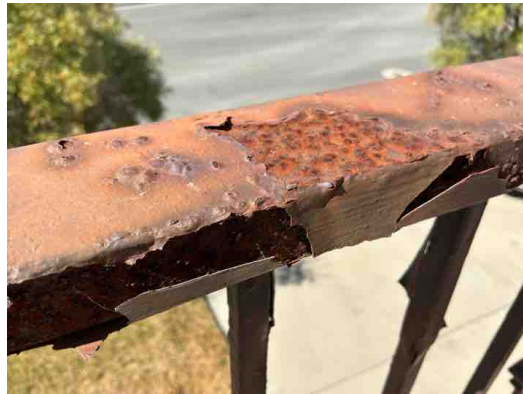
**FI 50:** **WATERPROOF DECK COATING CONDITION:** The **WATERPROOF DECK OFF THE FAMILY ROOM** appears to be at the end of its useful life, with visible damage at the waterproofing with suspected leaking and damage at the structural framing.

**E&C 51:** Some rust deterioration and/or damage noted at areas of the metal railings at the **WATERPROOF DECK OFF THE FAMILY ROOM**. Maintenance repair or upgrades are recommended for safety.

Recommend review a replacement by qualified waterproof decking contractor.

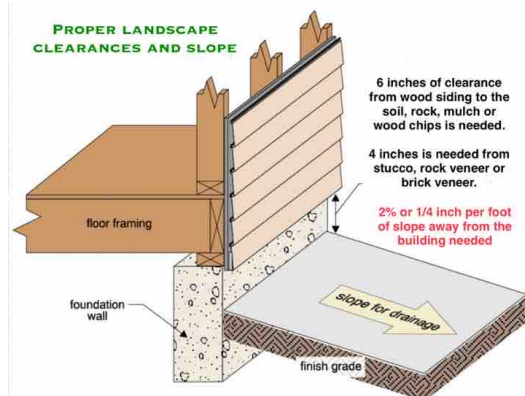
**E&C 53:** Recommend some proper landscape grading and maintenance along areas of the exterior. This should help ensure the proper flow of site water away from the building(s) and off the property. This will also help ensure proper clearances from the interior floor level, exterior stucco, wood or other siding to the top of soil. Trim trees and bushes that are making contact with areas of the exterior.

**MR 54:** Areas of insufficient slope of the soil away from the building along some areas of the perimeter foundation. A proper slope of the soil, patios and walkways should allow for water to flow freely away from the building, not allow water to flow against areas the foundation edges and water should not allow for ponding of water in areas near or at the foundation as this can cause erosion and/or settling of the foundation system.

**E&C MR 55:** Soil level found high at areas of the foundation. (Recommend 4 inches from the bottom of the exterior stucco siding to dirt, rock, mulch or wood chips).

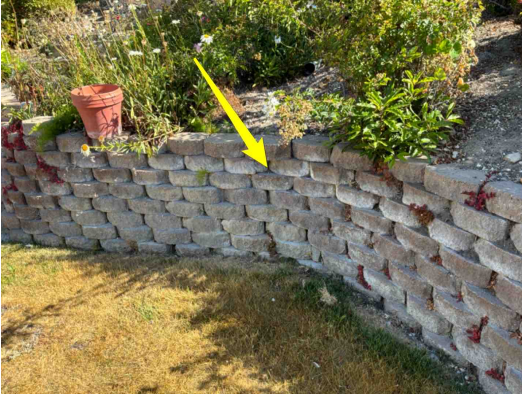
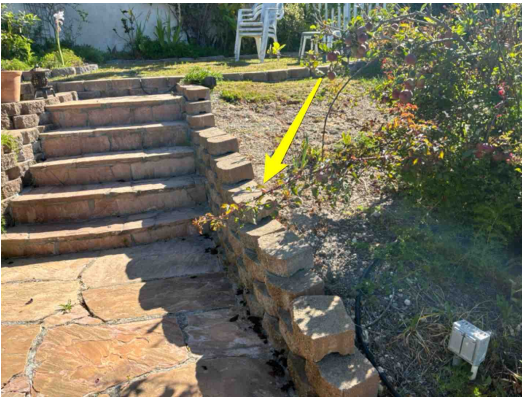
Example location

**FI 58:** Areas of some unusual leaning visible at areas of the stacked interlocking retaining wall system at the BACKYARD. This is indicative of a failure and/or an improper installation of the interlocking system. Client is advised to contact a qualified Civil engineer and/or a qualified contractor to evaluate the current condition and make appropriate corrections as needed.

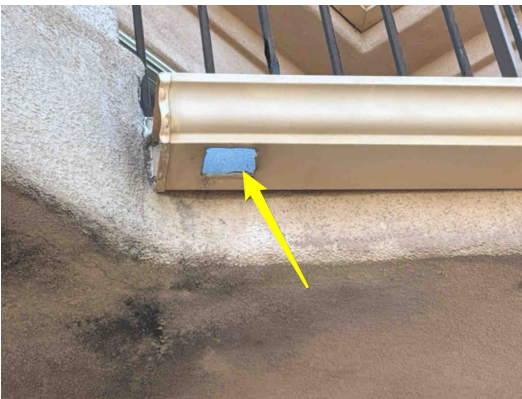
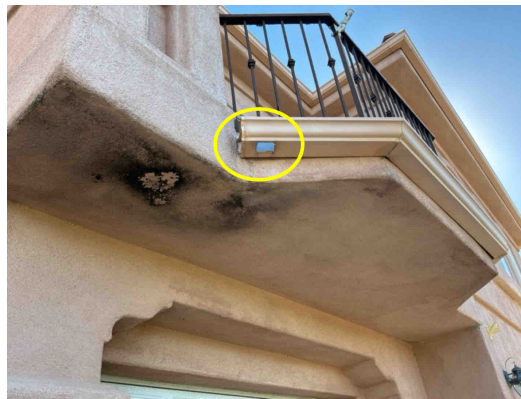
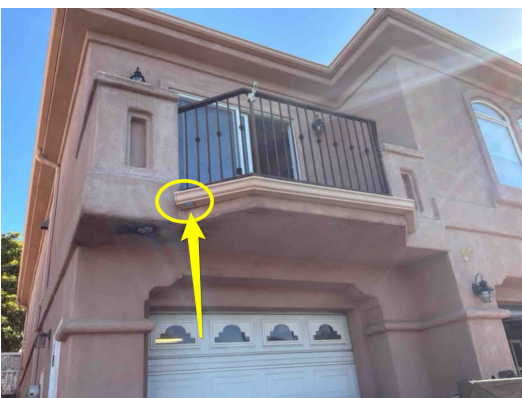
**E&C 74:** Missing a rain gutter downspout at the rain gutter installed on the ON THE FRONT OF THE HOUSE OF THE SMALL BALCONY OFF THE DINING ROOM - OVER THE SINGLE WIDE GARAGE VEHICLE DOOR.

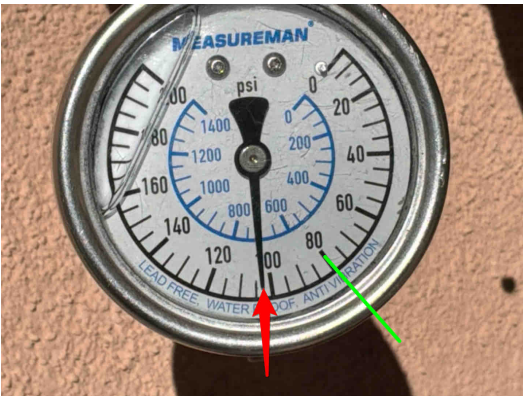
**E&C 81: Excessive water pressure** (above the maximum of 80-psi, **currently at: +100 +/-psi** ). Recommend the adjustment or repair of the pressure regulator.

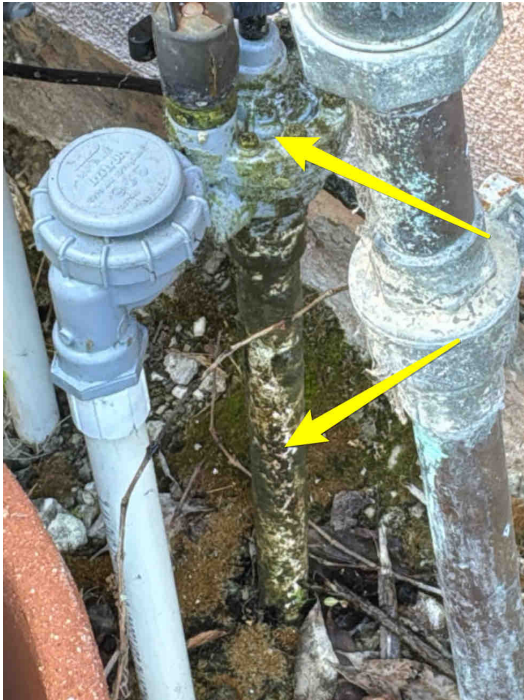
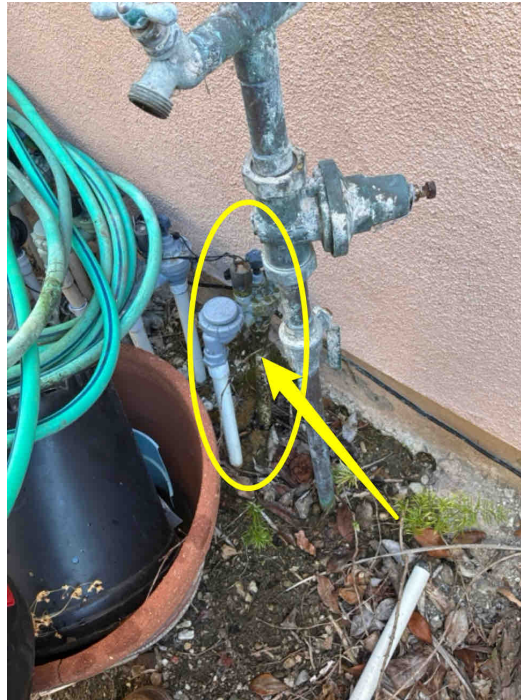
Active leaking of water

**E&C 86:** Active water leak found at A LAWN SPRINKLER WATER SUPPLY AND VALVE LOCATED NEXT TO THE MAIN HOUSE WATER SUPPLY SHUT OFF ON THE WEST SIDE OF THE GARAGE. Recommend further evaluation and repairs by qualified plumbing professional.

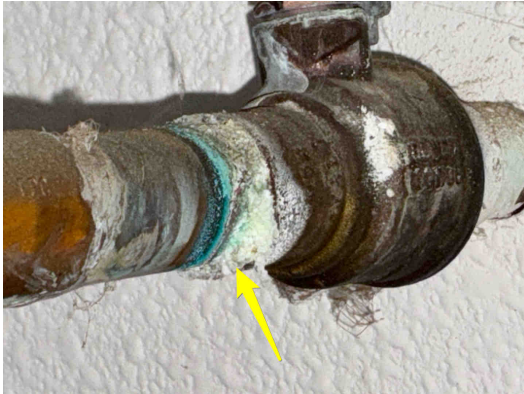
**E&C 105:** Evidence of past leaking with corrosion at the COLD water supply shut-off valve at the water heater. Recommend corrections by a licensed plumber.

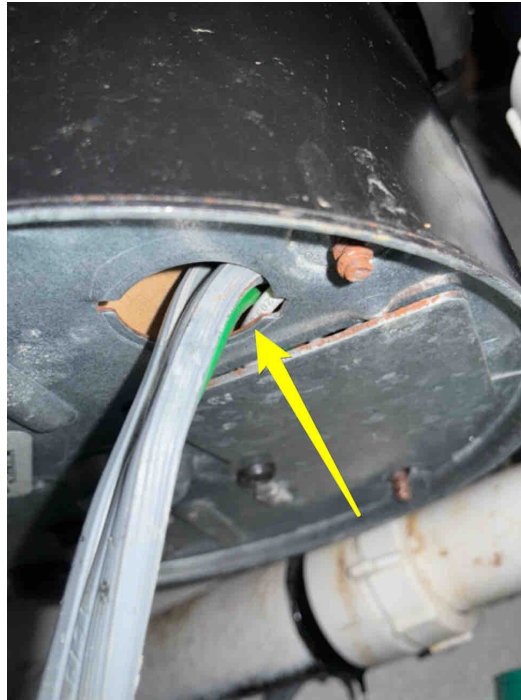
**SC 116:** Missing a proper electrical wire-bushing clamp at bottom of kitchen sink disposal.

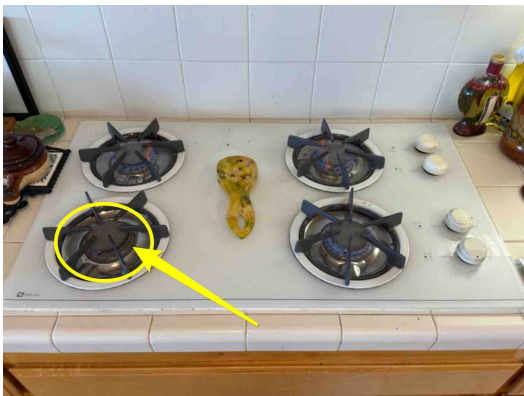
**E&C 120:** The FRONT LEFT Cook top burner did not operate or ignite properly when tested. Recommend cleaning / servicing.

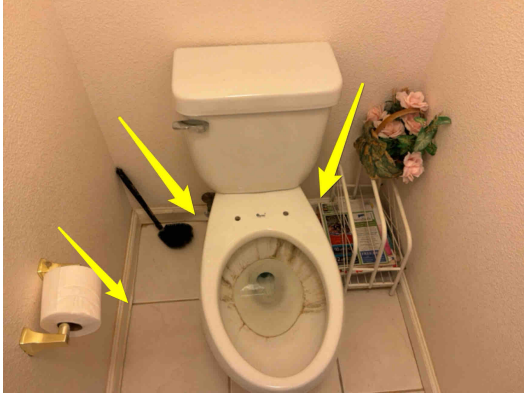
**FI 142:** Moisture stains and damage at the baseboards behind the toilet in the: PRIMARY BEDROOM BATHROOM.

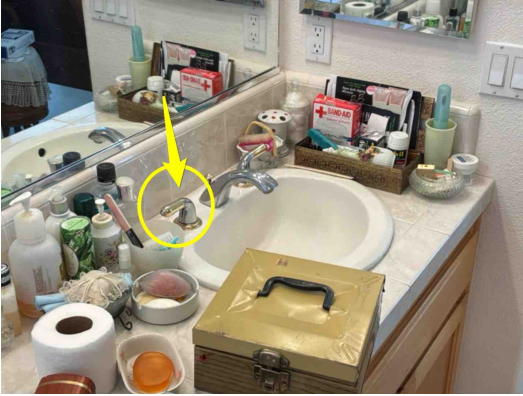
Example

**E&C 145:** Bathroom sink faucet leaks / drips from handle when on: PRIMARY BEDROOM BATHROOM

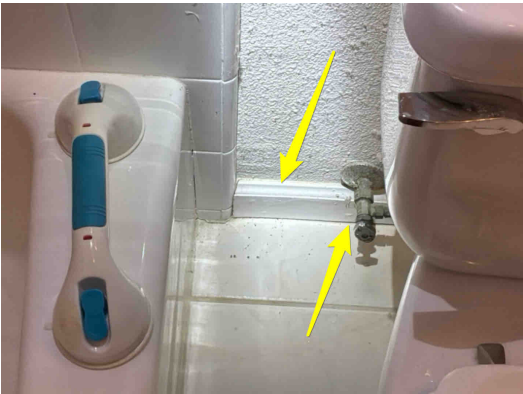
**E&C 148:** Moisture stains and damage to wall, floor and baseboards outside tub and behind the toilet in the: UPSTAIRS HALLWAY BATHROOM.

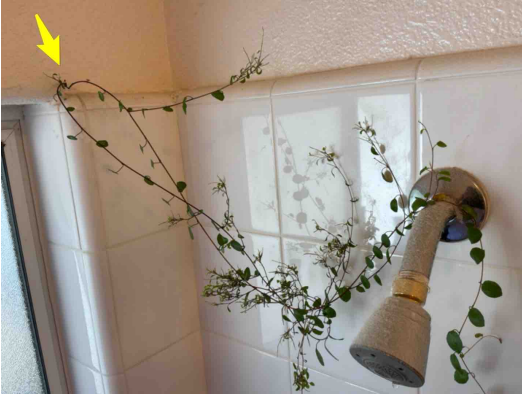
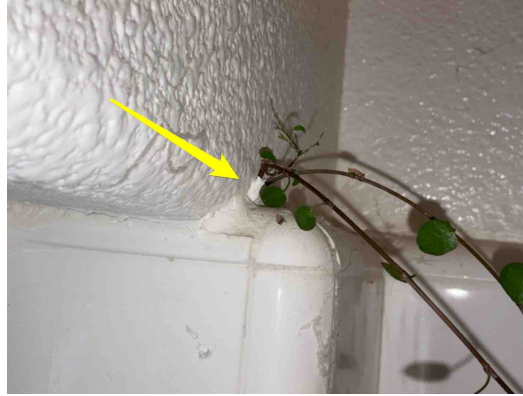
**FI** 151: Disclosure: A plant found growing out of the wall in the UPSTAIRS HALL BATHROOM SHOWER

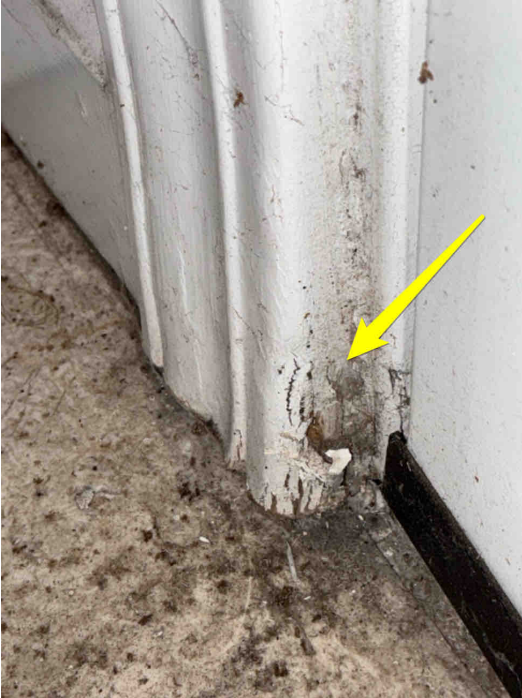
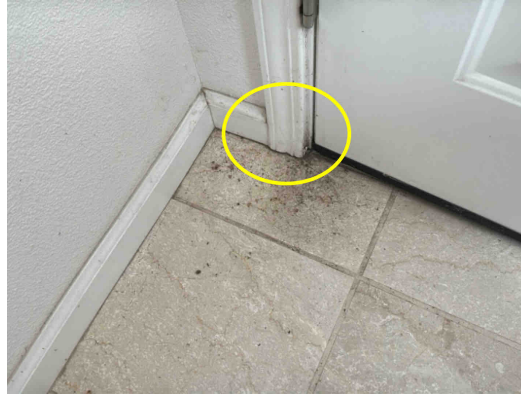
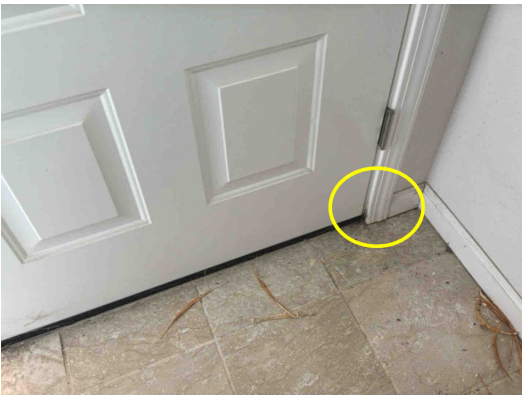
**FI 154:** Evidence of some moisture or water intrusion through the FRONT ENTRY WOOD DOOR with visible water stains and damage on the interior. The Front Entry door may leak due to poor or improper installation. Recommend additional review by qualified professional to evaluate the existing condition and make appropriate repairs as needed to prevent additional water intrusion and damage.

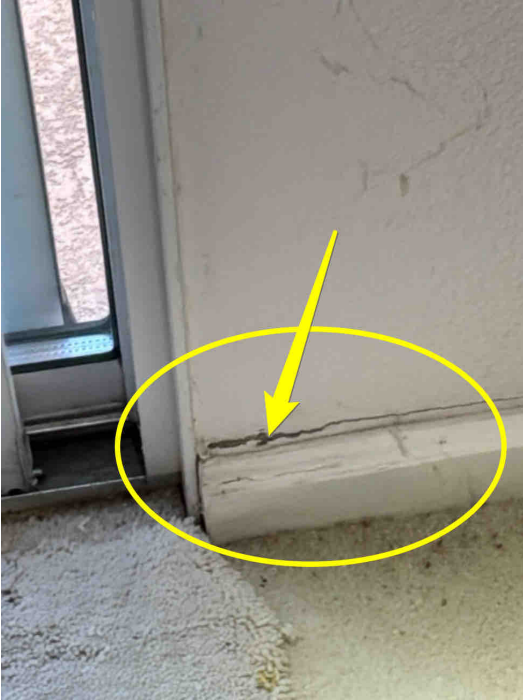
**FI 158:** Evidence of past water intrusion from around threshold area from exterior sliding glass door with stains and/or damage: DINING ROOM EXTERIOR SLIDING GLASS DOOR.

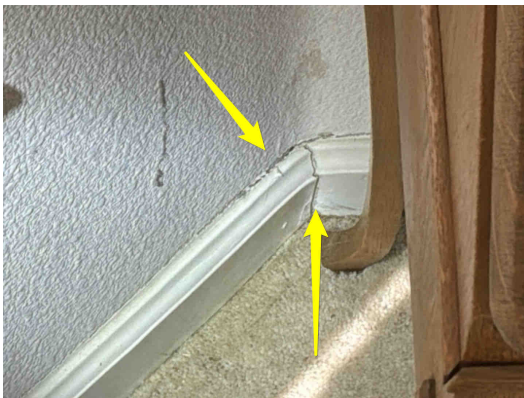
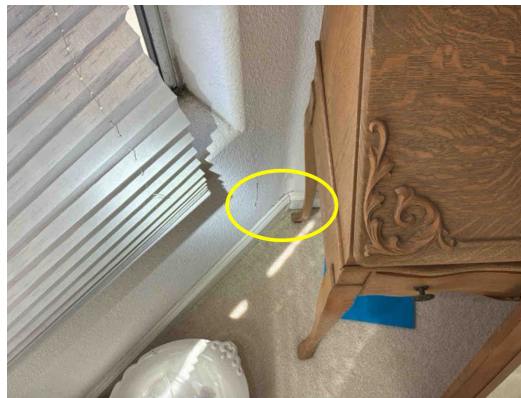
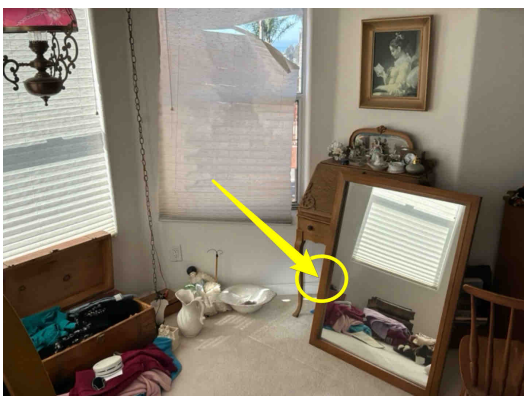
**FI 175:** Evidence of moisture stains and/or damage at the walls in the PRIMARY BEDROOM AT THE TURRET ALONG THE BASEBOARD UNDER THE WINDOW. Recommend further review of the water stains to determine the cause, the current condition and if repairs are needed.

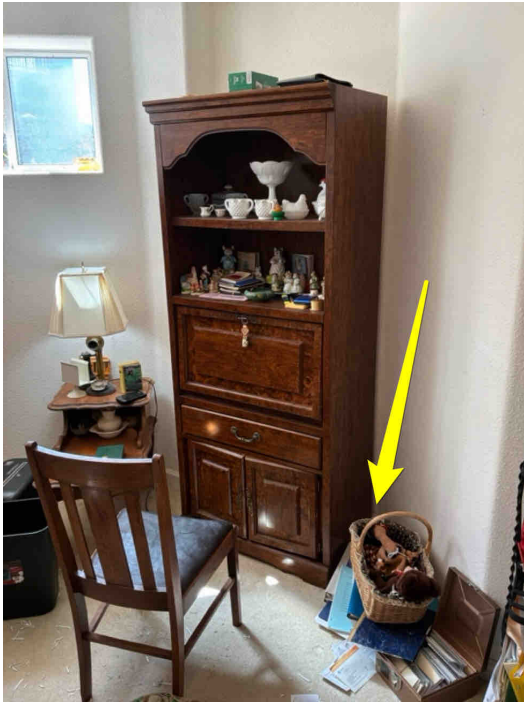
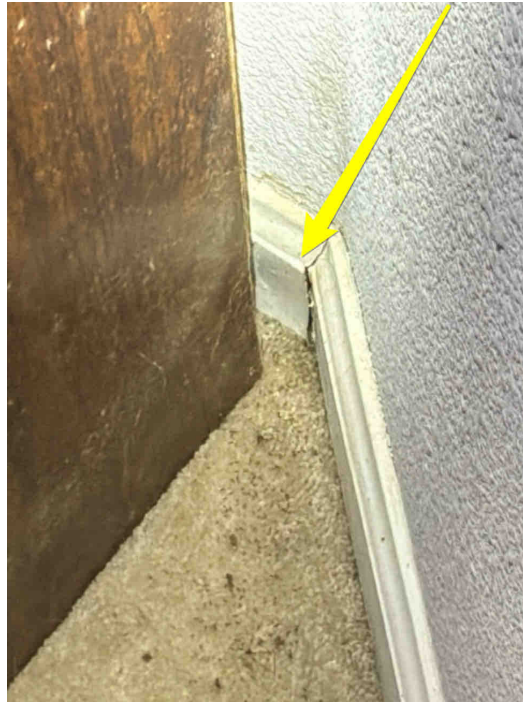
**FI 176:** Evidence of moisture stains and/or damage at the walls in the DOWNSTAIRS OFFICE OFF THE LAUNDRY ROOM ALONG THE EXTERIOR WALL IN THE TURRET. Recommend further review of the water stains to determine the cause, the current condition and if repairs are needed.

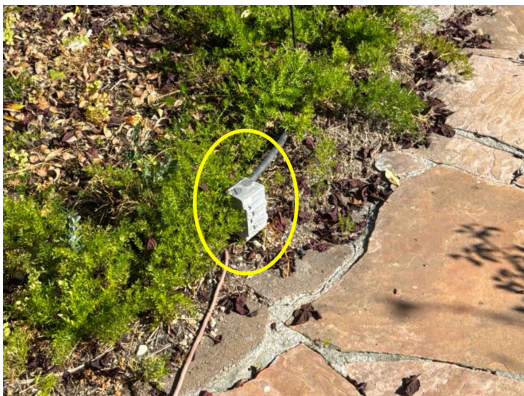
Example

**SC 192:** Improper and unsafe installation of an exterior electrical box below 12 inches above the soil AT AREAS OF ADDED EXTERIOR ELECTRICAL ALONG AREAS OF THE LANDSCAPE WALKWAYS AND OTHER AREAS AROUND THE PROPERTY. All exterior outlets and junction boxes are required to be a minimum of 12 inches above the soil. Have licensed electrician review the entire property and make appropriate corrections with electrical boxes properly supported and protruding a minimum of 12 inches above the surrounding grade.

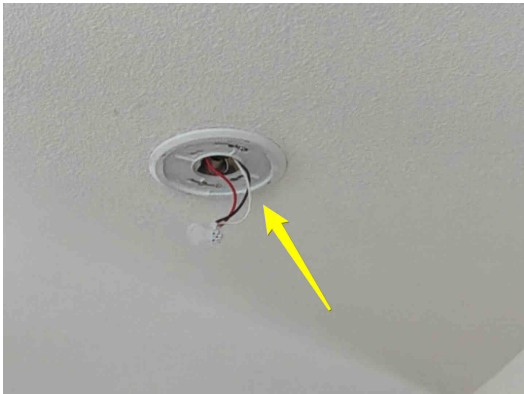
**SC 198:** **Smoke detector AND Carbon Monoxide detector are missing at required location: UPSTAIRS HALLWAY OUTSIDE THE PRIMARY BEDROOM**

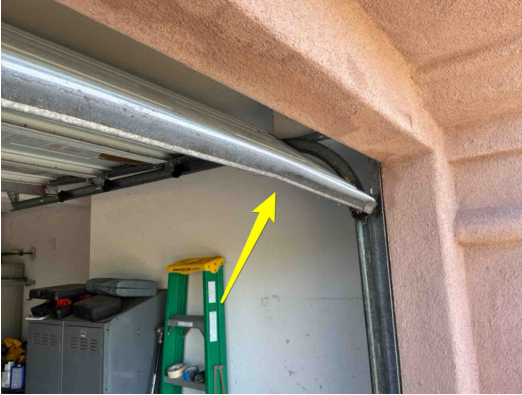
**E&C 208:** Disclosure: Some dented panel(s) at garage vehicle roll-up door.

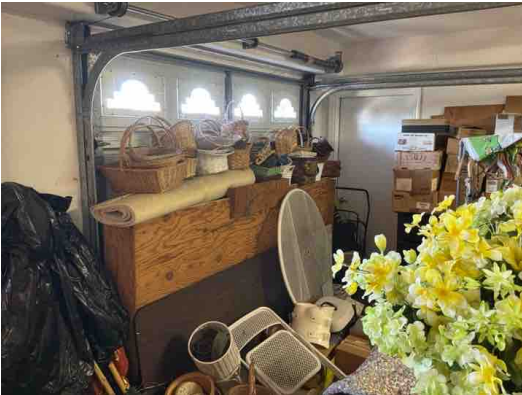
**E&C 209:** The single-wide garage vehicle door is not tested due to the excessive amount of occupants belonging stacked up tight against the door. Recommend having door tested and serviced once occupants belongings have been removed.
