# HOME INSPECTION REPORT

**5343 Caminito Mindy, San Diego, CA 92105**

**Report Number:** 2026010925KM

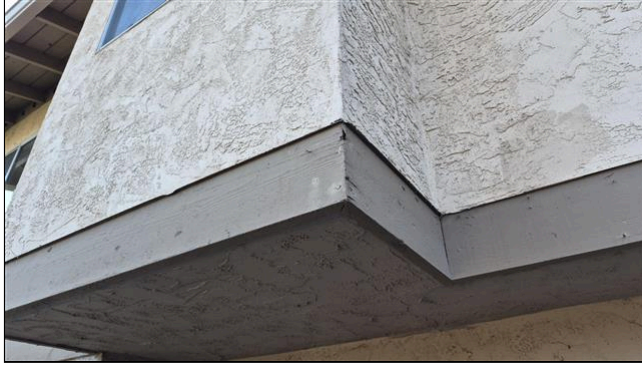
3.3 Item 1 (Picture)

Deterioration observed in areas of the eaves/fascia/exterior wood. Recommend further evaluation by a licensed branch 3 pest inspector, prior to the end of the contingency period.

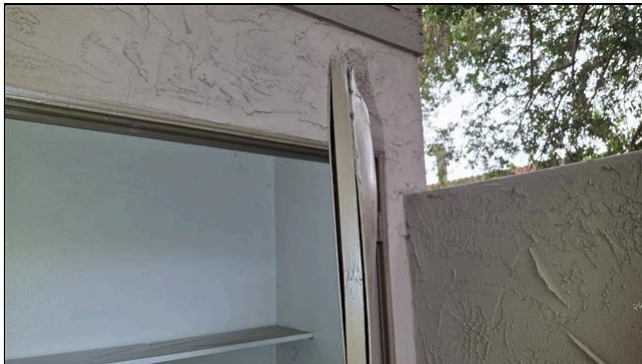
3.5 Item 1 (Picture)

Laundry closet door is deteriorated/delaminating. Recommend repair or replacement.

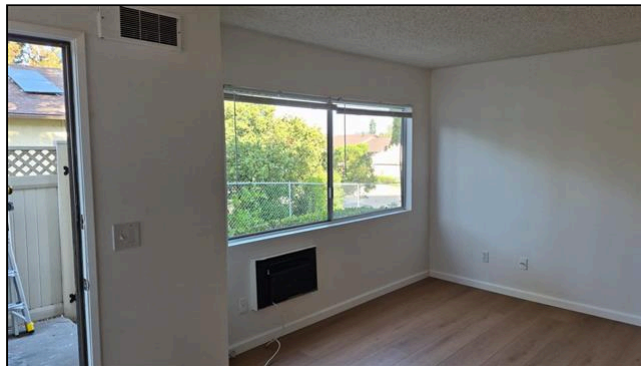
3.6 Item 1 (Picture)

(1) A number of windows are stuck shut or latches are difficult to operate. Suggest maintenance.

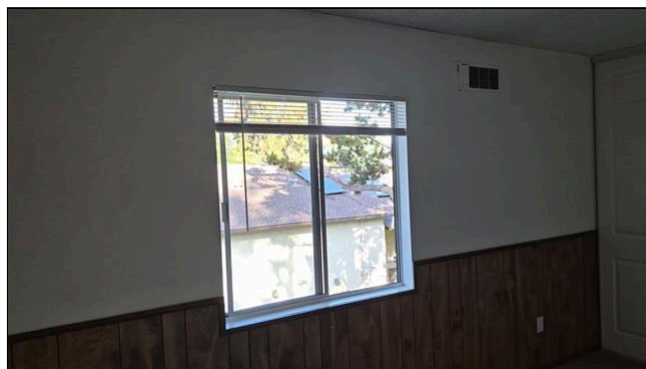
3.6 Item 2 (Picture)

(2) Window screens are torn, bent or missing in a number of areas. Suggest repair/replace.

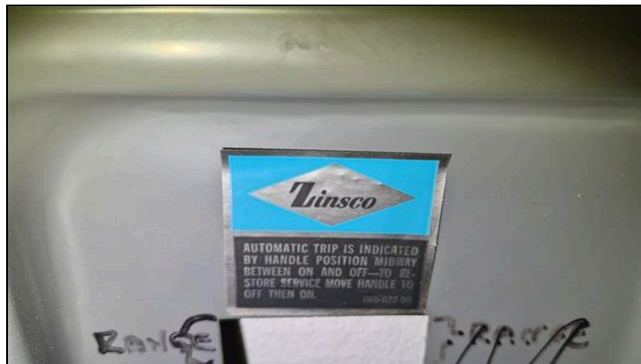
4.1 Item 1 (Picture)

📍 (1) Sub panel is manufactured by Zinsco. There have been known problems with this type of panel in the past. Recommend verifying condition with a qualified electrician, prior to the end of the contingency period.

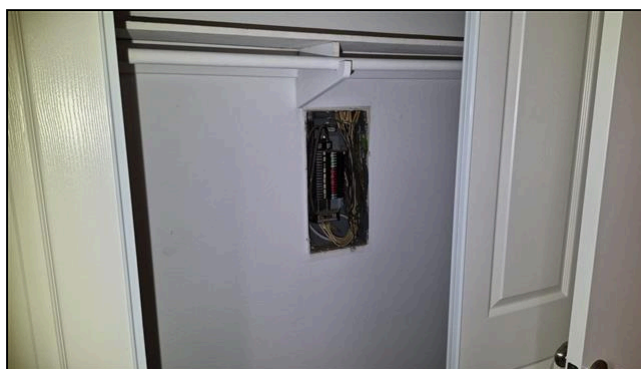
4.1 Item 2 (Picture)

📍 (2) Sub panel is installed inside a closet designed to store linen, clothing, or other flammable materials. Recommend relocating.

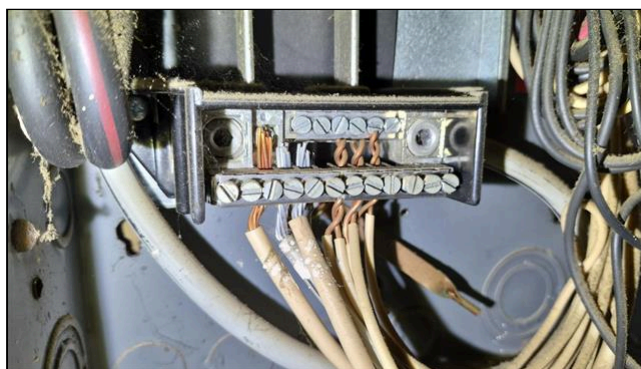
4.1 Item 3 (Picture)

📍 (3) Double wiring observed at the neutral busbar in the sub panel. Wiring should be separated into independent lugs. Recommend correcting.

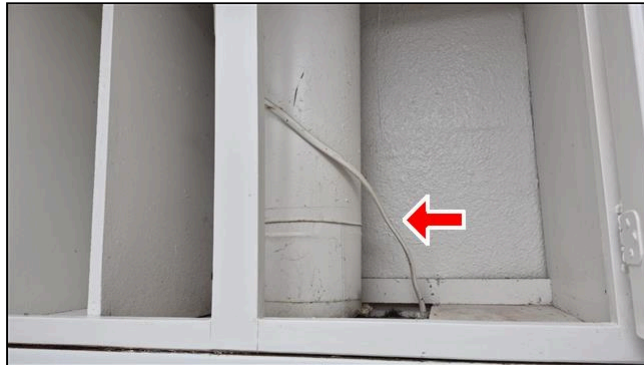
4.3 Item 1 (Picture)

📍 (1) Unprotected/unsupported wiring observed at kitchen exhaust fan. Recommend correcting.

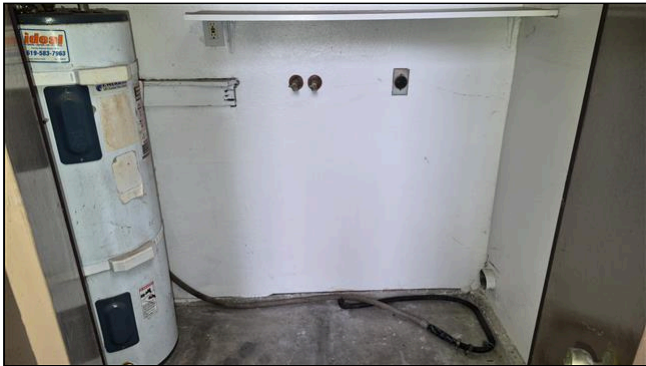
5.3 Item 1 (Picture)

(1) Washer connections/drain observed. Washing machine was not installed at time of inspection. Suggest verifying condition with seller prior to the end of the contingency period.

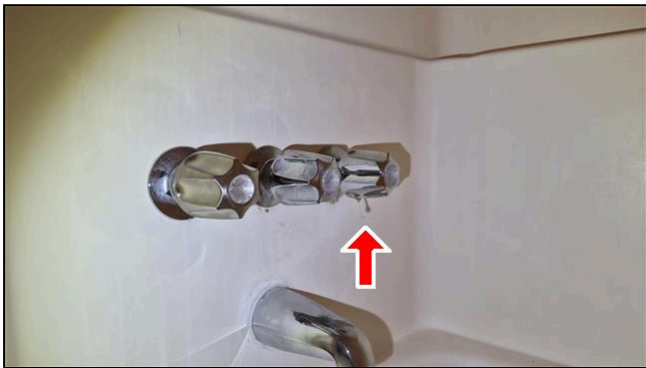
5.4 Item 1 (Picture)

🏠 (1) Leaking observed at the shower faucet handle in the 2nd level bathroom. Recommend repair.

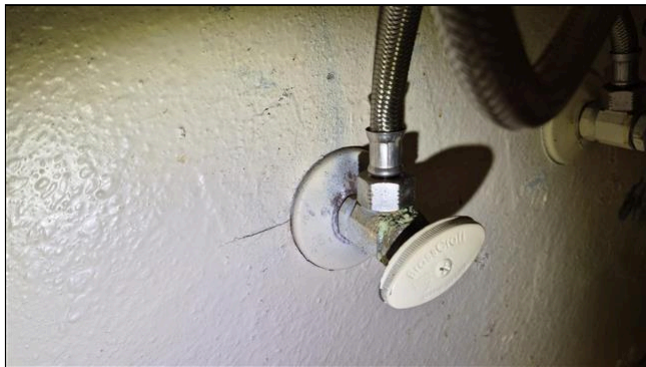
5.4 Item 2 (Picture)

📌 (2) Corrosion observed at the shut-off valves in a number of areas throughout the home. Recommend verifying operation and/or replacement of any inoperable valves.

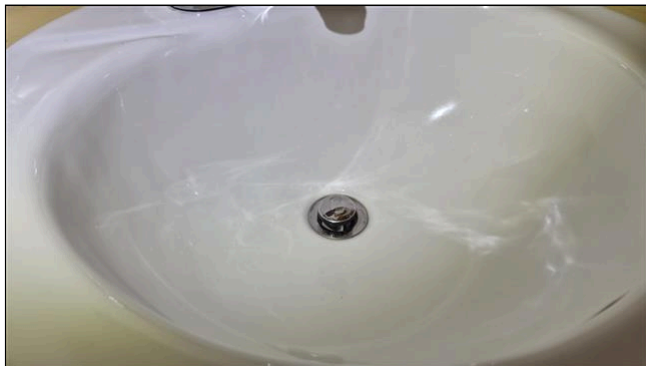
5.4 Item 6 (Picture)

(3) Missing/inoperable drain stoppers observed at the bathroom sinks/tubs. Suggest correcting.

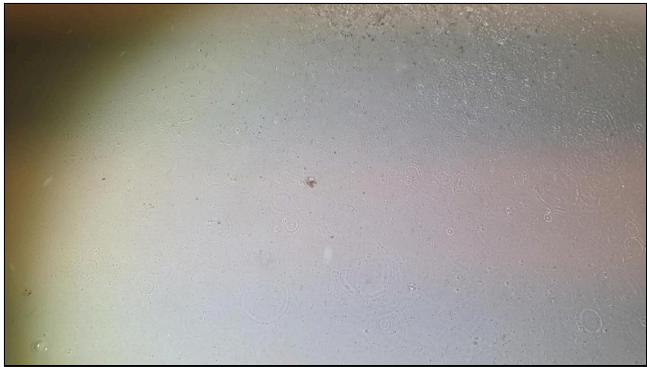
5.5 Item 1 (Picture)

🏠 (1) Leaking observed at 2nd level toilet tank. Recommend repair or replacement.

🏠 (2) Chipped/deteriorated surface observed at 2nd level bathroom tub. Recommend repair/ replacement.

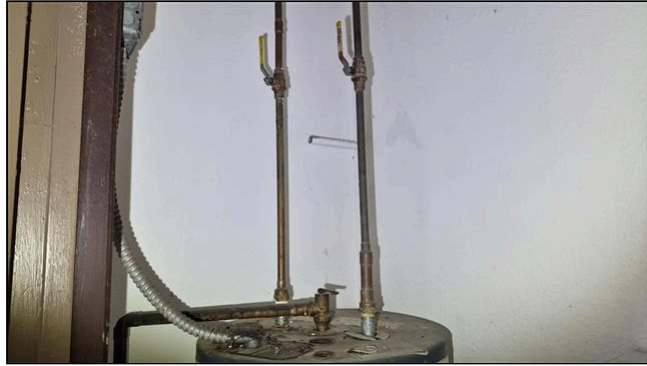
6.0 Item 1 (Picture)

Water lines are constructed of rigid material. Recommend installing flexible supply lines.

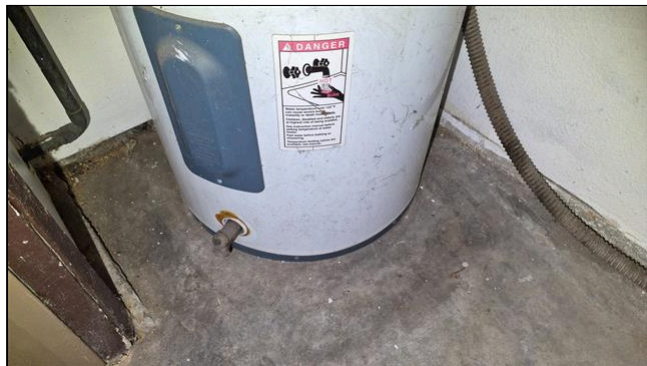
6.4 Item 1 (Picture)

Drip pan with drain line is not installed. Recommend installing.

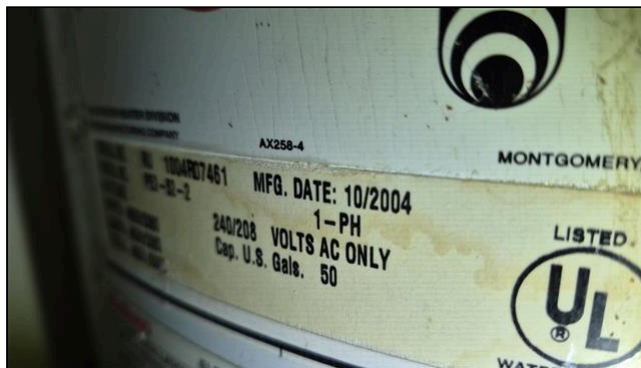
6.6 Item 1 (Picture)

🏠 (1) Water heater is beyond its estimated service life. The client is advised to verify overall condition with a qualified plumber.

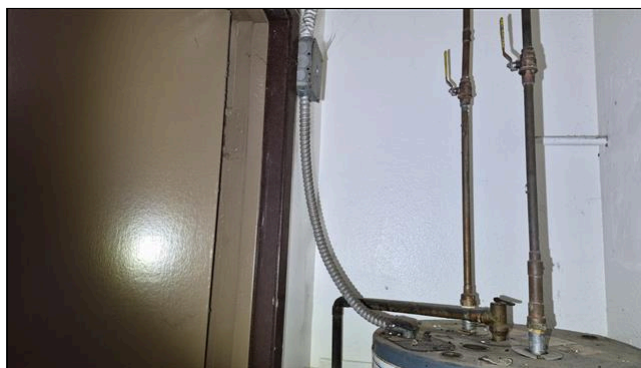
6.6 Item 2 (Picture)

🏠 (2) Electrical disconnect is not installed within sight of the water heater. Recommend correcting.

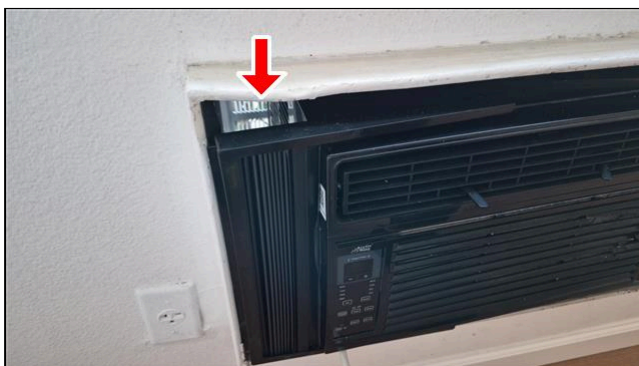
7.1 Item 2 (Picture)

(2) Window unit is unsealed/missing trim. Suggest repair.

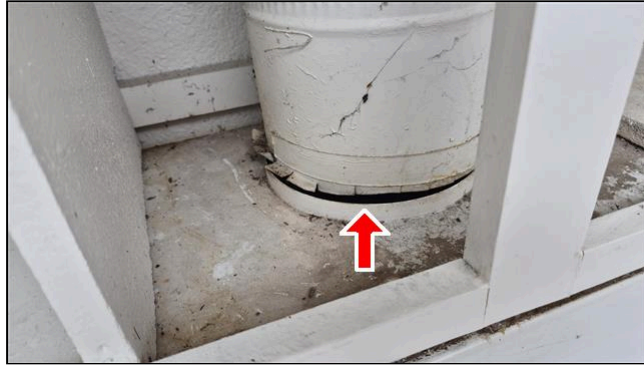
8.2 Item 1 (Picture)

📍 (1) Exhaust vent ducting is disconnected. Recommend repair.

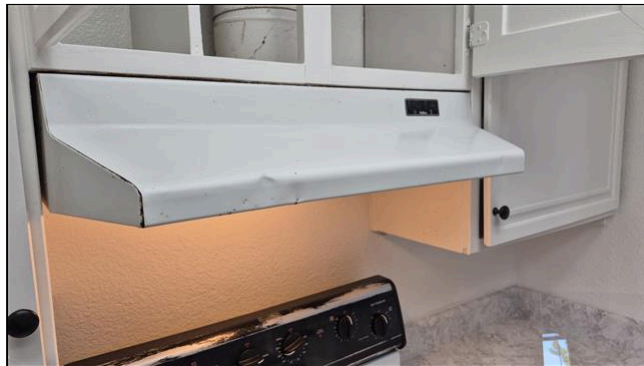
8.2 Item 2 (Picture)

(2) Exhaust hood is dented/damaged and nearing the end of its service life. Suggest replacement.

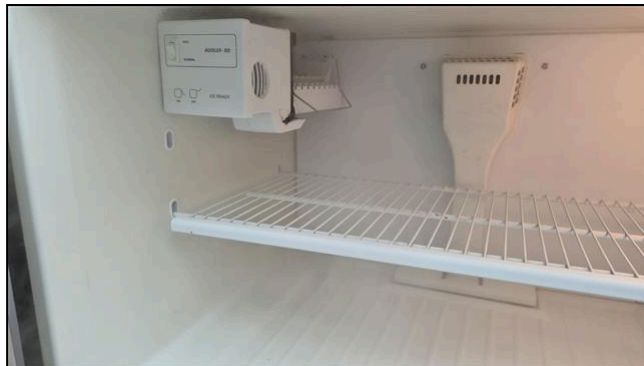
8.3 Item 1 (Picture)

Ice tray is missing at freezer. Suggest replacement.

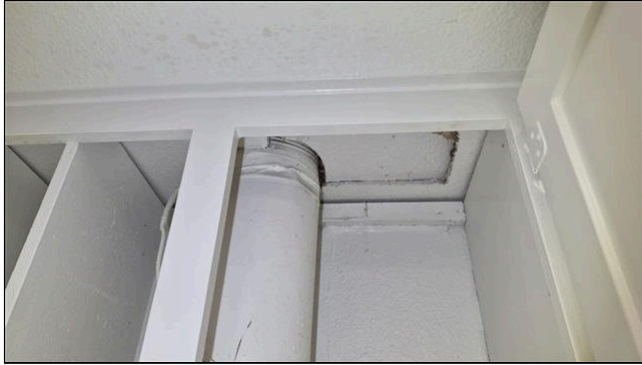
9.1 Item 1 (Picture)

(1) Leaking observed at kitchen exhaust hood from the 2nd level bathroom. Hidden damage

may not be observable. Recommend further review by a qualified professional, prior to the end of the contingency period.

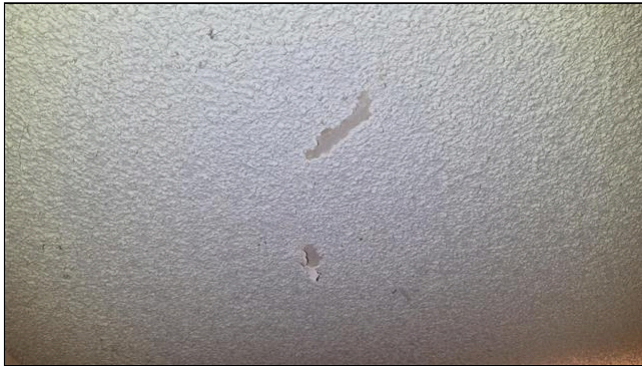
9.1 Item 4 (Picture)

(2) Chipped paint or popcorn ceiling texture observed in areas. Suggest repair.

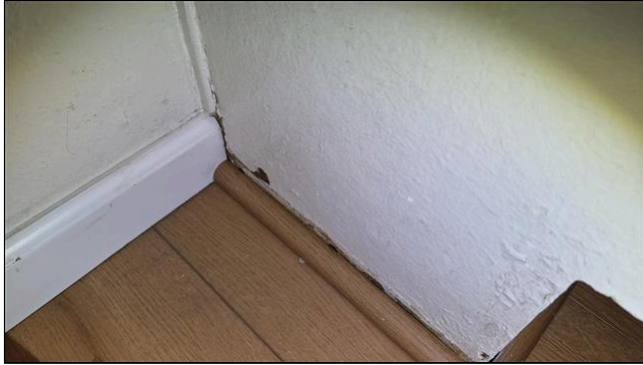
9.4 Item 1 (Picture)

(1) Moisture damage observed at bathroom vanities. Moisture/leaking was not detected at time of inspection. Suggest repair/replacement of moisture damaged components.

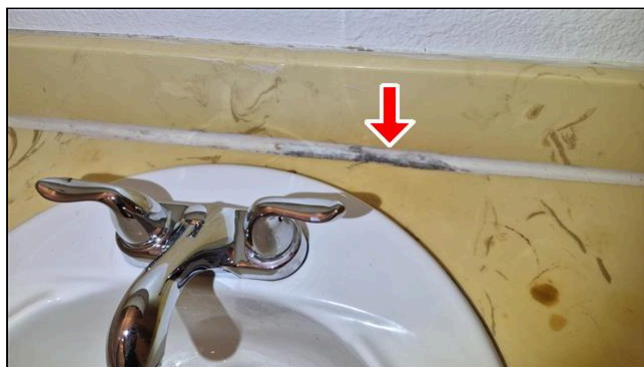
9.4 Item 6 (Picture)

(2) Deteriorated sealant or dark staining observed at bathroom sink backsplash. Suggest re-sealing.

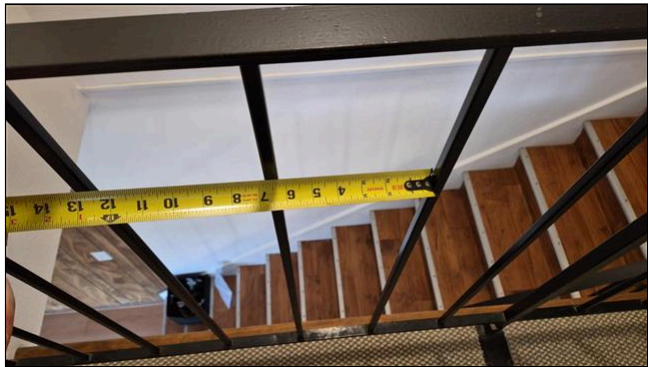
9.5 Item 1 (Picture)

The baluster spacing is wider than current standards recommend (4") at the 2nd level and stair railings - safety concern. Recommend correcting.
