# Inspection Report

**Kirk Lewis  
310 Cambridge Drive  
Cambria, CA 93428**

Report Date: 8/21/2026

Inspection location: **310 Cambridge Drive  
Cambria, CA 93428**

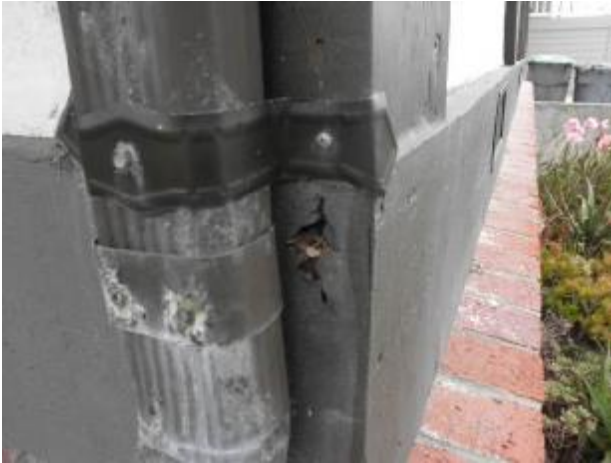
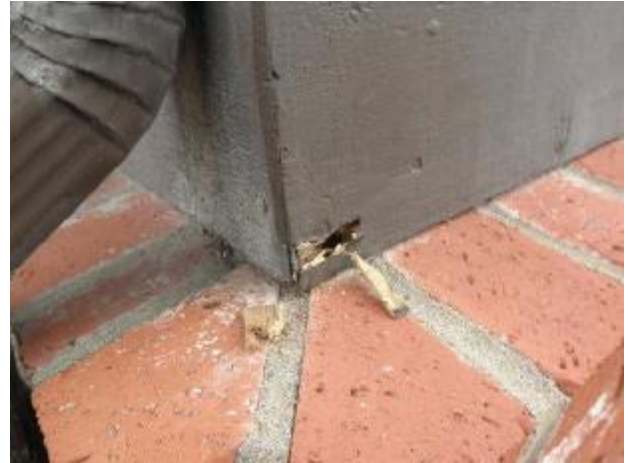
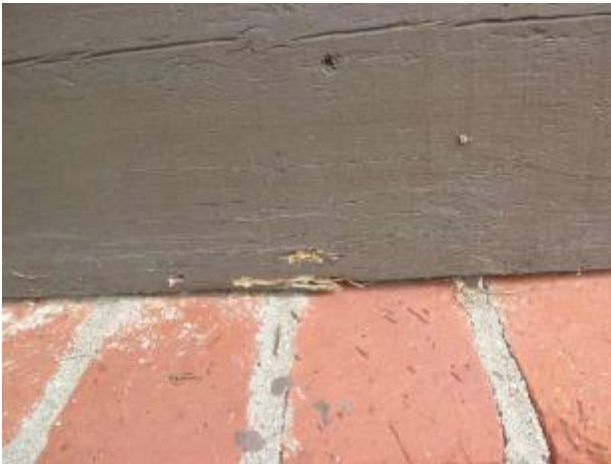
- 2.) There is possible termite damage and infestation at the following locations:

Example of termite damage to the wood trim.

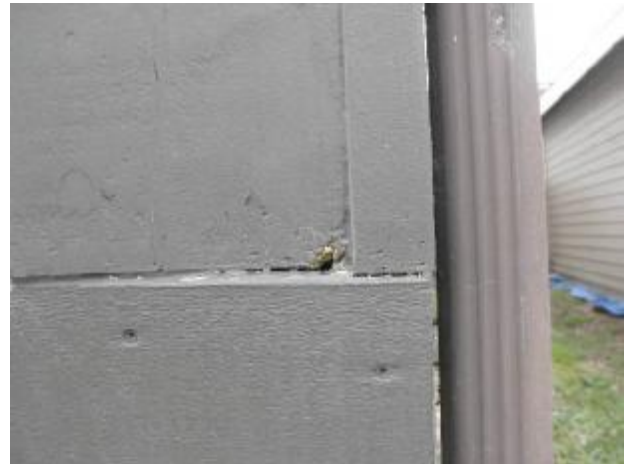
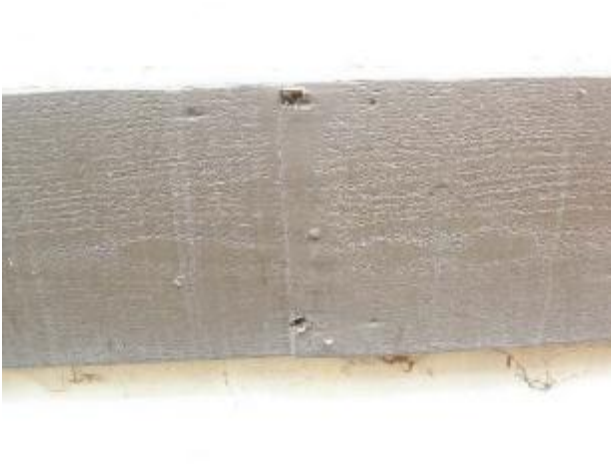
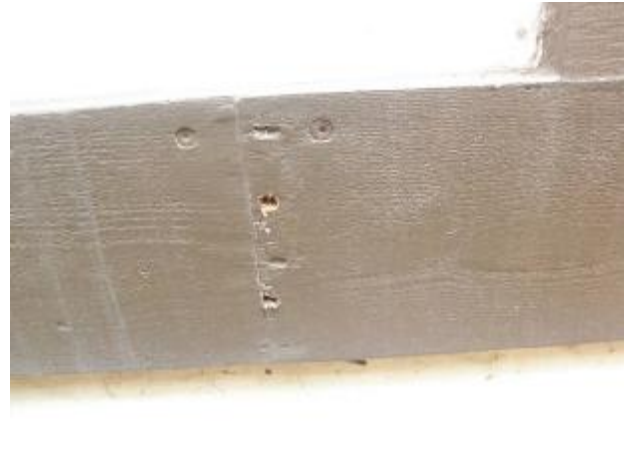
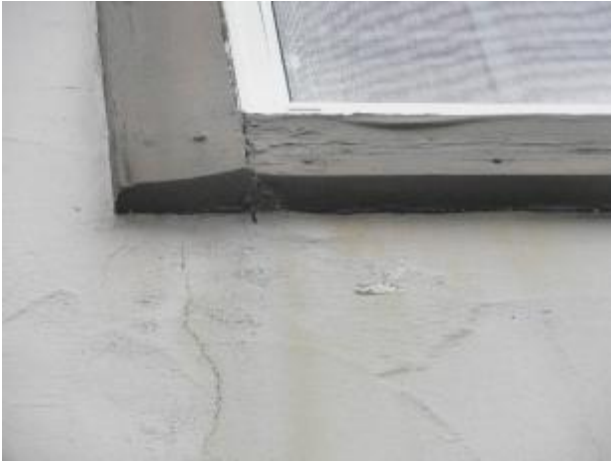
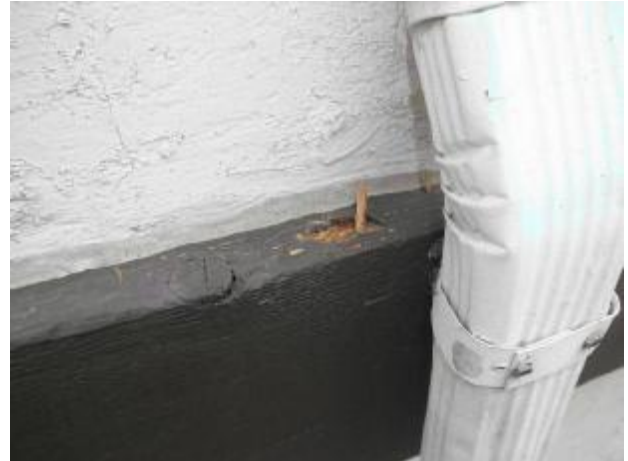
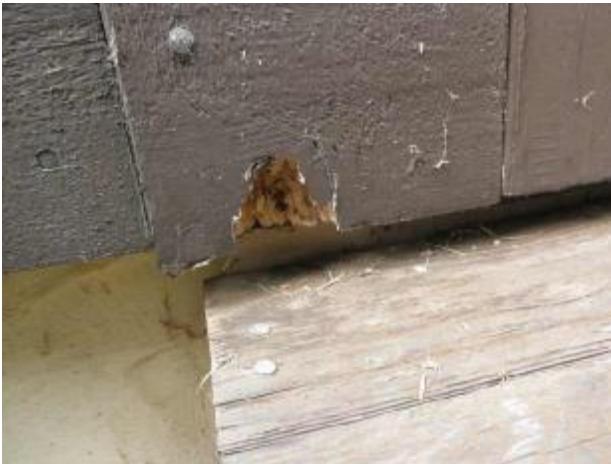
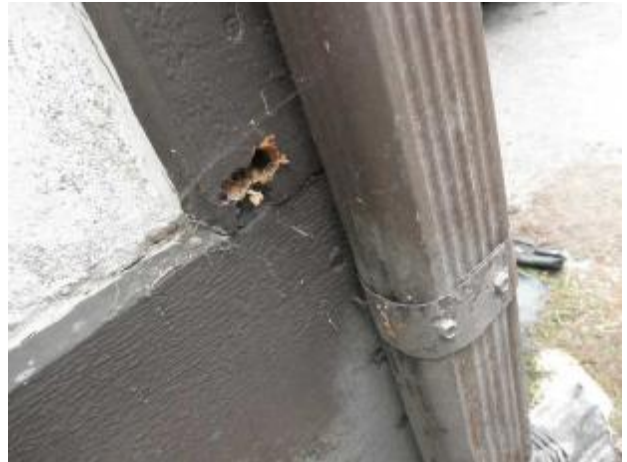
- 1.) There is moisture damage in the following locations:

Example of moisture damage to the exterior wood trim.

Example of moisture damage at the wood trim.

Moisture damage at the wood trim.

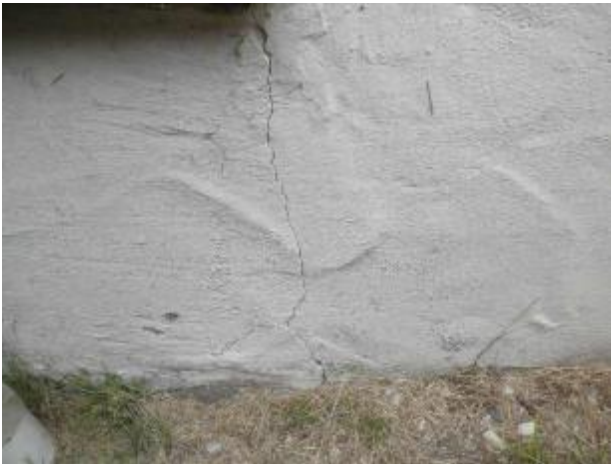
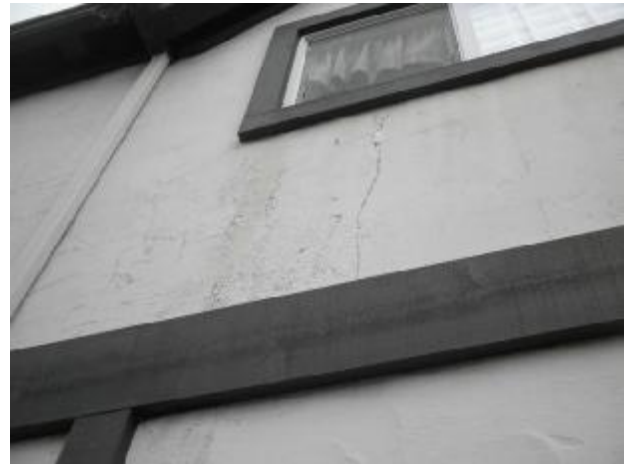
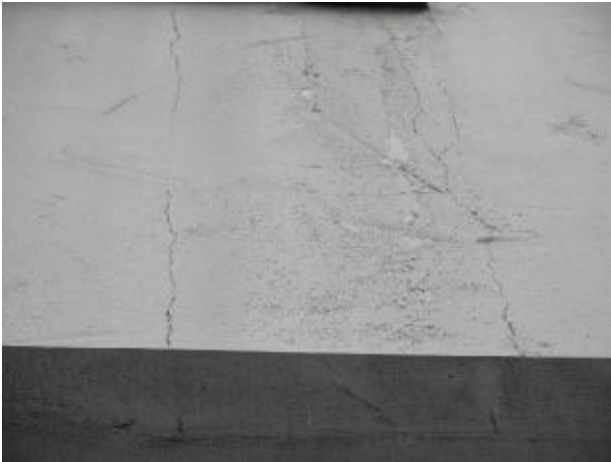
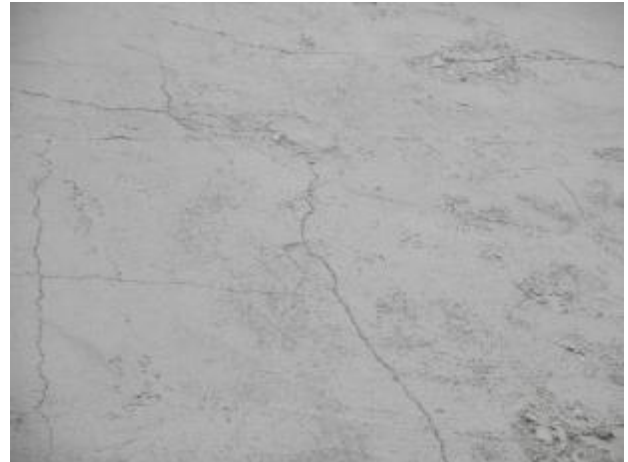
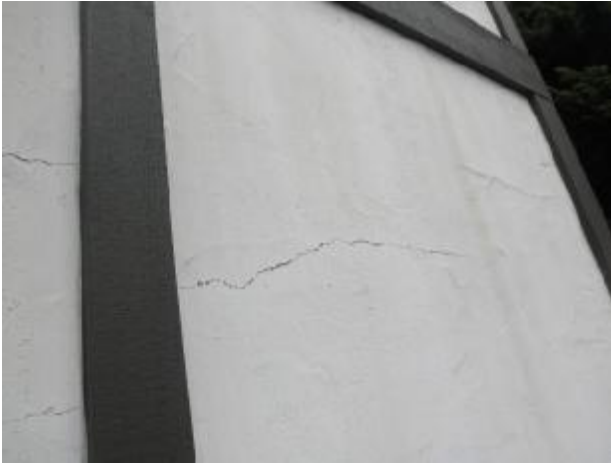
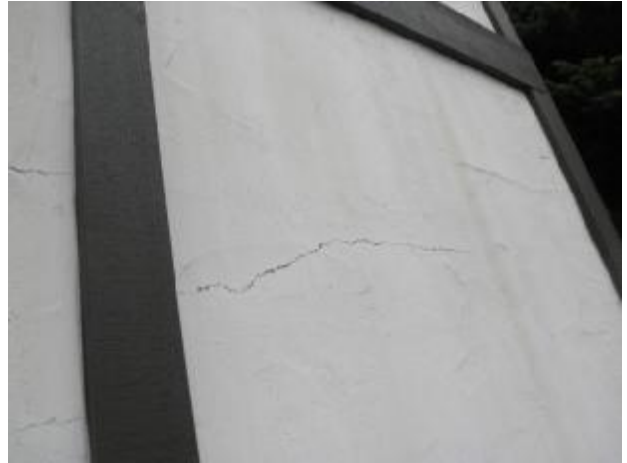
- 5.) There is excessive cracking at the SE portion of the stucco wall. This may be due to water getting behind the stucco area. Recommend further evaluation by a qualified and licensed General Contractor prior to the close of escrow.

Excessive cracking at the stucco SE wall.

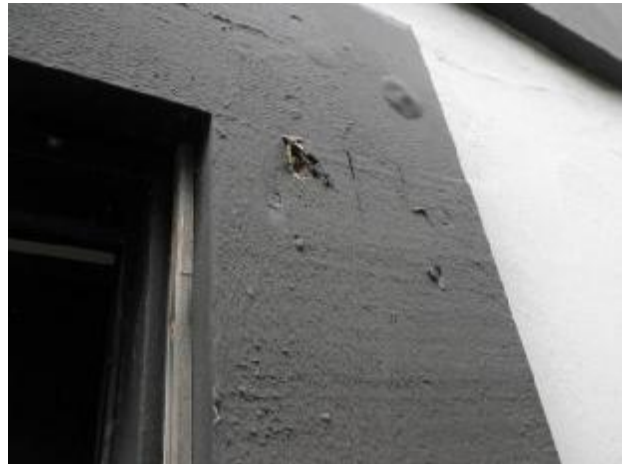
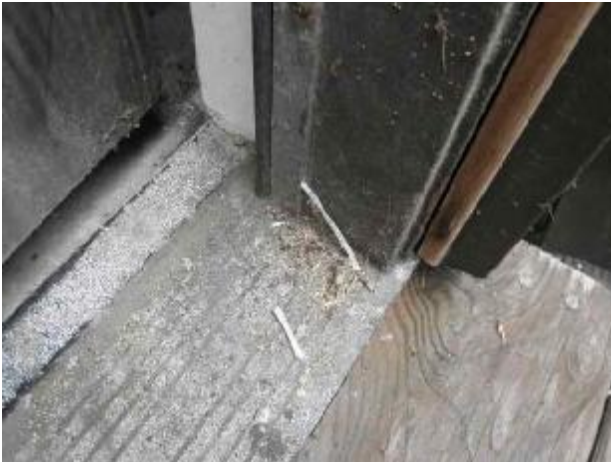
Moisture damage at the garage side door trim.

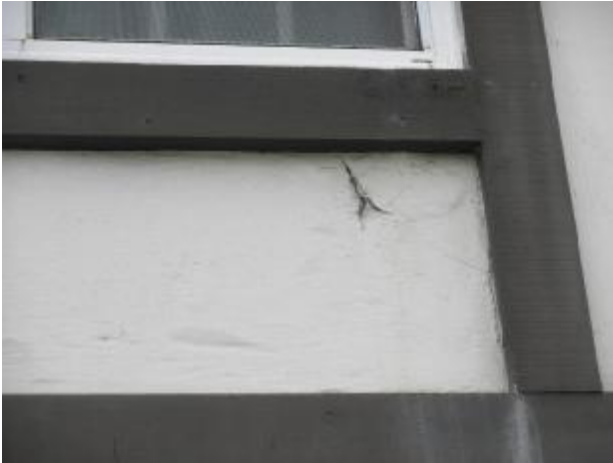
Damage to the stucco siding below the master bedroom window.

7.) There is damage to the stucco siding below the north master bedroom window.

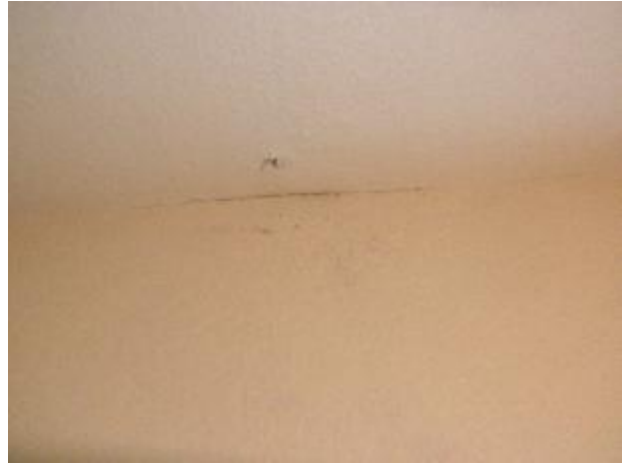
- 4.) There is an active leak at the siding as seen from the ceiling in the master bathroom. This is due to water getting behind the siding above the window area per the seller. Recommend repairs by a qualified and licensed General Contractor.

Active leak in the master bathroom above the toilet from the exterior siding.

1.) There is an active leak at the ceiling in the master bathroom. This leak appears to be from the siding per the seller.

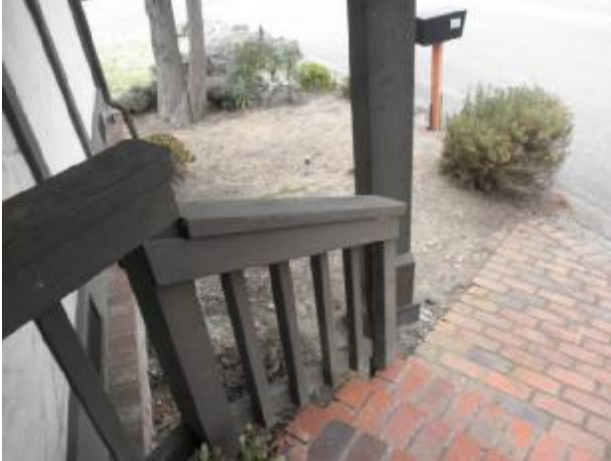
Nongraspable railing at the front entry.

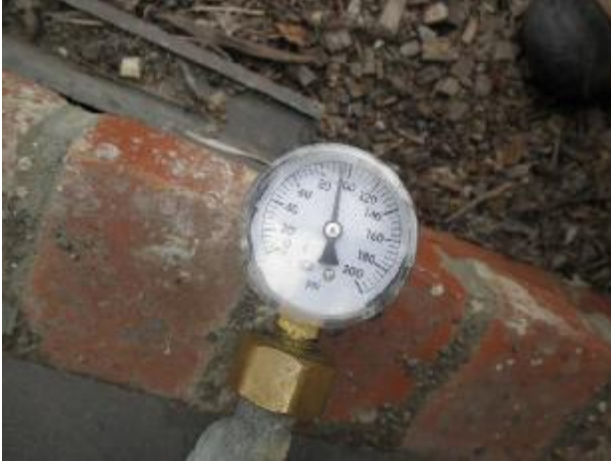
1.) The water pressure was measured at 95 psi. This exceeds the maximum allowable pressure of 80 psi. Recommend adjustment, rebuilding or replacement of the pressure regulator as needed to prevent a possible rupturing of a water line and flooding the home.

Water pressure is 95 pi.

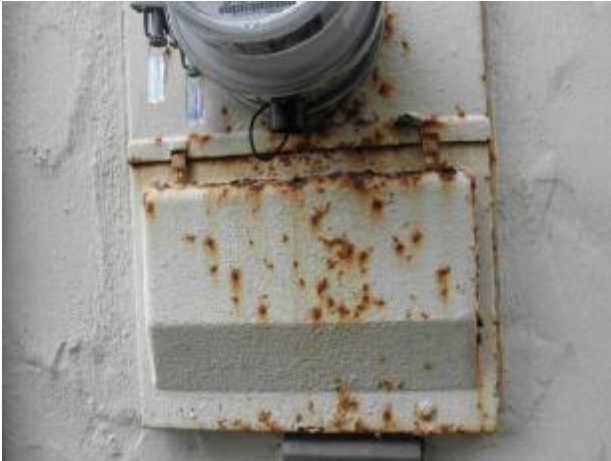
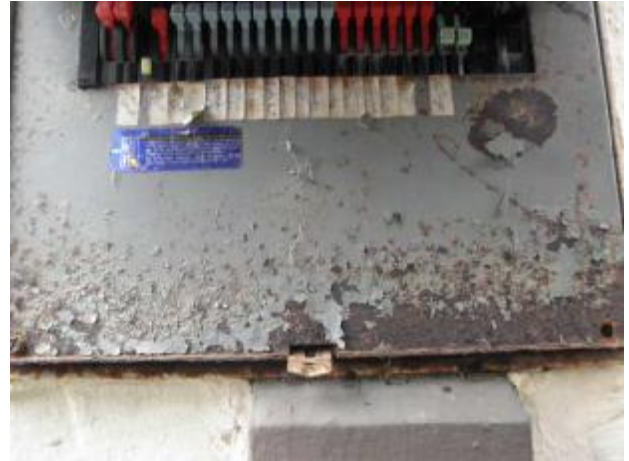
Rust damage at the main electrical panel.

1.) There is rust damage to the front of the main electrical panel and the dead front cover.

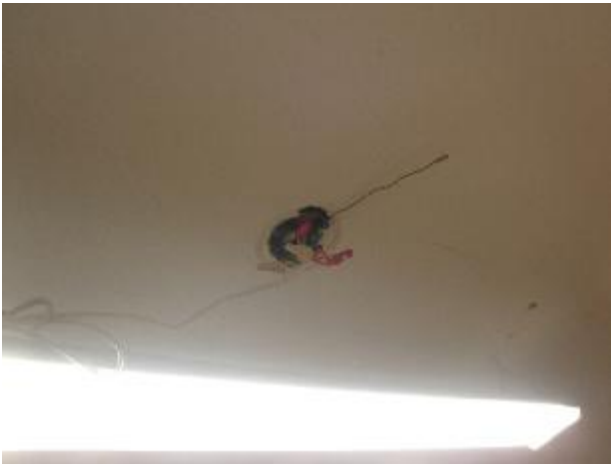
Spliced exposed wires in the garage.

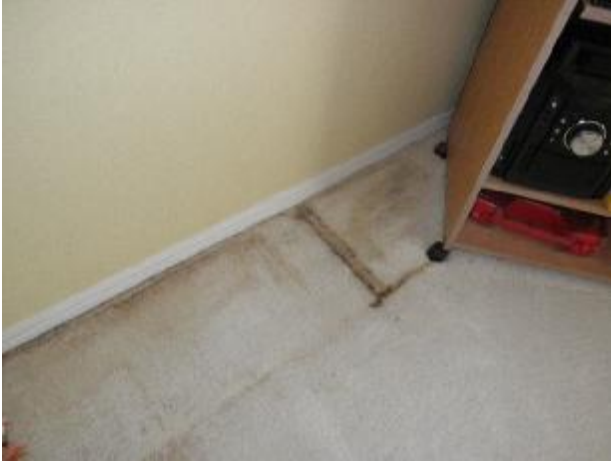
Old leak at the SW bedroom.

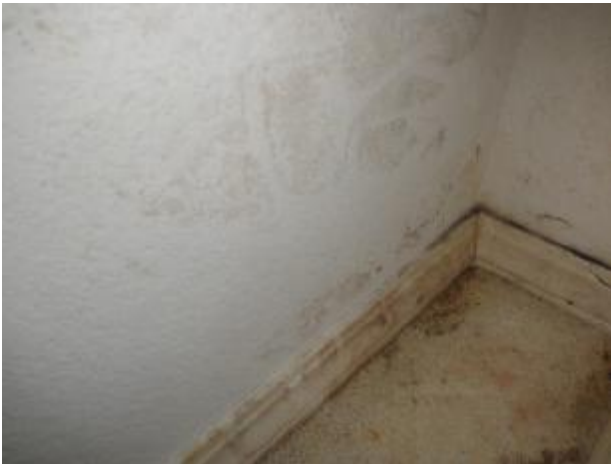
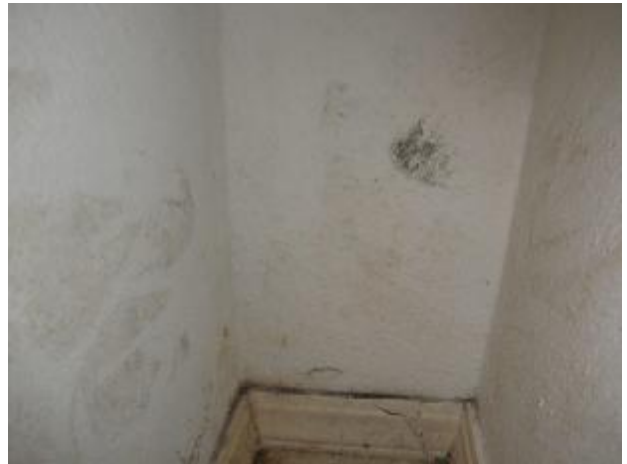
2.) There is an evidence of a leak at the base of the wall in the south hall bedroom closet. This has caused a black mildew like substance on the drywall. (See notes on the Deficiency Summary page at the end of the report regarding the potential for microbial contamination.)

Evidence of a leak at the south bedroom closet with black mildew like substance.

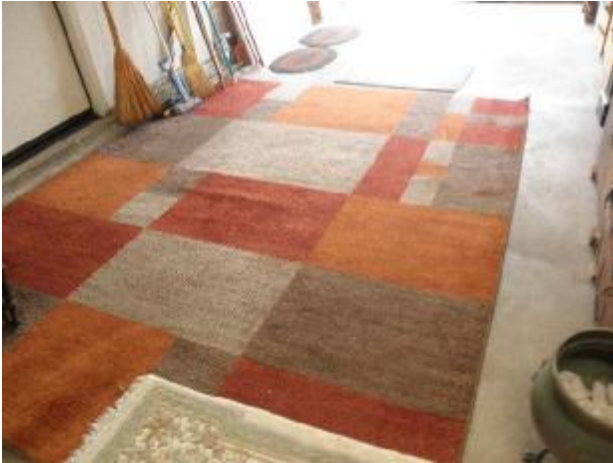
- 20 Fire Safety Hazard Note: The carpeting in the garage can absorb combustible chemicals and oil drippings from vehicles. For this reason we recommend removal of the carpeting in the garage.

Carpeting should be removed in the garage.

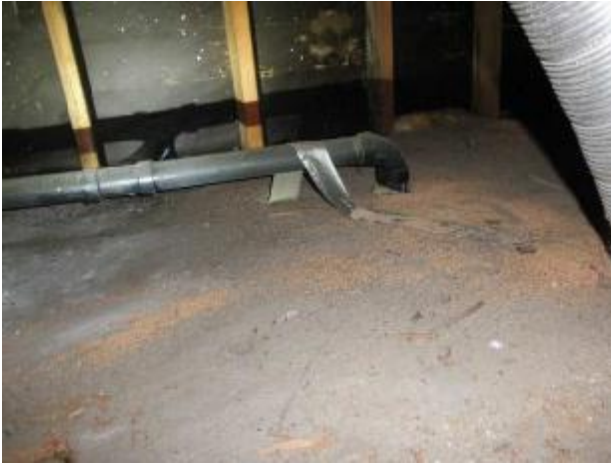
- 17 **Information Note:** There is evidence of possible termite infestation in the attic. Recommend further evaluation by a qualified and licensed Pest Control inspector prior to close of escrow.

Evidence of termites in the attic space.
