### *Inspection Report*

Address: 43 Buena Vista Ave San Luis Obispo, CA 93405

10/05/2026

Inspector: Taylor Vreeken, CCI

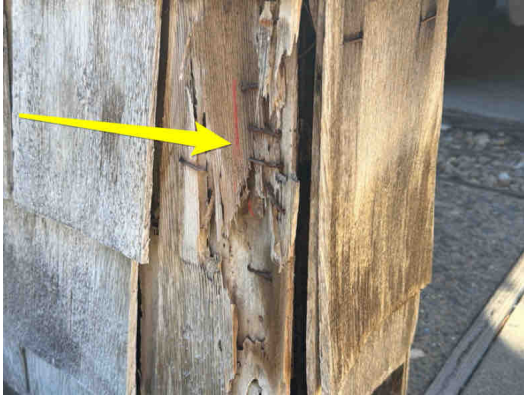
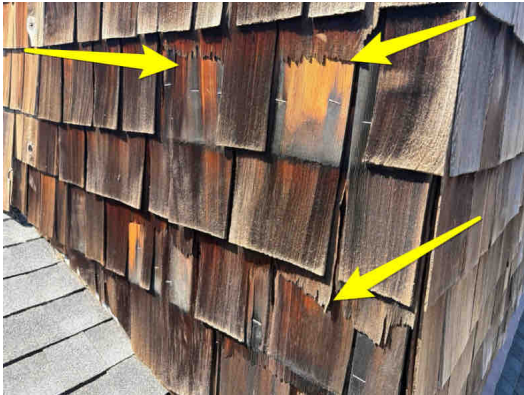
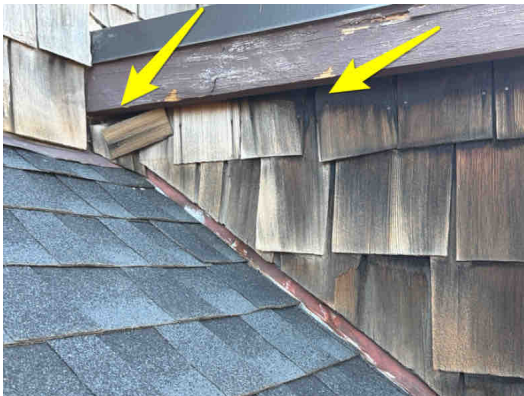
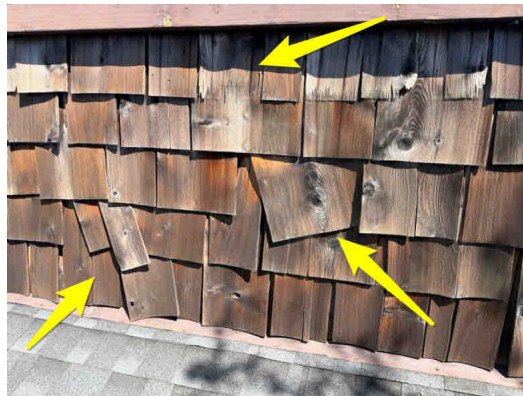
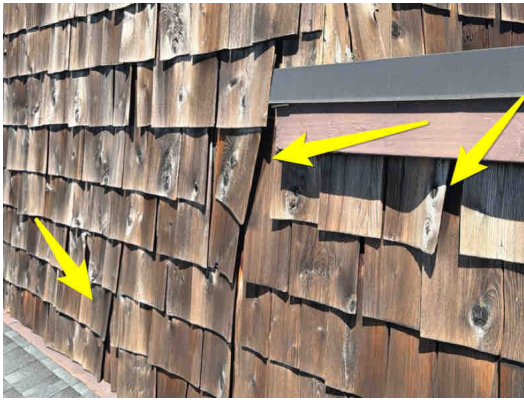
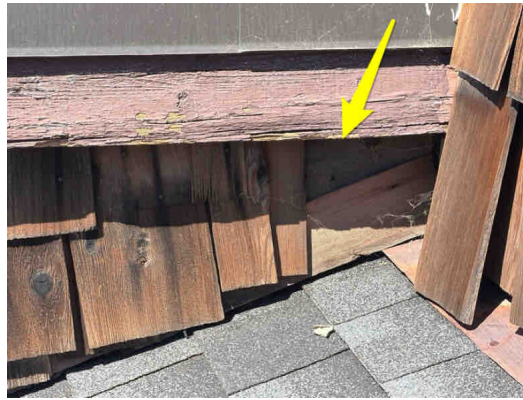
**E&C** **FI** **28:** Exterior wood shingle siding found heavily weathering/ deteriorated, with multiple areas of damage/deterioration. Too many individual defects and locations to list. Referred to termite report. Contact a qualified professional evaluation and repairs/replacement.

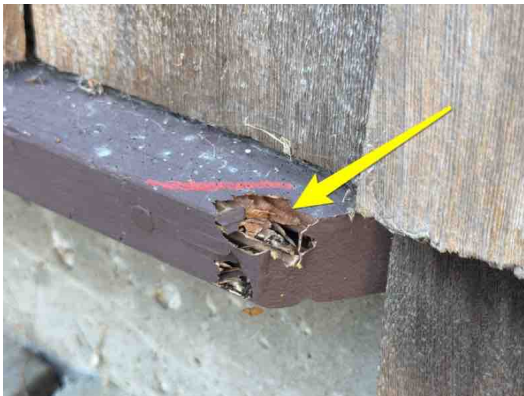
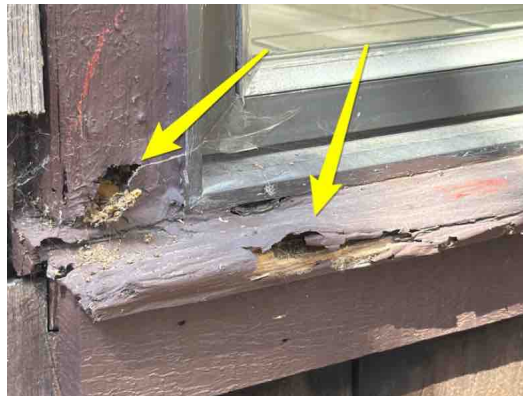
**E&C 32:** Some moisture and/or bug type damage & deterioration found at exterior areas such as eaves, fascia and/or trim. Refer to the termite report for locations and extent.

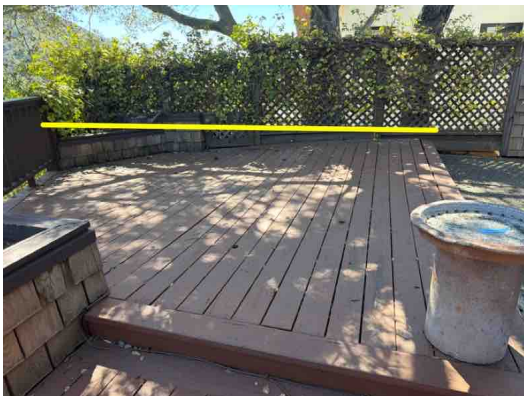
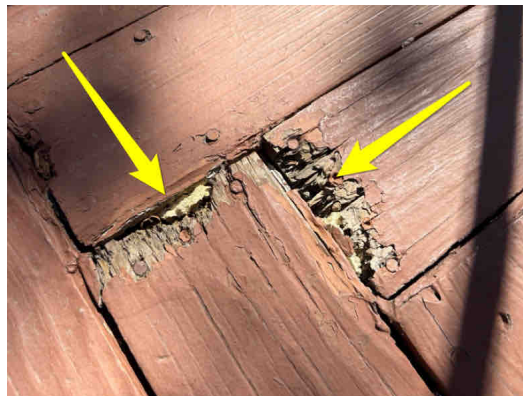
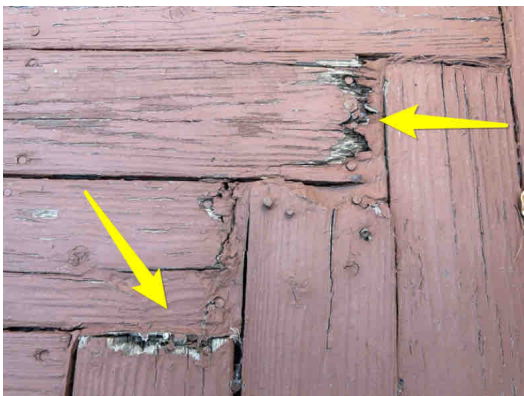
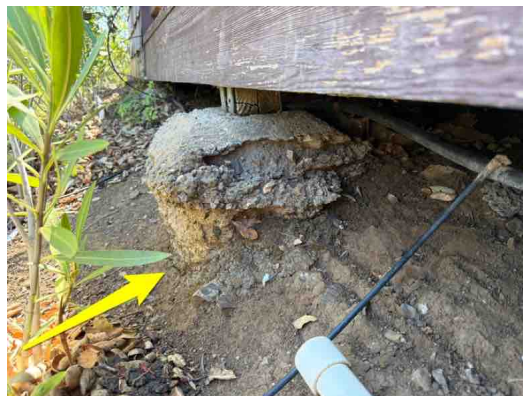
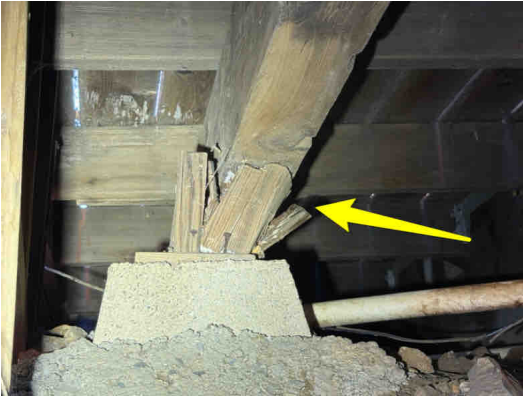
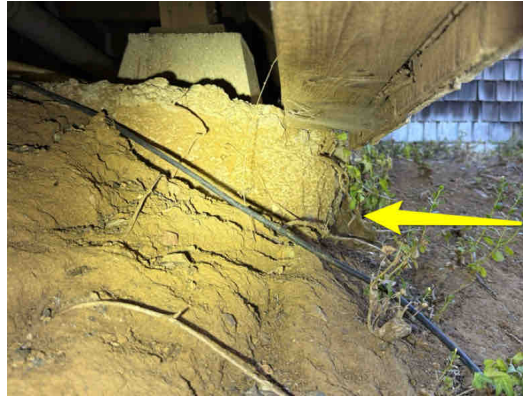
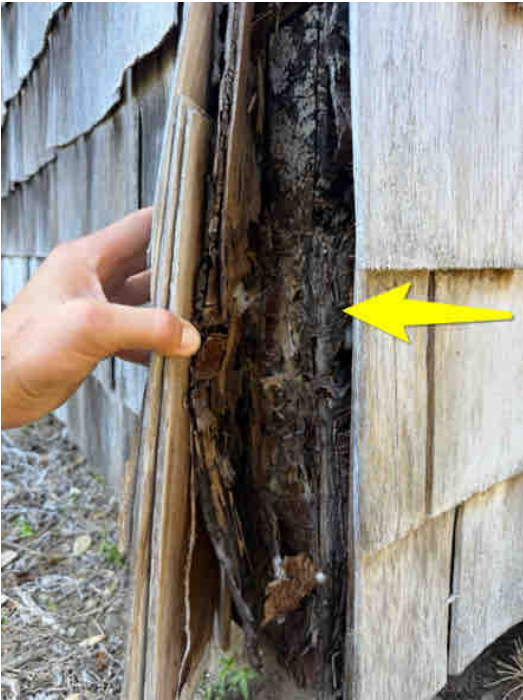
**E&C SC FI 35:** The NORTHWEST, NORTH, AND NORTH EAST WOOD DECKS have moderate to heavy moisture damage, structural settlement, and appear to be at the end of serviceable life. Too many individual defects and locations to list. Contact a qualified contractor for evaluation and repairs or replacement.

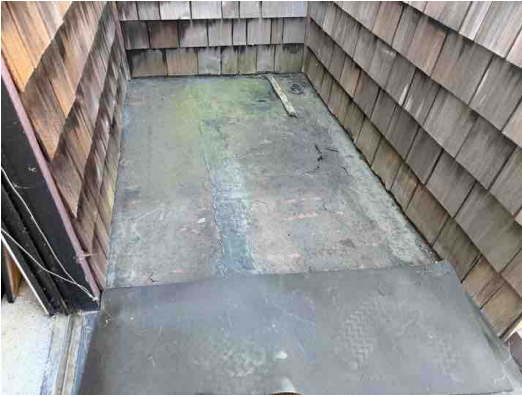
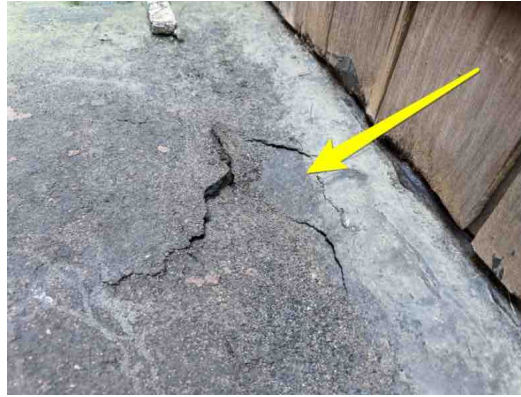
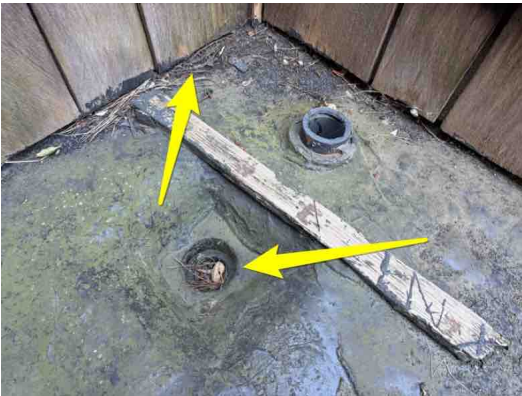
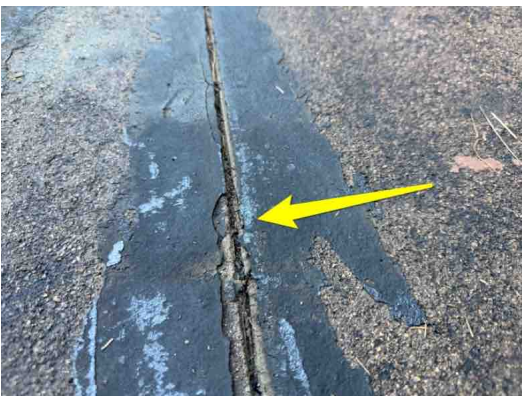
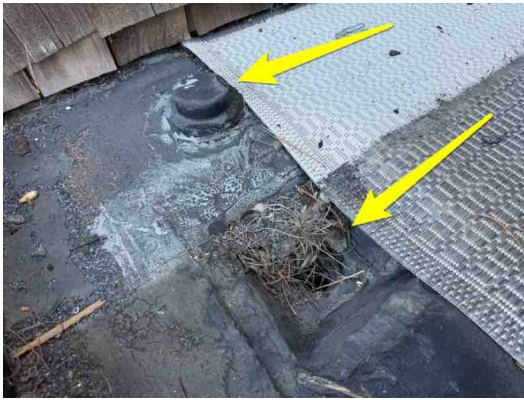
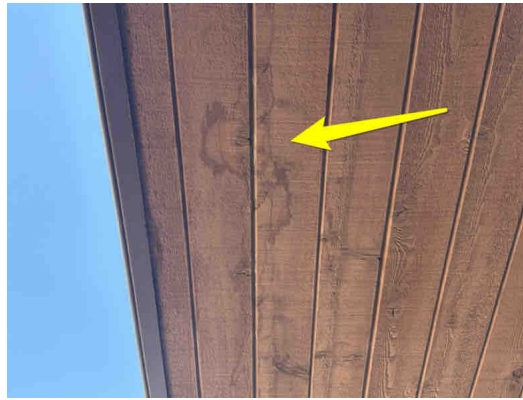
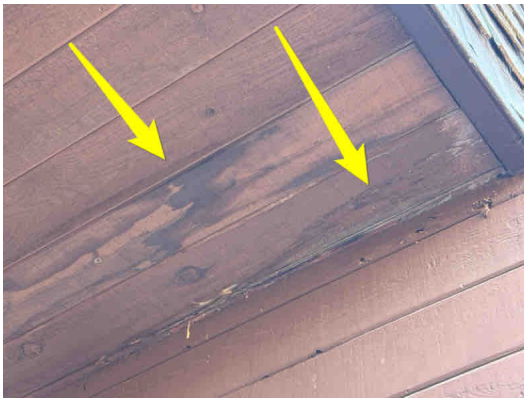
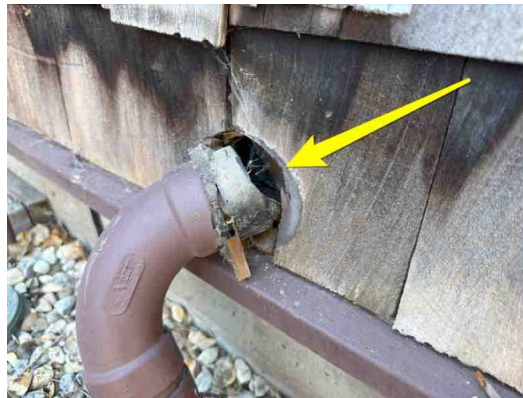
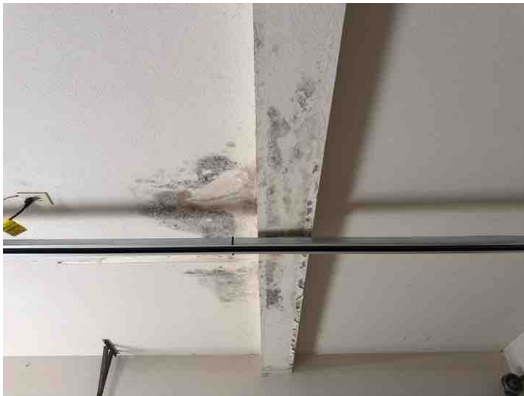
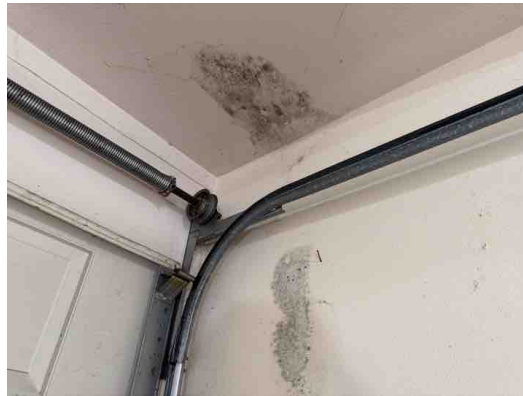
**E&C SC FI 36:** Both waterproof deck assemblies are heavily deteriorated and exhibit numerous defects, including cracked, separated, patched, and deteriorated waterproofing materials; areas of exposed/damaged underlying decking; deteriorated or improper perimeter/transition flashing; debris accumulation; and improper or deteriorated drainage components. Drain covers are missing, and a secondary/overflow drain at one deck is capped/covered. Evidence of moisture staining was also observed below portions of the decks. Due to the extent of deterioration and numerous defects, the waterproof integrity of these assemblies is considered compromised, and concealed moisture damage may be present that is not visible during a non-invasive inspection. Recommend comprehensive evaluation and repair/replacement as necessary by a qualified waterproof-deck/roofing contractor, including evaluation of the underlying sheathing/framing for moisture-related damage.

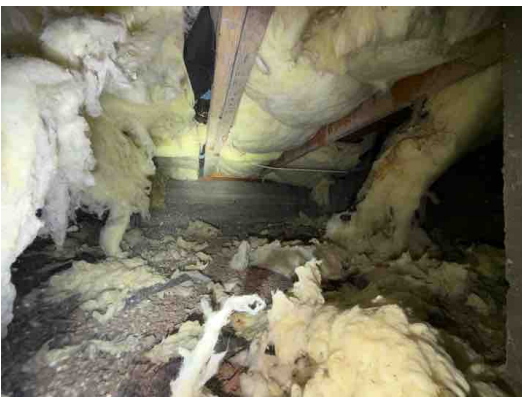
**MR 49:** Some loose, hanging or missing insulation in areas of the crawlspace.

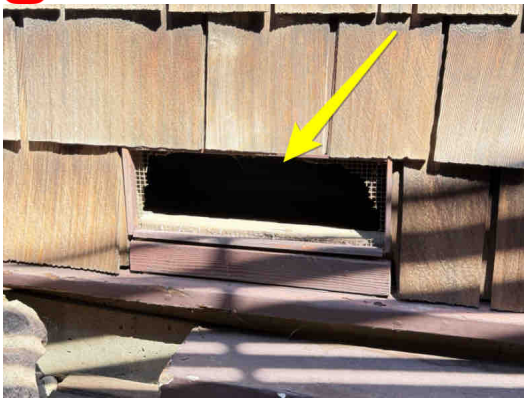
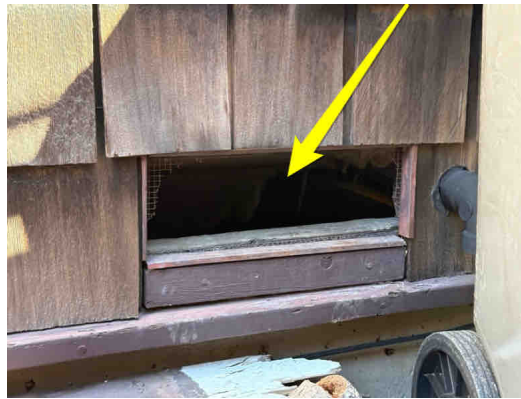
**E&C 53:** Damaged exterior crawlspace ventilation screens found in need of repair to help prevent critter intrusion.

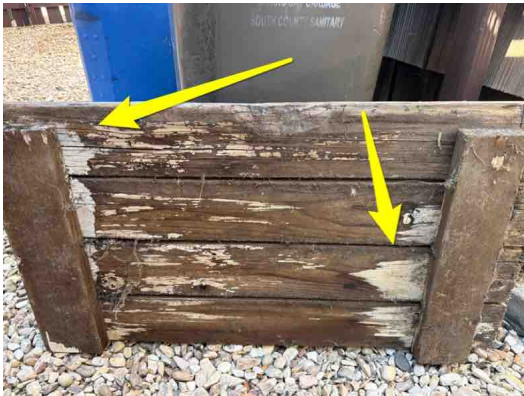
**E&C 54:** Moisture and/or bug type deterioration and/or damage found at the crawlspace access cover. Refer to the current Termite / pest inspection report for additional comments.

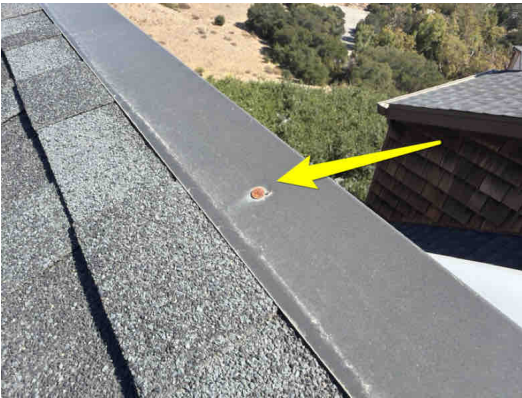
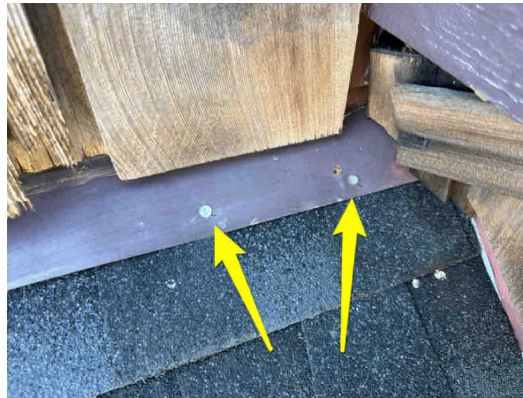
**MR 61:** Recommend sealing / covering the exposed nails at areas of roof flashing help prevent the nail from becoming loose and or becoming a roof leak. Maintenance recommended.

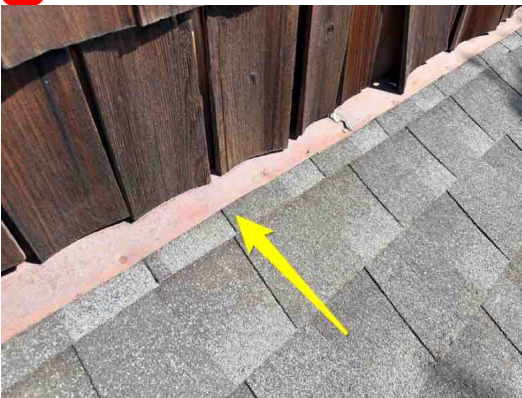
**FI 62:** Some roof flashings found rusted and deteriorated. Maintenance recommended.

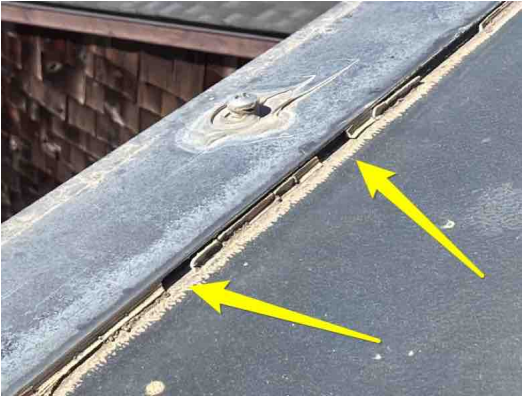
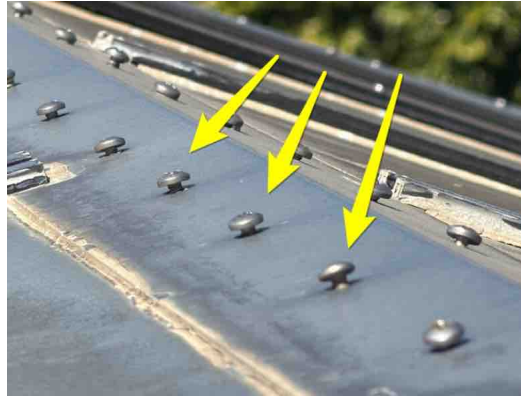
**E&C 64:** The large upper roof field-installed/custom skylight shows widespread deterioration and deferred maintenance, including deteriorated/missing sealant, separation and lifting at glazing/metal components, and numerous loose/backing-out fasteners. These conditions may compromise the skylight's weather resistance and increase the potential for water intrusion. Due to the custom construction and numerous areas requiring attention, recommend comprehensive evaluation, servicing, and repair by a qualified roofing/skylight contractor familiar with custom glazing systems.

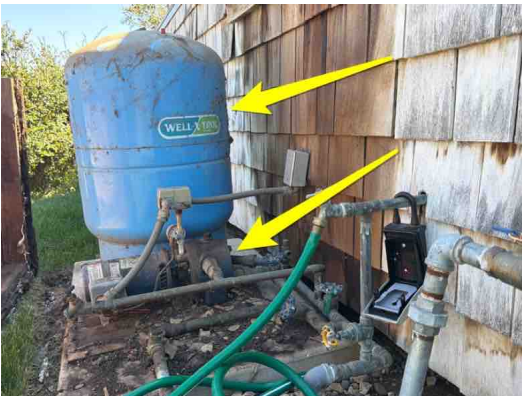
**E&C 76:** The water booster pump system does not appear to be operational. Recommend further evaluation by a licensed plumbing contractor familiar with booster systems.

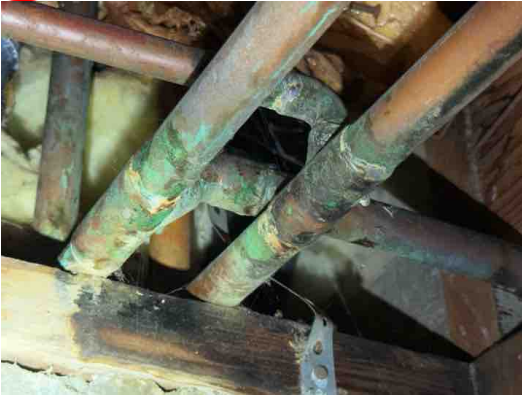
**E&C 81:** Some moderate corrosion noted at areas of the copper water supply piping in the crawlspace.

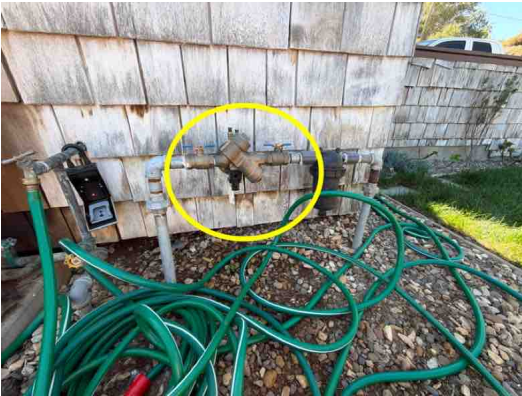
**E&C 82:** Active water leak found at NORTH EXTERIOR BACKFLOW PREVENTER DEVICE. Recommend further evaluation and repairs by qualified plumbing professional.

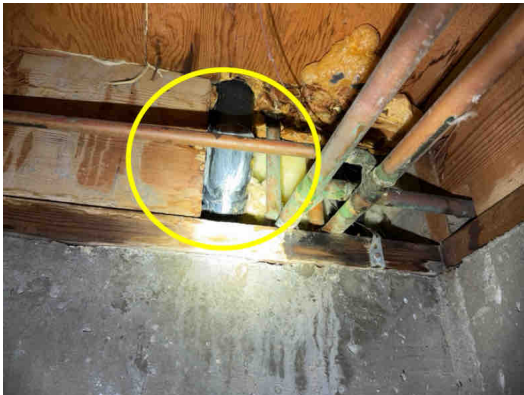
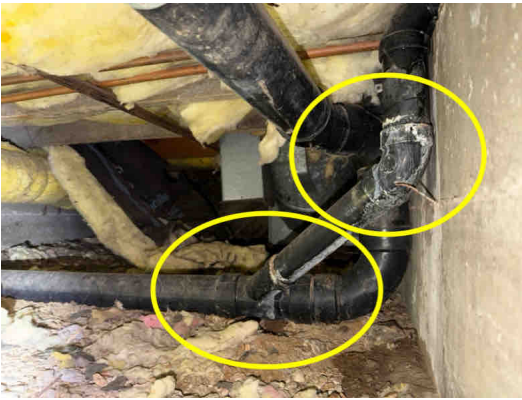
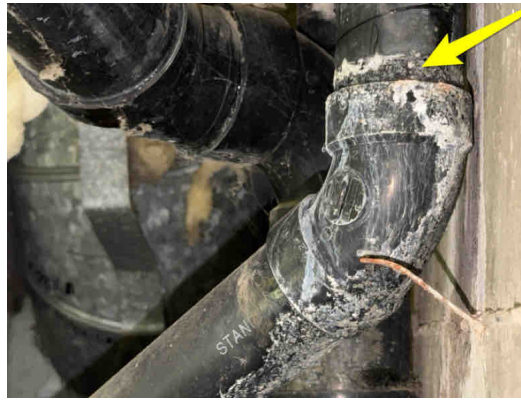
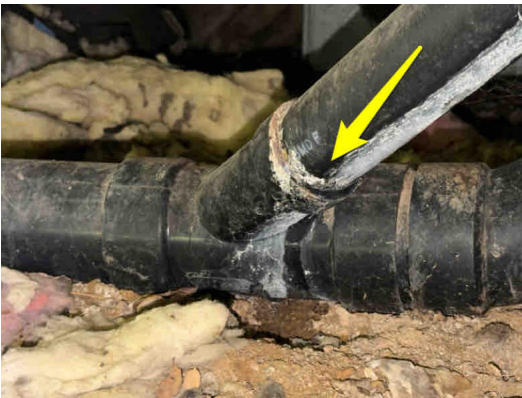
**E&C FI 89:** Active water leak(s) found in the waste pipe in the crawlspace: BELOW THE LAUNDRY AREA HALF BATHROOM. Have plumber check all waste piping throughout the crawlspace for any additional leakage.

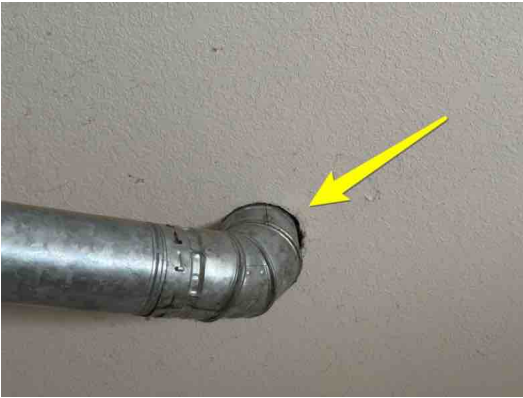
**SC 99:** Water heater vent pipe too close to combustibles as it passes through the drywall. Proper corrections are recommended per standards. Contact a qualified plumber.

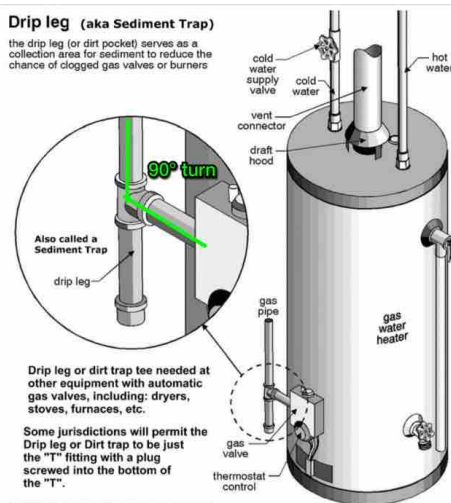
**SU 103:** Recommend the installation of the missing sediment trap / drip leg at the WATER HEATER gas piping at flex connection by a certified or licensed plumbing professional familiar with minimum requirements. [CPC 1212.8]

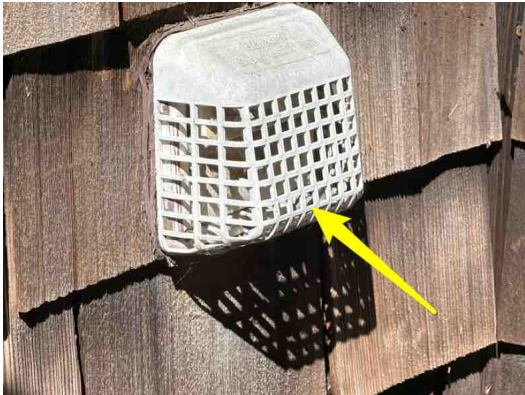
**SC 133:** An improper and unsafe use of a screened laundry dryer vent cap. A screened cover can collect lint and clog laundry dryer vent termination and is considered a safety hazard. Recommend corrections.  
(CRC § M1502.3)

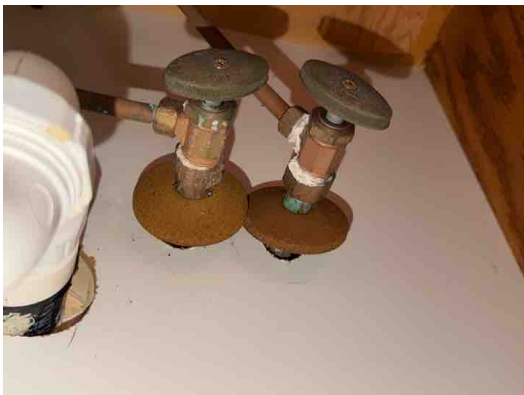
**FI 141:** Some corrosion found at water supply piping and waste piping connections under the bathroom sinks / evidence of past leaking.

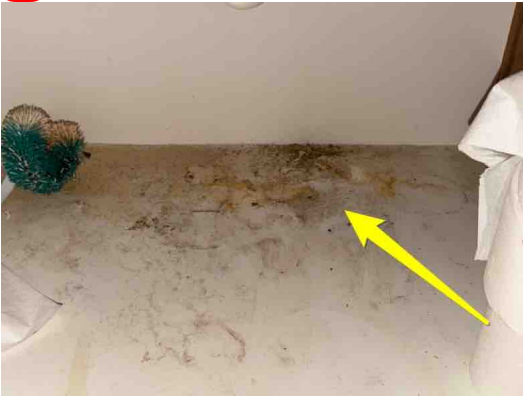
**FI** 142: Disclosure: Some minor past moisture stains noted below bathroom sinks.

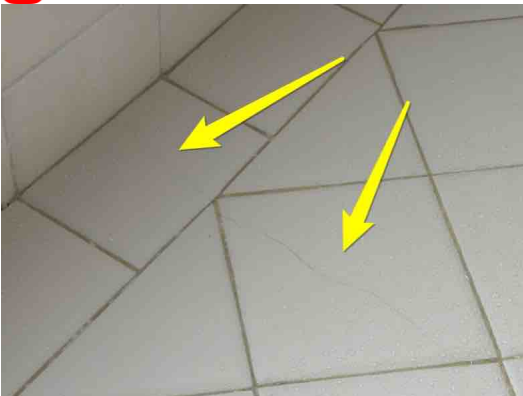
**FI** 148: Some cracked tiles found in the PRIMARY BEDROOM BATHROOM shower enclosure.

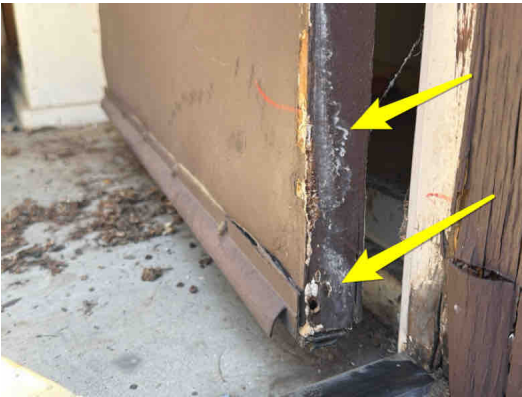
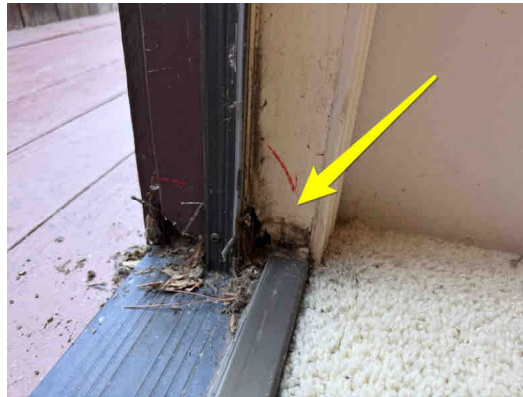
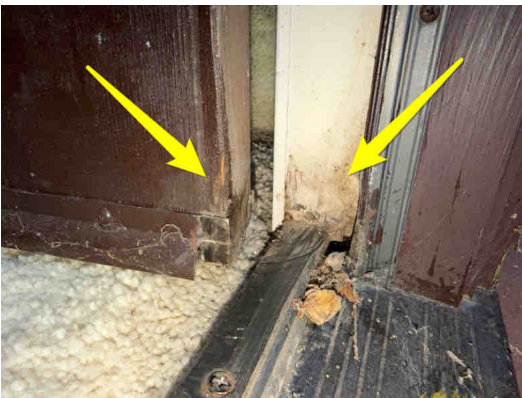
**E&C 157:** Moisture damage noted at multiple exterior wood doors, door jams, and/or trim components. Refer to termite report for extent and location locations.

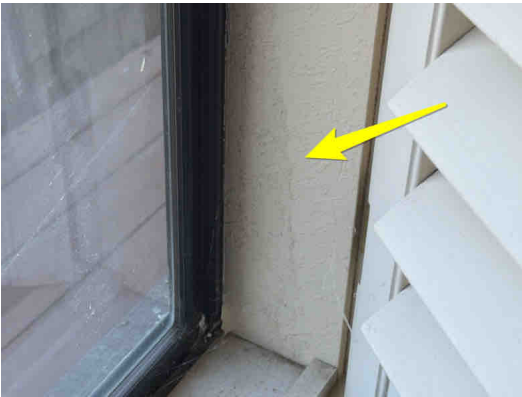
**FI 165:** Moisture stains and/or damage on the inside at some window sills. Refer to the termite report for additional comments and recommendations.

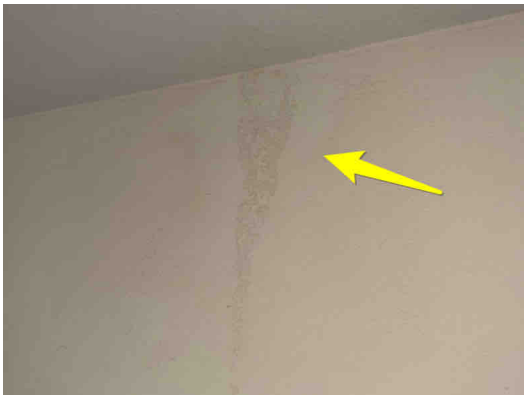
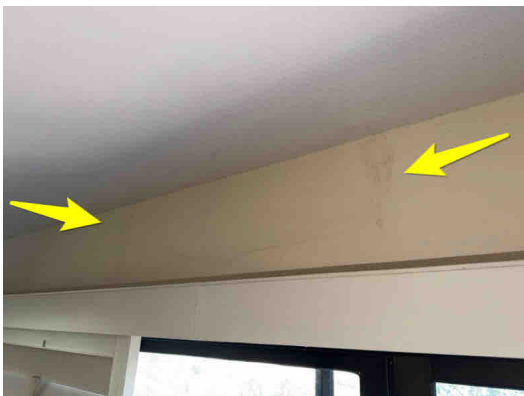
**FI 174:** Evidence of moisture stains and/or damage at the walls throughout the interior. Too many individual locations to list. Recommend further review of the water stains to determine the cause, the current condition and if repairs are needed.

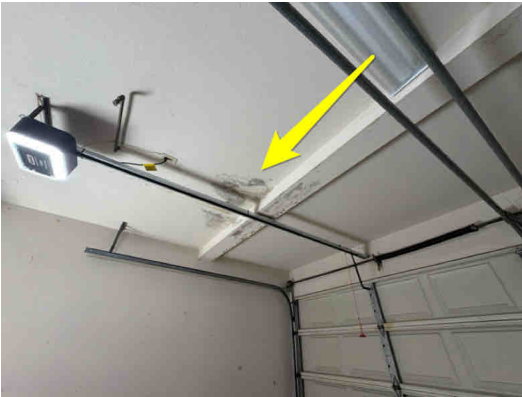
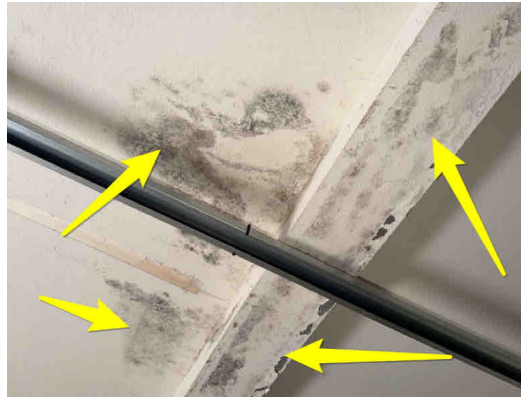
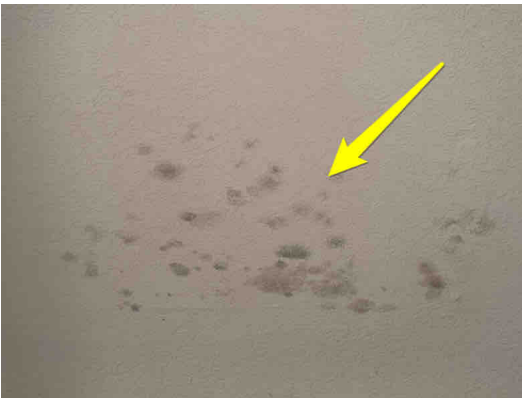
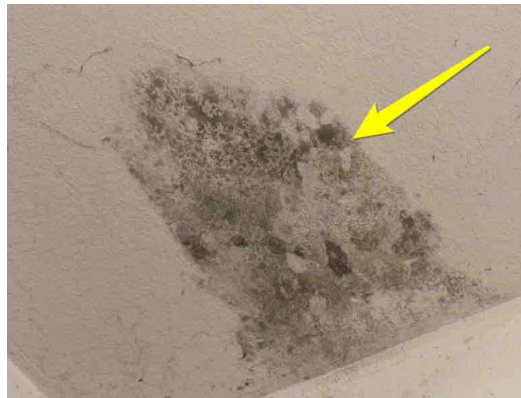
**SC FI 175:** Evidence of past moisture stains & damage with some visible mold growth on areas of the drywall: IN THE GARAGE BELOW THE UPPER WATERPROOF DECK and ADJACENT ROOFING. Recommend additional review by a qualified remediation professional. Recommend further review to determine if stains are current or old and if repairs are needed.

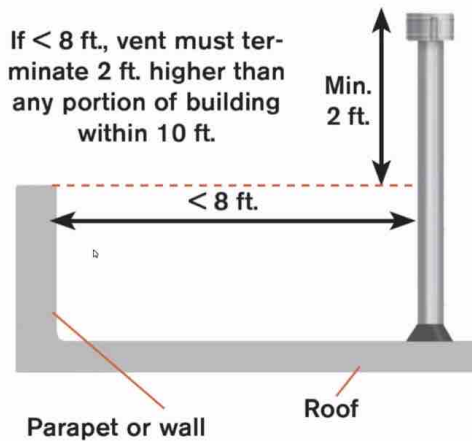
**SC 184:** The Furnace vent pipe terminates too low at roof. This can negatively affect the drafting of the furnace. A vent pipe within 8 feet of a headwall is required to terminate 24 inches above the upper roof. Contact a qualified plumbing professional familiar with minimum safety requirements for recommendations, repairs or upgrades.

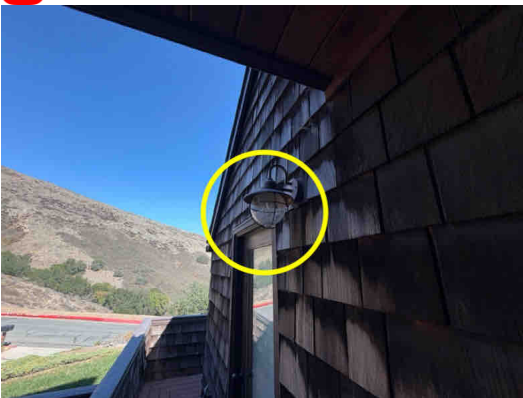
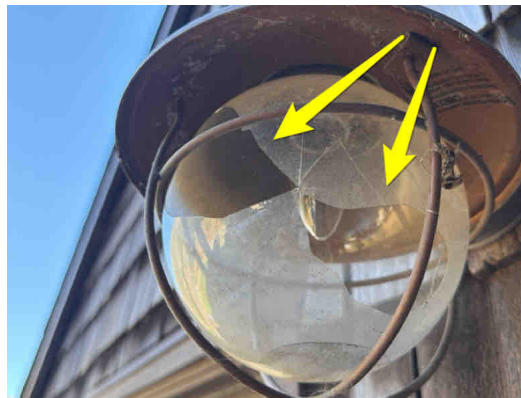
**E&C 197:** Lens at light fixture is cracked: EXTERIOR AT ENTRY

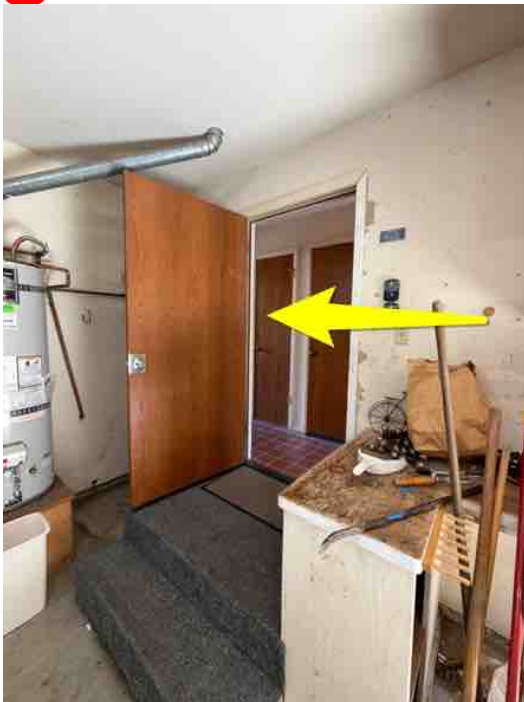
**SC 209:** Self-closer is non-operational at garage fire rated door to the living space.

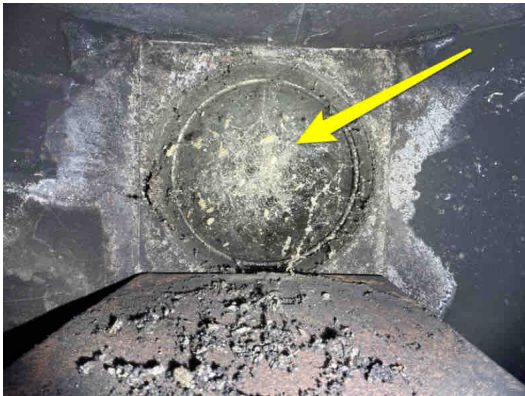
**MR** **225:** Recommend cleaning & sweeping the LIVING ROOM fireplace and chimney by a qualified chimney sweep.

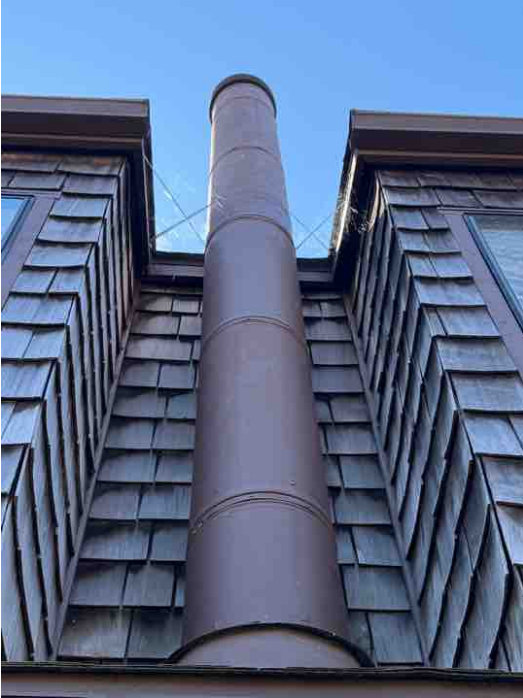
**E&C 233:** The fireplace chimney extends a substantial distance above the roof with no readily visible lateral bracing/support. Factory-built chimney systems are required to be installed and supported in accordance with the manufacturer's listed installation requirements, which commonly require additional support for extended chimney heights. Recommend evaluation and installation of required bracing/support by a qualified fireplace/chimney professional in accordance with the chimney manufacturer's specifications.
