# Building Inspection Report

**30136 Avenida De Calma, Rancho Palos Verdes, CA**

**Inspection Date:**  
9/1/26 2:00pm

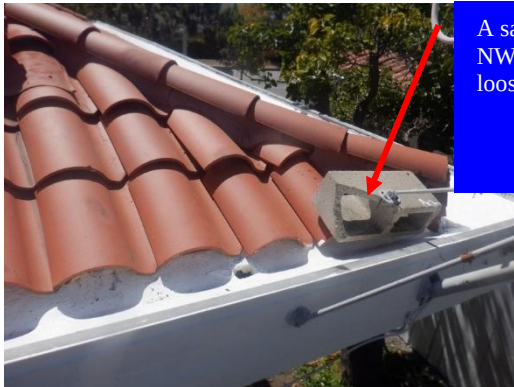
A satellite at the garage NW-corner is anchored to a loose concrete block

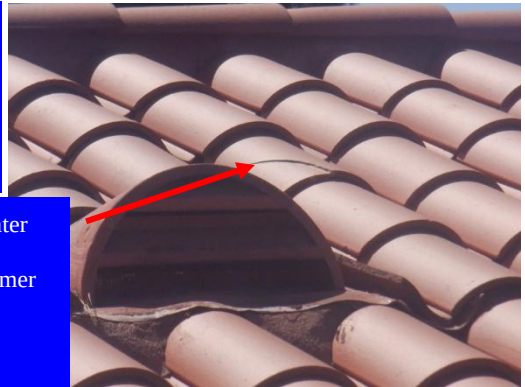
The roof's N-slope center area has a cracked tile adjacent to an attic dormer vent

- **Improve:** Minor repairs to the roofing are recommended (a cracked tile noted at the N-slope above a dormer vent, debris within the valleys at the E-slope, etc.); suggest corrections by a licensed roofing contractor.
- **Monitor:** The built-in gutter inlets should be provided screens/strainers.

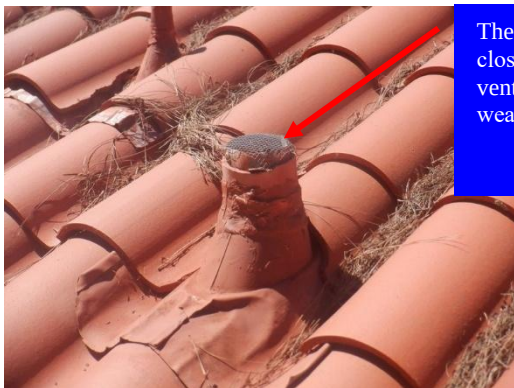
The E-exterior water heater closet's abandoned exhaust vent pipe is open to the weather...

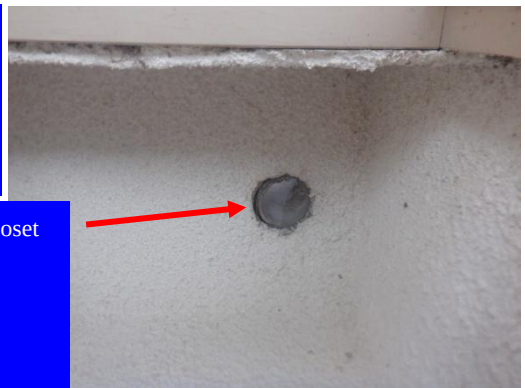
...That can enter the closet

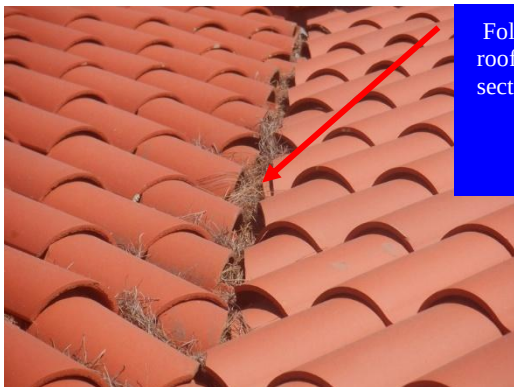
Foliage and debris upon roof slopes and valley sections should be removed

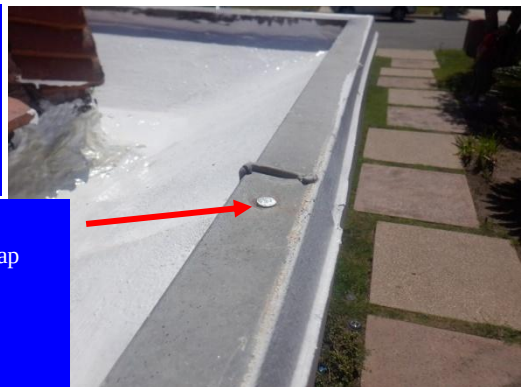
A few fasteners at the fascia board flashing cap require sealant

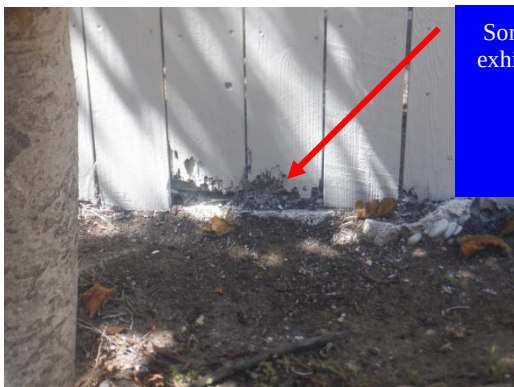
Some fencing sections exhibit deterioration

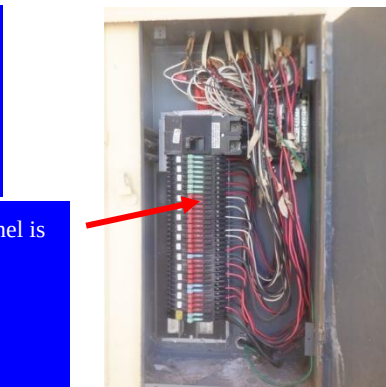
- **Safety Issue/Major Improve:** The "Zinsco-Sylvania" main electrical panel is an older component with known reliability/safety issues that feature both breaker and buss-bar configurations/design long abandoned. Further, the performance/reliability of these older units is considered to be fully depreciated and requiring immediate replacement (some insurance carriers are requiring their replacement); suggest corrections by a licensed electrical contractor.

The main electrical panel is a problematic Zinsco unit...

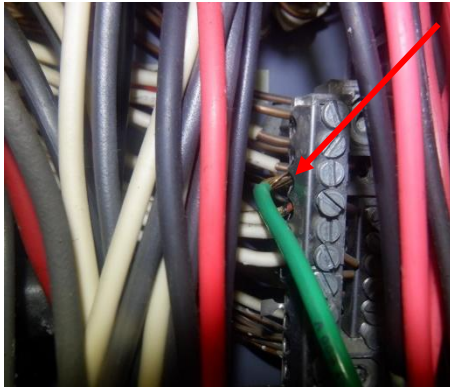
- **Safety Issue:** The electrical panel has a white insulated neutral conductor sharing a bus bar terminal with a green insulated equipment grounding conductor which is prohibited. White insulated neutral conductors must be provided a dedicated terminal to prevent arcing hazards; suggest repairs by a licensed electrical contractor.

...Where a white insulated neutral conductor and green insulated equipment grounding conductor share a bus bar terminal which is prohibited

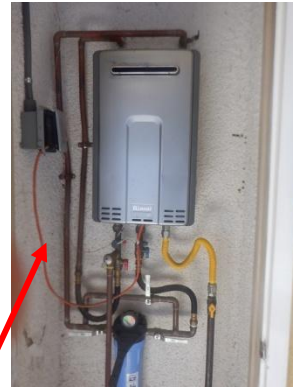
The tankless water heater uses a hard-wired extension cord...

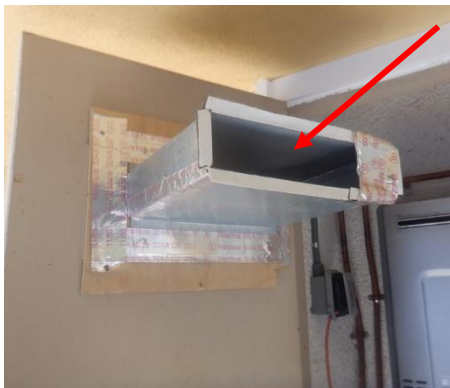
- **Safety Issue:** The tankless water heater is an outdoor unit that has been installed within an outdoor closet and fitted with an exhaust extension terminating at an opening in the closet door. This non-conforming exhaust assembly does not appear to have compromised the appliance or its operation but, such 'on-site' ingenuity would likely prevent any home warranty repairs. A better option would be to seal the door closed and mount the water heater to the outside of the door; suggest repairs by a licensed plumbing contractor.

...And the tankless water heater requires an on-site fabricated exhaust extension due to its improper location within a closet

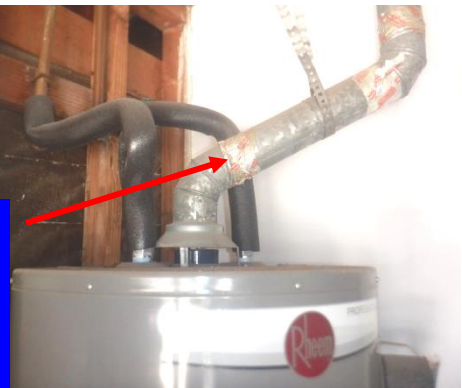
The garage water heater exhaust assembly is taped together when screws are specifically required

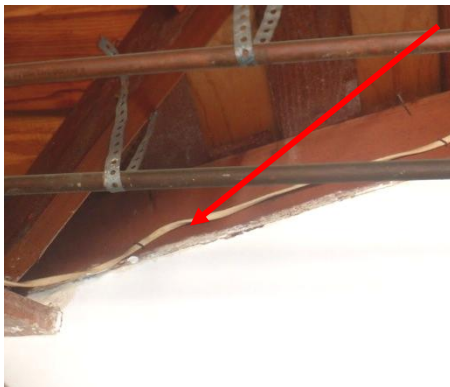
- **Safety Issue:** Exposed non-metallic electrical distribution cable/improper wiring noted at the garage rear wall overhead area present electrocution hazards as all exposed wiring must be enclosed within flexible or rigid metal conduit; suggest repairs by a licensed electrical contractor.

The garage rear wall overhead area has exposed non-metallic sheathed electrical distribution cable

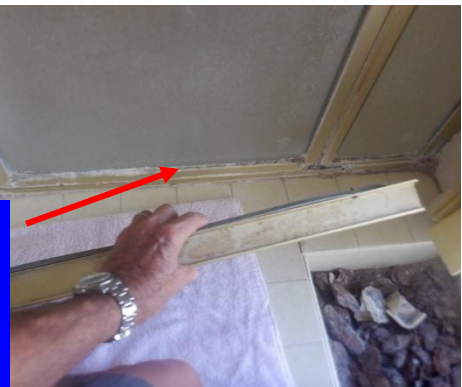
The master bathroom shower door frame shows extensive corrosion and a detached sweep seal

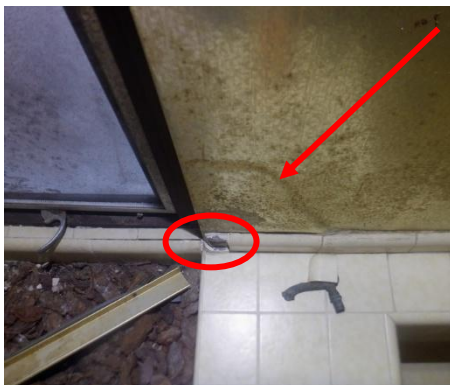
The master bath tub area rear wall and tile show damage

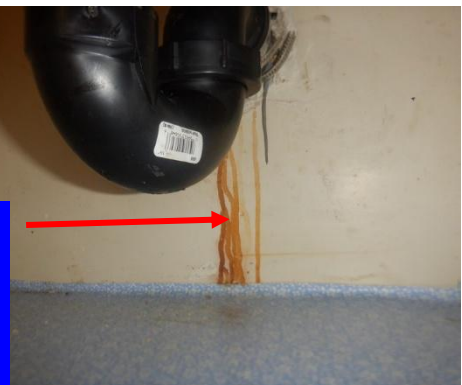
The master bathroom right sink drain assembly has leaked in the past

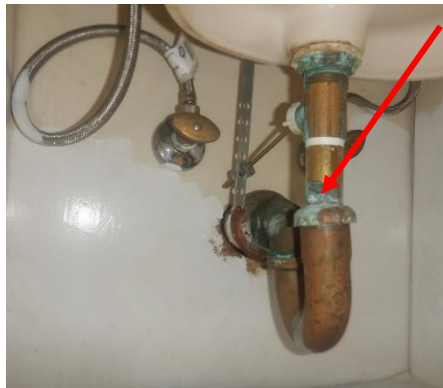
The E-hall bathroom right sink drain assembly is developing corrosion...

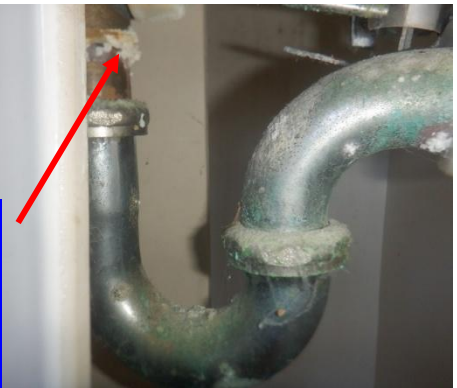
...As is the W-3/4 bath sink drain assembly...

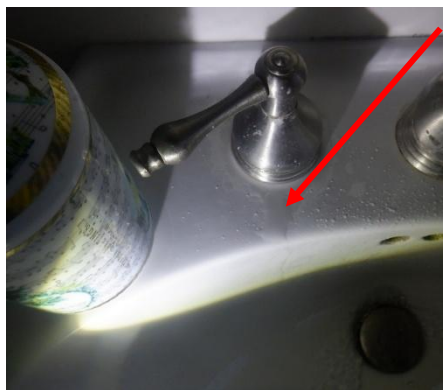
...Where that sink's hot water faucet leaks upon the sink deck

23. **Improve:** The W-3/4 bathroom sink hot water faucet leaks upon the sink deck; suggest repairs by a licensed plumbing contractor.

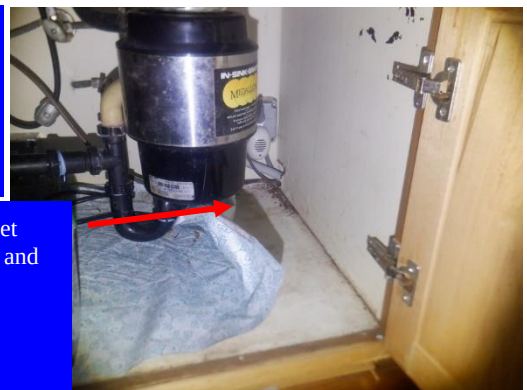
14. **Improve/Safety Issue:** The kitchen sink cabinet shelf and side panels exhibit damage and stains due to past water exposure that may have created conditions where hibernating organics exist at inaccessible areas. Areas of past moisture intrusion or current leakage often create conditions that are favorable for the growth of many fungus-like organisms (bacteria, mold, mildew, fungus and many other types of growth) that comprise indoor air quality. Damaged/stained materials should be replaced and/or the stained areas covered with an approved brush/roller application of mold encapsulating/neutralizing paint/surface treatment by licensed specialists following established protocols to assure organics do not 'kick-off' if re-wetted. Inspection for and identification of these conditions is beyond the scope of the CREIA Standards of Practice and would require consultation with an environmental specialist or licensed/Certified Industrial Hygienist.

The kitchen sink cabinet exhibits water damage and stains

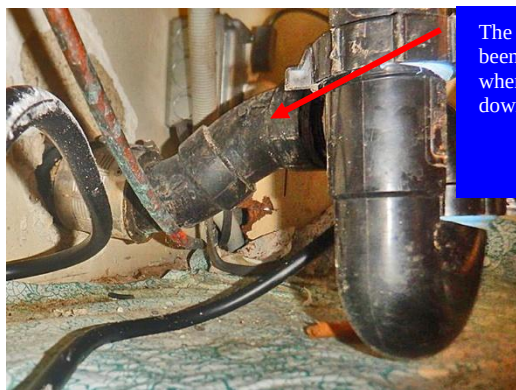
- **Improve:** An "S" trap has been used at the kitchen sink drain. S-traps should be replaced as they are subject to siphoning problems that drain the water seal from the p-trap and allow sewer gases to exit the drain inlet; suggest repairs by a licensed plumbing contractor.

The kitchen sink drain has been configured as an 'S-trap' where the trap arm has a step down...

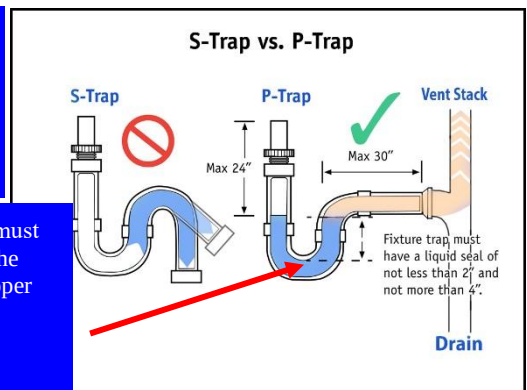
...When the trap arm must slope gently down to the wall inlet to assure proper drainage

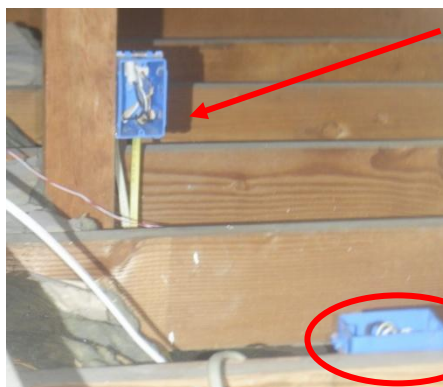
- **Safety Issue:** The master bedroom entry area attic has two open electrical junction boxes presenting fire/electrocution hazards that must be enclosed within **covered junction boxes**; suggest conforming installation.

The master bedroom entry area attic has open electrical junction boxes

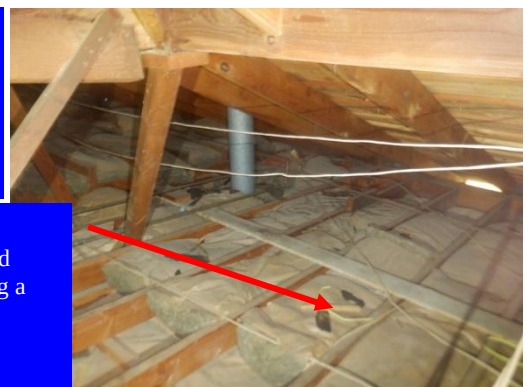
- **Improve/Safety Issue:** The attic insulation is an older and discontinued product that features a paper casing where some sections contain a manufacturer's warning label that the combustible paper may not be exposed due to its fire-spread hazard where additional insulation can be installed over this material to prevent fire spread issues.

The ceiling insulation throughout has exposed paper casing presenting a fire spread hazard
