# Property Inspection Report

67 Barbara Rd, Orinda, CA

**Inspection Date:** 07/08/2026 **Time:** 11:30

**Inspector:** Perry Knowlton

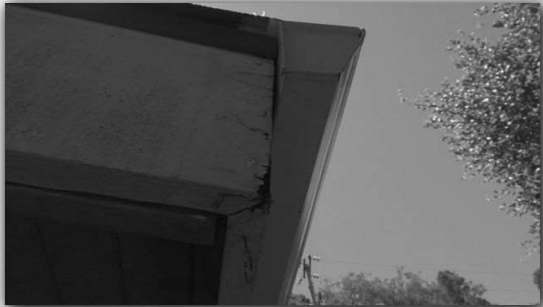
**Repair:** Sections of the roof framing are damaged. We recommend repair or replacement. The current pest report may provide more details on the extent of damage in the affected areas.

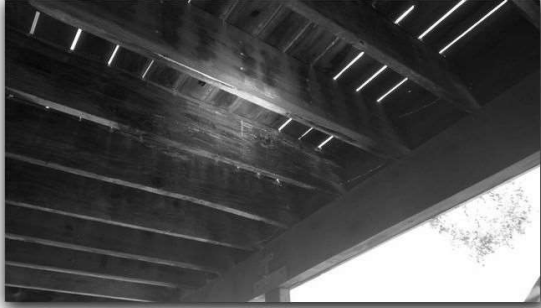
**Repair:** Sections of the deck support system are damaged and should be repaired or replaced.

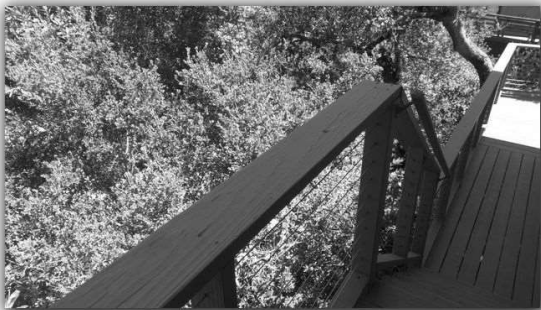
**Repair:** The deck guardrail is wobbly. We recommend that it be resecured or replaced.

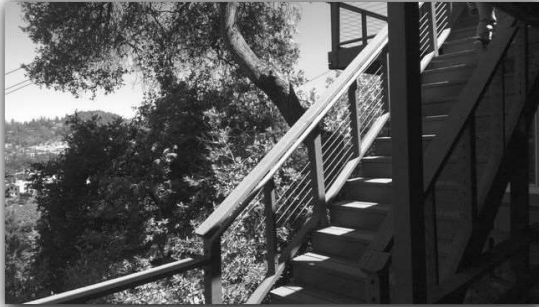
**Repair:** The handrail at the rear stairs is loose. We recommend it be resecured.

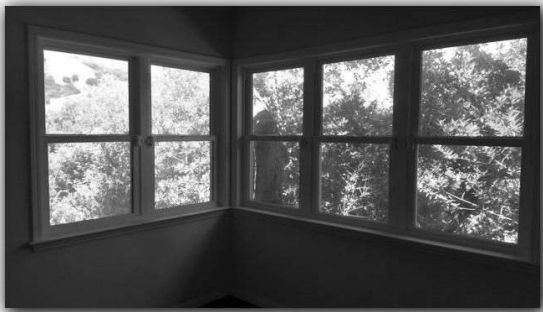
**Repair:** There is condensation between the panes of glass in one or more insulated glass units in the downstairs room (marked with red dot). This suggests failed seals between the panes. There is no simple "fix" for this condition. We recommend all failed insulated glass units be replaced. Failed seals (condensation) on insulated glass units are very often difficult to identify and sometimes can only be seen when the sun is shining through and the windows are clean. We make every effort to identify failed seals, however; we can make no guarantee that all windows with failed seals have been identified, for this reason we recommend you have all the windows further evaluated by a glass contractor.

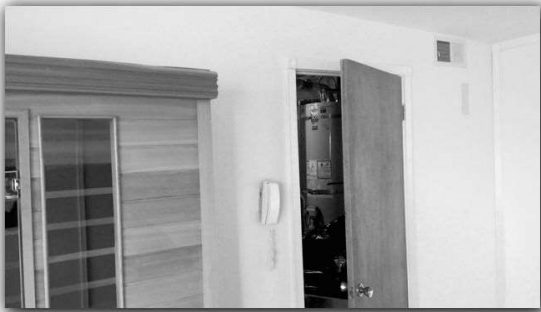
**Repair:** One or more doors rub its frame and are difficult to operate. We recommend the door(s) be planed or sanded for smoother operation.

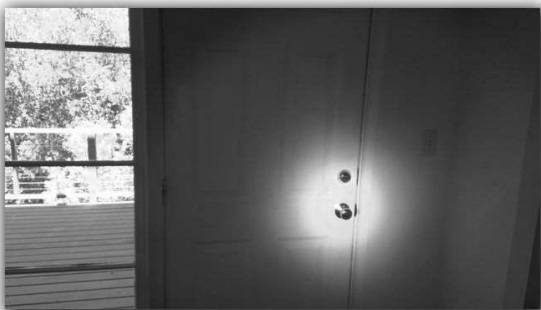
**Repair:** The dead bolt on the downstairs left room door(s) is the type that requires a key to operate from either side. This condition provides more security but can also be a hazard, especially in the event of a fire. Security needs to be weighed against the ability to quickly escape the building in the event of an emergency. Our recommendations are to replace the dead bolts with the types that are keyed on the exterior side only.

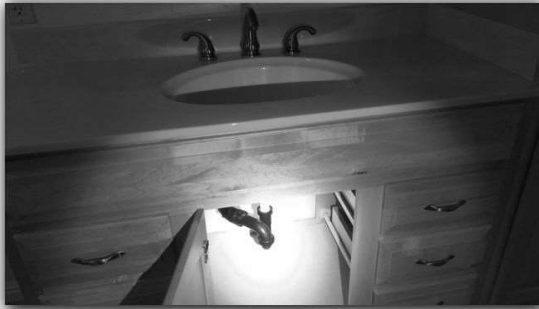
**Repair:** The downstairs hall bathroom water supply tubing under the sink is leaking. We recommend it be repaired or replaced.

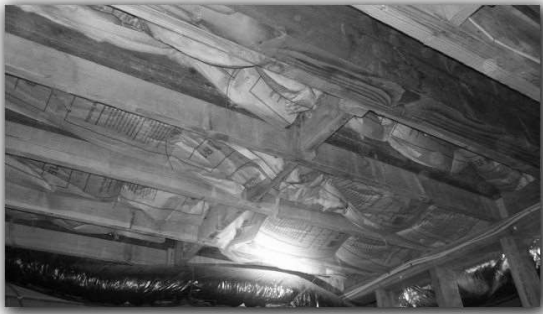
**Repair:** Some floor insulation is installed with the vapor barrier reversed. To meet manufacturer's specifications and avoid condensation and subsequent damage, we recommend it be reinstalled with the vapor barrier facing the heated areas as per manufacturer's specifications.

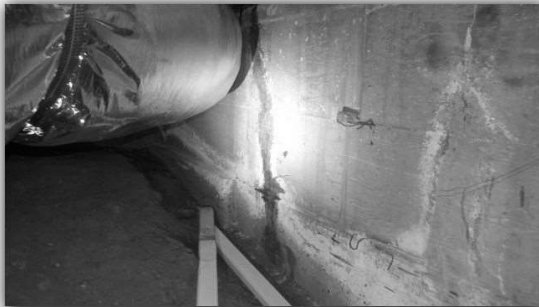
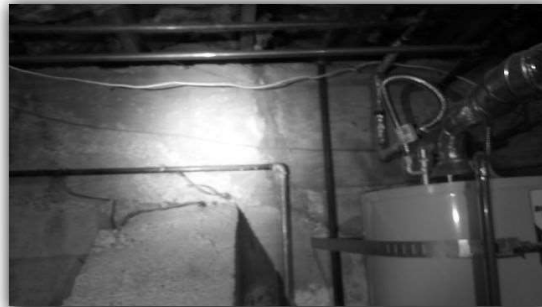
**Investigate Further:** Foundation cracks greater than 1/8 inch were visible at various areas. We recommend further inspection by an engineer to evaluate the condition of the foundation, its predicted future performance and / or the need for corrective repair.

**Investigate Further:** There have been repairs performed on this foundation in the past. We are not qualified to evaluate the repairs and recommend the repairs and any engineering associated with this work be reviewed by a licensed structural engineer.
