# WOOD DESTROYING PESTS AND ORGANISMS INSPECTION REPORT

#: 20268036

| BUILDING NO.<br><b>26229</b> | STREET<br><b>OBER AVE.</b> | CITY<br><b>LOMITA</b> | ZIP<br><b>90717</b> | Date of Inspection<br><b>09/23/2026</b> | NUMBER OF PAGES<br><b>1 of 8</b> |

| GENERAL DESCRIPTION:<br>Single story, stucco, family residence with an attached garage. It has a composition shingle roof and was vacant at the time of inspection. | Inspection Tag Posted:<br><b>Garage.</b> |

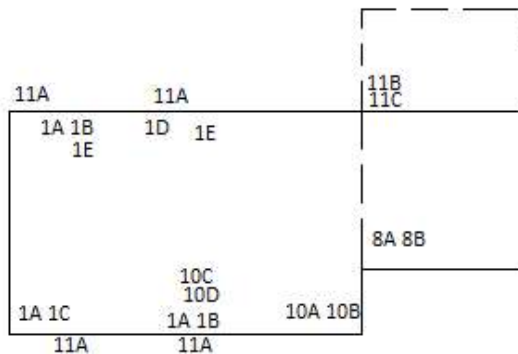
FINDING: Evidence of DRYWOOD TERMITES as indicated by 1A on the diagram. Evidence noted in or near: SUBFLOOR.

DRYWOOD TERMITE DAMAGE as indicated by 1B on diagram. The damage was noted in or near: SUBFLOOR.

Drywood termite pellets as indicated by 1C on the diagram.

FUNGUS DAMAGE indicated by 1D on diagram. The FUNGUS DAMAGE was noted in or near: SUBFLOOR.

CELLULOSE DEBRIS noted as 1E on the diagram.

Evidence of DRYWOOD TERMITES as indicated by 8A on the diagram. Evidence noted in or near: FRAMING.

Drywood termite pellets as indicated by 8B on the diagram.

| FINDING: | Evidence of DRYWOOD TERMITES as indicated by 10A on the diagram. Evidence noted in or near: WALLS, OPEN BEAM CEILING. |
| FINDING: | Evidence of DRYWOOD TERMITES as indicated by 10C on the diagram. Evidence noted in or near: HARDWOOD FLOOR. |
| FINDING: | DRYWOOD TERMITE DAMAGE as indicated by 10D on diagram. The damage was noted in or near: HARDWOOD FLOOR. |

| FINDING: | FUNGUS DAMAGE indicated by 11A on diagram. The FUNGUS DAMAGE was noted in or near: EAVES. |
| FINDING: | Evidence of DRYWOOD TERMITES as indicated by 11B on the diagram. Evidence noted in or near: RAFTERS. |
| FINDING: | DRYWOOD TERMITE DAMAGE as indicated by 11C on diagram. The damage was noted in or near: RAFTERS. |

RECOMMENDATION: 1A Fumigate the structure with a fumigant lethal to DRYWOOD TERMITES (Sulfuryl Fluoride). See the occupants fumigation notice for further details. This company is not responsible for delays or schedule changes due to inclement weather or other agencies, nor is it responsible for damage to roof or plants as a result of the fumigation. Refer to the occupant's fumigation notice/preparation sheet (sent separately) for additional information.

Remove and replace damaged wood as necessary with today's available widths and grades.
- ITEM NO. 1C

Remove or cover pellets in visible and accessible areas. NOTE: It is common for additional pellets to sift down over a period of time due to normal household vibrations. This estimate is to cover the pellets one time only.
- ITEM NO. 1D

We recommend scraping or brushing area and treating with a registered fungicide.
- ITEM NO. 1E

We recommend removing CELLULOSE DEBRIS of rake size or larger.

| RECOMMENDATION: 10D | It is recommended that owner contact a state licensed contractor to correct. |

| RECOMMENDATION: 11A | Remove and replace damaged wood as necessary with today's available widths and grades. |
| RECOMMENDATION: 11C | Scrape out termite damage and repair with appropriate wood filler. |
