## USA Home Inspectors

## Home Inspection Report

Prepared For:  
**Karen Saske**  
Property Address:  
**4669 Valencia Dr**  
**San Diego, CA 92115**  
Inspected On: Wed, Sep 2 2026 at 8:00AM

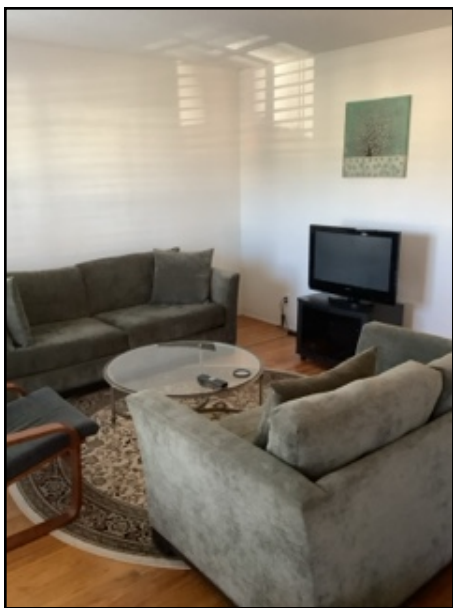
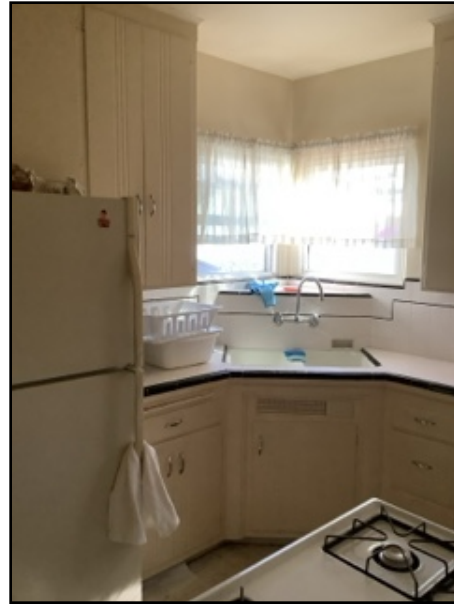
Personal property present at time of inspection. Some areas and systems are not fully visible due to current occupants personal items.

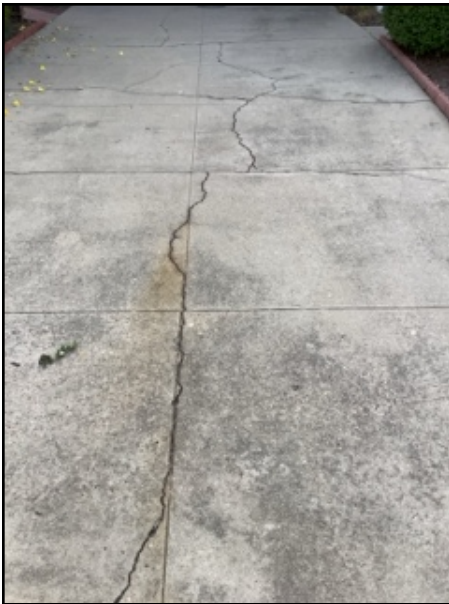
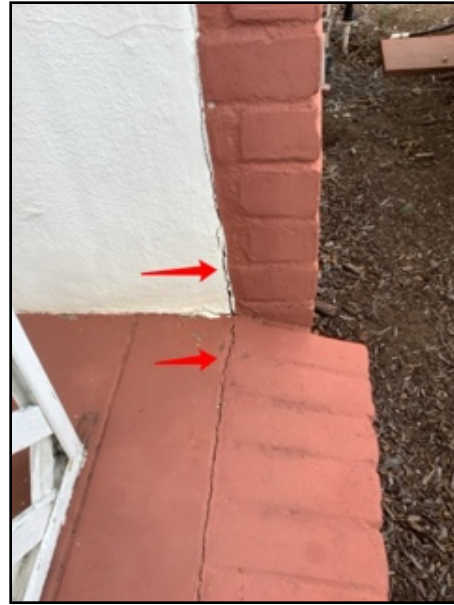
Cracks, stains, and uneven surfaces noted at driveway, walkways, and patio.

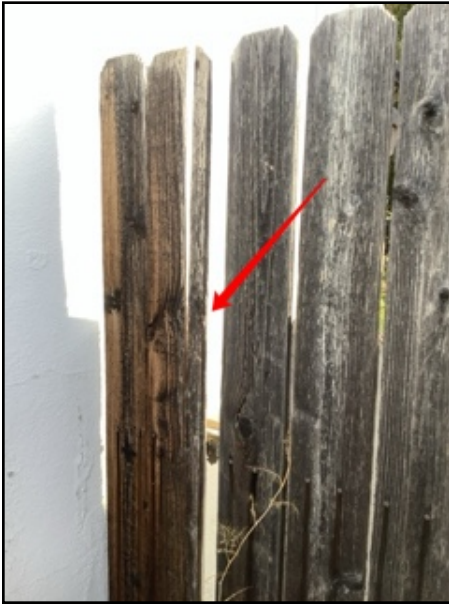
Figure 5-1

Loose boards, leaning, sunburned wood, missing screens, evidence of possible wood destroying organisms / dry rot leaking roof, and improper repairs all noted throughout patio cover and enclosure.

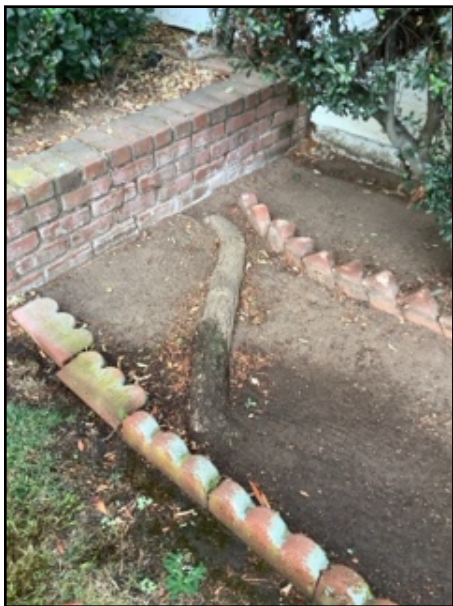
Figure 6-1

Large Ficus tree noted. Ficus trees are known to have invasive root systems. Historically, Ficus trees are known to damage plumbing, sidewalks, and foundations.

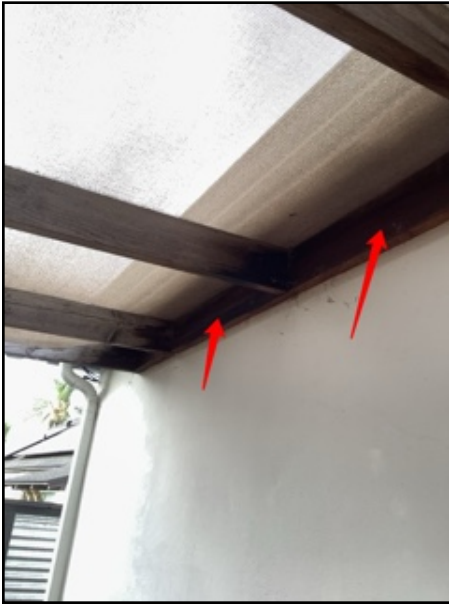
Figure 7-1

Ledger board noted not properly secured to structure. Rafters noted not properly secured to header with rafters hangers. Ledger over roof noted not secured to structure. Further evaluation needed by a more qualified tech technician

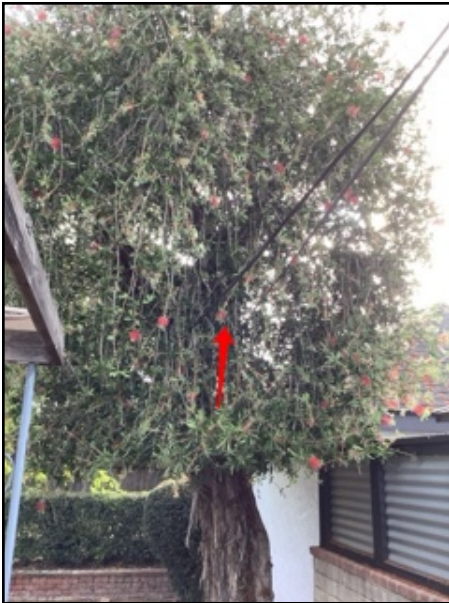
Figure 8-1

Telephone cable lines noted touching tree at time of inspection.

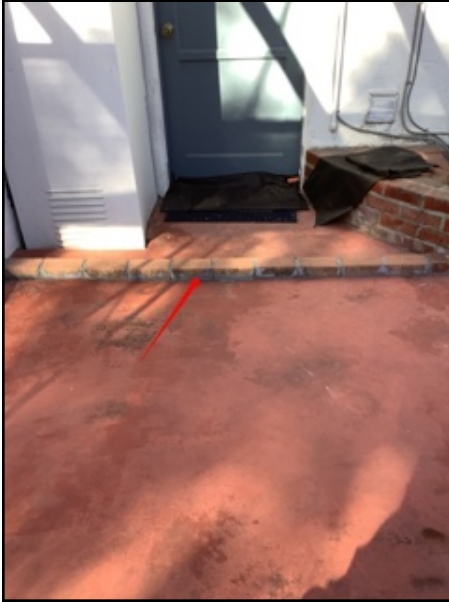
Figure 9-1

Row of bricks blocking garage side door. Tripping hazard.

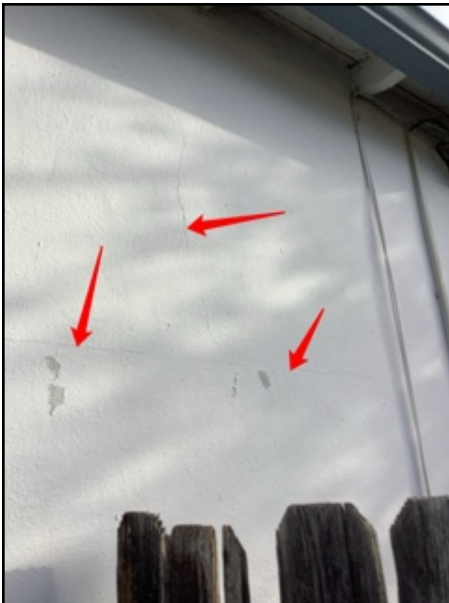
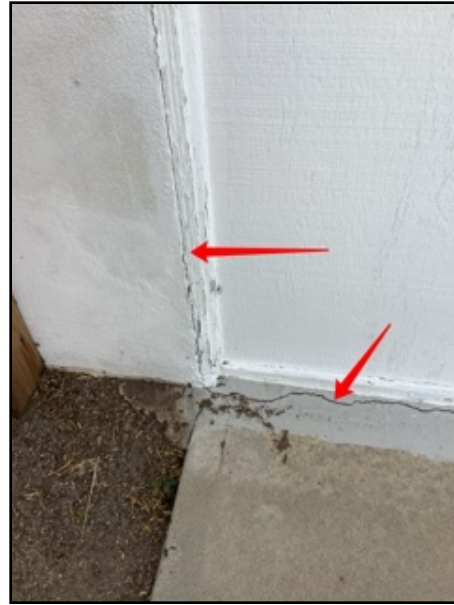
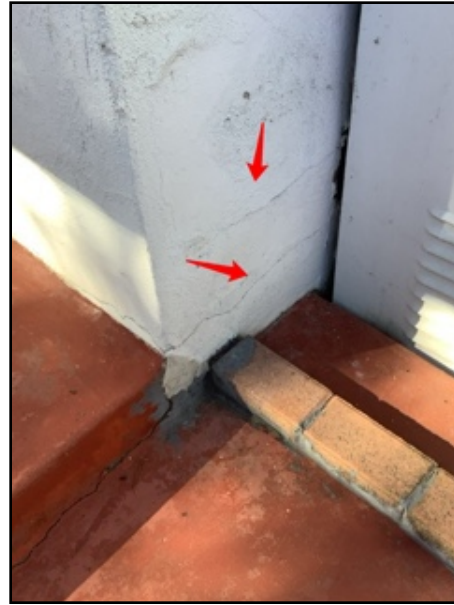
Defects such as peeling, holes, cracks, and patches noted at various places throughout exterior.

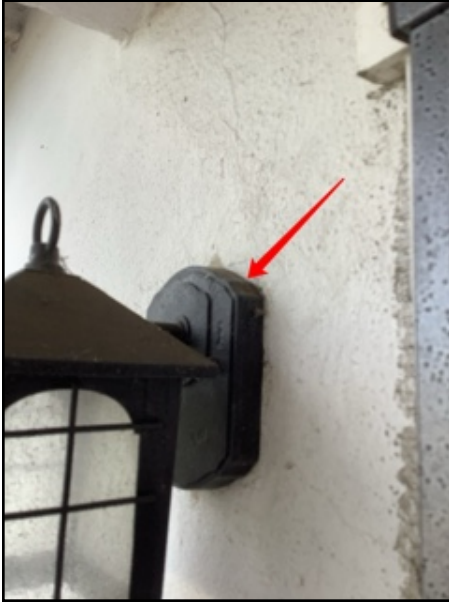
Figure 11-1

Exterior light fixtures noted loose and not sealed at the wall.

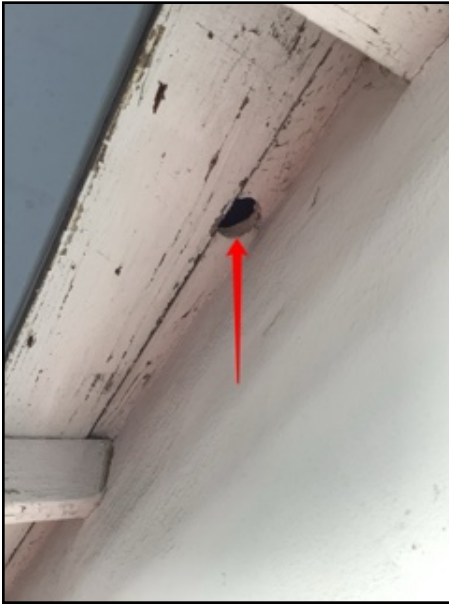
Figure 12-1

Pipes, wiring and holes penetrating exterior wall noted not sealed properly at wall. If penetration to exterior wall not sealed it leaves an opening for water intrusion and or insects.

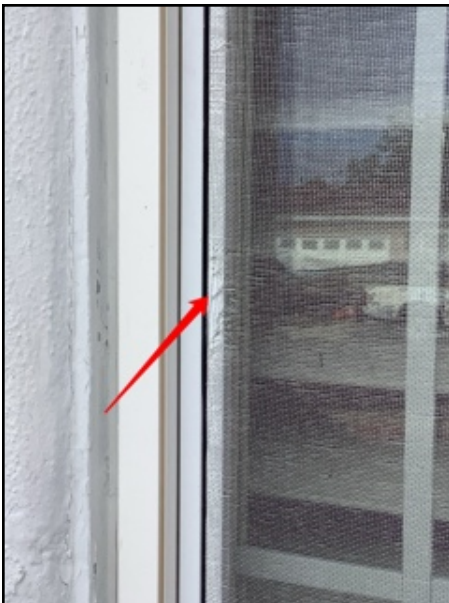
Figure 13-1

Window screens noted damaged/missing in various locations around structure.

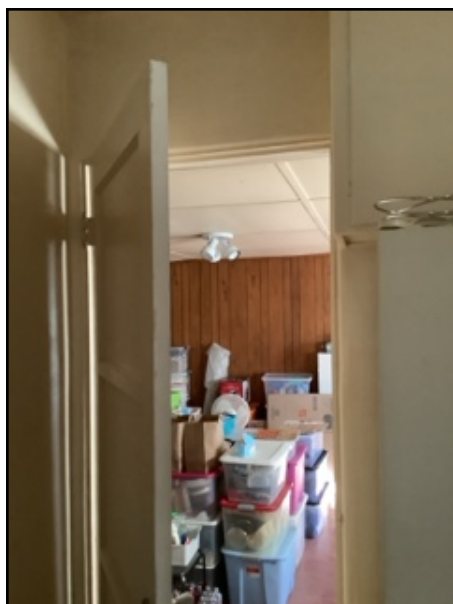
Figure 16-1

Garage entry doors are required to have at least a 20-minute fire rating or be solid wood of at least 1-3/8 inches thick with a self-closing hinge that closes the door completely against weatherstripping and the door latches secure for fire safety compliance.

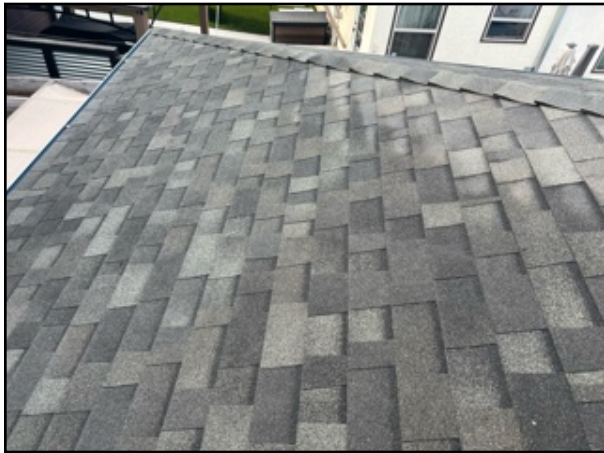
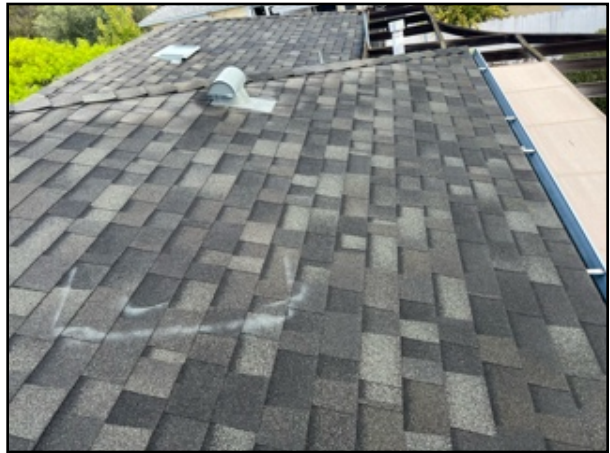
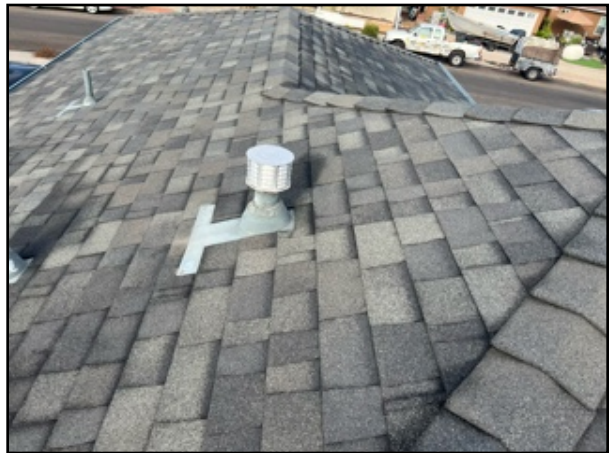
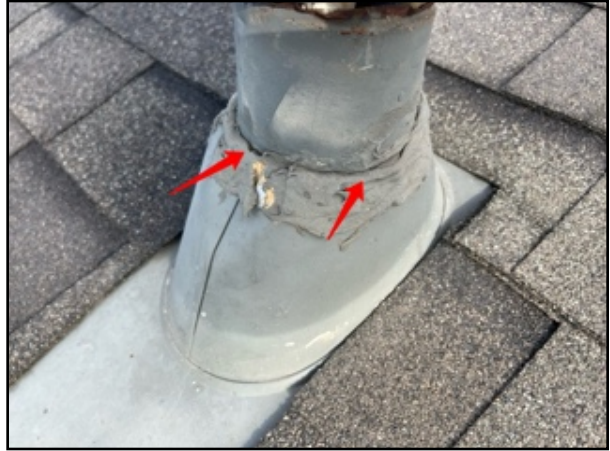
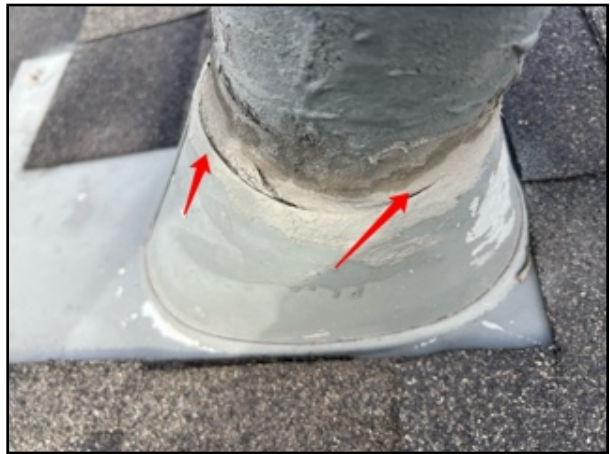
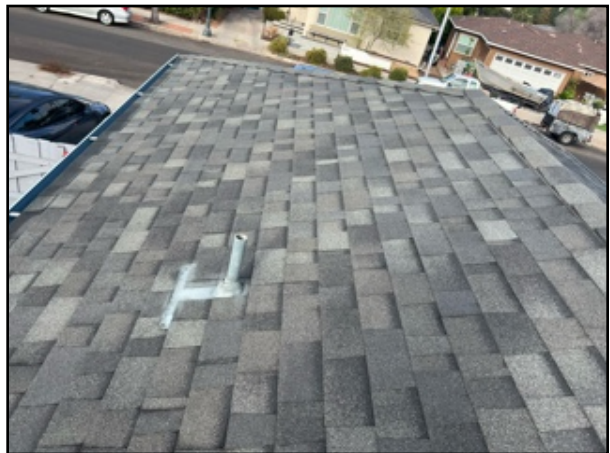
Crack sealant around flashing noted at various places. Standing water noted in gutters in various locations. Facial board near structure side noted opening not properly sealed.

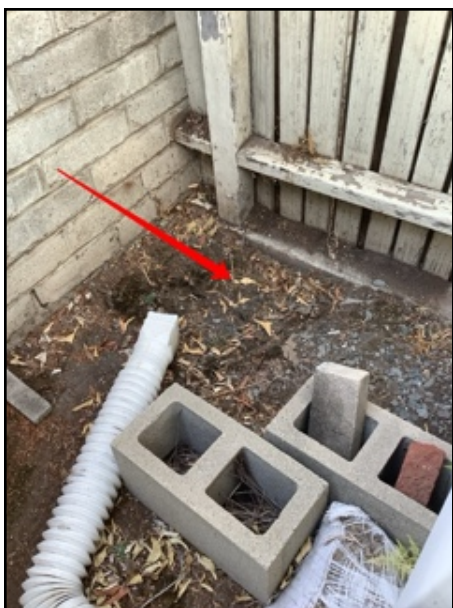
Figure 21-1

Downspout diverter noted water possibly building up against concrete wall. Standing water noted not at time of inspection.

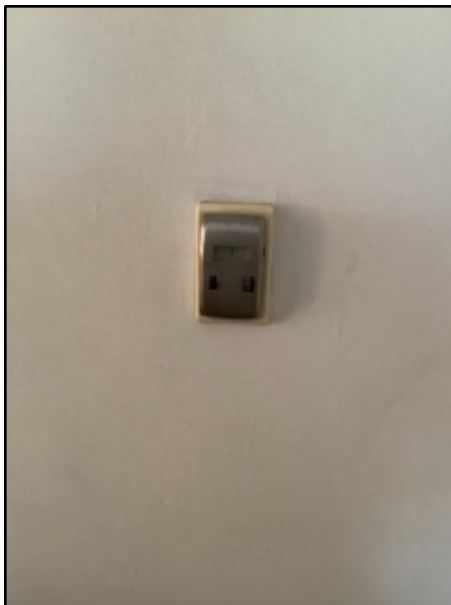
Figure 26-1

Thermostat located in living room behind front door. Thermostat noted adjustment when turning on. Further evaluation needed by a more qualified technician.

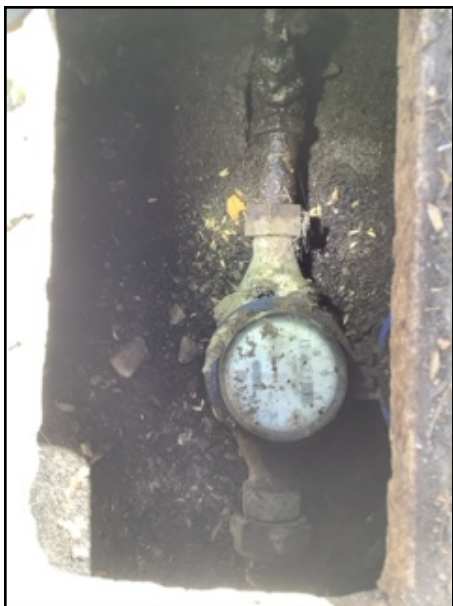
Figure 33-1

Water shutoff valve leading from water meter noted leaking at time of inspection.

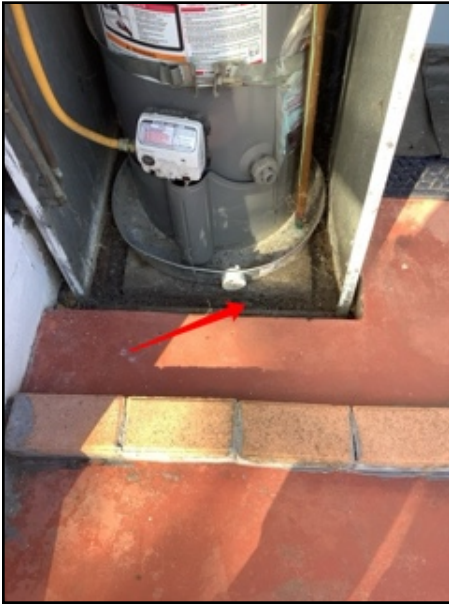
Figure 39-1

Water heater noted sitting below concrete slab. Slab slopes towards structure and water heater. Standing water could deteriorate bottom of water heater overtime. Recommend raising water heater up to height or above the concrete pad.

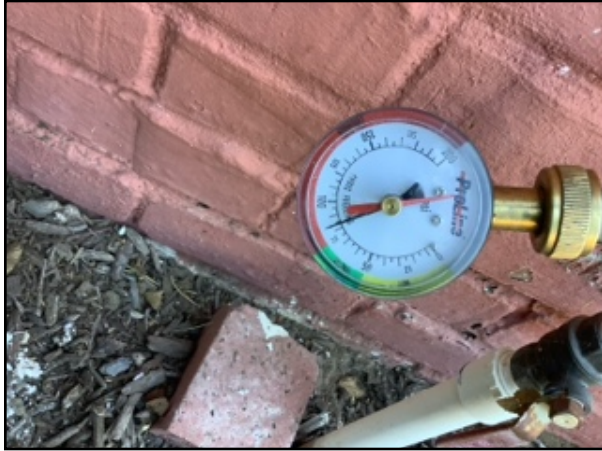
Figure 40-1

Water pressure is 80 psi. Most appliance manufacturers recommend pressure to be set between 50 and 80 psi.

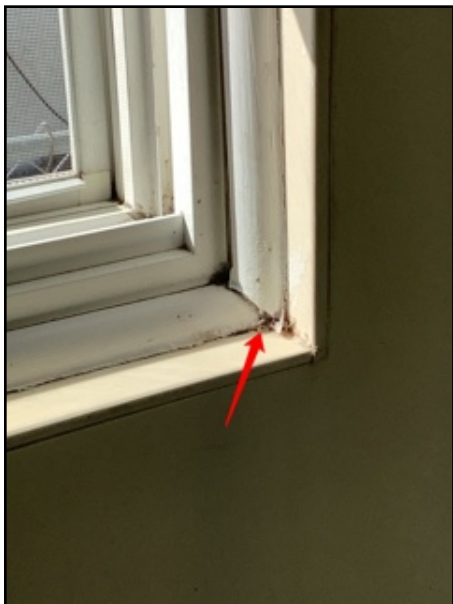
Figure 42-1

Caulking around windowsill noted cracked deteriorating. caulking in corners of shower stall and sill noted crack or deteriorating.

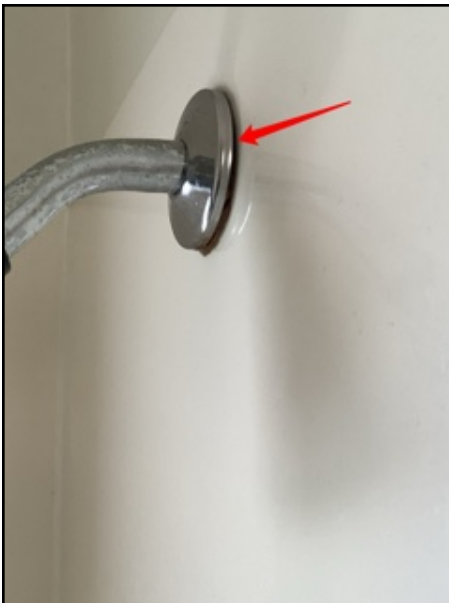
Figure 43-1

Shower pipe flange noted not properly sealed at wall.

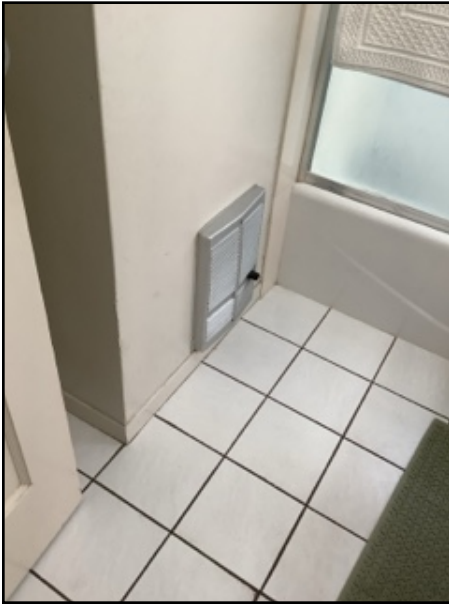
Figure 44-1

Bathroom heater noted smoking when turn on. Inspector turned off heater. Current resident said they haven't used it in over 16 years. Possible large amount of lent buildup on elements. Further evaluation needed by more qualified technician.

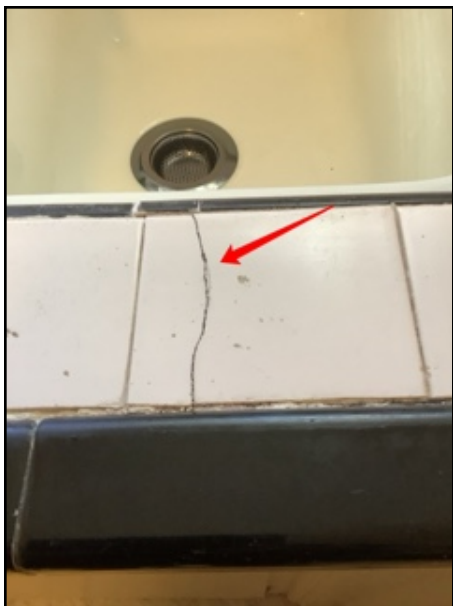
Figure 46-1

Comment 46:  
**REPAIR OR REPLACE:**  
Tile noted cracked in various locations along sink countertop.

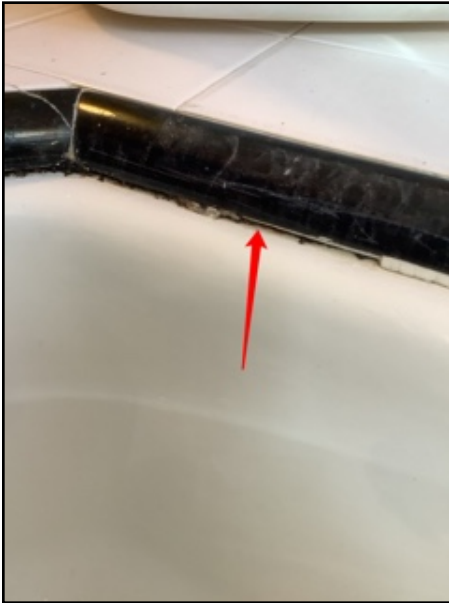
Figure 47-1

**Comment 47:**  
**REPAIR OR REPLACE:**  
Grout/caulking noted cracker deteriorating and various locations along sink countertop.

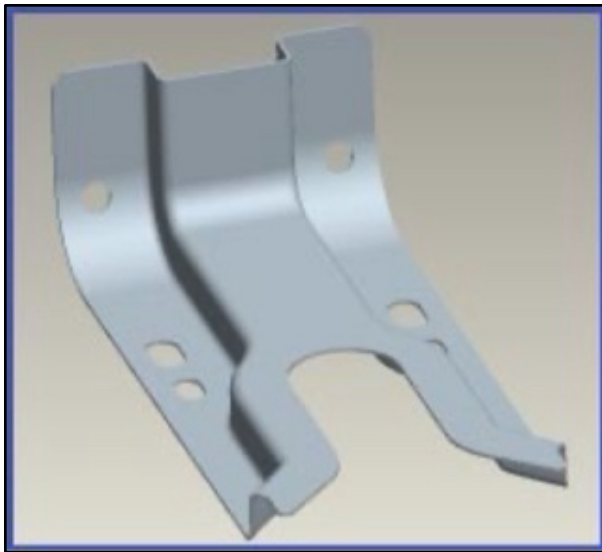
Figure 48-1

Anti-tip devices are not installed. While it may not have been required at the time of installation, anti-tip devices are required on all ranges built in 2012 or later.

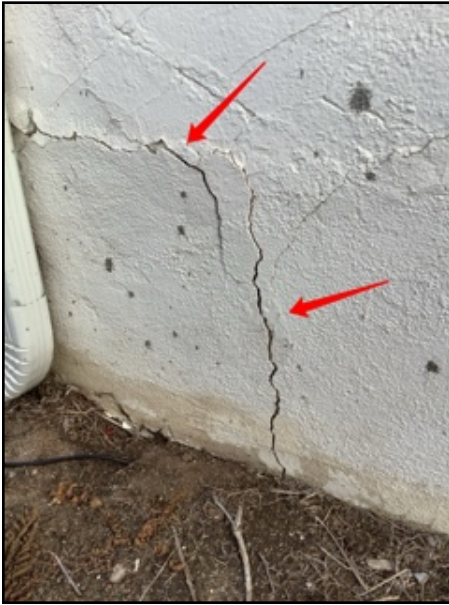
Figure 51-1

Minor cracking noted at exposed portions of foundation. Generally, cracks of less than ¼ inches and with no deviation are no cause for concern. Questions about structural integrity should be evaluated by a more qualified professional (such as a licensed engineer).

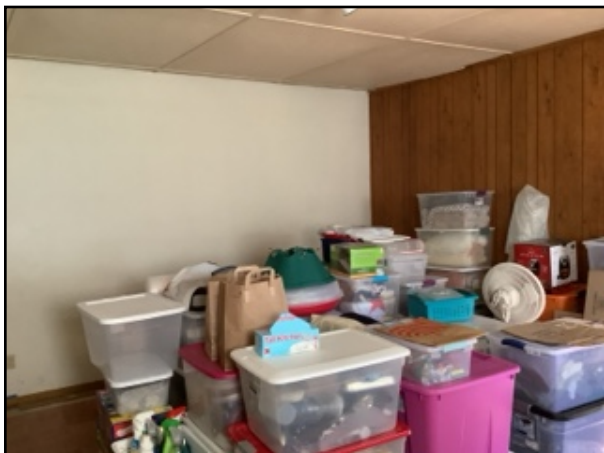
Figure 52-1

Apparent additions, extensions, or conversions are present. It is outside the scope of this inspection to determine if permits were obtained, if the space meets current code, and if the space is suitable for habitation. Vehicle door to garage noted sealed off at time of inspection.

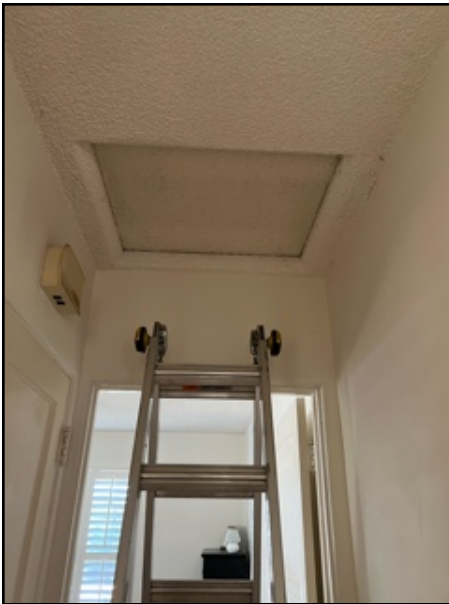
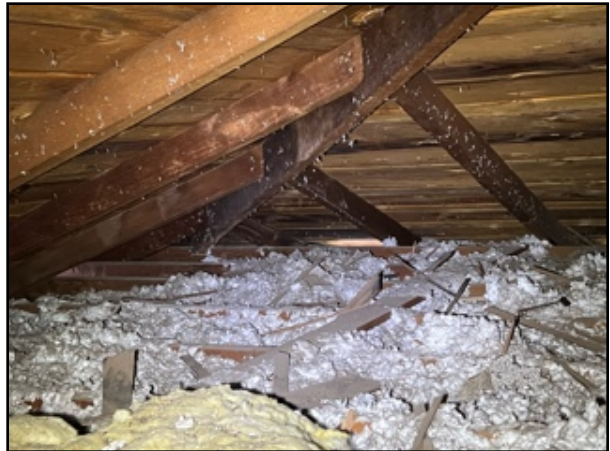
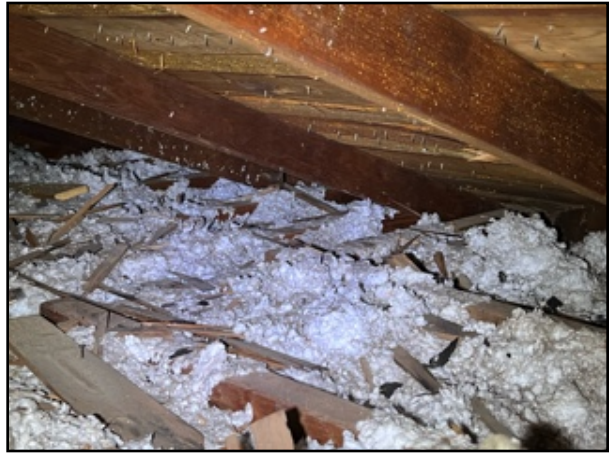
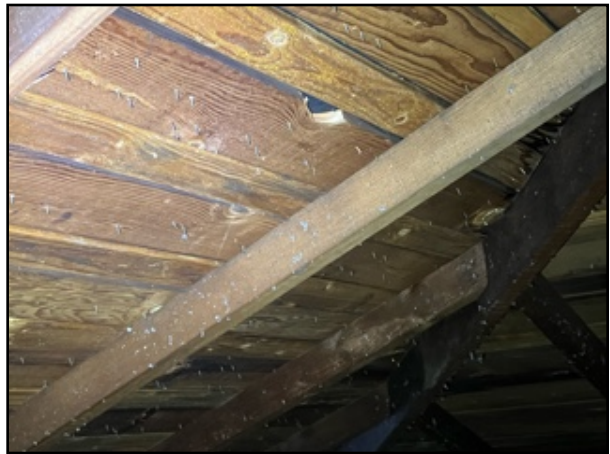
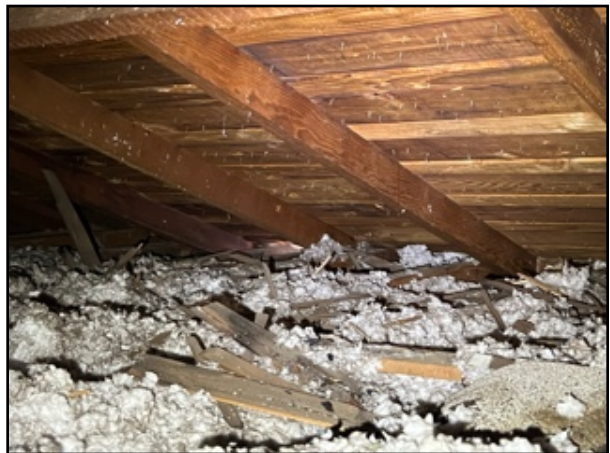
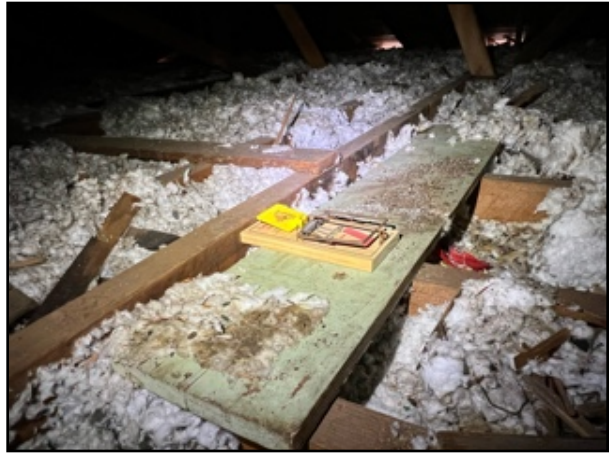
Pipes/wiring/holes noted in firewall not properly sealed at wall in various locations.

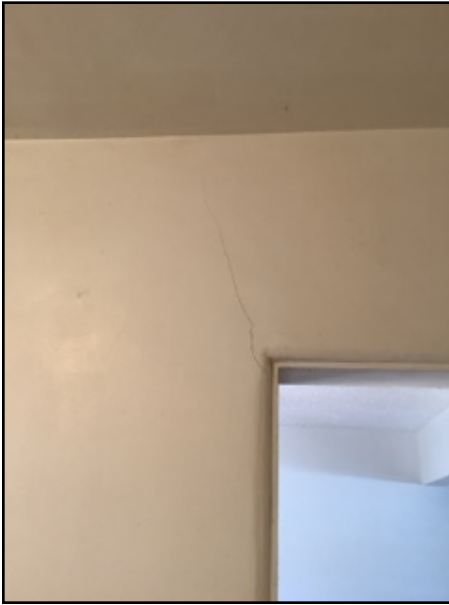
Figure 54-1

Minor paint, drywall damage, burned out bulbs, broken/missing covers and other minor cosmetic defects noted at various locations throughout the home.

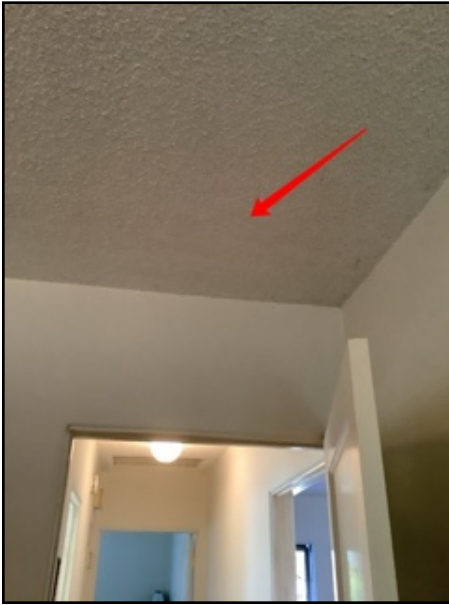
Figure 55-1

Smoke detectors noted not installed in sleeping areas at time of inspection.

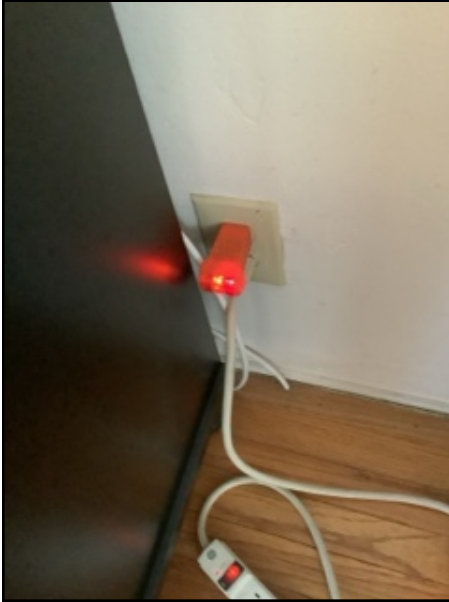
Figure 56-1

Hot and neutral noted reversed. Outlet located in bedroom.
