Report # W8035

# WOOD DESTROYING PESTS AND ORGANISMS INSPECTION REPORT

| Building Address:<br><b>12105 Eastglen Street, San Diego, CA 92131</b> | | Date of Inspection<br><b>09/22/2026</b> | Number of Pages<br><b>6</b> |

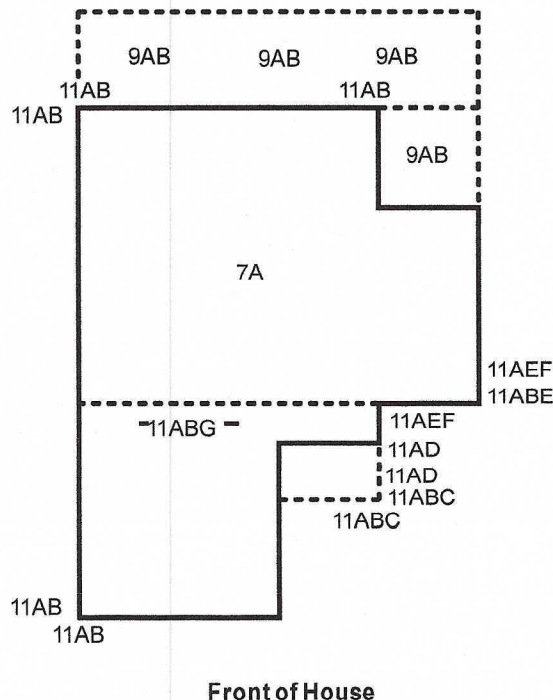
This Diagram is not to scale

- 7A (Section I)  
FINDINGS: Evidence of drywood termite infestation at attic framing as indicated on the diagram.  
RECOMMENDATION: Vacate the premises and seal the structure for fumigation with Vikane Gas. Remove or cover accessible evidence of infestation. Fumigation warranted for two years. Fumigation awareness notice must be signed prior to fumigation. See fumigation notice for terms and liabilities.

- 9A (Section I)  
FINDINGS: Evidence of drywood termite infestation at attached patio cover framing as indicated on the diagram.  
RECOMMENDATION: Vacate the premises and seal the structure for fumigation with Vikane Gas. Remove or cover accessible evidence of infestation. Fumigation warranted for two years. Fumigation awareness notice must be signed prior to fumigation. See fumigation notice for terms and liabilities.
- 9B (Section I)  
FINDINGS: Termite/Dry-rot wood members found at time of inspection at attached patio cover framing as indicated on the diagram.  
RECOMMENDATION: Replace termite/dry-rot damaged wood members as necessary. Painting is included in this estimate.

- 11A (Section I)  
FINDINGS: Evidence of drywood termite infestation at eaves as indicated on the diagram.  
RECOMMENDATION: Vacate the premises and seal the structure for fumigation with Vikane Gas. Remove or cover accessible evidence of infestation. Fumigation warranted for two years. Fumigation awareness notice must be signed prior to fumigation. See fumigation notice for terms and liabilities.
- 11B (Section I)  
FINDINGS: Evidence of termite/fungus damaged wood members noted at time of inspection at fascia/fascia trim as indicated on the diagram.  
RECOMMENDATION: Replace and or repair termite/fungus damaged wood members as necessary. Painting is included in this estimate.

- 11C (Section I)  
FINDINGS: Evidence of termite/fungus damaged wood members noted at time of inspection at porch column trim as indicated on the diagram.  
RECOMMENDATION: Replace and or repair termite/fungus damaged wood members as necessary. Painting is included in this estimate.

- 11D (Section I)  
FINDINGS: Evidence of termite/fungus damaged wood members noted at time of inspection at siding trim as indicated on the diagram.  
RECOMMENDATION: Replace and or repair termite/fungus damaged wood members as necessary. Painting is included in this estimate.

- 11E (Section I)  
FINDINGS: Evidence of termite/fungus damaged wood members noted at time of inspection at window trim as indicated on the diagram.  
RECOMMENDATION: Replace and or repair termite/fungus damaged wood members as necessary. Painting is included in this estimate.

- 11F (Section I)  
FINDINGS: Evidence of termite/fungus damaged wood members noted at time of inspection at planter shelf as indicated on the diagram.  
RECOMMENDATION: Replace and or repair termite/fungus damaged wood members as necessary. Painting is included in this estimate.

- 11G (Section I)  
FINDINGS: Evidence of termite damaged wood members noted at time of inspection at exposed beam/outlooker as indicated on the diagram.  
RECOMMENDATION: Replace and or repair termite/fungus damaged wood members as necessary. Painting is included in this estimate.
-
