# Inspection Report

**Stephen Gundrum  
1503 Plumas Court  
Paso Robles, CA 93446**

Inspection location: **1503 Plumas Court  
Paso Robles, CA 93446**Send report to: **Stacie Ormonde**

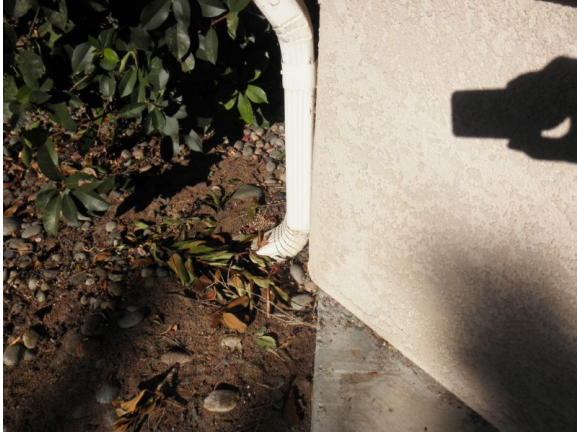
#R

**Maintenance Note:** Some of the down spouts have no splash block or extension to divert the runoff water away from the foundation. Recommend installing proper drainage of roof water away from the structure to reduce moisture against the perimeter of the foundation and potential foundation settlement.

Some of the down spouts need to be directed away from the foundation.

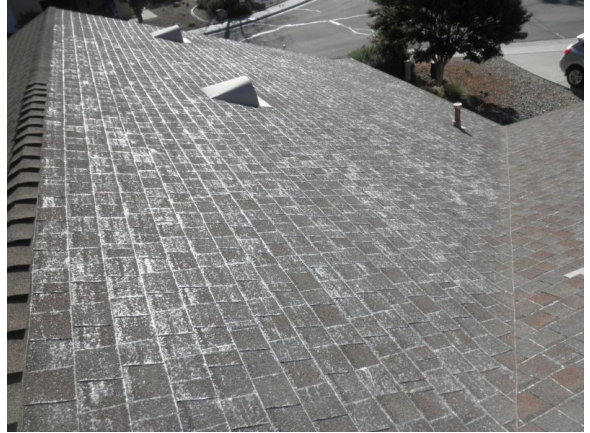
#R

**Information Note:** The roof appears to be in reasonable condition however, it is older and nearing the end of a normal life expectancy. General deterioration, cracking and delamination of the aggregate coating was observed. Budget for replacement of the roof soon.

General deterioration of the roof shingles due to age.

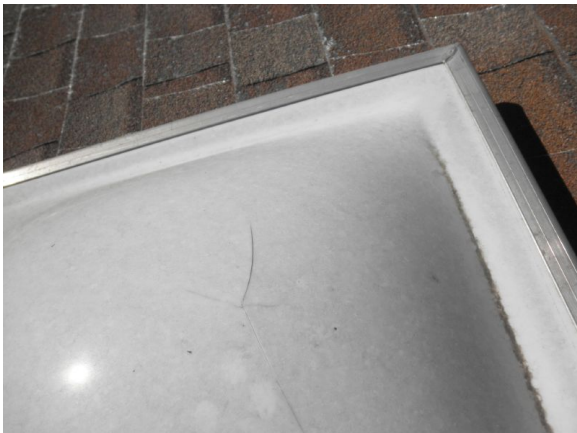
#R

- 1.) The skylight above the hallway is cracked.

Cracked skylight above the hallway.

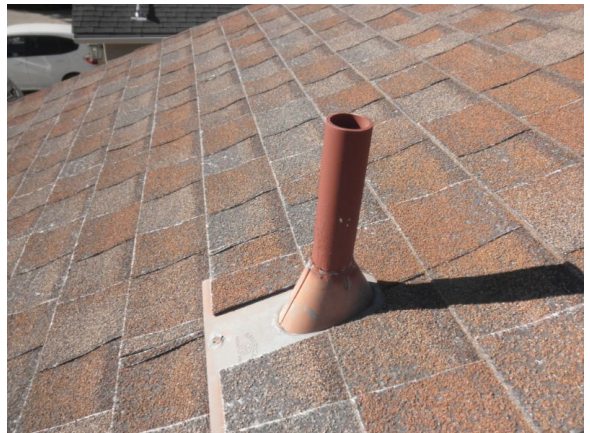
#R

**Maintenance Note:** The sealant at the roof flashings has become brittle and cracked from exposure to the sun. Recommend resealing the flashings to prevent water intrusion.

Deteriorated sealant at the vent flashings.

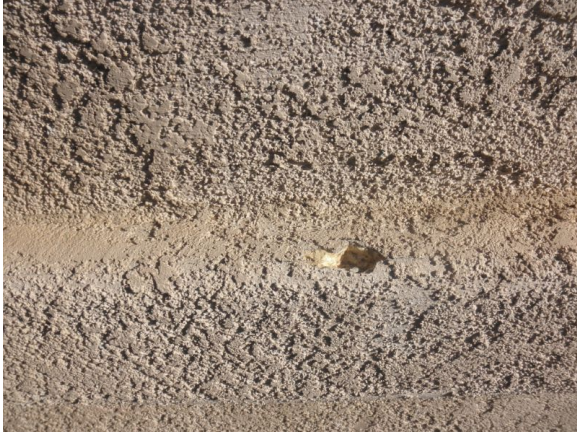
#EX

4.) There is some minor damage to the stucco reveal on the south wall of the garage.

Minor damage to the stucco reveal on the south side of the garage.

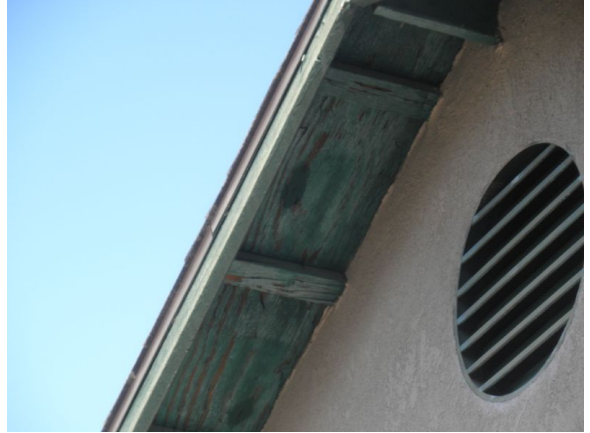
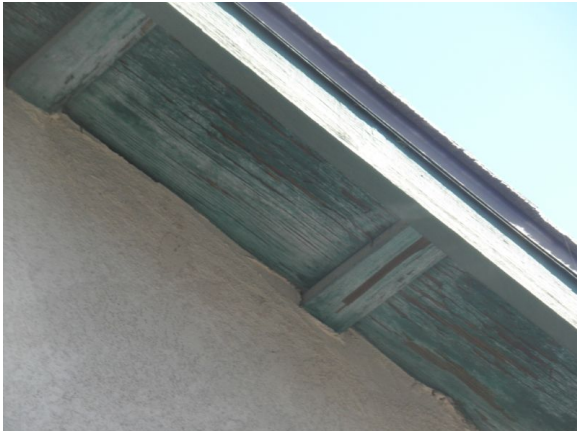
3.) Parts of the eaves are in need of painting.

Parts of the eaves are in need of painting.

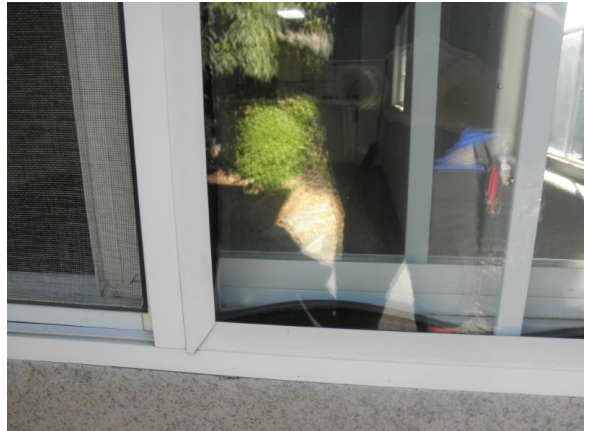
#EX

**Maintenance Note:** There is a manufacturing defect with dislodged weather stripping between the two panes of glass at the dual pane window in the garage and the two windows at the SW corner of the living room.

Example of the manufacturing defects at the windows.

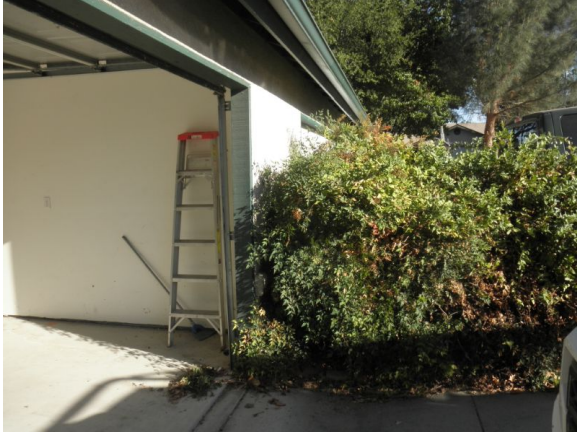
#GD

**Maintenance Note:** Trim the tree limbs and/or foliage to avoid contact with the home and prevent damage to the property.

The foliage needs to be cut back at the front of the garage.

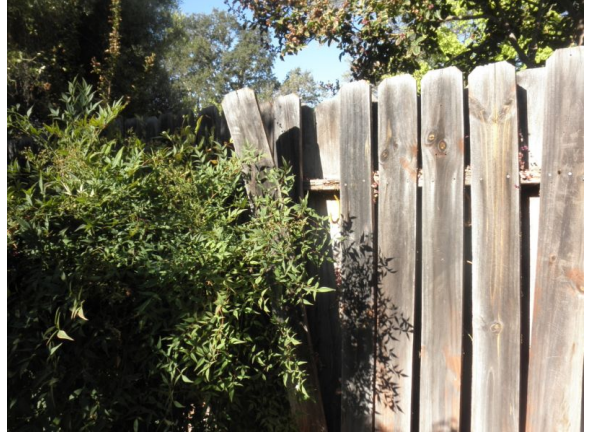
#GD

- 1.) Parts of the fencing in the backyard are damaged.

Parts of the fencing in the backyard are in need or repairs.

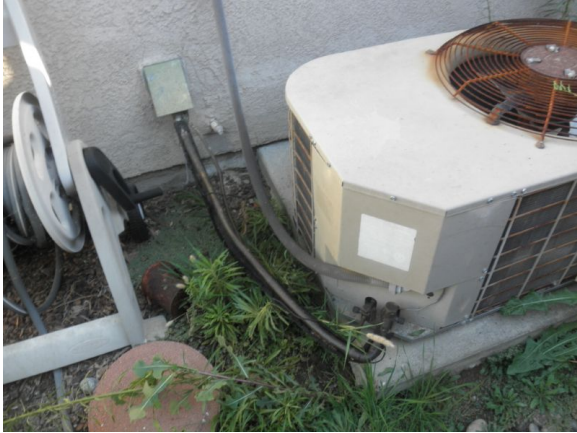
#HC

**Maintenance Note:** The insulation is deteriorated and in need of replacement at the low-pressure refrigerant line adjacent to the air conditioning condenser unit.

Deteriorated insulation on the low-pressure refrigerant line.

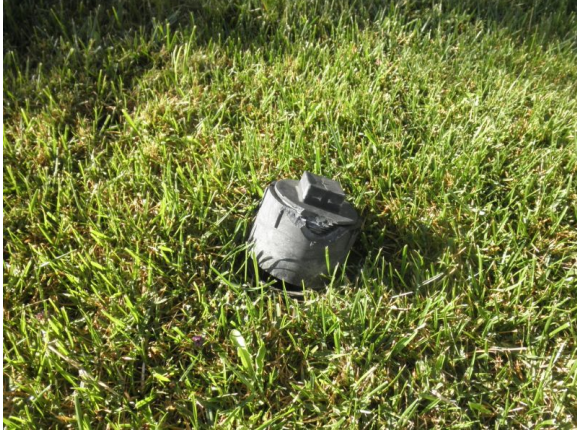
#P

- 1.) The main plumbing clean out in the front yard has a broken cap.

The main clean out cap is broken in the front yard.

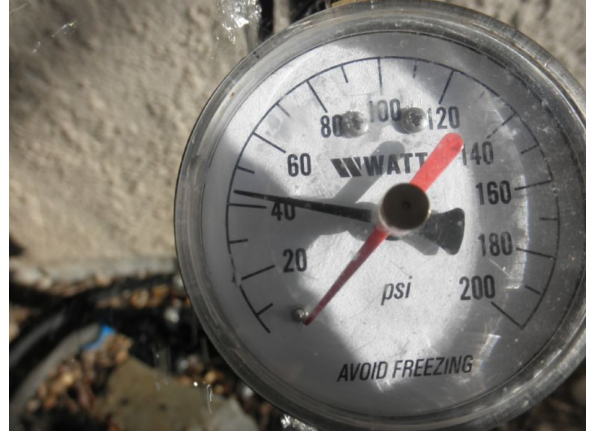
#P

**Information Note:** The water pressure was measured at 45 psi at the time of inspection. This is within a normal and acceptable range. Since the home is equipped with a pressure regulator it should be monitored and retested periodically to ensure that the pressure is below the maximum allowable of 80 psi.

The water pressure was measured at 45 psi.

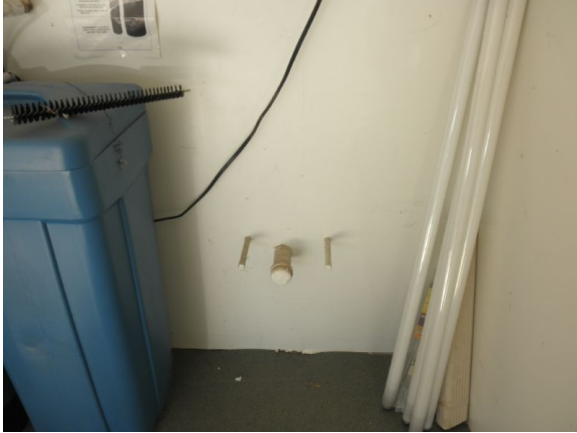
#K

**Information Note:** The garage is plumbed for a future laundry tub basin.

The garage is plumbed for a future laundry tub.

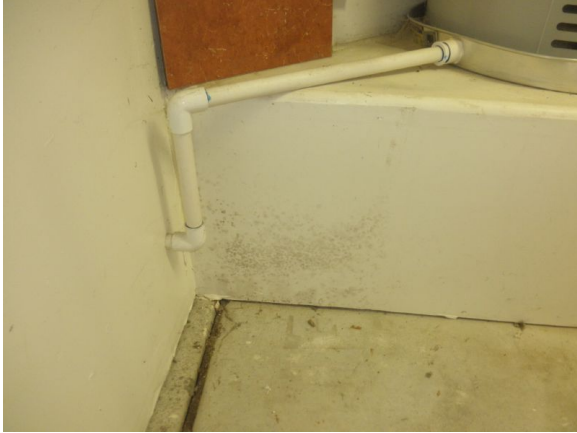
#GC

- 20 1.) There is a black mildew like substance on the water heater platform in the garage. (See notes on the Deficiency Summary Report regarding the potential for microbial contamination.)

Black mildew like substance on the water heater platform.
