# **Cornerstone Inspection**

## **Property Inspection Report**

**645 Moss Ave, Paso Robles, CA 93446**

**Date of Inspection: 8/19/2026 Time: 9:00 AM**

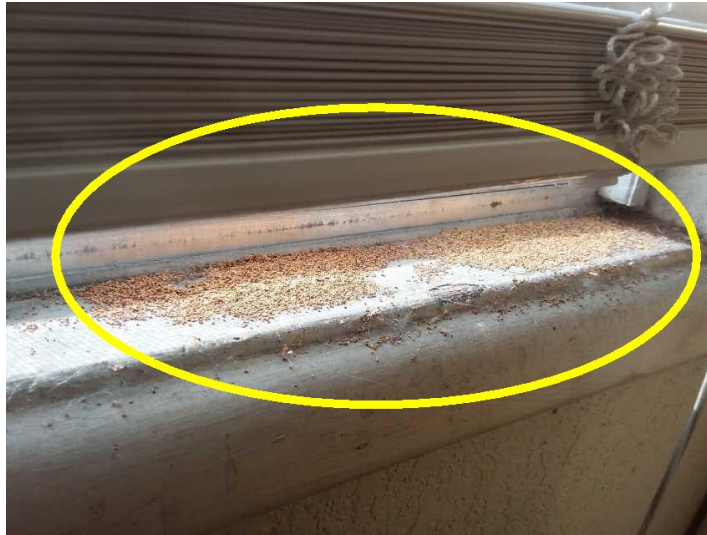
We have noticed the presence of pest droppings and you may wish to have a pest control company evaluate.

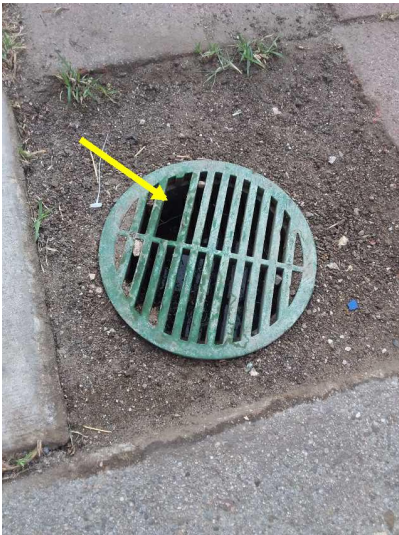
There is standing water or debris visible within the area drains, which could be indicative of at least a partial blockage. The tendrils of roots may have invaded the drains, but silt also tends to become trapped within the drain pipes and hardens during the summer months to the consistency of wet concrete and creates an impediment that commonly leads to a full blockage. Therefore, we recommend that the lines be flushed through to the street or to their termination point.

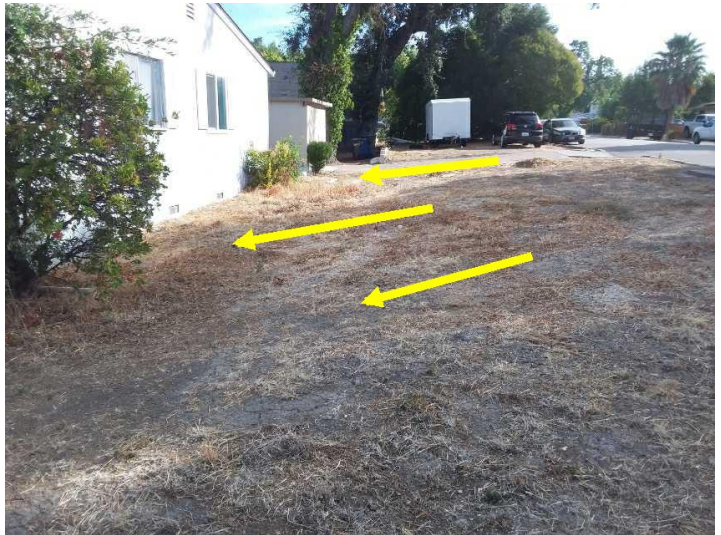
There are areas at the right side where water will be directed toward the house instead of away from it, as recommended. This not only allows for the possibility of moisture intrusion but also differential settling.

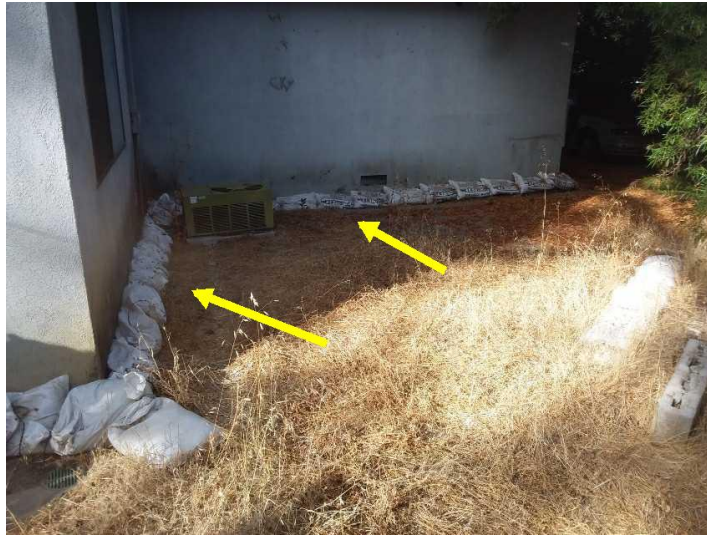
2.3. There are areas at the right side and rear where water will be directed toward the house instead of away from it, as recommended. This not only allows for the possibility of moisture intrusion but also differential settling.

There are areas at the right side and rear where water will be directed toward the house instead of away from it, as recommended. This not only allows for the possibility of moisture intrusion but also differential settling.

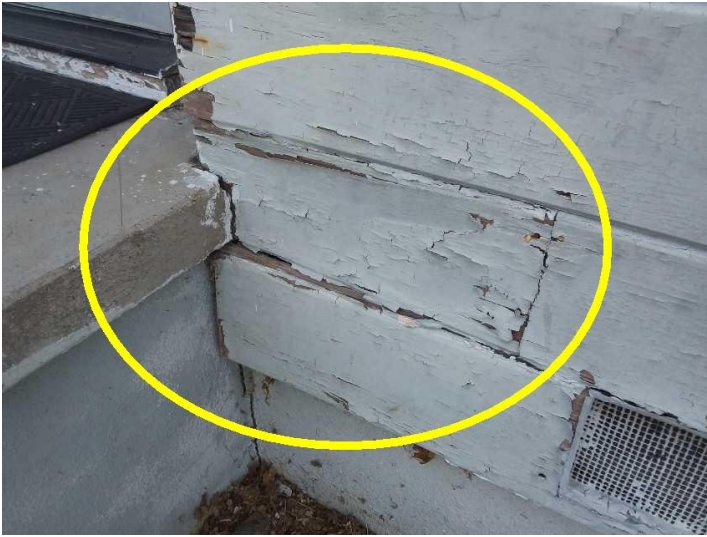
Portions of the wood siding are dry rot or moisture damaged, and should be evaluated by a termite inspector.

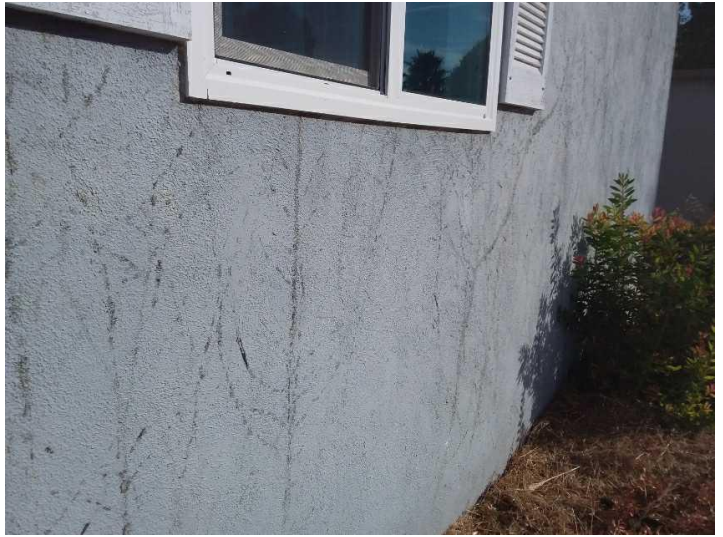
There are stains present that may be difficult to remove.

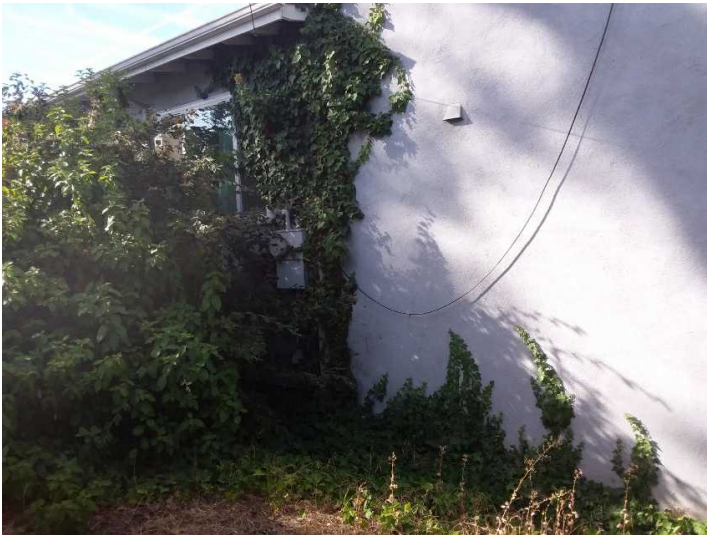
3.2. Vines, shrubs or bushes are growing on the house walls and although they are attractive they can introduce pests and rodents and accelerate deterioration. Therefore, you may wish to consider having them removed or cut back to 12 inches away from the home.

Vines, shrubs or bushes are growing on the house walls and although they are attractive they can introduce pests and rodents and accelerate deterioration. Therefore, you may wish to consider having them removed or cut back to 12 inches away from the home.

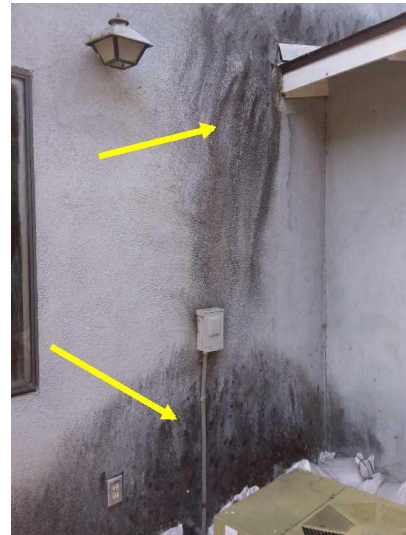
There are separations or nail-pops on the siding that need to be serviced/sealed.

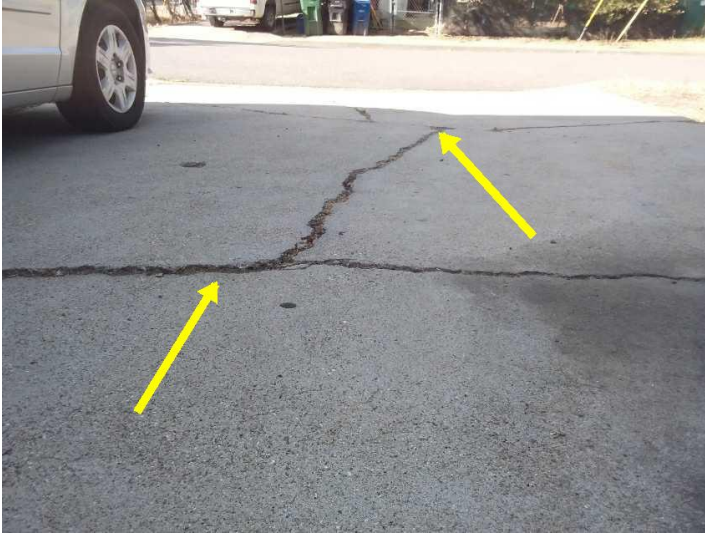
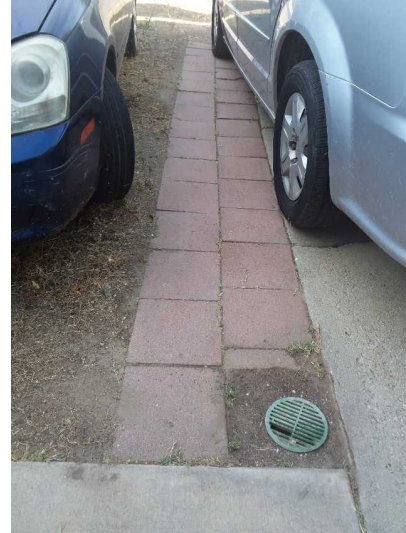
There is one or more offsets in the driveway that could prove to be trip-hazards.

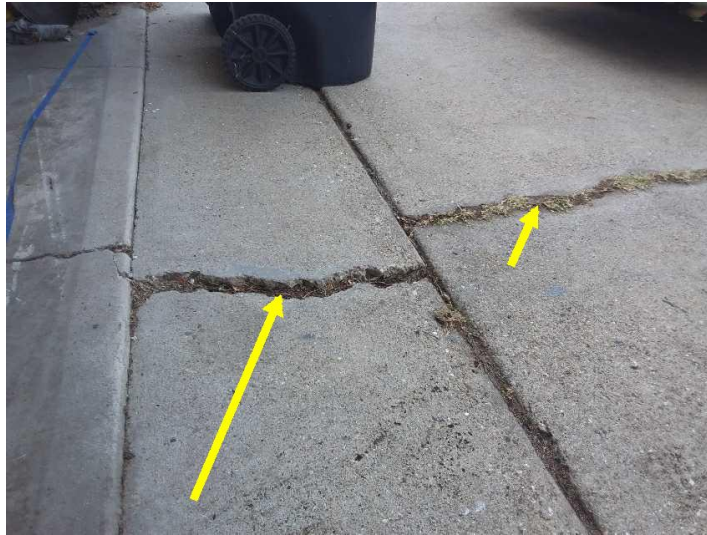
There is one or more offsets in the driveway that could prove to be trip-hazards.

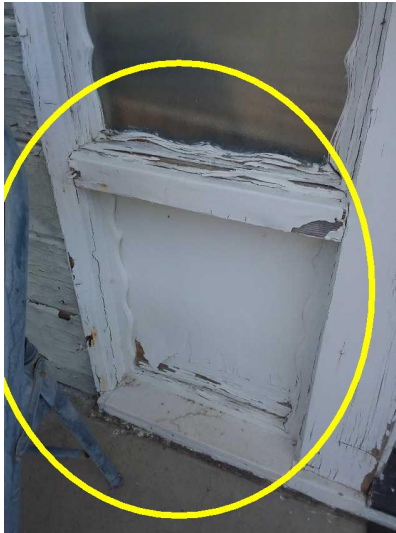
5.2. There is damage to the wood trim that should be evaluated by a termite inspector.

There is damage to the wood trim that should be evaluated by a termite inspector.

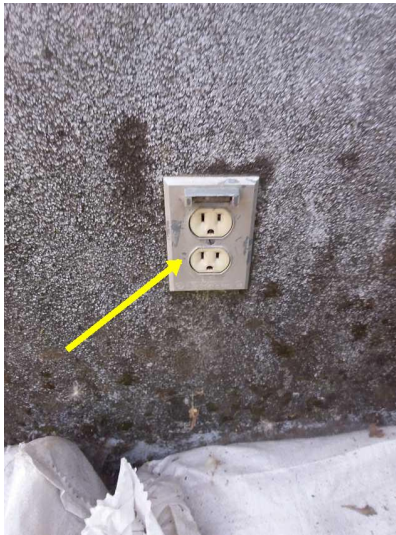
Some of the exterior electrical outlets do not have a weather rated cover or the cover is damaged and should be serviced.

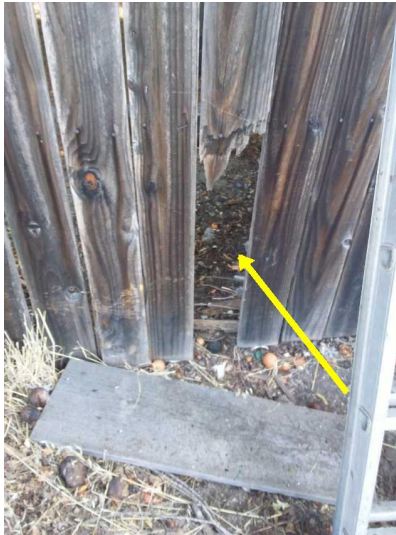
The fences have damage that you may wish to have repaired.

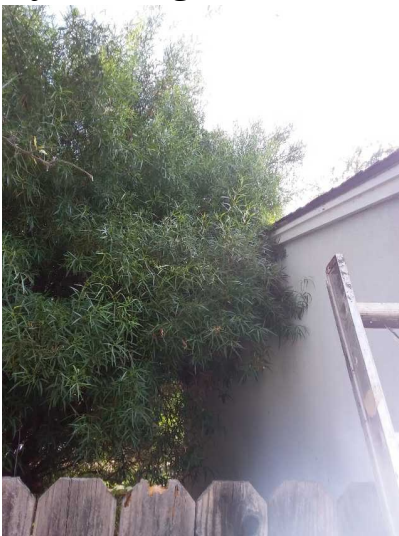
There are tree limbs over growing the residence that should be trimmed or monitored to insure that they do not impact or damage the roof or its components.

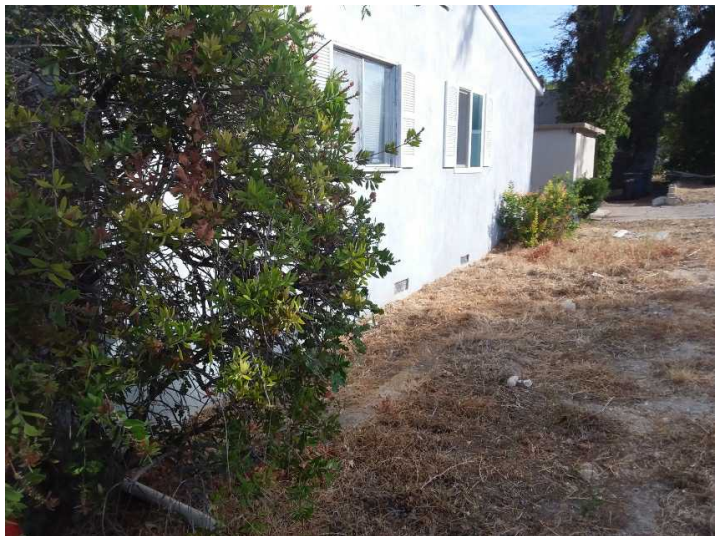
9.3. Vegetation is encroaching on the structure, and should be kept a minimum of twelve inches away for the general welfare of the walls and foundation.

Vegetation is encroaching on the structure, and should be kept a minimum of twelve inches away for the general welfare of the walls and foundation.

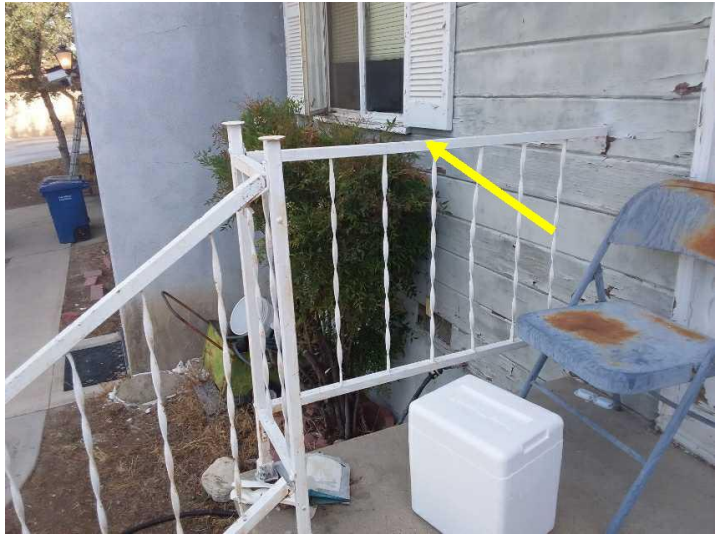
The balcony/deck guardrail does not conform to common safety standards. Common safety standards require them to be a minimum of 42 inches high when the standing surface is 30" or more above grade.

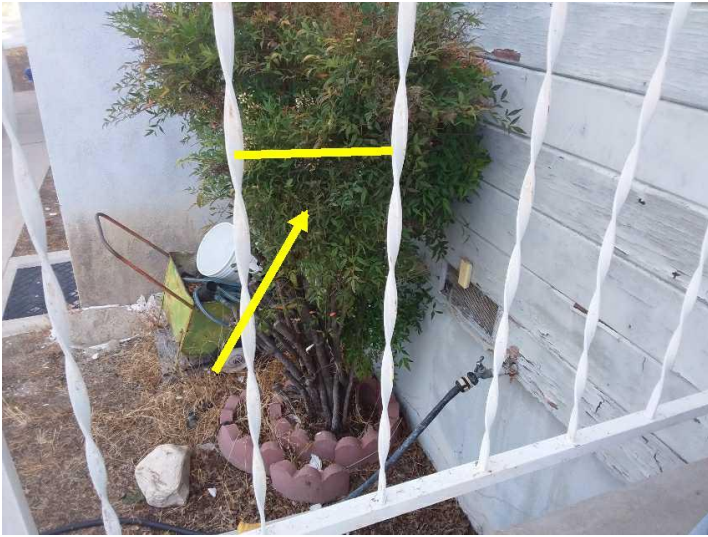
The balusters in the guardrail are more than 4" apart and are not child safe. Therefore, you may wish to add a protective barrier.

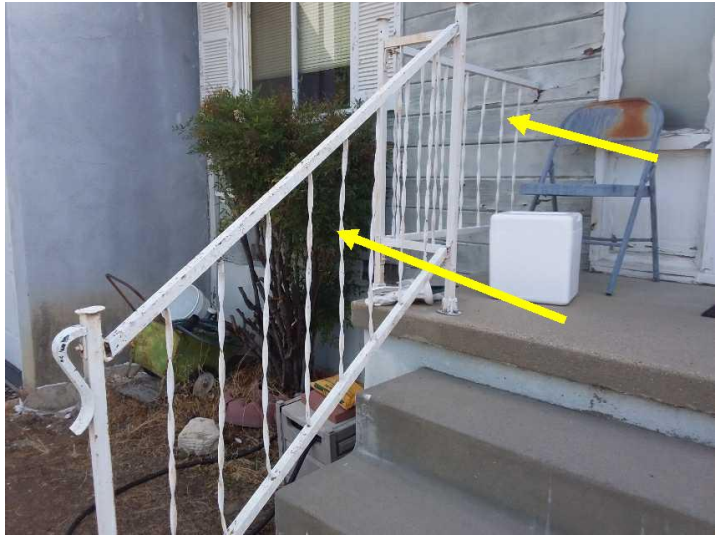
The guardrail is not secure, and should be serviced.

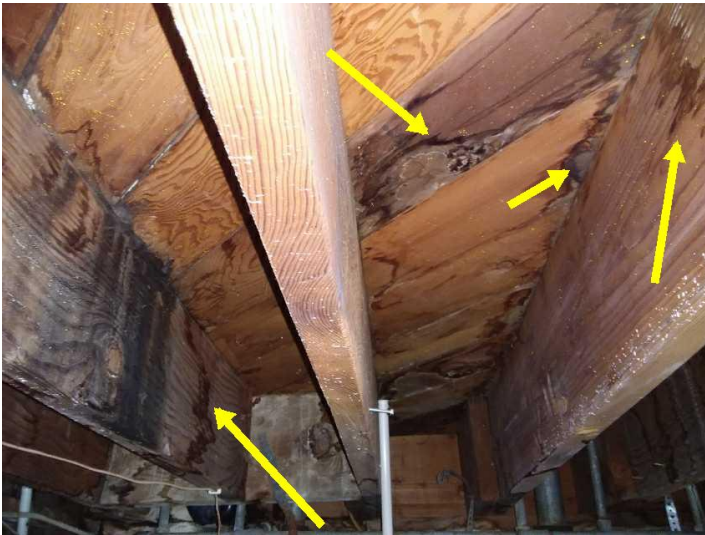
There are stains or moisture damage to the sub-floor beneath the residence. The termite inspector is responsible for pressure testing shower pans, and will evaluate and comment on the condition of the shower pan and any resulting damage to the intermediate floor framing.

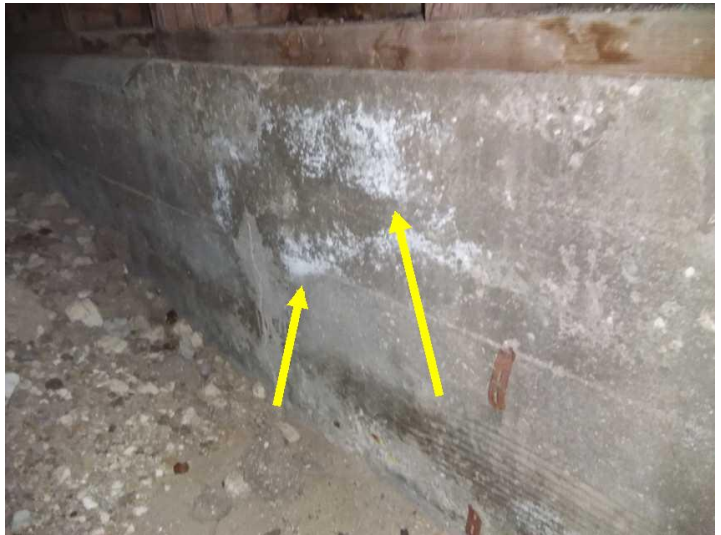
Moisture has entered the crawlspace, as is evident by salt crystal formations around the base of the stem walls. However, this is a common phenomenon that does not necessarily indicate a chronic or serious problem. The soils are currently dry, but it would be prudent to monitor this area.

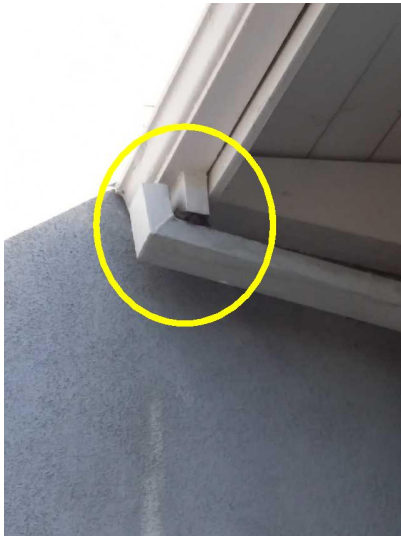
The gutters need to be serviced, such as reconnecting, sealing separated seams, cleaning them or making sure they are secure.

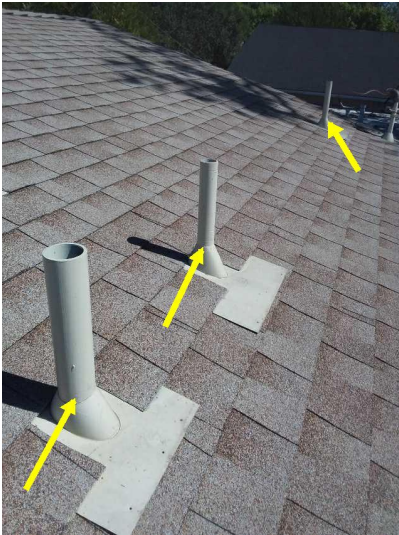
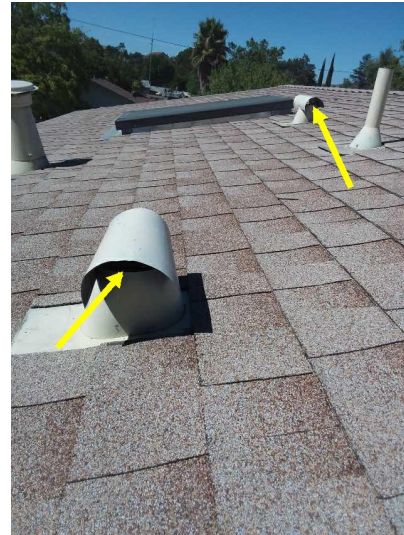
Some of the roof flashing need to be sealed or serviced. They are comprised of metal that seals valleys and vents and other roof penetrations, and are the most common point of leaks. This is particularly true of the flashing on a layered roof, which are covered by the roofing material and which are even more susceptible to leaks.

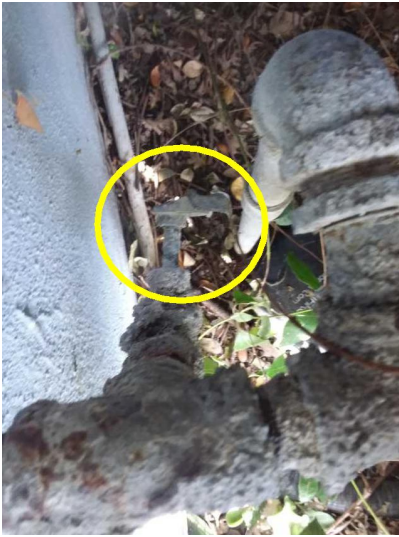
The main water shut off valve handle is missing or broken and it should be repaired.

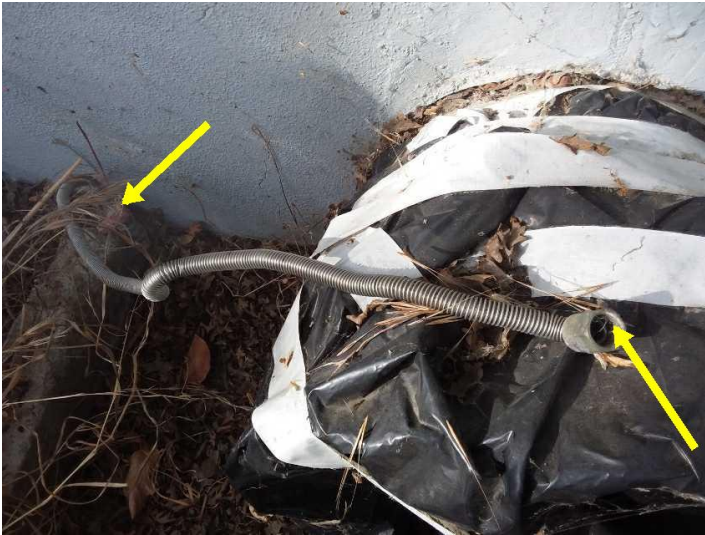
A gas pipe on the exterior of the home should be capped when not in use.

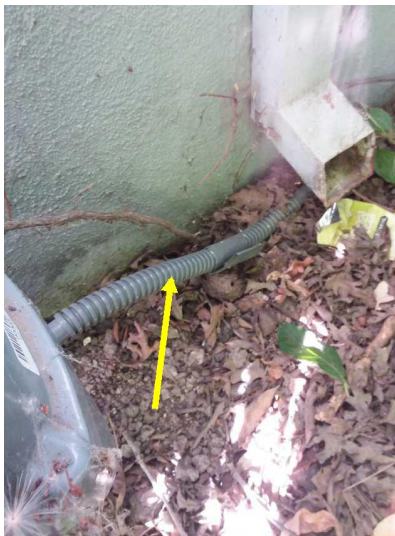
Corrugated Stainless Steel Tubing (CSST) is included for gas supply piping. Manufacturers believe the product is safer if properly bonded and grounded as required by the manufacturers installation instructions. Proper bonding and grounding of the product can only be determined by a licensed electrical contractor (Section 7196.2 to the Business and Professions code, SB 998). We recommend a qualified licensed electrical contractor certify proper bonding and grounding per the manufacture and California State standards.

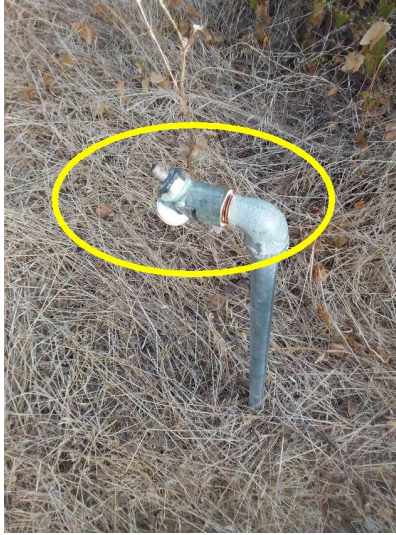
A hose bib at the rear has a missing or broken handle, which should be replaced. However, we may not have located and tested every hose bib on the property.

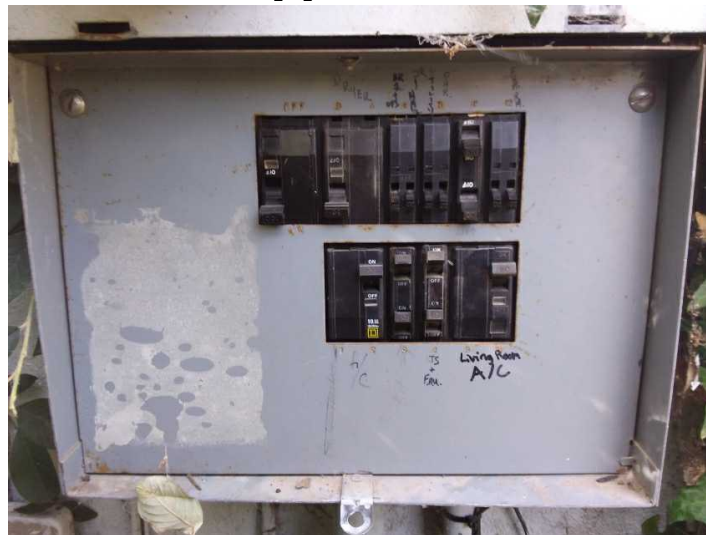
Various circuits are not labeled, which is recommended.

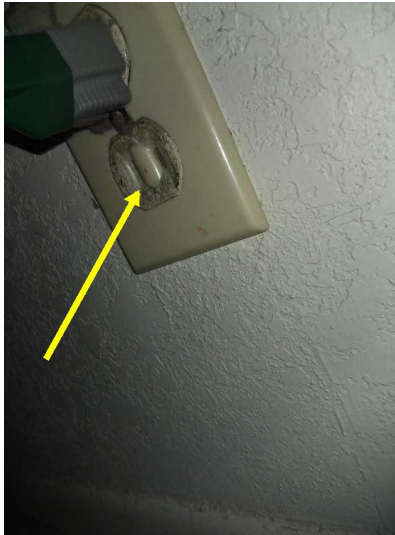
The ungrounded and obsolete outlets in the living room should be upgraded to include more modern and safer ones, which provide a pathway for the current to travel harmlessly to ground.

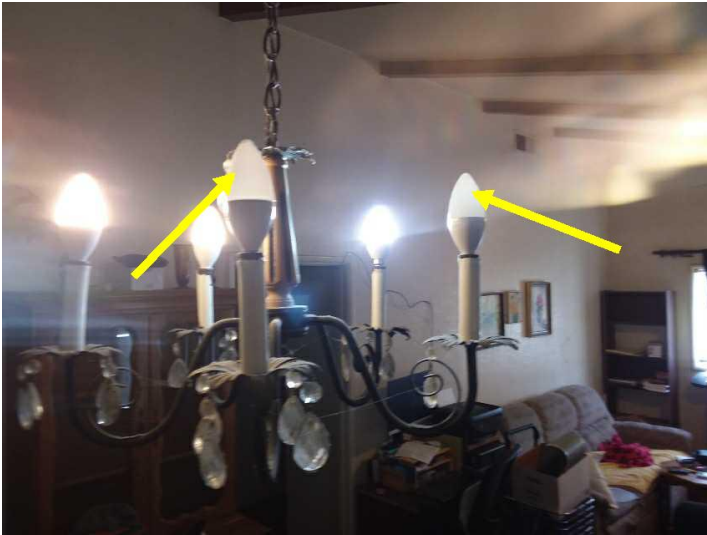
A ceiling light does not respond, and should be serviced.

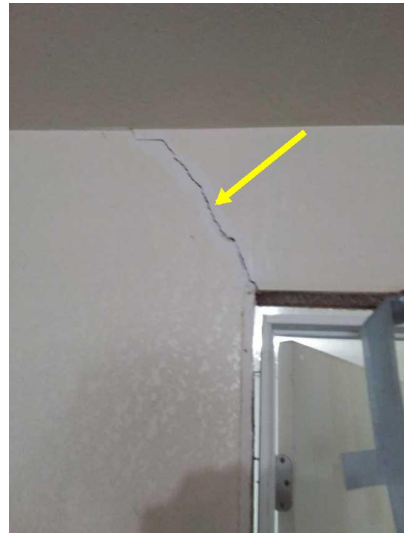
The walls have stress fractures which may have resulted from movement. I can elaborate on this issue, but you should have a specialist comment, and be aware that such cracks can reappear, and typically if they are not repaired correctly.

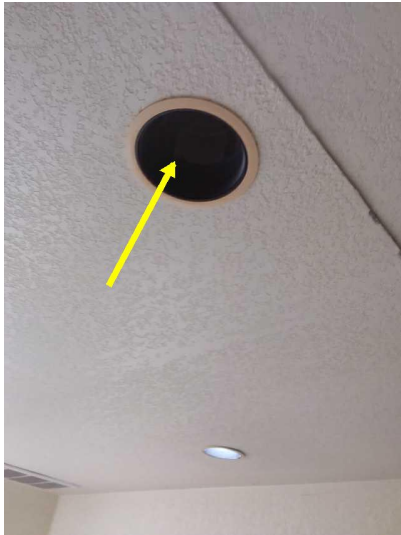
A ceiling light does not respond, and should be serviced.

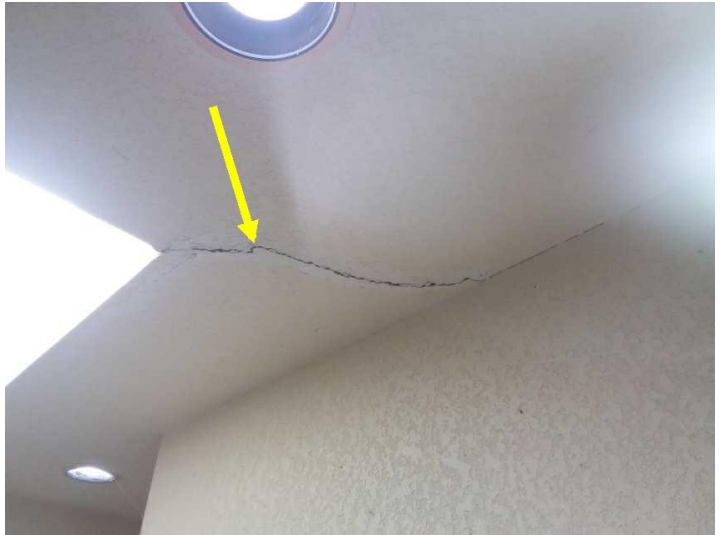
| Page 36 Item: 4 | Family Room | <p>4.16. The walls have stress fractures which may have resulted from movement. I can elaborate on this issue, but you should have a specialist comment, and be aware that such cracks can reappear, and typically if they are not repaired correctly.</p> <p>4.17. There is a mold-like substance that we will point out, which should be evaluated by a specialist. All molds flourish in a damp environment and many are commonplace, but some are toxic and represent a health threat.</p> |

The walls have stress fractures which may have resulted from movement. I can elaborate on this issue, but you should have a specialist comment, and be aware that such cracks can reappear, and typically if they are not repaired correctly.

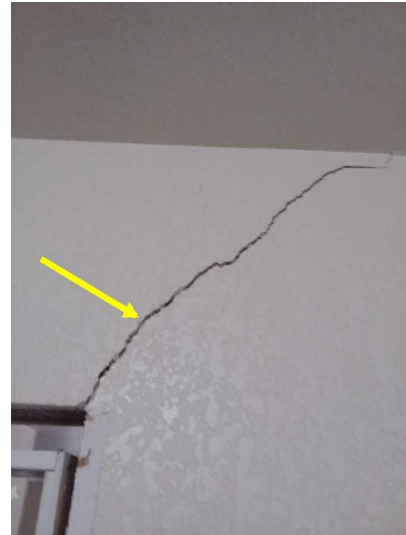
The walls have stress fractures which may have resulted from movement. I can elaborate on this issue, but you should have a specialist comment, and be aware that such cracks can reappear, and typically if they are not repaired correctly.

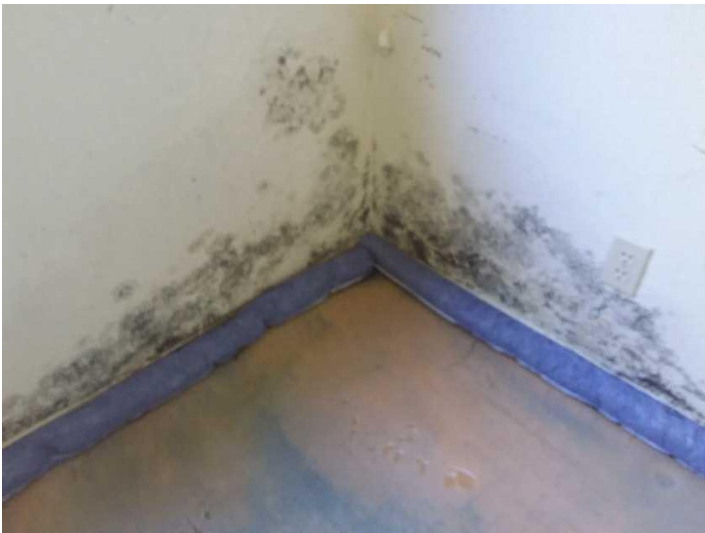
There is a mold-like substance that we will point out, which should be evaluated by a specialist. All molds flourish in a damp environment and many are commonplace, but some are toxic and represent a health threat.

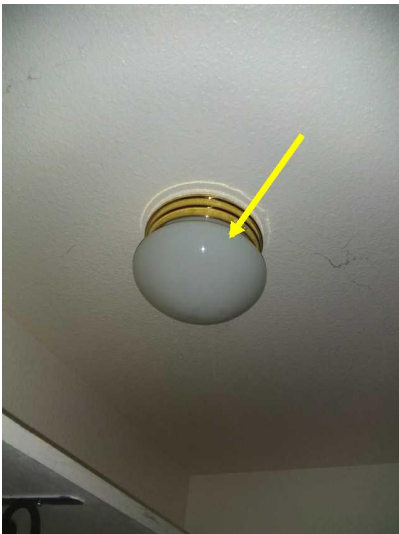
The light in the bedroom closet does not respond and should be serviced.

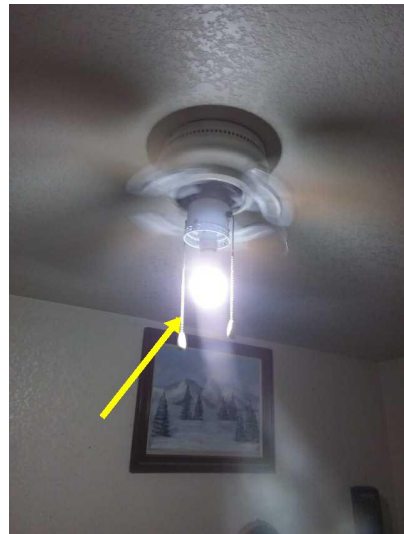
A light cover or globe is missing and should be installed.

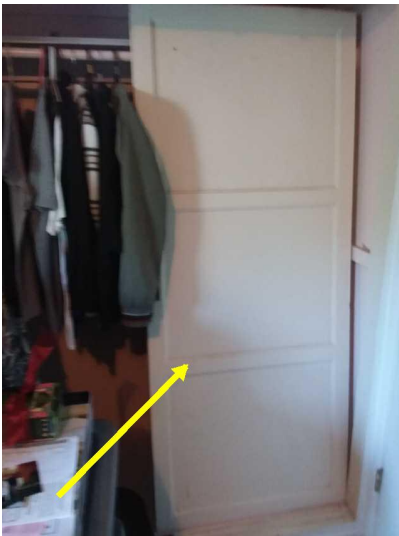
The closet doors do not roll smoothly and should be serviced.

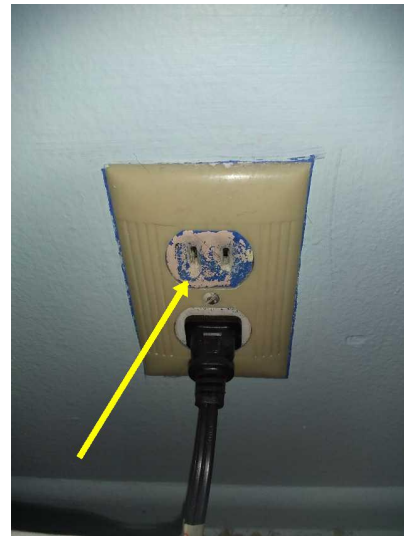
The obsolete and ungrounded outlets should be replaced with modern and safer ones, which provide a pathway for the electrical current to travel harmlessly to ground.

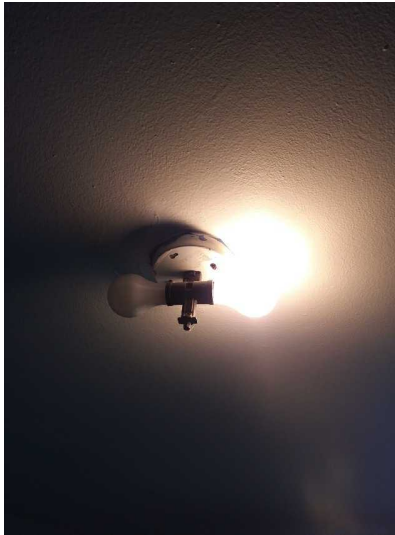
A ceiling light in the bedroom does not respond, and should be serviced.

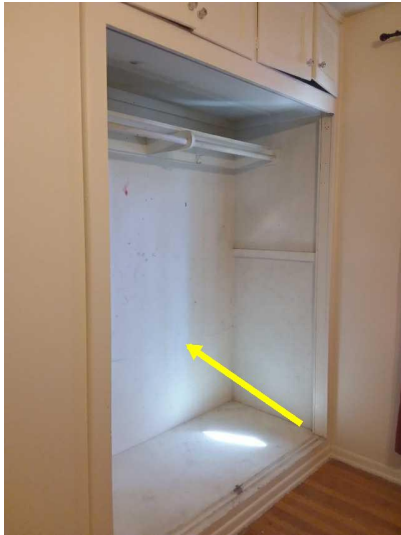
Closet doors are missing and you may wish to have it installed.

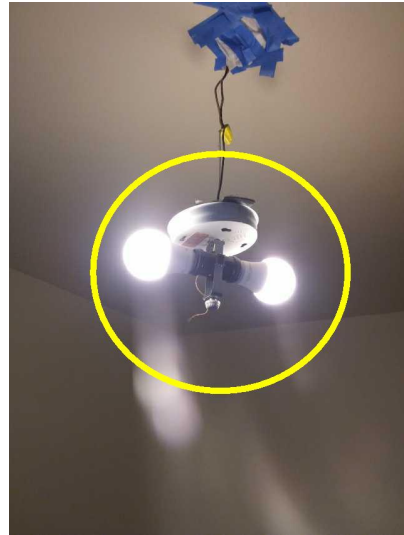
A light cover or globe is missing and should be installed.

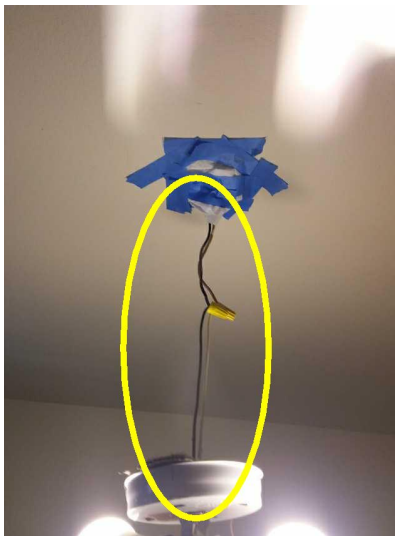
A ceiling light is loose or missing which should be replaced or the electrical box sealed.

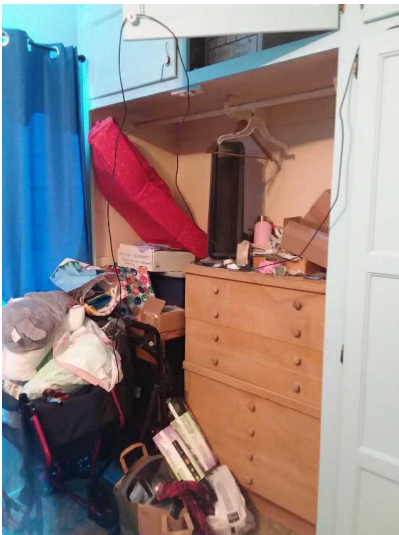
Closet doors are missing and you may wish to have it installed.

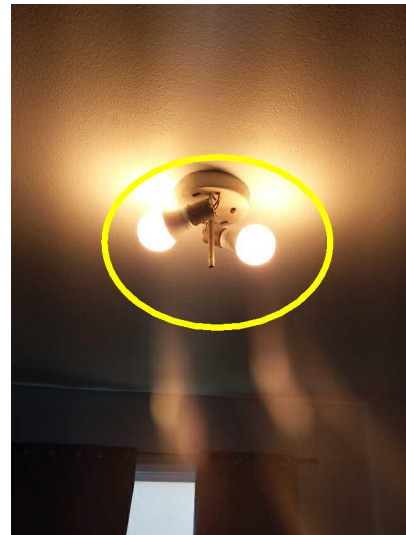
A light cover or globe is missing and should be installed.

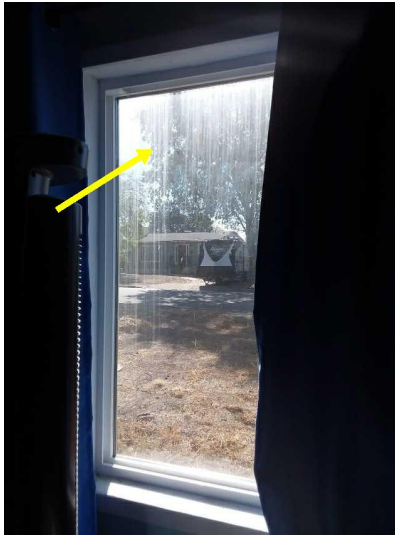
A window(s) may have a broken hermetic seal which you may wish to have replaced. This is evident from fogging, or condensation forming between the panes of glass that confirm that the seal has failed.

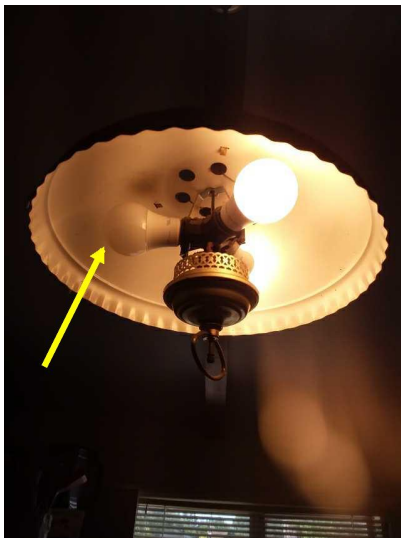
A ceiling light does not respond and should be serviced.

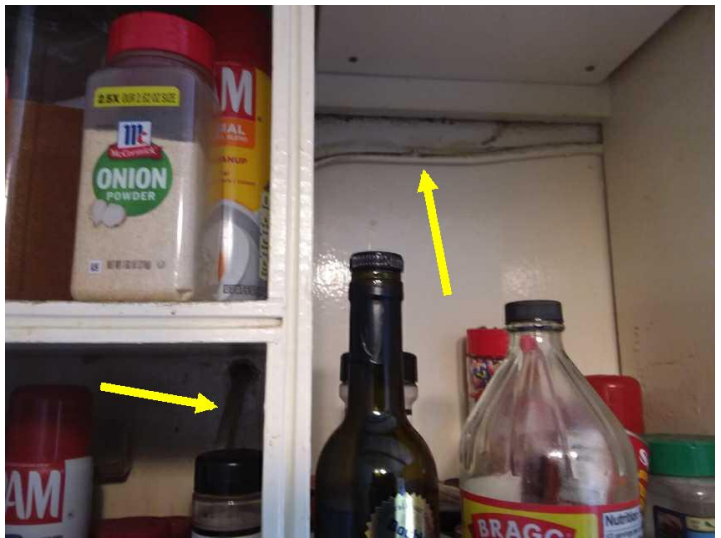
4.4. There is exposed romex or electrical cabling that should be protected by installing the romex inside the wall cavity, or properly wired into conduit.

There is exposed romex or electrical cabling that should be protected by installing the romex inside the wall cavity, or properly wired into conduit.

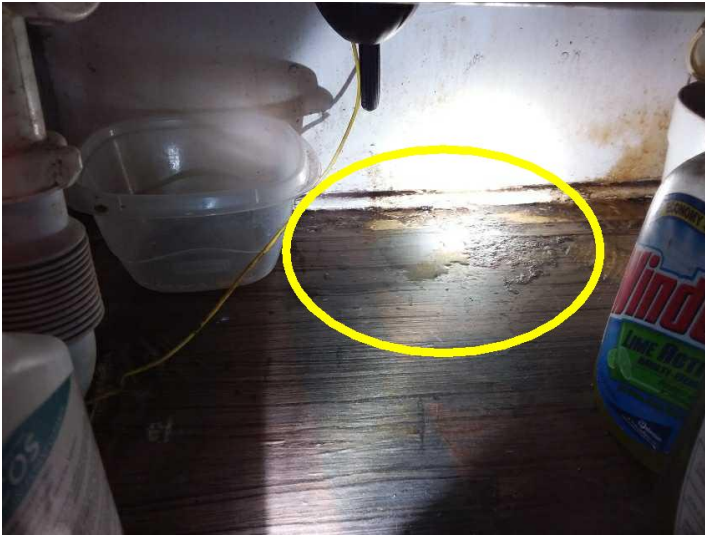
| Page 49 Item: 5 | Sink and Faucet | <p>5.5. There is a leak below the sink, which should be repaired.</p> |

There is a leak below the sink, which should be repaired.

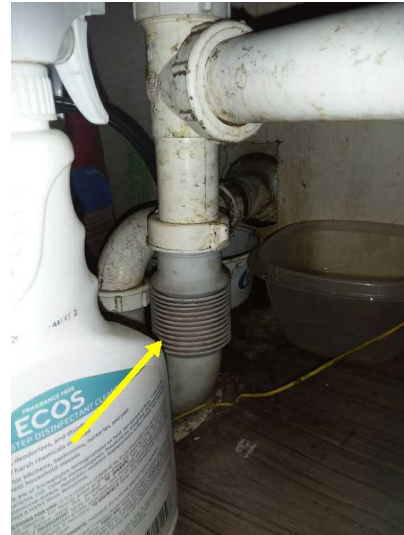
The sink employs an unconventional flexible drainpipe that could contribute to blockages.

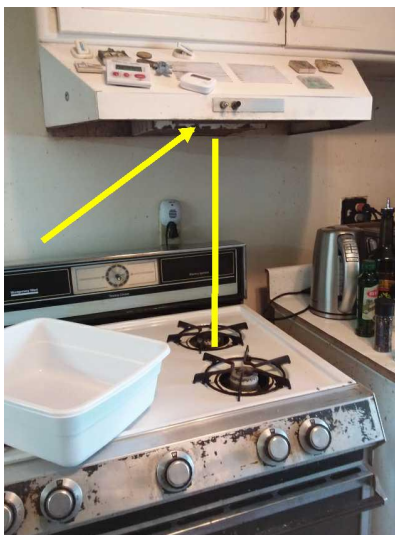
7.2. The range hood exhaust-fan is closer than the recommended 24 inches and should be used with caution.

The range hood exhaust-fan is closer than the recommended 24 inches and should be used with caution.

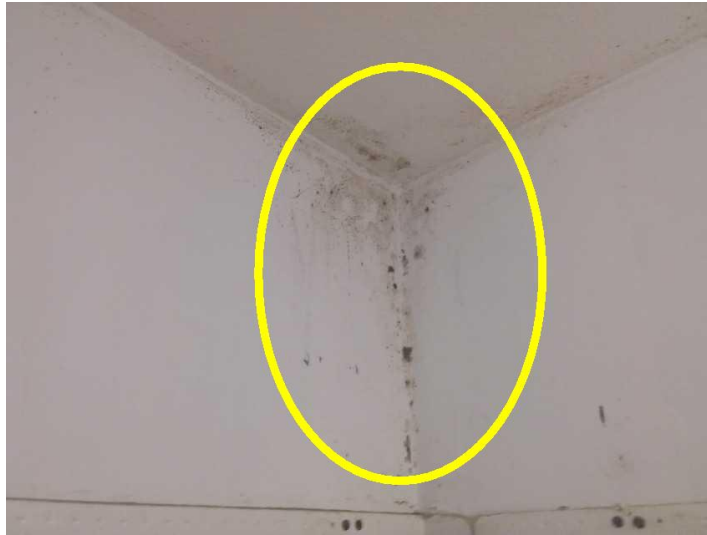
| Page 52 Item: 1 | 1st Guest Bathroom | <p>1.20. We have observed a mold like substance that should be evaluated by a certified specialist.</p> |

We have observed a mold like substance that should be evaluated by a certified specialist.

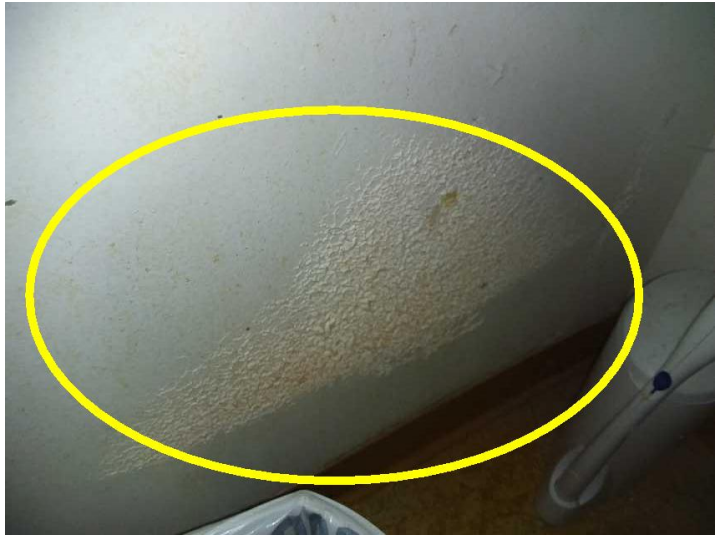
There is a moisture stain on the wall that should be explained by the sellers or further evaluated as to its cause.

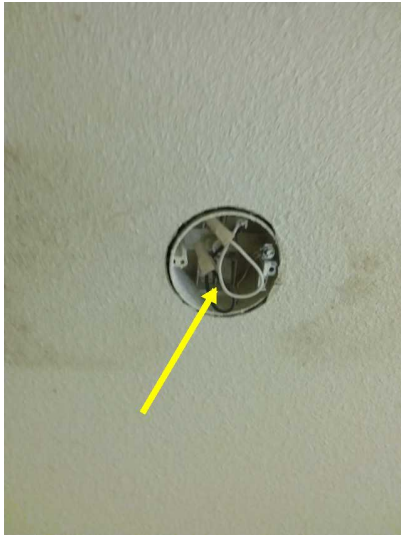
A ceiling light is missing which should be replaced or the electrical box sealed.

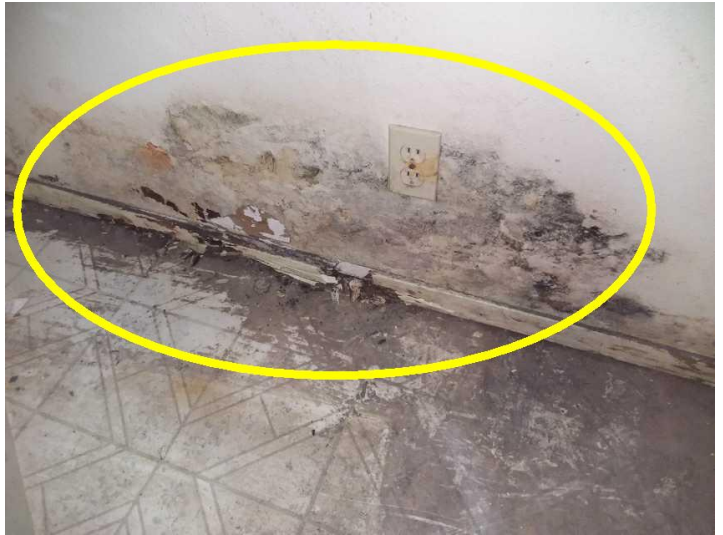
There is a mold-like substance that we will point out, which should be evaluated by a specialist. All molds flourish in a damp environment and many are commonplace, but some are toxic and represent a health threat.

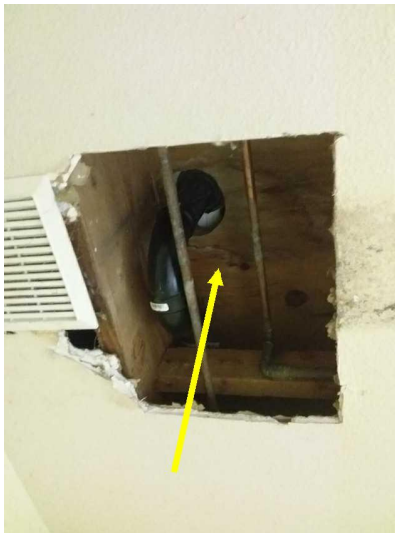
There has been a drywall/plaster repair that should be explained by the seller.

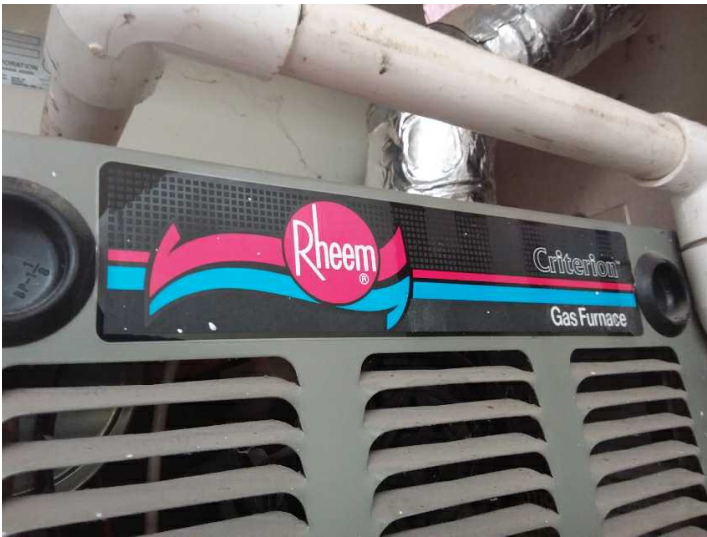
| Page 59 Item: 1 | Forced Air Furnace | <p>1.16. The furnaces are functional. However, they are beyond the commonly accepted design life of twenty years, and will need to be monitored more closely for evidence of metal fatigue. We recommend that you have it serviced and evaluated by an HVAC contractor prior to the close of the inspection period.</p> |

Serial number for furnace in stair closet BR5D302  
F1892 6229 - MANUFACTURED 1992

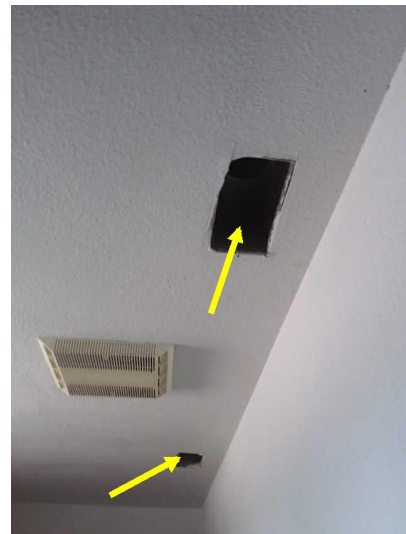
A wall register is missing in bathroom and should be  
replaced.

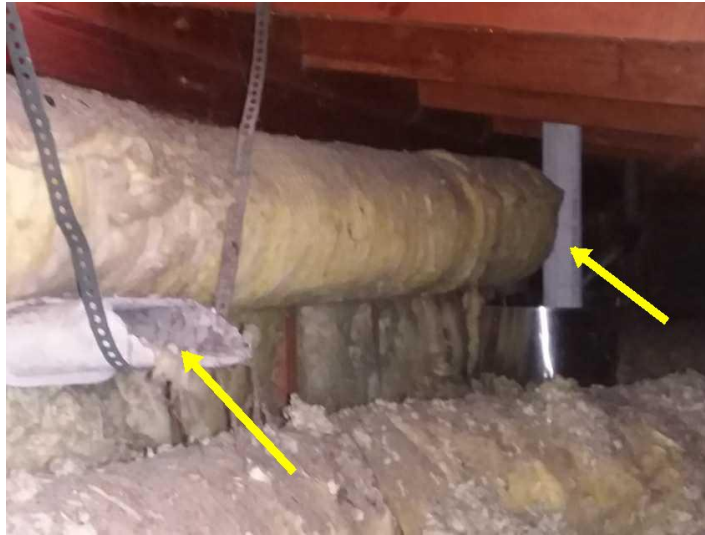
The heat vents include a clay-based type, known as a transite pipe that contains asbestos fibers, but which are encapsulated and thereby do not pose any viable health threat.

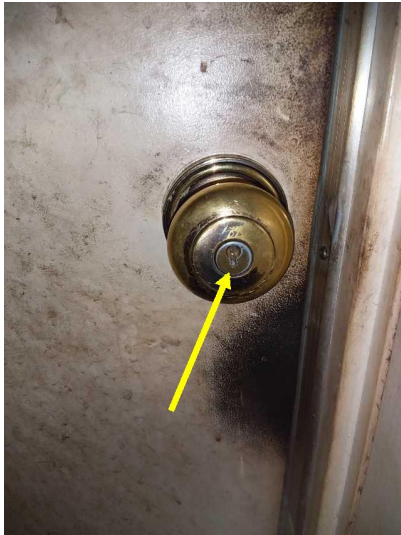
The keyed deadbolt could prevent or impede an emergency exit, and should be replaced with a safer latch type.

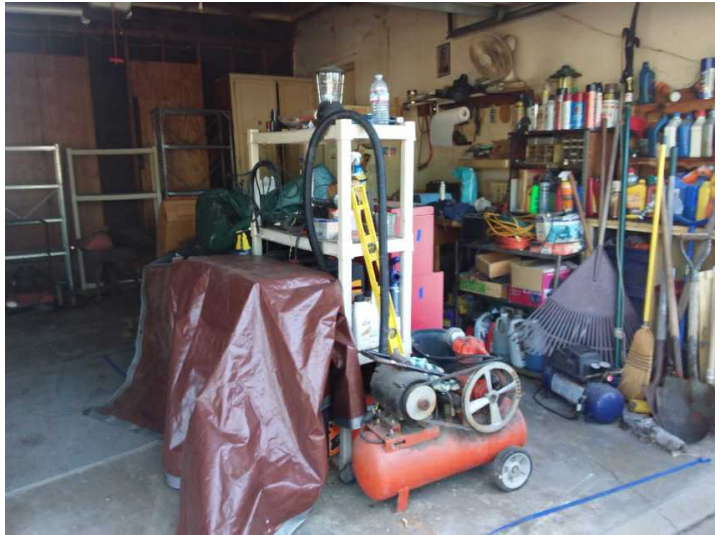
The garage is too full to permit a clear view of the entire slab and other components of the garage.

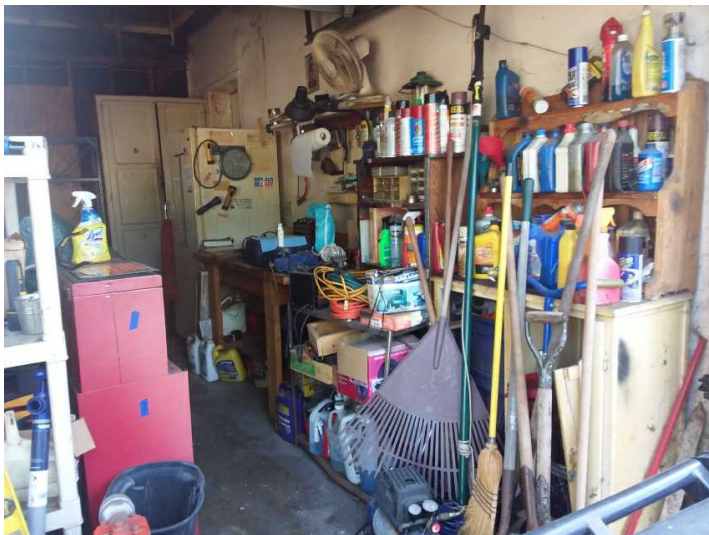
The garage walls are too full or covered to provide a clear view of them and other components of the garage.

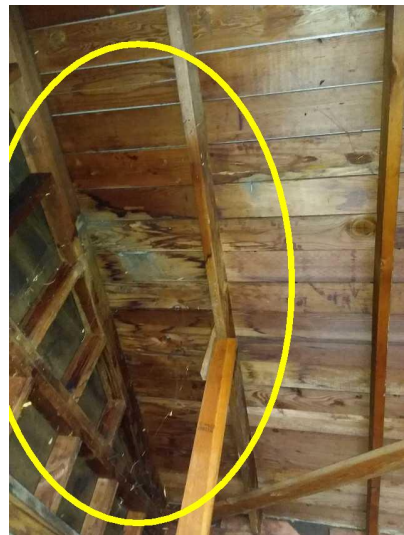
There is a moisture stain on the garage ceiling, the cause of which should be explained or explored further. However, we were not able to confirm that it is being caused by an active leak.

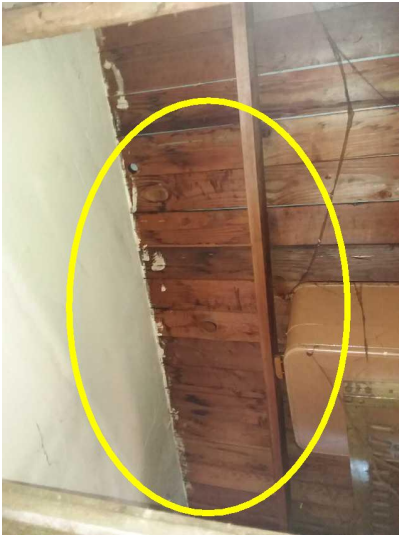
There is a moisture stain on the garage ceiling, the cause of which should be explained or explored further. However, we were not able to confirm that it is being caused by an active leak.

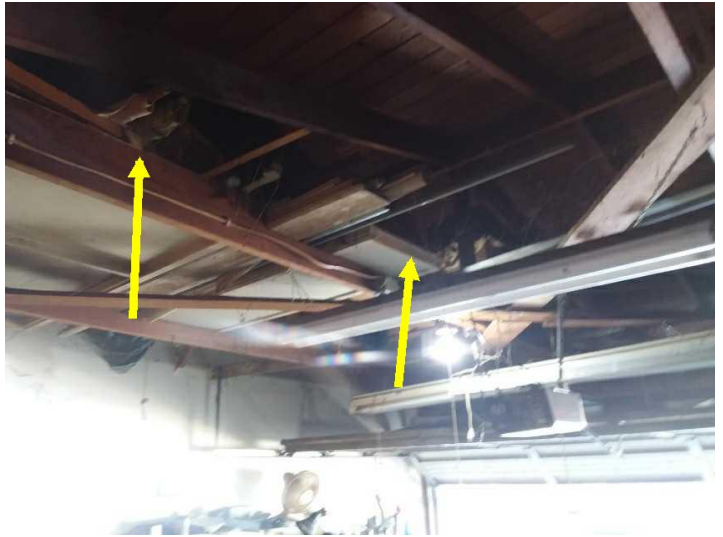
The storage space may have been added without the benefit of a permit, which could stress the roof framing. You may wish to verify this with the sellers. Regardless, you should limit the storage to lightweight items.

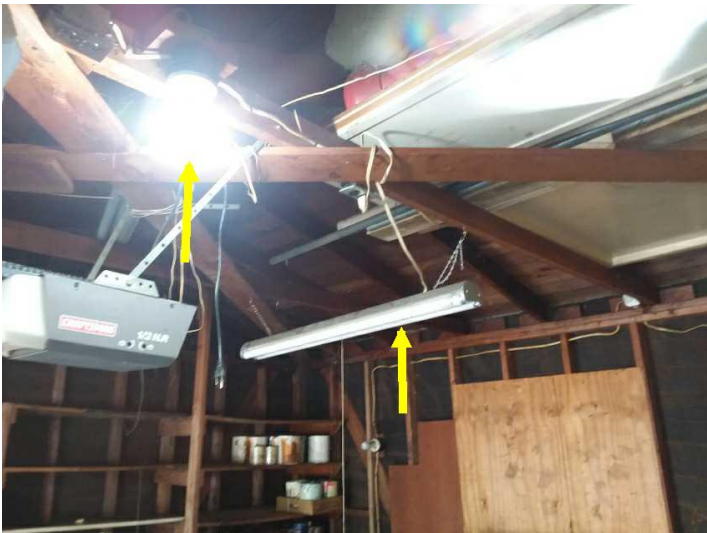
A light is missing its globe or cover and should be serviced.

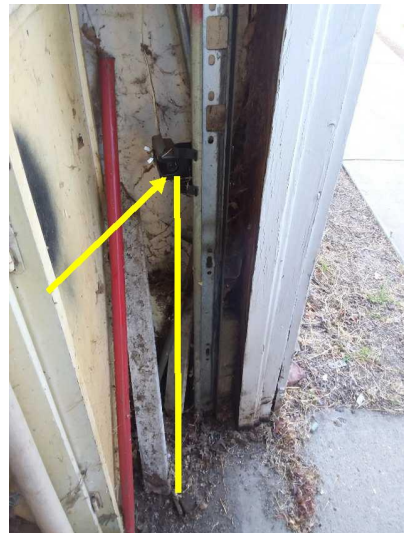
The infra-red auto-reversing sensor mechanisms are functional but located higher than the recommend six inches above grade.
