1628 Freeman Dr, Pine Mountain  
Club,, CA 93222

Emil Sarkisians  
11/07/2025

James Tomasko  
InterNACHI Certified Professional  
Inspector, CSLB General Contractor  
736872, DRE 1082969

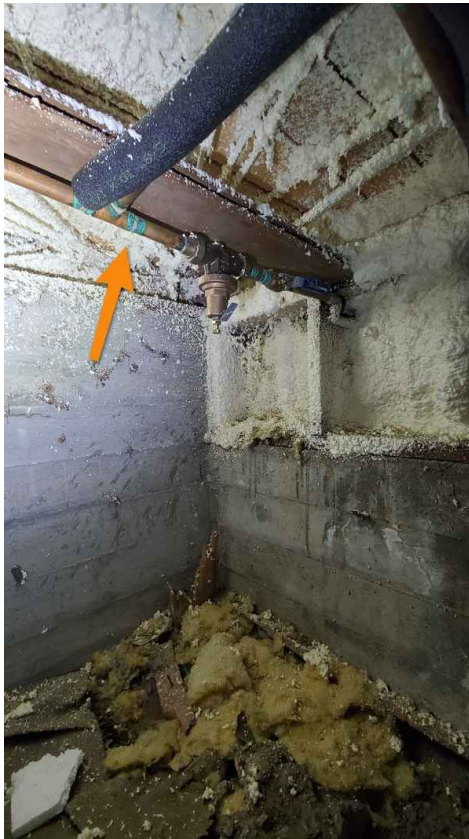
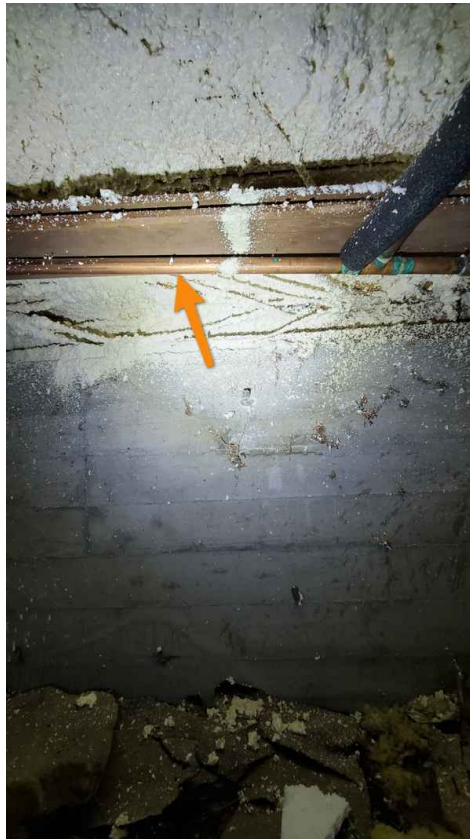
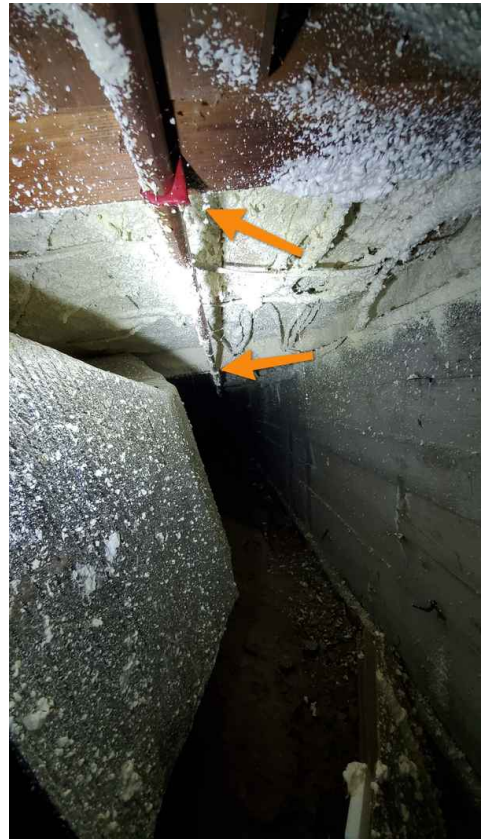
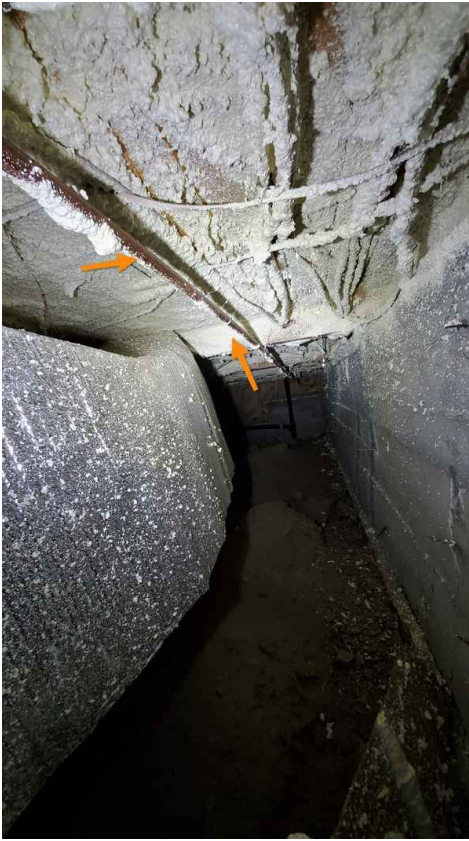
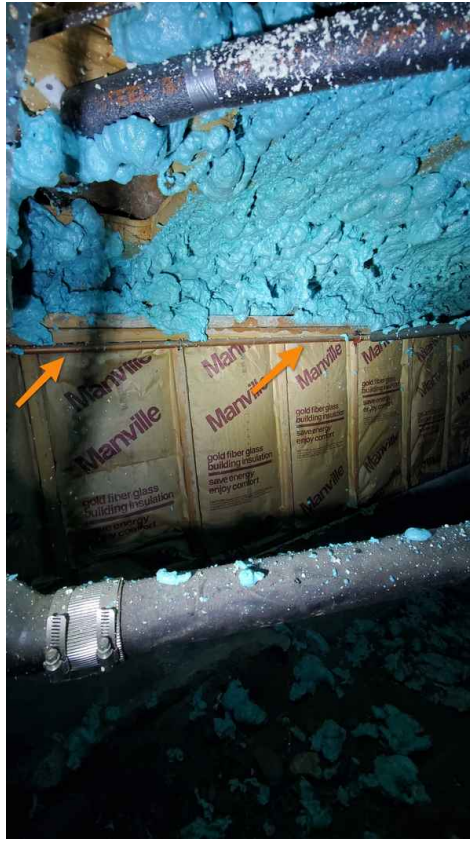
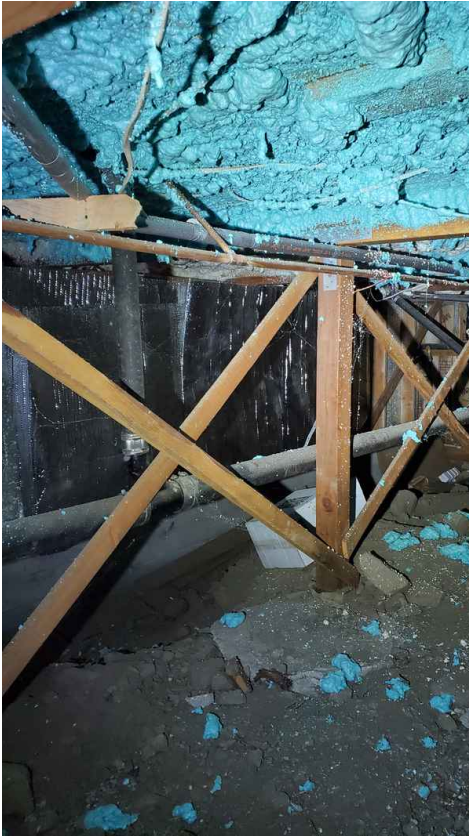
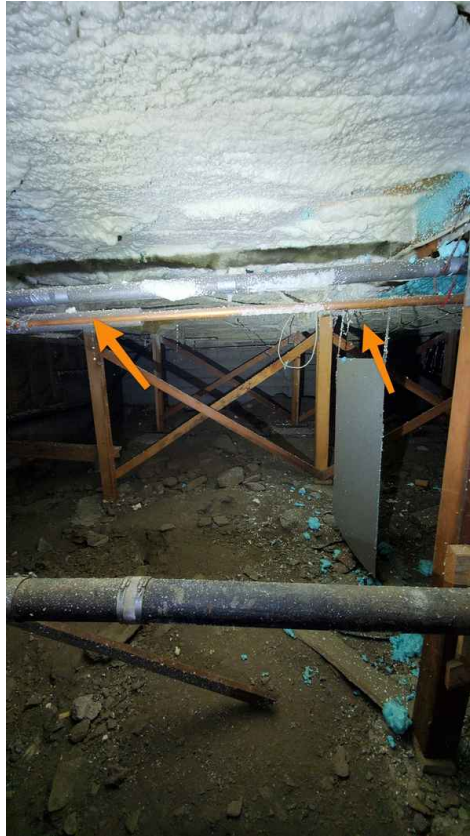
### 3.2.1 Crawlspace

#### **WATER SUPPLY LINES: INSULATION MISSING**

There are water supply lines in the crawlspace that are uninsulated. These lines are out side the thermal envelope and could freeze in extreme cold.

It is recommended these lines be insulated to prevent a hard freeze and potentially burst.

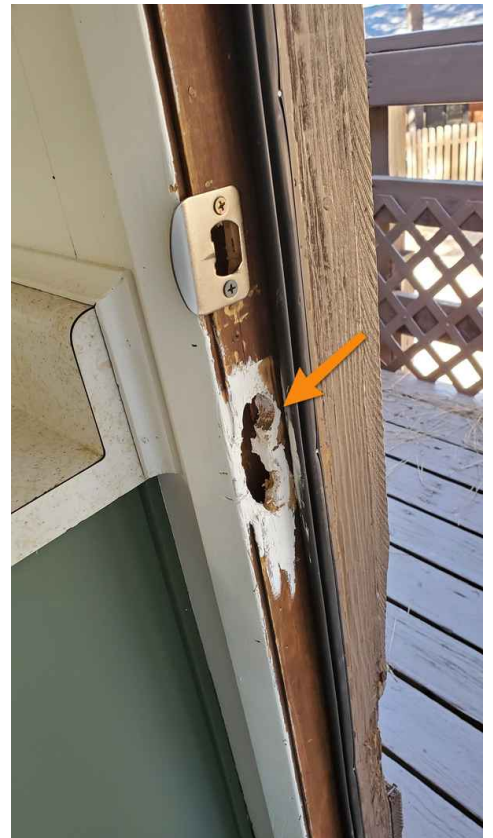
## 4.4.1 Door/Window Exteriors

**DOOR JAMB:**  
**DAMAGE/DETERIORATION, SEVERE**

Door jamb in the kitchen had severe damage or deterioration. You should consult with a qualified contractor to discuss options and costs for repair or replacement.

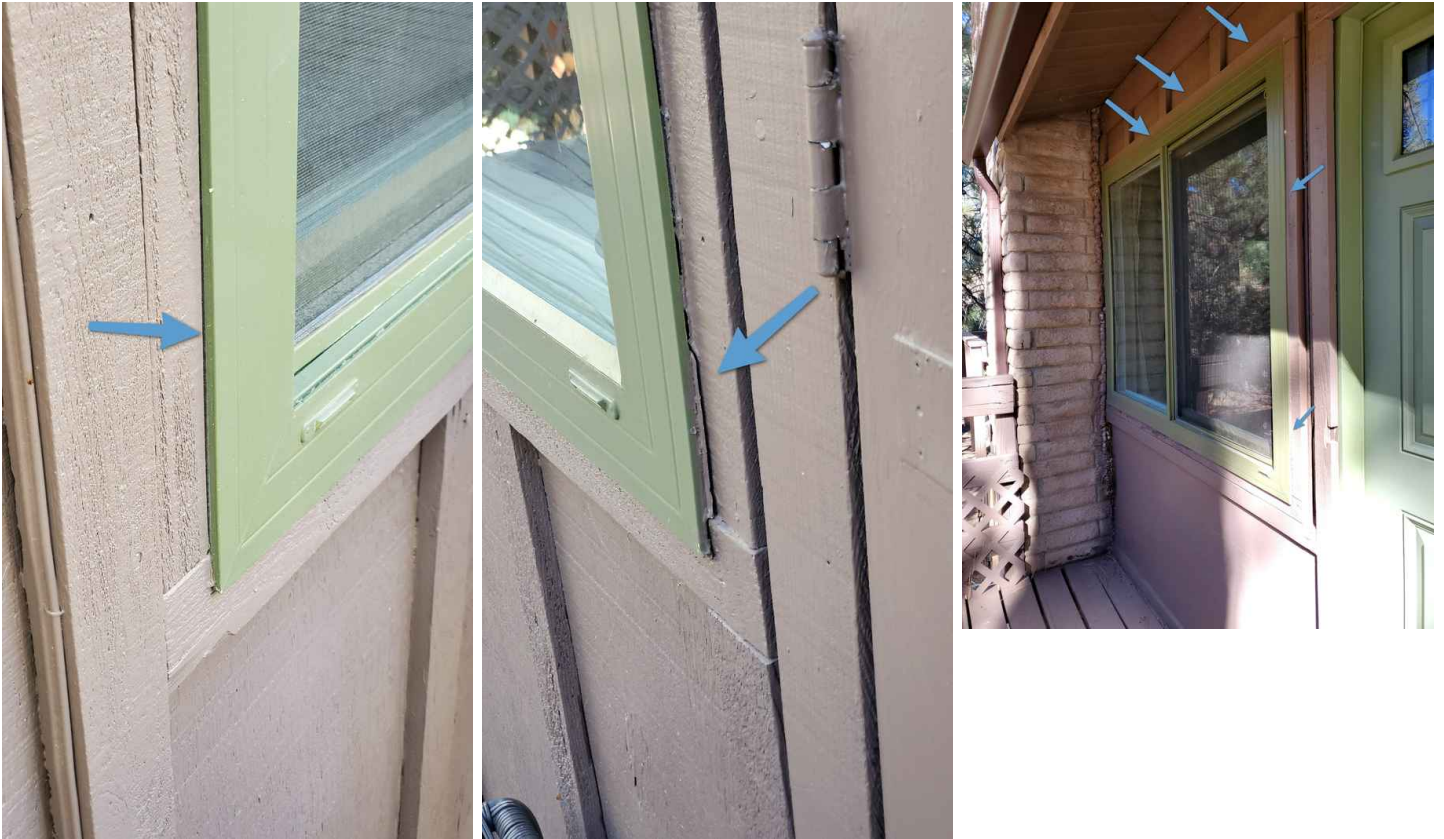
#### 4.4.2 Door/Window Exteriors

### FLUSH FIN REPLACEMENT WINDOWS

The home has newer Flush Fin Replacement windows. These types of windows require installations that vary by the type of window they replaced and the style of new window used.

You should be aware that many of the installations performed on homes have been done to the manufacturer's specifications. However, there is no way to determine if they have been done correctly or not in most cases because the old frames are either hidden (proper installation) or have been removed (improper).

It is advised to monitor the sealant around the window frame and any trim that is around or under the new flush frame window that has been installed. Maintenance of the sealant is important to prevent leaks into the wall/home interior.

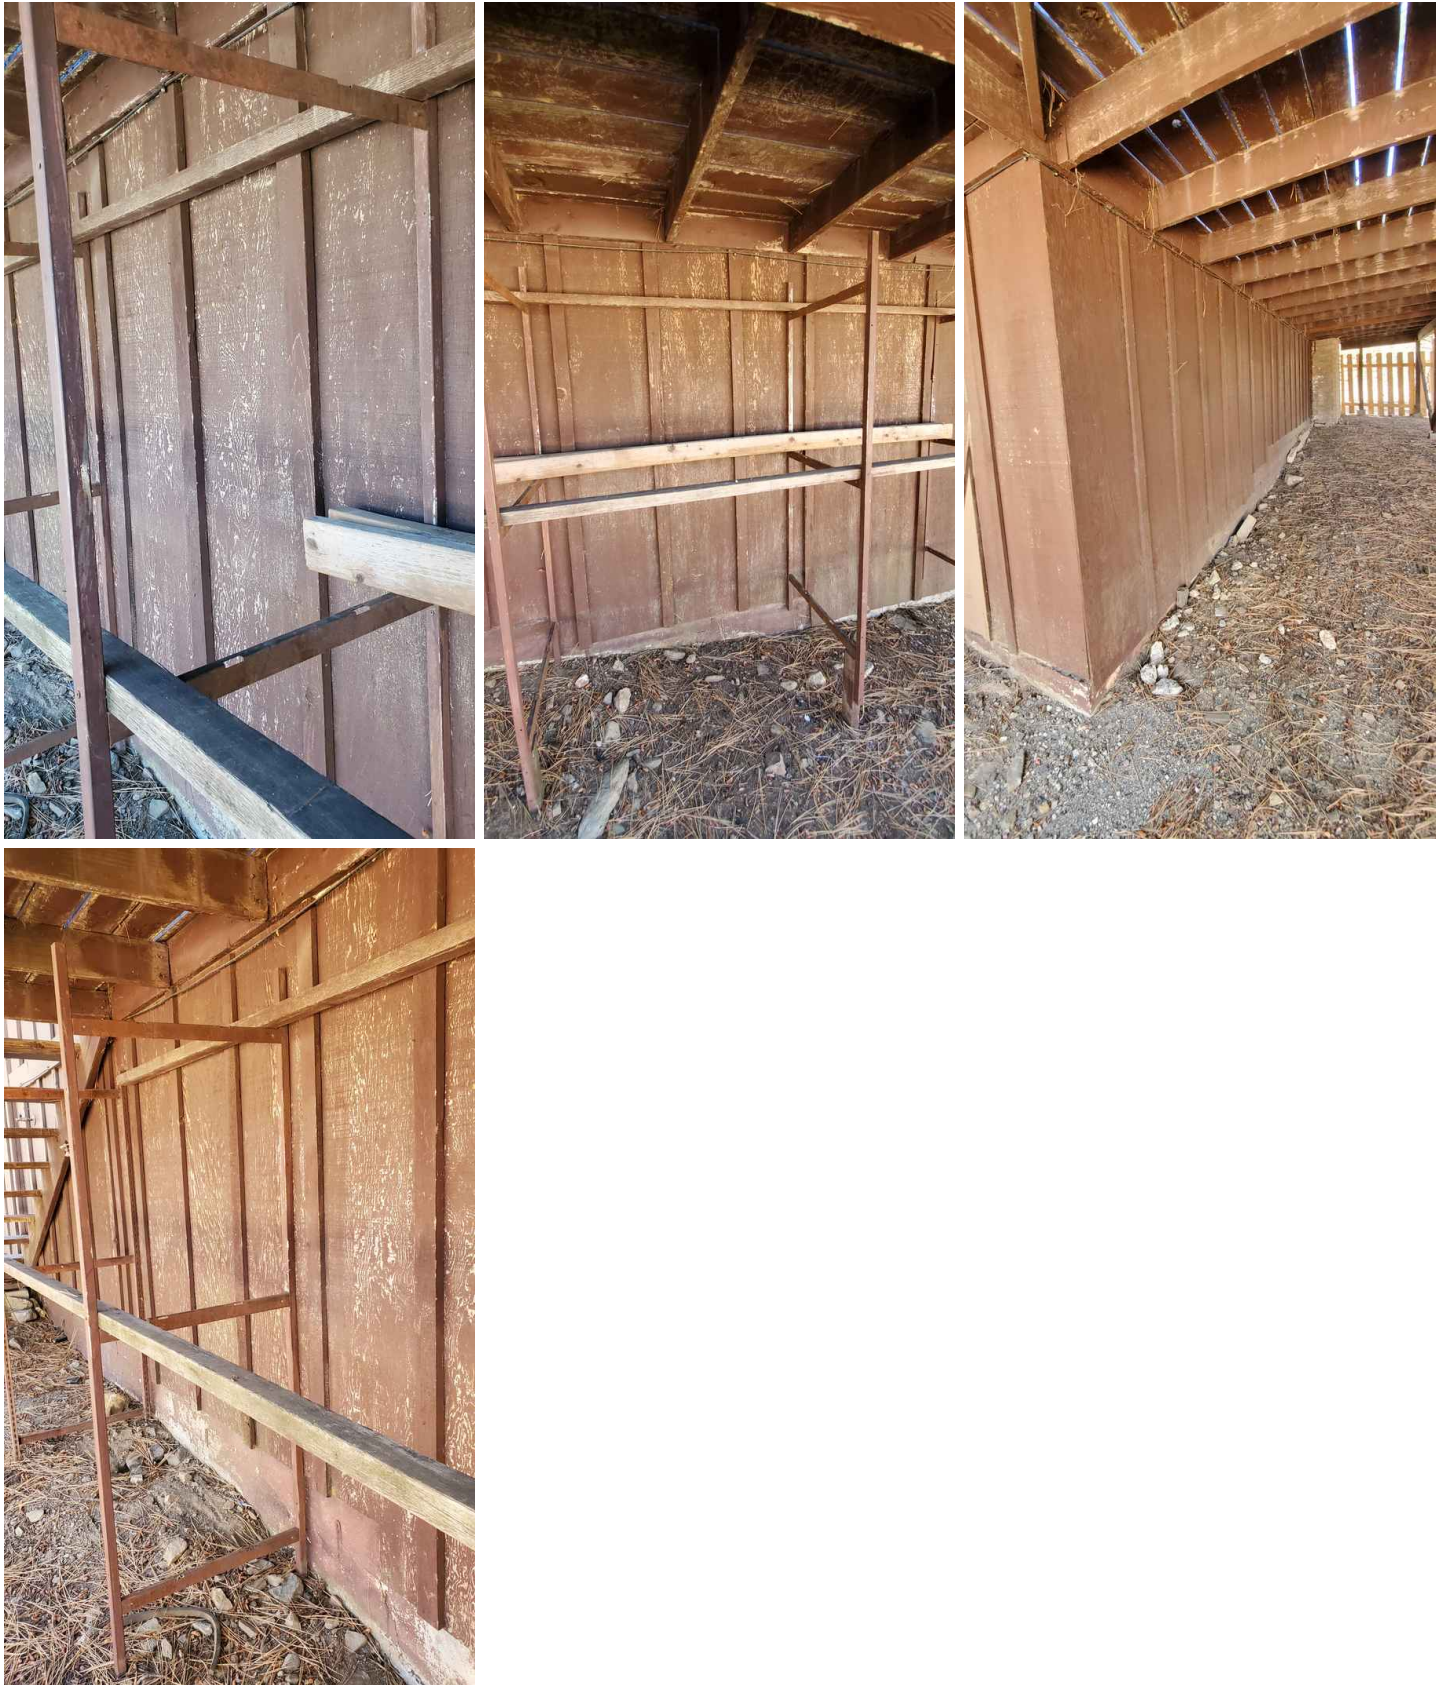
#### 4.5.1 Wood Siding

##### **DETERIORATION: MINOR**

Wood siding covering the exterior walls of the home exhibited minor general weathering, wear, and deterioration commensurate with its age.

It is need of maintenance- paint or stain.

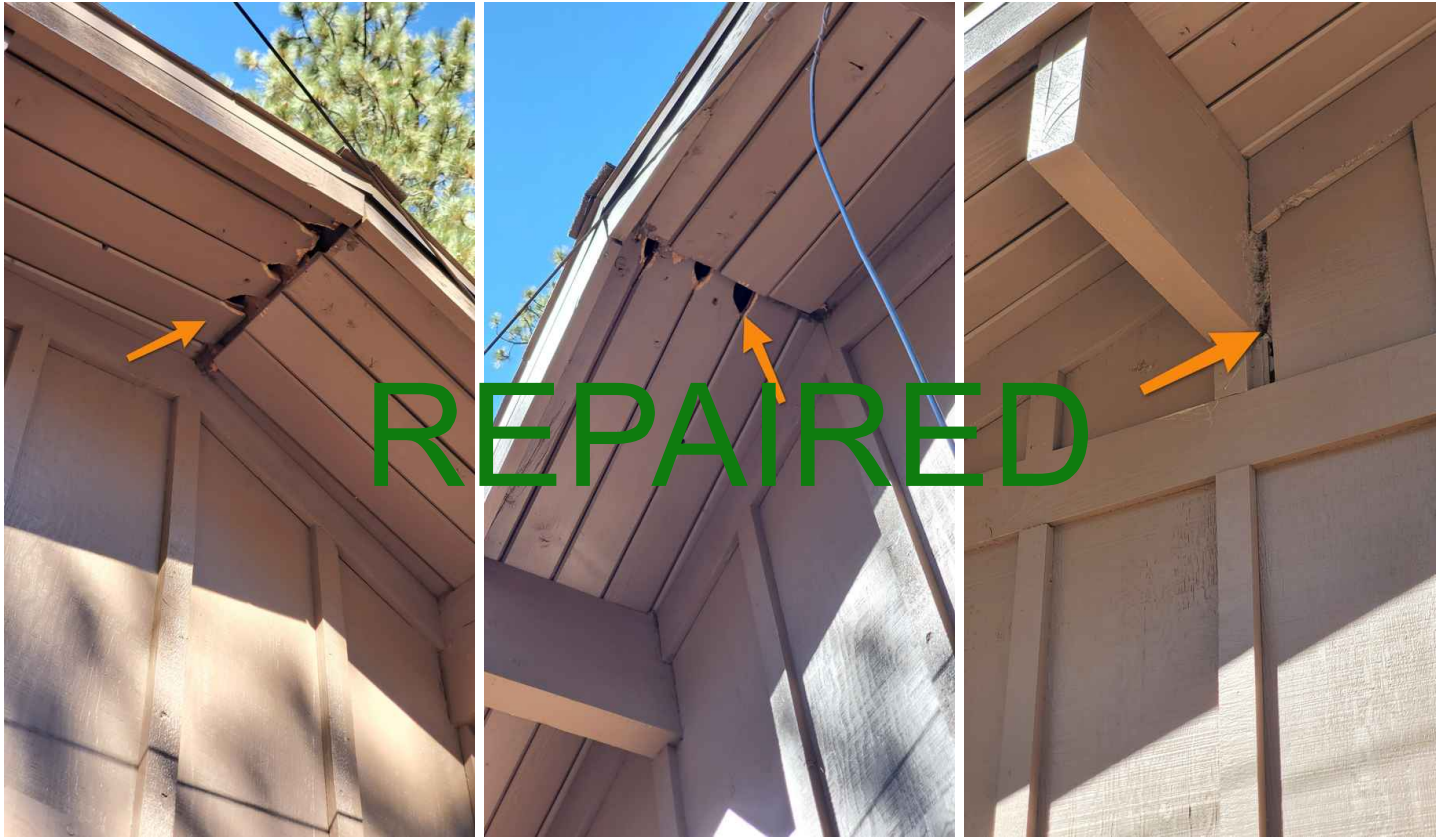
4.5.2 Wood Siding  
**DAMAGE: BIRD**

Holes in the wood were typical of those made by cavity-nesting species of birds during nesting activities. Birds can be quite persistent in creating new holes once existing holes are repaired. Plastic owls, dangling bright objects like CDs, and recordings of birds in distress are typically not effective long-term deterrents. A good way to help prevent future damage is to attach an appropriately-designed nesting box directly over a repaired hole. Nesting boxes and box designs are bird species-specific and are available online.

It is recommended that repairs be made to prevent pests and water intrusion into the wall cavity creating more damage to the home

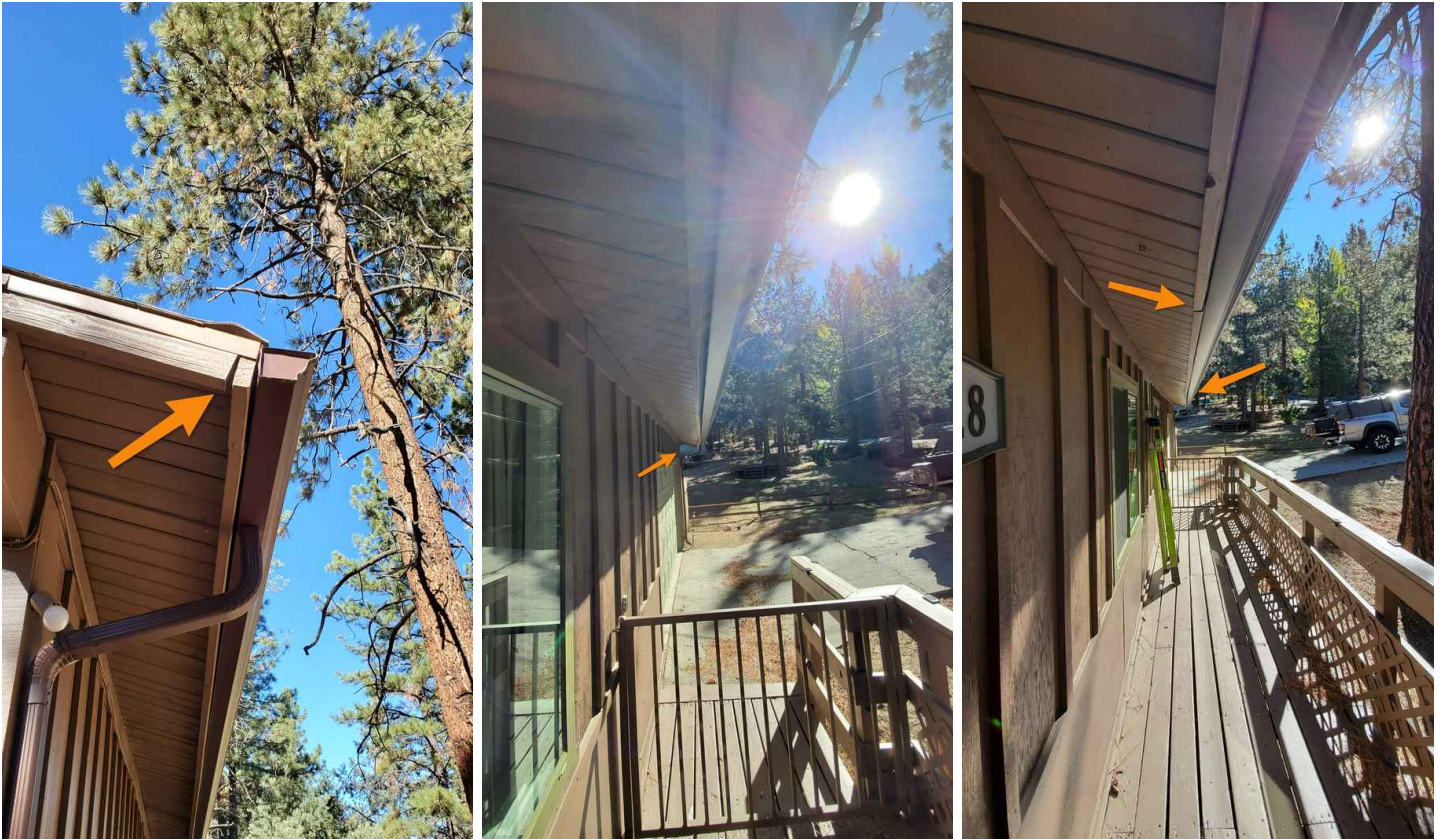
#### 4.6.1 Exterior Trim/ Eaves/Soffits

##### **FASCIA: LOOSE/DETACHED**

Fascia was loose or detached in places and needed repair or replacement. All work should be performed by a qualified contractor.

Poor repairs were done on the fascia and it is crooked.

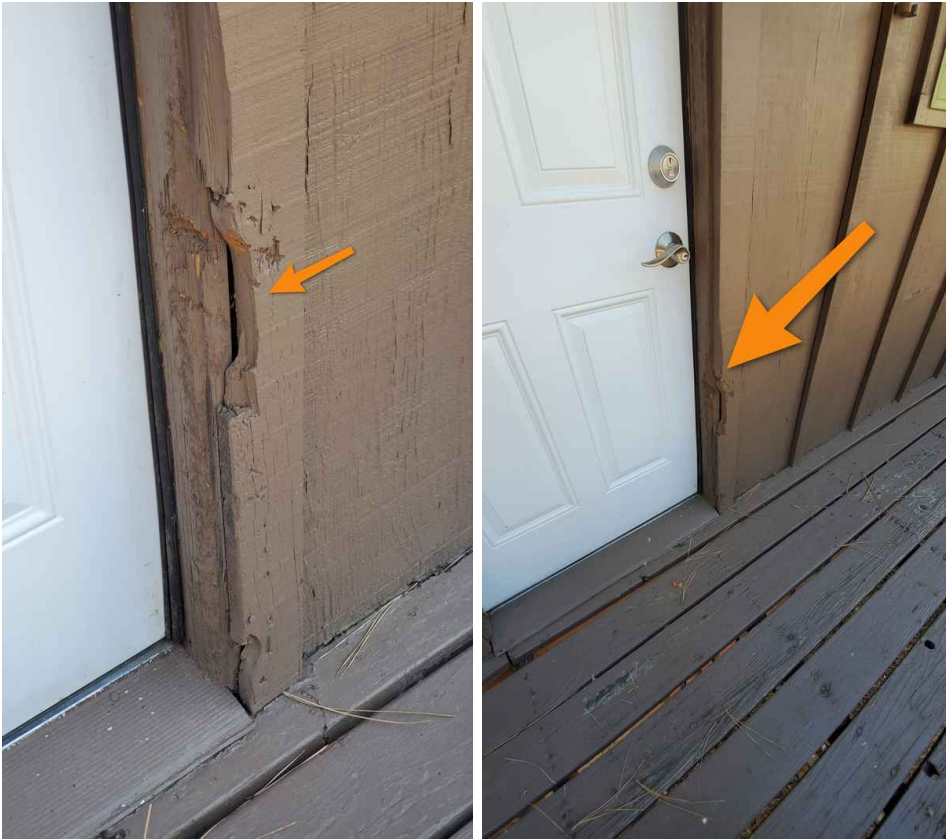
#### 4.6.3 Exterior Trim/ Eaves/Soffits

##### **DOOR TRIM: DAMAGE**

Door trim was damaged and needed repair. All work should be performed by a qualified contractor.

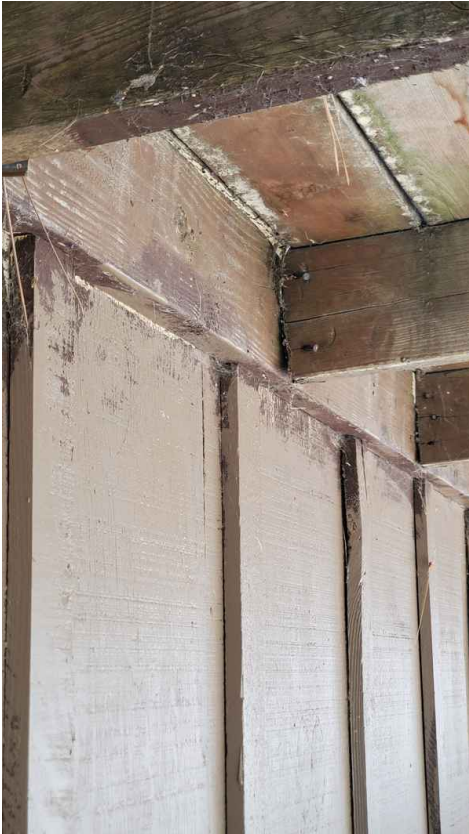
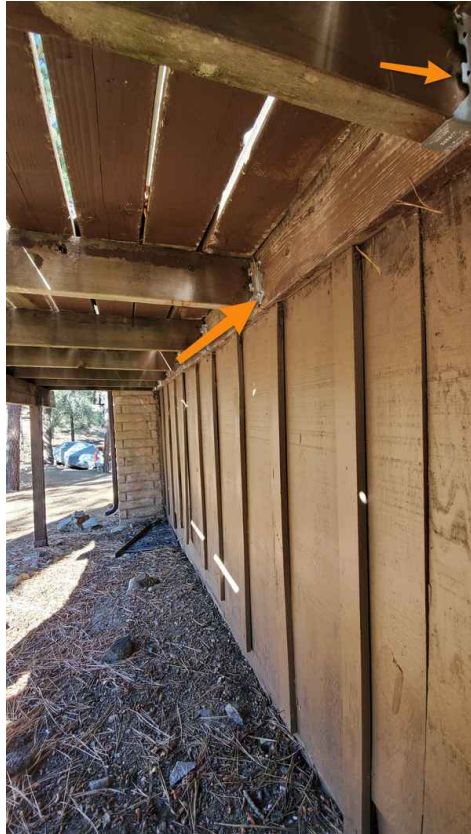
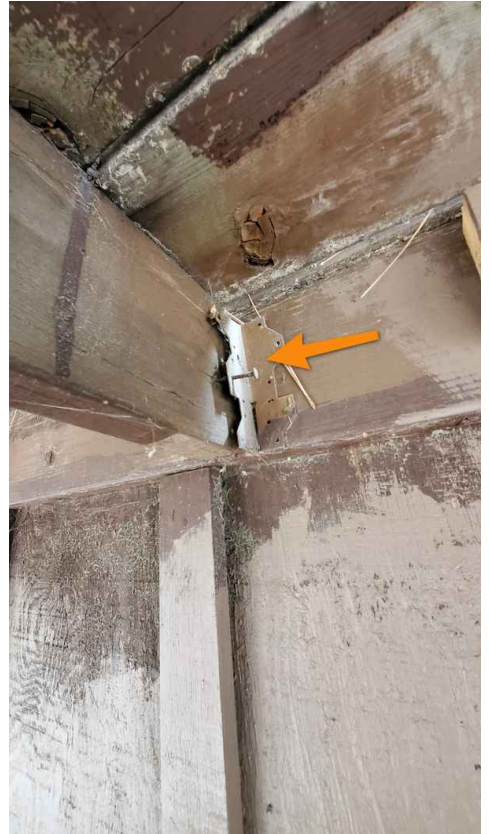
### ATTACHMENT: INADEQUATE

The method for attaching the decks in areas to the home appeared to be inadequate. The Inspector recommends that before the expiration of your Inspection Objection Deadline you consult with a qualified contractor to gain an idea of options and costs for correction.

No fatteners of joists to hangers

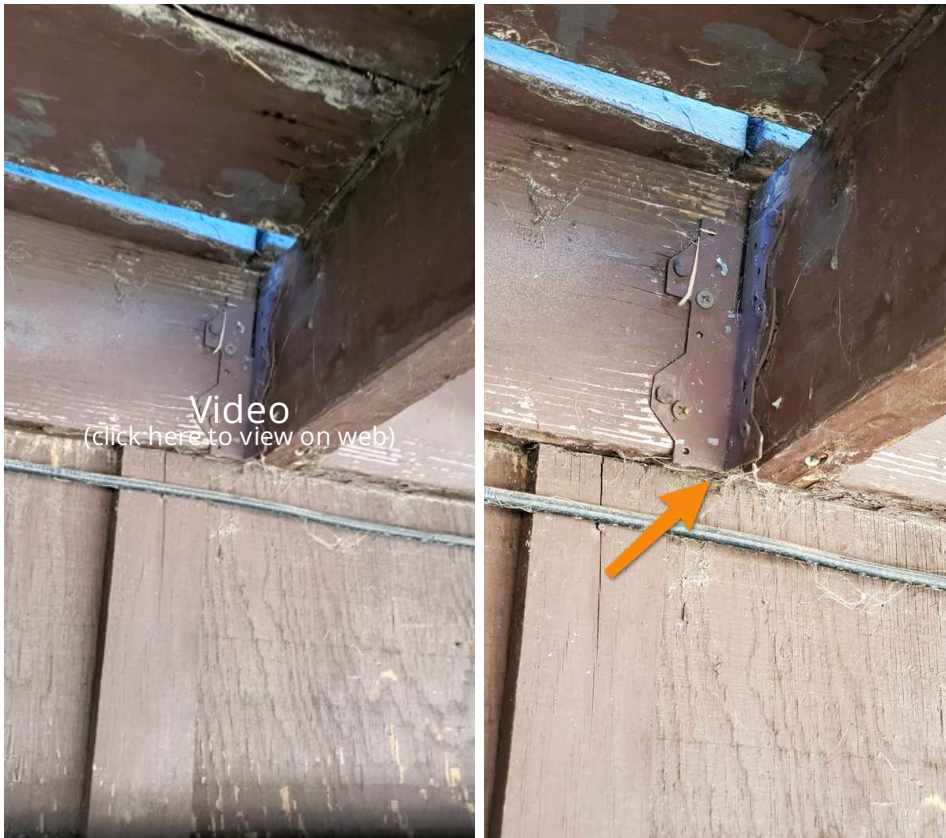
wrong type of hanger for purpose.

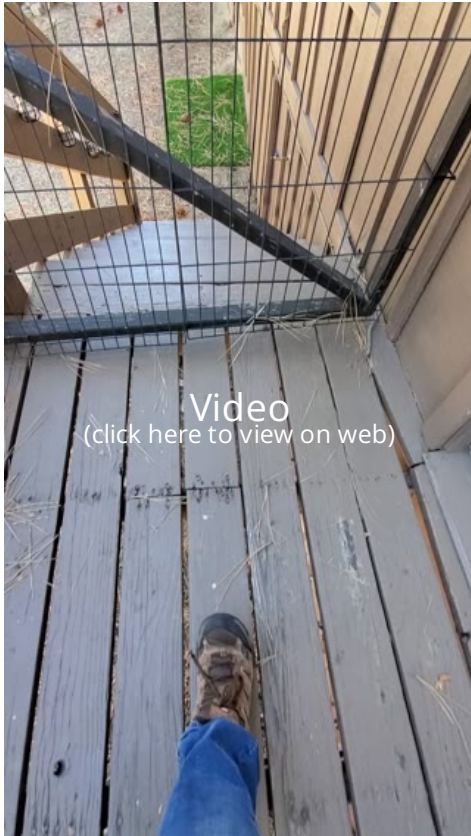
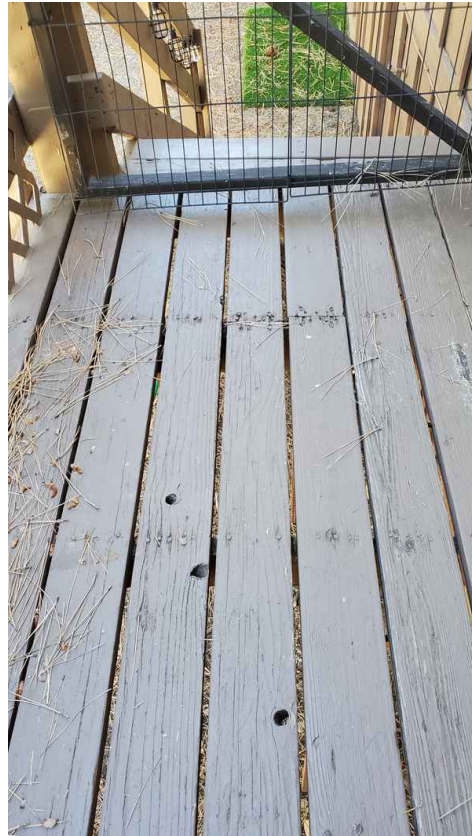
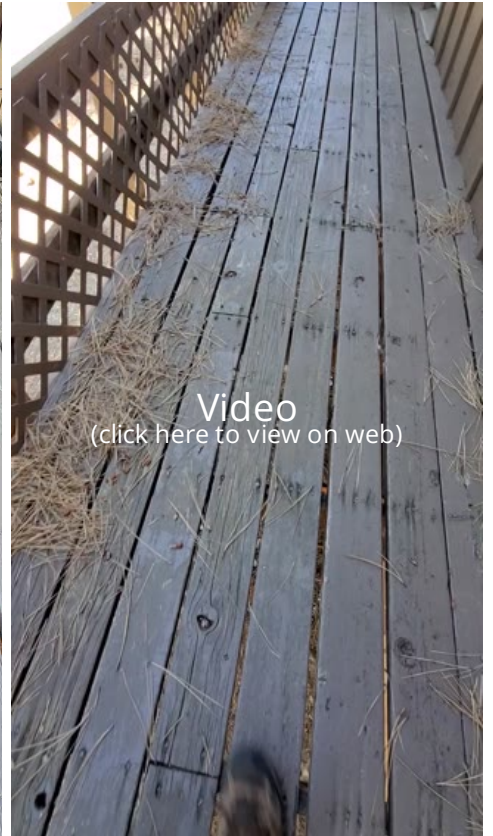
#### 4.7.2 Deck

### FLOOR: WEAR/DETERIORATION, SEVERE

Deck planking (the walking surface) had areas of severe wear or deterioration that require maintenance, repair or replacement. You should consult with a qualified contractor to discuss options and costs.

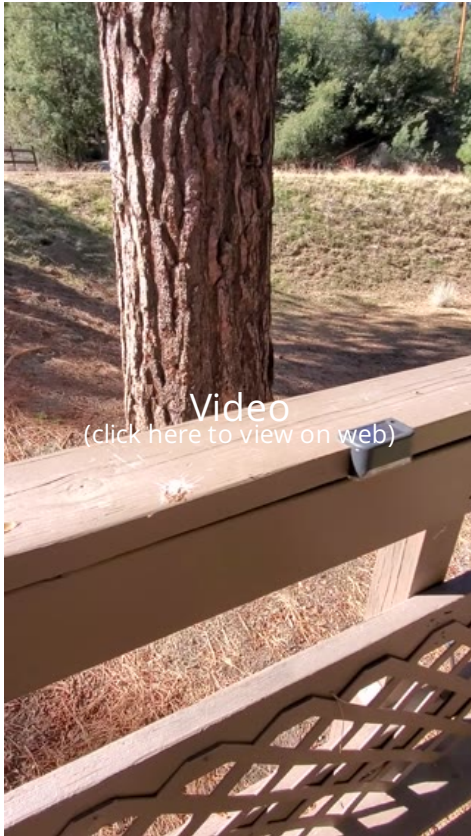
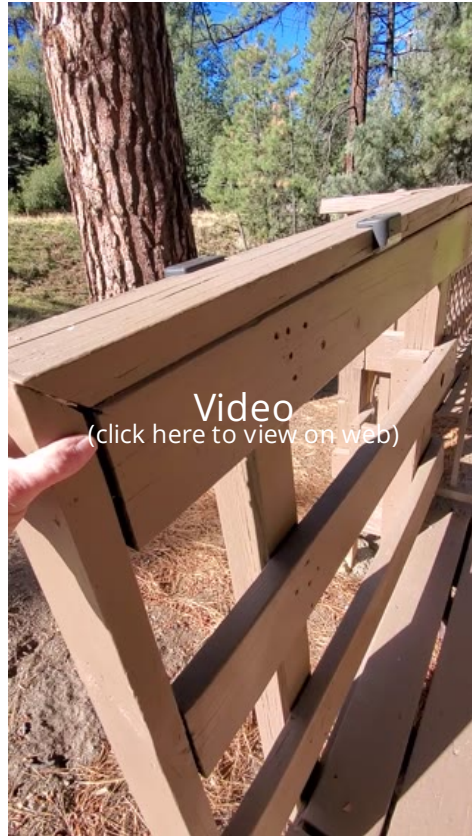
#### 4.7.3 Deck

##### **GUARDRAILS: LOOSE**

Deck guardrail assemblies were loose and should be made secure by a qualified contractor.

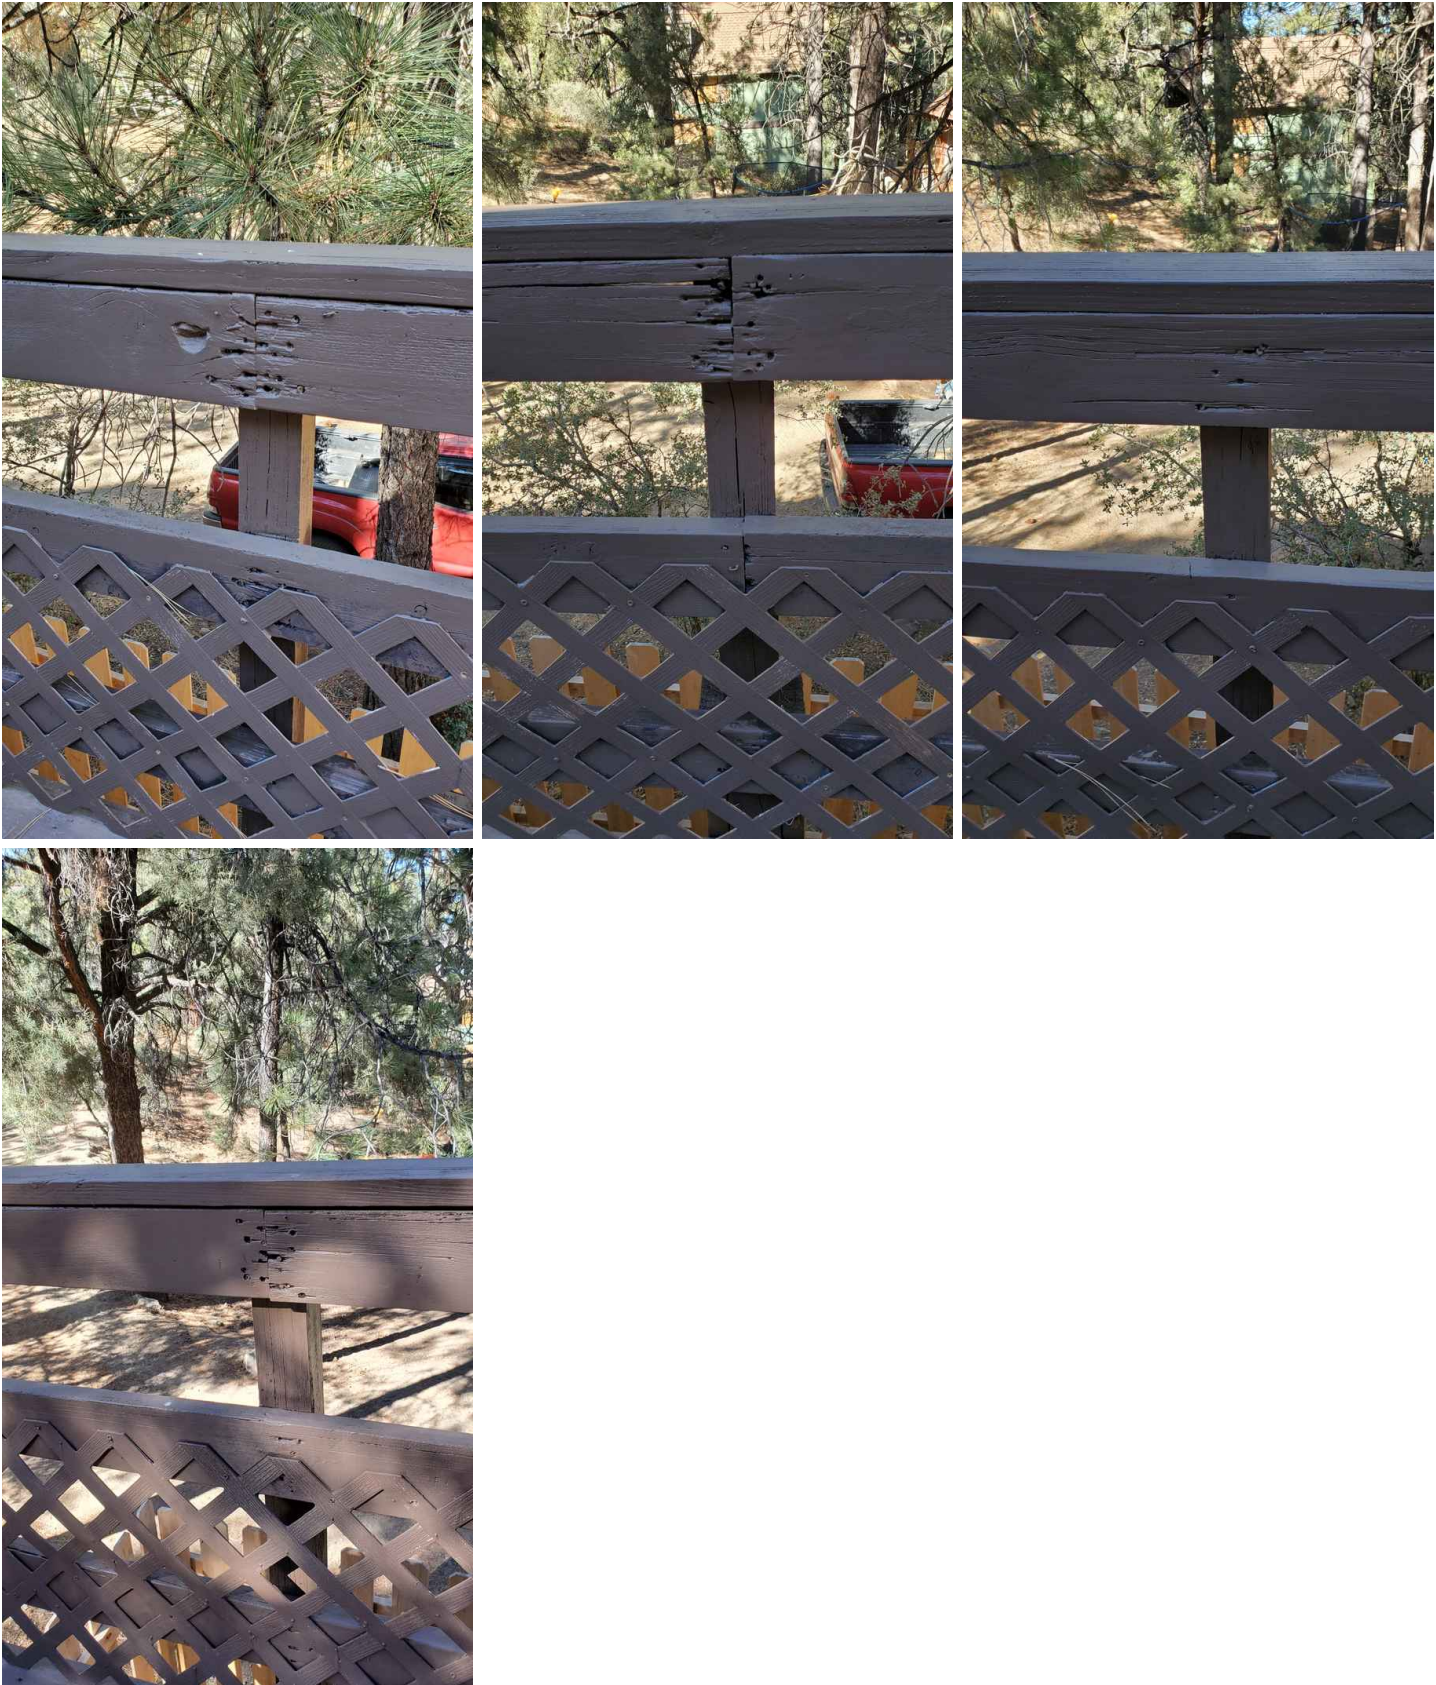
#### 4.7.4 Deck

##### **GUARDRAILS: DAMAGE, SEVERE**

At the time of the inspection, the deck guardrail assemblies exhibited severe damage. You should consult with a qualified contractor to gain an idea of options and costs for repair or replacement.

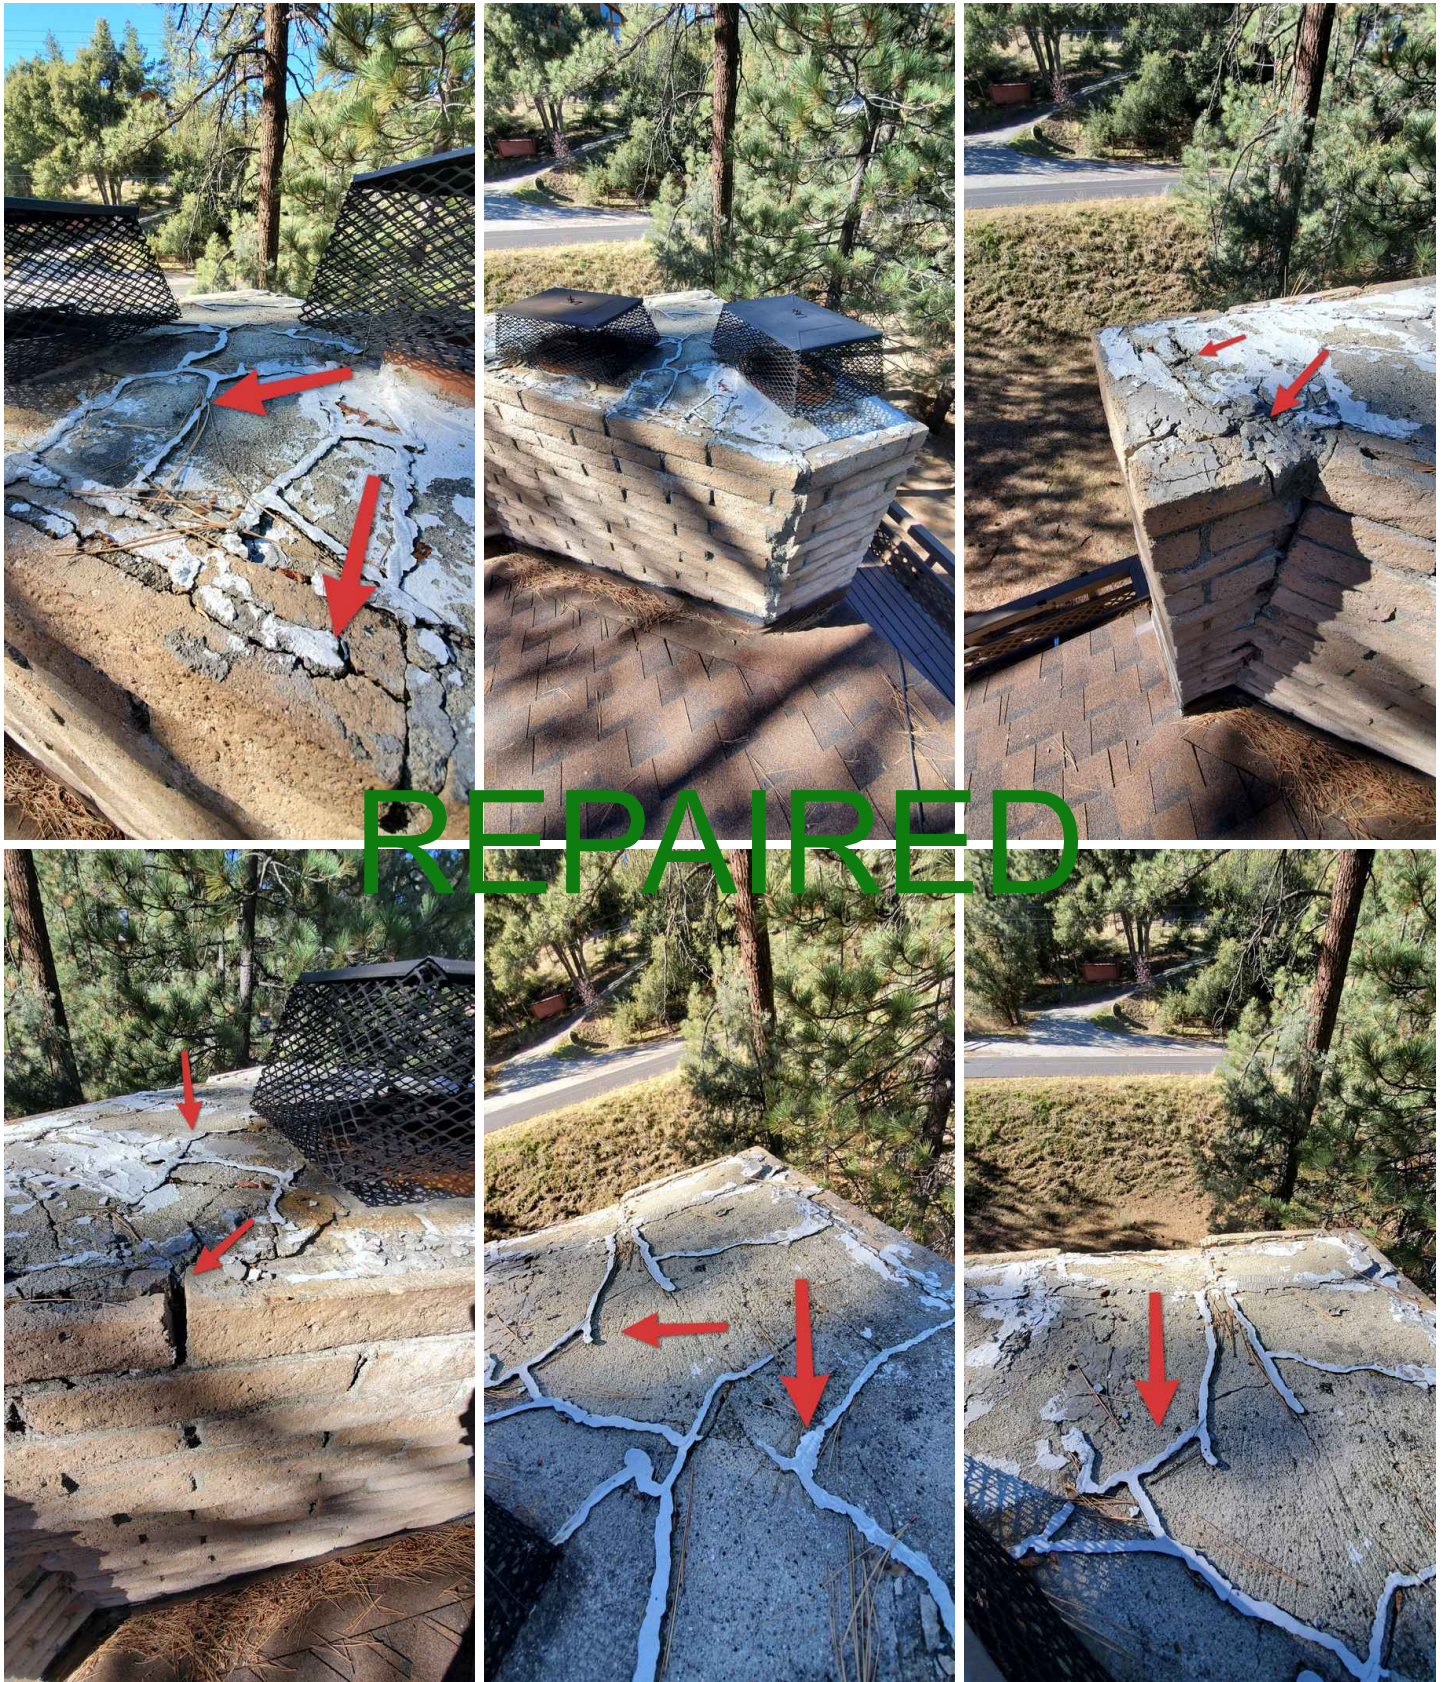
4.8.1 Chimney  
CHIMNEY CROWN: END OF USEFUL LIFE  
**REPAIRED**

The chimney crown was severely deteriorated and appeared to be at the end of its useful life. Failure of the crown can allow moisture intrusion of the chimney structure that can damage the structure and create unhealthy conditions. An evaluation should be performed by a qualified contractor to provide an estimate for work as necessary.

Failed caulking, inappropriate repair

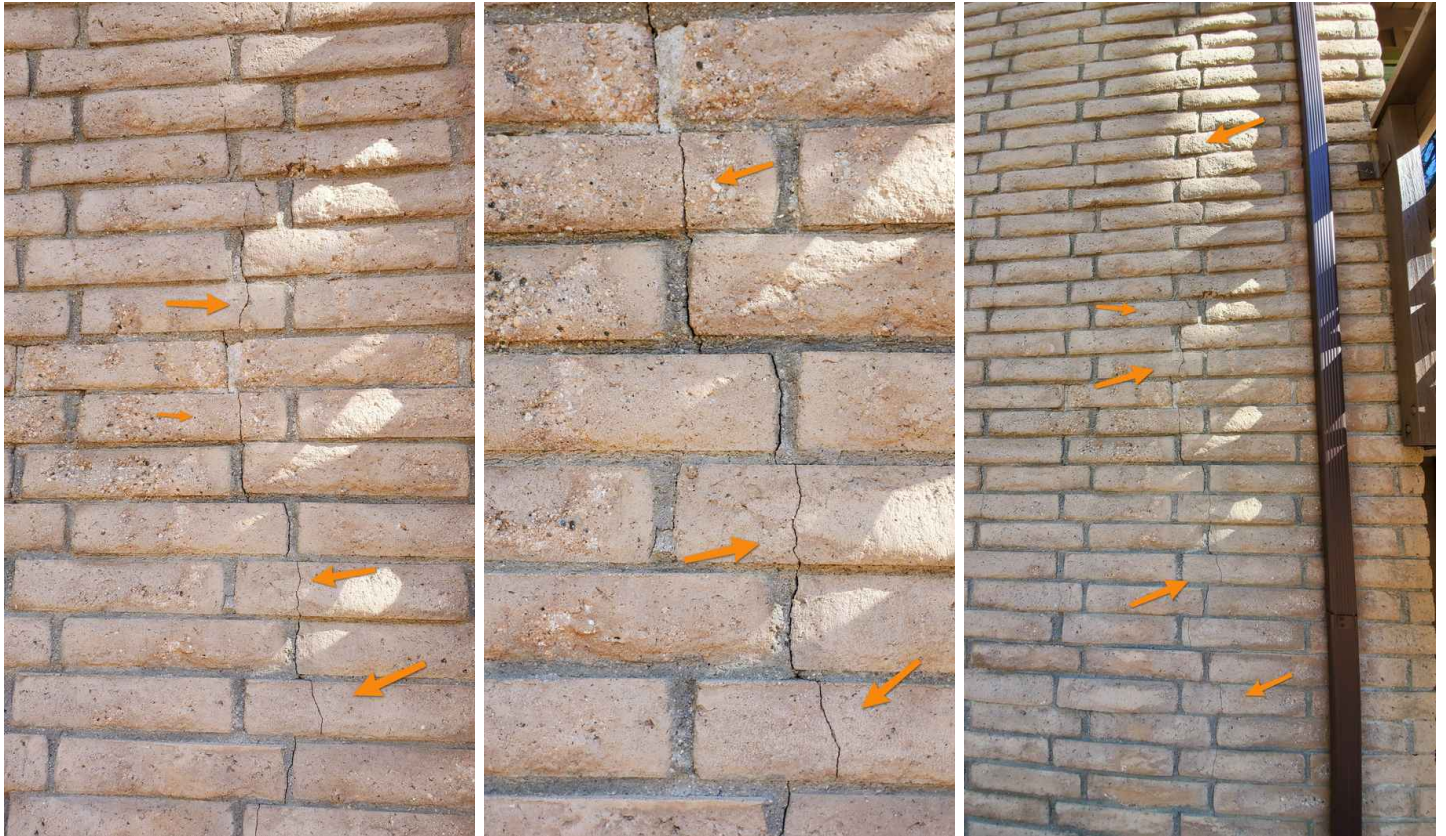
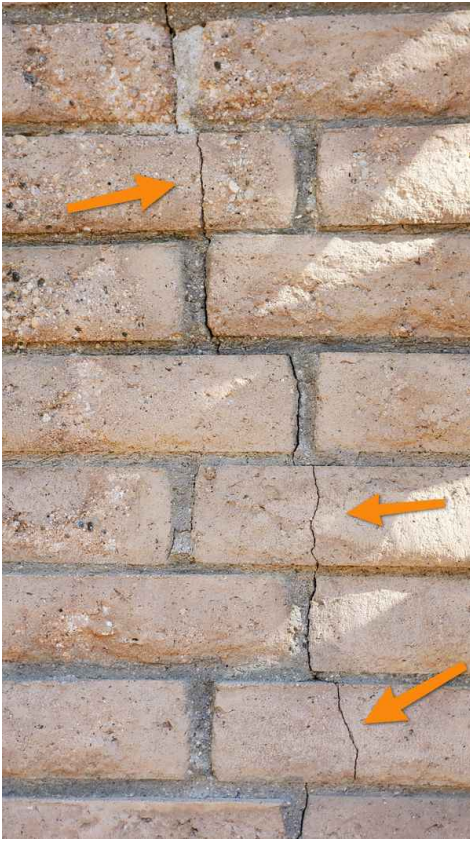
## 4.8.2 Chimney

**BRICK: CRACKING THROUGH BRICK**

The chimney had cracking through the brick. This condition appeared to be consistent with cracking caused by soil movement or seismic activity. If this condition was caused by inadequate compaction at the time of original construction, soil will have stabilized by now. If it was caused by expansive soil, or excessive amounts of moisture in the soil supporting the chimney, movement and cracking may continue. The Inspector recommends evaluation by a foundation repair contractor and crack repair by a qualified masonry contractor to help prevent future damage from freezing moisture.

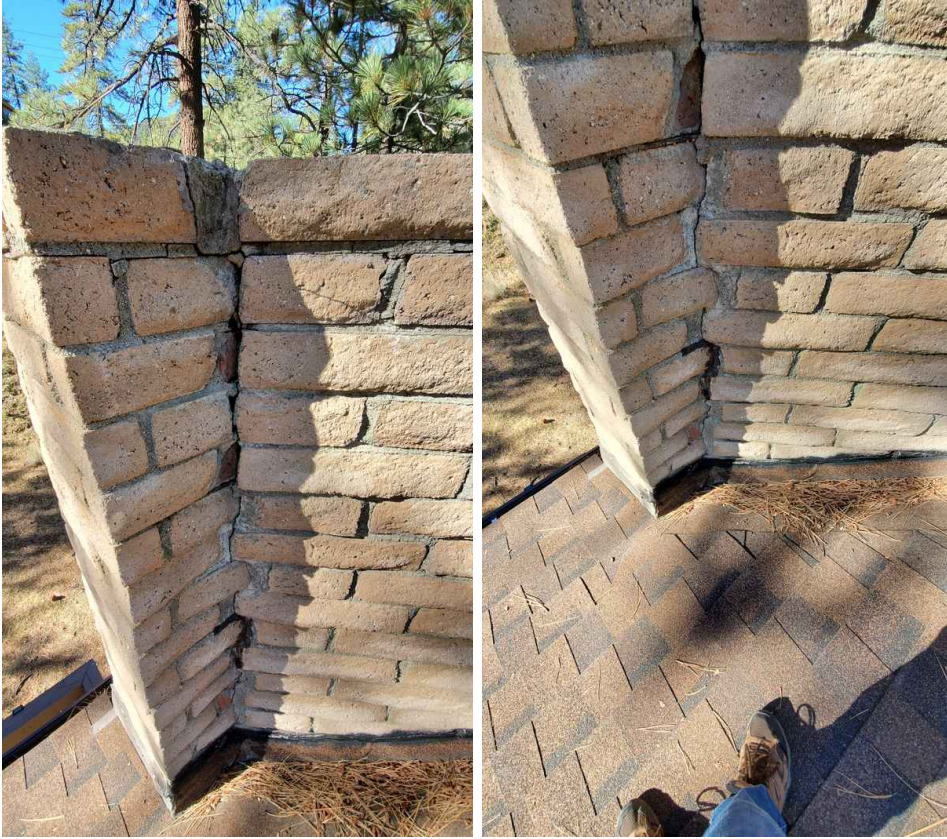
#### 4.8.3 Chimney

##### **BRICK: MORTAR DETERIORATED, REPOINT**

Mortar was missing or badly deteriorated at portions of the brick chimney. This condition will eventually cause bricks to loosen and fall. The Inspector recommends that before the expiration of your Inspection Objection Deadline you consult with a qualified masonry contractor to gain an idea of options and costs for re-pointing the chimney as necessary.

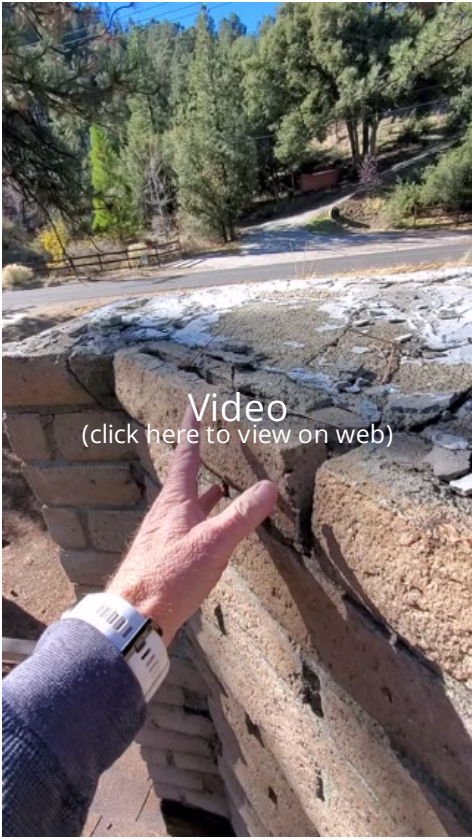
#### 4.8.4 Chimney

##### **BRICKS LOOSE**

The chimney had bricks that were visibly loose at the time of the inspection. Falling bricks may cause injury or death. The Inspector recommends that before the expiration of your Inspection Objection Deadline you consult with a qualified masonry contractor to gain an idea of options and costs for repair.
