1628 Freeman Dr, Pine Mountain  
Club,, CA 93222

Emil Sarkisians  
11/07/2025

James Tomasko  
InterNACHI Certified Professional  
Inspector, CSLB General Contractor  
736872, DRE 1082969

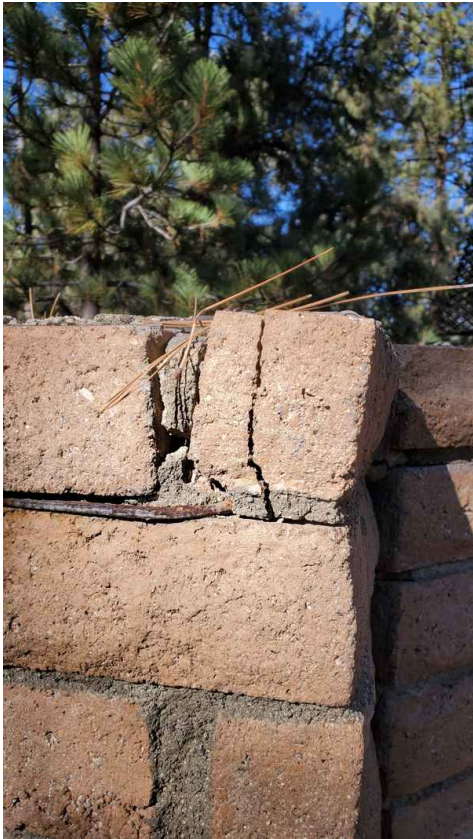
4.8.5 Chimney  
**BRICKS MISSING**

The chimney had bricks missing at the time of the inspection. This condition indicated a failure of the bond between mortar and brick and may cause other bricks to fall if not corrected. Falling bricks may cause injury or death. The Inspector recommends that before the expiration of your Inspection Objection Deadline an evaluation be performed by a qualified contractor.

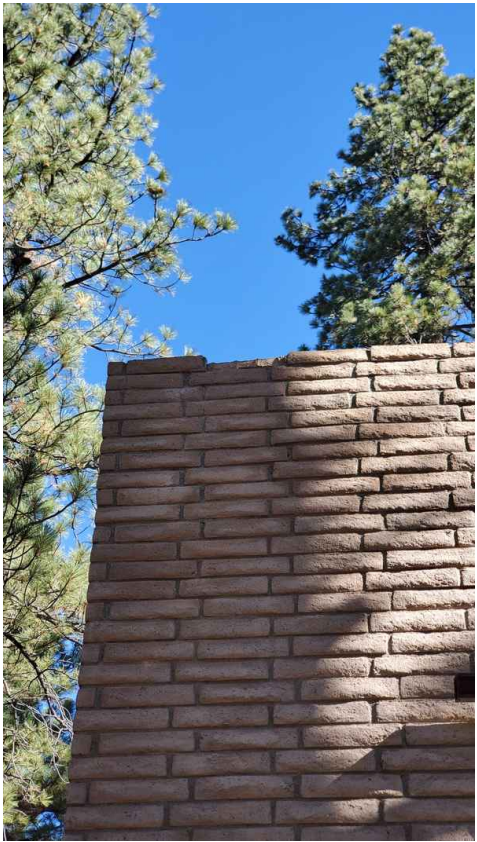
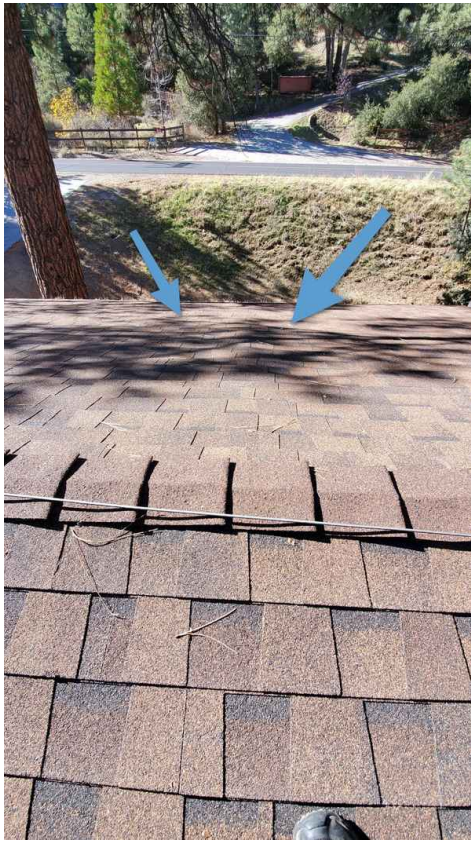
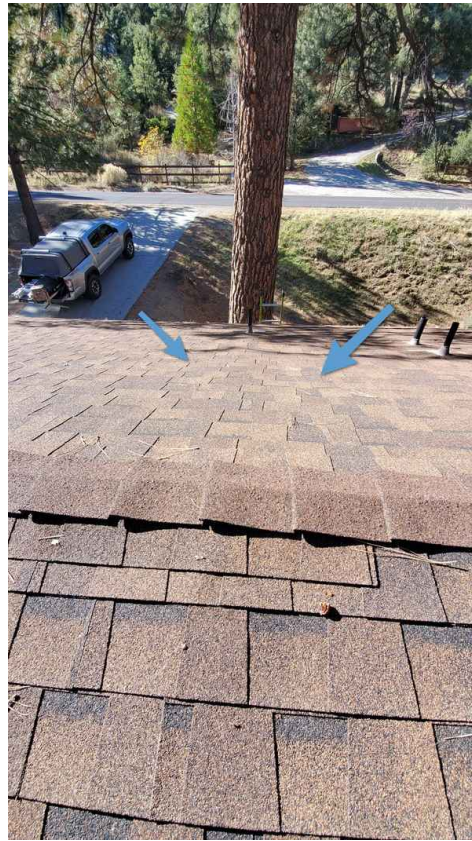
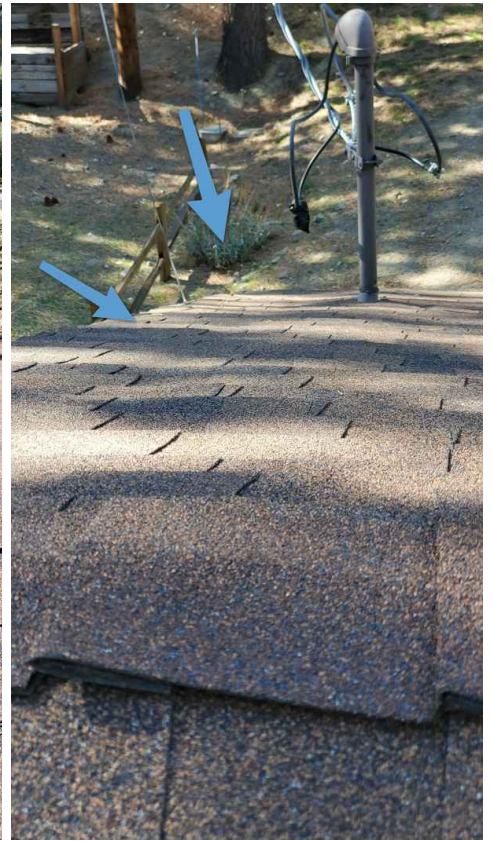
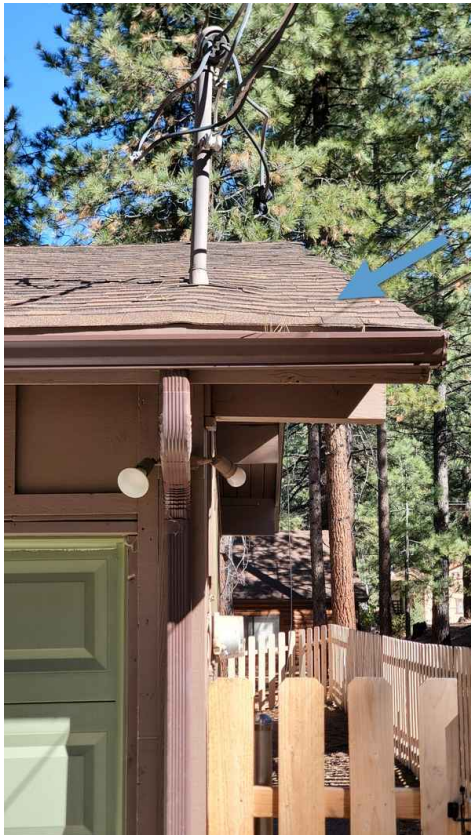
5.2.1 Roof Structure Exterior  
**LOW SPOTS: SAGGING SHEATHING**

Localized depressions (low areas) visible in the roof appeared to be the result of sagging roof sheathing. This could be from thin sheathing. The inspector was unable to access the attic space to determine the cause

Looks to be a failure of the fascia and roof deck

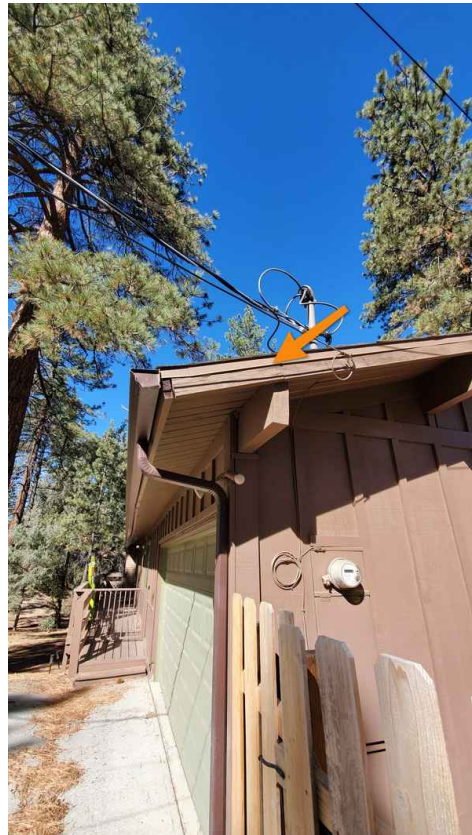
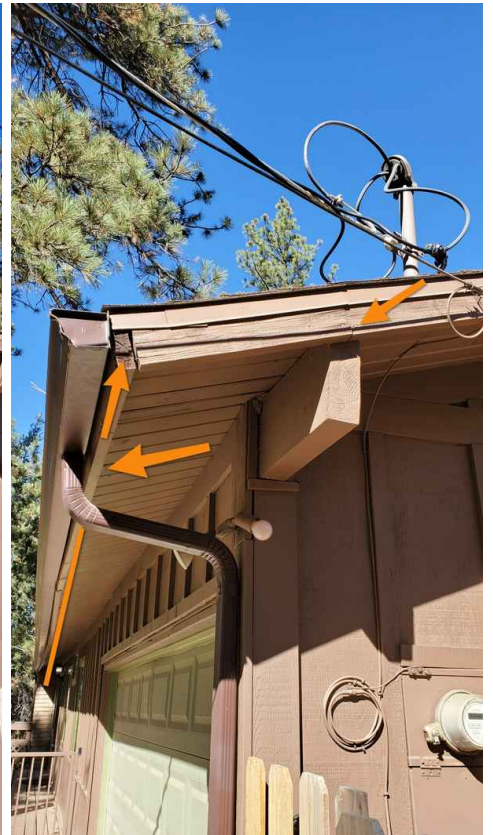
Poor workman ship, splice in the wrong place

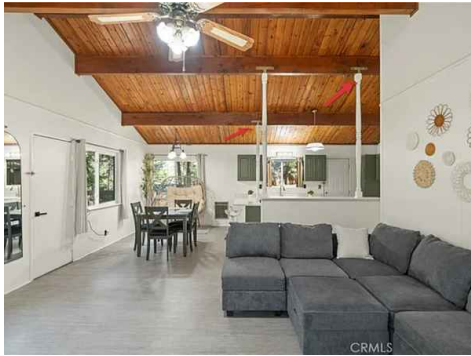
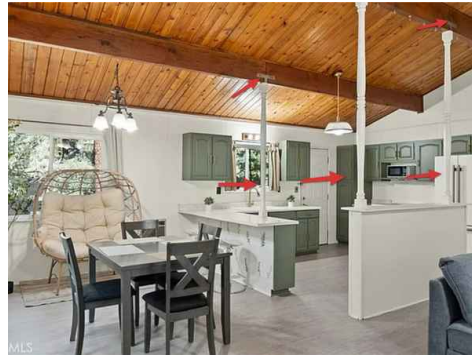
## 5.3.1 Roof Configuration

**BEAMS- SPLICES: KITCHEN AREA**

The beams in the kitchen area have splices that are strapped by T brackets.

The beams are being supported by less than 4X4 material to carry a roof load.

This condition is questionable and should be evaluated by an engineer to determine.

1. Are the posts adequate for the load.
2. Are the T straps and fastening sufficient to connect the beam together for the lateral shear.

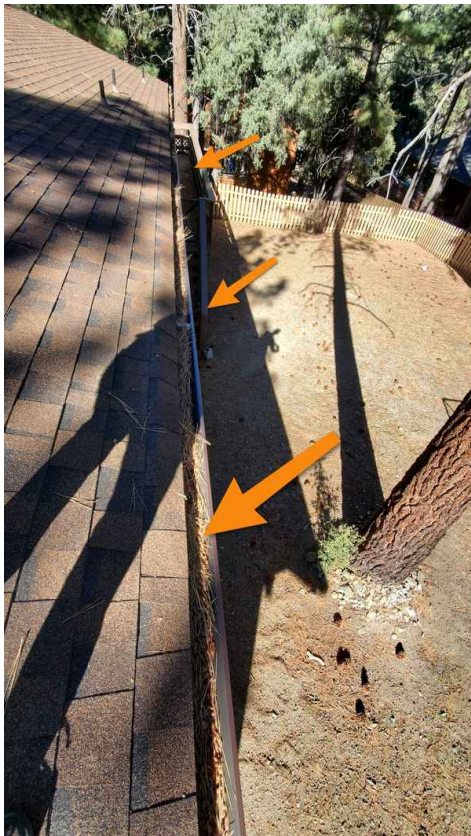
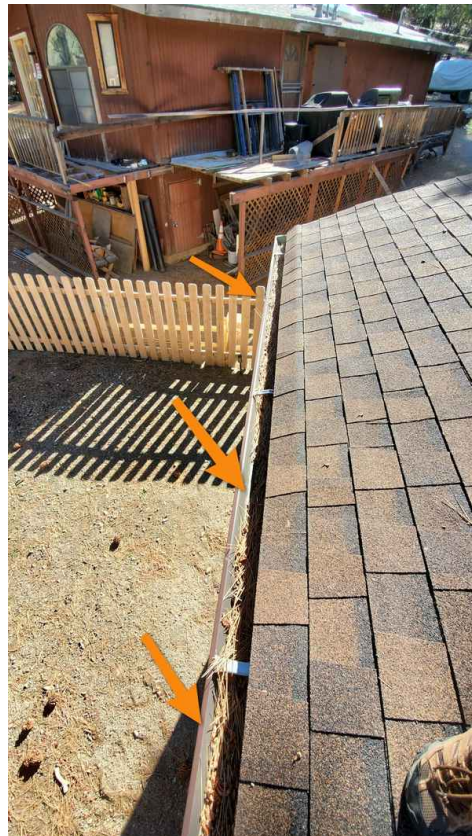
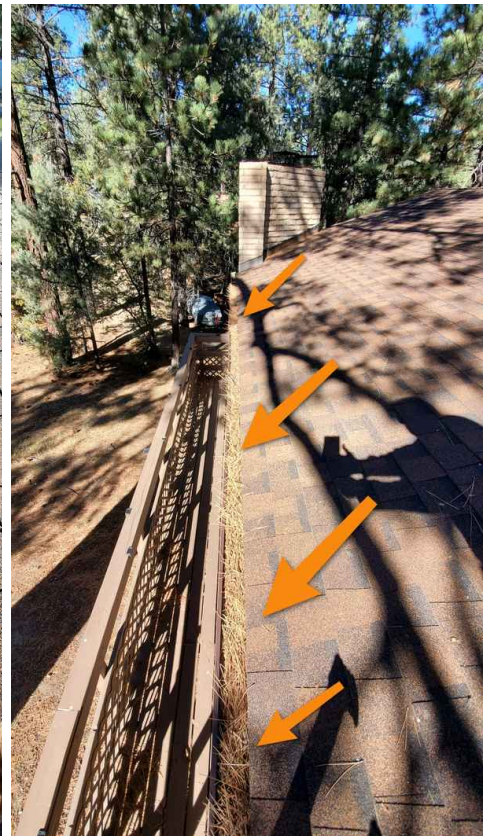
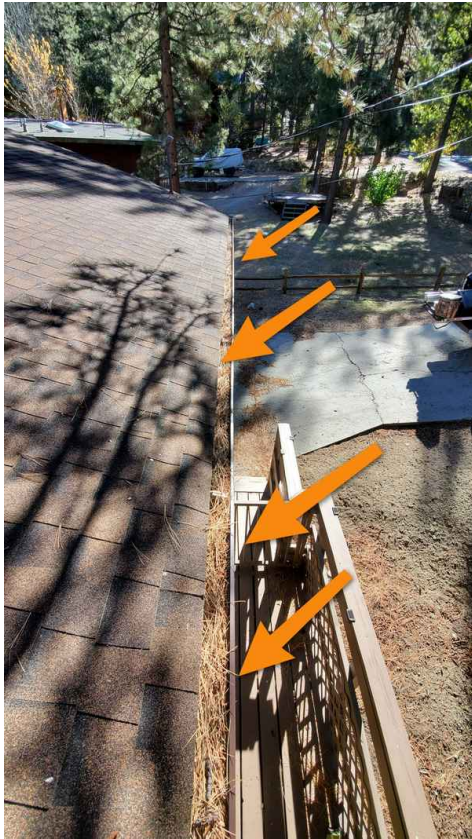
## 5.5.1 Roof Drainage

**GUTTERS: DEBRIS**

Debris accumulated in the gutters should be removed by a qualified contractor to encourage proper drainage.

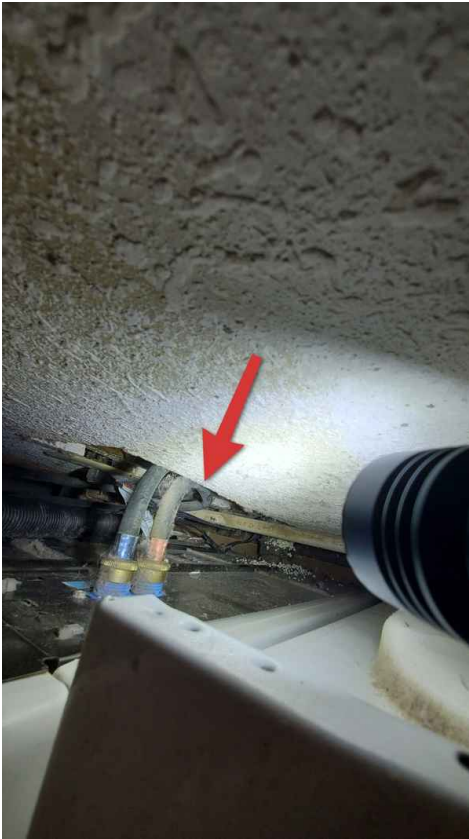
Behind washer and dryer

#### **WALLS: DRYWALL DAMAGE, SEVERE**

The garage walls exhibited severe drywall damage. The Inspector recommends that before the expiration of your Inspection Objection Deadline you consult with a qualified contractor to discuss options and costs for repair.

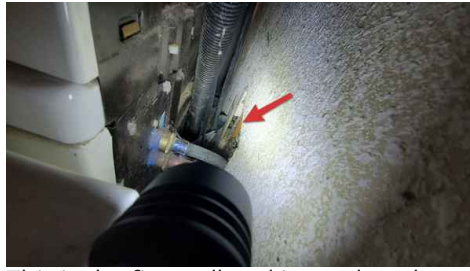
This is the fire wall and it needs to be complete.

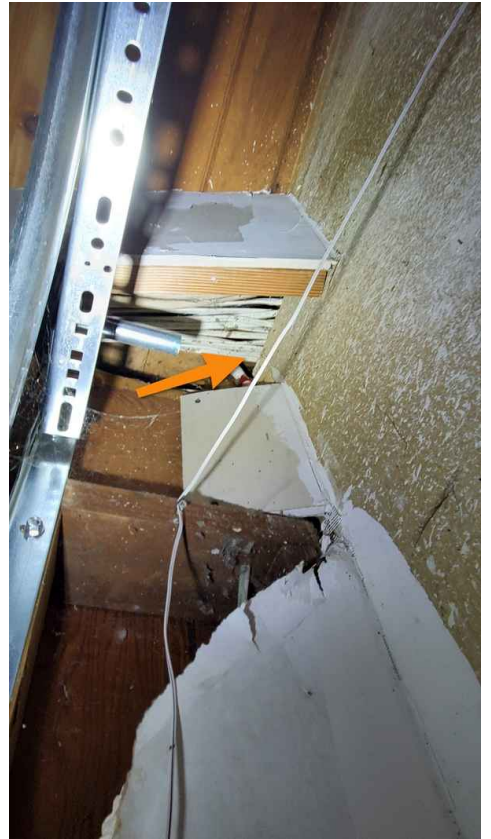
Firewall penetrations

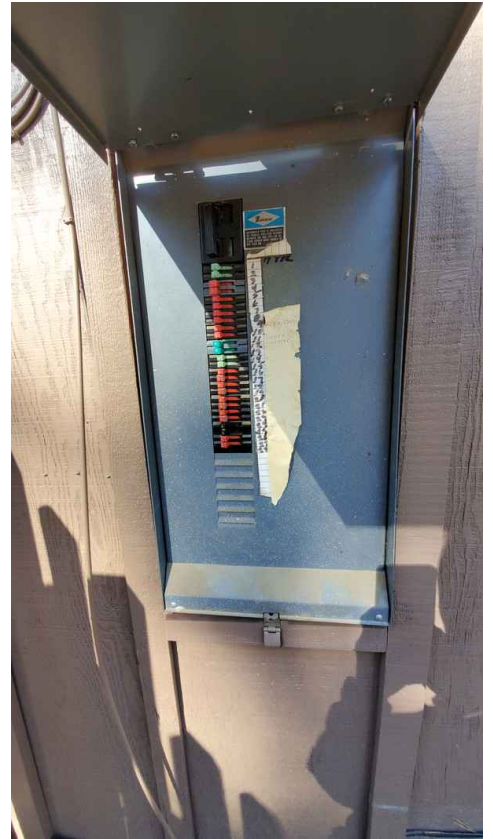
#### 7.4.1 Service Panel

**LABEL: CIRCUIT DIRECTORY, MISSING**

The service panel circuit directory label was missing. A properly-marked circuit directory should be installed by a qualified electrical contractor so that individual circuits can be quickly identified and shut off during an emergency.

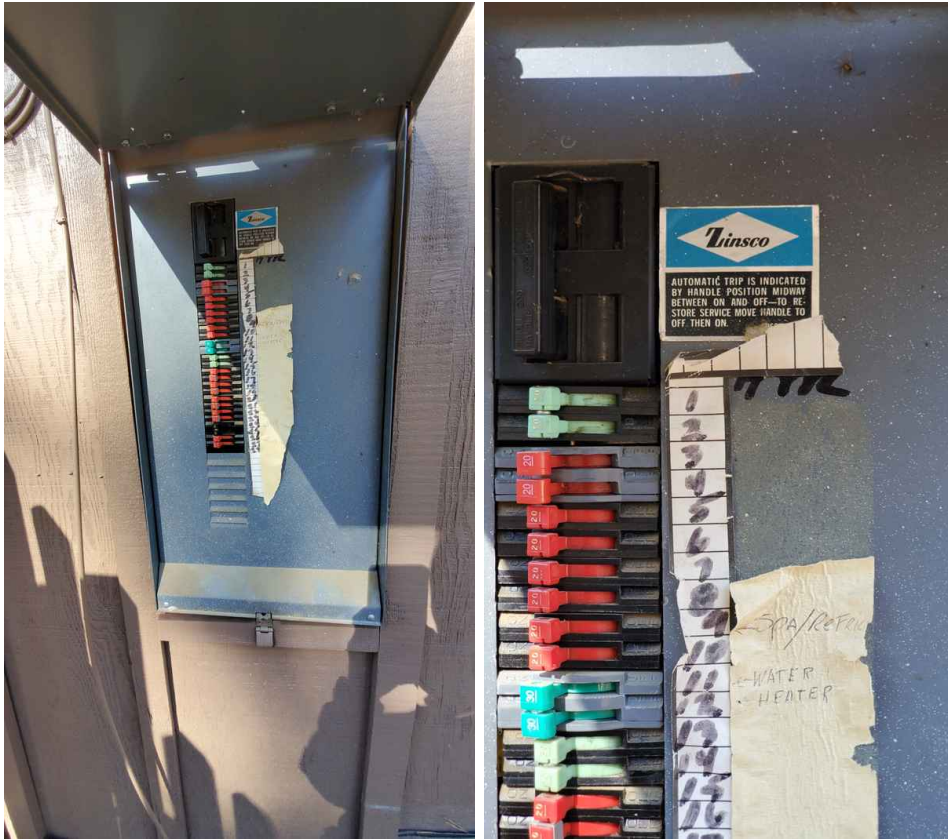
7.4.2 Service Panel

**MANUFACTURER: ZINSCO**

The service panel brand was Zinsco. Although there is no definitive study stating that these panels are a potential safety hazard, wide concern about their safety exists. Zinsco panels are widely reputed to have a significant rate of circuit breaker failure that can result in fire or electric shock hazard.

This panel appears to have been servicing the home for quite some time with out apparent issue.

However for safety reasons, you should consult with a qualified electrical contractor to discuss the necessity, options, and costs for replacement.

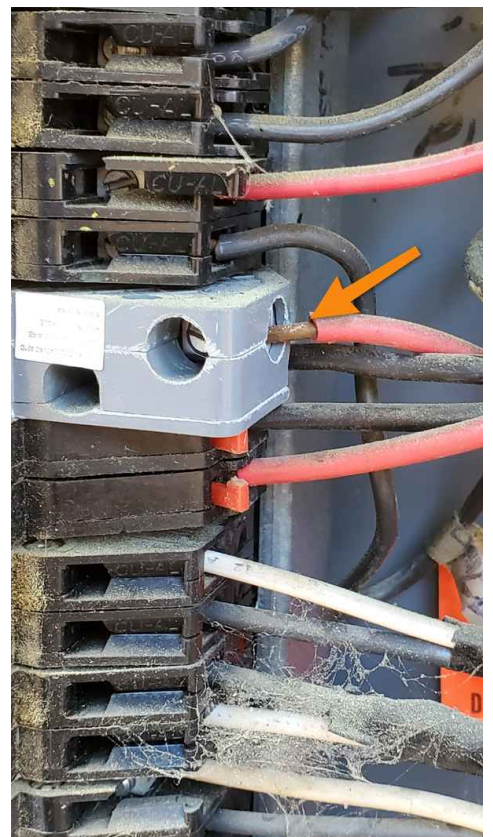
#### 7.4.4 Service Panel

##### **WIRE: OVEREXPOSED- LOOSE WIRE**

There appeared to be a loose or overexposed conductor in the main panel. This condition should be evaluated by an electrical contractor to ensure a tight connection and a safe condition.

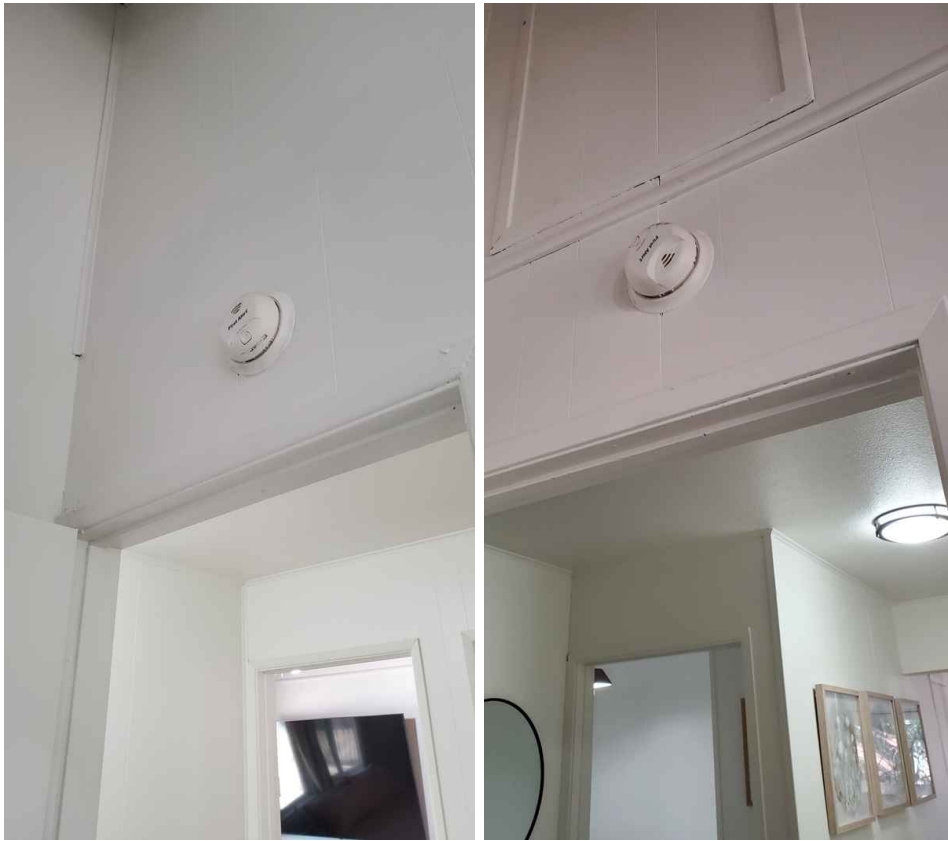
#### 7.10.1 Smoke Carbon Monoxide detectors

##### **SMOKE ALARM: MISSING, NOT FUNCTIONING**

There are smoke alarms missing or not functioning in the bedrooms and common aress.

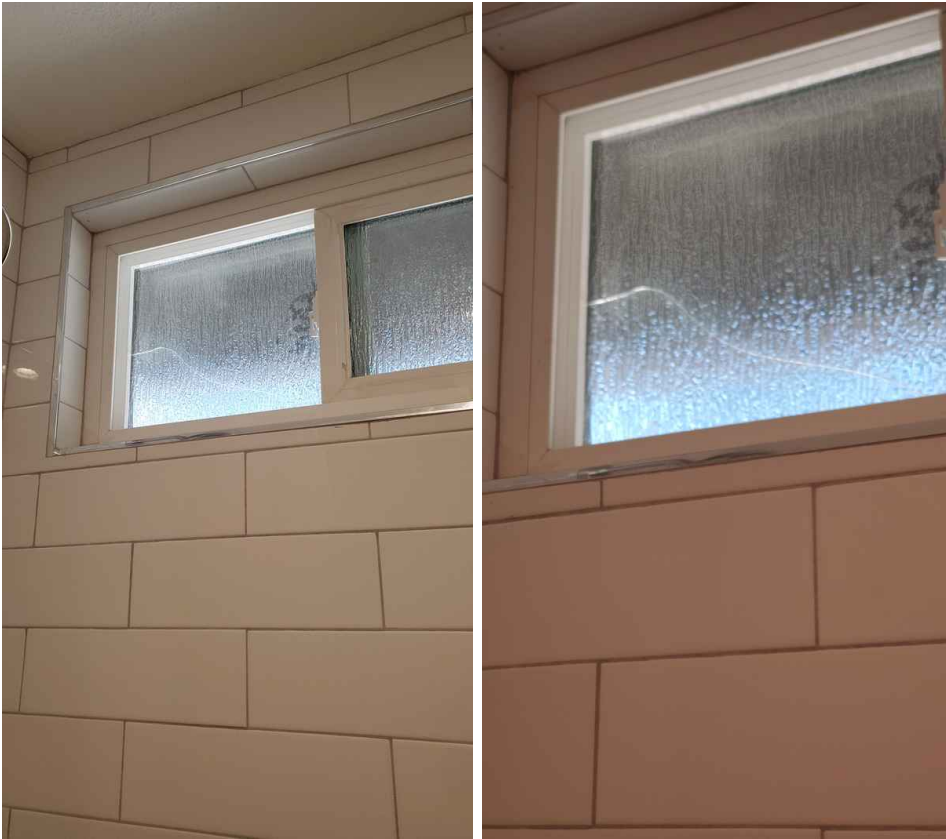
#### 8.8.1 Windows

##### **GLAZING: BROKEN PANES**

Some windows had broken panes.

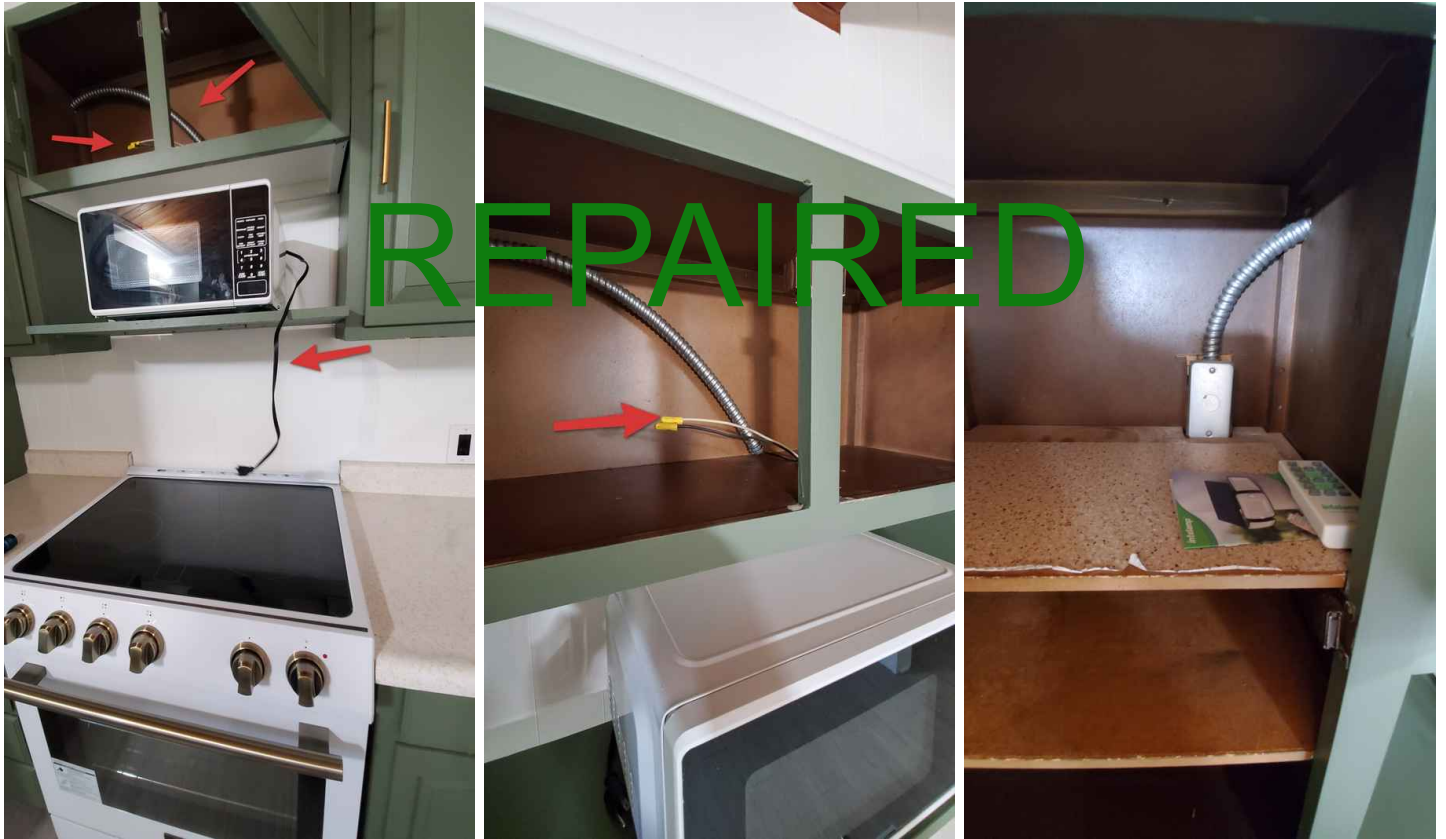
#### 9.12.1 Electrical

##### **ELECTRICAL FUTURE: MICROWAVE- UNFINISHED**

There appeared to be an electrical service for the microwave started but not completed. The exposed wires are not terminated and have wire nuts on hot wires.
