# JOHN ROBINSON'S INSPECTION GROUP

## RESIDENTIAL INSPECTION

2602 Upas St  
San Diego, CA 92104

08/18/2026

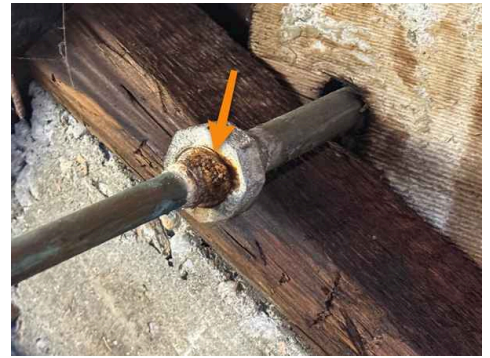
### 3.2.2 PLUMBING WATER SUPPLY AND DISTRUBUTION SYSTEM

**Attention Items****PIPES - EXCESSIVE CORROSION**

Recommendation

Contact a qualified plumbing contractor.

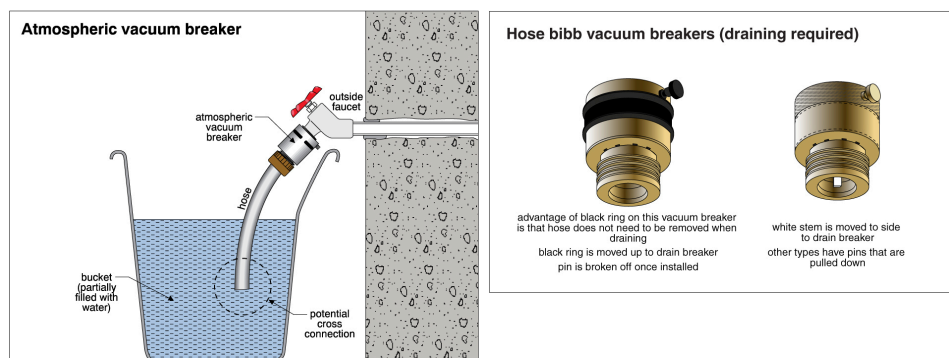
### 3.3.1 FIXTURES AND CONNECTED DEVICES

#### MISSING ANTI-SIPHON VALVES

Recommendation

Contact a qualified plumbing contractor.

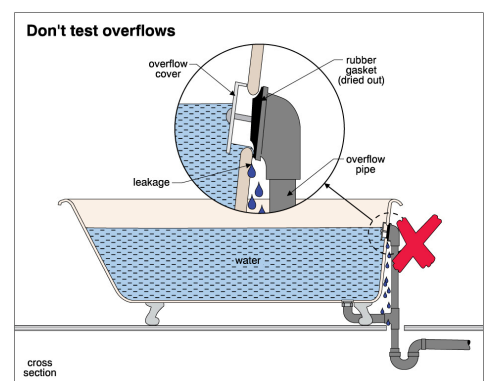
### 3.4.1 TUB/SHOWER FIXTURES

#### DRAIN OVERFLOW (FYI)

Recommendation

Contact a qualified plumbing contractor.

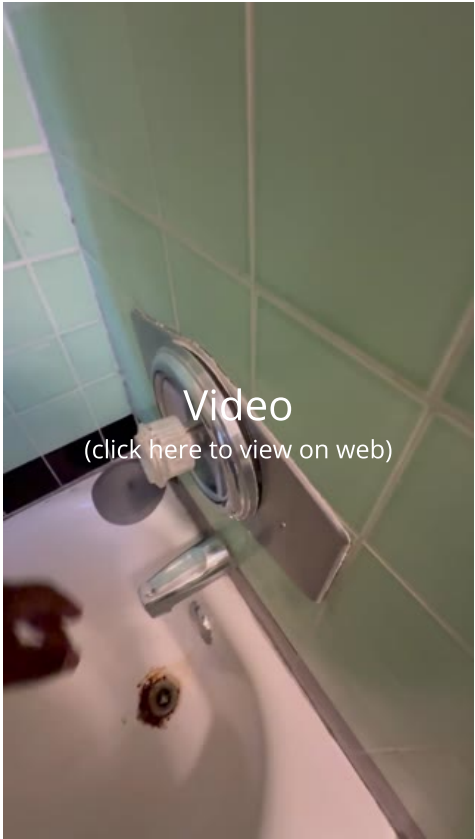
### 3.4.2 TUB/SHOWER FIXTURES

#### SHOWER HEAD - LEAK

Recommendation

Contact a qualified plumbing contractor.

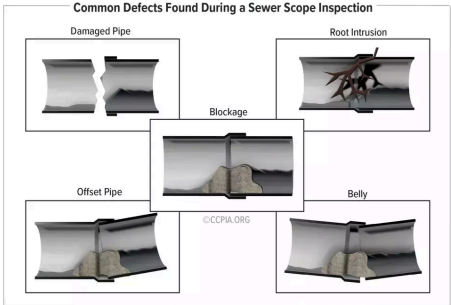
3.6.1 PLUMBING DRAIN, WASTE AND VENT SYSTEMS

DRAIN LINE SCOPE RECOMMENDED

Recommendation

Contact a qualified plumbing contractor.

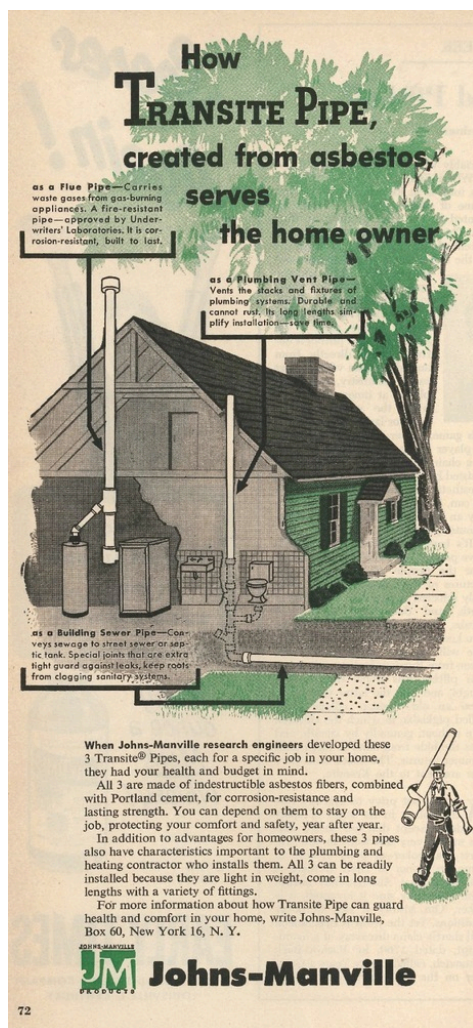
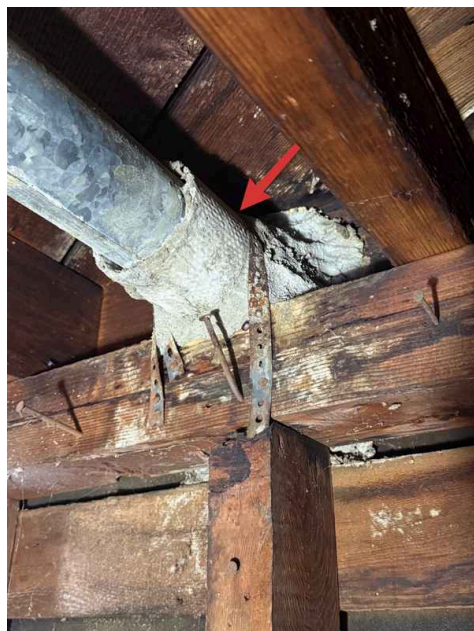
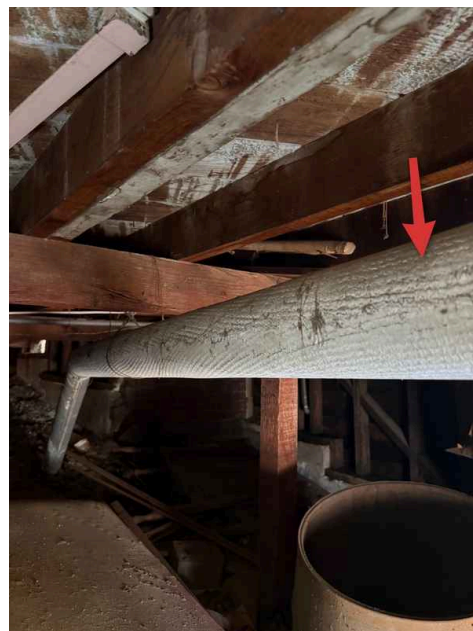
Example Noted at Crawlspace

This additional pipe was also noted to have Tran in the crawlspace, but no longer appears to be in use

Recommendation

Contact a qualified environmental contractor

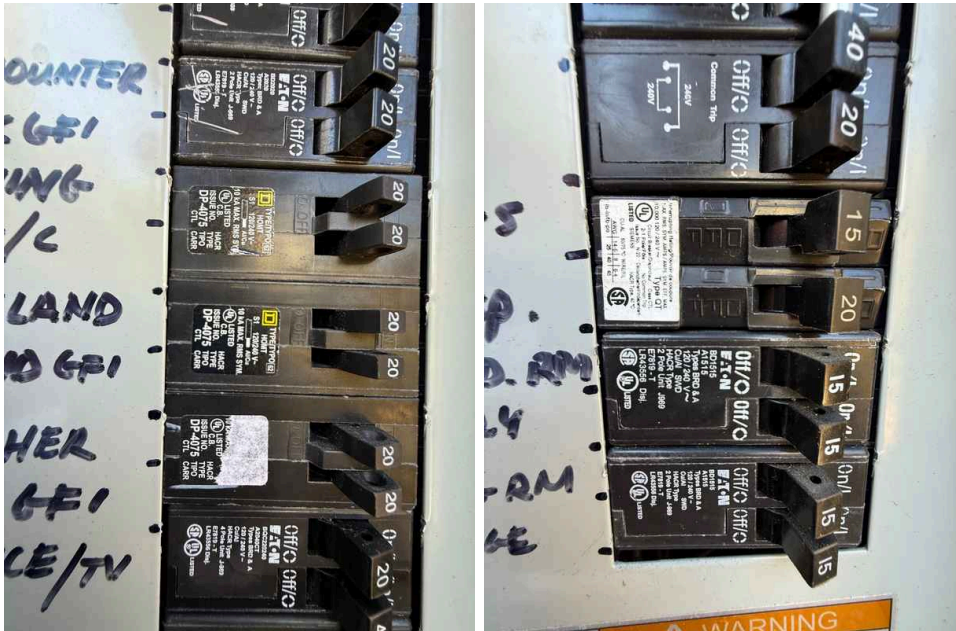
## 4.6.1 OVERCURRENT DEVICES (Circuit Breakers, Fuses) AND COMPATIBILITY OF THEIR AMPERAGE AND VOLTAGE

**BREAKERS - DON'T MATCH PANEL**

Recommendation

Contact a qualified electrical contractor.

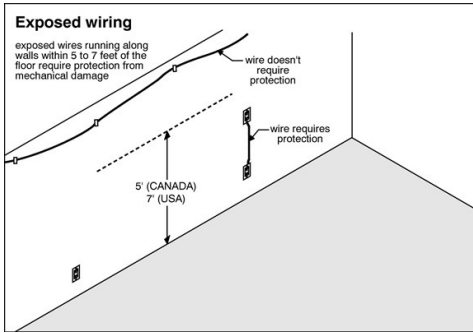
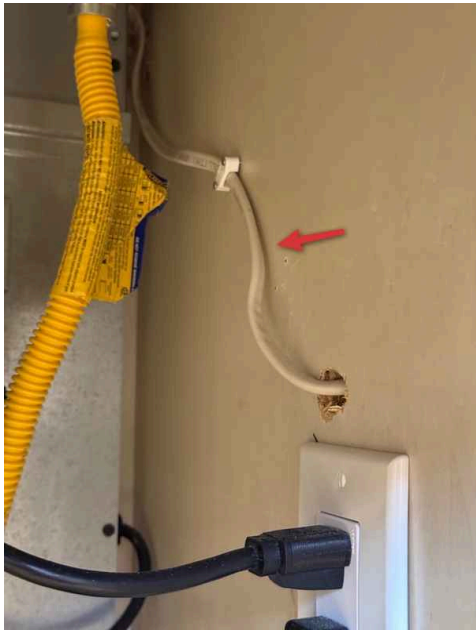
4.7.1 BRANCH CIRCUIT CONDUCTORS

EXPOSED ROMEX (UNPROTECTED WIRING)

Recommendation

Contact a qualified electrical contractor.

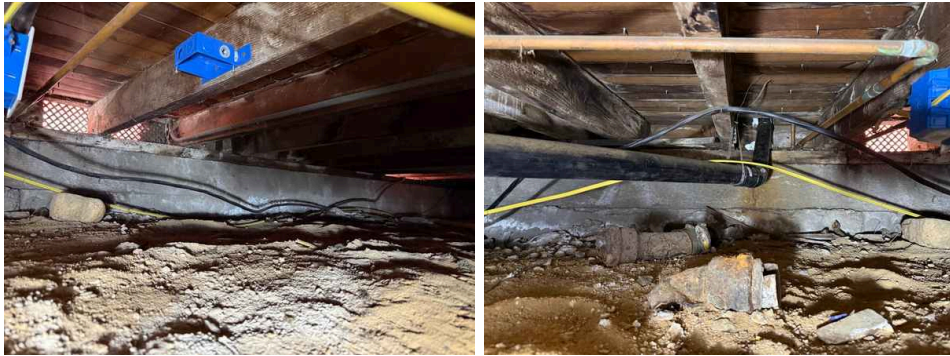
4.7.2 BRANCH CIRCUIT CONDUCTORS

UNSECURED WIRE - CRAWL SPACE

#### Recommendation

Contact a qualified electrical contractor.

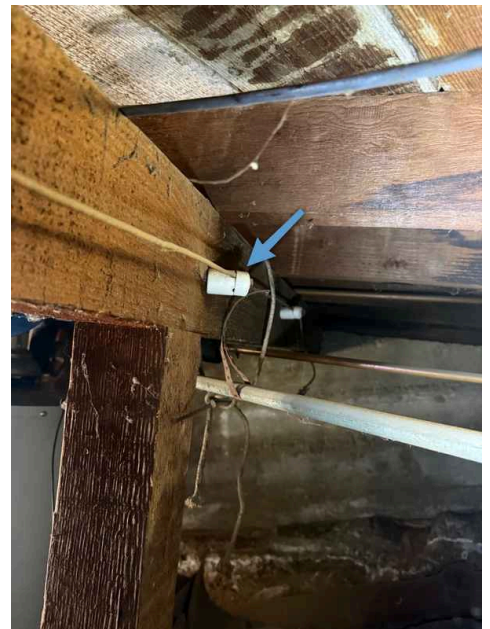
#### 4.7.3 BRANCH CIRCUIT CONDUCTORS

- 🔧 4.7.3 Electrical System - BRANCH CIRCUIT CONDUCTORS: Knob-and-Tube Wiring Observed (Appears Abandoned – Verification Recommended)
- ⊖ 4.8.1 Electrical System - FIXTURES AND CONNECTED DEVICES (Observed from a representative number operation of ceiling fans, lighting fixtures, switches and receptacles located inside the house, garage, and on the dwelling's exterior walls): Doorbell - Inoperable

#### Recommendation

Contact a qualified electrical contractor.

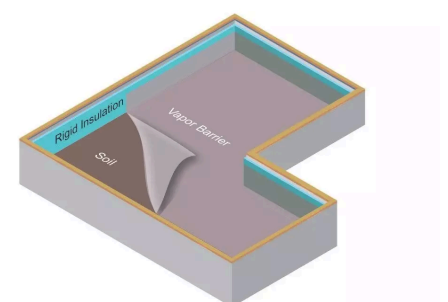
### 6.6.1 VAPOR RETARDERS (ON GROUND IN CRAWL SPACE OR BASEMENT)

#### VAPOR BARRIER - MISSING

The crawl space is not equipped with a vapor barrier. This is typical for older homes. A vapor barrier is any material used for damp proofing, typically plastic sheets, that resist the diffusion of moisture from the dirt below your home. This is important to keep the crawl space dry. A dry crawlspace will help forestall moisture-related issues, like the attraction of wood-destroying organisms, wood rot, and the attraction of organic growths and pests. We recommend further evaluation by a licensed insulation contractor before the removal of contingencies to determine what repairs are needed at this time and to determine if any latent defects exist.

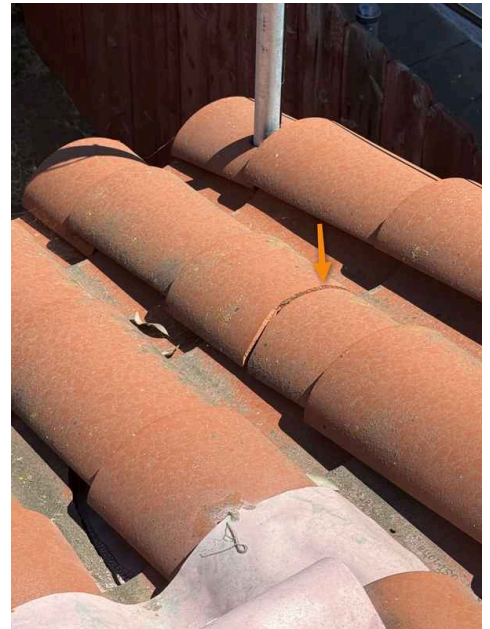
## 7.2.2 ROOF COVERINGS

**TILE - CRACKED OR DAMAGED**

Recommendation

Contact a qualified roofing professional.

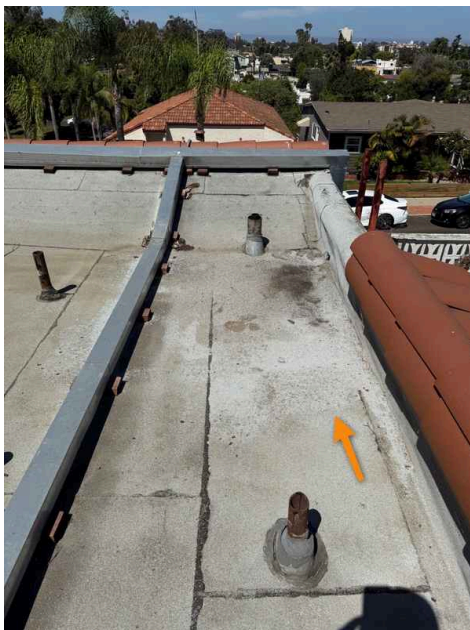
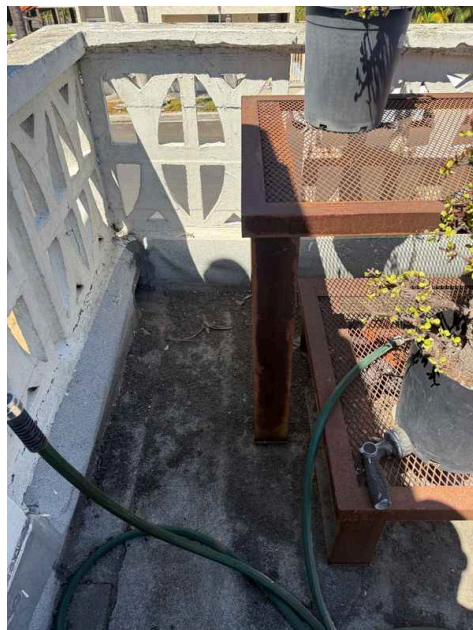
### 7.2.3 ROOF COVERINGS

#### FLAT ROOF - POOLING/PONDING

Example Noted at Here

Recommendation

Contact a qualified roofing professional.

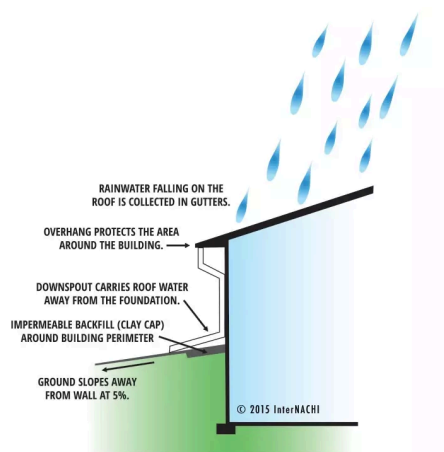
### 7.6.1 ROOF DRAINAGE SYSTEMS

#### **DOWNSPOUT - IMPROPER TERMINATION LOCATION**

Moisture Intrusion - Downspout

Contact a qualified gutter contractor

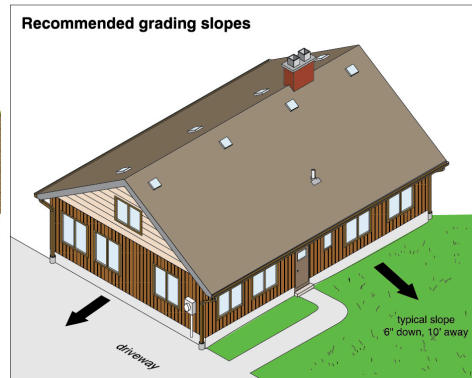
## 9.8.2 HARDSCAPE, WALKWAYS &amp; GRADING

**GRADING - NEGATIVE SLOPE IN GRADING**

## Recommendation

Contact a qualified grading contractor.

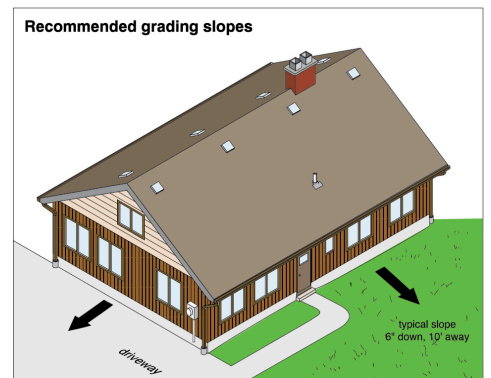
## 9.8.3 HARDSCAPE, WALKWAYS &amp; GRADING

**GRADING - STANDING WATER POSSIBILITY**

## Recommendation

Contact a qualified grading contractor.

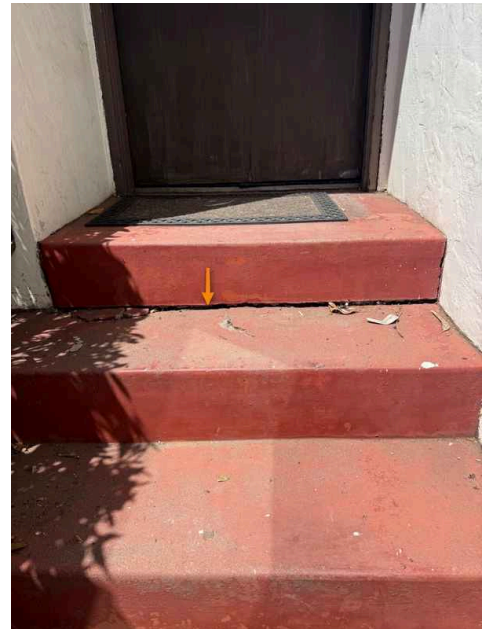
## 9.8.4 HARDSCAPE, WALKWAYS &amp; GRADING

**HARDSCAPE - TYPICAL SETTLEMENT CRACKS**

Example Noted at the front porch

Recommendation

Contact a qualified concrete contractor.

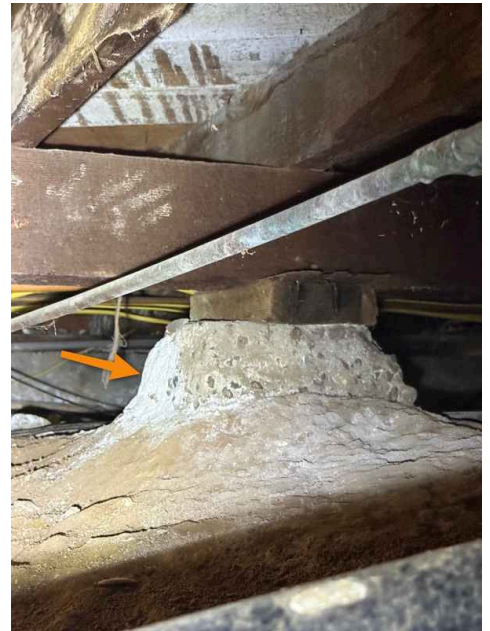
### 10.3.3 POSTS, PIERS AND COLUMNS

#### **PIERS - SPALLING/DETERIORATION**

Example Noted at CrawlSpace

Recommendation

Contact a foundation contractor.
