# Premier Home Inspection, Inc.

**Diane Harwell  
155 S. Beth Circle, Anaheim CA**

**Date: 09/10/2026**

**Report # 2260443**

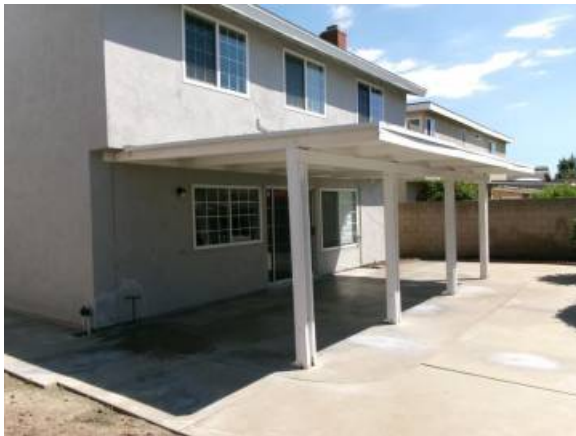
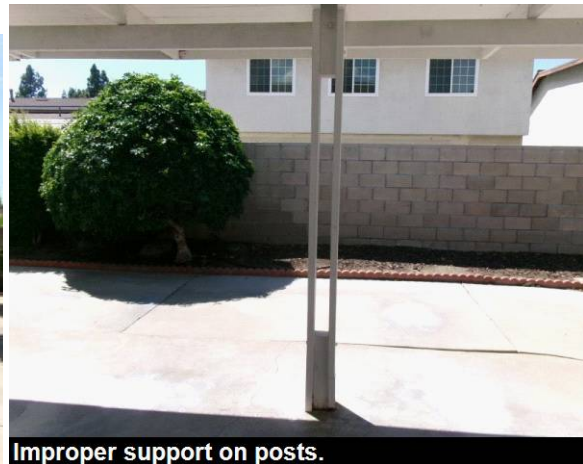
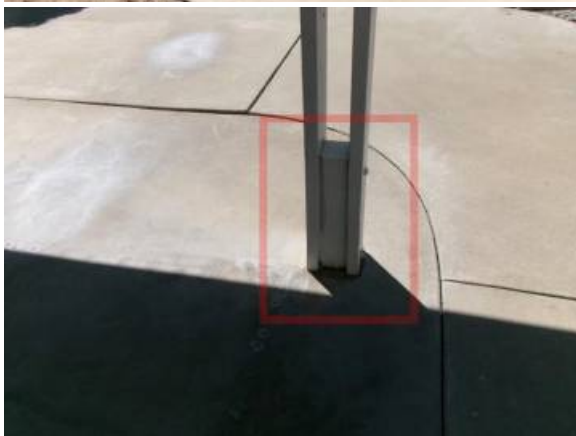
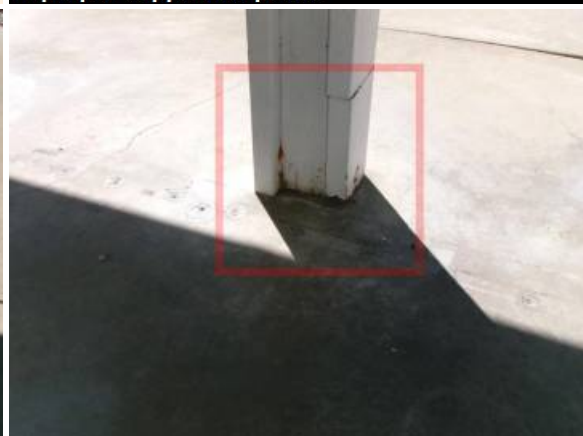
- \* The posts are not properly secured and supported to carry the load of this structure. The posts do not extend down to footings and up to the joists to be properly installed and supported in these areas. Repair and support properly as needed.
- \* Deterioration noted at base of posts. Repair or replace the damaged wood as needed.
- \* There is damaged wood to the beams and posts in several areas. Repair the damaged wood as needed.
- \* Check the termite report for all damaged wood to this structure and repair or replace the damaged wood in these areas as needed.
- \* Patio cover is not stable as it is currently installed. Additional support and repairs needed to the patio cover structure for proper support of structure.
- \* This structure appears to have been an addition done to the property. Check for signed off permits on this addition.

Improper support on posts.

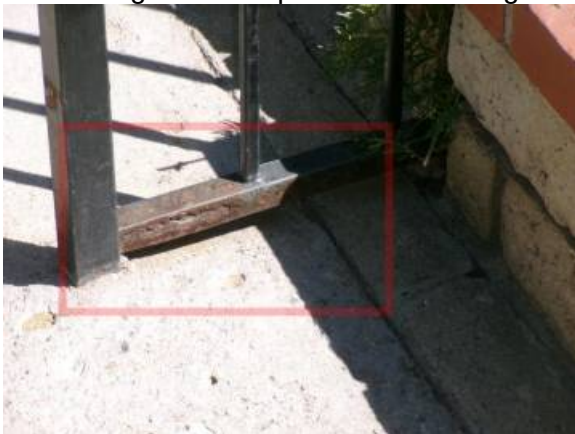
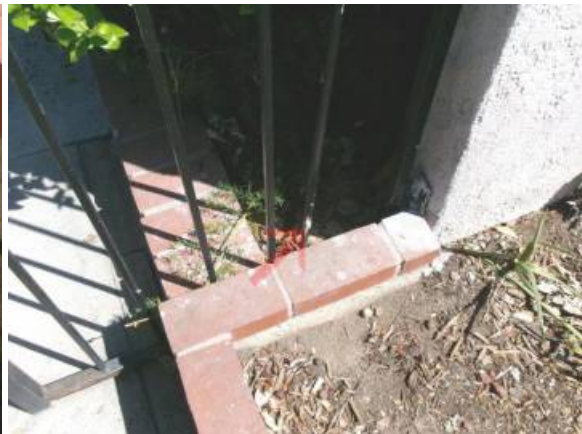
- \* The masonry fencing is in serviceable condition for its age.
- \* There is some rusting and damage to the wrought iron fence in the front courtyard. These areas need to be repaired and properly painted to protect the wrought iron fence in these areas of property.
- \* The gates are operational and in good condition in these areas.

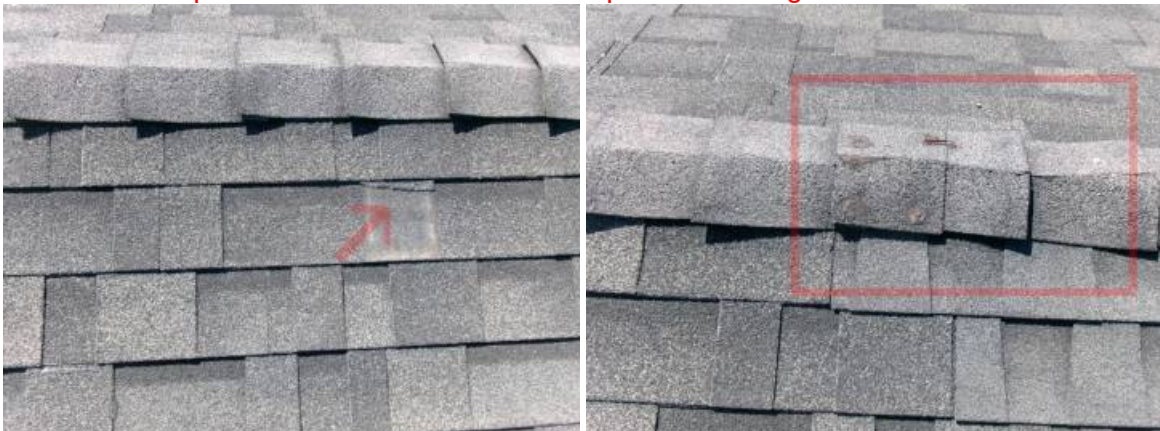
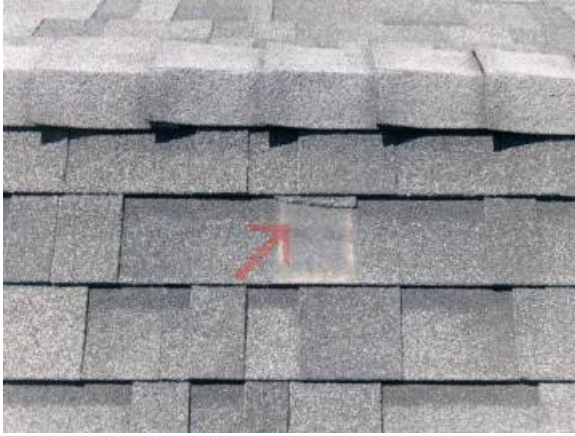
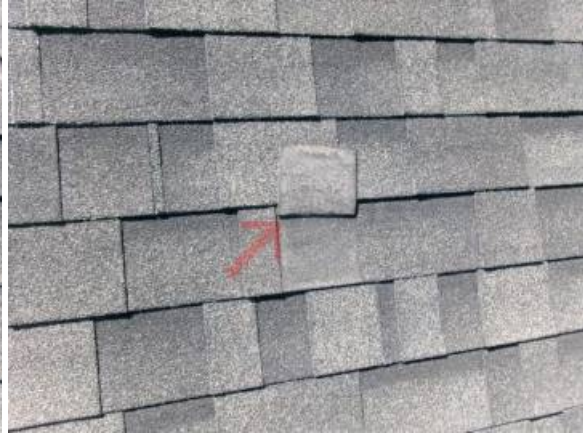
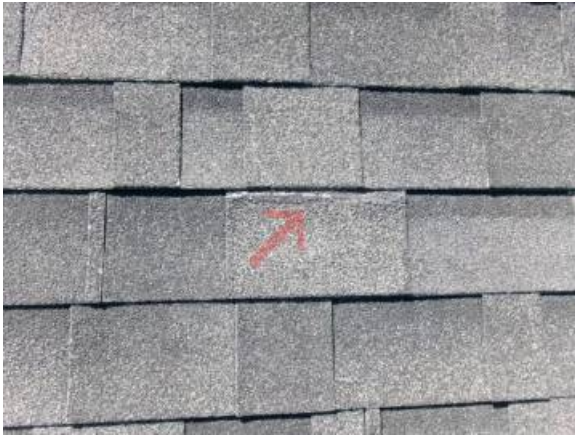
- \* The visible portions of the roof surface are in an acceptable condition for its age, periodic inspection and maintenance is recommended.
- \* The shingles are starting to deteriorate and weather in areas of the roof. There are loose granular material in some areas and some missing shingles in some areas of the roofs surface. There are exposed nails and nail heads on the roof in some areas. There should not be an exposed nails or staples on the roof shingles to be properly installed. The nails can lift or become damaged and leave holes in the roof in these areas. Properly repair and cover the nails or staples in all areas as needed. Repair the damaged areas to add life to the roof.

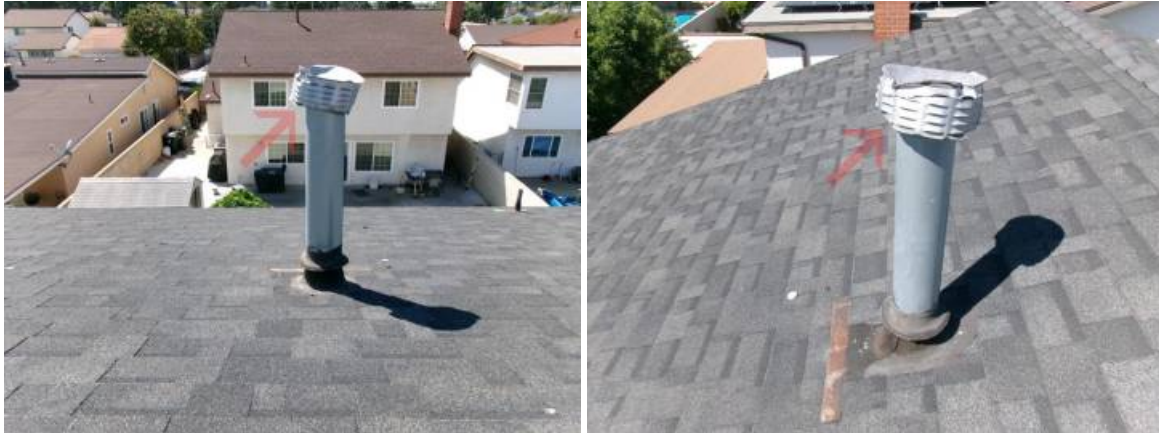
The flue vent cap and cover is damaged at the back of the roof. Replace the flue vent cover as needed.

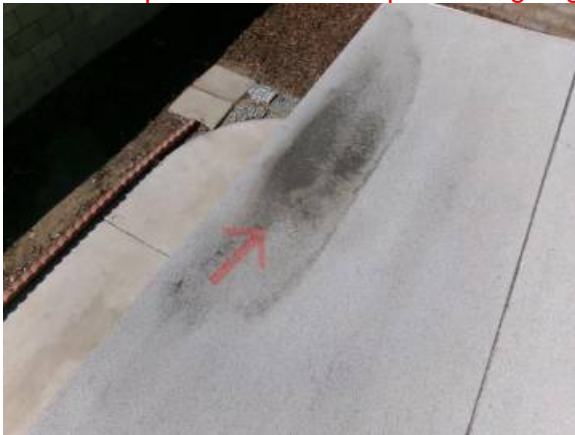
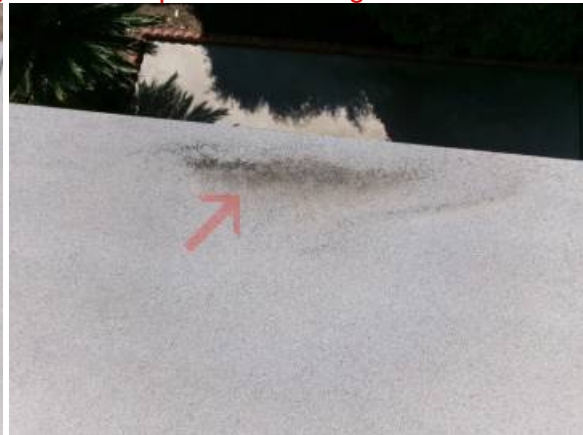
The visible portions of the roof surface are in an acceptable condition for its age, periodic inspection and maintenance is recommended. Evidence of ponding was observed. The presence of shallow ponds of water is not unusual, but regular maintenance of the areas is vital to prevent the build up of rotting vegetation and possible damage to the roof.

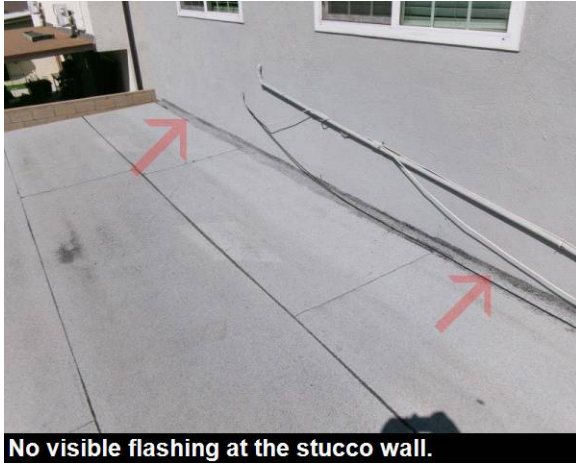
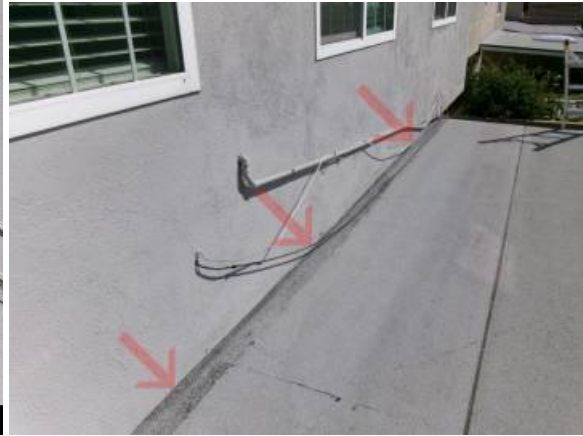
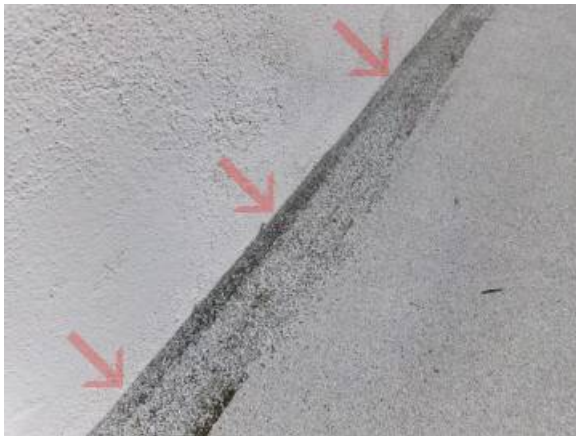
There are not any flashings installed at the stucco wall areas of the house. This area is not properly flashed and may leak through the patio cover roof at the house area. Repair as needed.

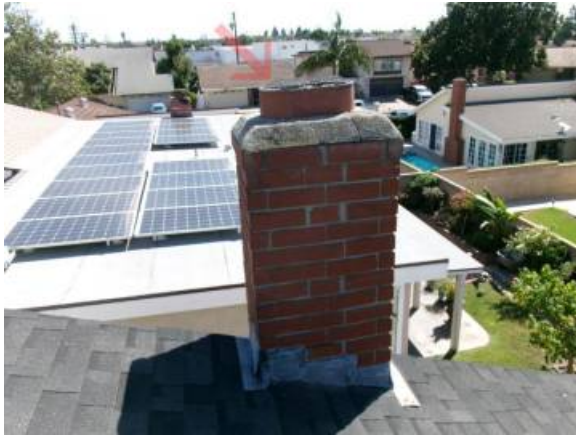
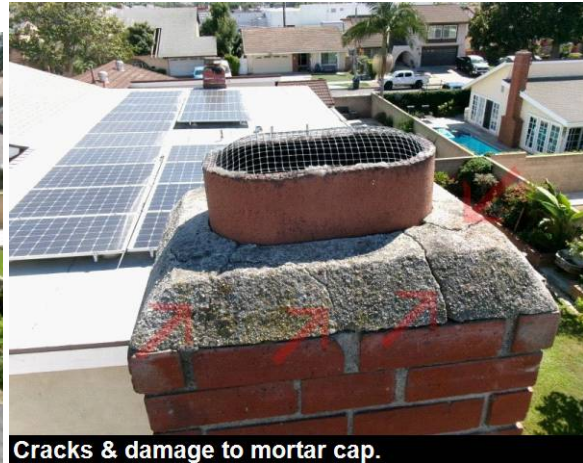
- \* The mortar chimney cap is designed to shed water of the chimney. This cap is cracked and has allowed water to enter the brick structure. Damage has occurred to the cap and the bricks below. We recommend the cap and bricks be repaired or replaced by a qualified chimney specialist.
- \* A spark arrester rain cap is needed for safety and to prevent water entry into the flue.

Cracks & damage to mortar cap.

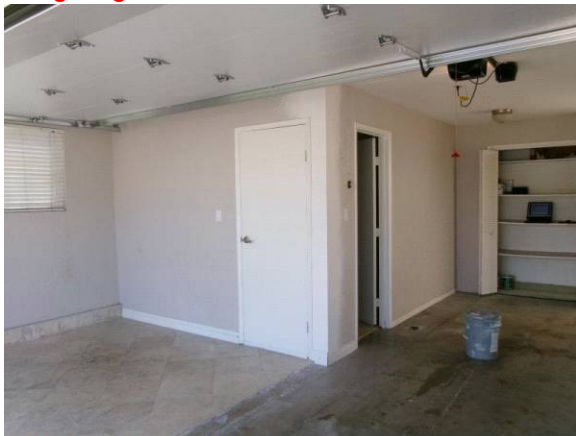
- \* The garage framing where visible appears properly installed and in good condition for its age. The garage framing can usually serve as an indicator of the type and quality of the framing in general.
- \* There is an attic in this area and this area is insulated as well.
- \* There are added walls in this area to divide up the garage space. The garage is not a functional two car garage as it is currently. Remove the walls to make this a functional two car garage as needed.

Added walls in garage.

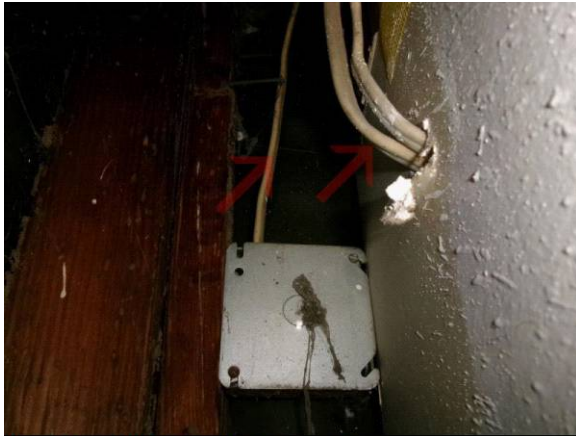
**Improper wiring in the garage.**

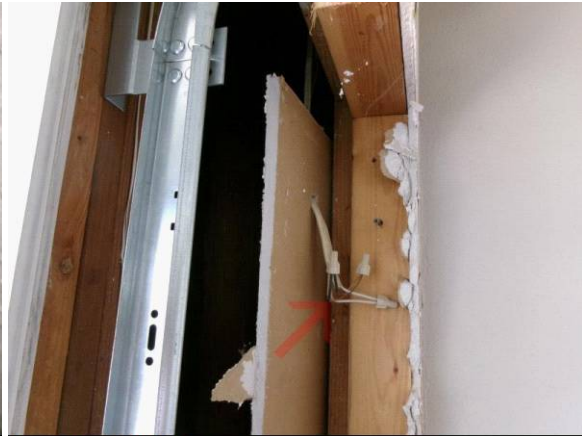
**Improper wiring in garage.**

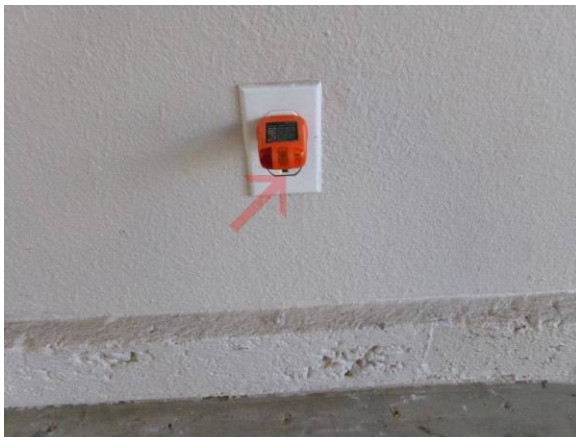
**No power to receptacle.**

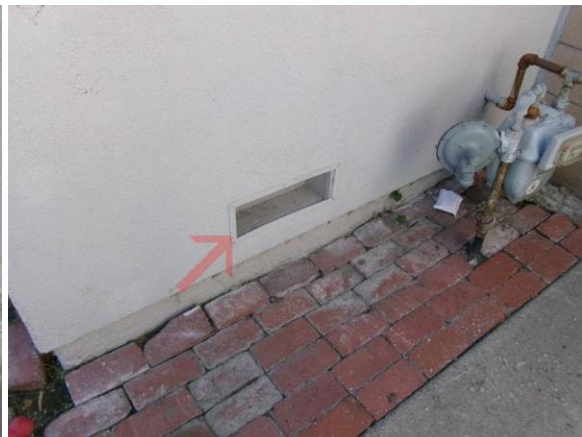
**Vents missing inside of garage.**

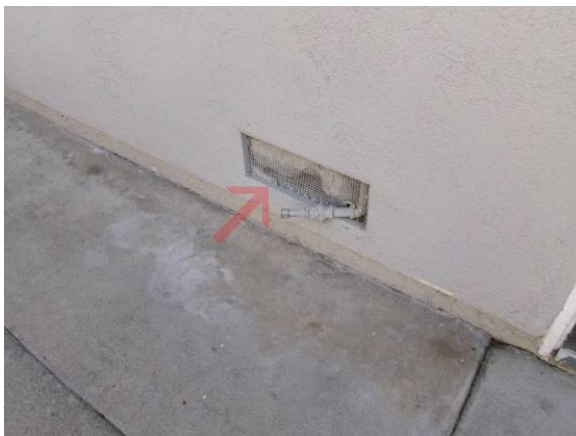
**Vents missing inside of garage.**

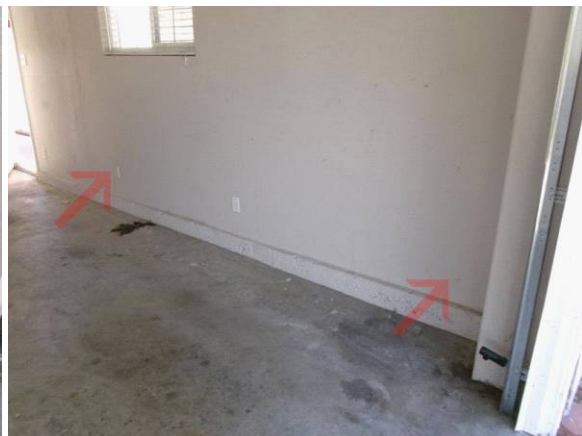
**Vents missing inside garage on side wall.**

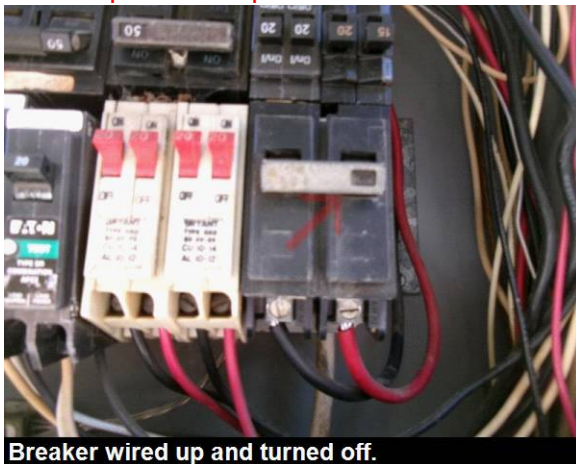
- \* The bottom 30 amp breaker that is labeled dryer is wired up and turned off inside of the panel. Check for its use and function and repair as needed.
- \* The bottom right side middle AFCI breaker does not properly fit in the panel. Some of the breakers are the wrong brand for this circuit breaker panel. This technically voids any warranty and possible replacement should be considered.

Breaker wired up and turned off.

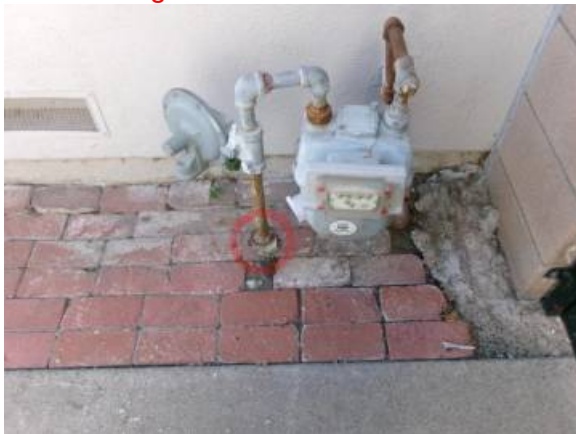
Meter located at right side of the building. The gas meter appears in serviceable condition. There is no meter wrench attached to the meter. We recommend purchasing a wrench or installing a seismic automatic shut off valve for safety.

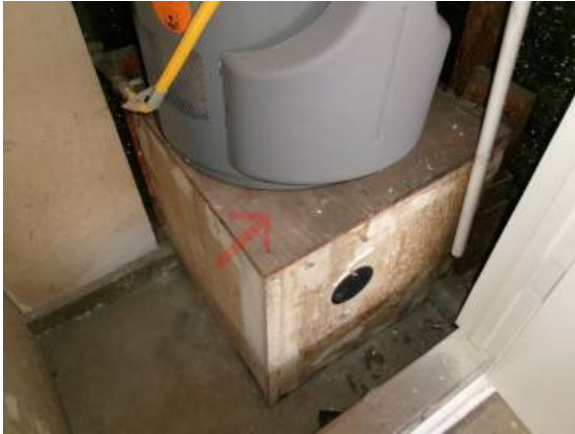
- \* The water heater tank and controls are in good condition.
- \* There is not a drain pan under the water heater unit. This is needed to drain this area away from the base of the stand for safety. Repair and add as needed.
- \* This water heater system does not have a thermal expansion tank system installed. This is required on water heaters that have a closed plumbing system. Repair and add as needed.
- \* The water heater system is not properly bonded with a bare bonding wire to complete the bonding of this unit and system. Repair and bond properly on the water lines and the gas line for safety as needed.

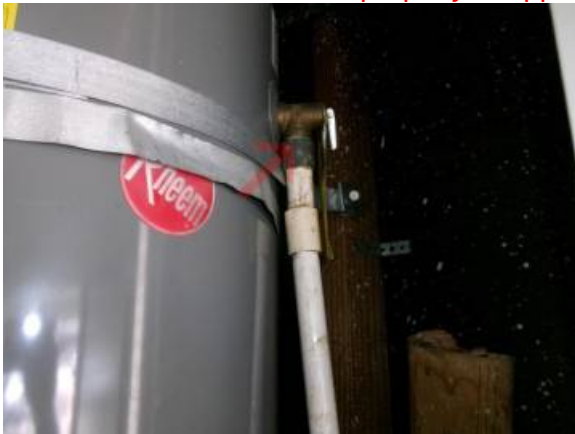
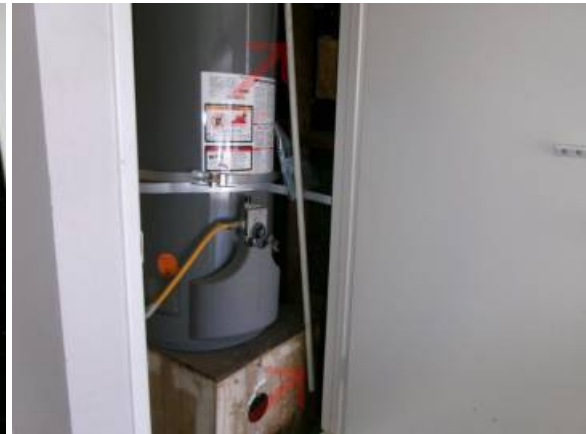
A temperature pressure relief valve is installed as required, it was not tested and it should not be altered or blocked off, if leakage occurs it should be replaced. The temperature/pressure relief drain pipe is plastic. This is not an approved material. We recommend it be replaced with ridge copper or galvanized steel with the correct size and terminated correctly as required. The overflow line is not properly strapped to the stand.

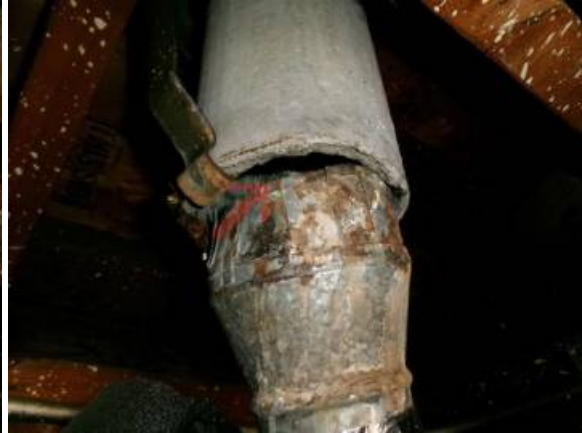
- \* The vent pipe is installed in a substandard manner. The piping is not properly connected and is allowing the products of combustion to spill out. We recommend new piping be installed if necessary and joints be secured with screws as required.
- \* There is Transite vent piping installed above the water heater in some areas. This type of vent piping has materials likely to contain asbestos related materials. Caution is needed when handling this type of vent piping. This section of vent piping should not be cut, damaged, modified or removed without proper care and caution.

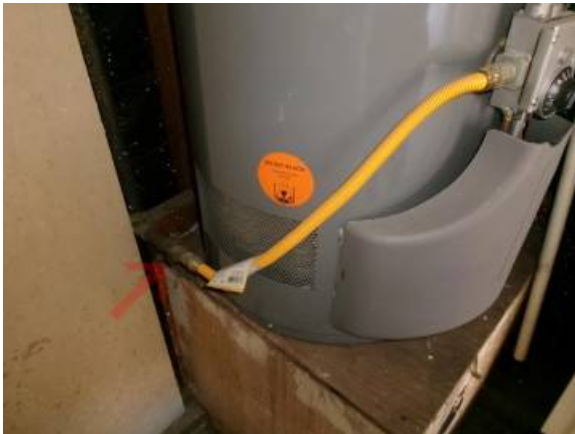
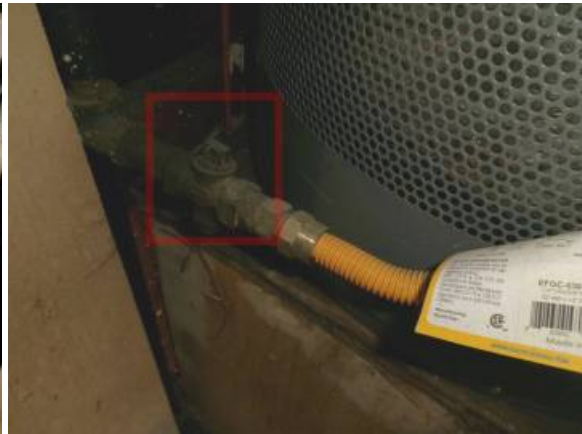
- \* The water heater has an out dated local gas shut off valve that requires a wrench. We recommend upgrading to a hand operated valve for ease of operation and safety.
- \* There is not a gas sediment trap on the gas line at the gas valve area. Repair and add as needed.

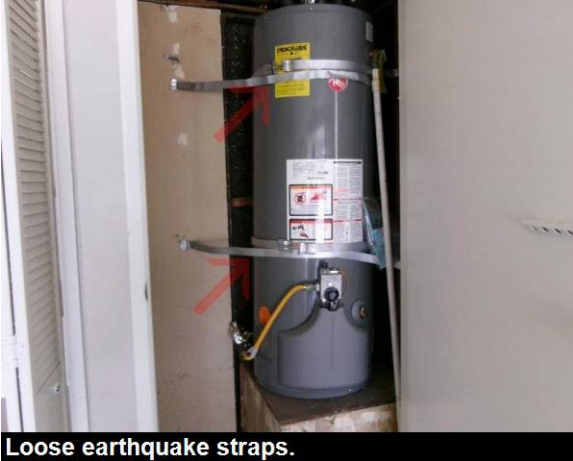
These straps are loose and need to be properly tightened for proper earthquake support.

Loose earthquake straps.

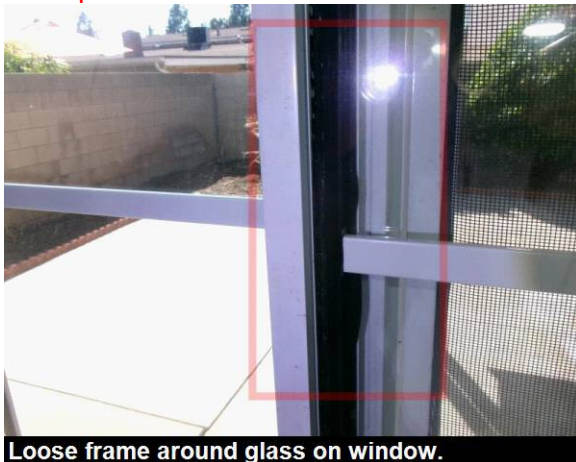
This sliding window is tight to operate properly. Check the rollers and repair as needed. The frame is loose and not properly secured around the glass on this window as well. Repair or replace this window as needed.

Loose frame around glass on window.

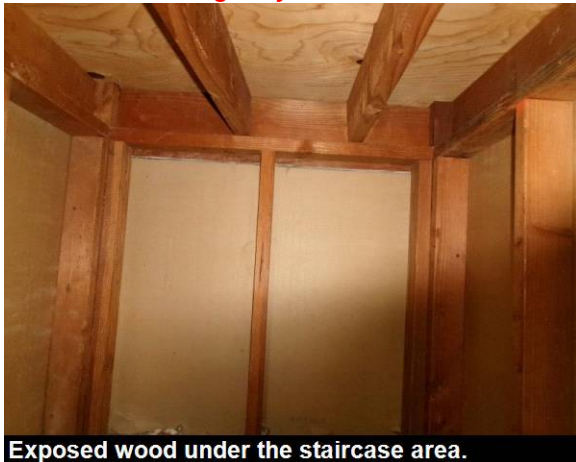
Interior stairs were used several times and appear serviceable. Stair handrail are properly installed, attached and in serviceable condition. The under side of the stairs has exposed wood framing. Drywall should be installed as required to prevent the spread of fire to the stairs.

Exposed wood under the staircase area.

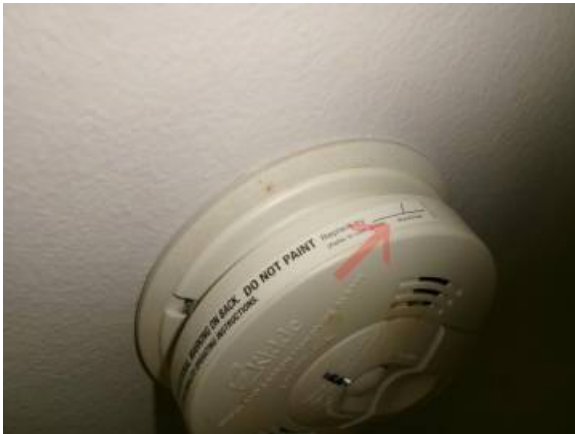
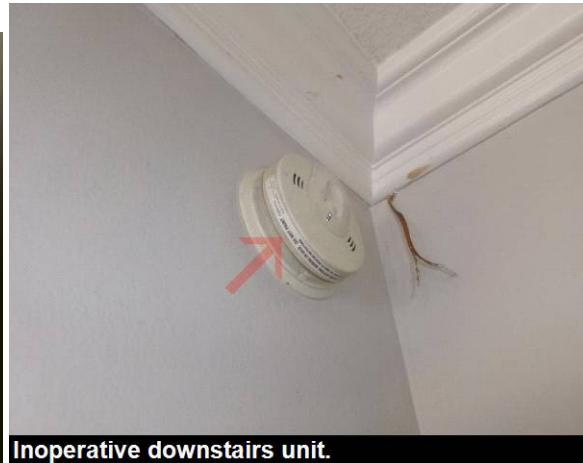
- \* The units in the downstairs and in the upstairs left side secondary bedroom both did not operate when tested. Repair or replace these units as needed.
- \* The smoke detector(s) in the house do not have dates on them. They should have a date on each unit with a lithium ion battery that is designed to last 10 years for safety and functional use. Repair or replace the smoke detectors with the proper units for safety and functional use as needed.
- \* The smoke detector(s) should not be installed within 36" of a door, register vent and/or window opening or within 36" of the end of a ceiling fan blades. They should also be installed on the ceiling or the upper wall and within 12" of the ceiling to be properly located and installed. Relocate as needed.

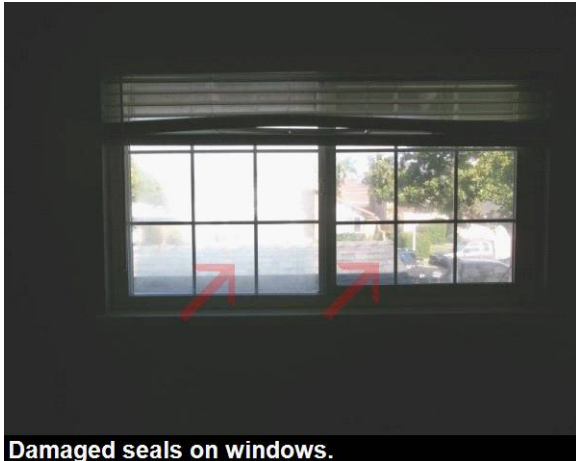
**Damaged seals on windows.**

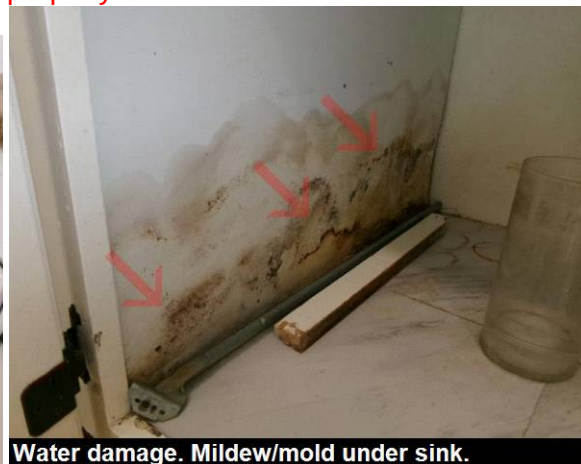
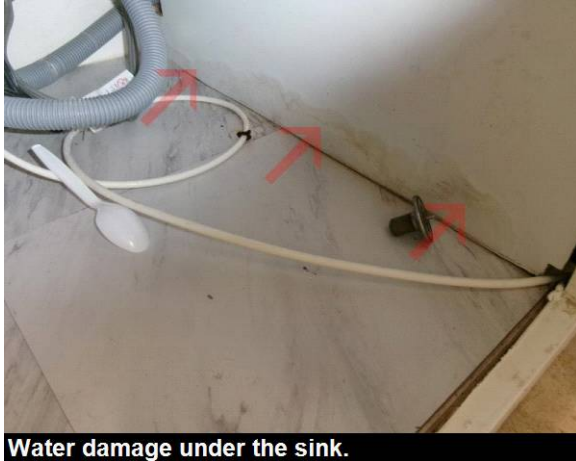
- \* The counter tops are in serviceable condition.
- \* There is some damage to the cabinet doors and drawers in these areas. Repair or replace the damaged areas as needed.
- \* There are water stains and damage to the base cabinet areas under the kitchen sink. Check for the source of these stains and damaged areas and repair as needed. Check for any mold or toxic mold to these areas and remove properly as needed.

Water damage under the sink.

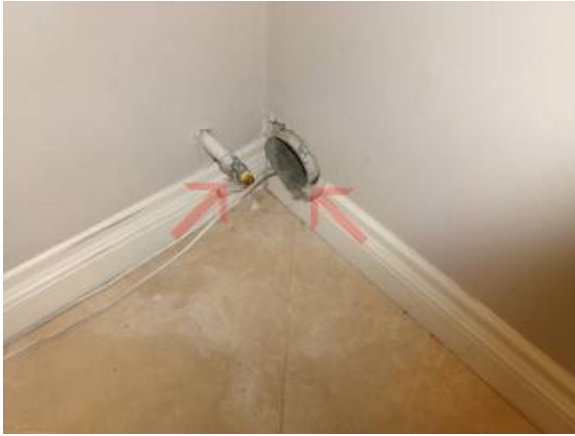
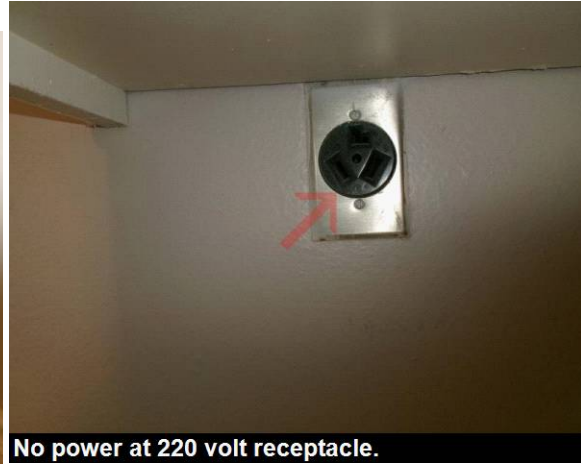
Dryer venting is provided that appears to be terminating to the exterior as required. There are both gas and 220 V. electric hookups for a dryer. **The 220 volt electrical outlet is not operational. Check the breaker in the electrical panel and repair as needed.**

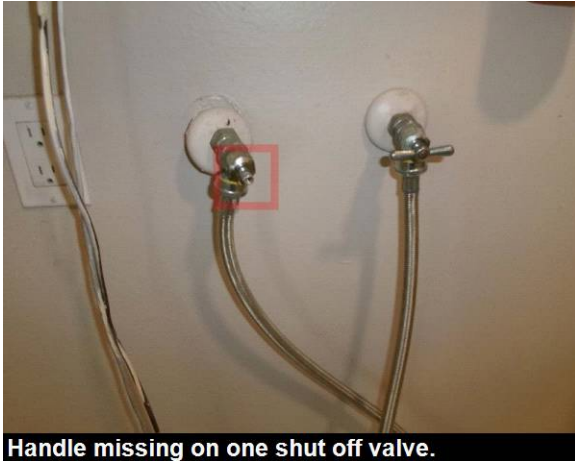
**The handle(s) missing on the washer hookup valves and the valve can not be properly operated. Replace the damaged valves as needed.**

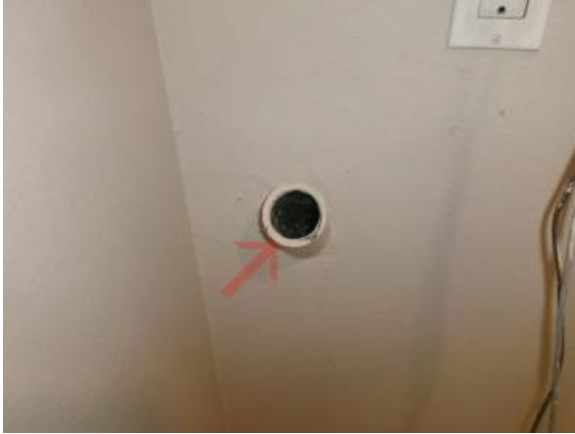
There is not an exhaust fan in this area to vent out the laundry room. The fan is beneficial to properly vent moisture out of this area. This is required on all newer installations. Repair and add as needed.

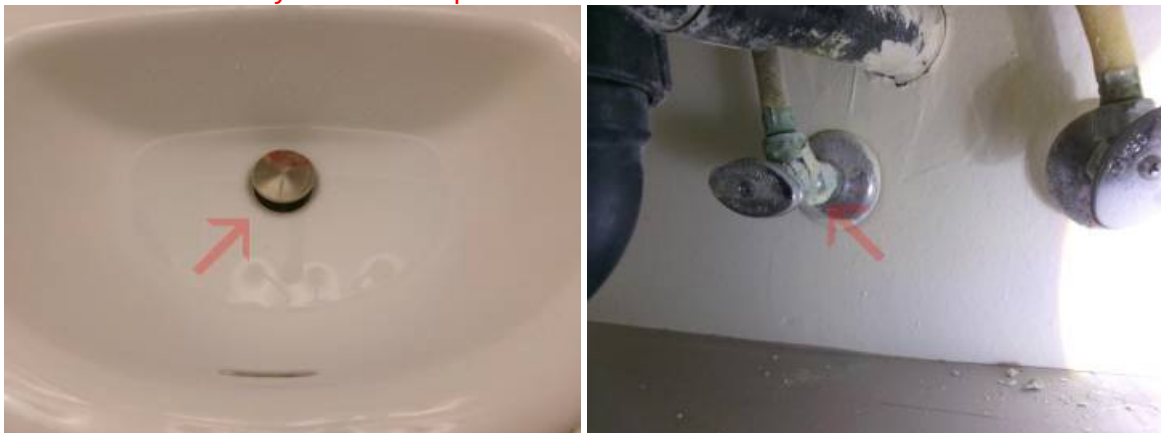
The sink(s) is properly installed and in good condition. The sink faucet(s) was properly installed and operable. Counters/cabinets appear serviceable. **The following item(s) were noted at the drain: Drainage is slower than normal. We recommend it be cleaned of hair and grease or replaced if necessary. The shut off valve handles are corroded under the sink area. These valves may leak when operated or are used.**

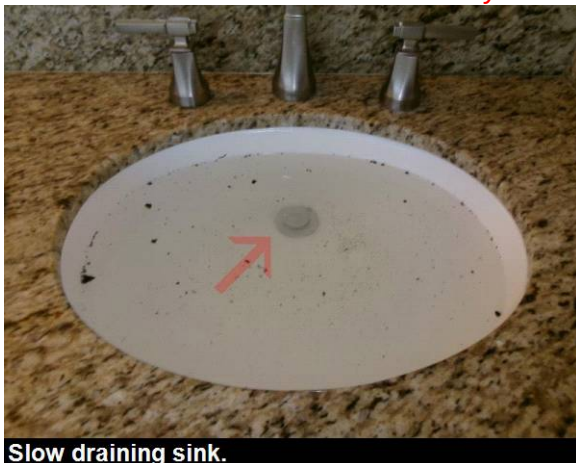
- \* The sink(s) is properly installed and in good condition.
- \* Counters/cabinets appear serviceable.
- \* The right side sink faucet hot and cold water lines are reversed at this faucet. Repair so hot water is on the left side for safety and functional use as needed.
- \* The following item(s) were noted at the drain: Drainage is slower than normal for both of these sinks. We recommend they be cleaned of hair and grease or replaced if necessary.

Slow draining sink.

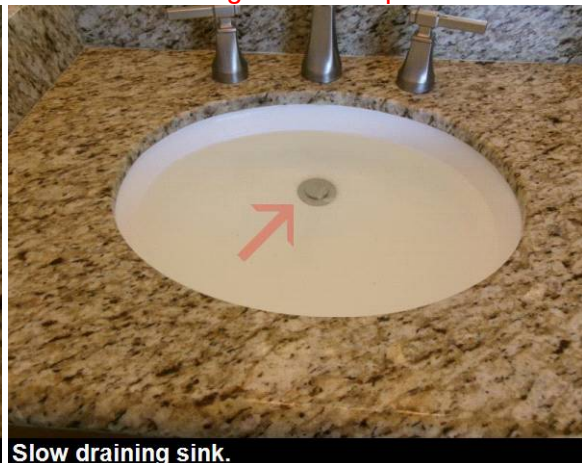
Slow draining sink.

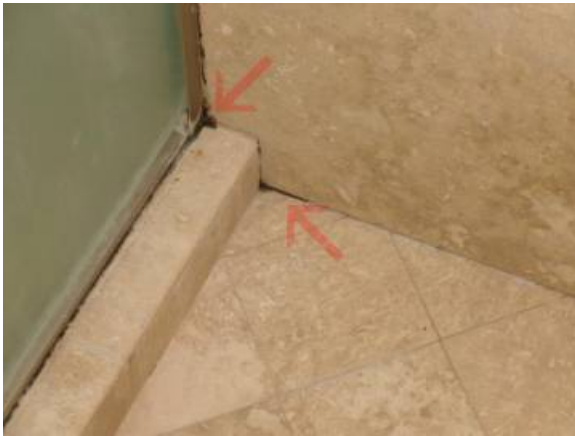
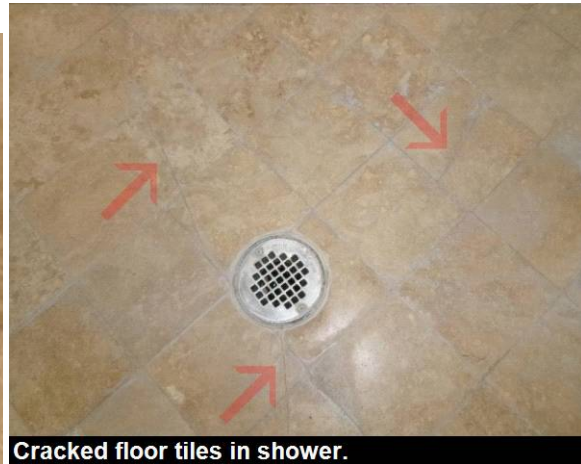
- \* There is mildew and mold to the shower walls in several areas of the shower. Clean and remove all damaged and affected areas as needed. Check for any leaks in these areas and properly repair and seal off properly in these areas as needed.
- \* There are some cracked and/or broken tiles on the floor areas of the shower. Repair or replace the damaged tiles in this area as needed.
- \* Caulking and/or re-grouting is needed to prevent water intrusion in these areas. Repair and seal off properly as needed.

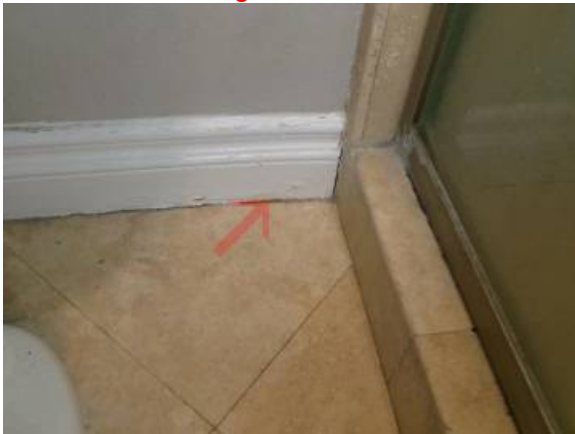
Moisture damage is noted at the wall or floor outside the shower area. The source of the moisture should be identified and corrected. Repairs may reveal further damage into the wall or floor framing.
