### Inspection/Certification

Inspection Address: **675 Redondo Road, Templeton CA 93465 (Main House)**

Inspection Address: **675 Redondo Road, Templeton CA 93465**

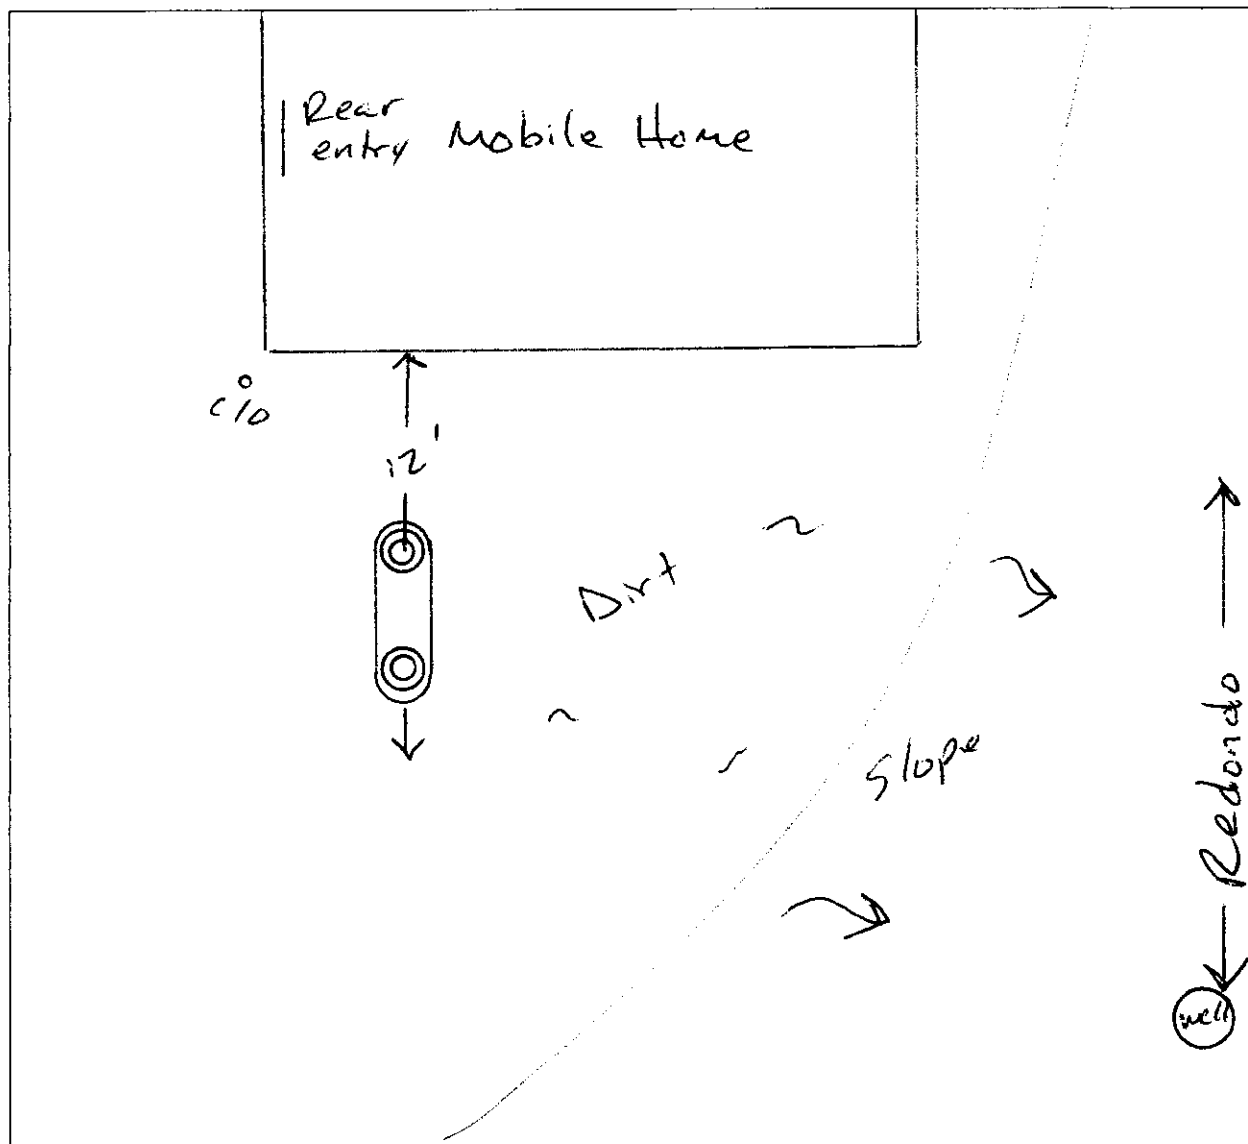
main house

Comments: 1000 Gallon plastic tank w/ risers to grade + filter in secondary

☒ Full Diameter Access Risers to Grade      Depth From Top of Tank to Grade 12"

Distance to wellhead 150' +      Clean Out Present yes

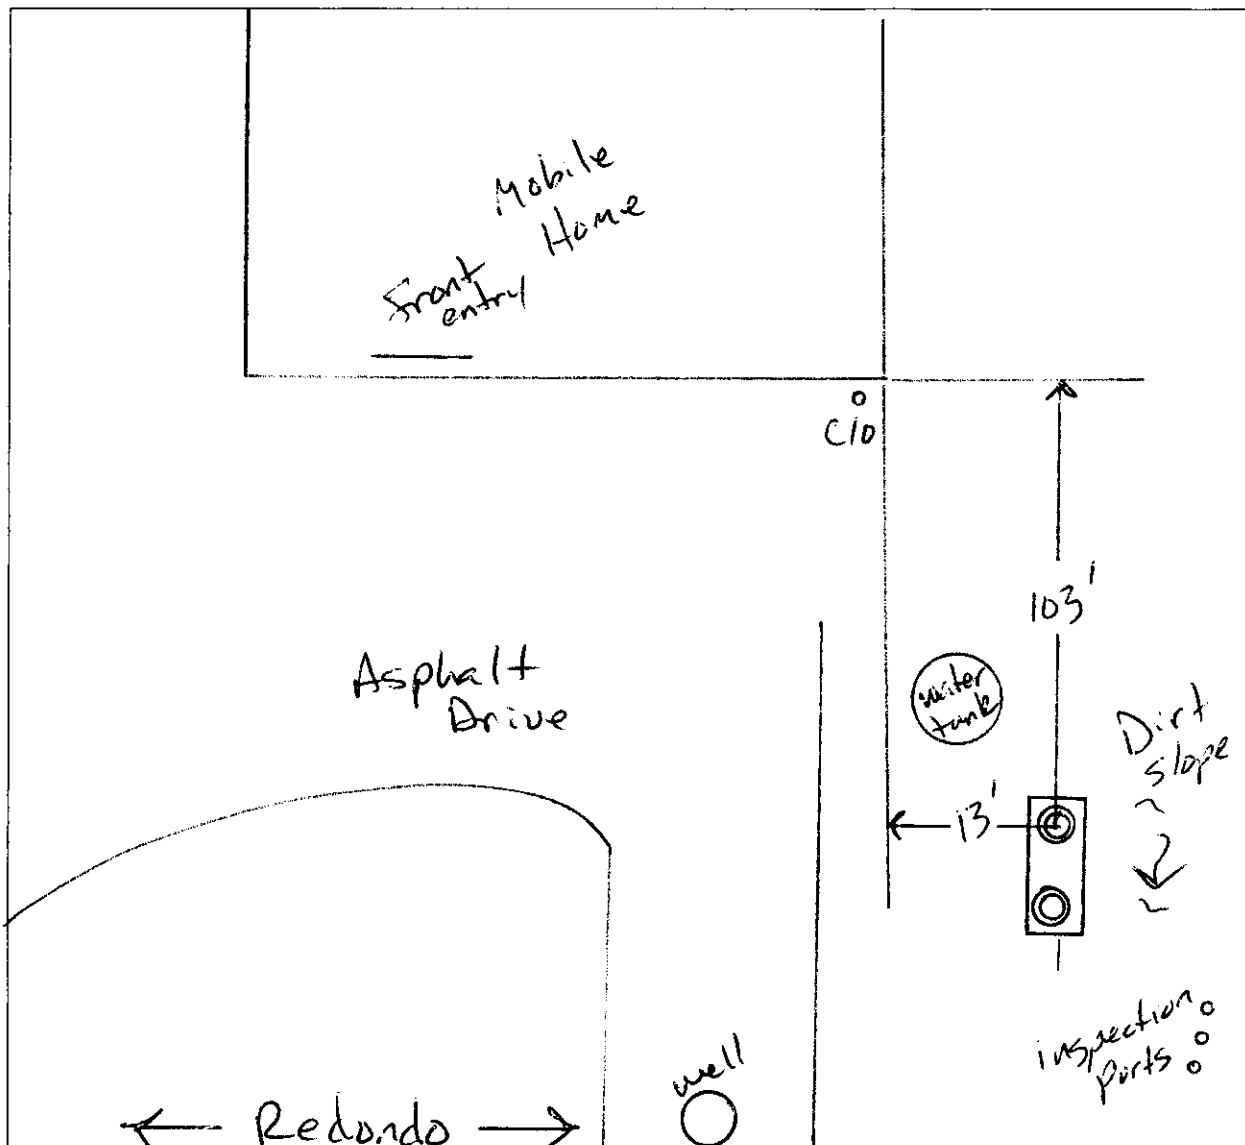
Comments: 1,200 Gallon Concrete tank w/ Risers to  
grade

☒ Full Diameter Access Risers to Grade

Depth From Top of Tank to Grade 12"

Distance to wellhead 150'

Clean Out Present yes

Comments: **Alliance Septic Service recommends re-grading around the septic tank to not have rain water collect around it. Septic tank should be serviced every 3-5 years. Effluent filter should be cleaned every 6-12 months.**
