### *Inspection Report*

Address: 604 Country Club Dr San Luis Obispo, CA 93401

10/07/2026

Inspector: Taylor Vreeken, CCI

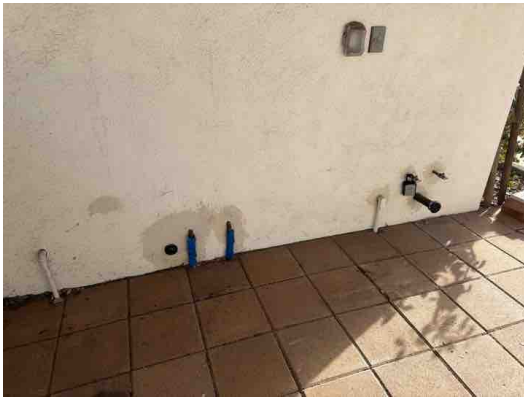
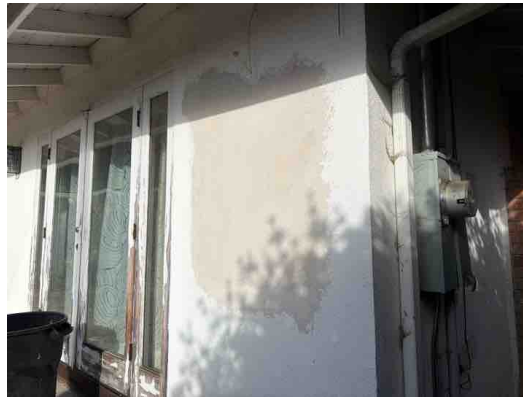
**FI DS 36:** Multiple past stucco repairs noted throughout. Ask seller for details.

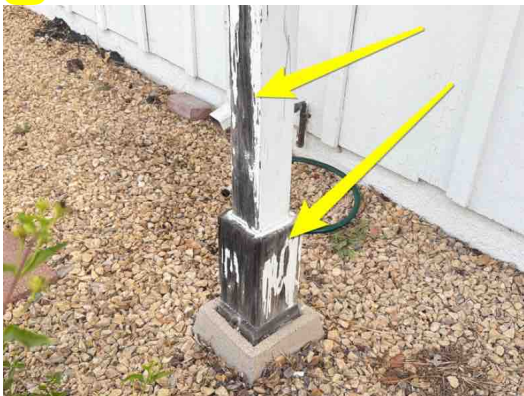
**MR 37:** Deteriorated paint at areas of the exterior.

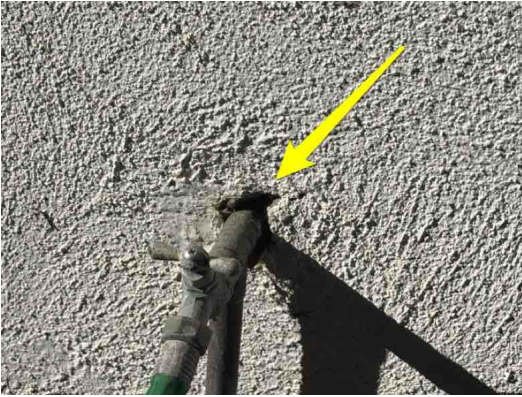
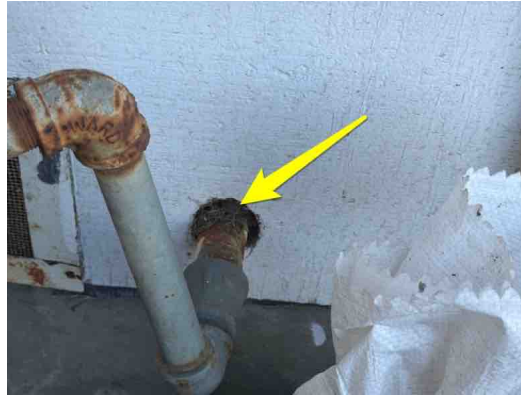
**MR 38:** Recommend sealing holes in exterior walls to prevent water intrusion around areas such as unused open holes in the exterior siding and trim, exterior light fixtures, around exterior electrical boxes and covers, and where utility pipes and/or wires pass through the exterior walls. Have a qualified painter or licensed professional evaluate the entire exterior and seal openings where needed.

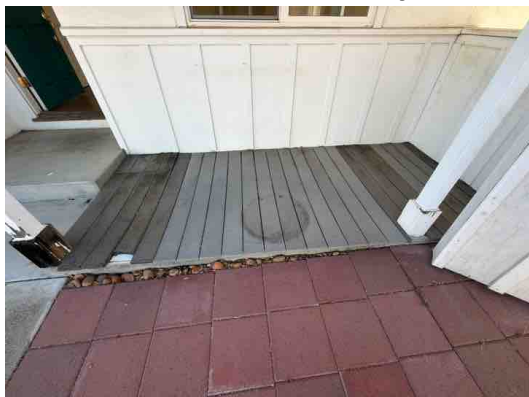
43: DECK LOCATION: **FRONT ENTRY DECK**

**E&C FI 44:** The FRONT ENTRY DECK wood deck is constructed on grade, preventing visual inspection of the supporting framing below. The deck planks exhibited sponginess and deflection when walked on, which may be indicative of moisture deterioration to the concealed decking and/or supporting framing. The extent of any concealed damage could not be determined during this visual, non-invasive inspection. Recommend further evaluation and repair/replacement of deteriorated materials as needed by a qualified contractor.

**E&C 45:** Some moisture and/or bug-type damage and deterioration found at areas of the wood decking and/or wood deck railings: FRONT ENTRY DECK. *Refer to the termite report for additional comments and recommendations.*

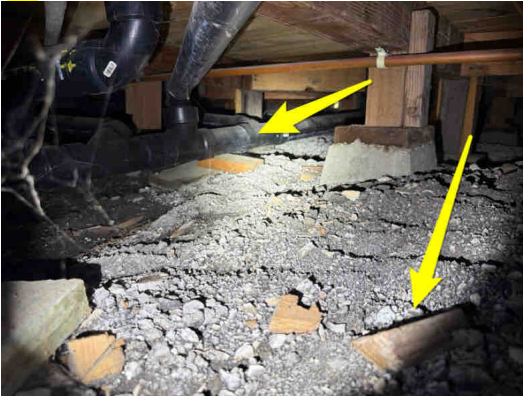
**MR 59:** Cellulose and/or debris noted in areas of the crawlspace. Recommend removal.

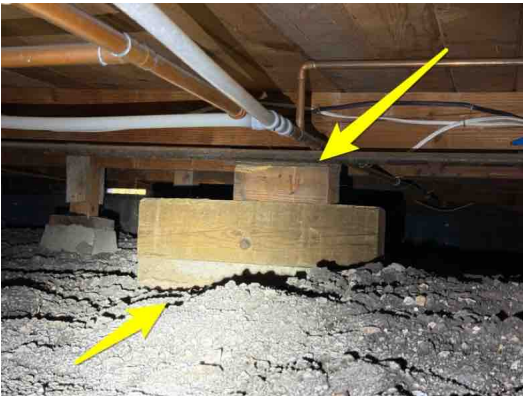
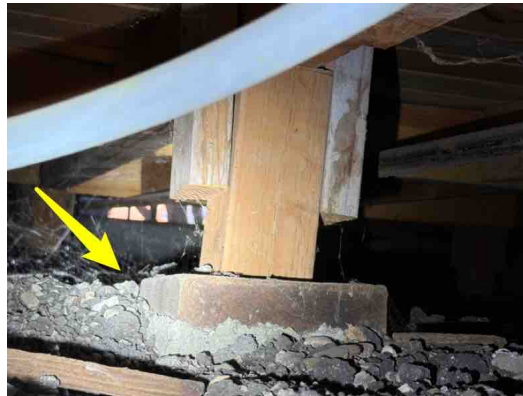
**MR 60:** Earth to wood contact found in areas of the crawlspace. Upgrades recommended. Refer to termite report for locations.

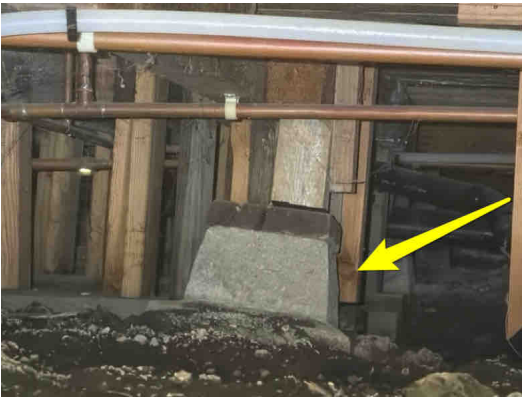
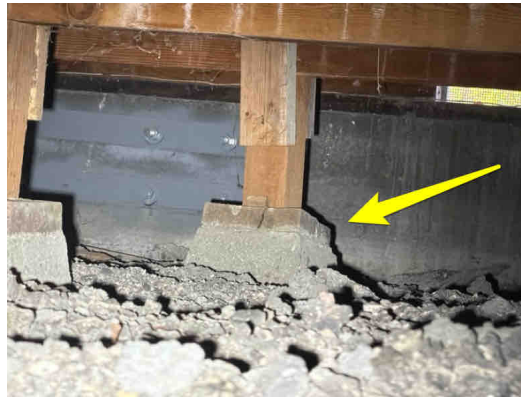
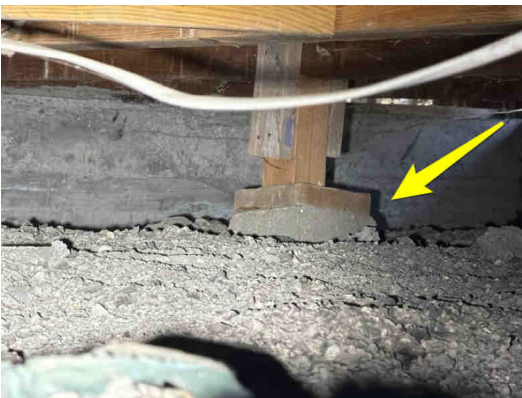
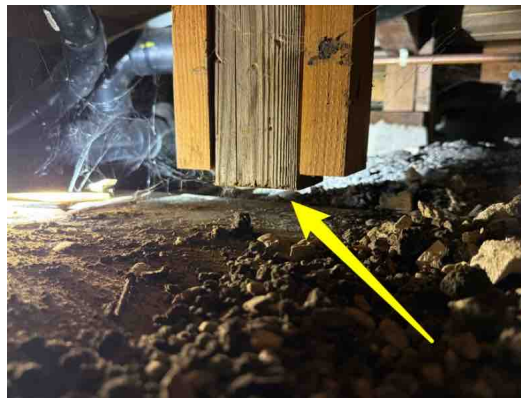
**E&C 61:** Multiple structural support posts in the crawlspace show signs of moderate shifting and settlement with uneven framing and interior floors. Recommend further review and repairs by qualified foundation professional.

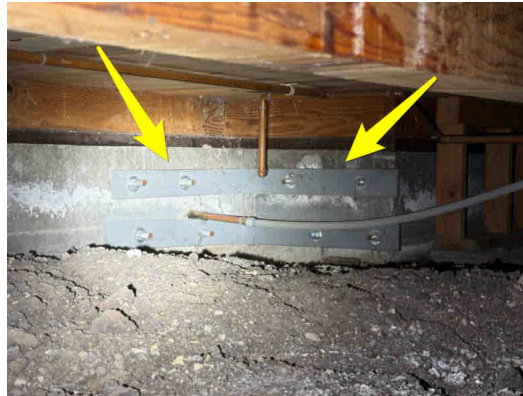
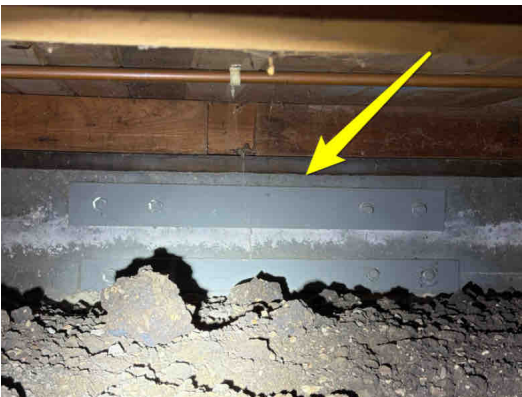
**DS 62:** Exterior bolts/steel plates and related modifications noted at the foundation and appear consistent with a previous foundation repair or reinforcement. The extent, design, installation method, and condition of concealed components cannot be determined during a visual, non-invasive inspection. Recommend obtaining any available permits, engineering documentation, warranties, and repair records for review. If documentation is unavailable, further evaluation by a qualified foundation contractor or structural engineer is recommended.

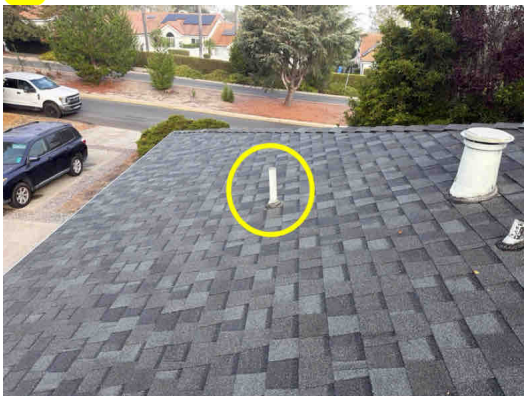
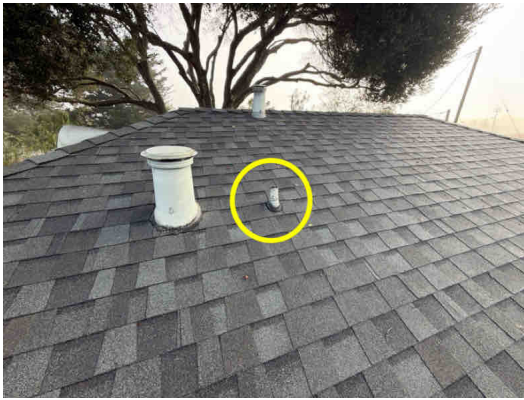
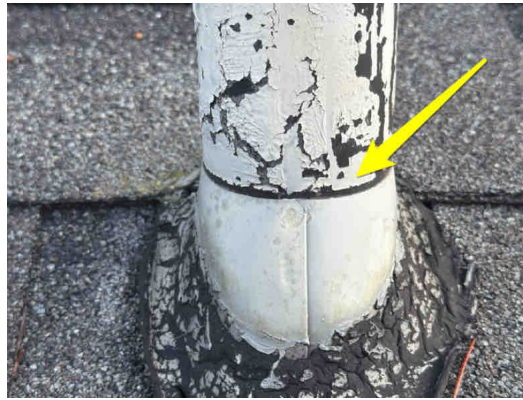
**MR 70:** Missing and/or deteriorated sealant at roof jack flashings.

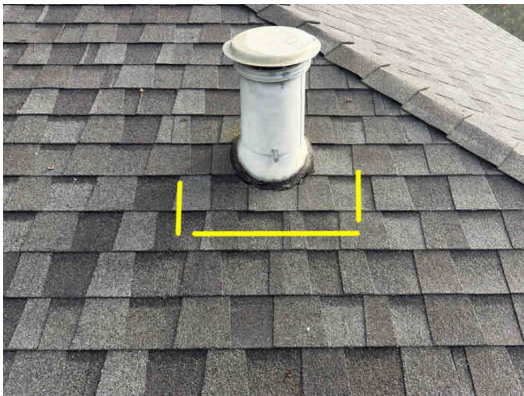
**MR DS 71:** Disclosure: Improper installation of the roof jack flashings where the apron terminates below the roof shingles. This is considered a sub-standard installation for a single layer of roofing and will require continuous maintenance or repairs. Upgrades recommended.

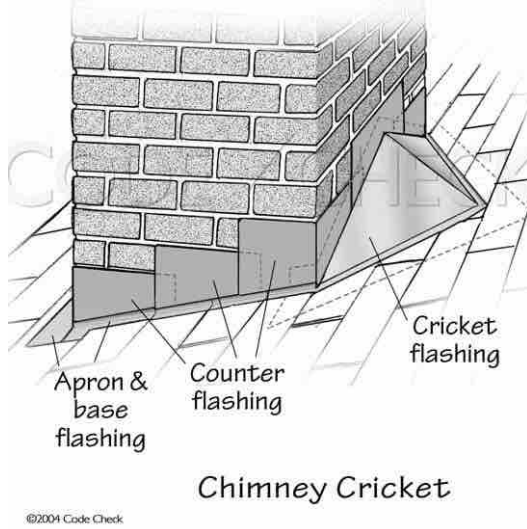
**E&C 72:** Missing / recommend a proper chimney cricket per standards at the LIVING ROOM fireplace chimney chase, to help prevent a buildup of debris and water behind the chimney.

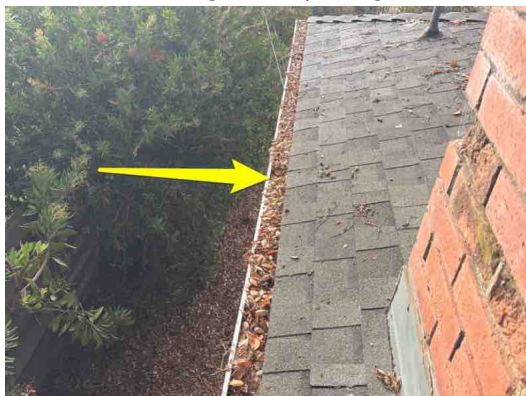
**MR 75:** Recommend some typical rain gutter maintenance. This should at minimum consist of cleaning, sealing, and re-fascinating and repairing of loose or damaged gutters and downspouts.

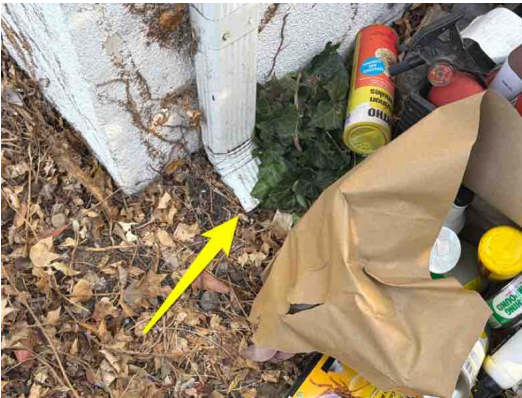
**MR 77:** Recommend cleaning/ removing debris at the rain gutter downspout terminations to allow for proper drainage.

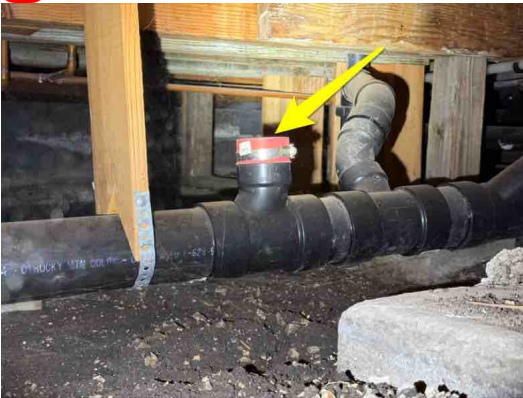
**E&C 98: Improper use of a thin temporary construction cap as a permanent waste line cap: CRAWLSPACE**

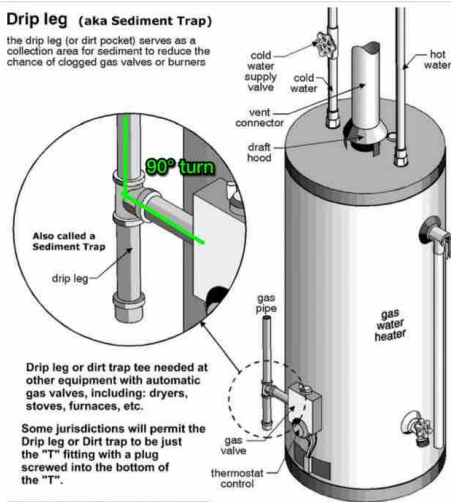
**SU 112:** Recommend the installation of the missing sediment trap / drip leg at the WATER HEATER gas piping at flex connection by a certified or licensed plumbing professional familiar with minimum requirements. [CPC 1212.8]

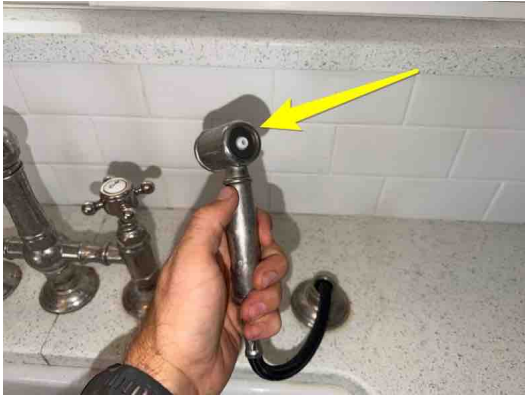
**121:** Kitchen sink faucet spray button is damaged and/or missing.

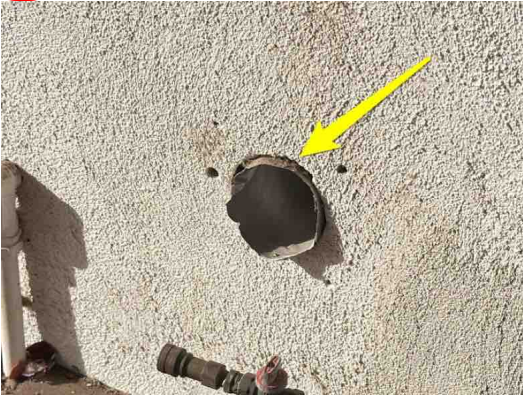
**E&C 138:** Damaged/ Missing laundry dryer vent cap. Recommend replacement or repairs.

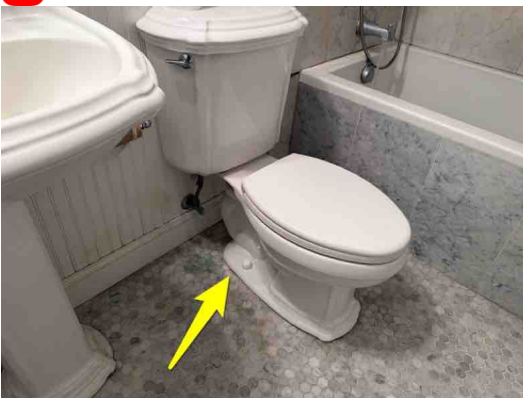
**E&C 141:** Toilet loose at floor: HALLWAY BATHROOM

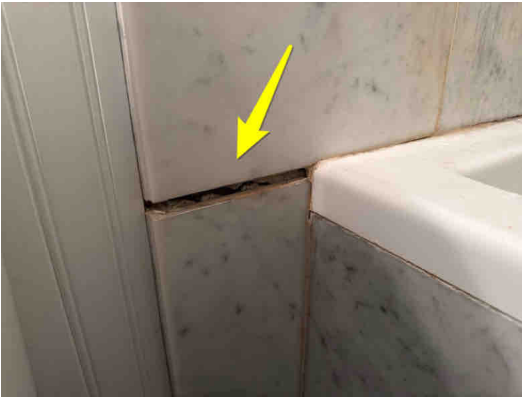
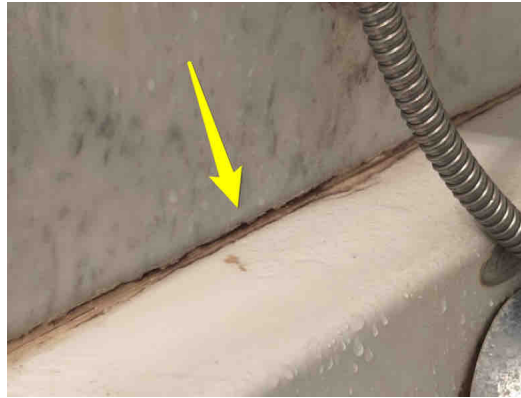
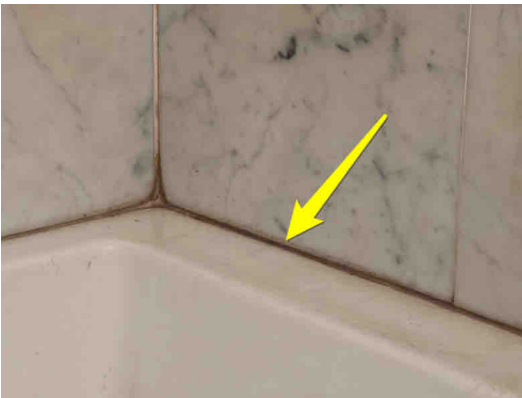
**MR 150:** Some visible, moderate and heavy deterioration to the grout in areas of the tiled shower enclosure.  
Maintenance recommended: HALLWAY BATHROOM

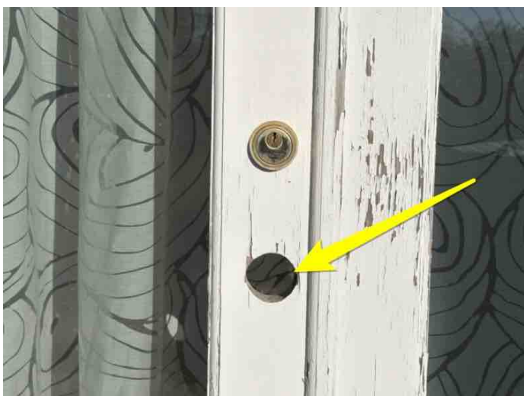
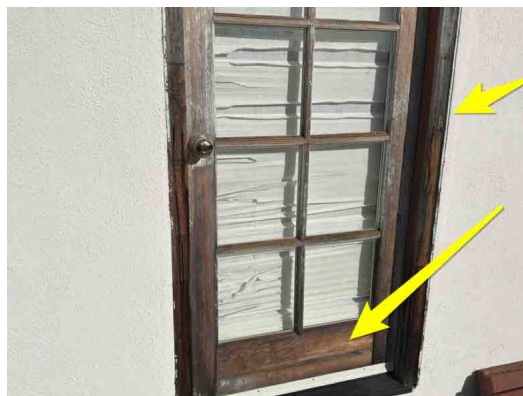
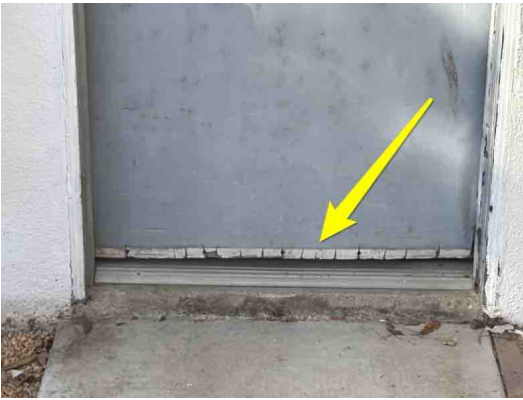
**E&C 155:** Multiple exterior doors were observed with significant deterioration and/or deferred maintenance. Conditions noted include deteriorated or damaged door materials and finishes, damaged or missing weatherstripping, missing or damaged hardware/door knobs, and other installation or maintenance-related defects. Due to the number of doors and conditions present, individual defects are not separately listed. Recommend evaluation of all exterior doors and repair or replacement as needed by a qualified contractor to provide proper operation, weather resistance, security, and protection from further deterioration.

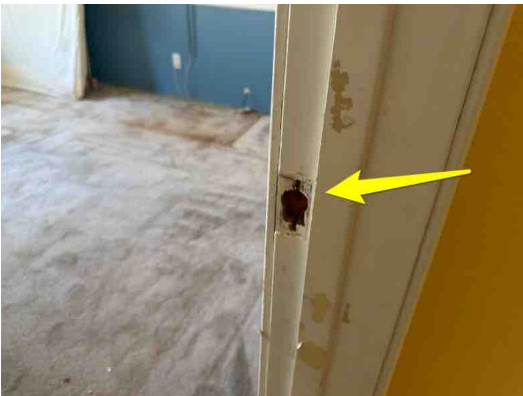
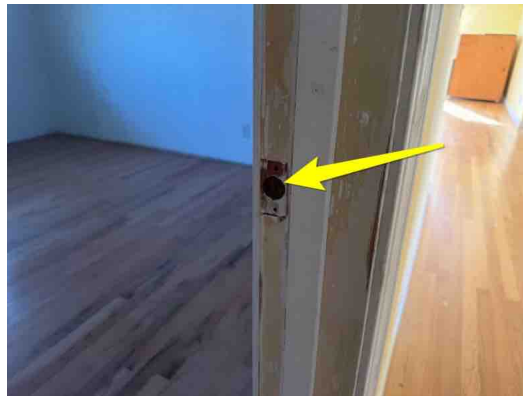
**156:** Multiple interior doors throughout the home were observed to be unfinished and/or incomplete, with various defects including missing door hardware, missing or incomplete strike plates, doors rubbing or binding at the flooring or frames, unfinished surfaces, and other installation deficiencies. Due to the number and variety of conditions present, individual defects and locations are not specifically listed. Recommend evaluation of all interior doors and completion, adjustment, and repair as needed by a qualified contractor.

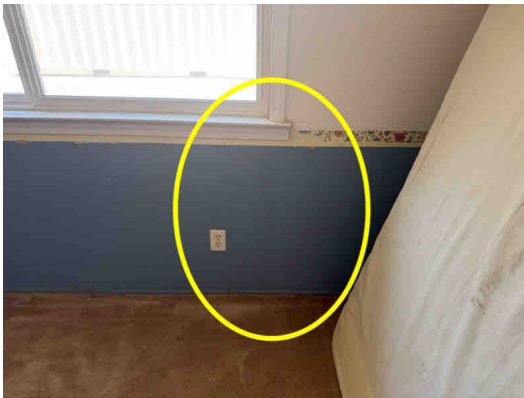
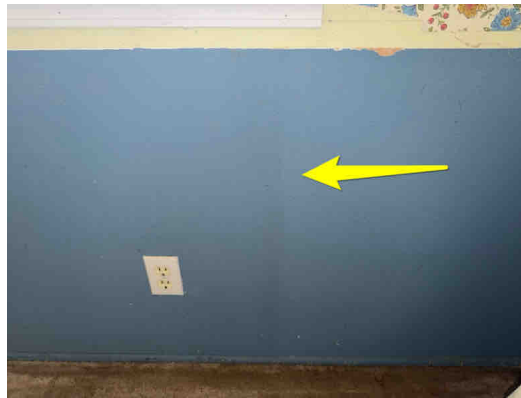
**FI 160:** Evidence of water intrusion with stains and/or damage on the interior of the window in: PRIMARY BEDROOM.

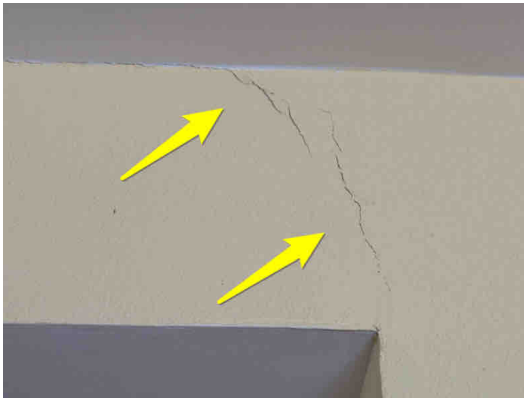
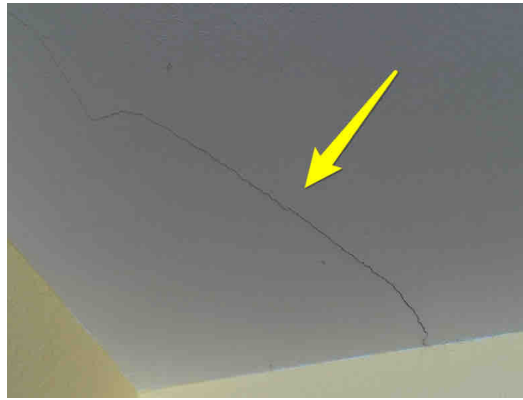
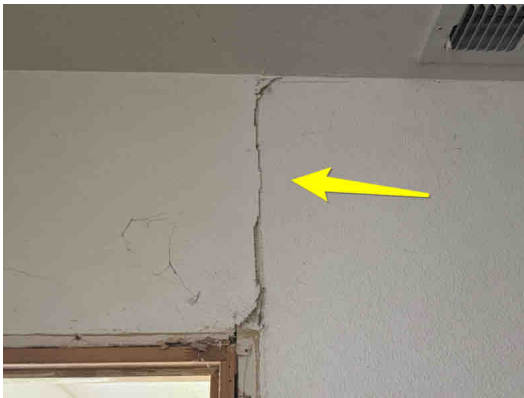
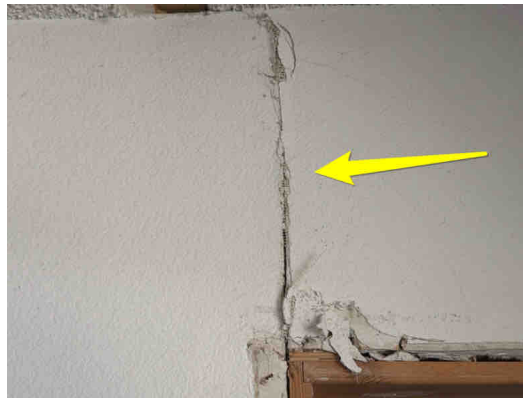
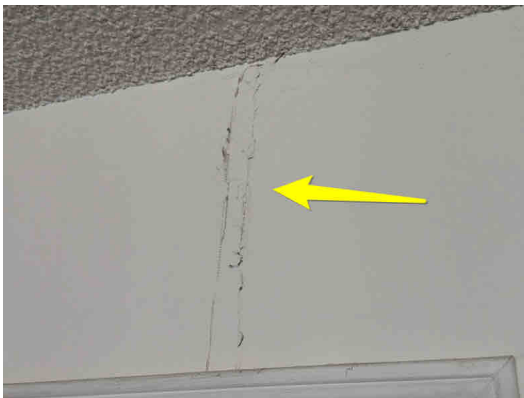
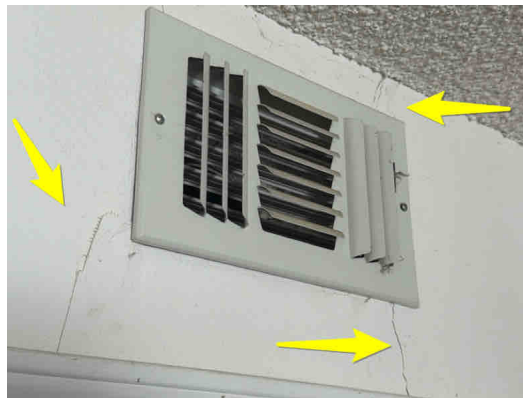
**E&C 178:** Several cracks noted throughout interior drywall indicative of moderate and minor structural movement.

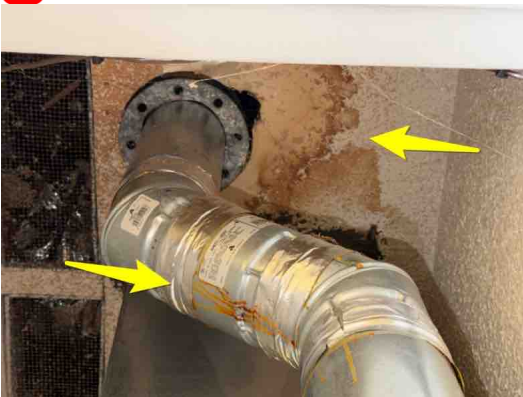
**FI 185:** Moisture stains noted at the enclosure ceiling around the furnace vent pipe. Past roof leak.

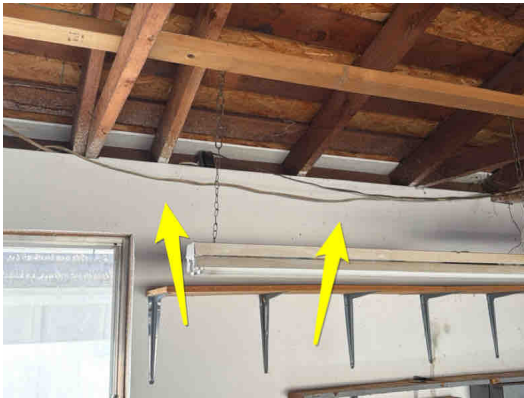
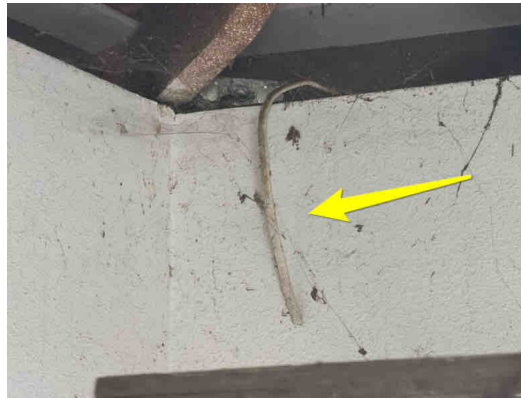
**SC 197:** Improper exposed electrical wiring, "Romex" improperly installed subject to physical damage, not in a conduit or raceway per standards: MULTIPLE AREAS IN THE GARAGE  
NEC 334.15(B)  
NEC 300.4

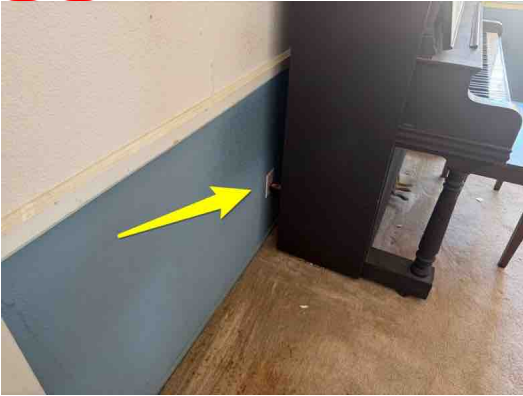
**SC FI 199:** Electrical outlet found non-operational: PRIMARY BEDROOM EAST WALL

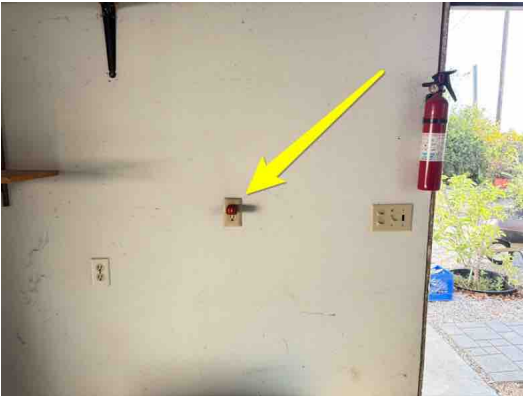
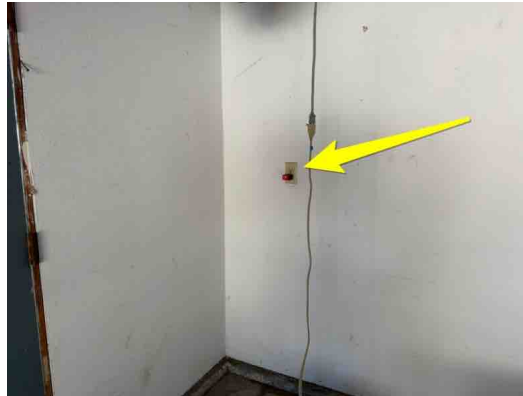
**SC 200:** Miswired electrical outlet (Reverse polarity) found at: MULTIPLE IN THE GARAGE and BEDROOM-2 EAST WALL. Have electrician check all outlets and correct as needed.

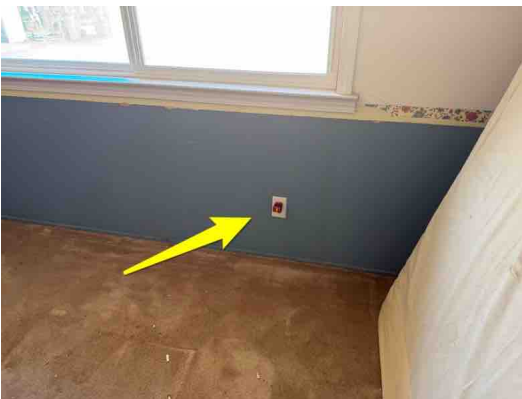
**SC 202:** Three-prong electrical outlets did not test properly grounded: LIVING ROOM WEST WALL and PRIMARY BEDROOM SOUTH WALL. Have electrician check all outlets for proper grounding.

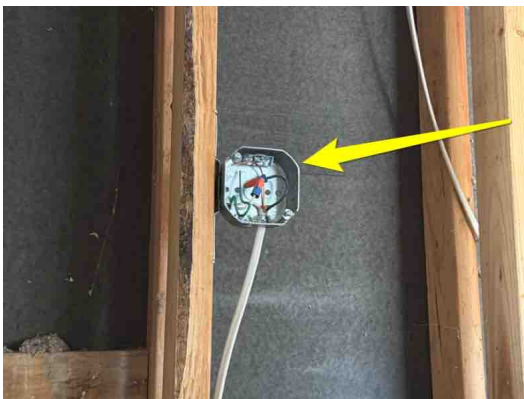
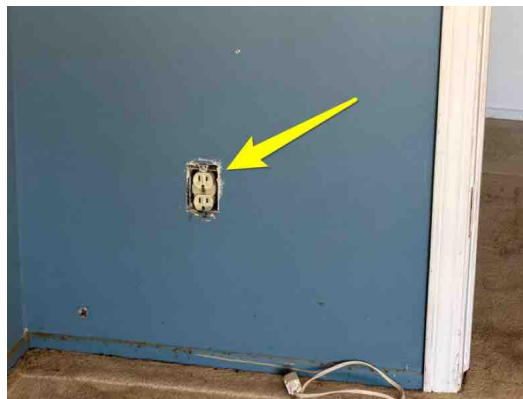
**SC 206:** Missing electrical cover plate: MULTIPLE IN THE GARAGE/ PRIMARY BEDROOM and PRIMARY BEDROOM BATHROOM

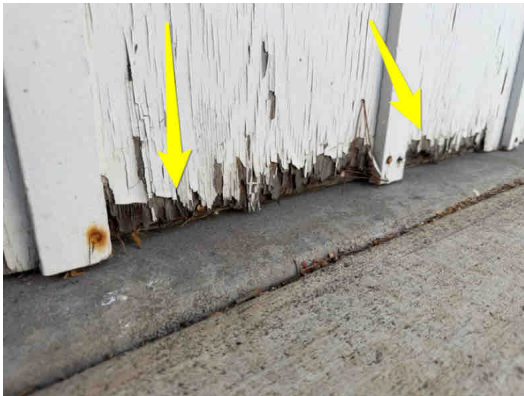
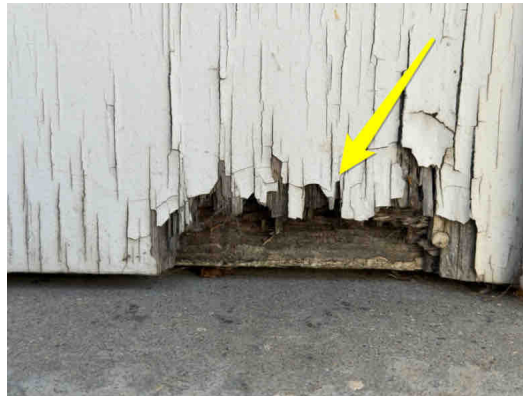
**E&C 222:** Some moisture stains & damage at garage vehicle door, door jam and/or trim. Refer to the termite report for additional comments and recommendations.

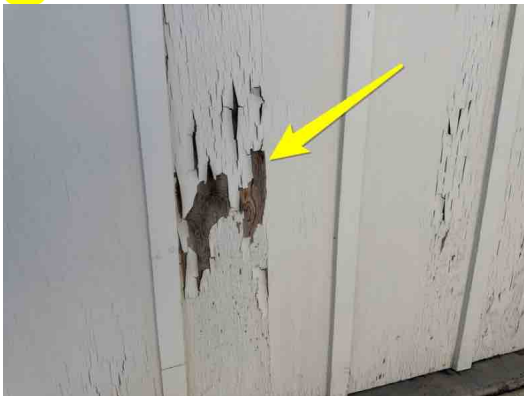
**MR 223:** Deteriorated finish at wood garage vehicle door.

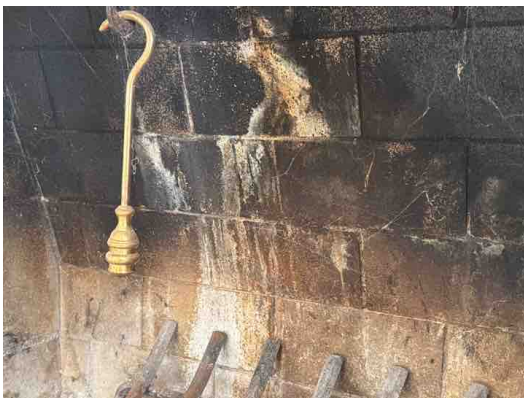
**FI 233:** Evidence of some water and or moisture intrusion with efflorescence inside the LIVING ROOM interior fireplace firebox. Maintenance or repair recommended as this is indicative of excessive amount of water getting into the fireplace chimney. This can cause rust deterioration to structural reinforcing steel and other metal components as well as caused some deterioration to the masonry bricks and blocks. Contact a qualified Fireplace and Chimney Professional.

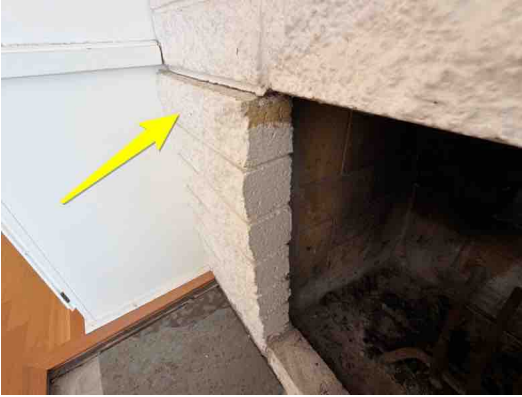
**E&C 235:** The masonry veneer at the front of the fireplace was loose and could be moved by hand. Loose masonry may continue to deteriorate or detach and may indicate inadequate bonding or attachment to the underlying fireplace assembly. Recommend repair by a qualified masonry contractor to properly secure/reconstruct the affected veneer and evaluate the surrounding masonry for similar conditions.

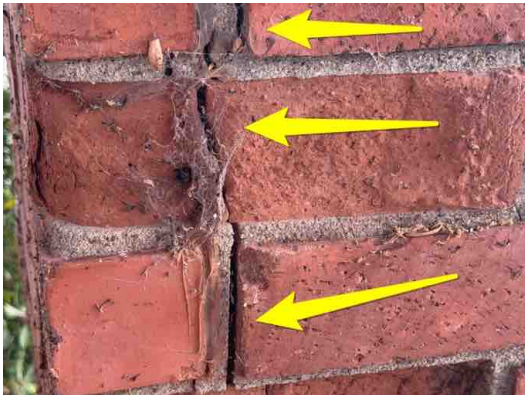
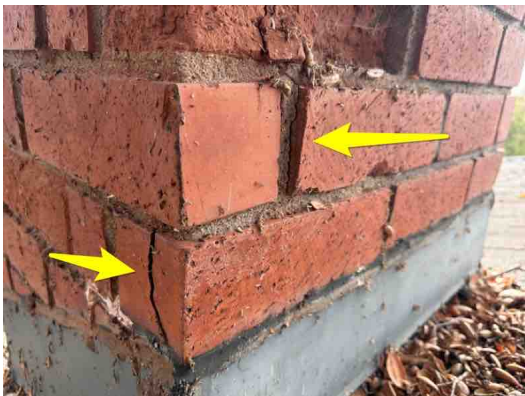
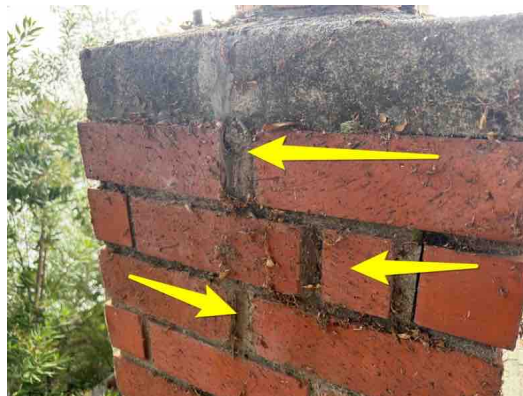
**242:** Visible cracking and separation were noted at portions of the chimney masonry, including separation through brick and mortar joints. The cause and extent of the movement cannot be determined during a visual, non-invasive inspection and may be related to movement or other underlying conditions. Recommend further evaluation by a qualified masonry contractor and repair as necessary; structural evaluation should be performed if significant movement or instability is identified.
