HEDDERMAN SERVICES

## FOUNDATION INSPECTION

8139 Silent Deep Dr  
Rosenberg, TX 77469

05/28/2026

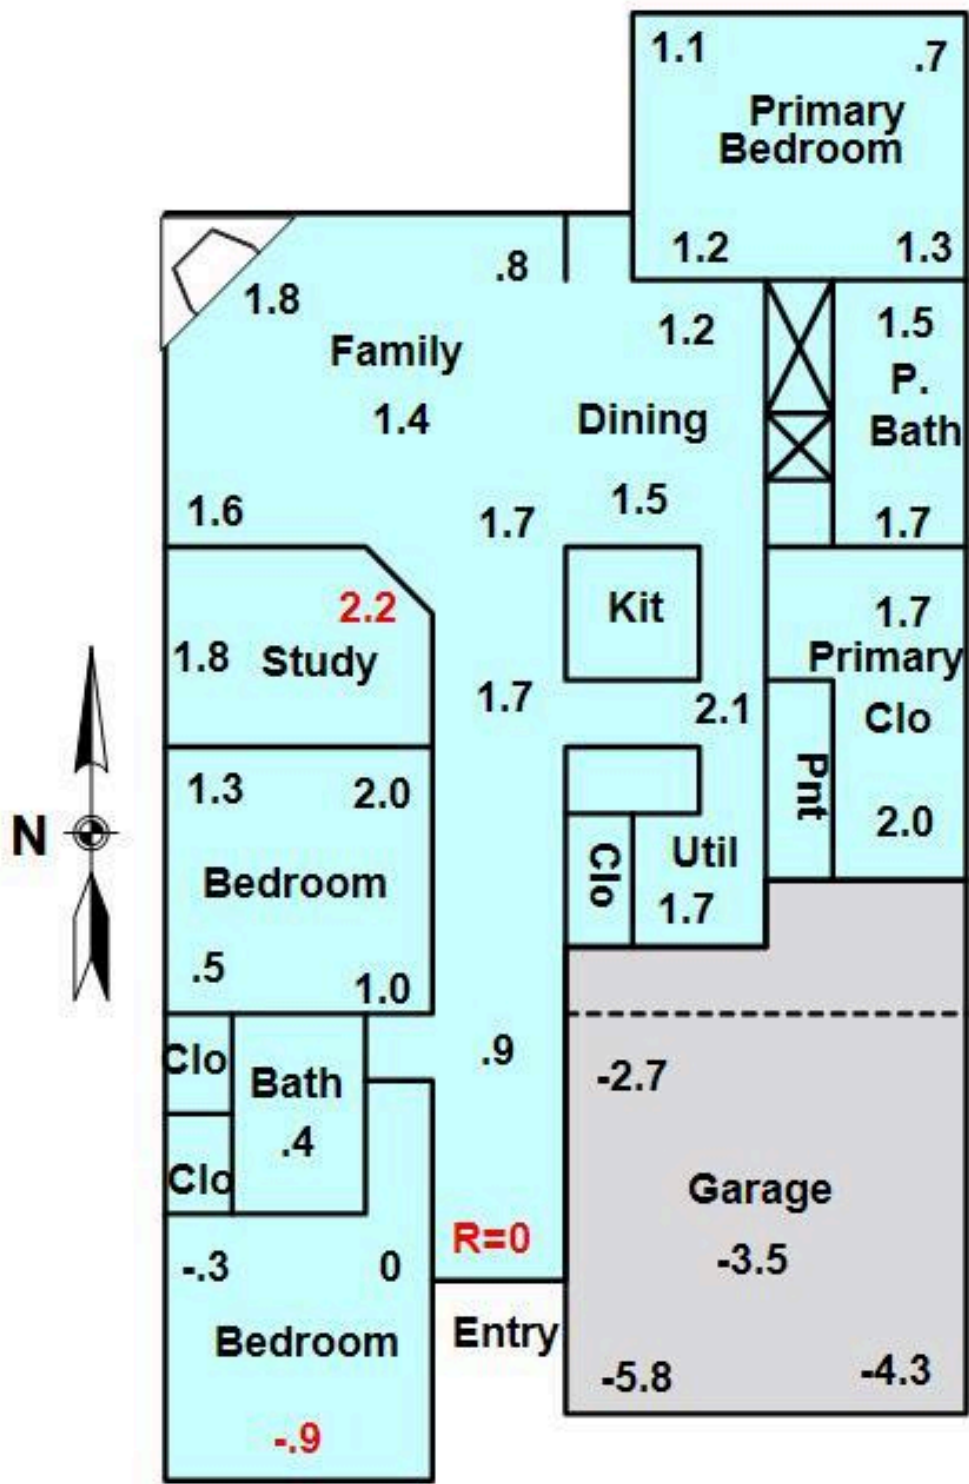
The floors were checked with an electronic level, and were observed to be sloping. The difference in elevation between the high point and low point was 3.1 inches. The high point was located at the study, and the low point was located at the front bedroom. The unlevelness takes place over a horizontal distance of approximately 40 to 45 feet.

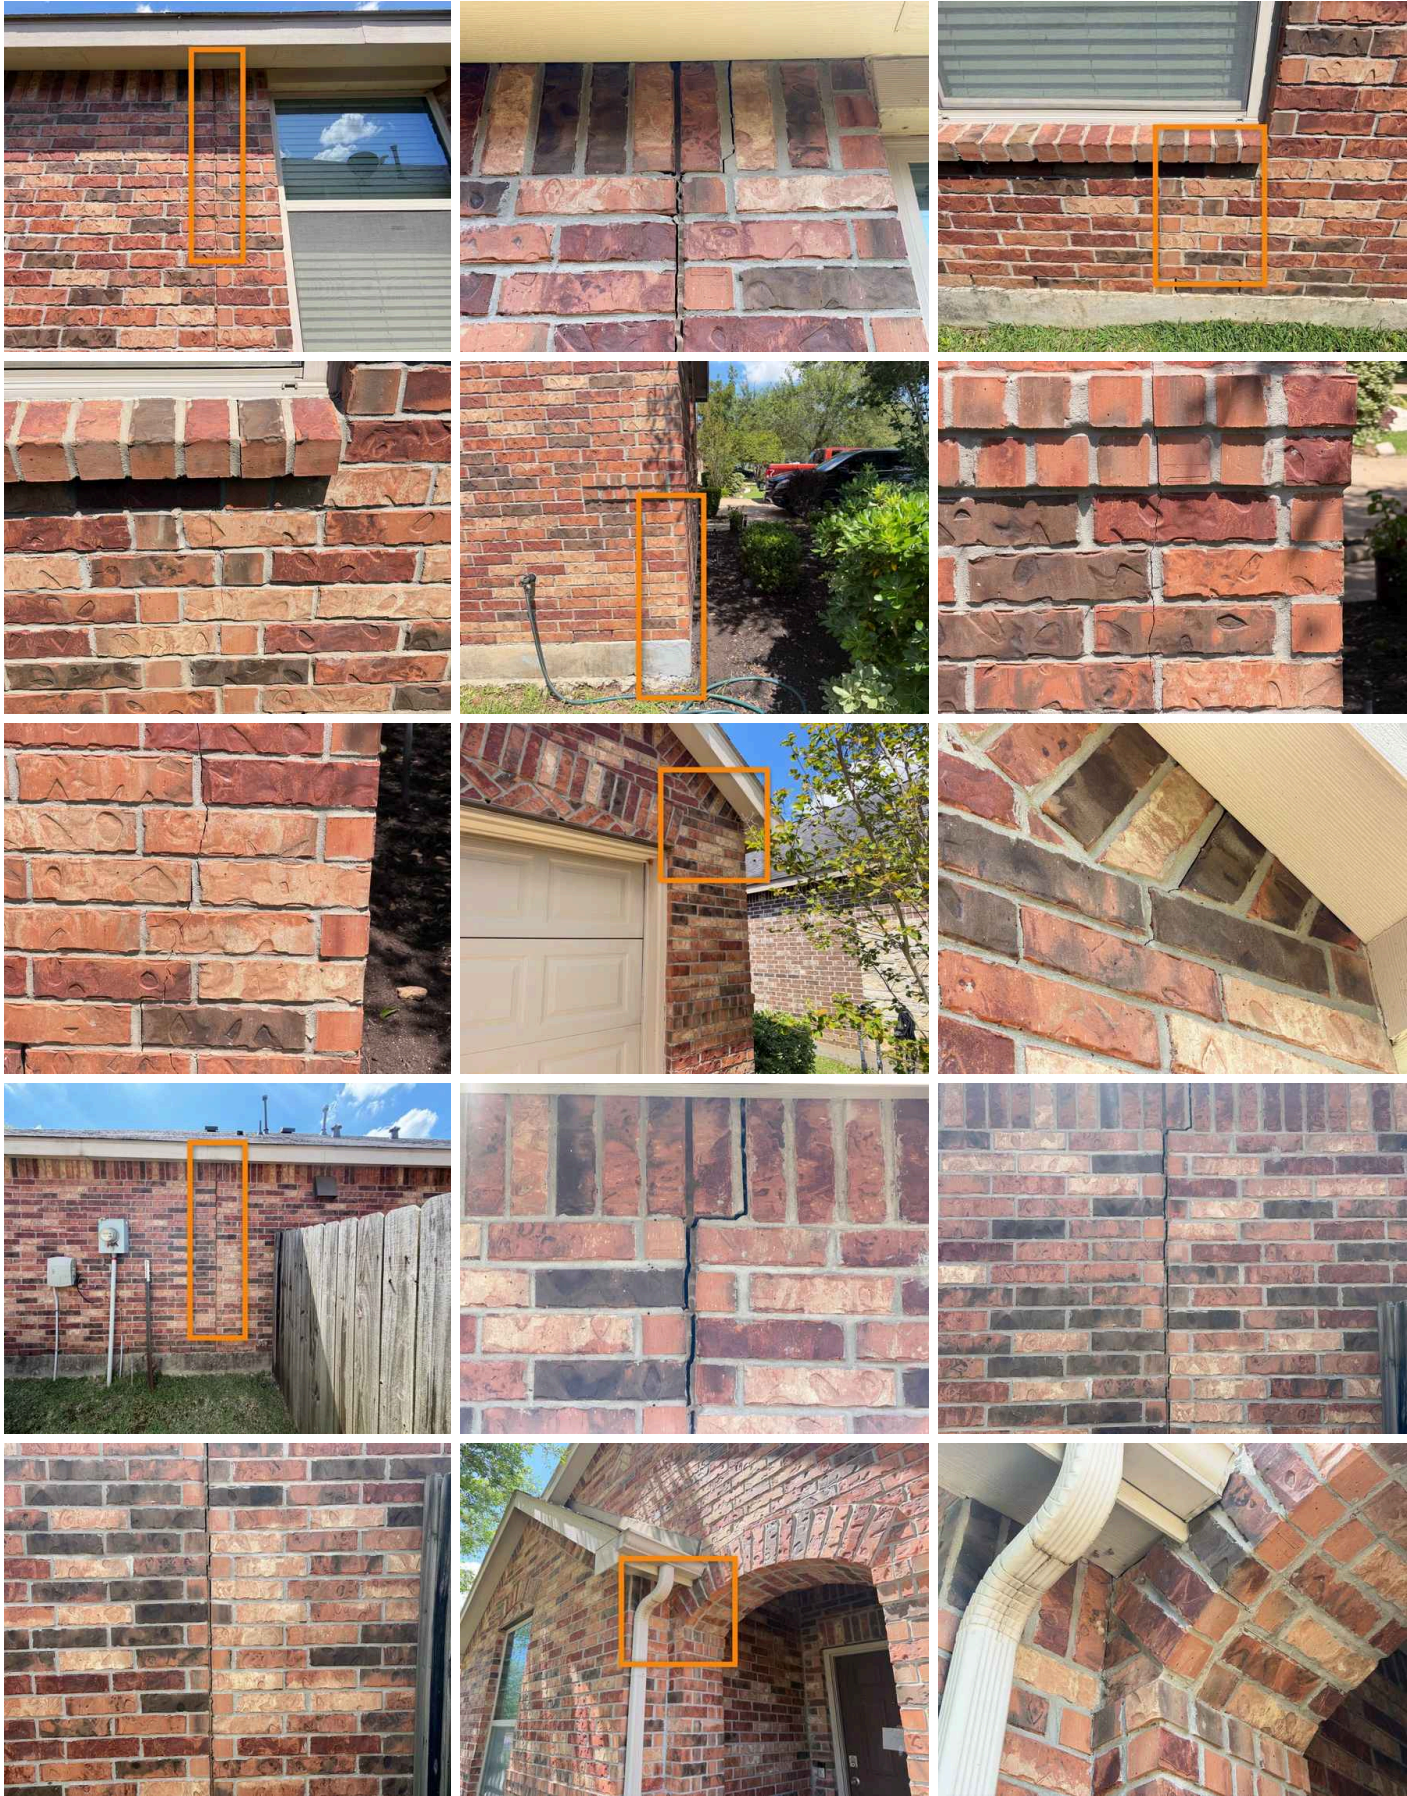
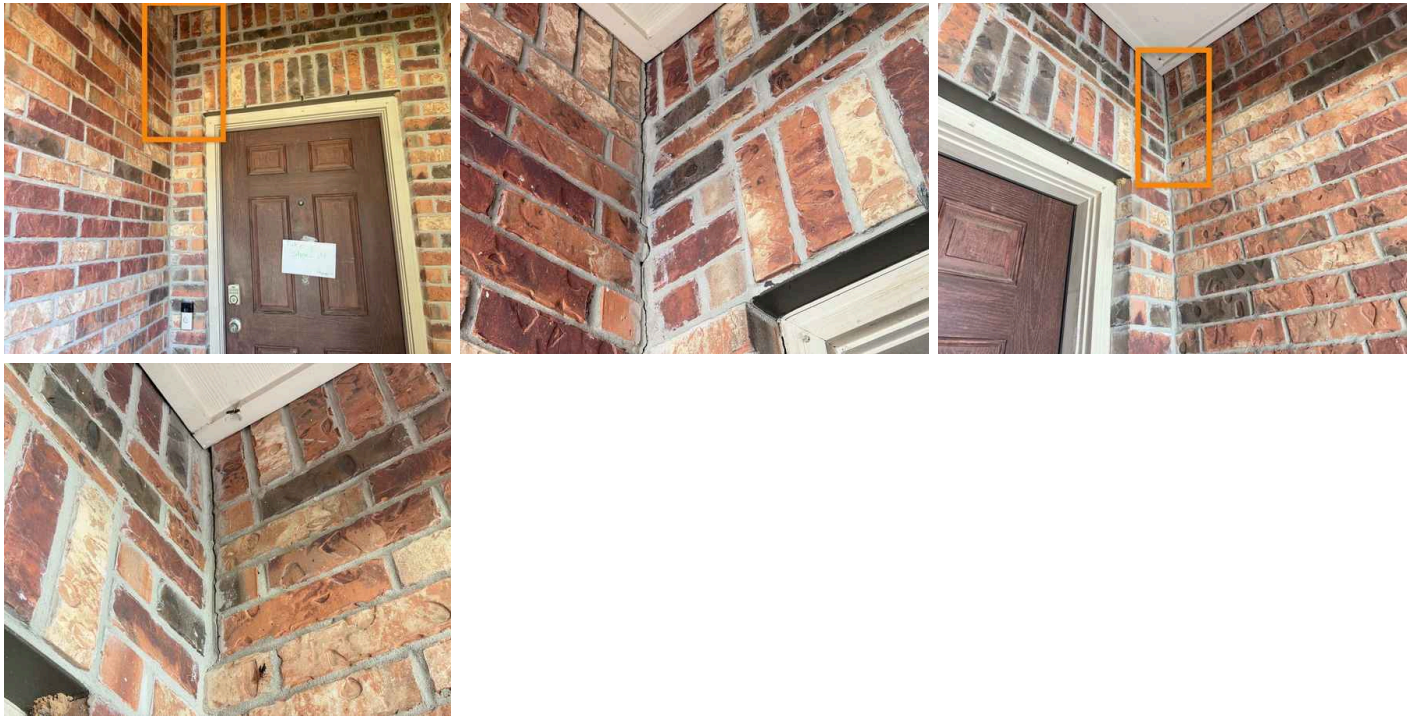
Cracks and/or patches were observed in the exterior veneer at the time of the inspection, including at the locations shown in the photos.

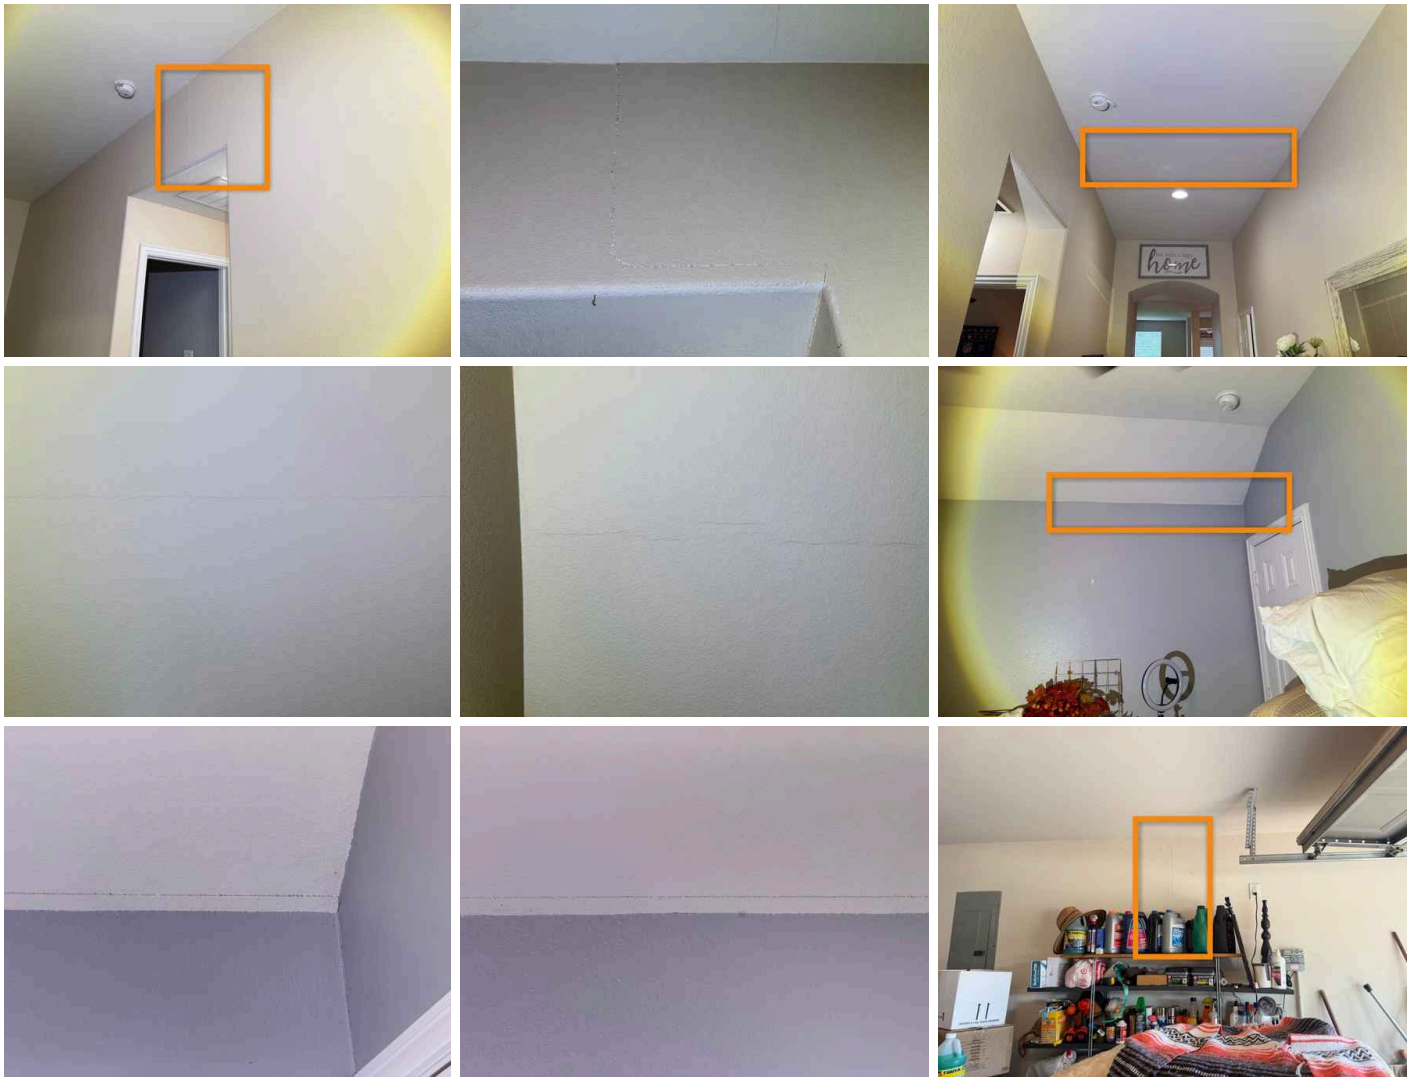
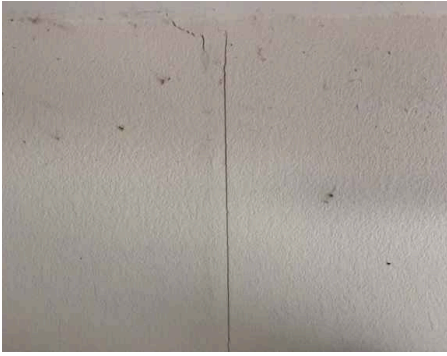
Sheetrock cracks, patches, and/or compression ridges were observed in the house during the inspection, including at the above locations.

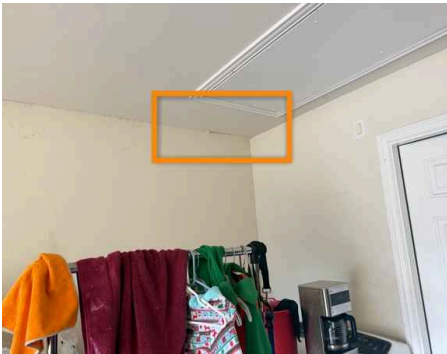
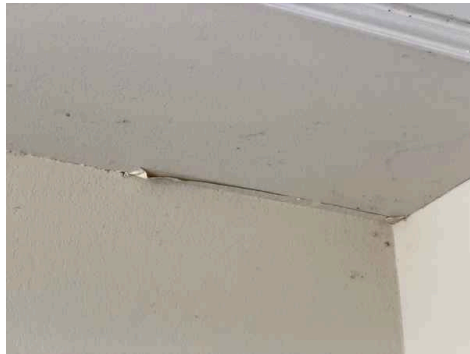
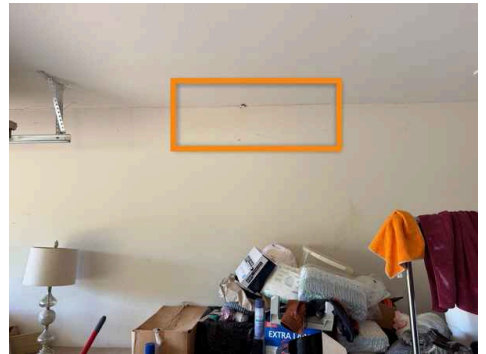
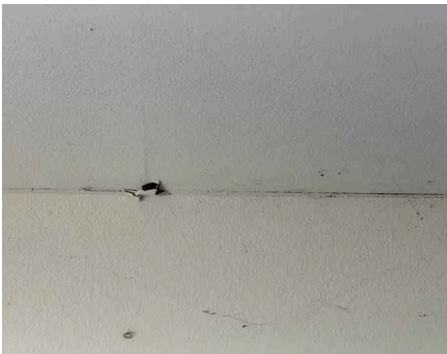
The sheetrock tape was observed to be wrinkled at some locations during the inspection including at the above locations.

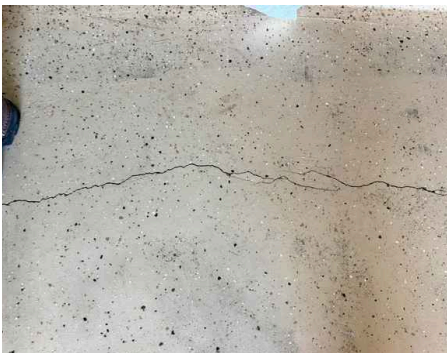
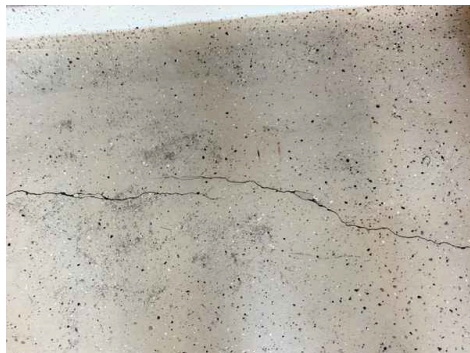
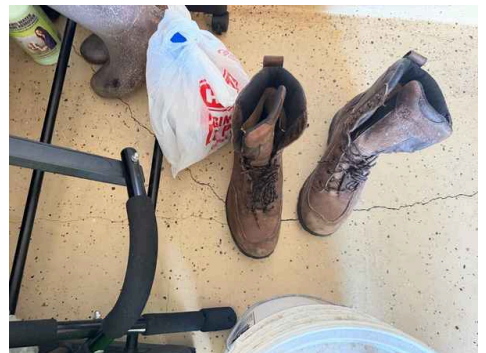
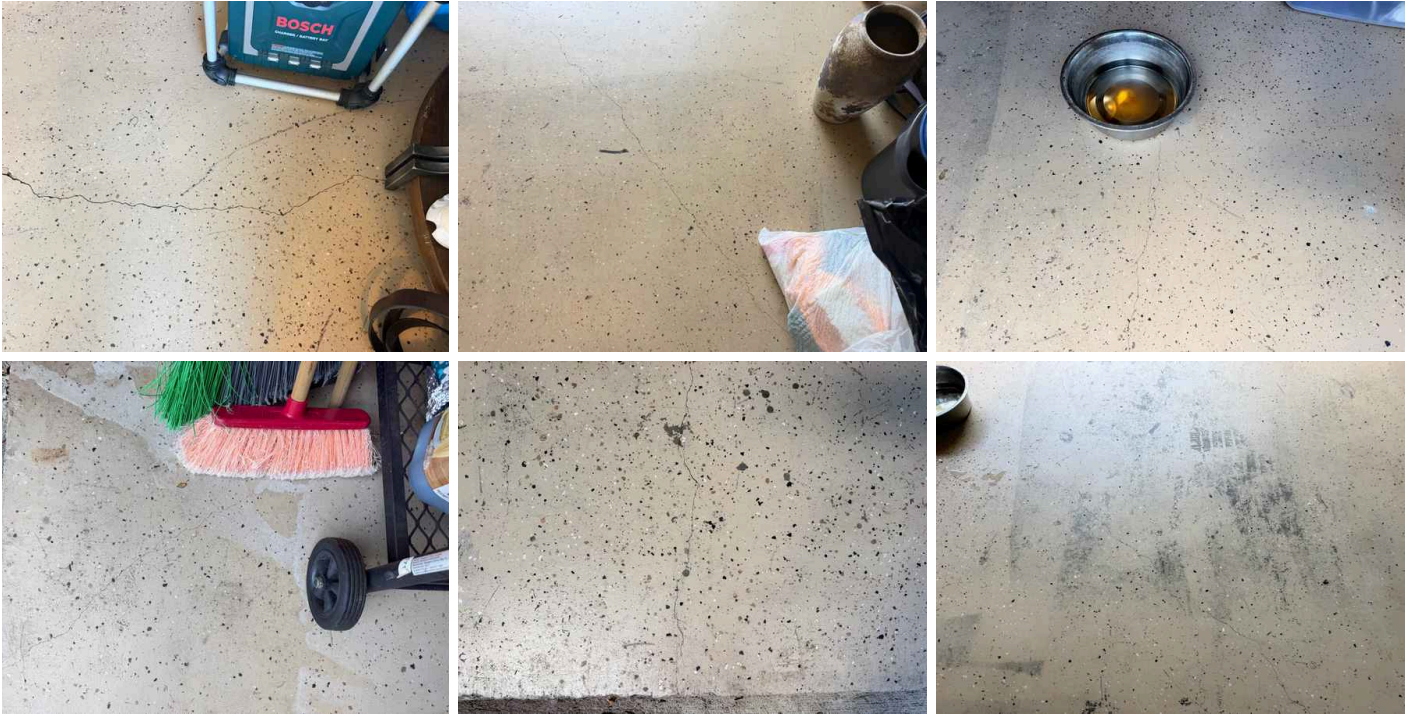
Cracking of the foundation concrete exists in virtually all foundations. It is pointed out that cracking is a normal property of concrete and other brittle materials, and Hedderman Engineering, Inc. assumes no responsibility should cracks be found that are not mentioned in this report. Some cracking was observed in this concrete foundation, including at the garage floor.

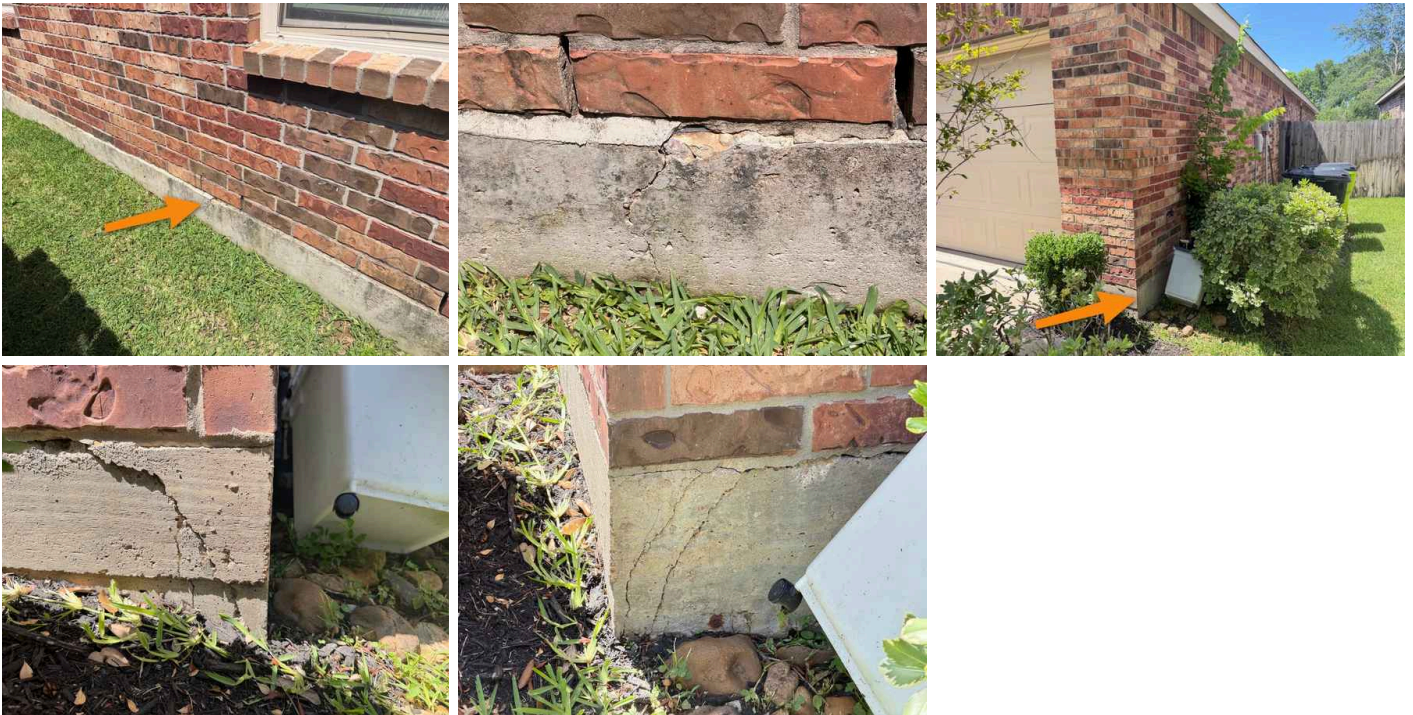
The foundation concrete was observed to have hairline cracks, including at the above locations.

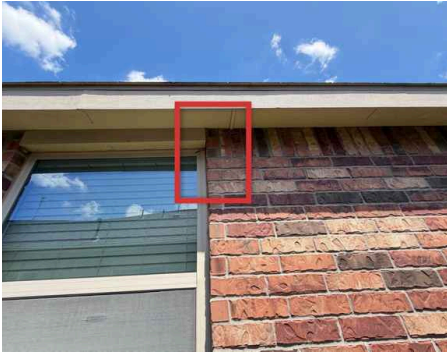
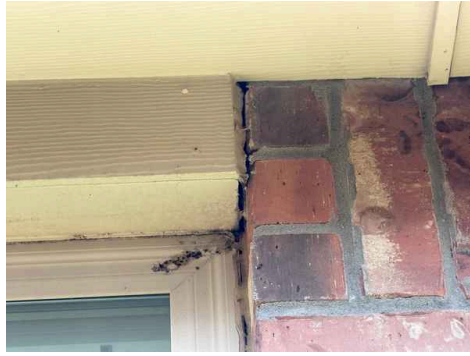
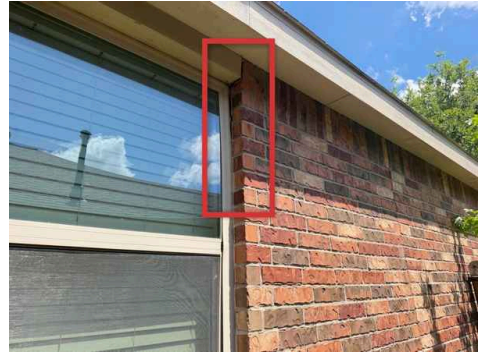
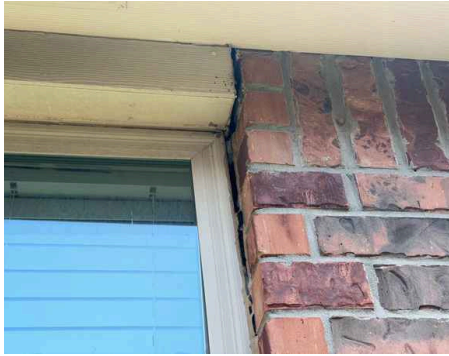
The window frame was separated from the exterior brick veneer apparently due to movement.

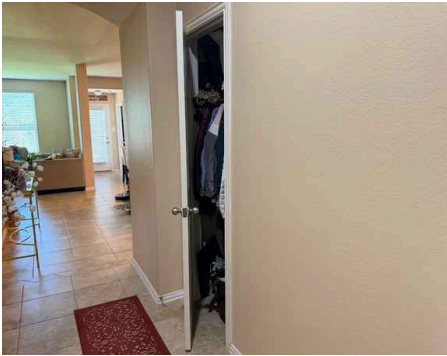
Front Closet

Doors that would not latch due to misalignment of the striker plate and the locking mechanism were observed.

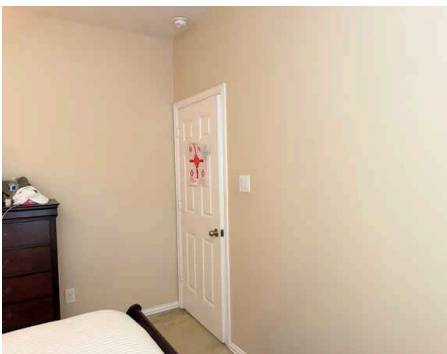
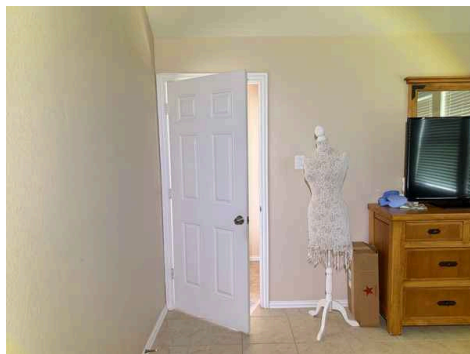
North Bedroom, Primary Bedroom

"Ghost" doors, where the door swings open and/or shut by itself due to unlevelness were observed.

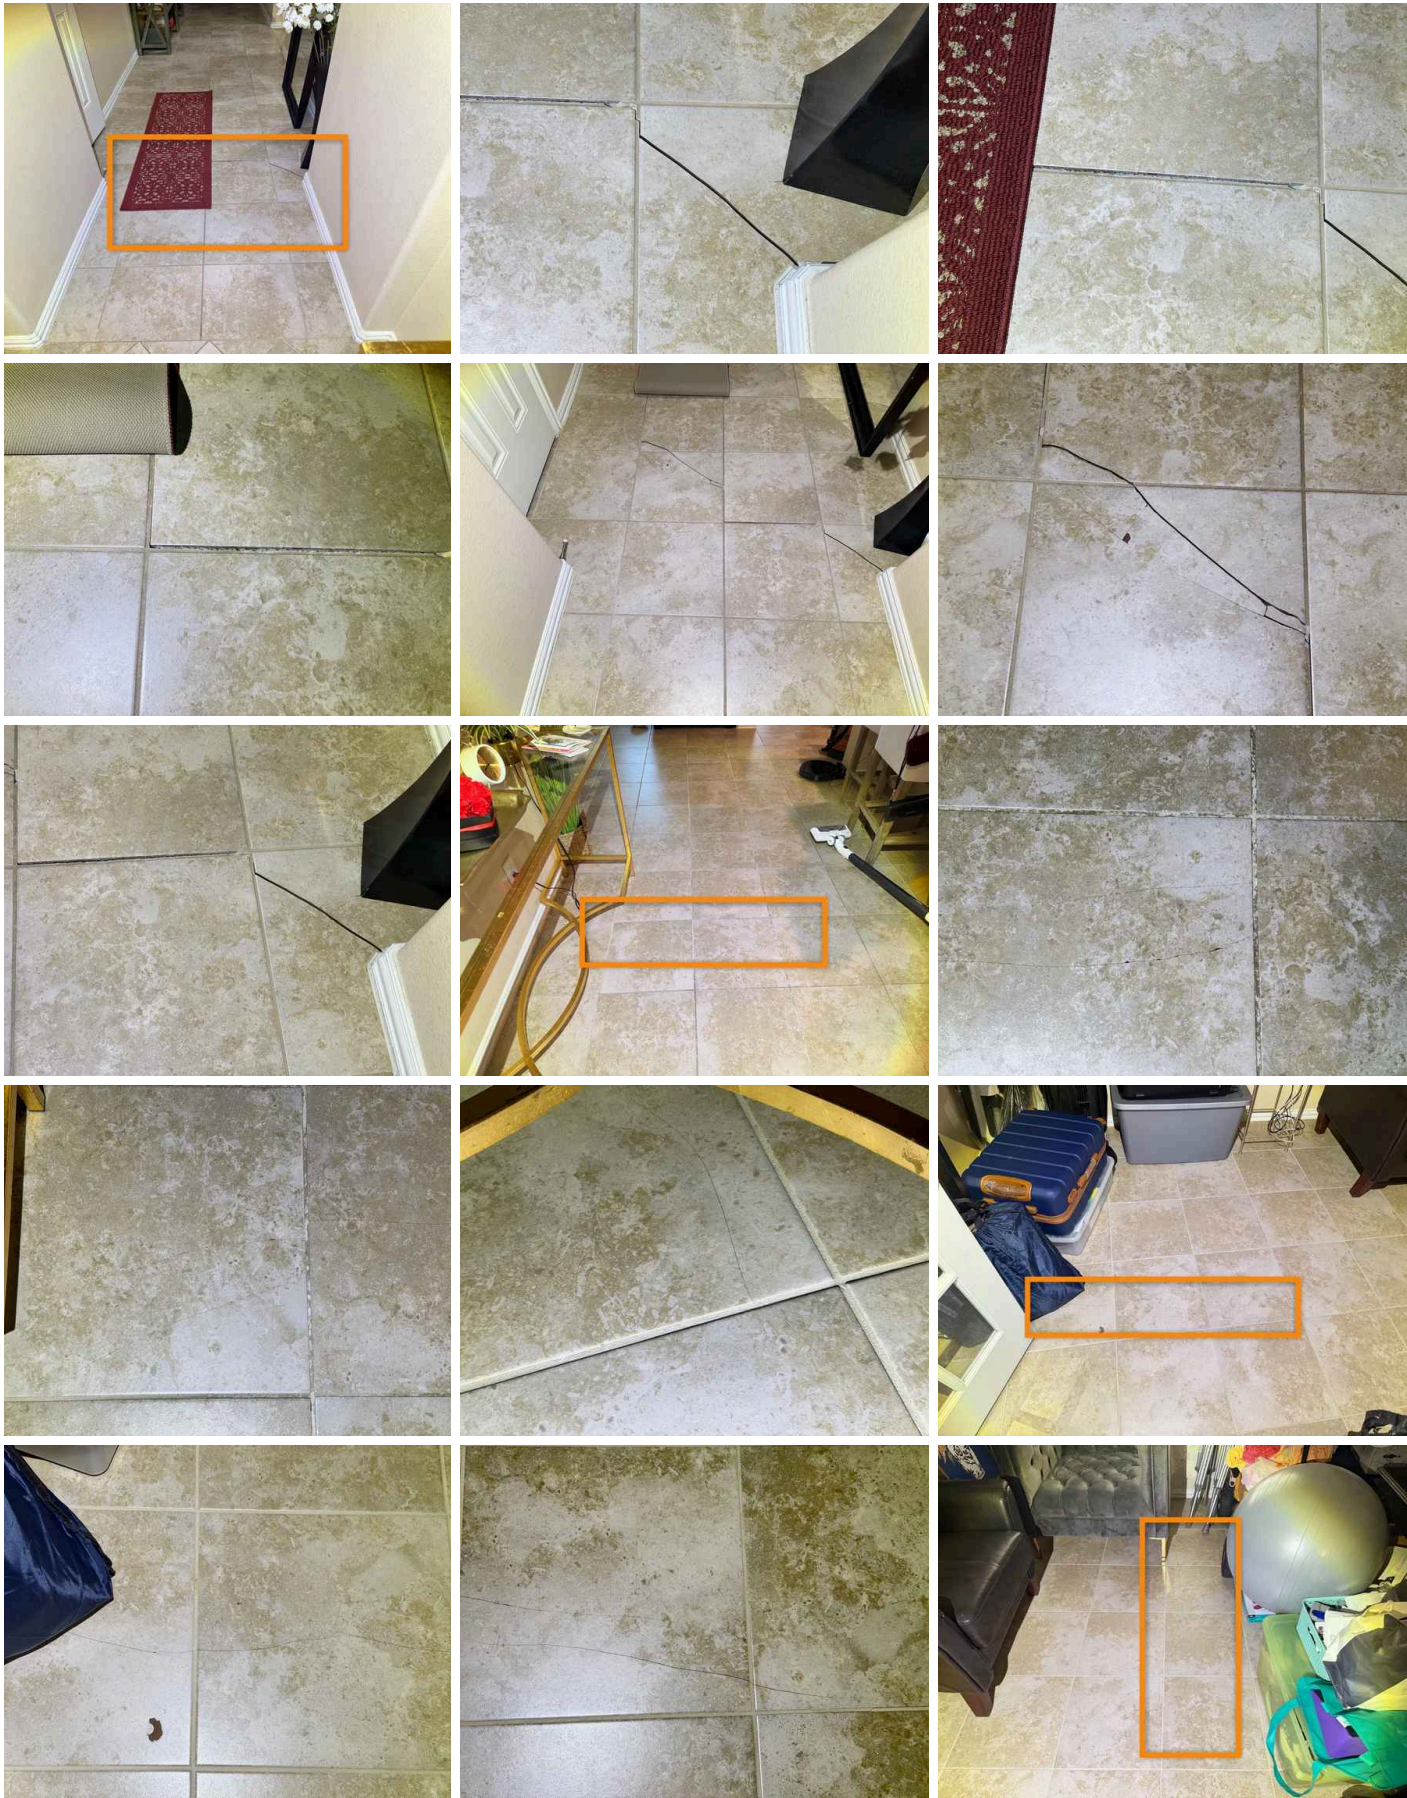
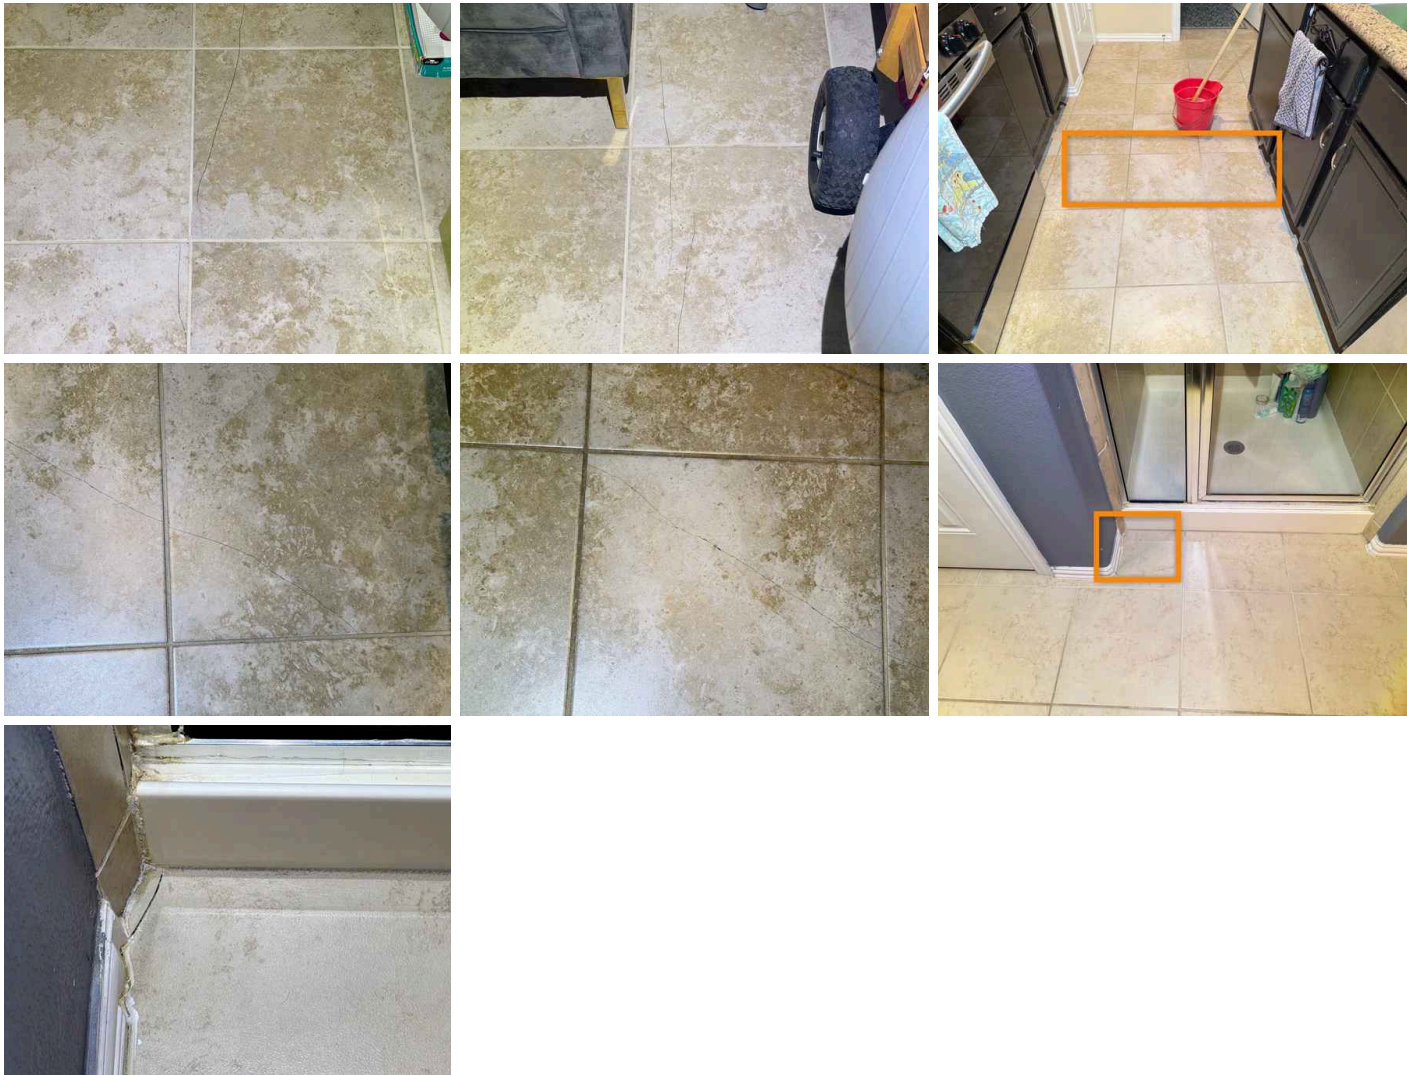
Throughout the house

We observed that the floor tile was cracked at one or more locations which can be an evidence of foundation movement.

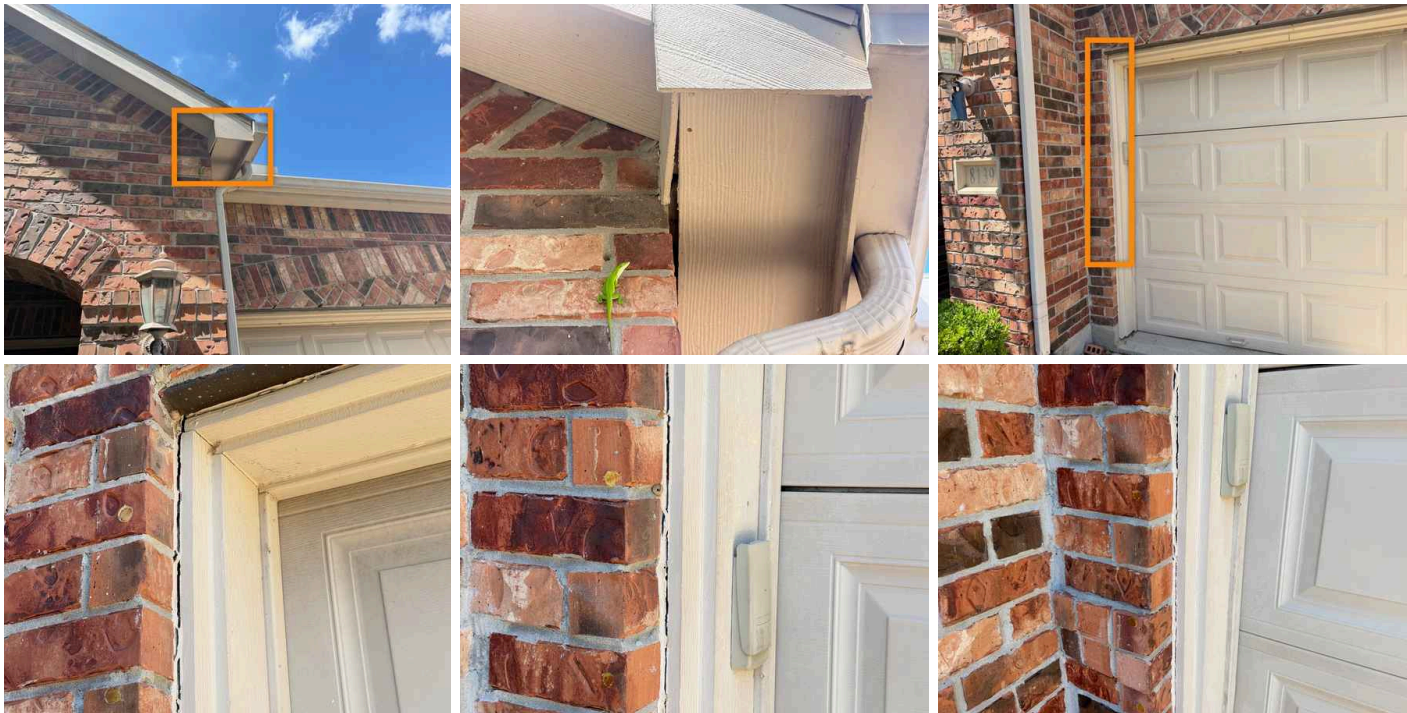
We observed separations between the veneer and siding, and the separations appear to be related to movement of the foundation.

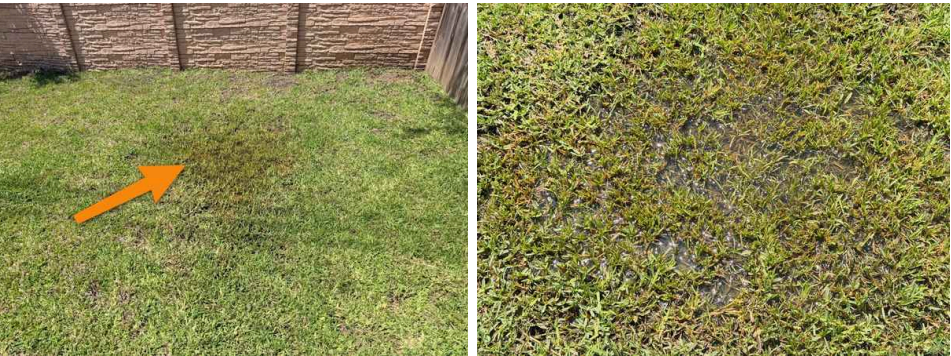
4.6.1 Perimeter Grading/Drainage

Water was observed to be ponding at some locations on the property due to the recent rains. Have a service company specializing in drainage solutions provide a solution and cost estimate to eliminate the poor drainage conditions, as poor drainage can contribute to foundation movement.

Recommendation  
Contact a qualified professional.

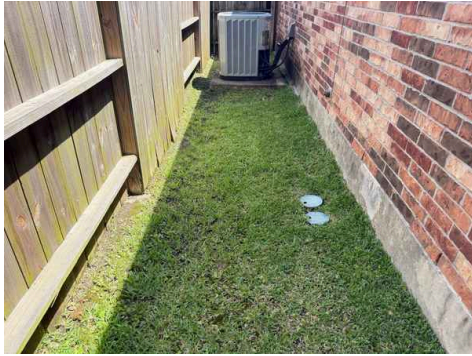
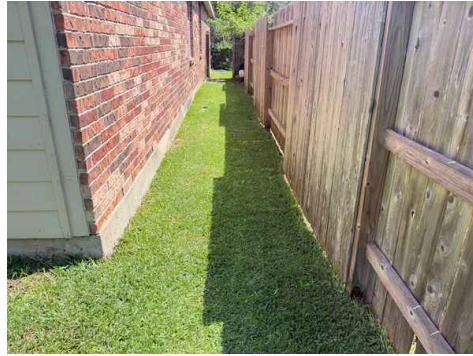
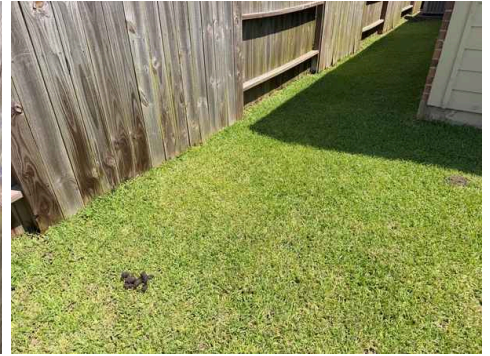
#### 4.6.2 Perimeter Grading/Drainage

The drainage was observed to be poor at some low areas where it appears that water will pond. It is recommended that a company specializing in drainage solutions be contacted to provide a recommended solution, along with a cost estimate to provide proper drainage.

Contact a qualified professional.

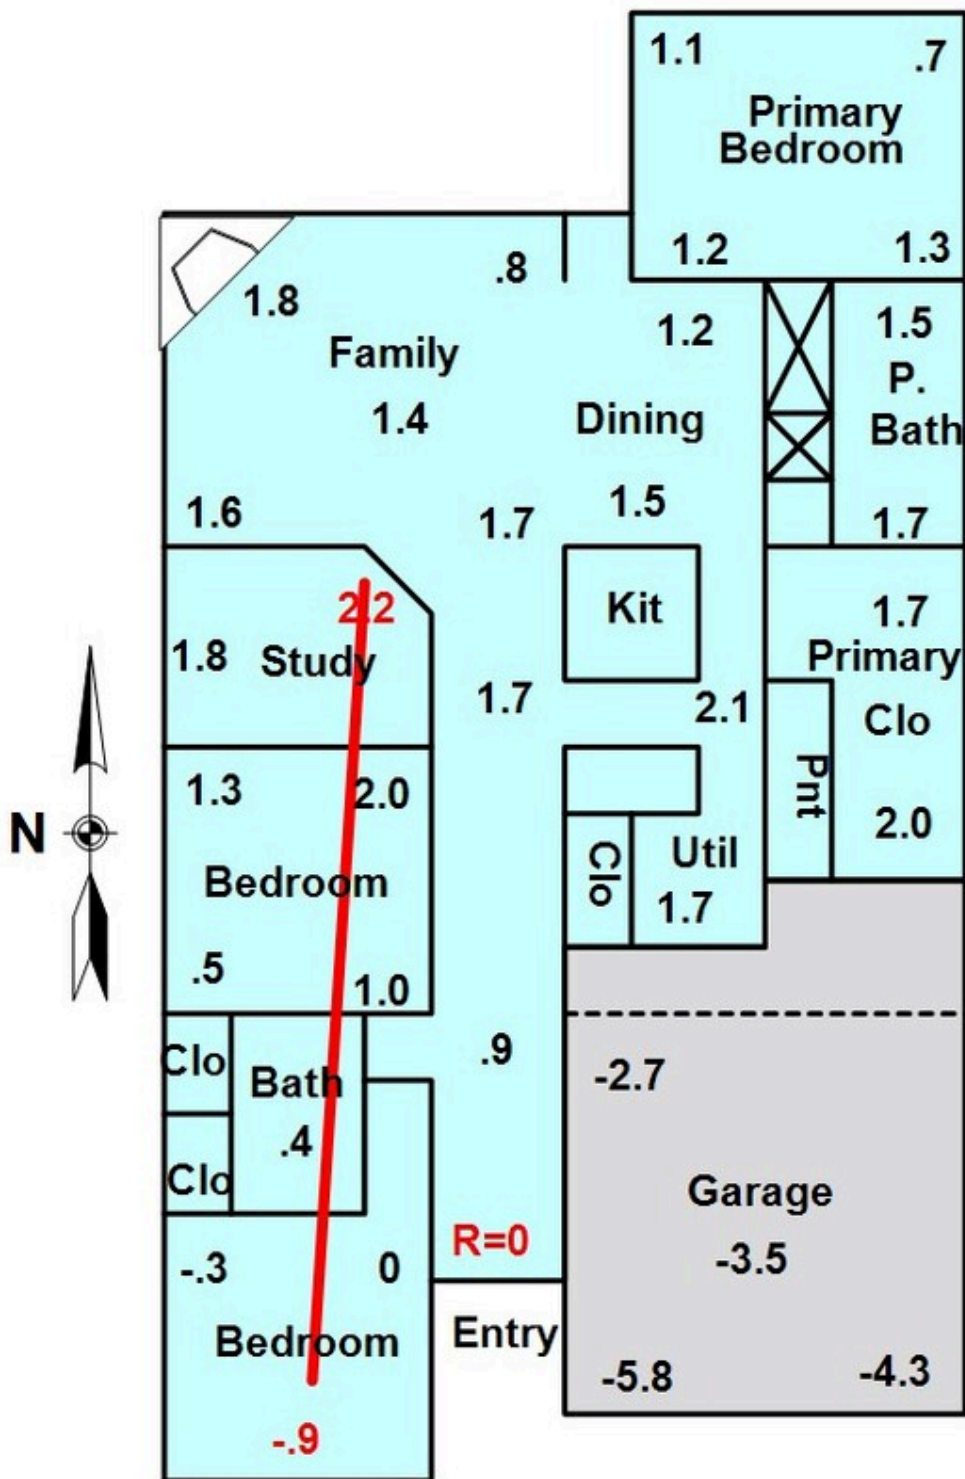
**Elevation Readings**  
**8139 Silent Deep Drive**  
**(Not to Scale)**

From the point of curvature located at the west bedroom to the south bedroom ( $L = 30$  feet), the maximum allowable deflection is 2.00 inches. We calculated a deflection of 2.23 inches at the time of inspection across this span, which is **greater than the maximum allowable deflection**. This observation can be observed along the **Red Line** in the sketch below.

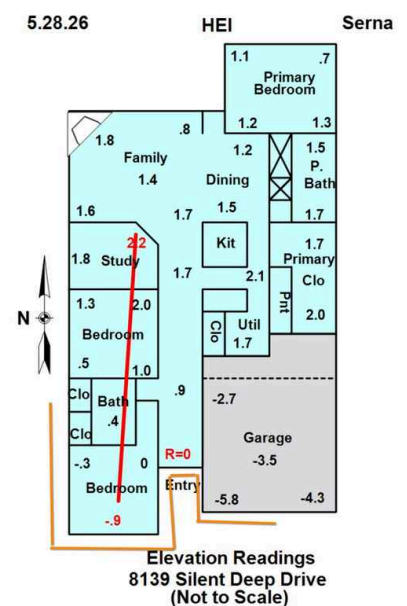
Most of the structures previously inspected by this firm have experienced some degree of differential foundation movement, and this structure was no exception. After careful examination, the engineering analysis above showed that the degree of the foundation movement is more than what is acceptable by the standards set forth by the American Society of Civil Engineers. The most significant movement was located at the south.

Approximate area in need of repair.

Due to the more than acceptable amount of movement of the foundation of this structure, the foundation needs to be releveled. It is recommended that at least three foundation repair contractors be contacted in order that they may make their own assessment of the scope and cost of the work needed to bring this foundation back to an acceptable degree of levelness. Each foundation repair contractor should provide their own design proposal showing the types of piers to be used to underpin the foundation, the number of piers, and the pier locations, along with their warranty information. Note that HEI does not prepare or approve foundation repair designs due to a multitude of potential engineering, legal, and/or ethical issues.
