### FOUNDATION INSPECTION

8139 Silent Deep Dr  
Rosenberg, TX 77469

Heri Serna  
05/28/2026

## 5: FOUNDATION ANALYSIS

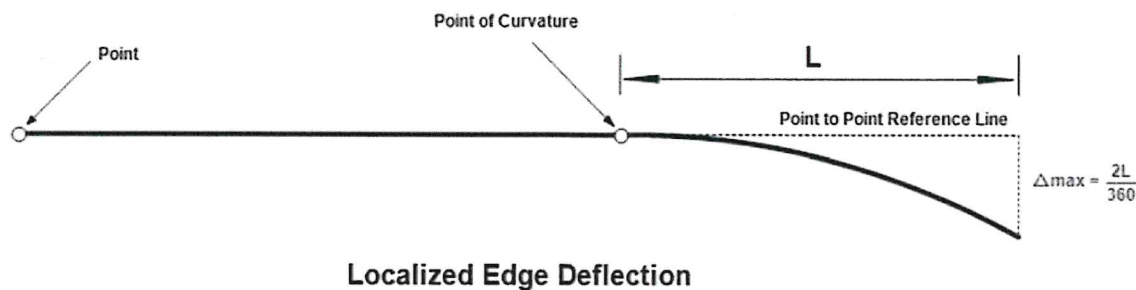
According to the ASCE Guidelines, the evaluation of localized localized edge-condition deflections shall be evaluated as a cantilevered member (allowable deflection = one inch deflection in a 15-foot horizontal distance ( $2L/\Delta = 360$  per the building code)).

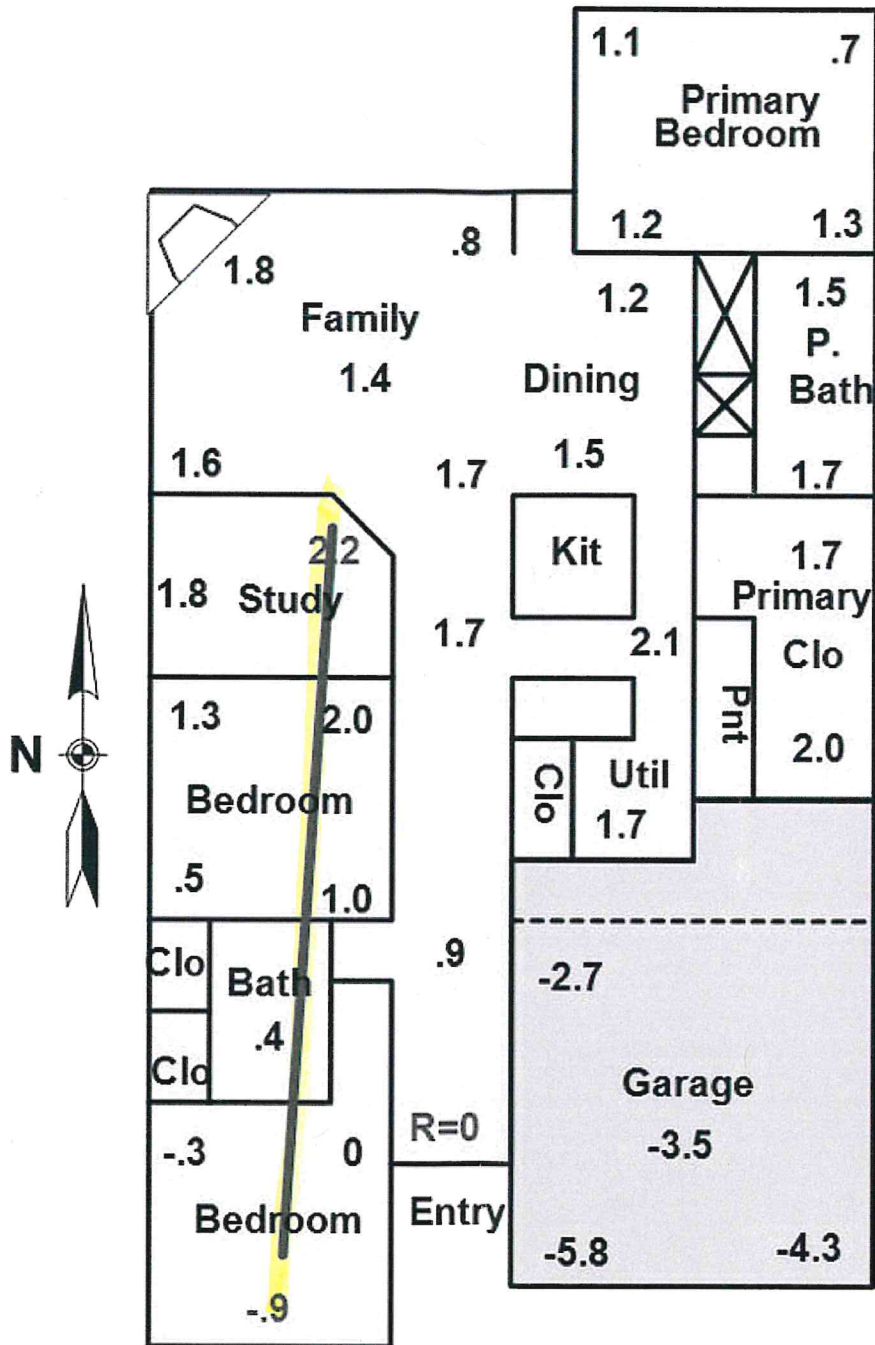
From the point of curvature located at the west bedroom to the south bedroom ( $L = 30$  feet), the maximum allowable deflection is 2.00 inches. We calculated a deflection of 2.23 inches at the time of inspection across this span, which is **greater than the maximum allowable deflection**. This observation can be observed along the Red Line in the sketch below.

Most of the structures previously inspected by this firm have experienced some degree of differential foundation movement, and this structure was no exception. After careful examination, the engineering analysis above showed that the degree of the foundation movement **is more than what is acceptable by the standards set forth by the American Society of Civil Engineers**. The most significant movement was located at the south.

Due to the more than acceptable amount of movement of the foundation of this structure, **the foundation needs to be releveled**. It is recommended that at least **three foundation repair contractors** be contacted in order that they may make their own assessment of the scope and cost of the work needed to bring this foundation back to an acceptable degree of levelness. Each foundation repair contractor should provide their own design proposal showing the types of piers to be used to underpin the foundation, the number of piers, and the pier locations, along with their warranty information. Note that HEI does not prepare or approve foundation repair designs due to a multitude of potential engineering, legal, and/or ethical issues.

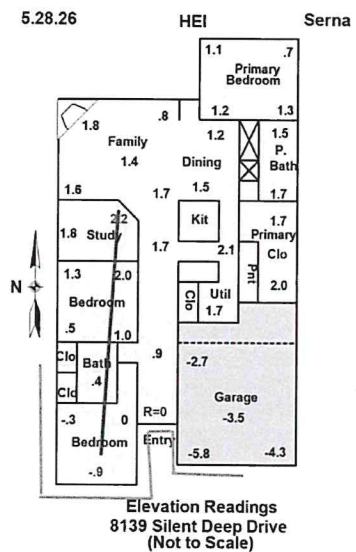
Approximate area in need of repair.

Contact a foundation contractor.
