## PROPERTY INSPECTION REPORT FORM

| 4102 Avenue M 1/2 , Galveston, TX 77550 | |

DATE OF INSPECTION: 01/19/2023

Inspection No. 521350-1345

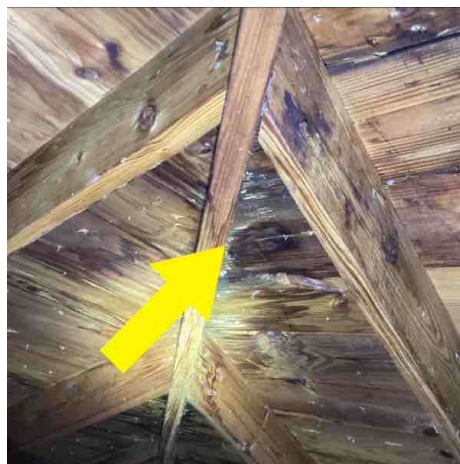
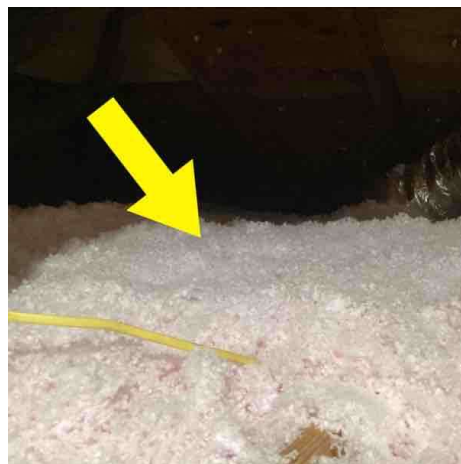
☒ ☐ ☐ ☒**D. Roof Structures and Attics***Comments:*

- Attic was entered for inspection
- Insulation was approximately 8-10 inches thick at time of inspection (blown in fiber type insulation).
- There were multiple areas where sheathing was showing staining. Possibly due to prevent roof leaks. No moisture was detected at time of inspection.

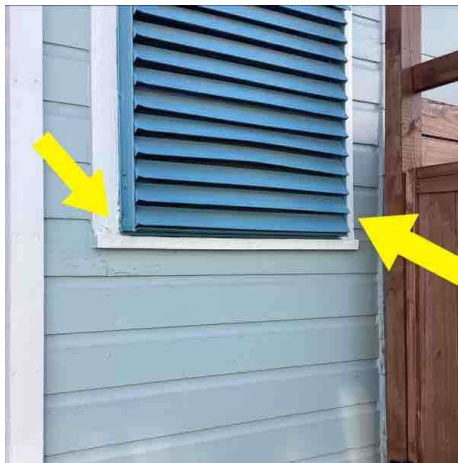
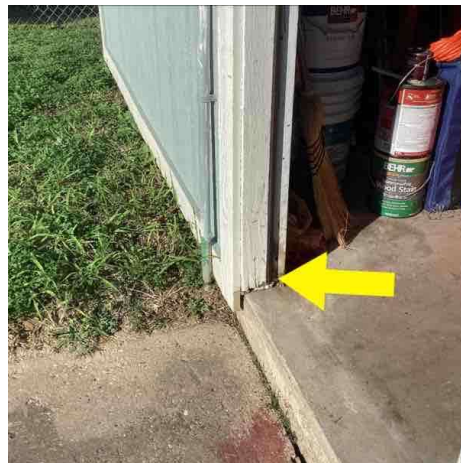
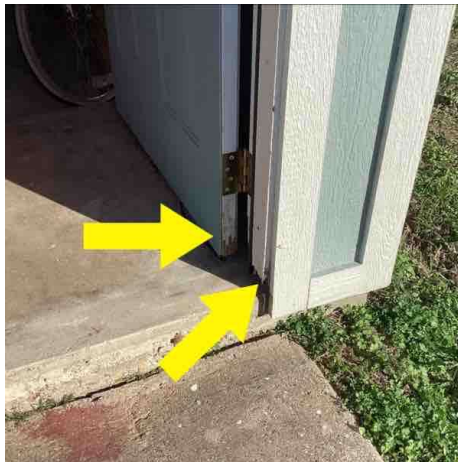
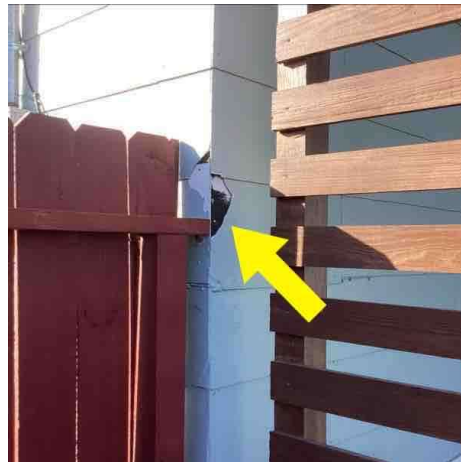
**I = Inspected****NI = Not Inspected****NP = Not Present****D = Deficient****I NI NP D\***☒ ☐ ☐ ☒**E. Walls (Interior and Exterior)***Comments:*

- Cement board and wood siding with wood trim (exterior) Drywall with wood trim (interior). Wood siding and trim (garage).
- There was minor wood rot noted at left side back window trim. Recommend repairs/replacement as needed to prevent further deterioration and damages.
- There was moderate wood rot noted at garage entry door frame and door. Recommend having qualified contractor evaluate and repair or replace as needed to prevent further deterioration and damages.
- There was damaged siding noted at back right corner of the home. Recommend repairs as needed to prevent possible water penetration and further damages.

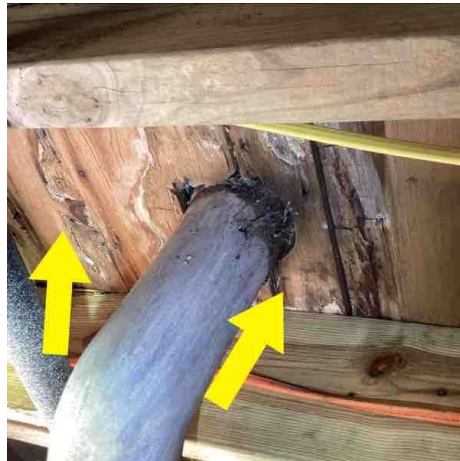
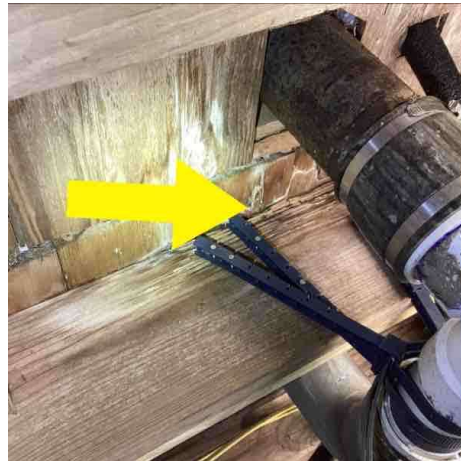
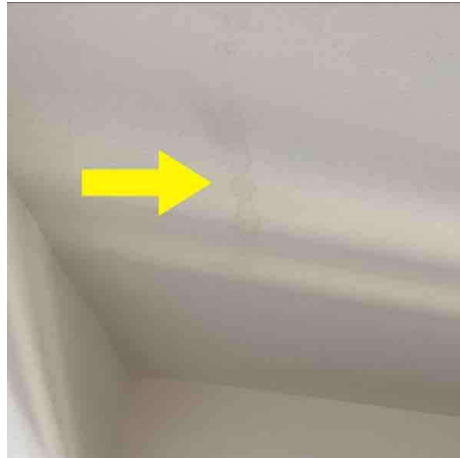
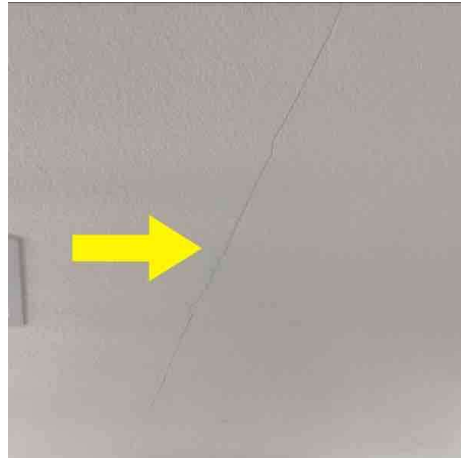
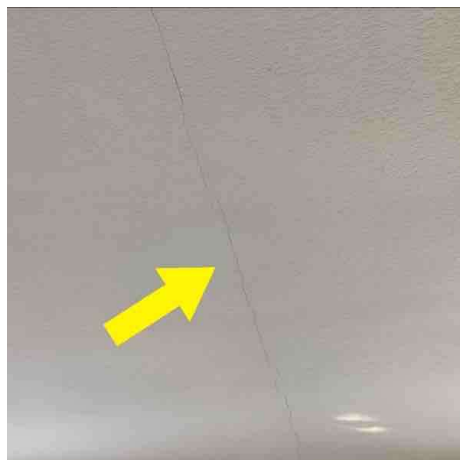
**F. Ceilings and Floors***Comments:*

- There were signs of previous water leaks under bathroom with minor wood rot/deterioration noted. Recommend having qualified contractor evaluate and repair as needed to prevent further deterioration and damages.
- There was staining noted ceiling in laundry room area(previous roof leak). No moisture was detected at time of inspection.
- There we're stress moderate cracks noted at ceiling in kitchen and living areas (possibly due to recent leveling work).

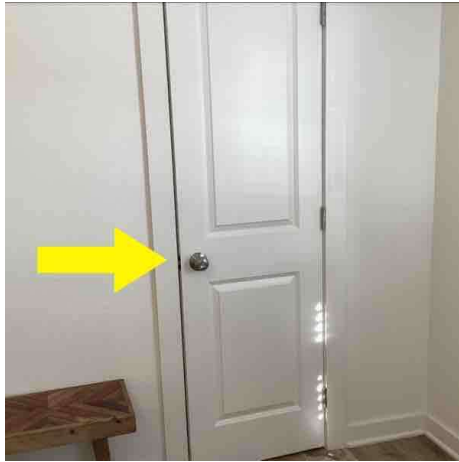
**I = Inspected****NI = Not Inspected****NP = Not Present****D = Deficient****I NI NP D\***☒ ☐ ☐ ☒**G. Doors (Interior and Exterior)***Comments:*

- Front bedroom closet door was not latching at time of inspection. Recommend repairs/adjustments as needed for proper latching.

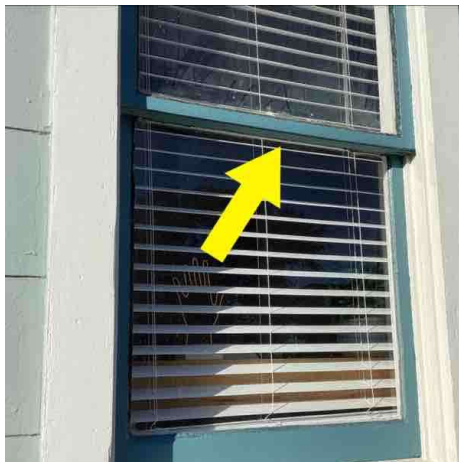
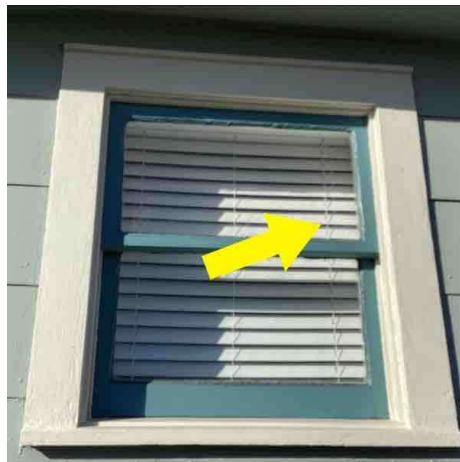
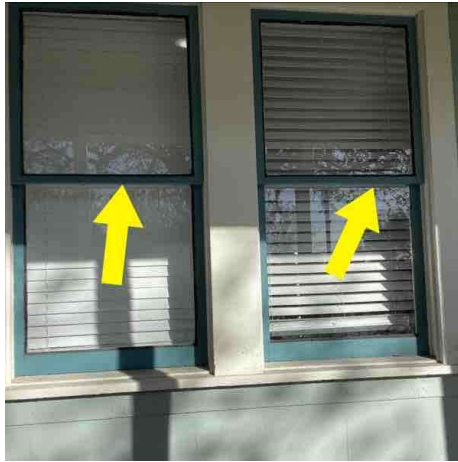
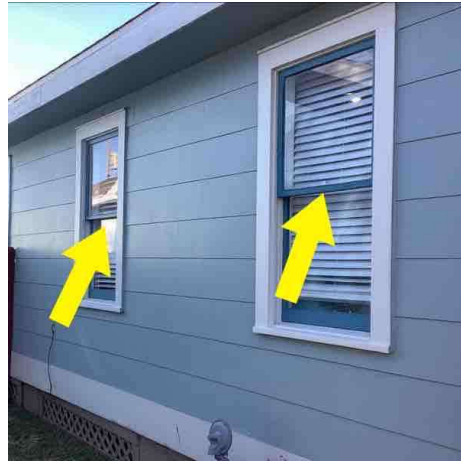
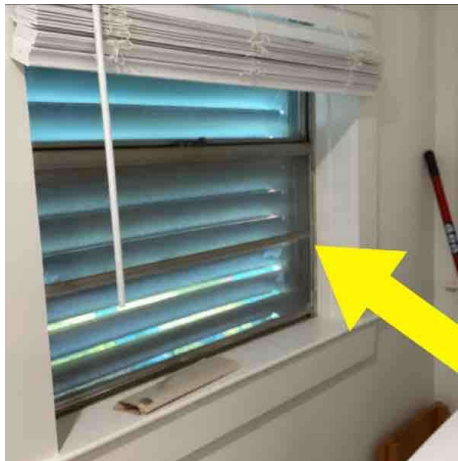
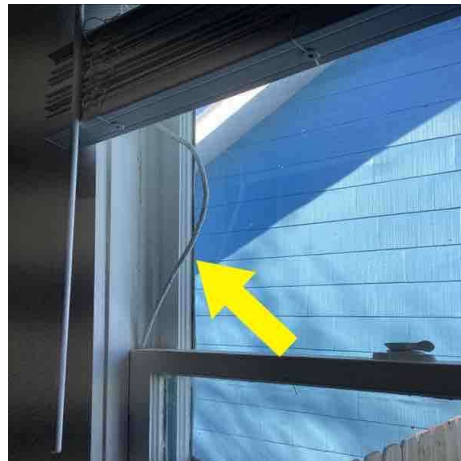
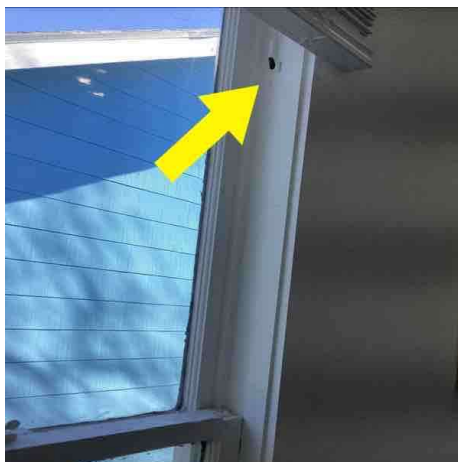
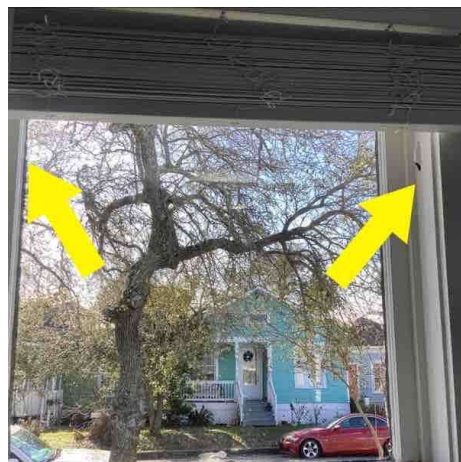
☒ ☐ ☐ ☒**H. Windows***Comments:*

- Windows were noted as being old and in various states of repair. Multiple windows were noted as being painted shut/damaged or missing opening hardware/not staying in the open position when opened. Recommend having qualified contractor evaluate and repair or replace as needed for proper operation and emergency egress.
- Bathroom window was noted as having a cracked glass. Recommend replacement glass to prevent possible water penetration and further damages.
- Multiple windows were noted as having damaged or missing window glazing. Recommend reglazing as needed to prevent possible water penetration and further damages.

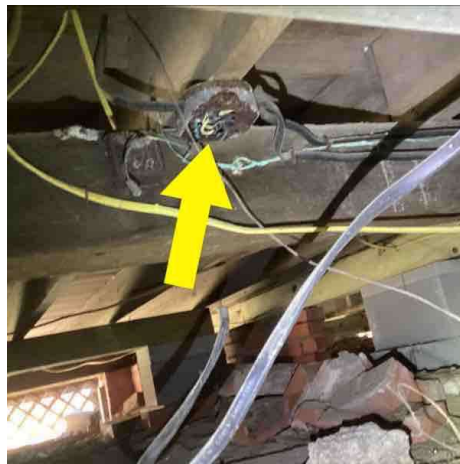
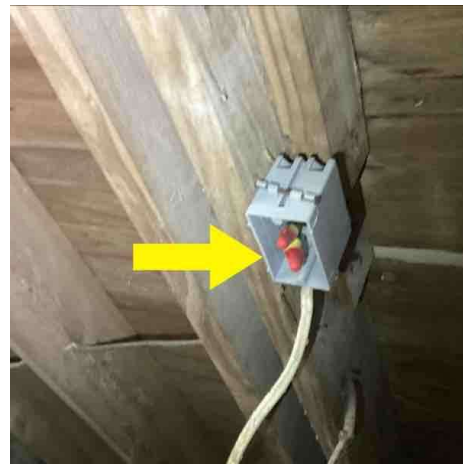
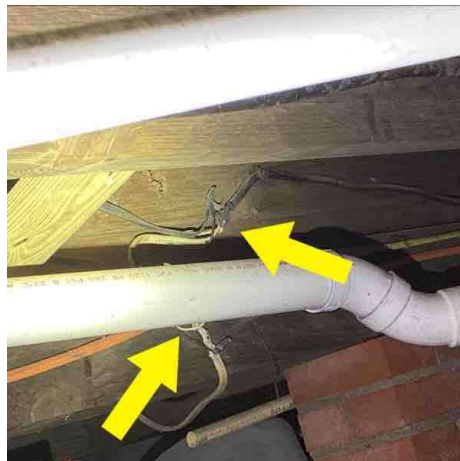
**I = Inspected****NI = Not Inspected****NP = Not Present****D = Deficient****I NI NP D\***☒ ☐ ☐ ☒**B. Branch Circuits, Connected Devices, and Fixtures***Comments:*

- All wiring appears to be copper and in good condition.
- Smoke detectors responded normally to function testing. Smoke detectors are required in all sleeping rooms in areas just outside of sleeping rooms and in the living areas of each floor. Recommend installing smoke detector in hallway as required for safety.
- Recommend installing carbon monoxide detectors for added safety.
- There we're two open junction boxes noted under the home. Recommend installing cover plates as needed for intended protection and safety.
- There we're two open wire splices noted under the home. Wire splices should be made in closed junction boxes. Recommend having licensed electrician evaluate and repair as needed for intended protection and safety.

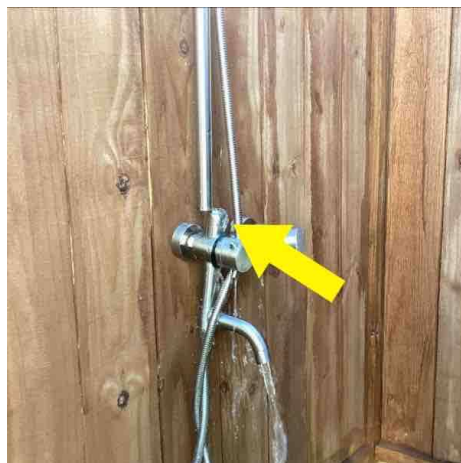
#### A. Plumbing Supply, Distribution Systems and Fixtures

- Water meter was not located at time of inspection. Recommend asking seller for location.
- Main water cut off is located under the home.
- Static water pressure was 50 psi. at time of inspection. Normal water pressures should be between 40 and 80 psi.
- Plumbing supply lines appeared to be of PEX piping.
- Water line at outdoor shower was noted as being damaged. Recommend repairs or replacement as needed for proper operation.

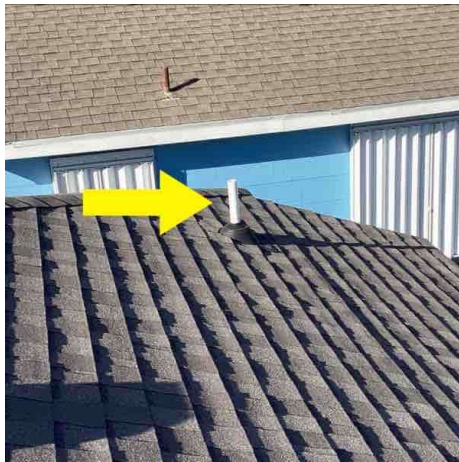
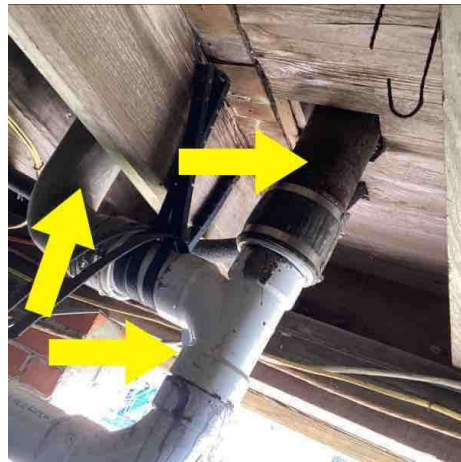
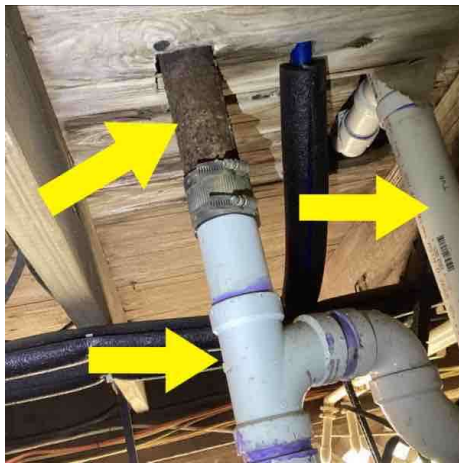
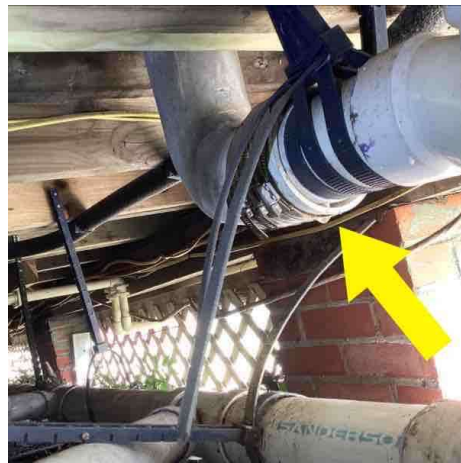
**I = Inspected****NI = Not Inspected****NP = Not Present****D = Deficient****I NI NP D\***☒ ☐ ☐ ☒**B. Drains, Wastes, and Vents***Comments:*

- Drain lines appeared to be of PVC and cast iron piping.
- Recommend having licensed plumber evaluate condition of cast iron piping and replace as needed.
- There was water noted to be dripping at drain line connection under the home. Recommend having licensed plumber evaluate and repair as needed to prevent further leakage.
- Plastic plumbing vent was noted as missing the required paint or covers at rooftop (to protect from ultraviolet deterioration). Recommend painting for intended protection.

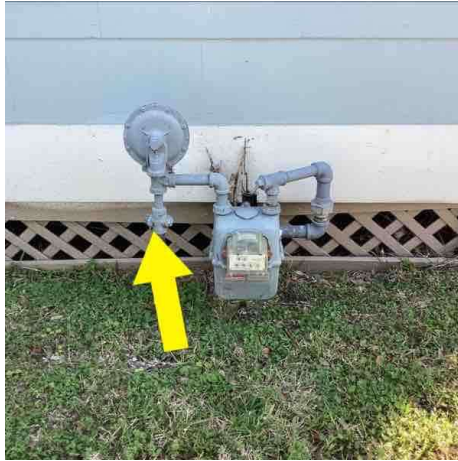
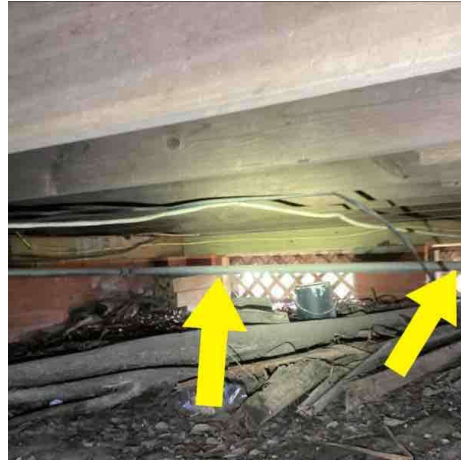
**I = Inspected****NI = Not Inspected****NP = Not Present****D = Deficient****I NI NP D\***☒ ☐ ☐ ☒**E. Gas Distribution Systems and Gas Appliances***Comments:*

- Gas meter is located on the left exterior of the home.
- Main gas shut off is located at the gas meter.
- Supply piping appeared to be of galvanized piping.
- There were areas where gas lines under the home were noted as not being properly supported. Recommend having qualified contractor evaluate and repair as needed for proper support.

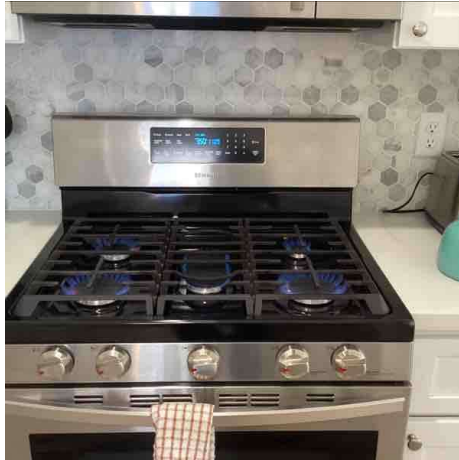
**I = Inspected****NI = Not Inspected****NP = Not Present****D = Deficient****I NI NP D\***☒ ☐ ☐ ☒**D. Ranges, Cooktops, and Ovens***Comments:*

- Oven and cook tops we're operating as designed at the time of inspection.
- Oven anti - tip device is missing or disconnected. This is a safety hazard for small children and should be corrected for safety.

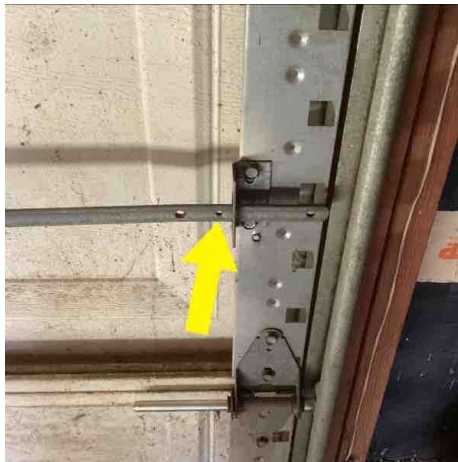
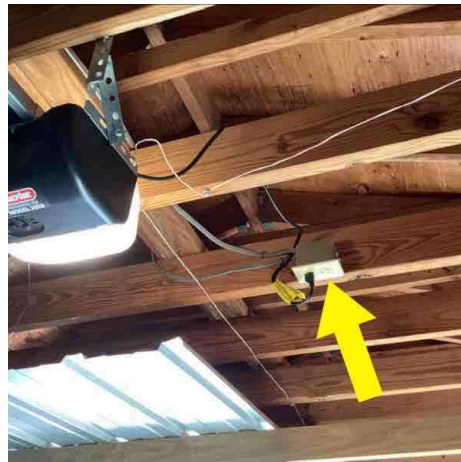
**I = Inspected****NI = Not Inspected****NP = Not Present****D = Deficient****I NI NP D\***☒ ☐ ☐ ☒**G. Garage Door Operators***Comments:*

- Automatic garage door opener was tested and operates normally.
- Photo-electric sensors performed as intended.
- Automatic reversing feature performed as intended.
- Permanent hold-open device at manual lock mechanism, (required with auto-opener present), was noted as missing. Recommend installing hold open device as required to prevent possible door damages.
- Garage door operators are required to be on a GFCI outlet. Recommend having a licensed electrician replace outlet with a GFCI outlet to prevent possible electrical shock.

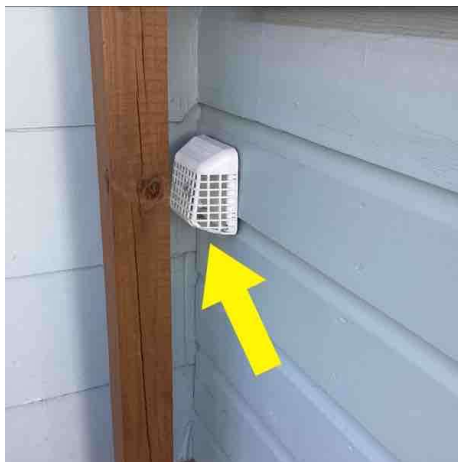
☒ ☐ ☐ ☒**H. Dryer Exhaust Systems***Comments:*

- Dryer vents appears to vent to the outside through a "screened" vent connector. Lint from dryers will clog vents obstructing air flow from the dryers. This is a fire hazard and should be corrected for safety
