**May 15, 2026**

# PROPERTY INSPECTION REPORT FORM

| 12704 Rio Nueces Ln, Rosharon, TX 77583<br><i>Address of Inspected Property</i> | |

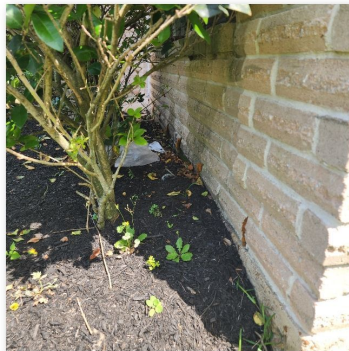
- The soil line was observed to be marginally high on the north side of the structure. Under current building standards there should be at least 4-inches of foundation visible below masonry veneer and 6-inches of foundation visible below wood type veneer.

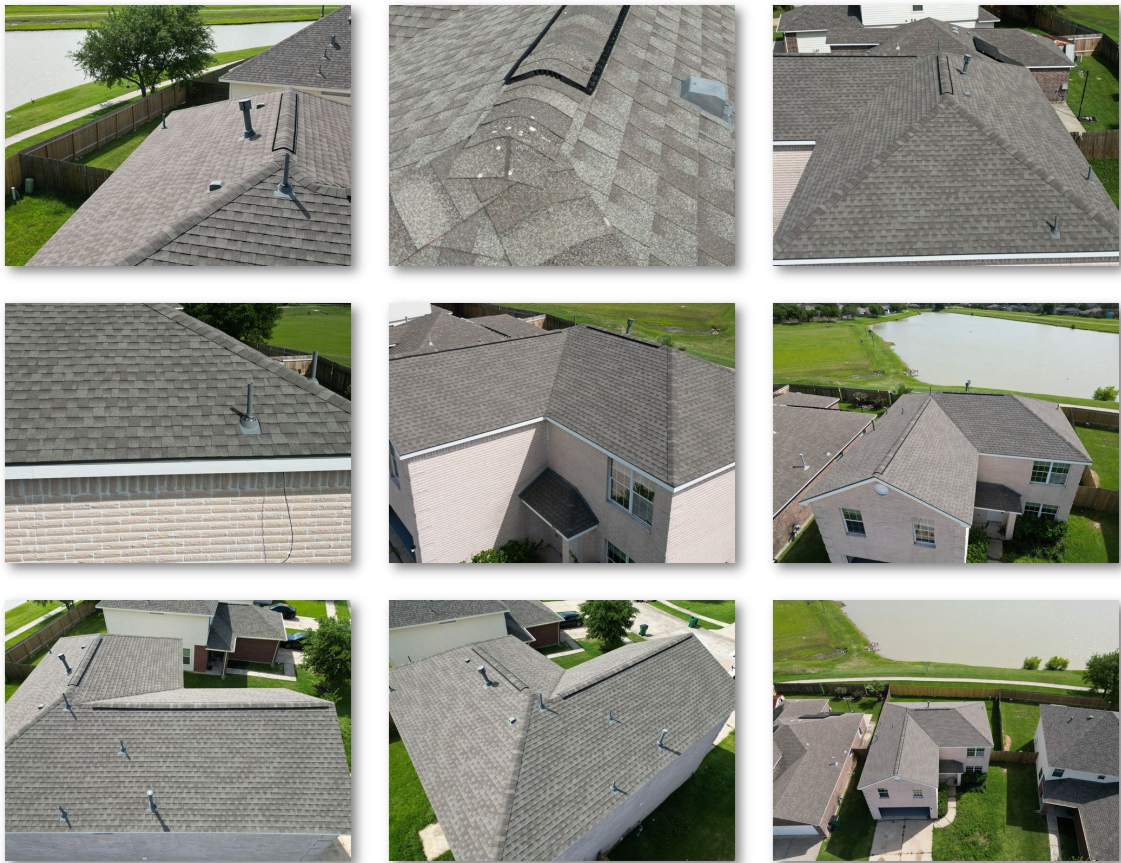
**Note:** Roof fasteners (nails and/or staples) were observed to be exposed and should be properly sealed at the ridge caps and flashing areas.

**Note:** The inspector inspected the roof with a drone due to the height and structure type. The drone will help identify major issues but cannot detect the smaller deficiencies that can be identified by walking the structure.

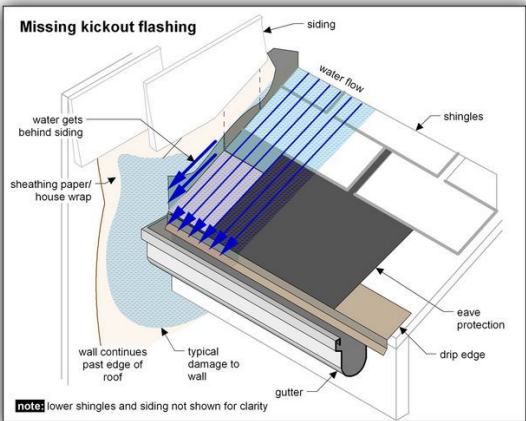
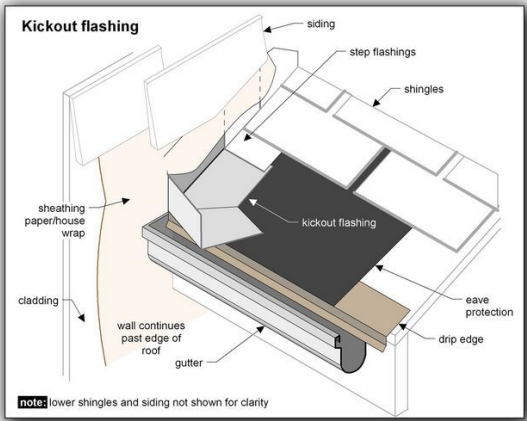
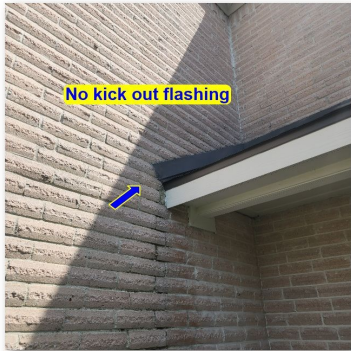
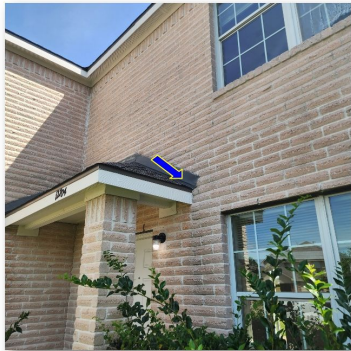
**Flashing Details**

- It is recommended to seal one or more of the plumbing vent stack rubber boots to prevent water intrusion at this location.
- There was no kickout flashing details observed at the lower bottom edge of the roof line interface and the sidewall that continues past the edge of the roof. The lack of this kickout flashing could allow water to penetrate at these points.

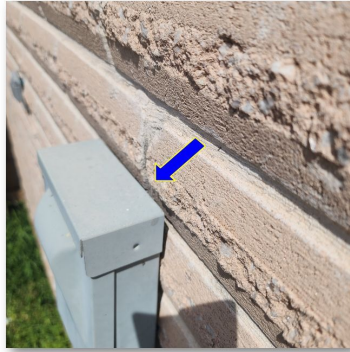
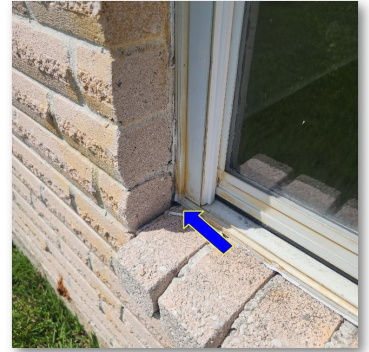
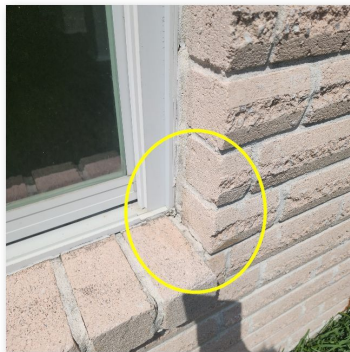
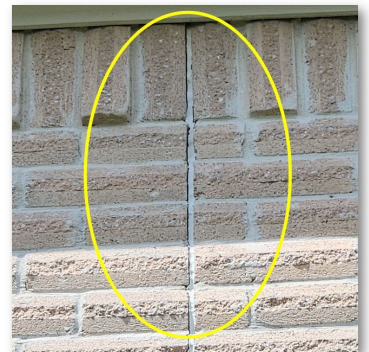
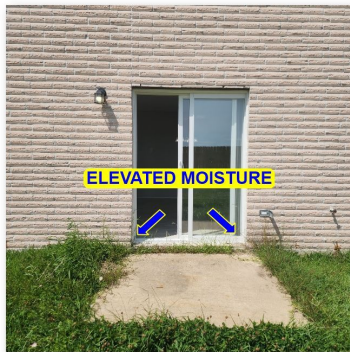
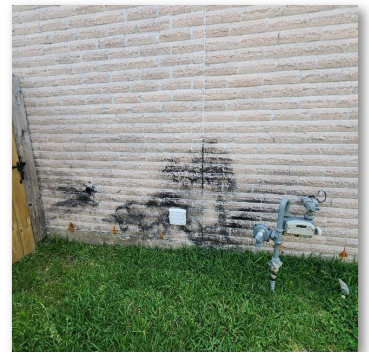
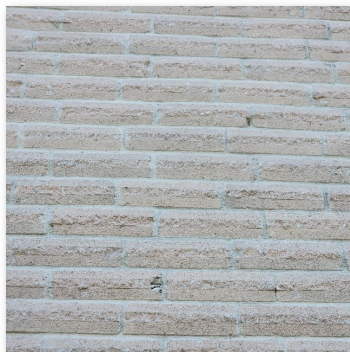
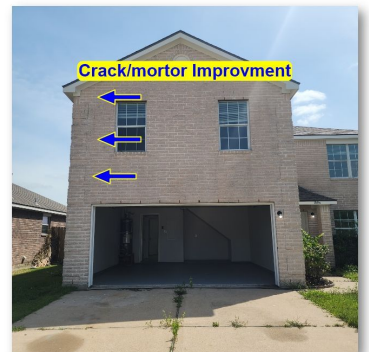
#### Exterior Walls & Surfaces

- The area between the exterior cladding / veneer and all of the wall penetrations / openings should be properly sealed. Areas such as utility connections, downspouts, hose bibbs, lighting fixtures, receptacles, vent termination covers, etc. It is recommended to use an elastomeric sealant.

- All joints between two different types of siding should be properly sealed. It is recommended to use elastomeric sealant.
- Caulking improvements are recommended for the area between the exterior veneer and the window frames. It is recommended to use an elastomeric sealant.

- The wall expansion joint(s) should be properly sealed on the east side, west side of the structure. It is recommended to use an elastomeric sealant.
- Mortar improvements are recommended for the exterior masonry veneer on the north, east and west sides of the structure.

- The weepholes in the lower course of the exterior masonry veneer were observed to be blocked and/or sealed. The weepholes should be reopened to help vent the wall voids and release any absorbed rain water from behind the exterior masonry veneer walls.

- The wood veneer trim has some deterioration or damage on the north side of the structure.

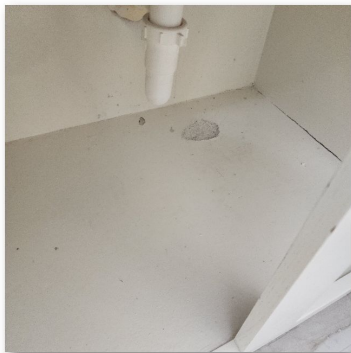
**Cabinets & Cabinet Surfaces**

- Cabinet surface damage was observed in the kitchen; primary bathroom; hall bathroom.

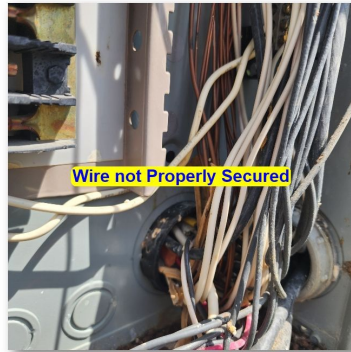
- The breakers (overcurrent devices) in the electrical panel are not properly labeled.
- There is no surge protection device installed at the panel box. Under the current National Electrical Code, all electrical systems should have surge protection. This is an "as built" condition. It is recommended to add a surge protection device to the panel box.

- An unmarked white wire was found connected to a hot breaker in the panel. While white wires are sometimes used as 'hot' conductors for 240-volt circuits, they must be permanently re-identified with black or red tape/marker at all terminations to identify them as energized. This creates a potential safety hazard for technicians assuming it is a neutral wire. **Recommendation: Have a licensed electrician properly identify the wire.**

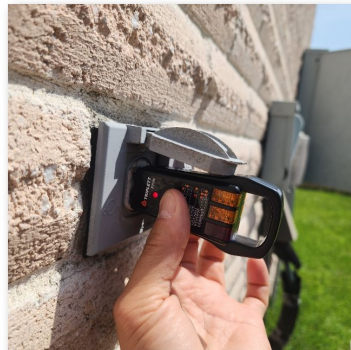
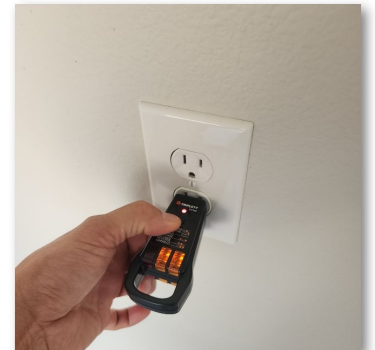
### Receptacle Outlets

- One or more of the receptacles are inoperative. This receptacle(s) and circuit should be investigated and corrected as necessary. Receptacle(s) were located in the front porch.
- The garage area, laundry area, north exterior wall, west exterior wall receptacles are not connected to a ground fault circuit interrupter (GFCI) device. Under current electrical standards, these receptacles should have GFCI protection.

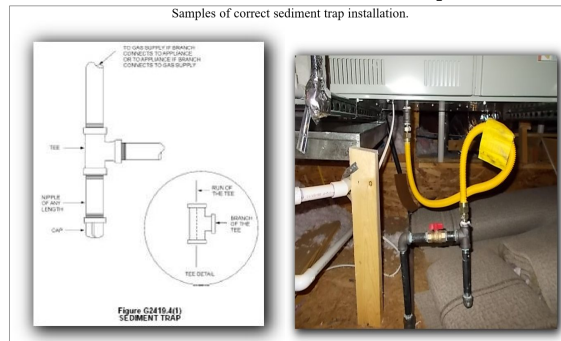
- The roof level flue storm collar should be properly sealed to help prevent water intrusion into the structure.
- The heater gas supply line is not equipped with a sediment trap just before the gas appliance connector. This condition does not meet current installation requirements and should be corrected.

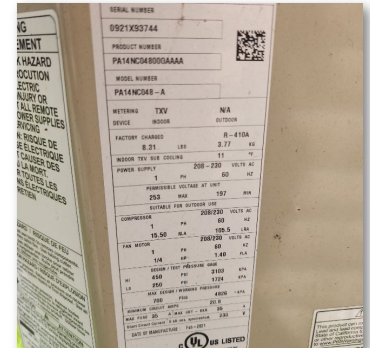
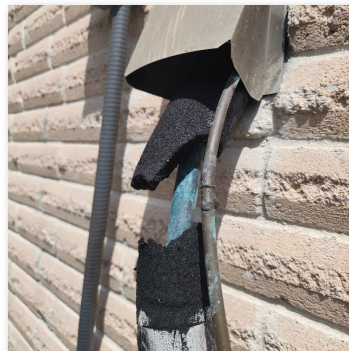
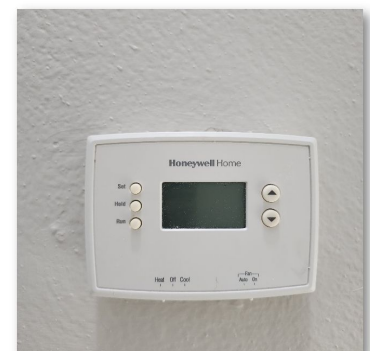
- The air conditioning system was inoperative at the time of the inspection.
- Damaged, deteriorated and/or missing insulation on the refrigerant lines should be repaired or replaced at the outside condenser.

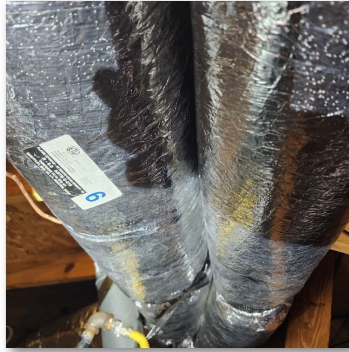
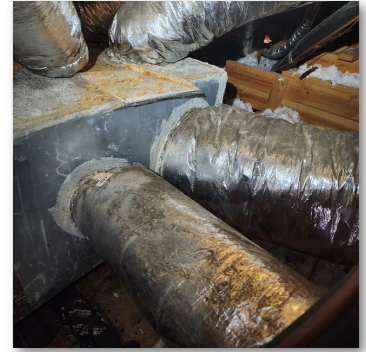
#### Duct System, Chases and Vents

- The duct work in the attic area is not properly separated to help prevent condensation from developing. It is recommended to separate the duct work with a minimum intervals of 1.5-inches.
- The duct system was observed to be dirty and should be cleaned for air quality purposes.
- The supply ductwork in the attic has an R6, Which is less than the current recommended R8 for this climate zone. This can lead to reduced energy efficiency and potential condensation issues. Recommend evaluation and sealing/upgrading of insulation by a qualified HVAC Contractor.

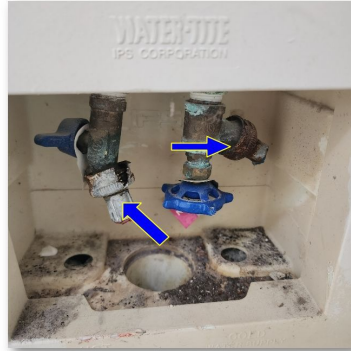
##### Water Supply System

- The Spigot is not functioning properly at the time of inspections

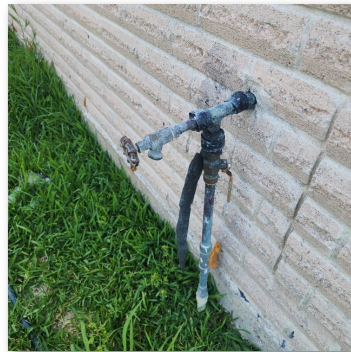
##### Exterior Faucets/Fixtures

- The exterior water hose bib (faucet) is leaking at the handle when operated on the south side, east side of the structure.
- One or more of the exterior water hose bibs (faucet) do not have a back-flow or anti-siphon device (Vacuum Breakers) in place.

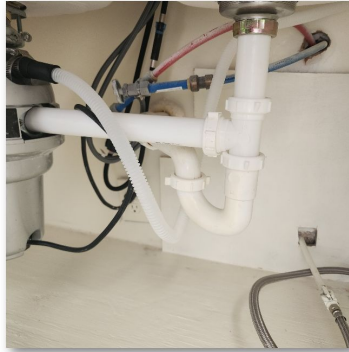
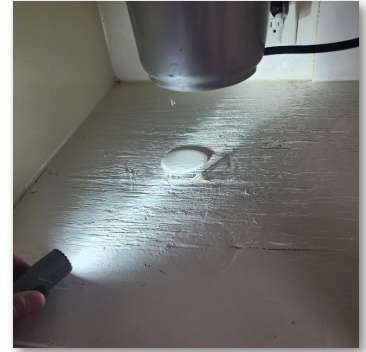
- The drain leaks water into the cabinet.

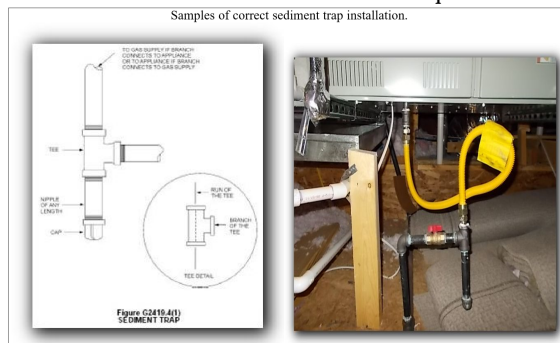
- The water heater gas supply line is not equipped with a sediment trap just before the gas appliance connector. This condition does not meet current installation requirements and should be corrected.

Samples of correct sediment trap installation.

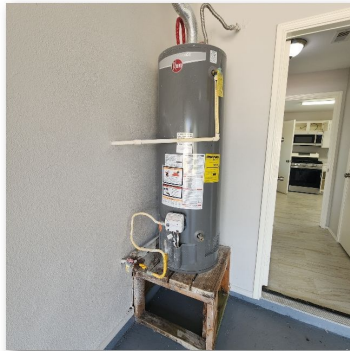
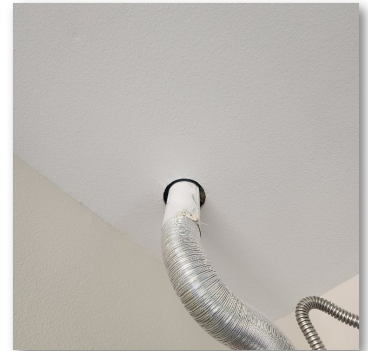
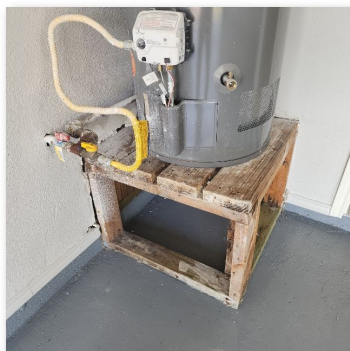
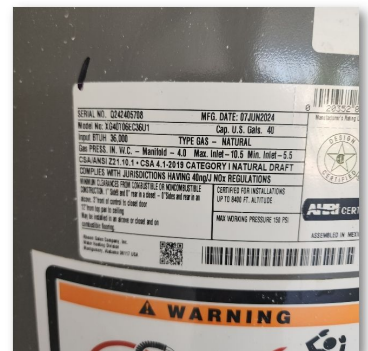
- The water heater flue (vent pipe) has inadequate clearance from combustible materials. Double walled vent pipes should have at least 1-inch of clearance and single walled vent pipes should have at least 6-inches of clearance from combustible material.
- The water heater flue was observed to be an older single wall type. Under current mechanical standards, the exhaust flue should be a Type-B double wall flue.
- There is no pan installed under the water heater.

P2801.5.2 Pan drain termination. The pan drain shall extend full-size and terminate over a suitably located indirect waste receptor or shall extend to the exterior of the building and terminate not less than 6 inches (152 mm) and not more than 24 inches (610 mm) above the adjacent ground surface.

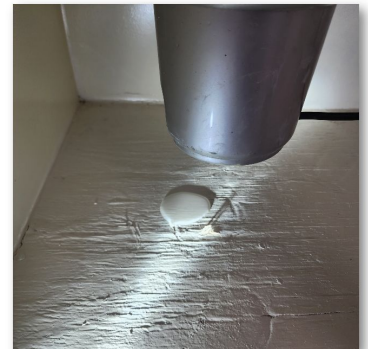
- The food waste disposer is leaking water into the cabinet area. This condition should be further evaluated and corrected as necessary.
