# Inspection Report

4425 Fuqua St  
Houston TX 77048

# PROPERTY INSPECTION REPORT FORM

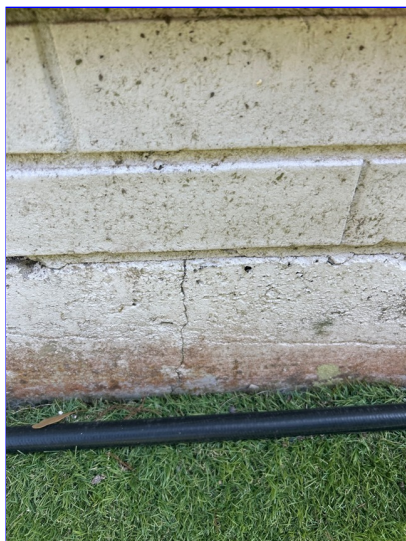
(2) There is some slab edge cracking. There is little to no deflection across the crack. This type of flexural crack is generally the result of seasonal variations in soil moisture causing the soils to shrink and/or swell exerting pressure on the foundation.

This type of crack is not structurally significant.

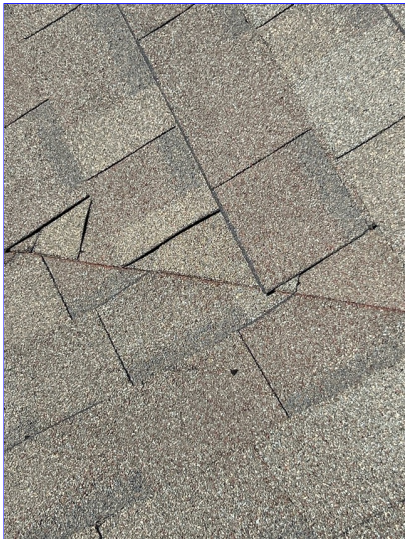
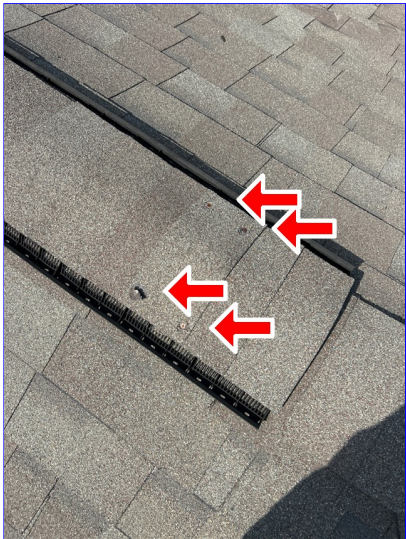
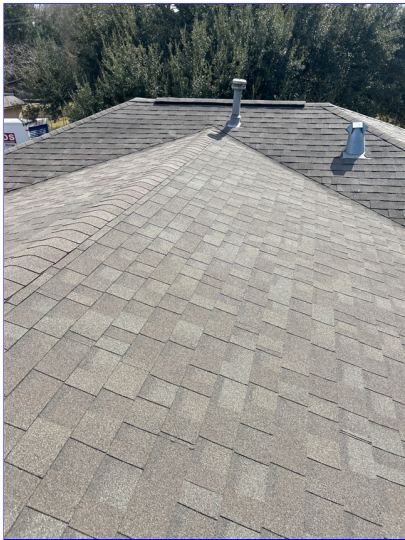
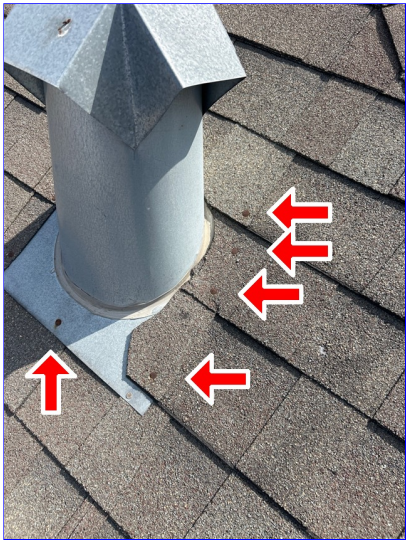
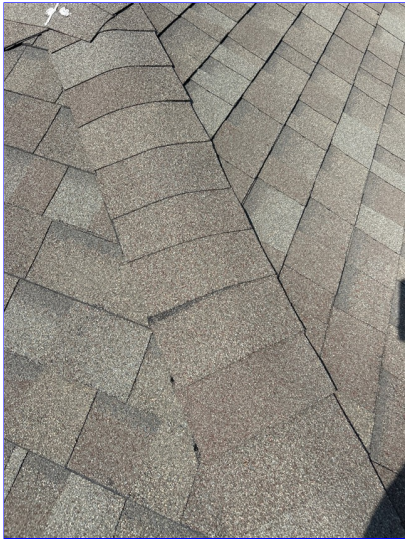
(1) The roof covering, is not new and shows signs of wear consistent with its age. The overall condition of

the roof covering appears to be acceptable and no signs of any current moisture penetration into the structure were observed. This roof covering is probably around 4 to 8 years old. This type of architectural style composition shingles typically lasts about 20 years in this climate.

A general seal up of roof penetrations, exposed nail heads and flashings is recommended as routine maintenance.

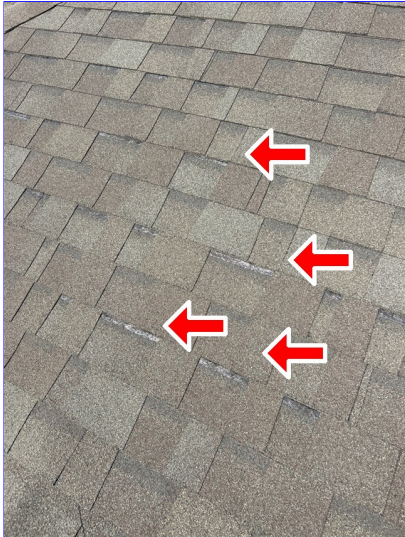
(2) Defective shingles observed at the front of the home. Recommend replacing.

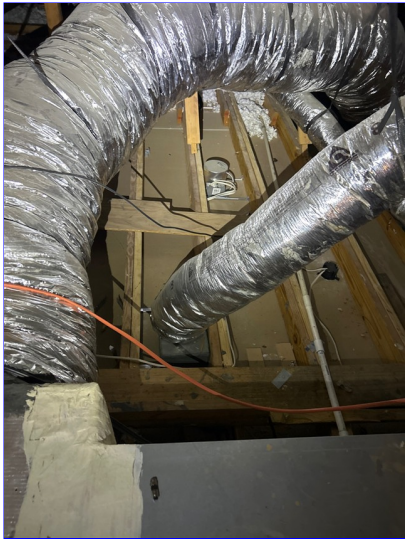
(1) Missing or displaced insulation was observed in the attic. Recommend correction.

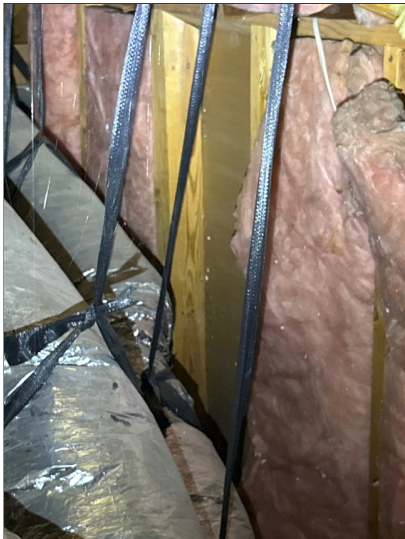
(2) Insulation is displaced at walls, viewed from the attic space. I recommend correction for energy efficiency reasons.

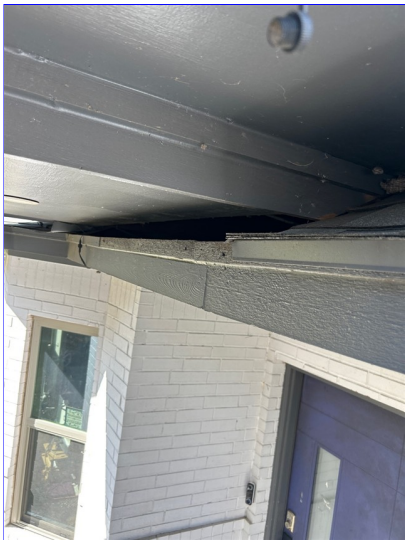
(3) Open area observed at the front of the home should be screened to prevent pest from entering.

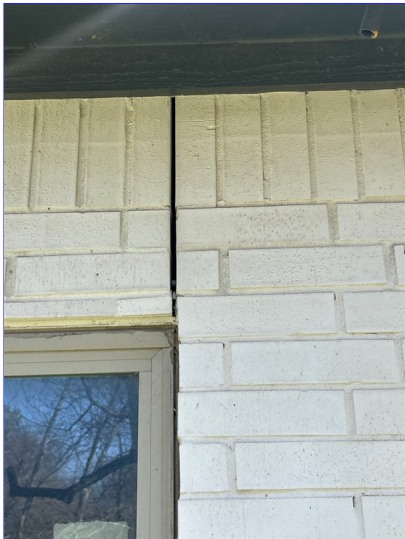
(1) The brick veneer expansion joint sealant has failed/missing, or not properly installed. Recommend correction.

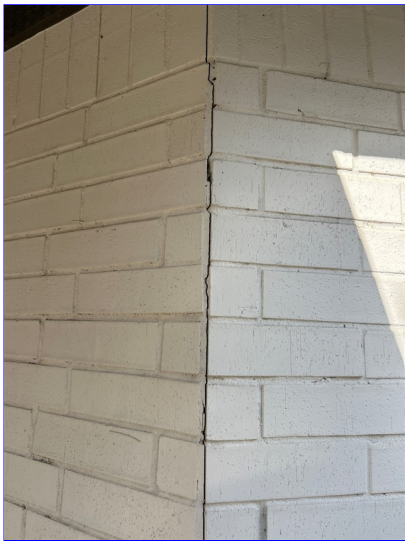
(2) Brick veneer mortar cracks were observed. This condition is cosmetic in nature and not structurally significant. The cracking of the brick veneer is likely due to flexing of the foundation during repeated seasonal changes. The expansive clay soil in the area is prone to excessive swelling during rainy periods and shrinkage during dry periods.

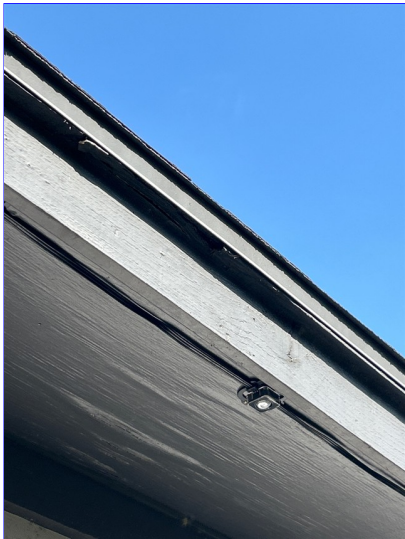
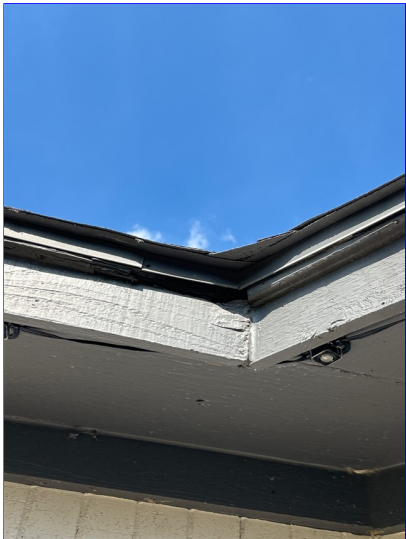
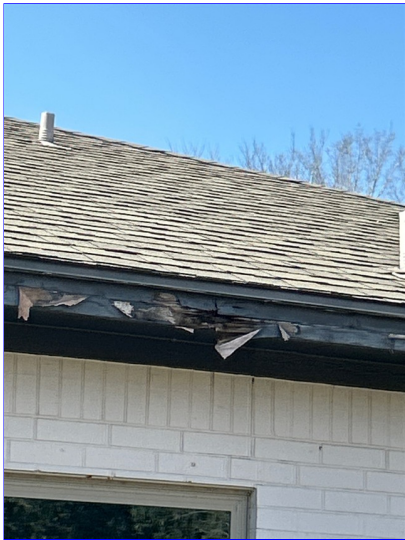
(3) Wood rot was observed on the fascia and trim at the front and side of the home. Recommend repair.

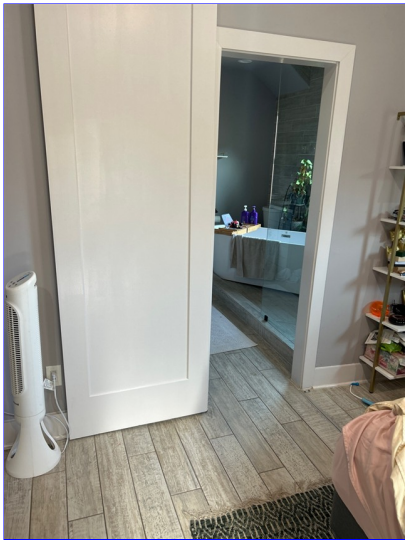
(2) The barn doors at the primary and guest baths does not have a guide at the bottom and will swing out. Recommend correction.

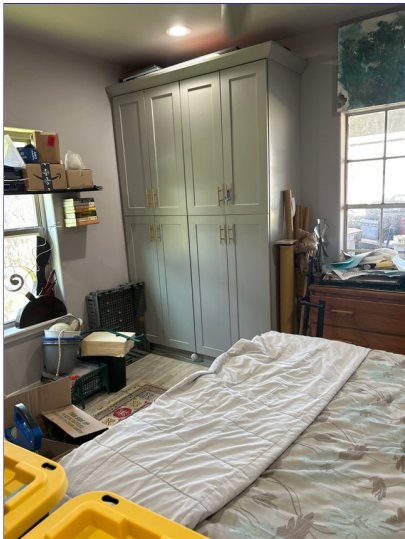
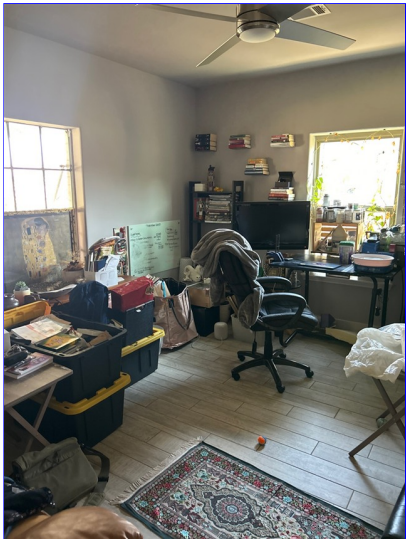
- (1) There are missing/damaged screens. Recommend replace or repair as needed.
- (2) I could not check all windows and outlets in the home due to the contents.

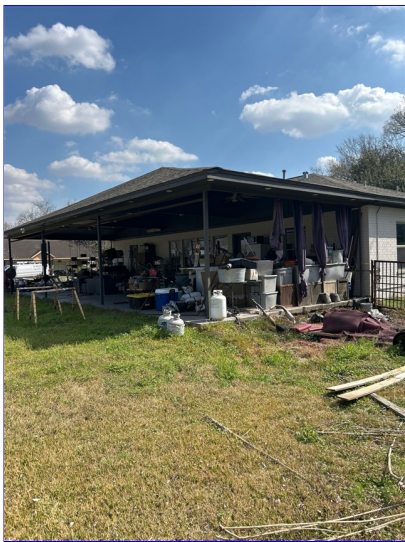
The patio cover at the back of the home was built after the home was built. I am unable to tell if the proper footings were used or if it was correctly attached to the rest of the structure.

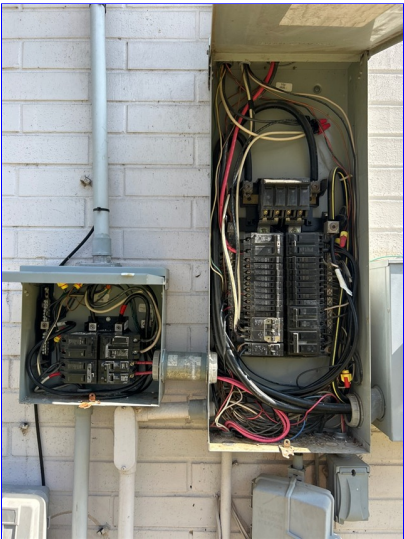
(1) The main electrical service panel and sub panel, shown with dead front cover removed for inspection purposes. The panel inspected okay.

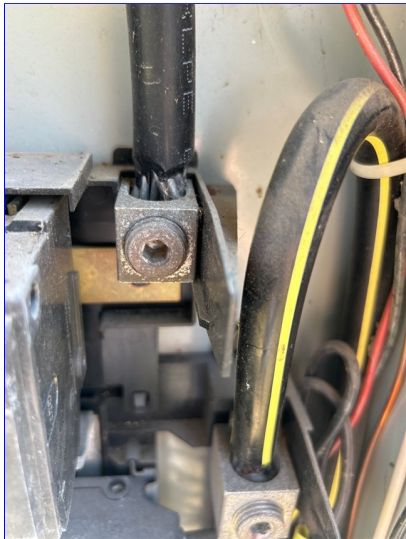
(2) The panel is not equipped with a whole house, surge protection device. This may not have been required during the time period that this home was built. More stringent building codes have been established since that time and currently all dwellings are required to be equipped with a whole house surge protection device. I recommend that you consider adding one of these devices.

(3) Anti-oxidant paste, was not observed on service entrance conductor terminations. Anti-oxidant paste is recommended to prevent corrosion at the terminations.

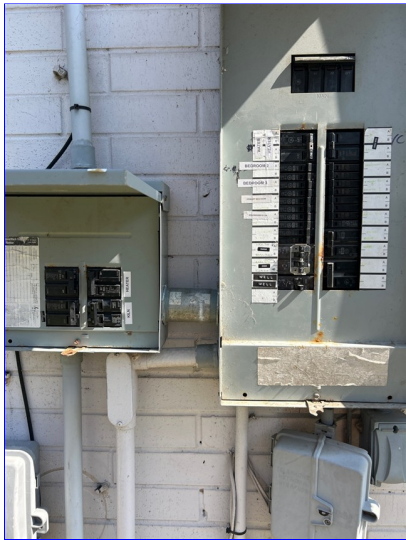
(4) The electrical panel is not properly labeled. Labels are missing and/or illegible or confusing. I recommend correcting for safety reasons.

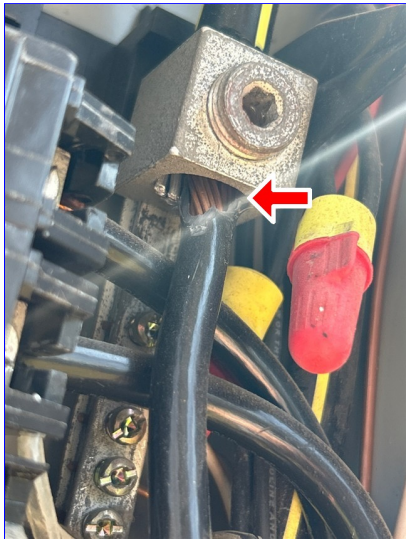
(5) Some lugs, are double tapped with copper and aluminum wire together.

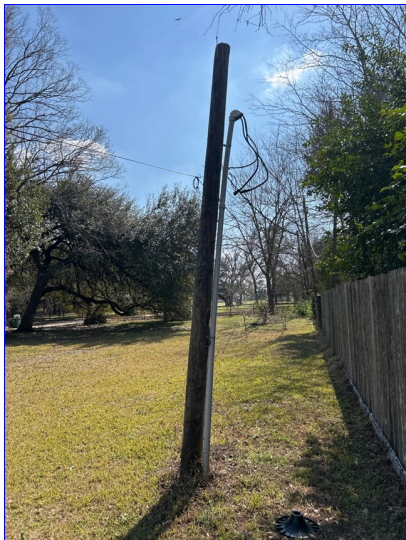
(6) The service pole is leaning. Recommend correction.

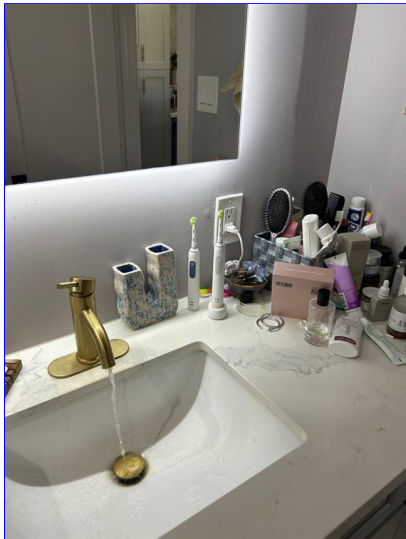
- (1) Kitchen receptacles are either not **accessible** and/or not Ground Fault Circuit Interrupter (GFCI) and Arc Fault Circuit Interrupter (AFCI) protected. This may not have been required during the time period that this home was built. More stringent building codes have been established since that time and currently all kitchen outlets are required to be **accessible**, GFCI & AFCI protected in new construction. I recommend that you consider upgrading all kitchen counter outlets to GFCI & AFCI protection for personal safety reasons.
- (2) Ground Fault Circuit Interrupters (GFCI's), were not observed to be installed in all required wet locations. GFCI's are intended to protect persons from accidental electrocution in locations susceptible to moisture. I recommend that you upgrade all applicable locations to GFCI protection for personal safety reasons.

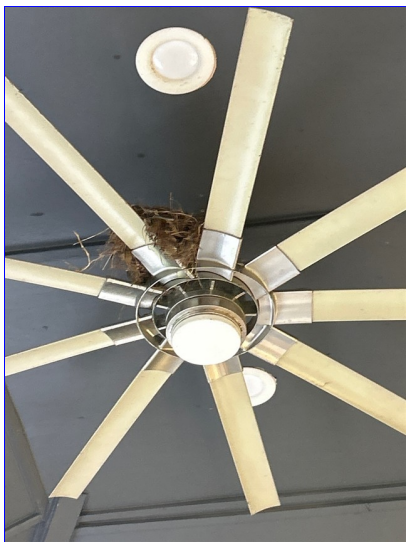
(3) I can only get one of the ceiling fans on the back porch to turn on. One had a bird nest in it.

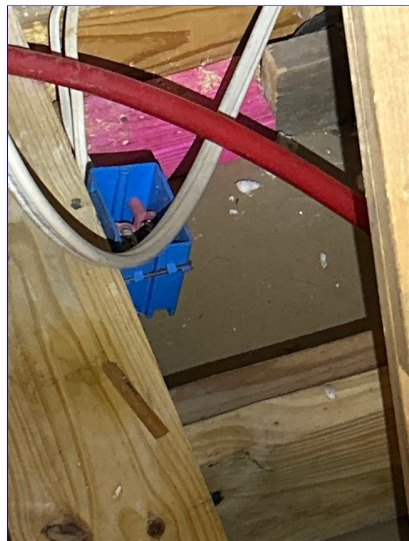
(5) There are damaged/missing receptacle/switch, cover plates. These plates should be replaced for safety reasons.

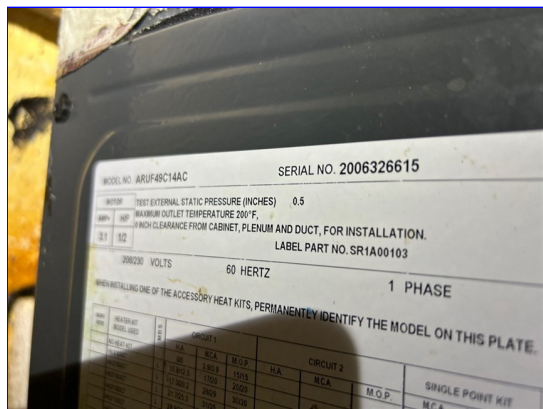
(2) The unit appeared to operate normally using the standard controls. I could not determine if the heat exchanger is cracked or not without dismantling the furnace. Dismantling of components is outside of the scope of a standard home inspection.

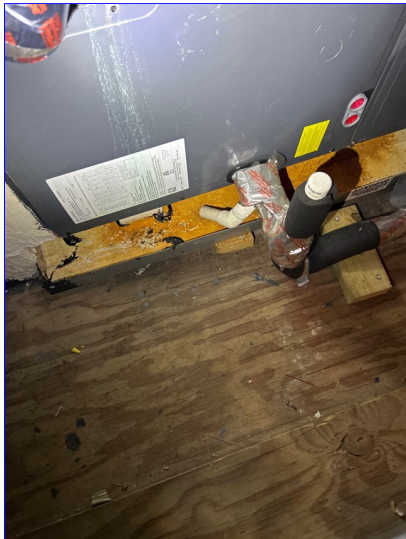
(3) The AC drain pan in the attic has rust. Recommend replacing.

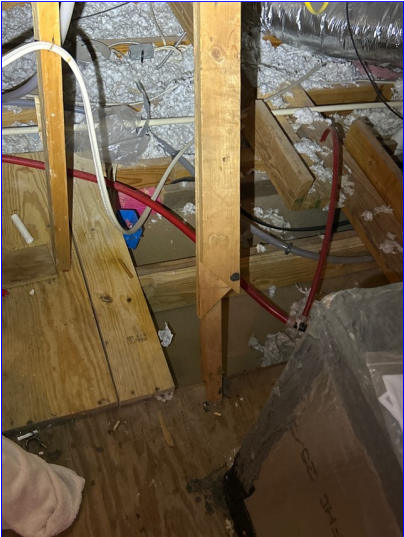
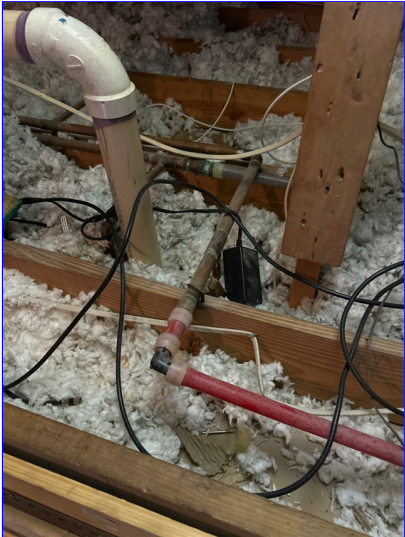
- (1) The tank for the toilet is loose in the primary bathroom.
- (2) Exposed water pipes observed in the attic space are not properly protected from freezing. Water pipes should be buried under the insulation or properly wrapped to prevent breakage from freezing.

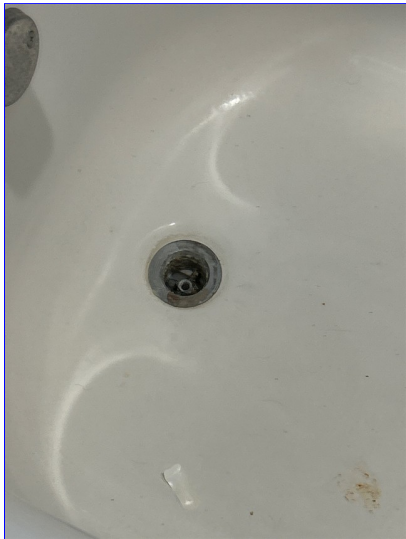
- (1) The stopper is missing or inoperative, from some fixtures.

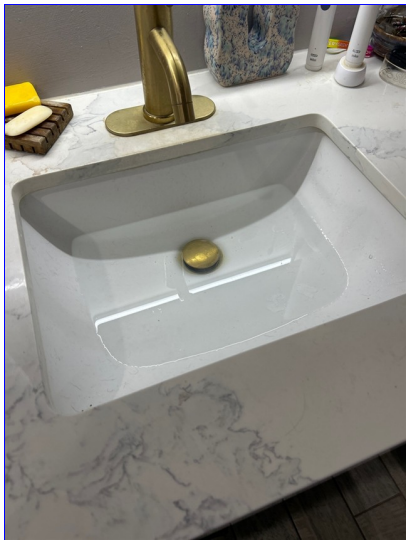
(2) The guest bathroom sink drains slow. Recommend correction.

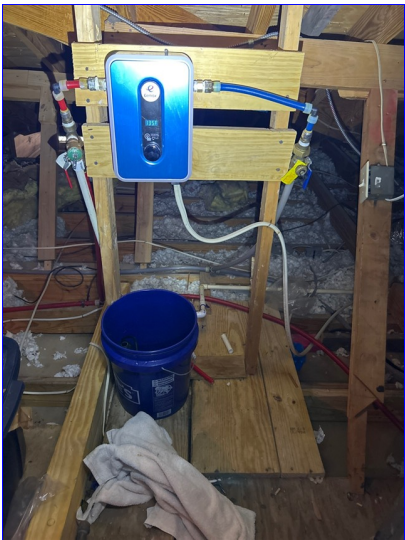
(2) There is no drain pan underneath the water heater at the attic. Recommend correction.
