# 4843 Bricker St

# Houston, Texas 77033

| Type | <b>Home Inspection and Floor<br/>Plan Report - 4843 Bricker St</b> |
| Inspected by | <b>HomeTeam Inspection Service -<br/>North Houston</b> |

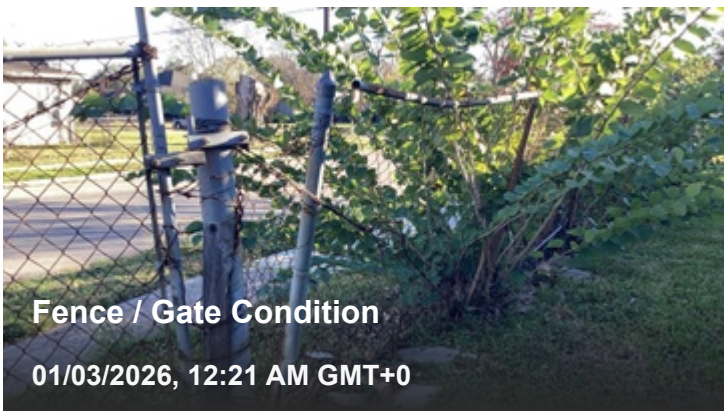
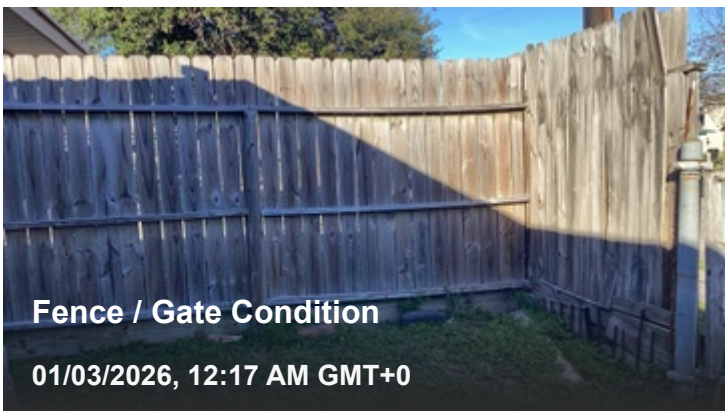
Damaged Fence / Gate

The fence or gate is damaged in one or more areas.

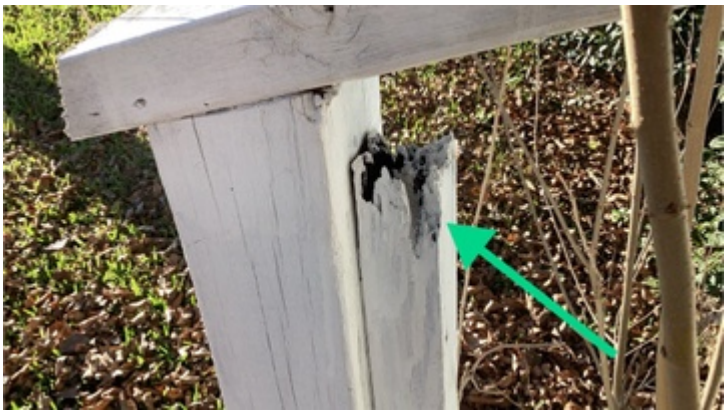
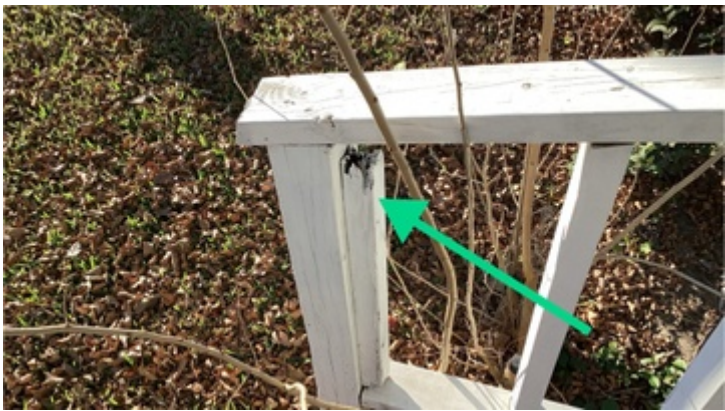
Wood Rot Observed

Wood rot is observed on / in the property.

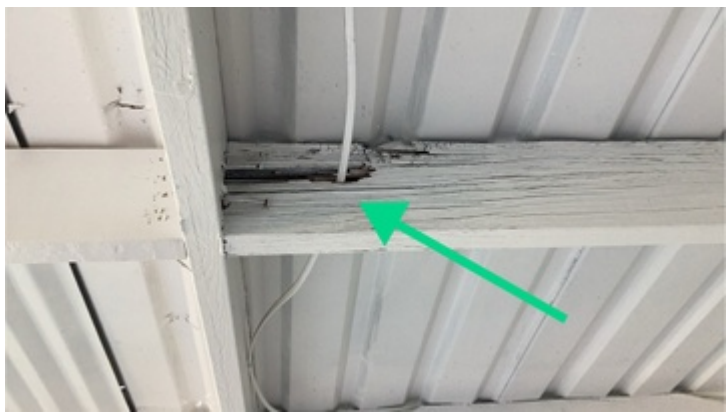
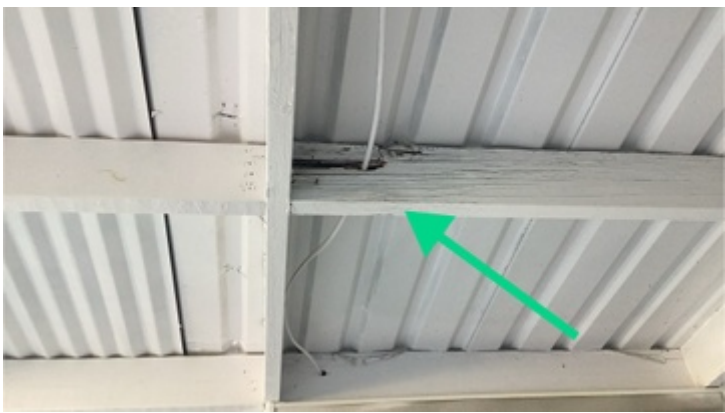
**Wood Rot Observed**

Wood rot is observed on / in the property.

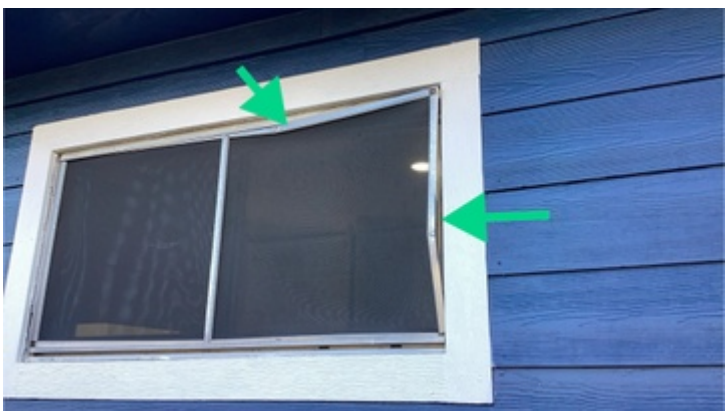
Damaged Screen

One or more window screens are damaged.

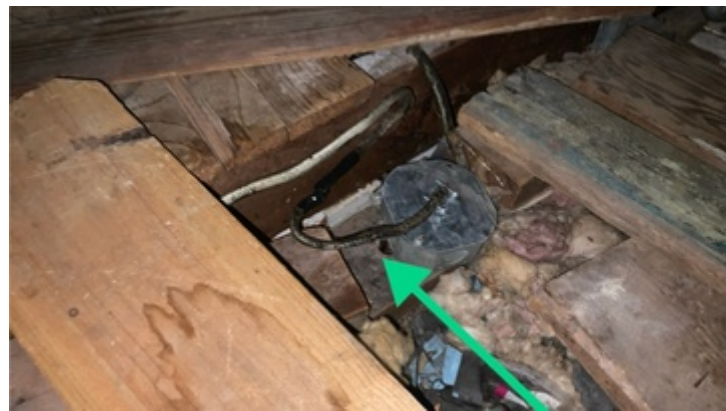
## Cloth Wiring Present

There is cloth-wrapped wiring present.

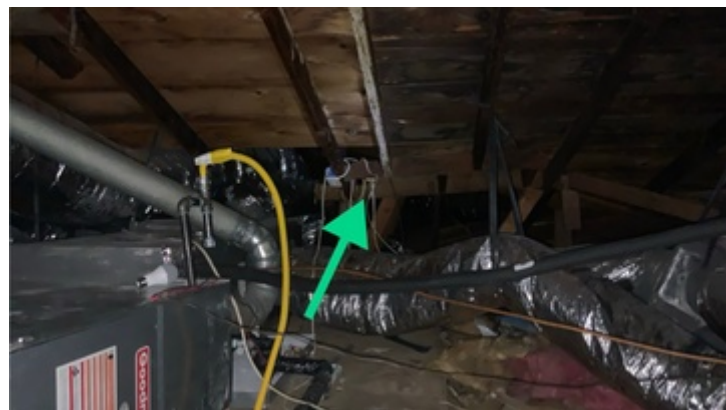
## Wiring

Wiring in the attic space not protected in junction box

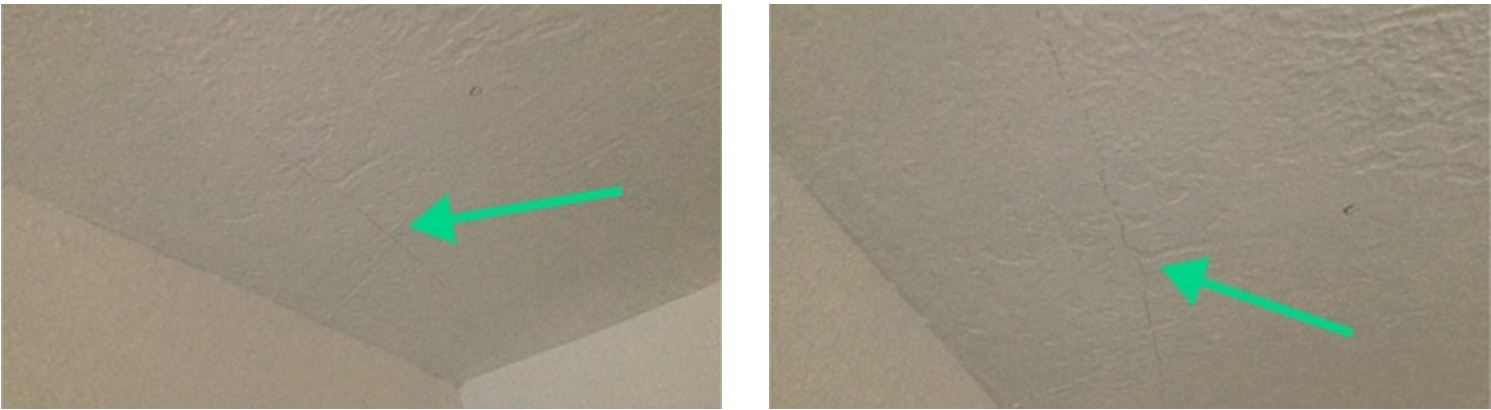
Minor Wall Cracks

There is minor cracking on the wall / ceiling.

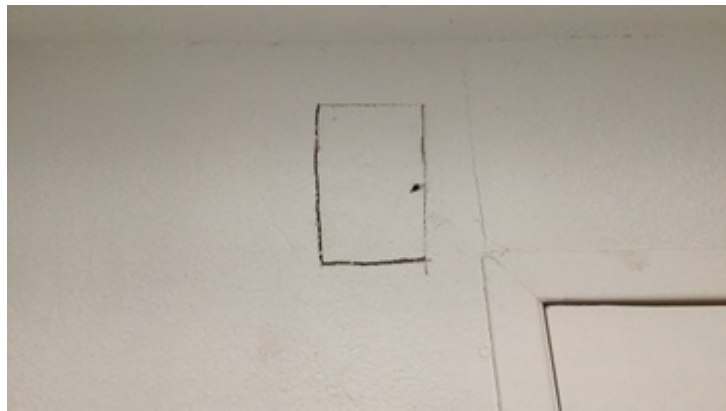
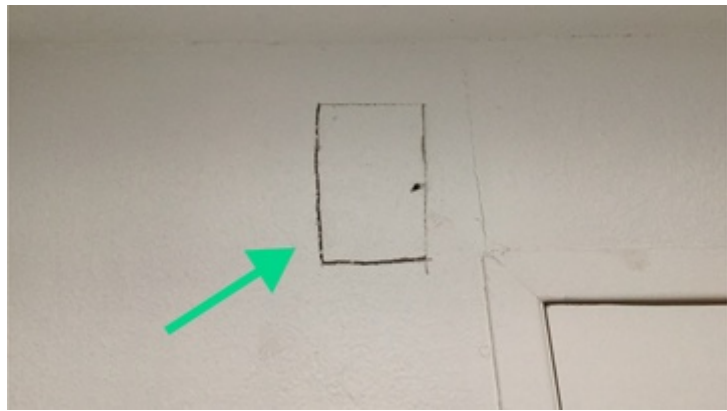
## Damaged Drywall

The drywall is damaged.

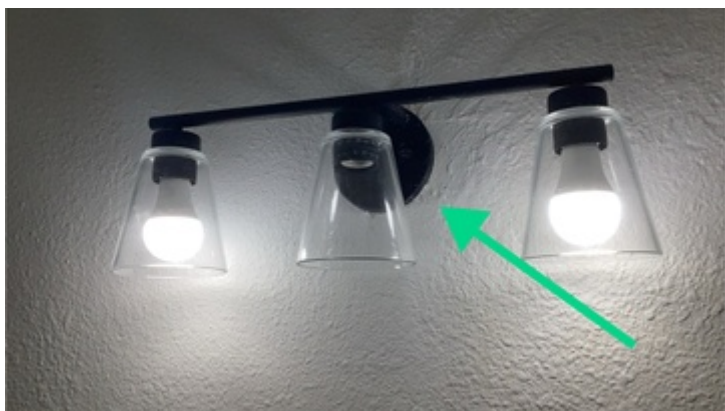
## Inoperable or Missing Light Bulb

One or more light bulbs have burnt out or are missing.
