# Inspection Report

**Property Address:**  
5443 Queensloch Dr  
Houston TX 77096

# PROPERTY INSPECTION REPORT FORM

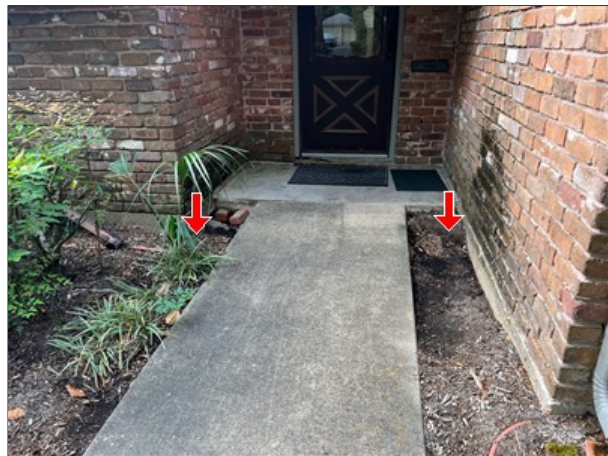
(4) Drainage swales at rear and sides of home appears to have low spots. Water will most likely pool in the drainage swales and not drain normally towards the street. Possible remedies might include the installation of catch basins, or French Drains at low spots connected to underground drain pipe to the street.

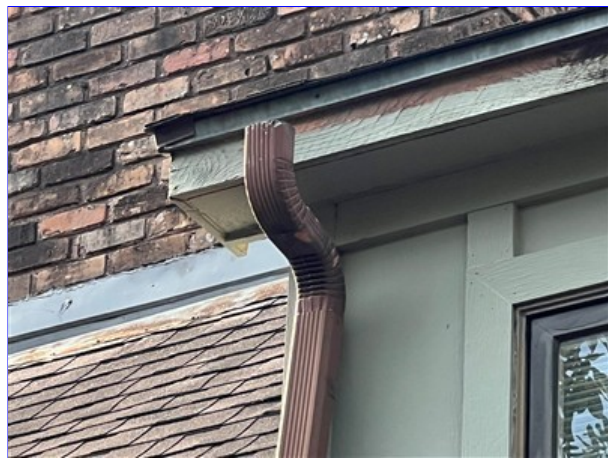
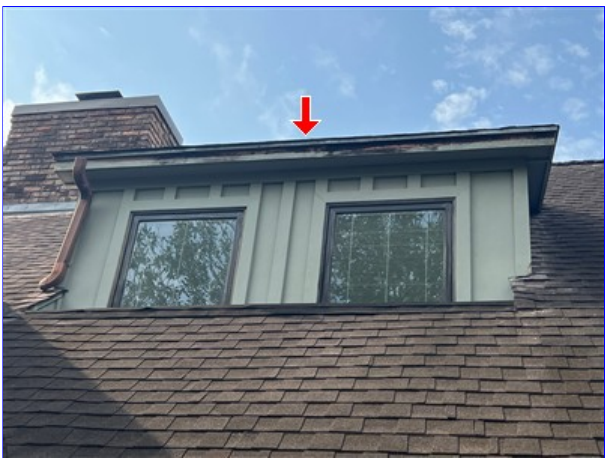
(5) At the front of the home, a gutter channel was missing. Recommend correction.

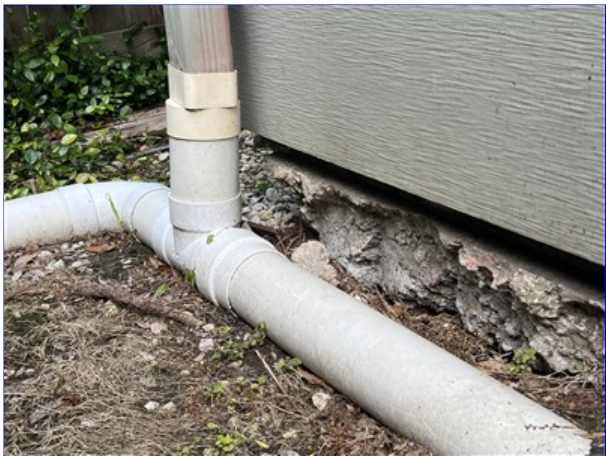
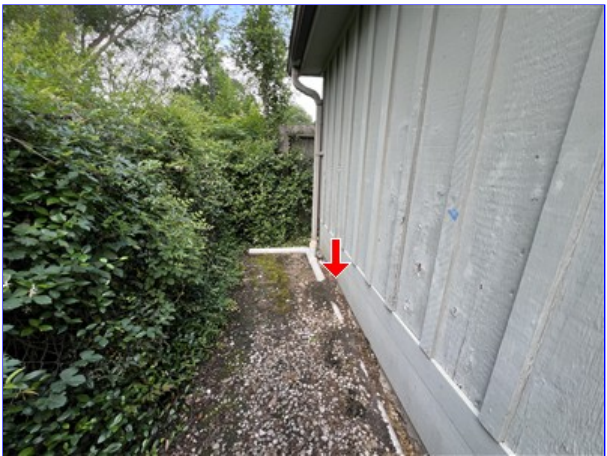
(7) At the back right of the garage, some ground erosion was observed. Recommend correction to support the exposed foundation.

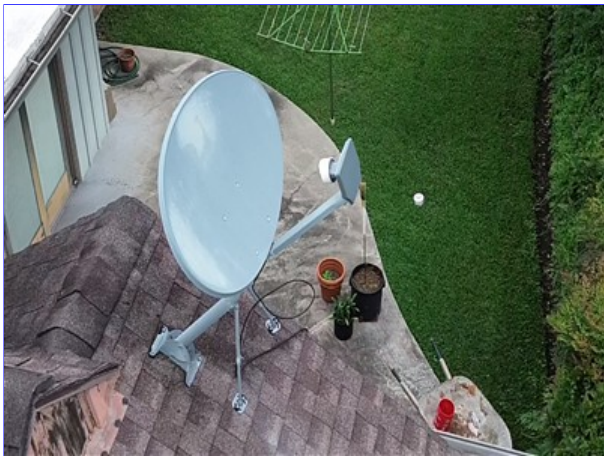
(2) The satellite dish and mounting bracket was observed mounted on the roof covering. The securing screws penetrate the roof covering, underlayment and sheathing. Over time, this installation will most likely leak water into the structure causing water damage. A better installation might be to bolt the dish to a vertical structural element and seal the bolts/screws to insure that water does not penetrate the building envelope. If you choose to remove the dish from its current location, immediate repair to the roof covering is recommended.

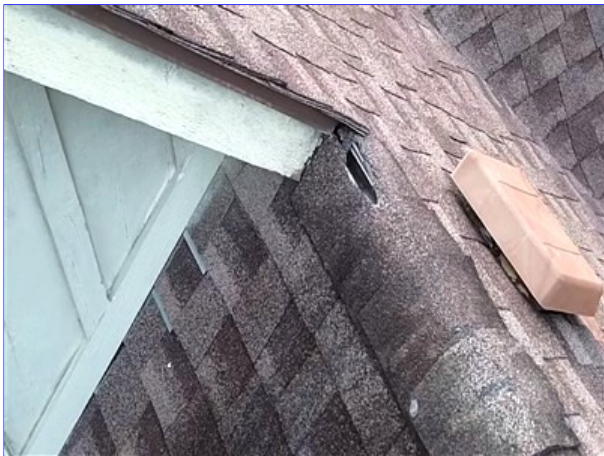
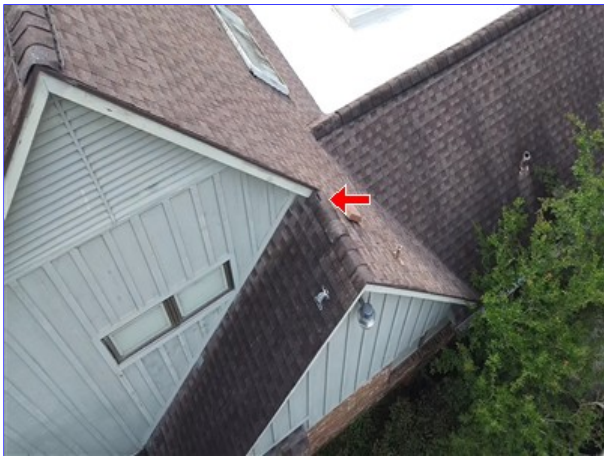
(3) Damaged and/or missing shingles were observed on the roof surface. Recommend correction

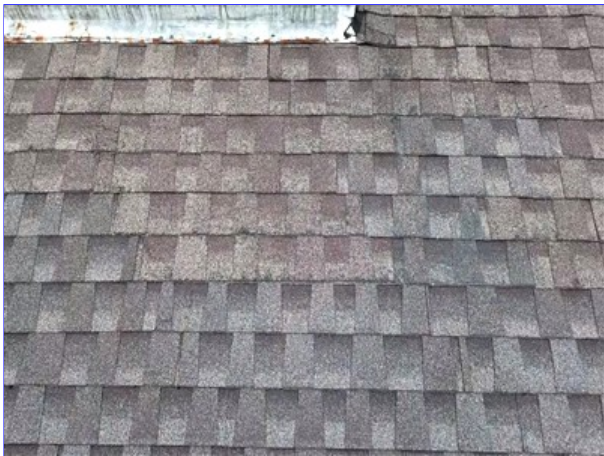
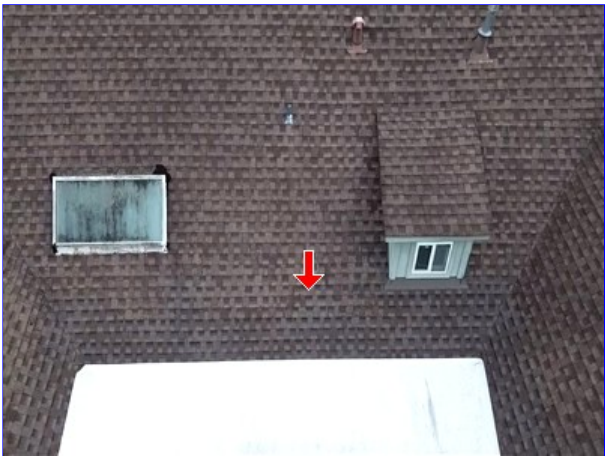
(4) Previous roof repairs were observed.

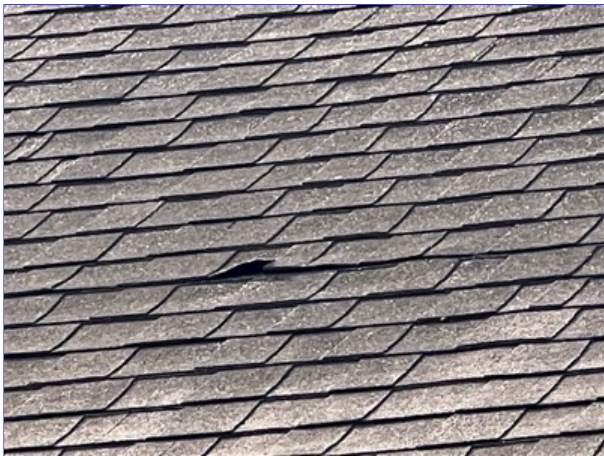
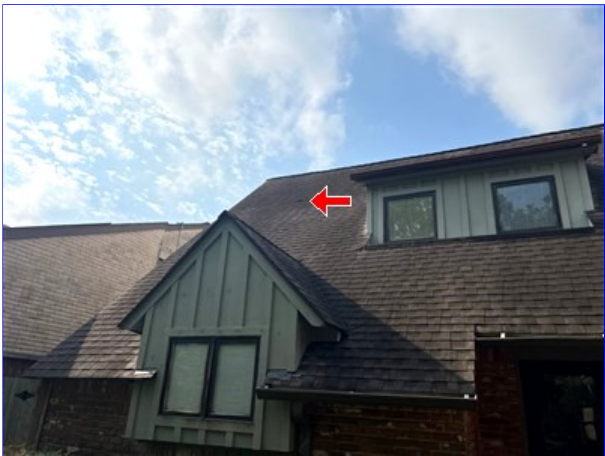
(5) Some shingles are not sealed down at the edge. I recommend that the shingles be sealed down at the edge to prevent uplift and tear off during periods of high wind. Recommend correction.

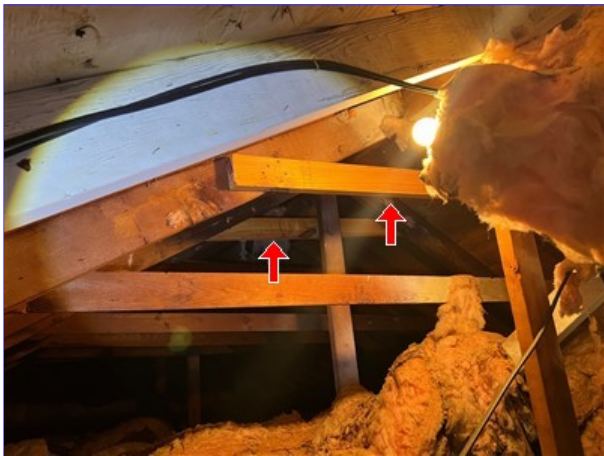
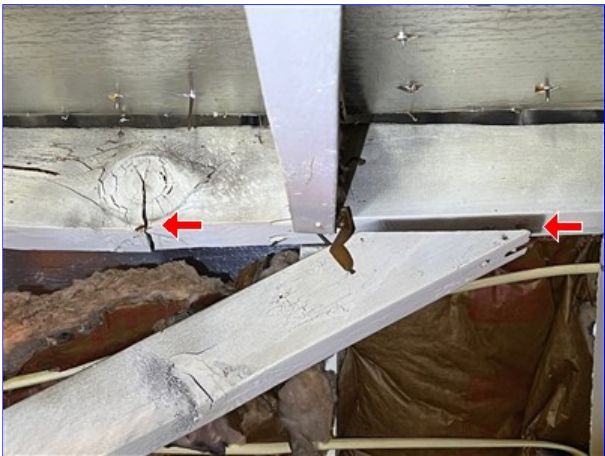
(1) At the right side of the garage, the roof ridge beam was sagging. From the garage attic space, additional rafter collar ties were observed installed. A crack in the ridge beam and separation of structural supports from the ridge beam was observed. Recommend consulting a professional contractor/ framer to evaluate further.

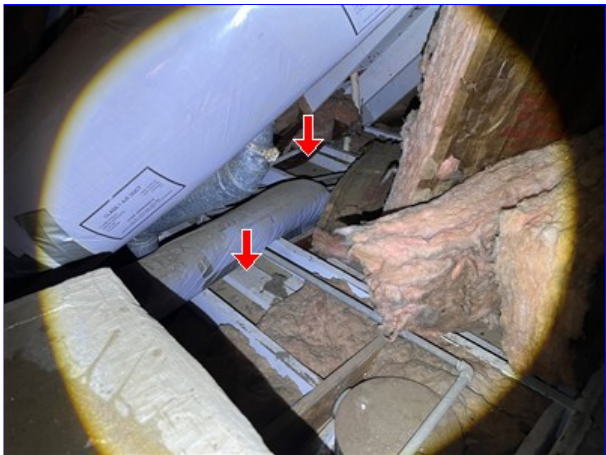
Ceiling attic access

(4) Missing or displaced insulation was observed in the attic. Recommend correction.

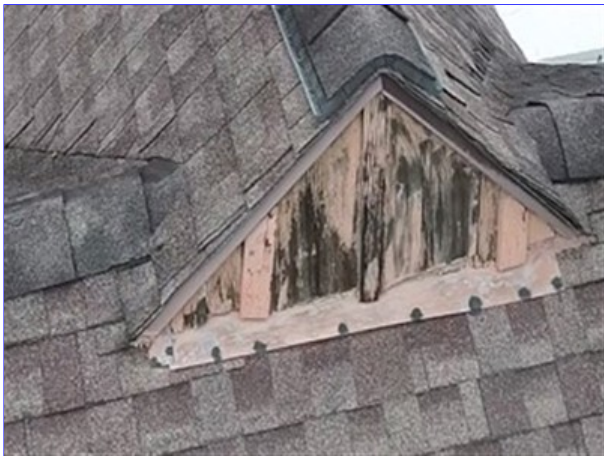
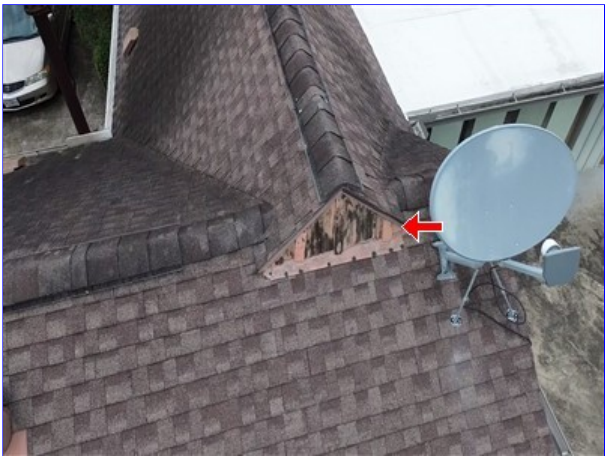
Garage apartment back

(1) Paint was weathered or missing on some areas of the exterior wall. Recommend correction.

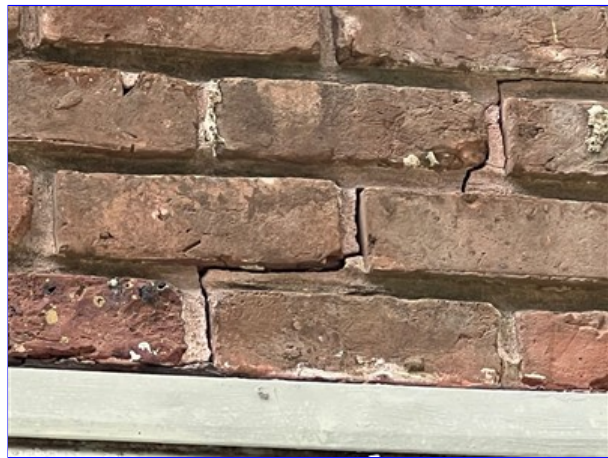
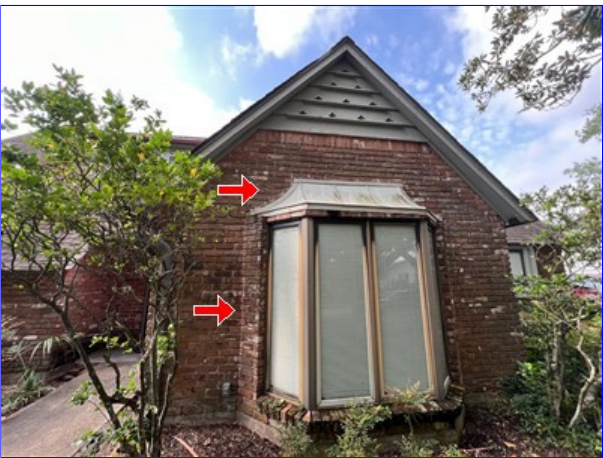
(4) Brick veneer mortar cracks were observed. This condition is cosmetic in nature and not structurally significant. The cracking of the brick veneer is likely due to flexing of the foundation during repeated

seasonal changes. The expansive clay soil in the area is prone to excessive swelling during rainy periods and shrinkage during dry periods.

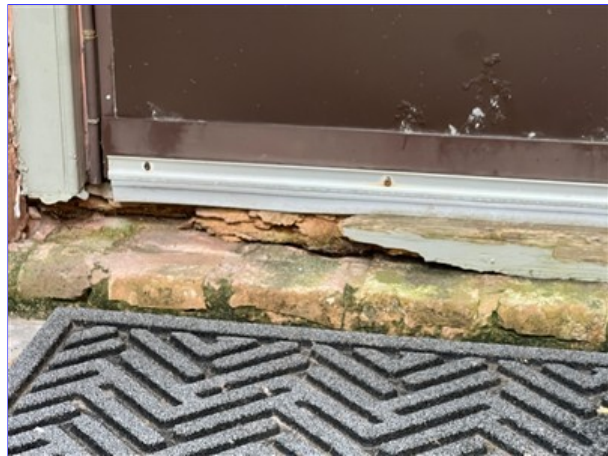
Front door

(5) Wood rot was observed on some areas of the exterior wall and/or trim. Recommend correction to all damaged materials.

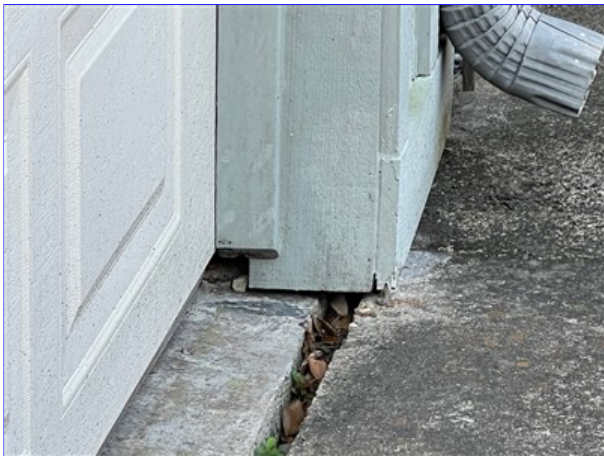
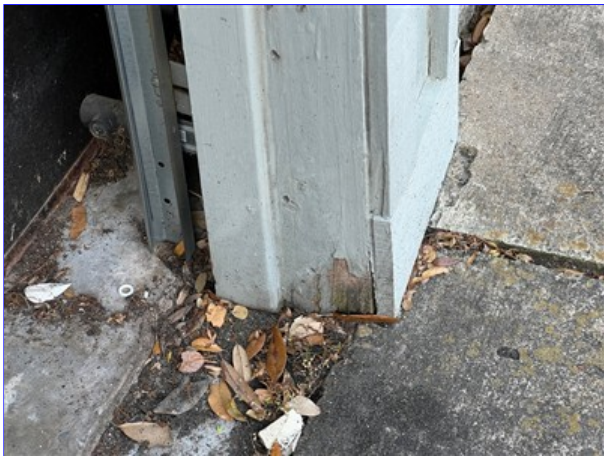
(6) Garage trimmers were not cut out a 45° angle at the floor. Recommend correction.

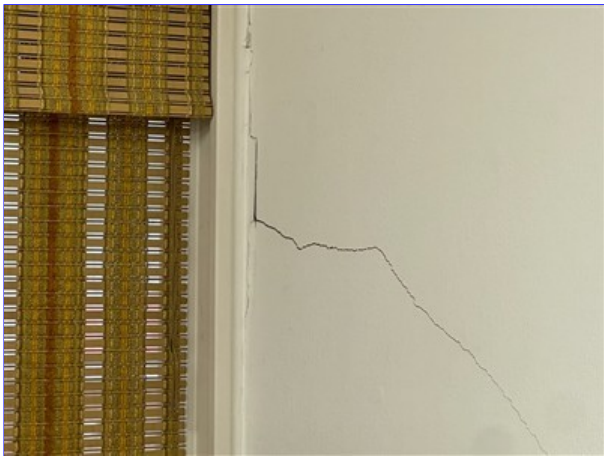
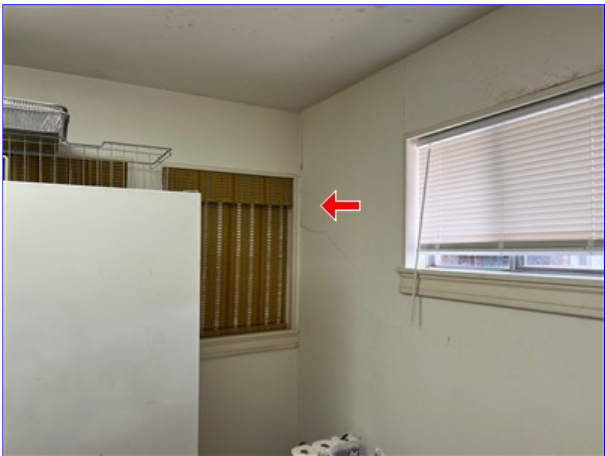
(7) Drywall stress cracks observed in the home. Some locations observed:.. Laundry room.

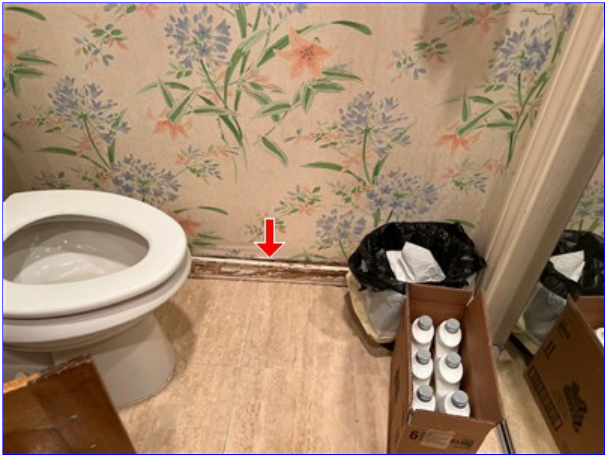
Primary bathroom

(8) At the primary bedroom half bathroom, moisture damage was observed at the baseboards of the exterior facing wall. The exterior side of the wall was missing mortar between a section of bricks and may be a possible source of moisture intrusion. Recommend correction to all damaged materials and consulting, a professional contractor to evaluate further.

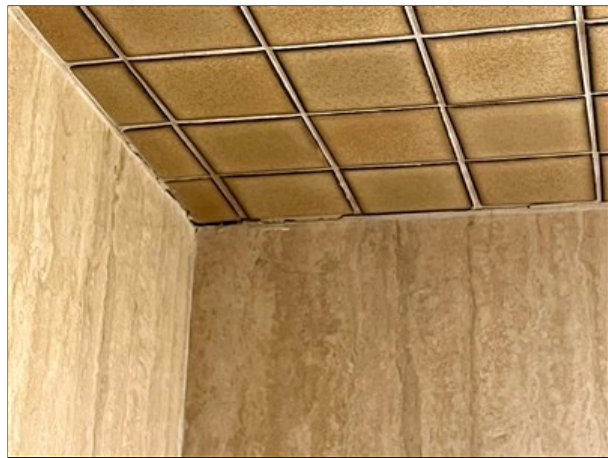
Primary bathroom

(9) All shower, tub, tile and what surround areas should be sealed. Recommend correction while grout/ sealant that has degraded or was missing.

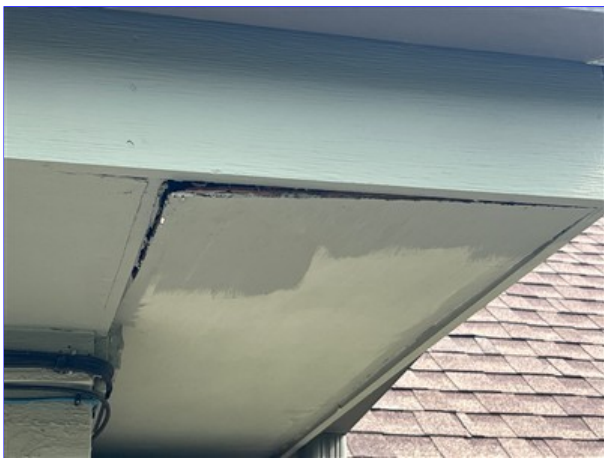
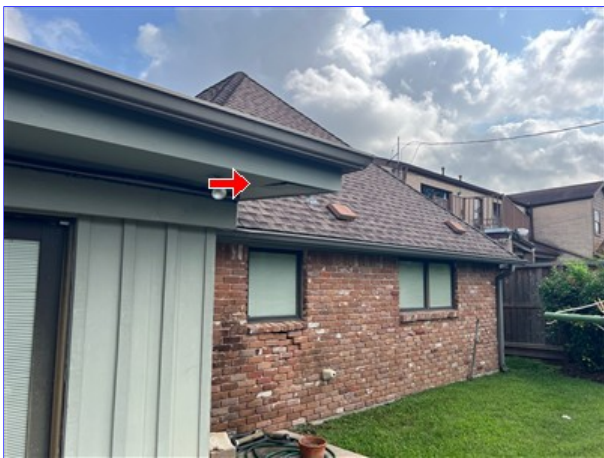
(1) Loose and/ or damaged materials were observed at some areas of the exterior soffit/ ceiling wood panel. Recommend correction.

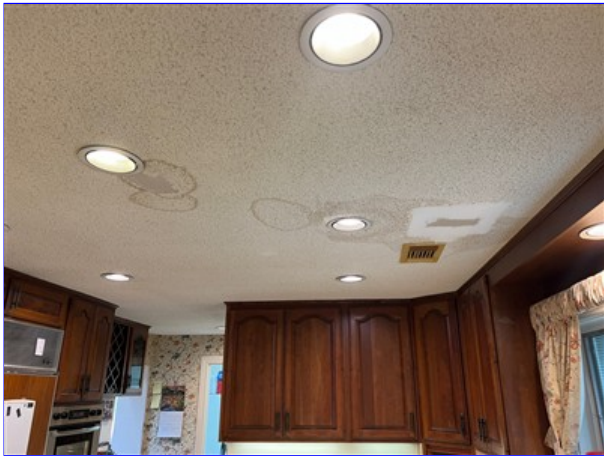
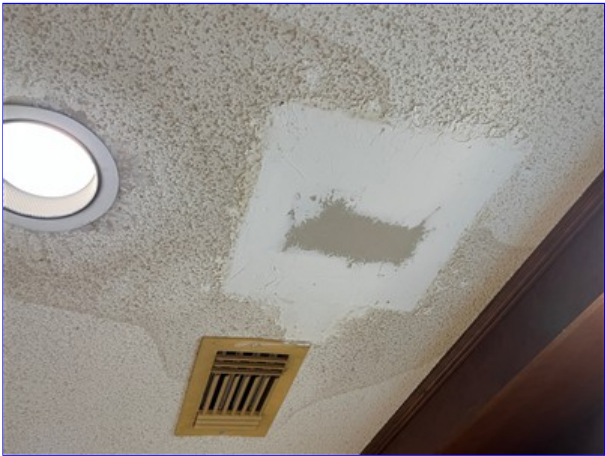
(4) At the kitchen, moisture stains were observed at the ceiling. The area was tested with a moisture meter and there were no high moisture readings detected during testing. Recommend correction to all damaged materials and consulting a professional contractor to evaluate further.

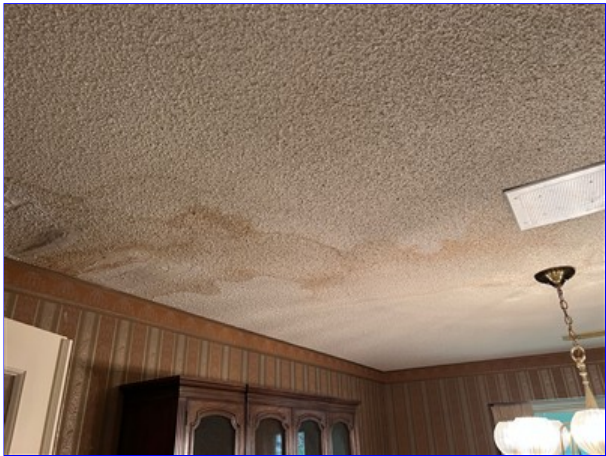
(5) At the dining room, moisture stains were observed at the ceiling. The area was tested with a moisture meter and there were no high moisture readings detected during testing. Recommend correction to all damaged materials and consulting a professional contractor to evaluate further.

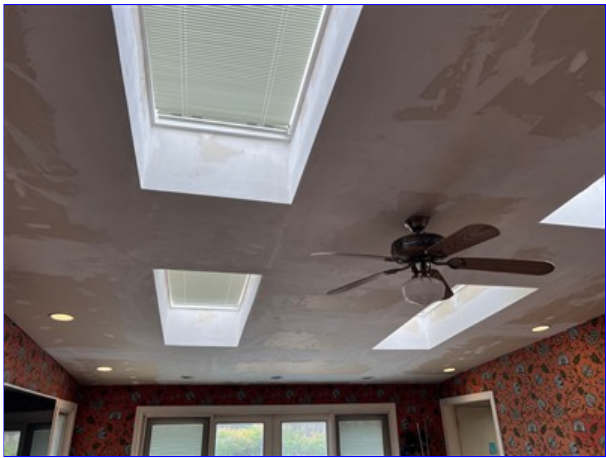
(6) At the sun room/ living area, unfinished ceiling drywall repairs were observed. Recommend correction.

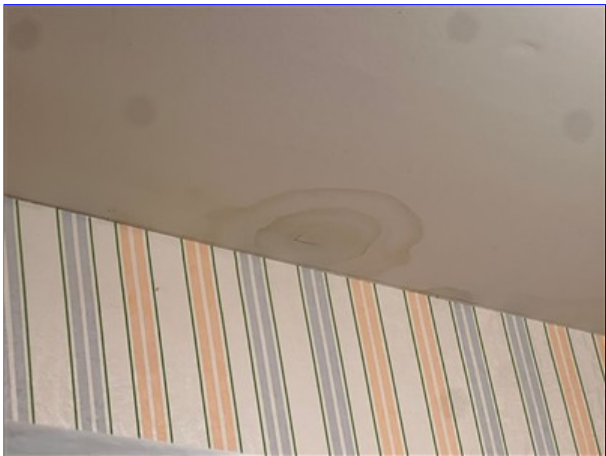
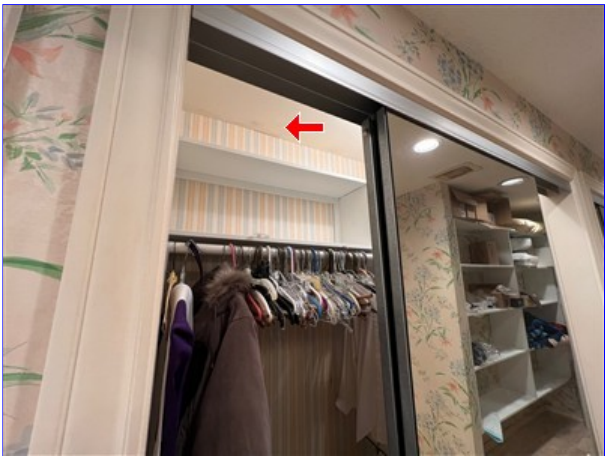
(7) At the primary bathroom half bathroom closet, moisture stains were observed at the ceiling. The area was tested with a moisture meter and there were no high moisture readings detected during testing. Recommend correction to all damaged materials and consulting a professional contractor to evaluate further.

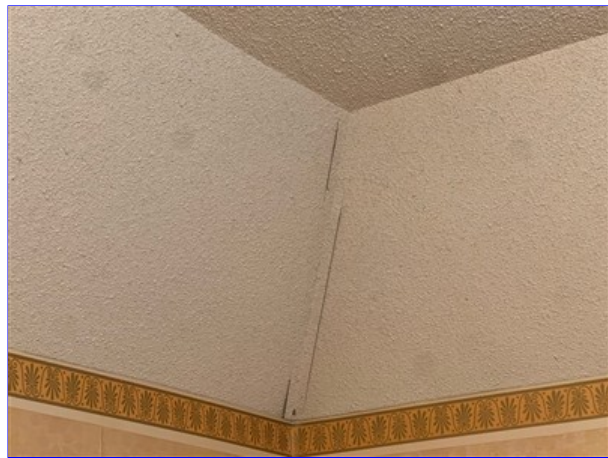
Primary bedroom

(8) Drywall tape joint cracks and/or nail pops were observed around the home. These are cosmetic in nature, and can be repaired as needed.

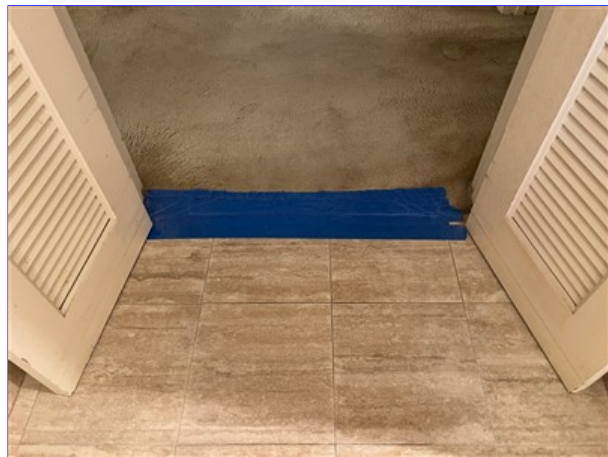
Primary bathroom

(9) Floor transition threshold piece was missing. Recommend correction.

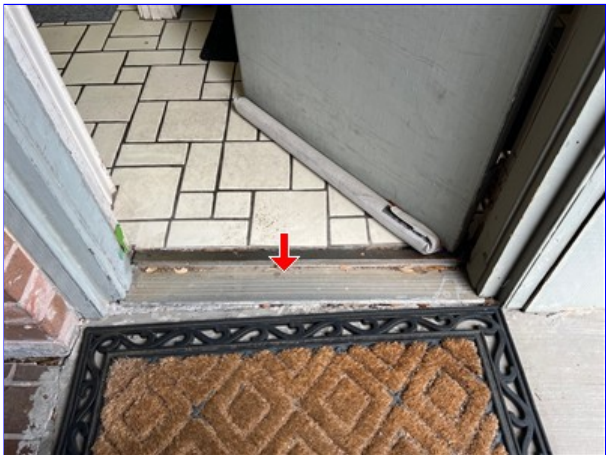
(1) At the back door, the threshold plate was loose. Recommend correction.

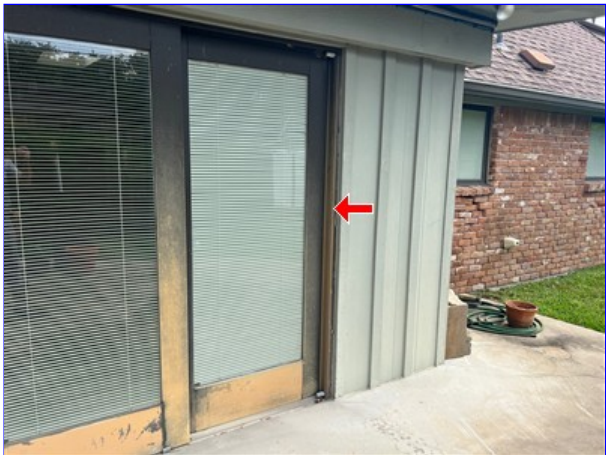
Garage apartment

(2) The perimeter sealant around door frames has deteriorated or was missing. Recommend correction.

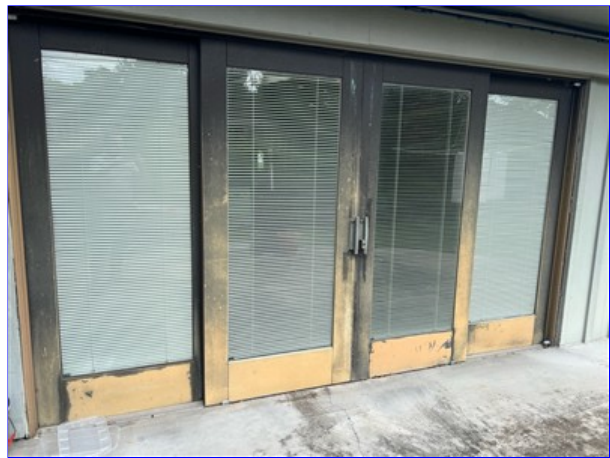
(3) The exterior finish of the back sliding doors was weathered/damaged. Recommend correction to protect an extended life of the material.

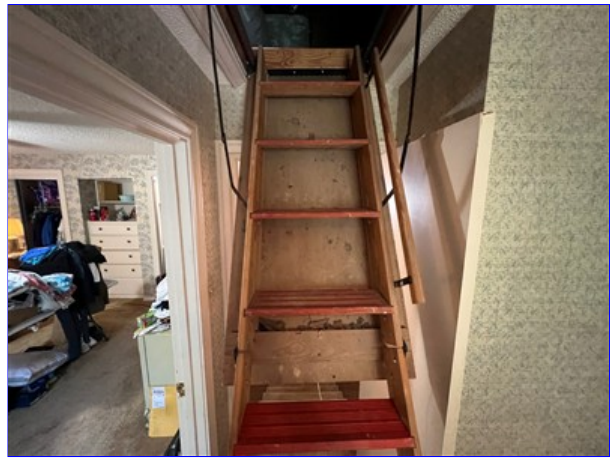
(4) The attic access door (pull down stairs), is not insulated or weather stripped. This door separates a non-conditioned space (attic) from the interior conditioned space and should be insulated and weather stripped for energy efficiency reasons.

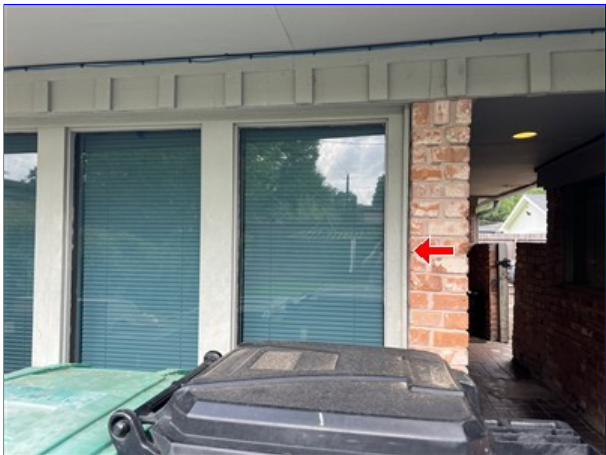
(1) Exterior perimeter sealant has deteriorated or was missing at some windows. Recommend correction.

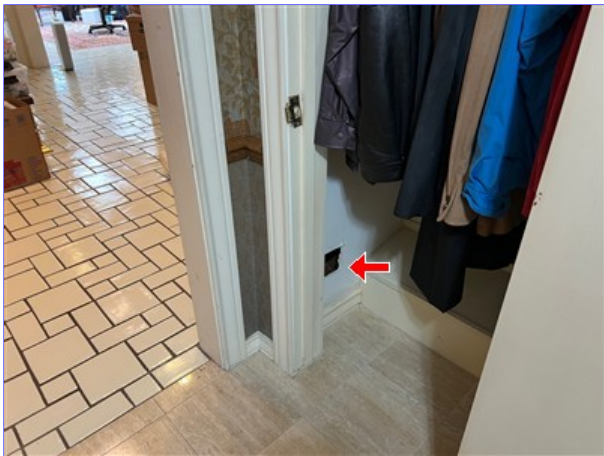
(2) The gas valve for the vented gas pipe was in a closet outside the reach of the fireplace. Recommend relocating closer.

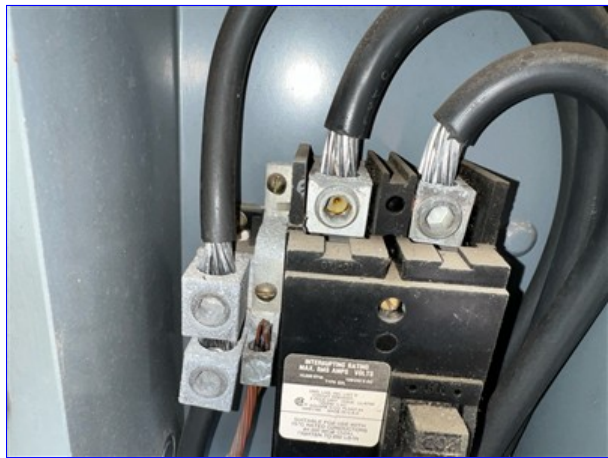
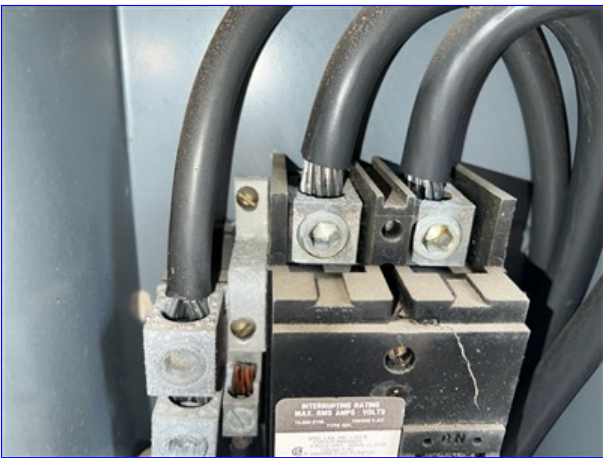
- (2) The panel is not equipped with a whole house, surge protection device. This may not have been required during the time period that this home was built. More stringent building codes have been established since that time and currently all dwellings are required to be equipped with a whole house surge protection device. I recommend that you consider adding one of these devices.
- (3) Anti-oxidant paste, was not observed on service entrance conductor terminations. Anti-oxidant paste is recommended to prevent corrosion at the terminations.

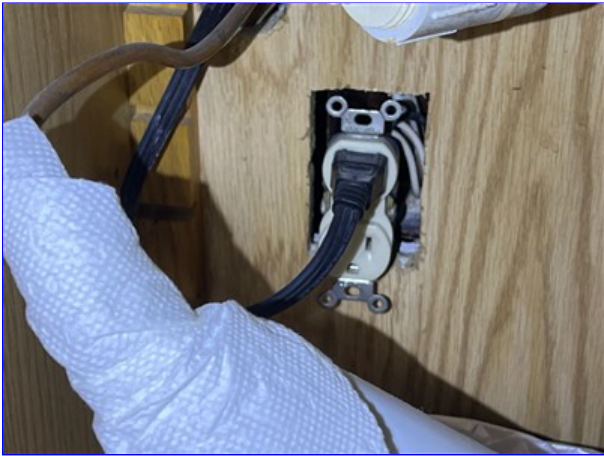
Kitchen wet bar cabinet

(7) Some electrical outlets were loose at the wall. Recommend correction. Some locations observed:..  
Kitchen wet bar cabinet.

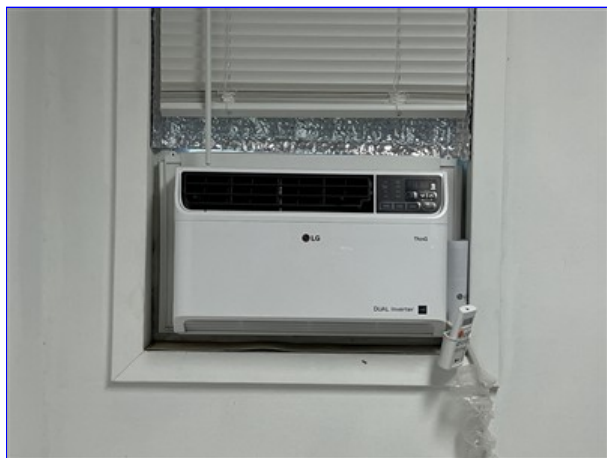
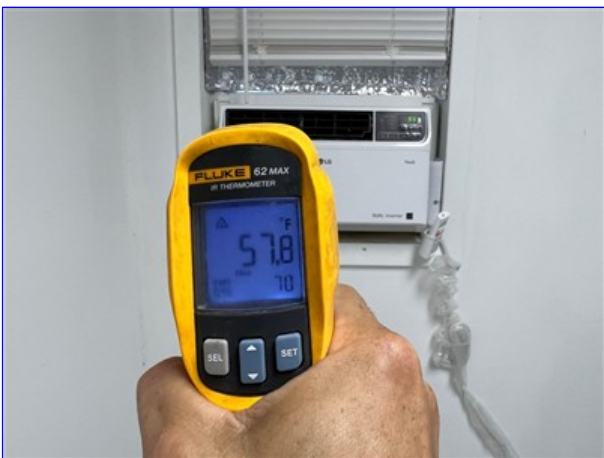
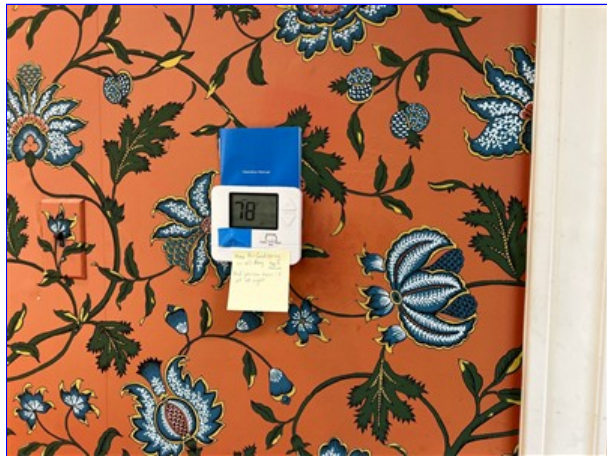
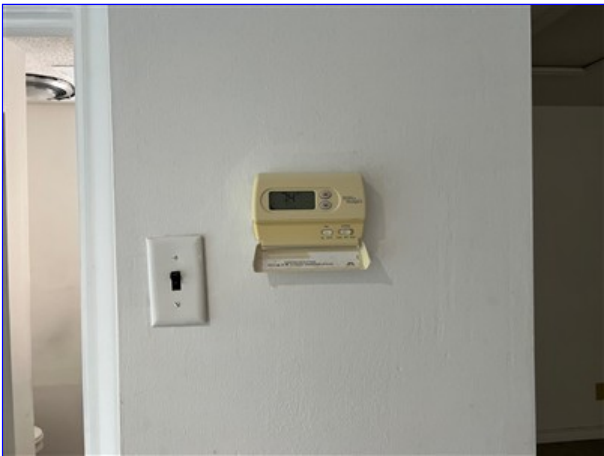
I recommend that you consult with a licensed heating ventilation and air conditioning professional to evaluate further.  
(3) At the garage apartment, the central AC unit was turned off and return air plenum intentionally blocked. Per the owner, the unit is operational and can be made active. It is controller by two thermostats for the same zone (Garage apartment, Sunroom living area)

A window unit was installed for cooling purposes. The window unit was producing conditioned air at 57°F.

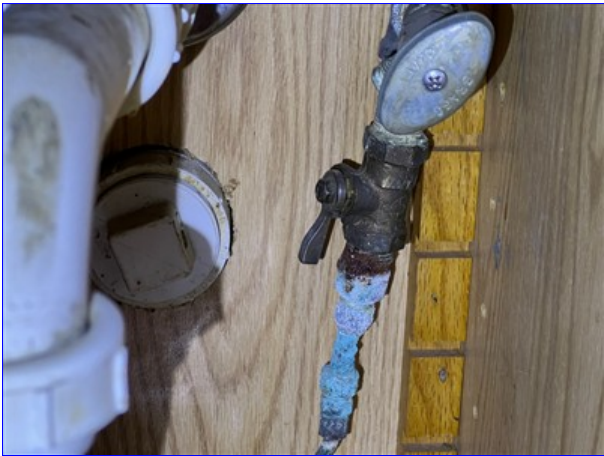
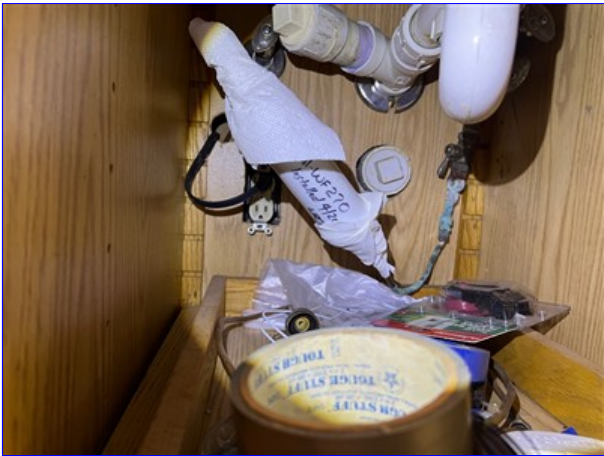
At the kitchen wet bar, corrosion was observed at the copper line tee off. There were no active leaks at the time of inspection. Recommend correction and further evaluation by a licensed plumber.

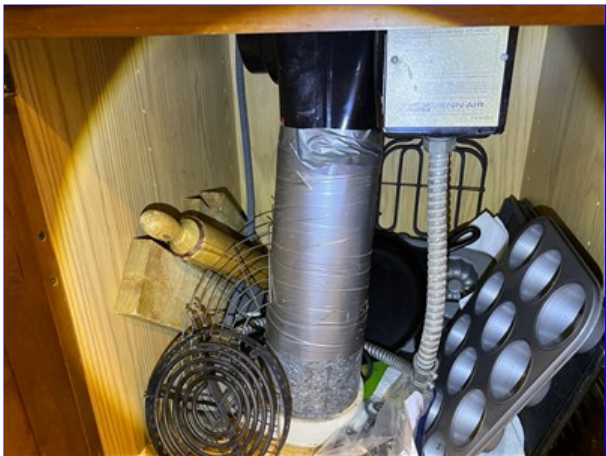
☐ ☐ ☐ ☒ **C. Range Hood and Exhaust Systems**  
**Exhaust/Range Hood:** DOWNDRAFT  
**Comments:**  
At the downdraft vent pipe, duct tape was used. This is an improper material for this type of installation. Recommend correction.
