# Inspection Report

**Property Address:**  
24902 Pavonia Lake Lane  
Tomball TX 77375

**House To Home Inspection**

# PROPERTY INSPECTION REPORT FORM

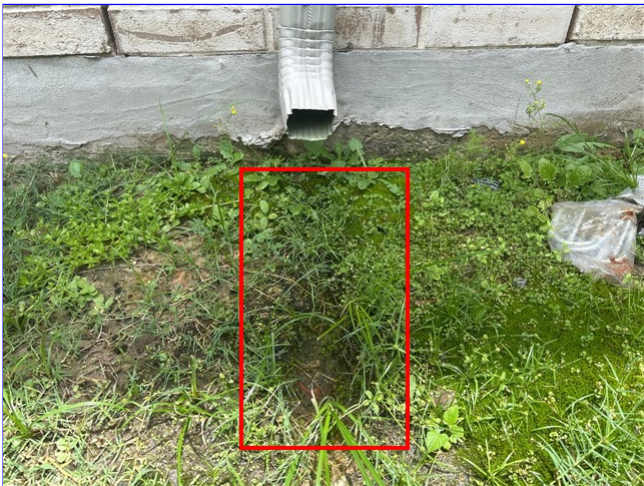
The splash blocks and/or gutter drain lines are missing at one or more of the gutter downspouts around the house. Splash blocks and/or gutter drain lines help to direct water draining from the roof away from the foundation and prevent washed out areas. I recommend evaluation by a qualified gutter installation contractor to repair or replace the splash blocks and/or gutter drain lines as needed.

B. Item 1 (Picture) View of gutter downspout missing splashblock and washed area

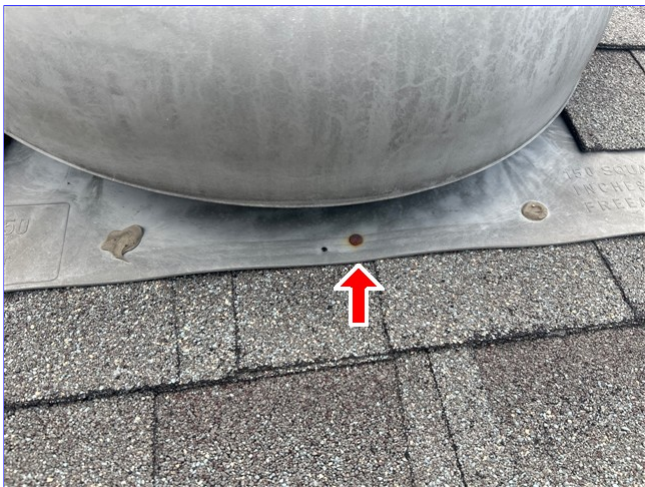
(1) There are one or more exposed nail heads on the roof ridge shingles and flashing areas. Exposed nail heads can rust and potentially fail which may cause roof shingle damage or roof leaks. I recommend having a qualified roofing company seal all nail heads. The pictures shown may not be all inclusive of every exposed nail.

D. Item 1 (Picture) View of exposed nail head at passive roof vent

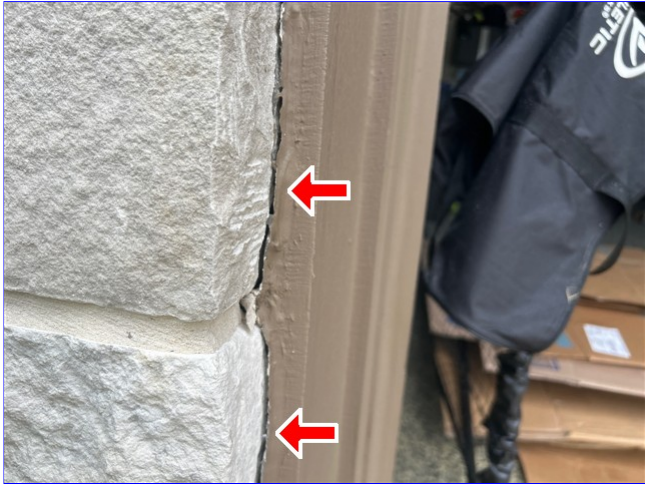
There were three or more areas of the exterior walls in need of being sealed such as, but not limited to wall penetrations, brick to siding transitions, and/or expansion joints. These areas present avenues for moisture and insect intrusion into the home structure and I recommend having a qualified contractor evaluate and apply caulking as needed throughout the exterior of the home.

E. Item 1 (Picture) View of brick veneer to garage door frame transition not sealed

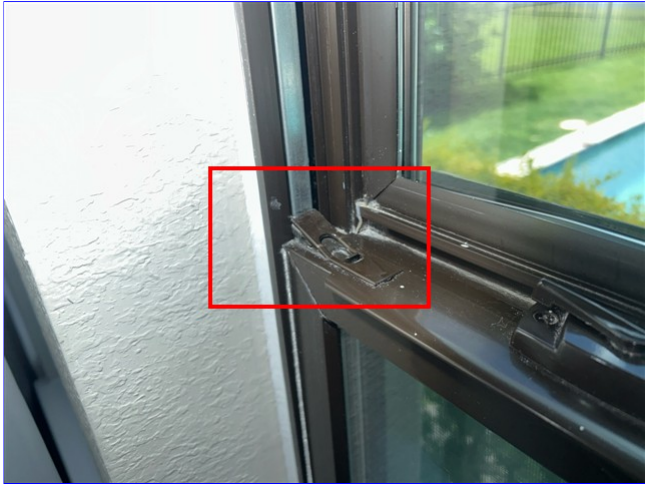
The window tilt levers were broken off at one or more of the windows throughout the home. The one I detected was the right hand window in the primary bedroom. In this condition the window does not properly open and may not tilt in for cleaning. I recommend consulting with a qualified window contractor to evaluate and repair as needed.

H. Item 1 (Picture) View of broken window tilt lever

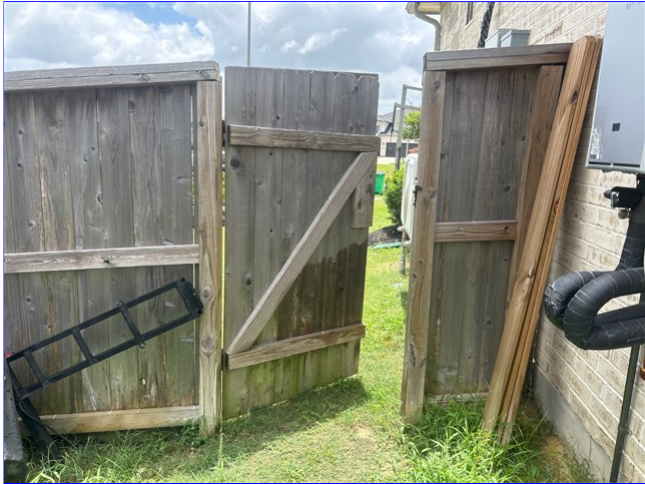
The home has a pool installed in the backyard and one or more of the privacy fence gates do not have self closing and latching hardware as required by current building standards. This hardware is required to prevent unauthorized access to the people and to prevent accidental drowning. I recommend consulting with a qualified fencing contractor to ensure the privacy fence gate is self closing and latching.

L. Item 1 (Picture) View of privacy fence gate not self closing or latching

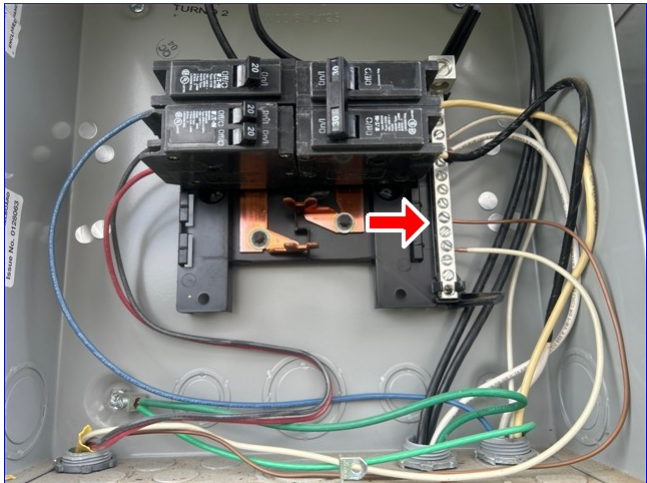
(1) The ground and neutral wires are bonded together in both electrical panels. Current building standards require the the bonding of the neutral and ground conductors be bonded together at the first means of service disconnect. In this condition return voltage on the neutral buss bars may allow electrical current to flow onto the bonded equipment, such as the metal enclosure of the breaker panel, which poses a shock hazard to building occupants. I recommend having a licensed electrician evaluate and repair as needed.

A. Item 1 (Picture) View of ground wire lugged into neutral buss bar of pool equipment sub panel

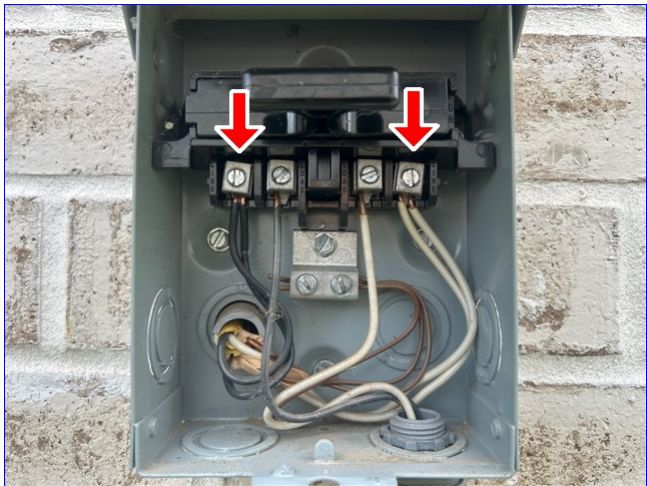
(2) There are double lugged power wires at the water heater service disconnect. Power wires should not share lugs/breakers but rather have separate lugs for each power wire as most electrical enclosures having a rating of only one wire per lug. In this condition the expansion of the wires when hot may result in the lug screws loosening and causing loose electrical connections which is an arc and fire hazard. While no evidence of loose electrical connections or arcing was present, I recommend further evaluation and repair by a licensed electrician.

A. Item 2 (Picture) View of double tapped line side lugs on water heater service disconnect

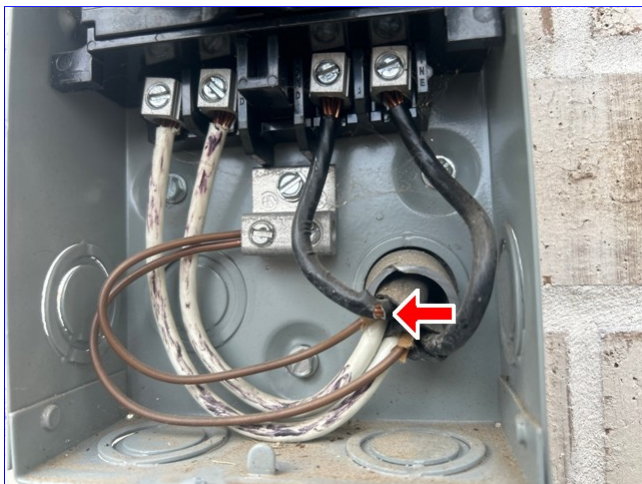
(3) The wire insulation on the wires of the top cooling system service disconnect was improperly cut exposing the wire conductor. This presents an arc hazard and while no evidence of arcing was observed, I recommend further evaluation by a licensed electrician.

A. Item 3 (Picture) View of exposed wire conductor with damaged insulation

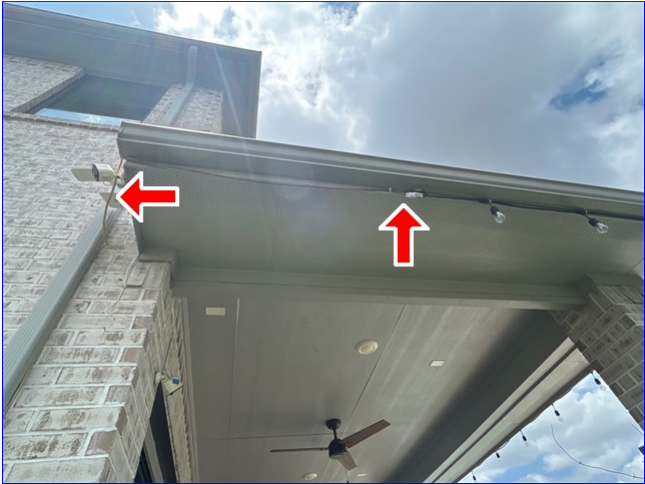
(1) There is an extension cord used for permanent wiring at the rear porch of the home. Extension cords are not rated for permanent wiring and the insulation may rapidly deteriorate with exposure to the weather elements. I recommend further evaluation and repair by a licensed electrician.

B. Item 1 (Picture) View of extension cord used for permanent wiring at rear porch

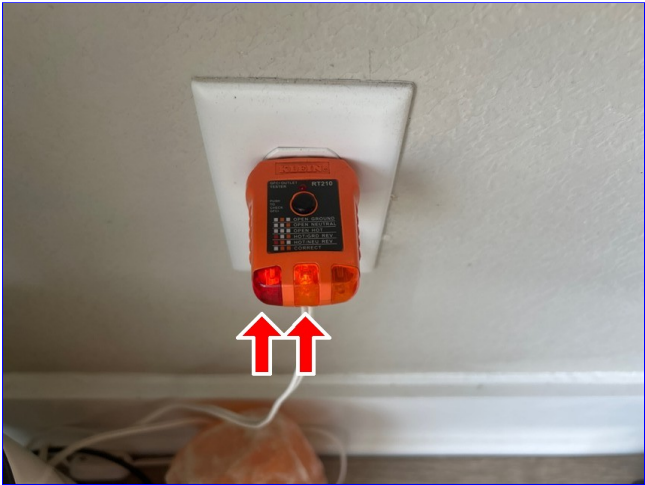
(2) There was an improperly wired outlet at one or more locations throughout the home. The hot and neutral wires were reversed. In this condition the outlet may not be properly protected from ground faults which poses a shock hazard as well as may damage sensitive electrical equipment. I recommend further evaluation and repair by a licensed electrician.

B. Item 2 (Picture) View of reverse polarity outlet in the foyer area of the home

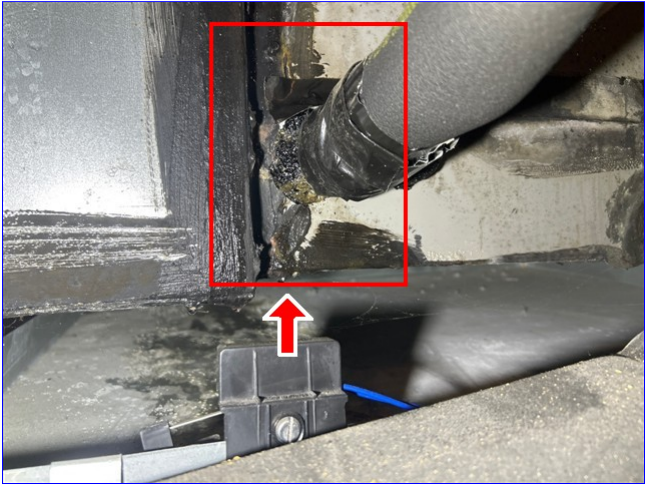
- (1) There was condensation forming on the outside of the evaporator and supply plenum of cooling system  
2. Condensation forming on the outside of the system may leak onto the attic floor and the ceiling below causing moisture damage. This is also a potential indicator of an airflow or insulation issue with the system and I recommend further evaluation and repair by a licensed HVAC technician as needed.

B. Item 1 (Picture) View of condensation forming on the outside of cooling system 2 in the attic space

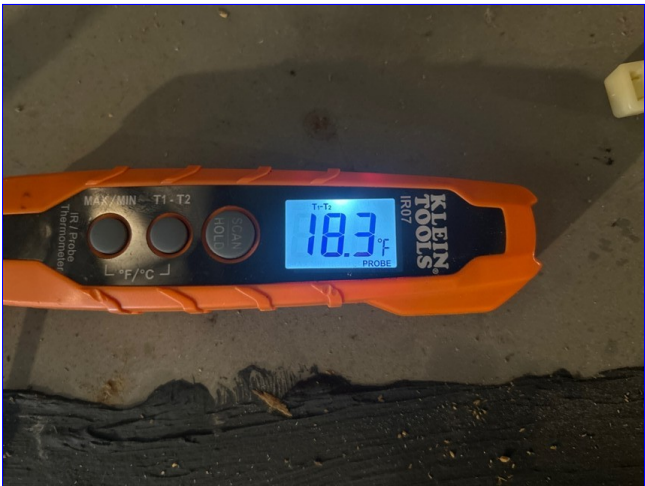
(3) The temperature delta between the return air and the cooled supply air across the evaporator coil for cooling system 2 was on average 18.3 degrees F. This is considered an acceptable temperature delta. The Delta on a correctly functioning cooling system should approximately be between 15 and 22 Degrees F depending on humidity and other factors.

B. Item 2 (Picture) View of the measured delta T across the indoor component of cooling system 2

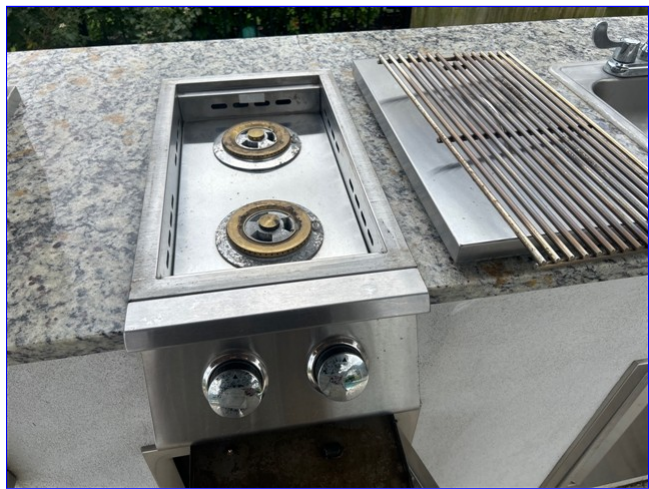
H. Item 1 (Picture) View of outdoor gas range unable to light the burners

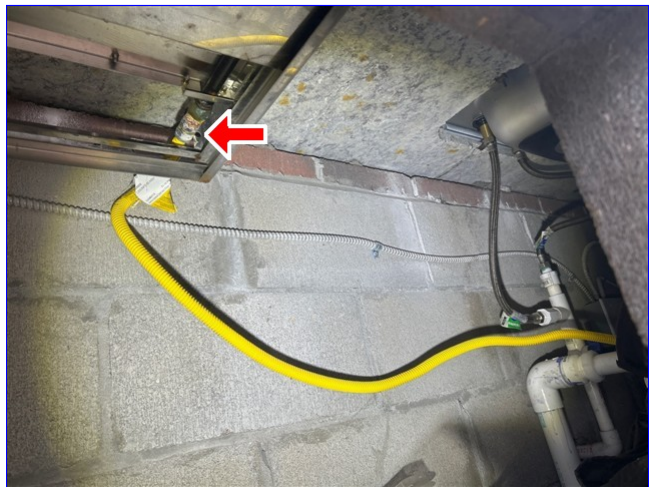
The gas range did not have an accessible gas shutoff valve at the outdoor cooking equipment. The shutoff valve is a quick means of turning the gas off to the appliance in the event of a fire or other emergency. I recommend consulting with a licensed plumber to add a gas shutoff valve at the outdoor cooking equipment as needed.

H. Item 2 (Picture) View of gas line serving the outdoor gas range missing shutoff valve
