## FOUNDATION INSPECTION

5407 Fleming Rock Ln  
Fulshear, TX 77441

08/04/2026

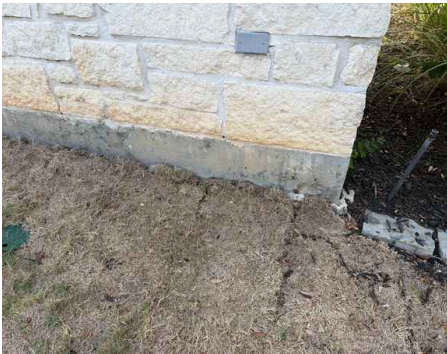
The foundation was a concrete slab on grade, and was reinforced with post tensioned cables.

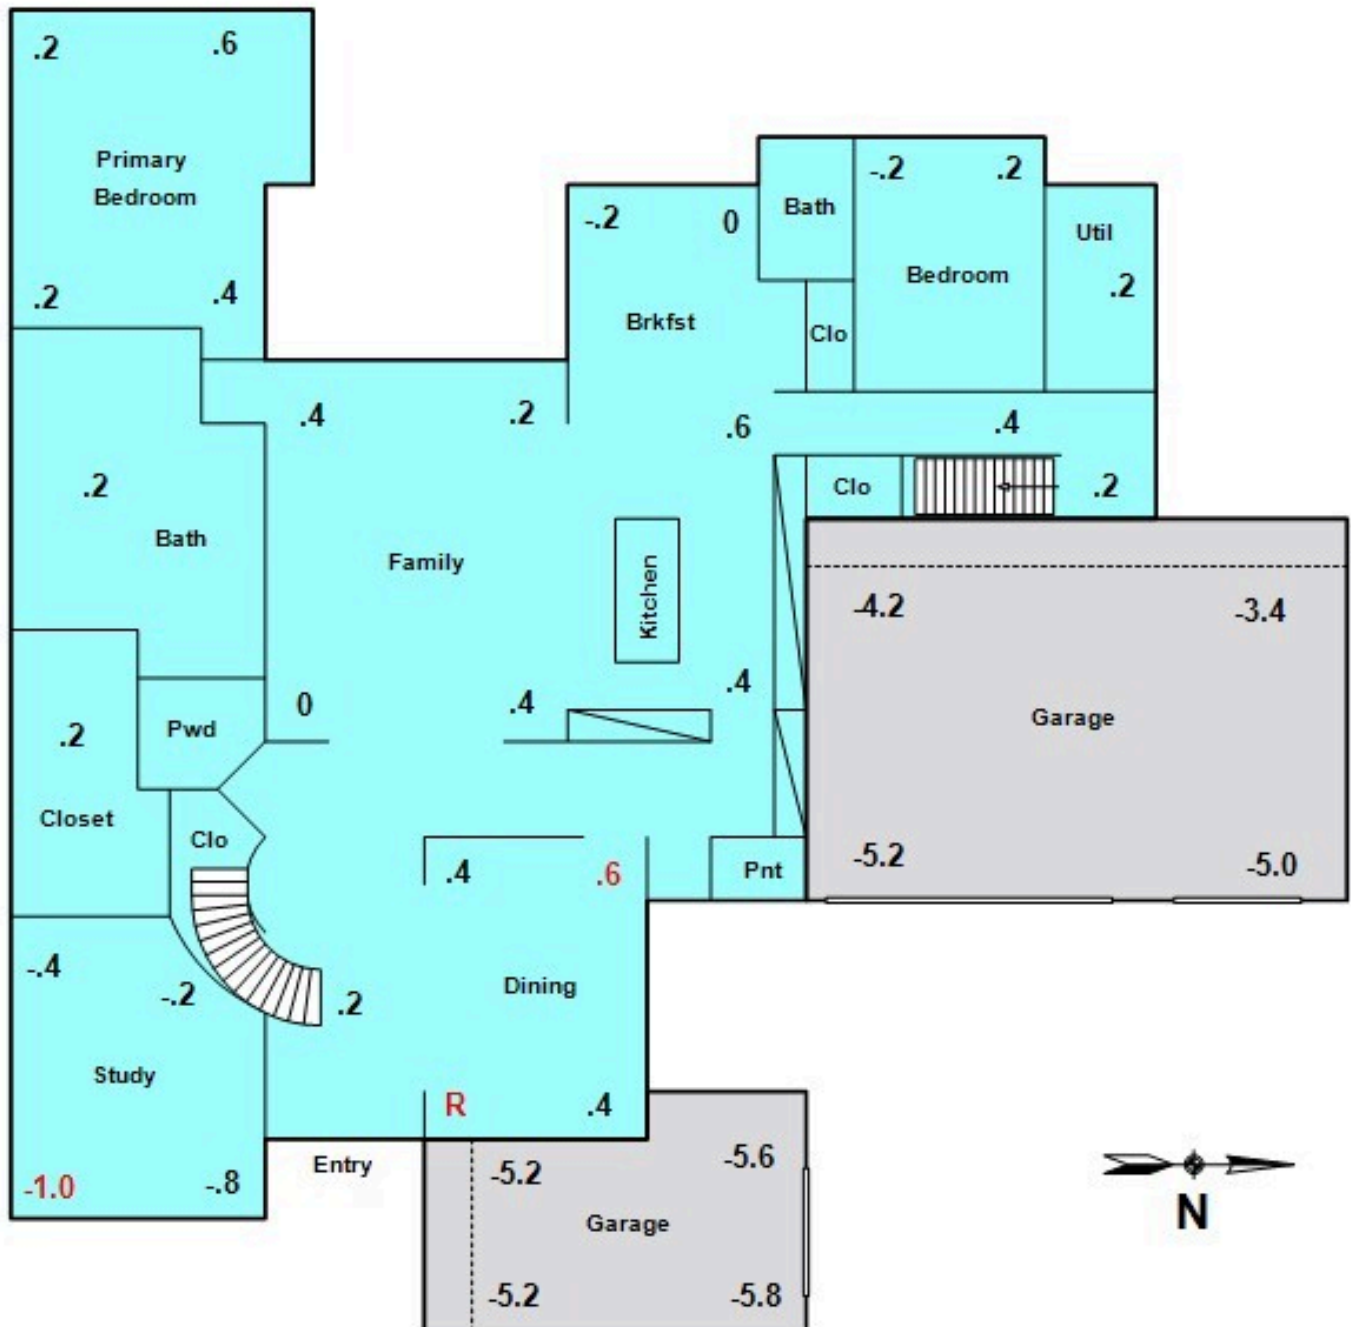
### Elevations Readings 5407 Fleming Rock Lane

The floors were checked with an electronic level, and were observed to be sloping towards the southeast side of the house. The difference in elevation between the high point and low point was 1.6 inches. The high point was located at the dining room, and the low point was located at the study. The unlevelness takes place over a horizontal distance of approximately 40-45 feet.

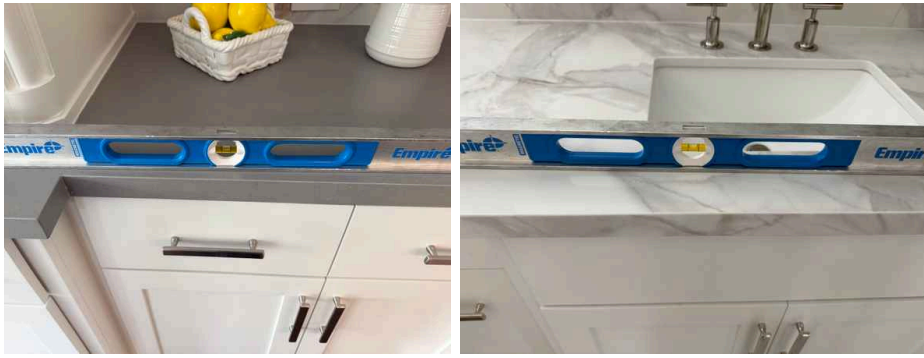
Normally horizontal surfaces (countertops, door frames, etc.) were observed to be generally level

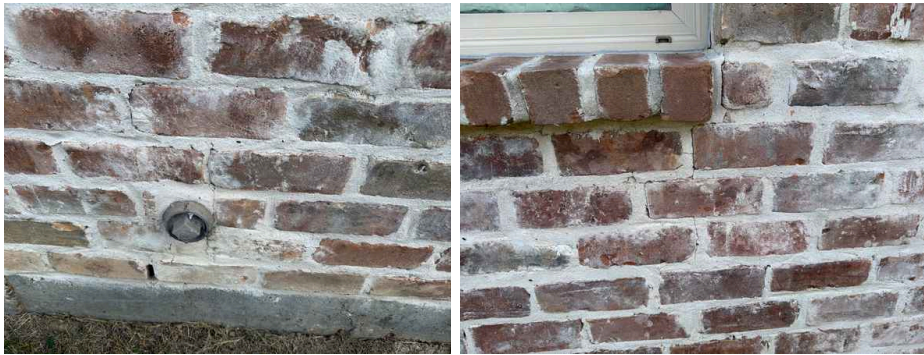
South

We observed that cracks in the exterior veneer were minimal in number and degree at the time of the inspection.

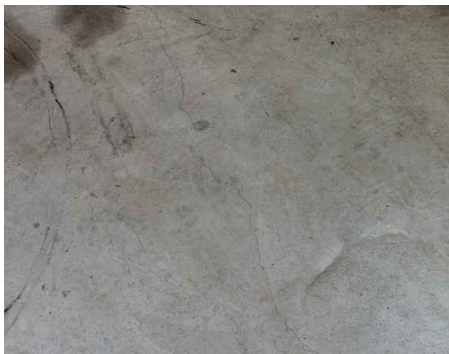
Cracking of the foundation concrete exists in virtually all foundations. It is pointed out that cracking is a normal property of concrete and other brittle materials, and Hedderman Engineering, Inc. assumes no responsibility should cracks be found that are not mentioned in this report. Some cracking was observed in this concrete foundation, including at the garage floor.

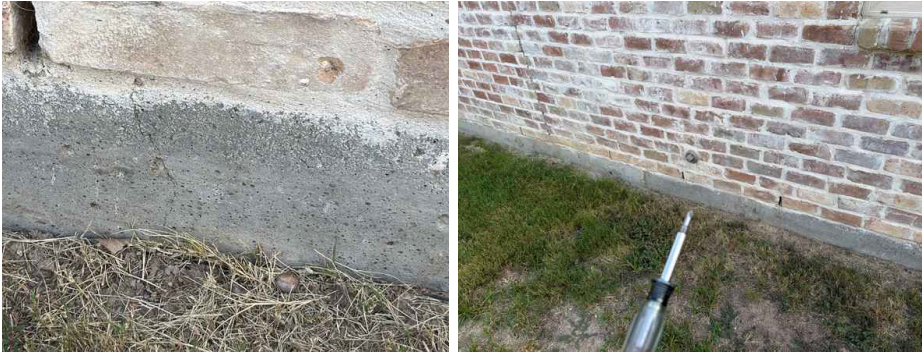
South

The foundation concrete was observed to have hairline cracks, including at the above locations.

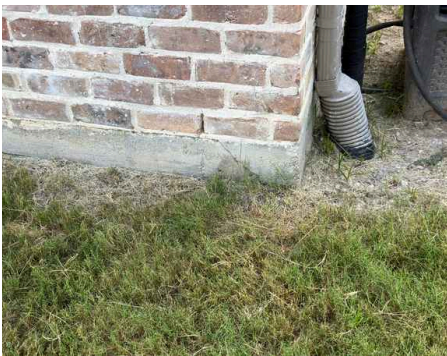
Southwest

The corner of the foundation was observed to be chipped at the above locations. This condition is typically caused by differences in thermal expansion between the brick veneer and the concrete foundation. Also, this condition can be caused by a lack of reinforcement in the corner of the foundation during original construction. In our opinion, this condition does not affect the overall structural integrity of the foundation.

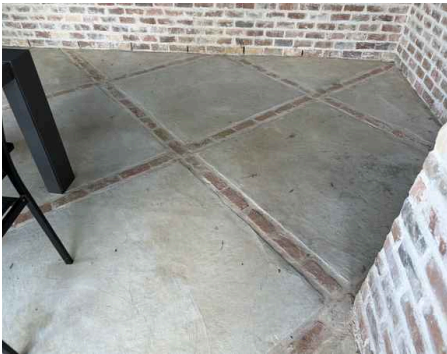
It is pointed out that a portion of the foundation concrete could not be viewed due to the concrete patio that adjoined the foundation.

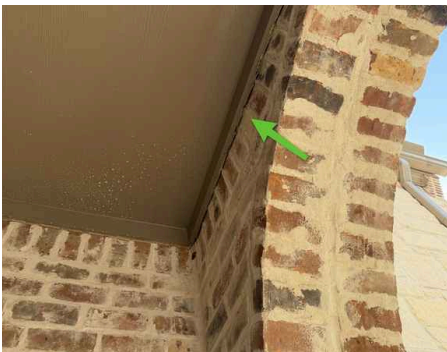
front

The frieze board was separated at the roof soffit, apparently due to movement of the foundation.

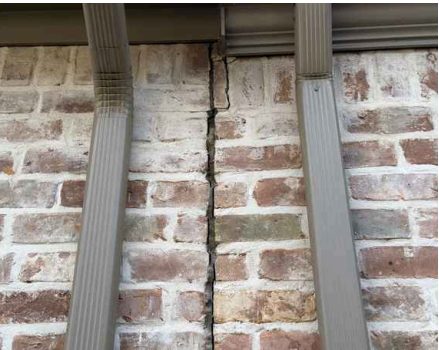
South

We observed separations at the expansion joint.

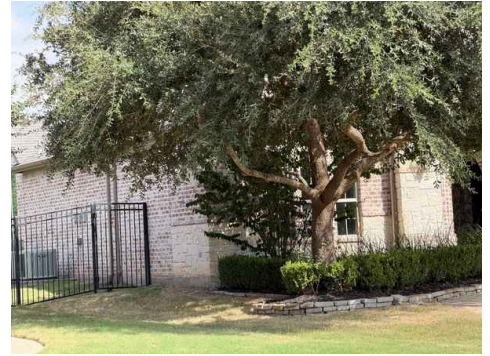
Trees and/or foliage were observed in the vicinity of the house which can contribute significantly to differential movement of the house foundation. Care should be taken to prevent the trees and foliage from removing an excessive amount of water from near the foundation of the house.

Contact a qualified professional.

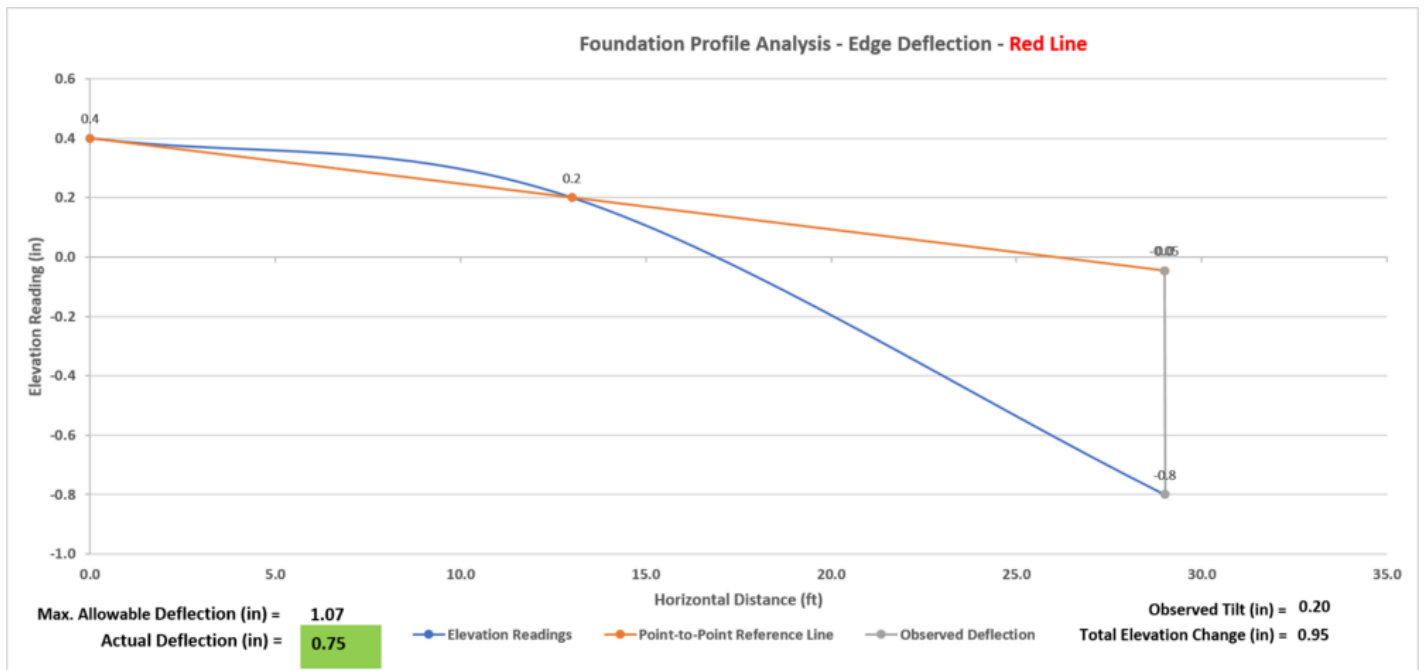
From the point of curvature located at the foyer to the study ( $L = 16$  feet), the maximum allowable deflection is 1.07 inches. We calculated a deflection of 0.75 of an inch at the time of inspection across this span, which is **less than the maximum allowable deflection, and is acceptable**. This observation can be observed along the **Red Line** in the sketch below.

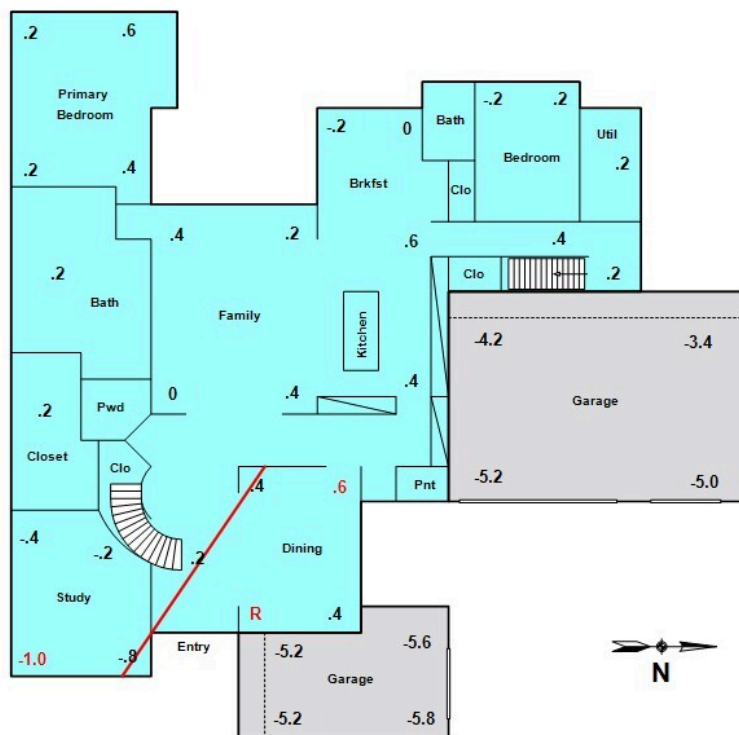
Most of the structures previously inspected by this firm have experienced some degree of differential foundation movement, and this structure was no exception. After careful examination, it is our opinion that the evidences of movement observed do not indicate excessive or unusual foundation movement. However, the foundation showed evidences of some differential movement at the southeast side of the house.

After careful examination, it is our opinion that the overall degree of the existing foundation movement for this structure is moderate, and is acceptable for a house of this age and type construction. The foundation is, in our opinion, functional and is not in need of releveling.

As a routine recommendation, it is recommended that the evidences of differential movement be monitored in the future to determine if the condition is stabilized, or if the foundation is continuing to settle. It is pointed out for your information that, due to the nature of the soils in this area, it is reasonable to expect that some movement of the foundation will happen in the future. It is also recommended that the soil around the foundation be kept moist by a regular watering program as the condition of the soil indicates.
