## SUMMARY

7318 Avenue J, Houston, TX 77011

TREC #24019

Bryan & Bryan Inspections

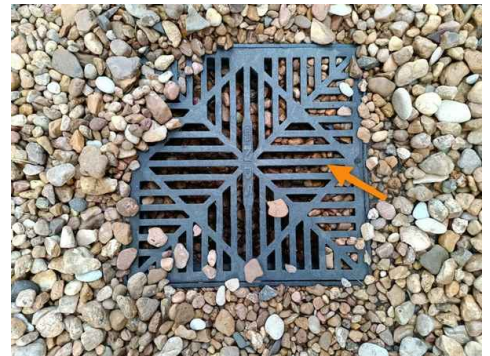
Right

#### **GRADING & DRAINAGE: CLOGGED CATCH BASINS**

Clogged catch basins will prevent the perimeter drainage system from operating correctly. Evaluate and remedy as needed.

Contact a qualified landscaping contractor

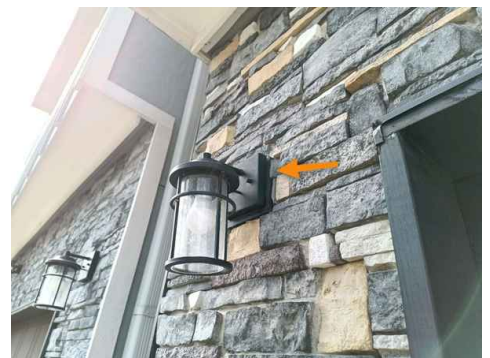
#### **EXTERIOR: SEAL EXTERIOR SURFACES**

One or more exterior surfaces were not adequately sealed/caulked. Proper sealing helps protect building materials from moisture intrusion, wood deterioration, and insect entry points, while also enhancing durability and appearance. See attached photos for examples. Seal all exterior surfaces as needed.

Light fixtures, front

Contact a qualified professional.

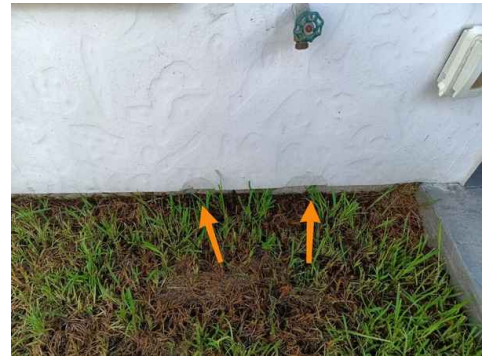
**EXTERIOR WALLS: SURFACE DEFECTS**

The exterior wall coverings, such as siding, trim, fascia, soffit, and/or eaves had observable defects. Examples include, but are not limited to:

Damaged siding, rear

Contact a qualified professional.

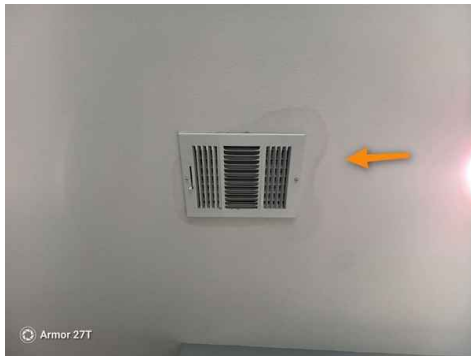
2nd Floor left bedroom

**CEILING: EVIDENCE OF PREVIOUS MOISTURE CONTACT**

Ceiling showed signs of previous water intrusion. Tested negative for moisture at the time of the inspection. Evaluation and remediation is recommended.

Contact a qualified professional.

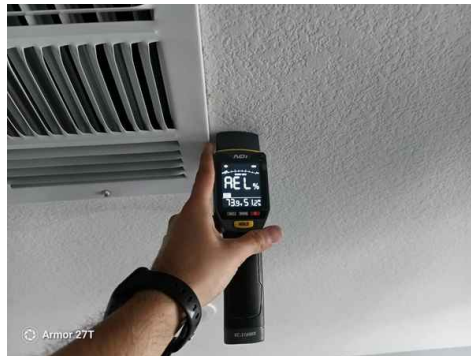
2nd Floor left Bedroom, tested dry

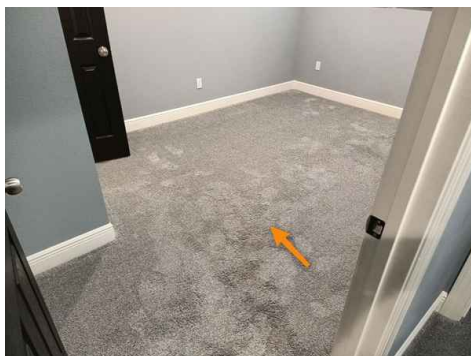
2nd Floor left bedroom

**FLOORING: SQUEAKY SUBFLOORING**

Squeaky subflooring is not uncommon and is usually caused by wood subflooring that isn't properly attached to the joists. These can generally be repaired by a flooring contractor. Evaluation and remediation is recommended.

Contact a qualified professional.

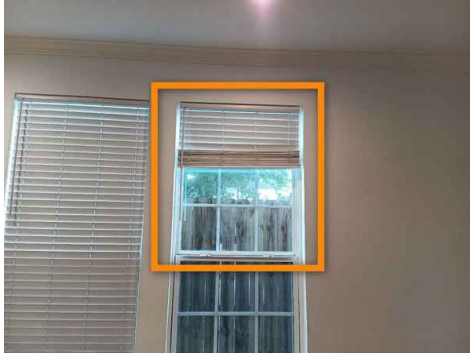
Living Room

**WINDOWS: FAILED SEALS OR LOW-E COATINGS**

There was evidence of failed seals or the Low-E coating on the panes was deteriorated. Evaluation and remediation by a window professional is recommended.

Contact a qualified window repair/installation contractor.

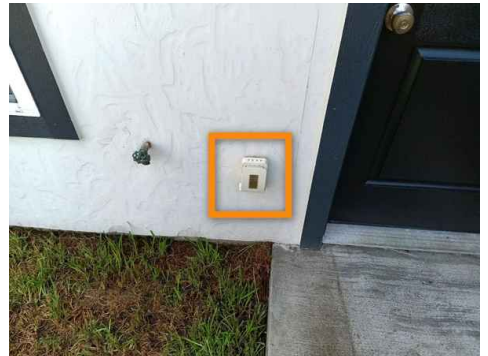
Exterior

**RECEPTACLES: GFCI PROTECTION INADEQUATE/MISSING**

GFCI protection was inadequate or missing. Current building standards recommend the installation of ground fault protection:

GFCI protection was not present in one or more of these locations. Evaluation and remediation is recommended.

Contact a qualified electrical contractor.

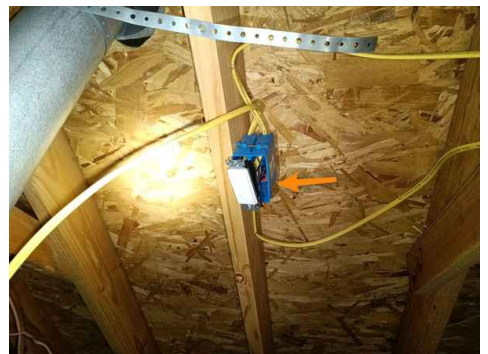
**RECEPTACLE/SWITCH COVERS: MISSING, LOOSE OR DAMAGED**

One or more receptacle/switch cover plates were missing, loose or damaged. Replacement of cover plates is recommended for safety. Evaluate and remedy as needed.

Loose, furnace switch

Contact a qualified electrical contractor.

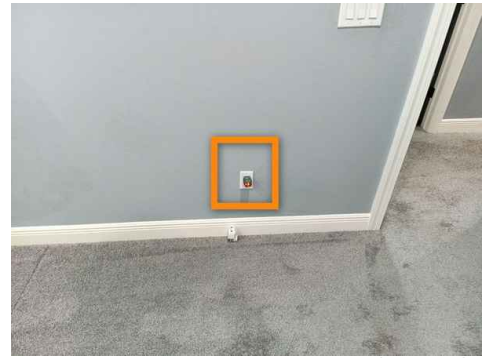
#### RECEPTACLES: IMPROPER WIRING

Receptacles were not wired correctly. Evaluation and remediation is recommended.

Hot / neutral reversed, second floor left bedroom

Contact a qualified electrical contractor.

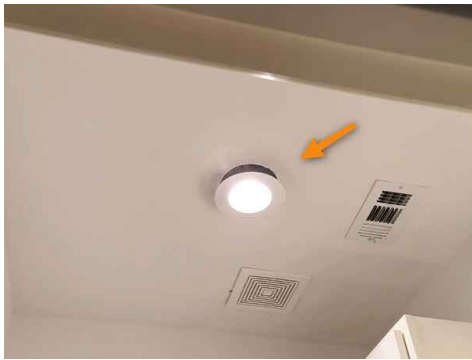
#### LIGHTS: FIXTURES OR GLOBES DAMAGED/MISSING/LOOSE

Light fixtures or globes were missing, damaged or loose. Evaluation and remediation is recommended.

Loose, half bathroom

Contact a qualified electrical contractor.

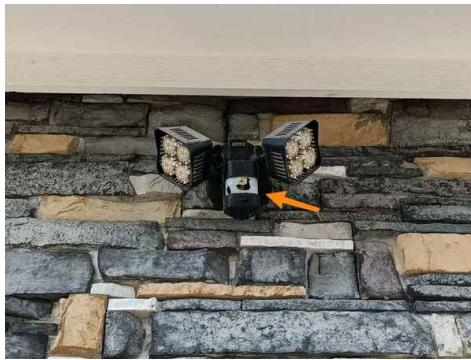
Damaged sensor, front

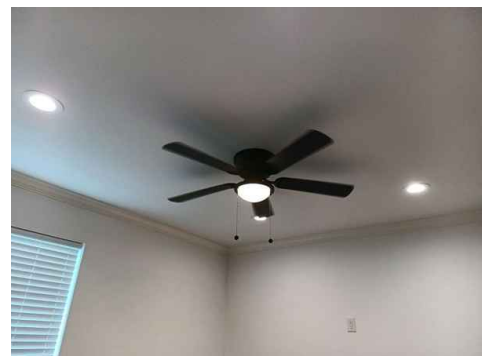
Living Room

#### FAN ONLY OPERATES WHEN LIGHT IS OFF

When the wall switch is flipped in the up position only the fan works and the light doesn't. And when the switch is flipped to the down position, the fan does not work and the light turns on. The wiring appears to not have been connected correctly. Evaluate and remedy as needed.

Contact a qualified professional.

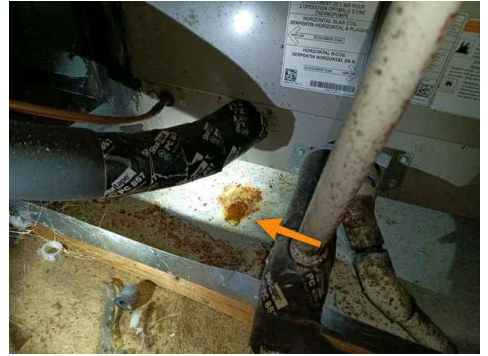
**CONDENSER: INSULATION MISSING/DAMAGED ON REFRIGERANT LINES**

There was a small gap in the insulation where the refrigerant line connects to the cabinet. This is causing some condensation to drip into the pan, indicated by the arrow in the photo. Evaluate and remedy as needed.

Contact a qualified HVAC professional.

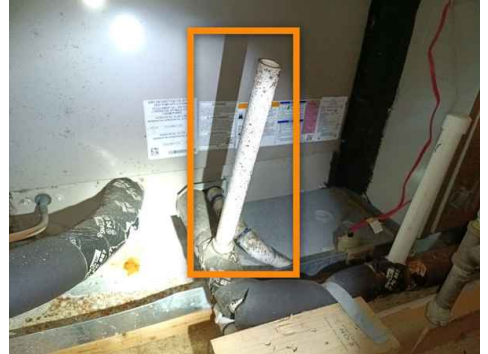
**CONDENSATE SYSTEM: INSULATION MISSING OR DAMAGED ON DRAIN LINES**

The pipe was condensating, adding additional pipe insulation is recommended.

Contact a qualified HVAC professional.

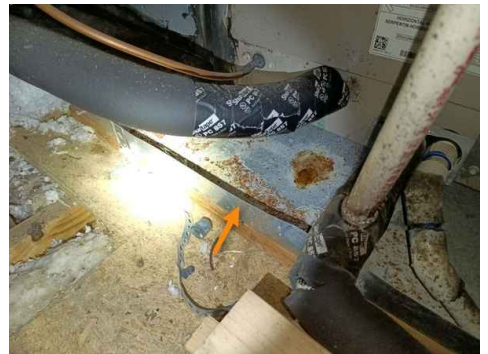
**CONDENSATE SYSTEM: EMERGENCY PAN DEFECTS**

The emergency overflow pans had one or more defects at the time of the inspection. Examples include, but are not limited to:

Corrosion, dry at time

Contact a qualified HVAC professional.

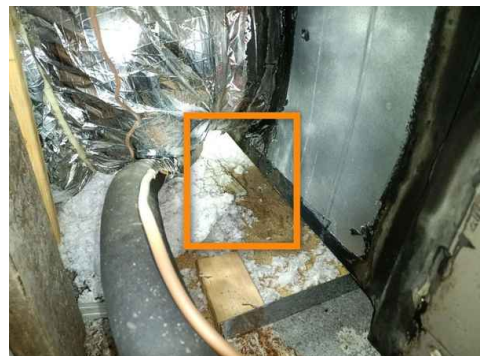
Under supply plenum

**CONDENSATE SYSTEM: DISCOLORATION UNDER, AROUND OR ON HVAC EQUIPMENT**

Discoloration under, around or on HVAC equipment indicates prior moisture contact. The area was dry at the time. Evaluation and remediation is recommended.

Contact a qualified HVAC professional.

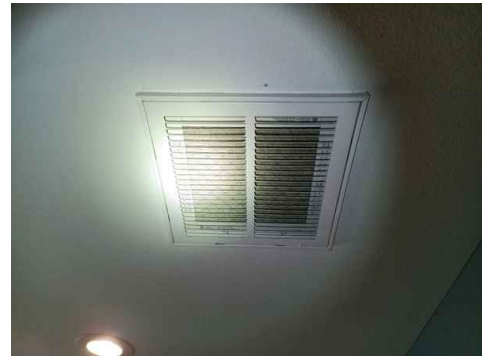
**FILTERS: REQUIRES REPLACEMENT OR MISSING**

The furnace filters may have been beyond their expected lifespan or were missing. In addition, inspector cannot determine what effect this has on the temperature readings. Replacement is recommended.

Dirty, primary bedroom

Recommended DIY Project

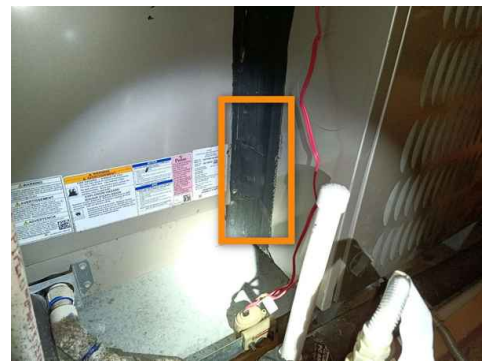
**DUCTS: DEFECTS PRESENT**

The HVAC ducts had one or more defects present at the time of the inspection. Examples include, but are not limited to:

Air leakage, coil cabinet

Contact a qualified HVAC professional.

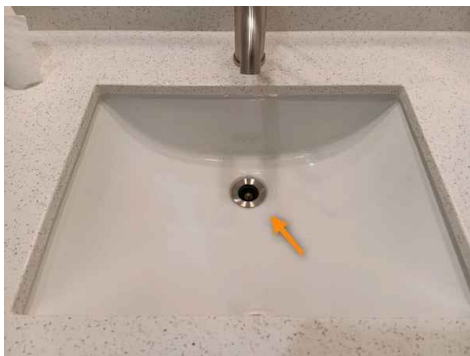
**FIXTURES: DRAIN STOPS MISSING, DAMAGED OR INEFFECTIVE**

Drain stops had issues that prevented them from working properly. Evaluation and remediation is recommended.

Missing stopper, half bathroom

Contact a qualified plumbing contractor.

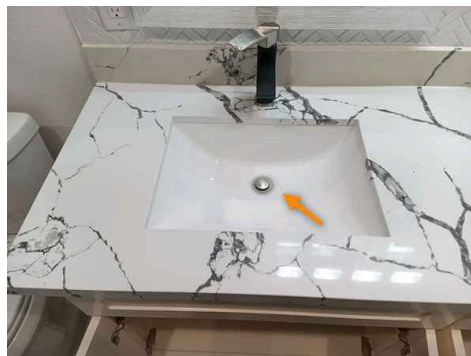
Stuck, Primary Bathroom

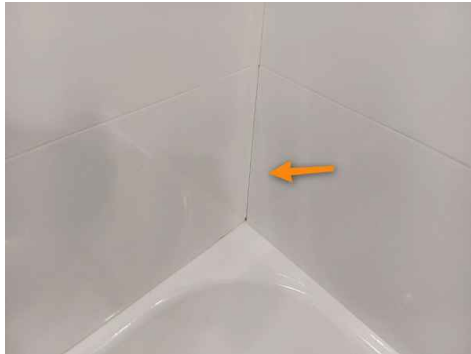
2nd Floor hall bathroom

**SHOWER/TUB: MISSING/DETERIORATED CAULKING OR GROUT**

Evaluation and remediation is recommended.

Contact a qualified professional.

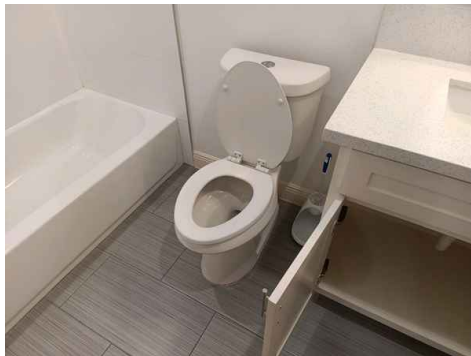
2nd Floor Hall Bathroom

**TOILETS: DID NOT FLUSH PROPERLY**

The handle needed to be held down to flush properly, typically an adjustment in the tank can be done. Evaluation and remediation is recommended.

Contact a qualified plumbing contractor.

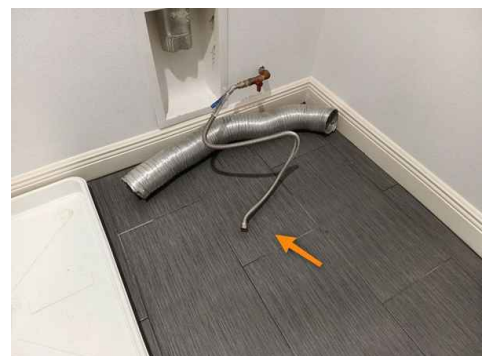
Laundry Area

**GAS PIPING: UNCAPPED GAS SUPPLY LINES**

Uncapped gas supply lines were present. Gas supply lines should be capped for safety when not in use. Evaluation and remediation is recommended.

Contact a qualified plumbing contractor.

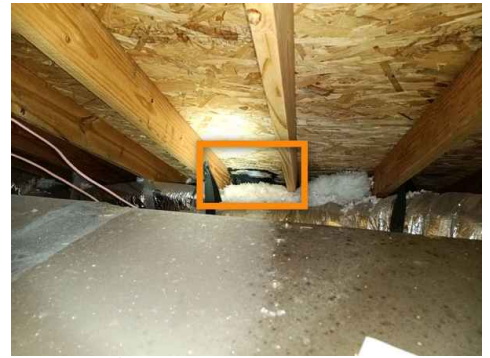
Middle of attic

#### LOOSE VENT PIPES

The bathroom exhaust vent pipes came loose from the underside of the roof. This can allow some of the exhaust into the attic. Evaluate and remedy as needed.

Contact a qualified professional.
