## SUMMARY

1130 Twin Deer Ln , Canyon Lake, TX  
78133

Sharon Leshikar  
08/24/2026

Aaron Paul  
TREC #24606  
Bryan & Bryan Inspections  
737-206-8318  
[office@inspectorteam.com](mailto:office@inspectorteam.com)

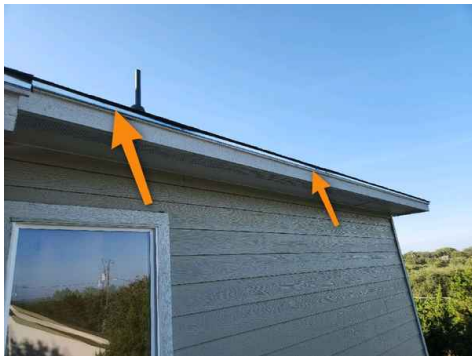
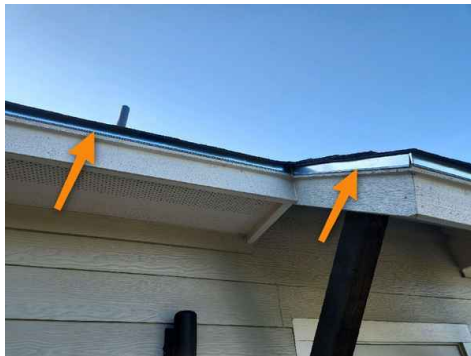
#### DRIP EDGE DEFICIENCIES

Unpainted

Deficiencies with the drip edge were present at the time of inspection. Evaluation and remediation is recommended.

For Example: Unpainted Drip Edge Flashings

Contact a qualified roofing professional.

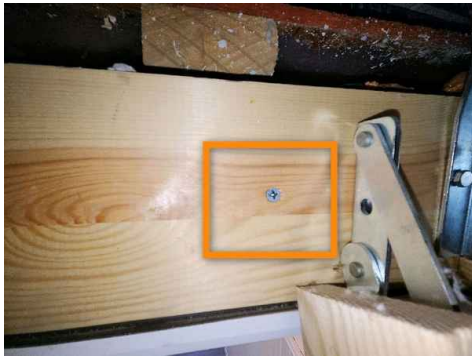
#### PULL-DOWN STAIRS/LADDER DEFECTS PRESENT

Screws Used

The pull-down ladder/stairs had one or more defects at the time of inspection. Evaluate and remedy as needed.

For Example:Attic Laddered should be mounted with 9d nails or lag bolts not construction screws

Contact a qualified professional.

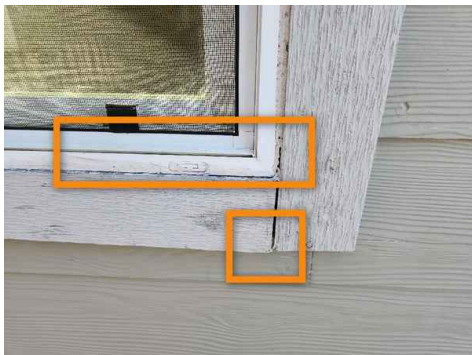
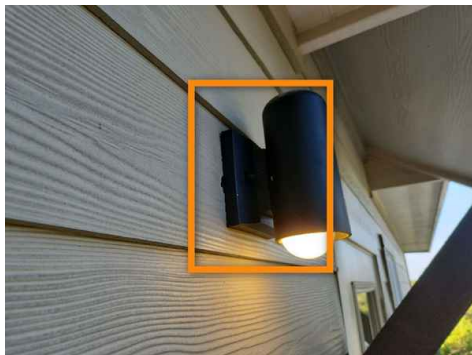
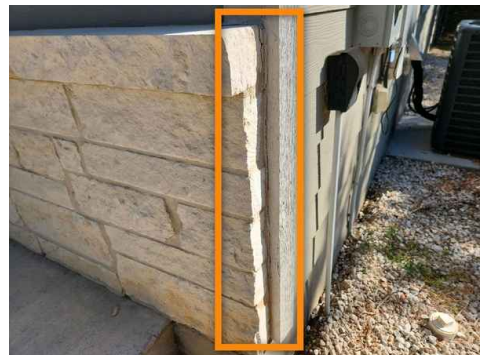
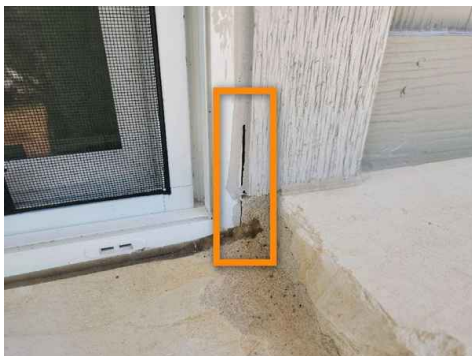
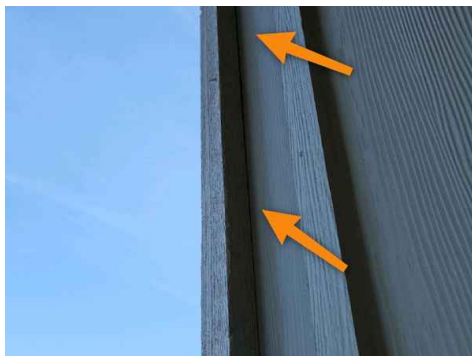
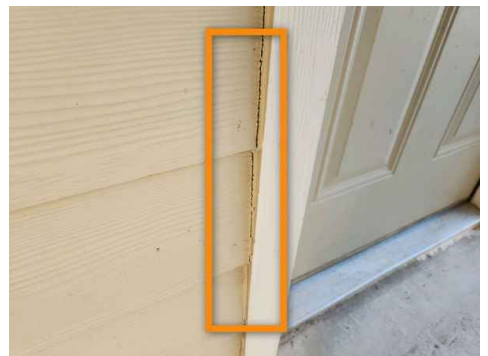
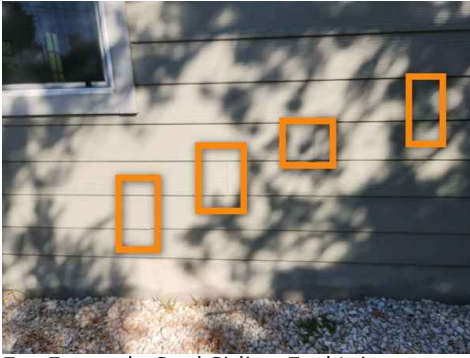
#### **EXTERIOR: SEAL EXTERIOR SURFACES**

One or more areas were not properly sealed/caulked. Most exterior sealants have a lifespan of 5 to 8 years and should be regularly maintained with that lifespan in mind. Evaluation and remediation is recommended.

For Example:Seal Around Windows and Trim Boards

For Example:Seal Around Light Fixtures

For Example:Seal Trim Boards

For Example:Seal Around Windows

For Example:Seal Door Trim

For Example: Seal Siding End Joints

Contact a qualified professional.

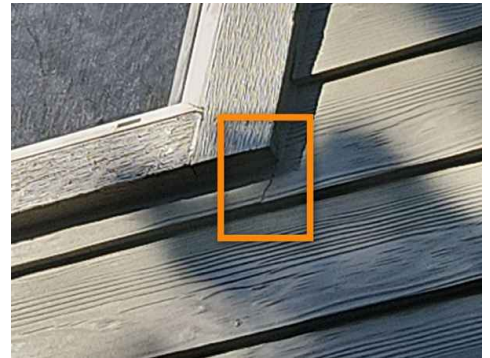
### EXTERIOR WALLS: SURFACE DEFECTS

The exterior wall coverings, such as siding trim, fascia, soffit or eave had defects present. Evaluation and remediation as needed.

For Example: Damaged Siding Rear

Contact a qualified professional.

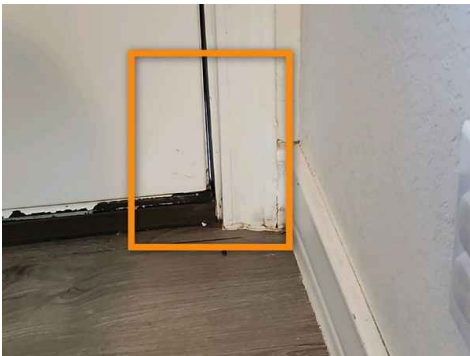
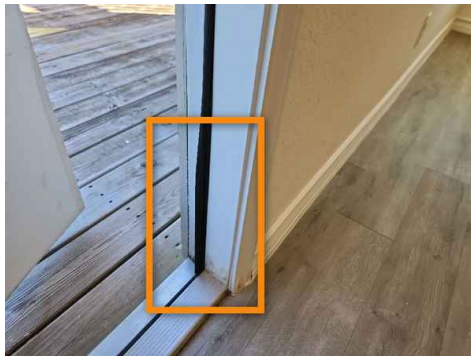
### DOORS: WEATHERSTRIPPING MISSING OR DAMAGED

Door was missing standard weatherstripping. This can result in significant energy loss and moisture intrusion. Evaluation and remediation is recommended.

Visible Daylight at Side Entry

Primary Bedroom Balcony

Contact a qualified door repair/installation contractor.

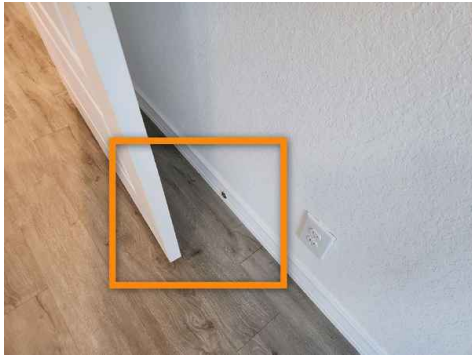
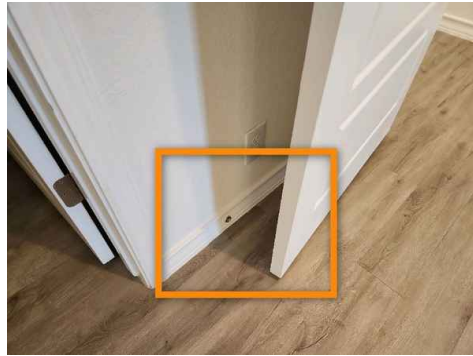
### DOOR HARDWARE: MISSING/DAMAGED HARDWARE

One or more doors had missing or damaged hardware. Evaluation and remediation is recommended.

Missing Door Stoppers 2nd Floor Bedrooms

Missing Door Stopper Primary Bedroom

Recommendation  
Contact a qualified professional.

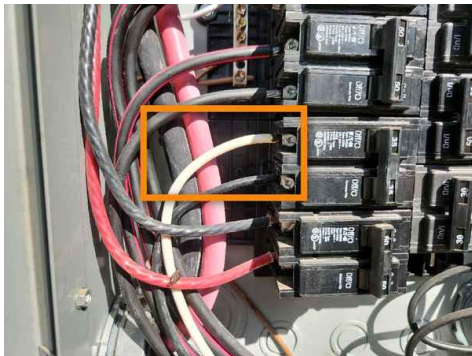
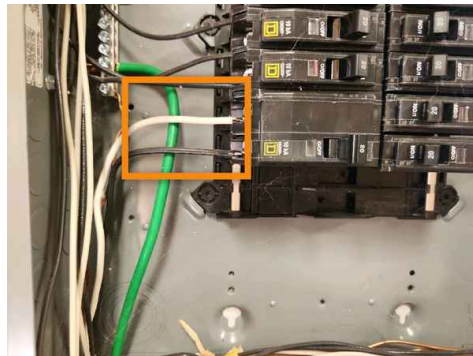
#### **WHITE WIRES NOT MARKED**

White wires connected to breakers were not marked with black or red electrical tape to indicate that they are "hot". Evaluation and remediation is recommended.

Recommendation  
Contact a qualified electrical contractor.

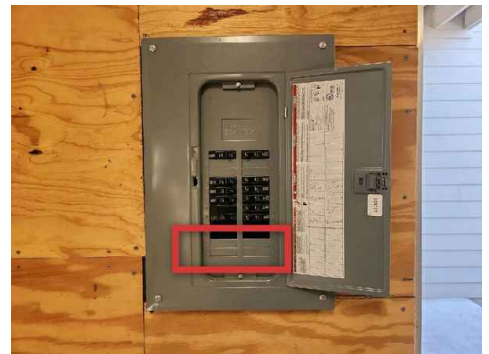
Garage Electrical Panel

#### **MISSING KNOCKOUTS**

Safety "knockouts" were missing from the panel cover. Evaluation and/or remediation by a licensed electrician is recommended.

Recommendation  
Contact a qualified electrical contractor.

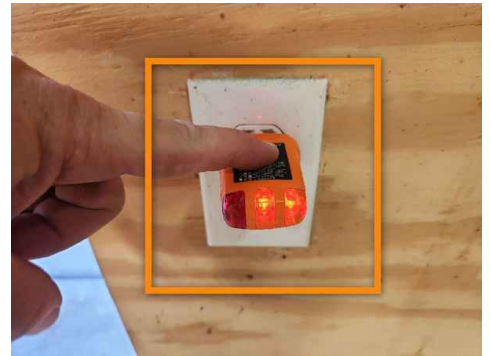
#### RECEPTACLES: GFCI PROTECTION INADEQUATE/MISSING

GFCI protection was not present in one or more of these locations. Evaluation and remediation is recommended.

For Example: Garage near the Entry

Contact a qualified electrical contractor.

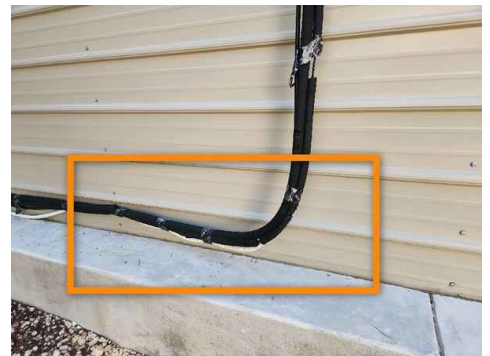
Garage Mini Split

#### CONDENSER: INSULATION MISSING/DAMAGED ON REFRIGERANT LINES

Missing or damaged insulation on refrigerant lines can cause energy loss and condensation. Evaluation and remediation is recommended.

Contact a qualified HVAC professional.

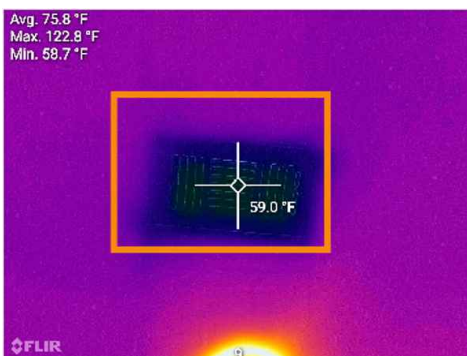
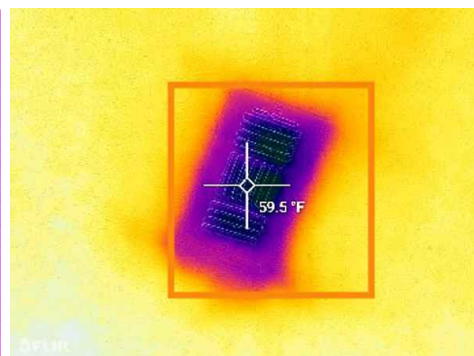
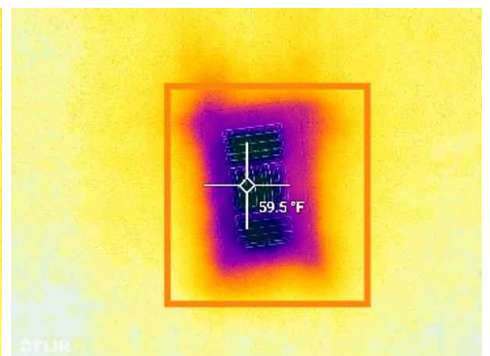
#### REGISTERS: REDUCED AIR FLOW

A supply air register that varies in temperature by more than 5 degrees from the others on the same floor indicates poor performance. Evaluate and remedy as needed.

Contact a qualified HVAC professional.

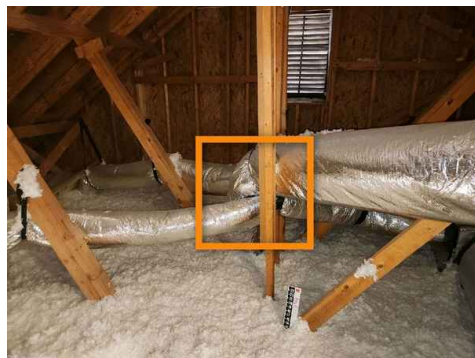
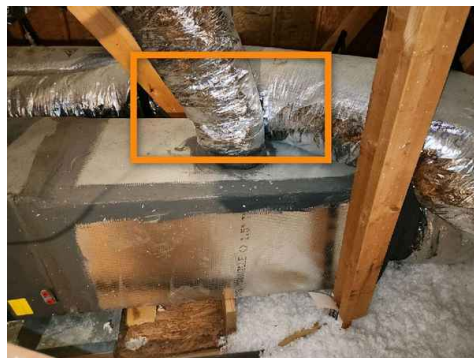
**DUCTS: DEFECTS PRESENT**

At the time of inspection one or more defects were present in the duct work. Evaluation and remediation as needed.

For Example:Ducts In Contact in the Attic

For Example:Ducts in Contact in the Attic

Contact a qualified professional.

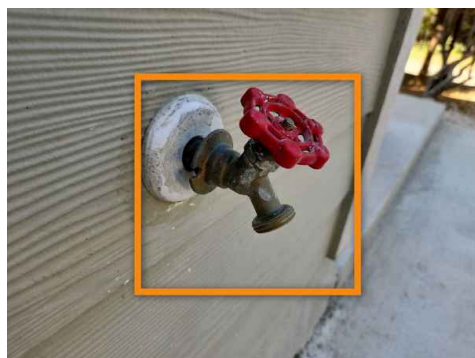
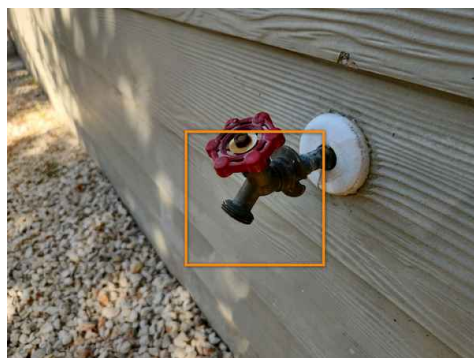
For Example: Left Side

**HOSE BIBB (OUTDOOR FAUCET): BACKFLOW PREVENTION MISSING**

Hose bibbs were missing a backflow preventer. These devices prevent contamination of potable water. Evaluation and remediation is recommended.

Contact a qualified plumbing contractor.

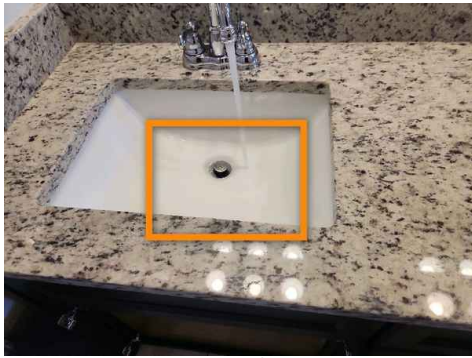
Primary Bathroom Left Side

**FIXTURES: DRAIN STOPS MISSING, DAMAGED OR INEFFECTIVE**

Drain stops had issues that prevented them from working properly. Evaluation and remediation is recommended.

Contact a qualified plumbing contractor.

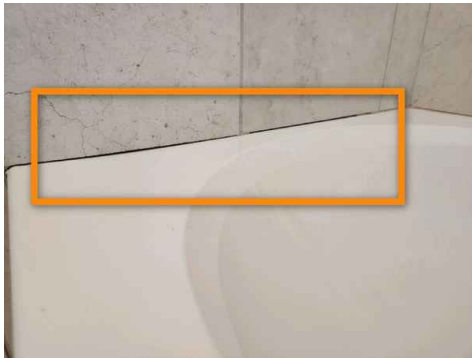
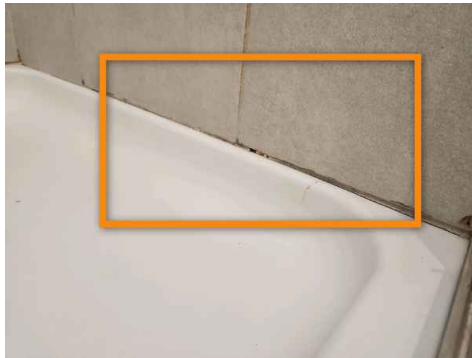
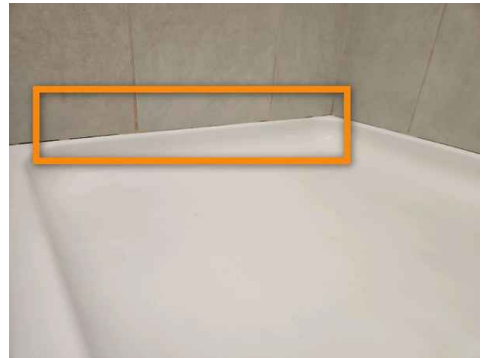
### **SHOWER/TUB: MISSING/DETERIORATED CAULKING OR GROUT**

Evaluation and remediation is recommended.

Contact a qualified professional.

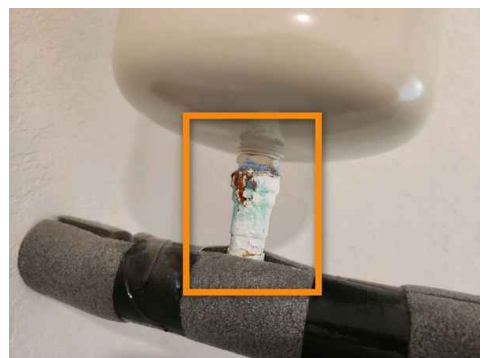
### **SUPPLY PIPING: CORROSION**

Various plumbing lines, fittings or valves were corroded. Evaluation of all plumbing lines and/or remediation by a licensed plumber is recommended.

Corroded Fittings at Water Heater  
Expansion Tank

Contact a qualified plumbing contractor.

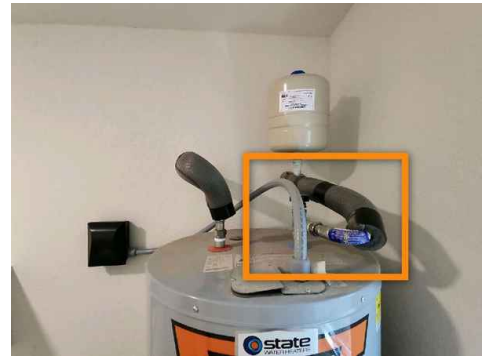
Water Heater

### **TANK: COLD WATER SHUTOFF MISSING**

The water heater tanks did not have cold water shutoff valves. Evaluation and remediation is recommended.

Recommendation  
Contact a qualified plumbing contractor.

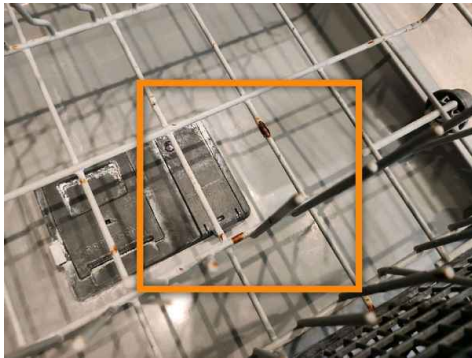
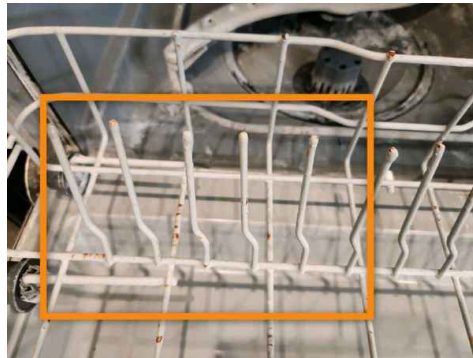
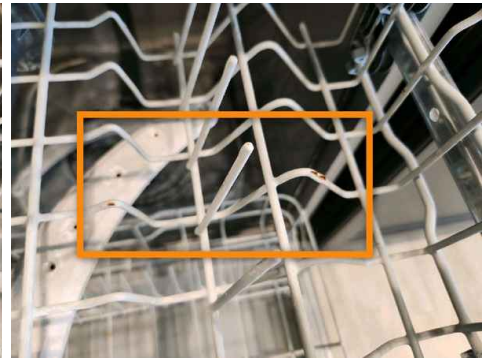
#### 6.1.1 A. Dishwashers **CORRODED DISH RACKS** MULTIPLE LOCATIONS

There was evidence of corrosion on dishwasher racks. Evaluation and remediation is recommended.

Recommendation  
Contact a qualified professional.

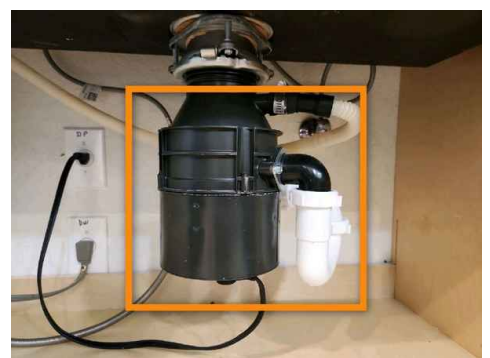
Kitchen

#### 6.2.1 B. Food Waste Disposers **DEBRIS**

The garbage disposal sounded as if it had debris in it. Evaluation and remediation is recommended.

Recommendation  
Contact a qualified professional.

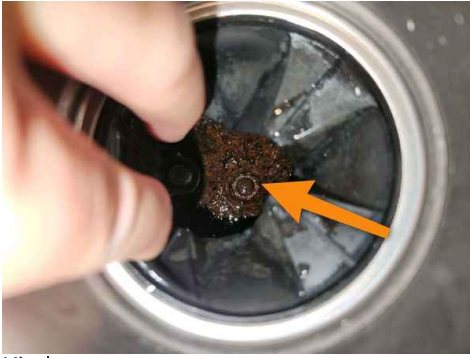
Kitchen

#### 6.2.2 B. Food Waste Disposers **CORROSION**

There was evidence of corrosion on or in the disposal. Evaluation and remediation is recommended.

Recommendation  
Contact a qualified professional.

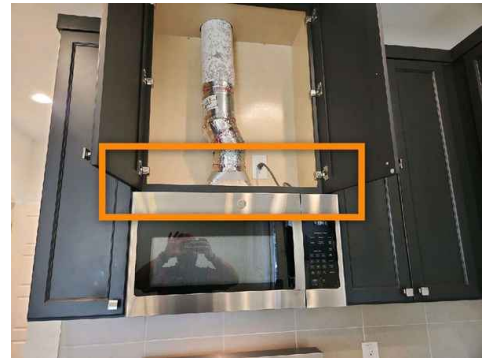
Kitchen

#### **VENTS TO EXTERIOR AND RECIRCULATES**

When vented to the exterior the exhaust fan should not also recirculate. Evaluation and remediation is recommended.

Contact a qualified professional.

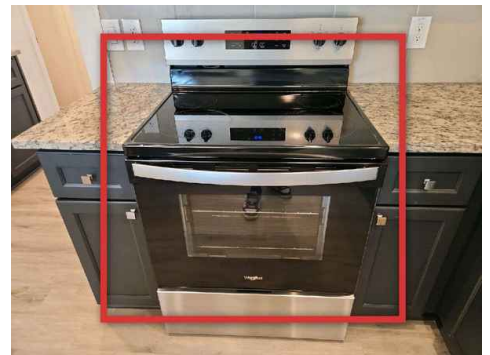
Kitchen

#### **MISSING ANTI-TIP DEVICE**

There was no anti-tipping device installed on the oven/range to prevent tipping if the door is climbed on while opened. This is a possible safety hazard. Evaluation and remediation is recommended.

Safety Hazard

Contact a qualified professional.
