## RESIDENTIAL INSPECTION REPORT

1130 Twin Deer Ln  
Canyon Lake, TX 78133

# PROPERTY INSPECTION REPORT FORM

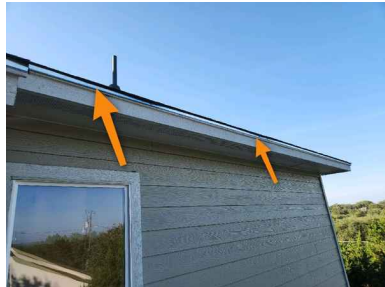
Unpainted -

Deficiencies with the drip edge were present at the time of inspection. Evaluation and remediation is recommended.

For Example: Unpainted Drip Edge Flashings

Recommendation: Contact a qualified roofing professional.

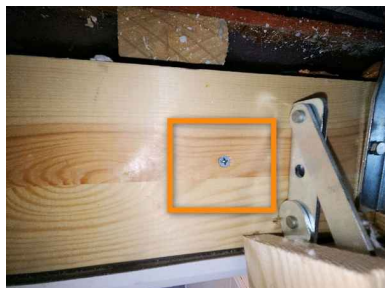
Screws Used -

The pull-down ladder/stairs had one or more defects at the time of inspection. Evaluate and remedy as needed.

For Example: Attic Ladder should be mounted with 9d nails or lag bolts not construction screws

Recommendation: Contact a qualified professional.

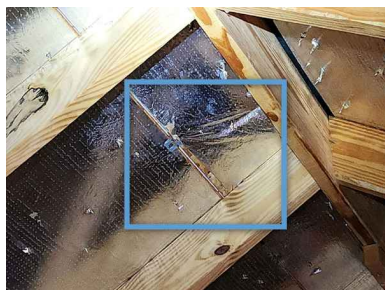
Attic

One or more areas of the radiant barrier was Loose or damaged. This condition reduces the effectiveness of the barriers ability to reduce heat buildup. Evaluate and remedy as needed.

Recommendation: Contact a qualified professional.

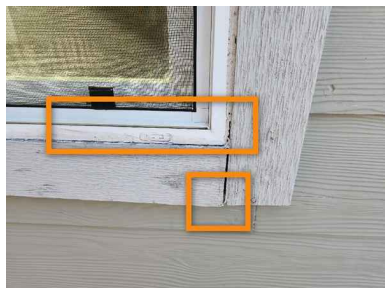
All Exterior Wall Penetrations, Doors/Windows, Light Fixture(s), Trim Boards, End to End Joints -

One or more areas were not properly sealed/caulked. Most exterior sealants have a lifespan of 5 to 8 years and should be regularly maintained with that lifespan in mind. Evaluation and remediation is recommended.

For Example:Seal Around Windows and Trim Boards

Recommendation: Contact a qualified professional.

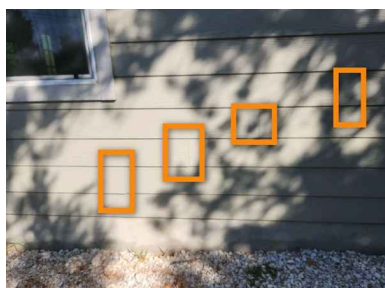
For Example:Seal Siding End Joints

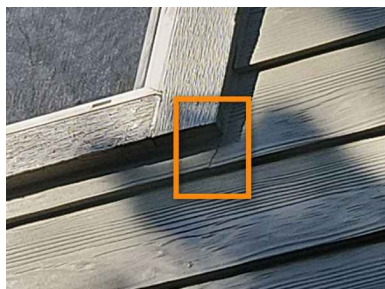
Damaged -

The exterior wall coverings, such as siding trim, fascia, soffit or eave had defects present. Evaluation and remediation as needed.

For Example:Damaged Siding Rear

Recommendation: Contact a qualified professional.

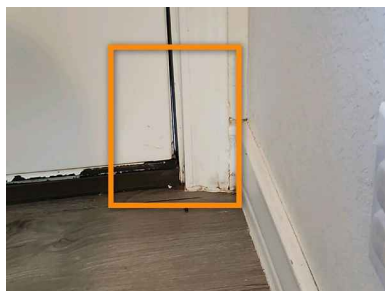
Door was missing standard weatherstripping. This can result in significant energy loss and moisture intrusion. Evaluation and remediation is recommended.

Visible Daylight at Side Entry

Recommendation: Contact a qualified door repair/installation contractor.

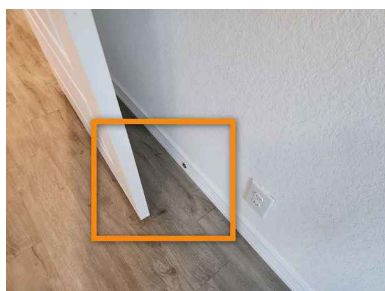
One or more doors had missing or damaged hardware. Evaluation and remediation is recommended.

Missing Door Stoppers 2nd Floor Bedrooms

Recommendation: Contact a qualified professional.

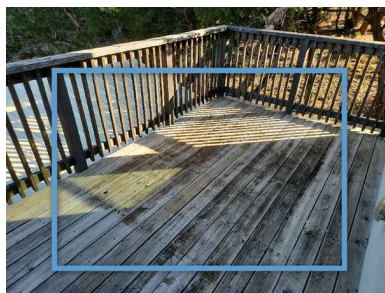
2nd Floor Balcony

Deck was weathered and/or water damaged. Application of water sealant or weatherproofing is recommended.

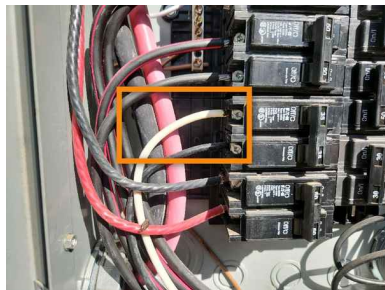
Exterior

White wires connected to breakers were not marked with black or red electrical tape to indicate that they are "hot". Evaluation and remediation is recommended.

Recommendation: Contact a qualified electrical contractor.

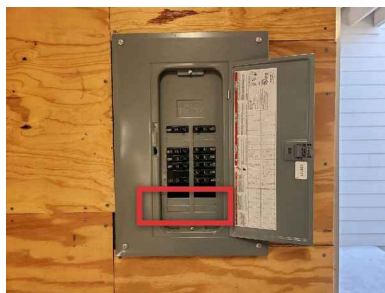
Garage Electrical Panel

Safety "knockouts" were missing from the panel cover. Evaluation and/or remediation by a licensed electrician is recommended.

Recommendation: Contact a qualified electrical contractor.

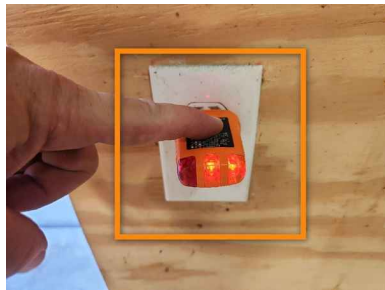
GFCI protection was inadequate or missing. Current building standards recommend the installation of ground fault protection:

GFCI protection was not present in one or more of these locations. Evaluation and remediation is recommended.

For Example: Garage near the Entry

Recommendation: Contact a qualified electrical contractor.

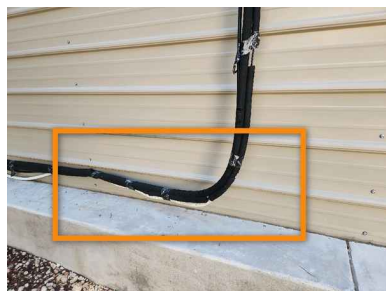
Garage Mini Split

Missing or damaged insulation on refrigerant lines can cause energy loss and condensation. Evaluation and remediation is recommended.

Recommendation: Contact a qualified HVAC professional.

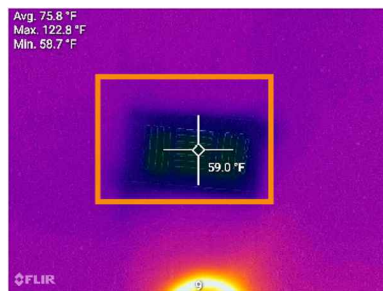
Primary Closet

A supply air register that varies in temperature by more than 5 degrees from the others on the same floor indicates poor performance. Evaluate and remedy as needed.

Recommendation: Contact a qualified HVAC professional.

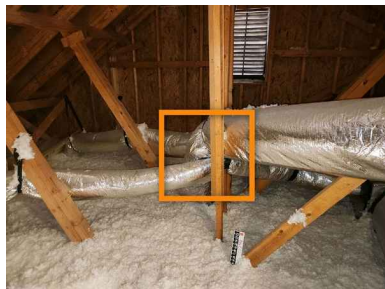
At the time of inspection one or more defects were present in the duct work. Evaluation and remediation as needed.

For Example:Ducts In Contact in the Attic

Recommendation: Contact a qualified professional.

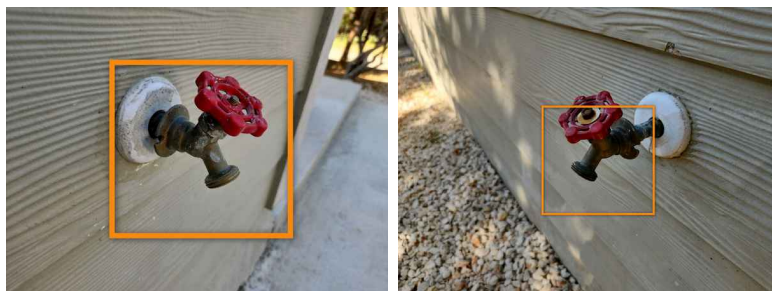
For Example: Left Side

Hose bibbs were missing a backflow preventer. These devices prevent contamination of potable water. Evaluation and remediation is recommended.

Recommendation: Contact a qualified plumbing contractor.

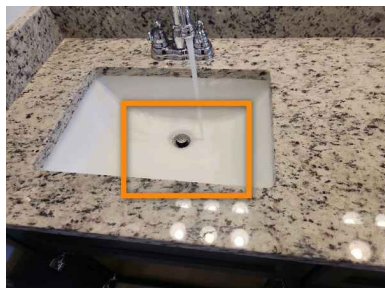
Primary Bathroom Left Side

Drain stops had issues that prevented them from working properly. Evaluation and remediation is recommended.

Recommendation: Contact a qualified plumbing contractor.

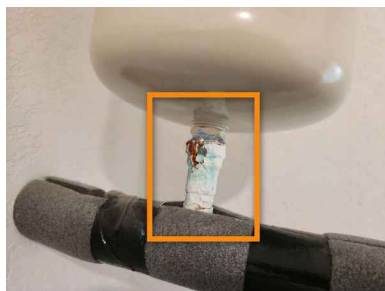
Various plumbing lines, fittings or valves were corroded. Evaluation of all plumbing lines and/or remediation by a licensed plumber is recommended.

Corroded Fittings at Water Heater  
Expansion Tank

Recommendation: Contact a qualified plumbing contractor.

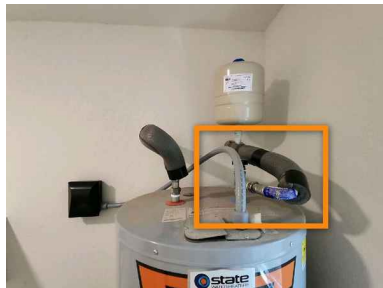
Water Heater

The water heater tanks did not have cold water shutoff valves. Evaluation and remediation is recommended.

Recommendation: Contact a qualified plumbing contractor.

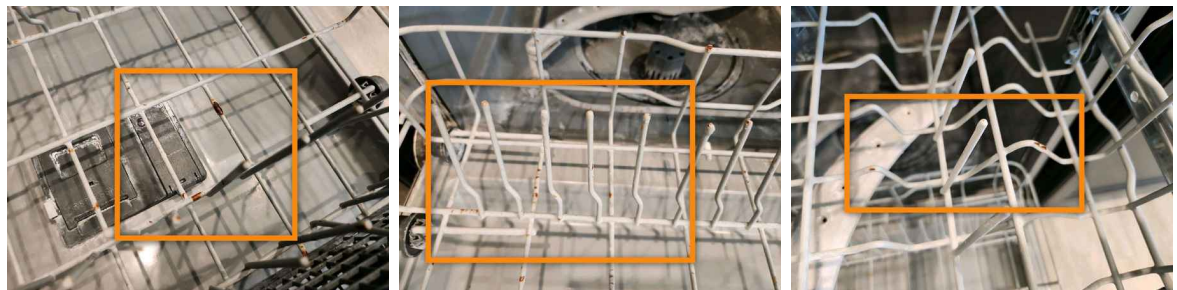
Kitchen

There was evidence of corrosion on dishwasher racks. Evaluation and remediation is recommended.

Recommendation: Contact a qualified professional.

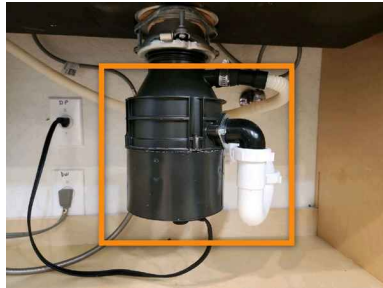
Kitchen

The garbage disposal sounded as if it had debris in it. Evaluation and remediation is recommended.

Recommendation: Contact a qualified professional.

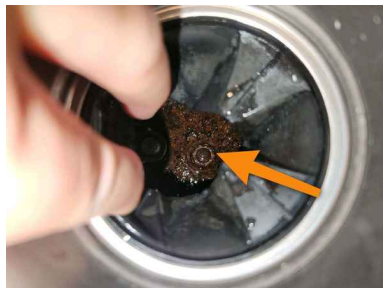
Kitchen

There was evidence of corrosion on or in the disposal. Evaluation and remediation is recommended.

Recommendation: Contact a qualified professional.

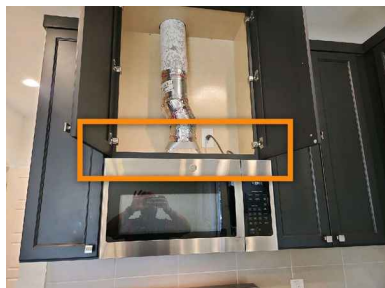
Kitchen

When vented to the exterior the exhaust fan should not also recirculate. Evaluation and remediation is recommended.

Recommendation: Contact a qualified professional.

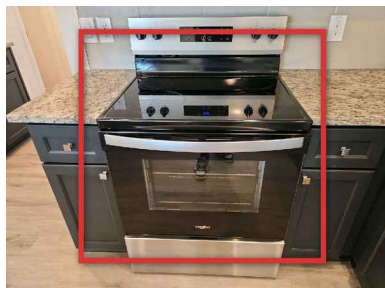
Kitchen

There was no anti-tipping device installed on the oven/range to prevent tipping if the door is climbed on while opened. This is a possible safety hazard. Evaluation and remediation is recommended.

Recommendation: Contact a qualified professional.
