Lone Star Stucco, LLC

## Moisture Assessment Report

2409 Langston Street

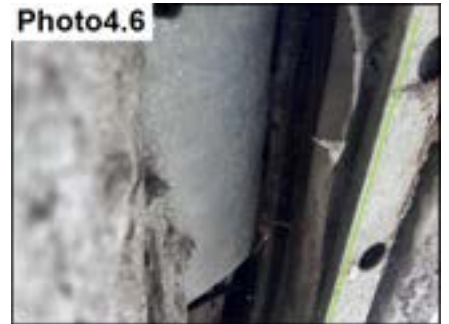
Photo4.6

Proper Grade Termination with Weep Screed / Positive Detail

| Grid Location | Item Description | Moisture Readings | Substrate Condition | Observations |
|---|---|---|---|---|
| Green Lines | Grade Termination | | | Stucco appears to be typically detailed at grade for the time of this construction. The inspector suggests that this is a positive detail and recommends no modification at this time but to always keep soil away from the structure. Please refer to photos #4.2, #4.3, #4.4, #4.5 and #4.6 for more detail. |

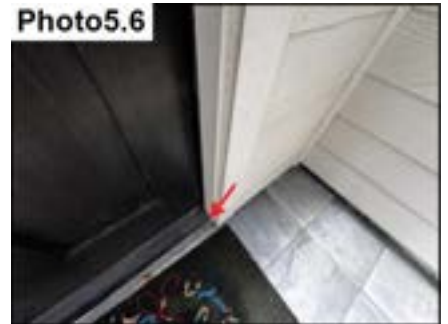
Photo5.6

Door Trim and Miter Sealant / Seal

| Grid Location | Item Description | Moisture Readings | Substrate Condition | Observations |
|---|---|---|---|---|
| Red Arrows | Doors | | | The door trim and miter sealants are aged or separated at this location. The inspector suggests to have a qualified waterproofing contractor seal this area with a low modulus sealant in an effort to prevent moisture intrusion. These types of sealants are of high quality and compatible with stucco and other termination points. Please refer to photos #5.2, #5.3, #5.4, #5.5 and #5.6 for more detail. |

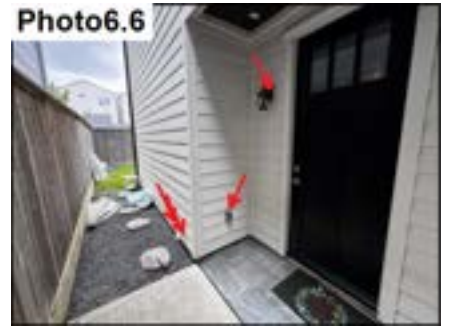
Photo6.6

Penetration Sealants / Seal

| Grid Location | Item Description | Moisture Readings | Substrate Condition | Observations |
|---|---|---|---|---|
| Red Arrows | Penetrations | | | The penetration sealants are aged in this location. The inspector suggests to have a qualified waterproofing contractor seal this area in an effort to prevent moisture intrusion. Please refer to photos #6.2, #6.3, #6.4, #6.5, #6.6, #7.1, #7.2, #7.3 and #7.4 for more detail. |

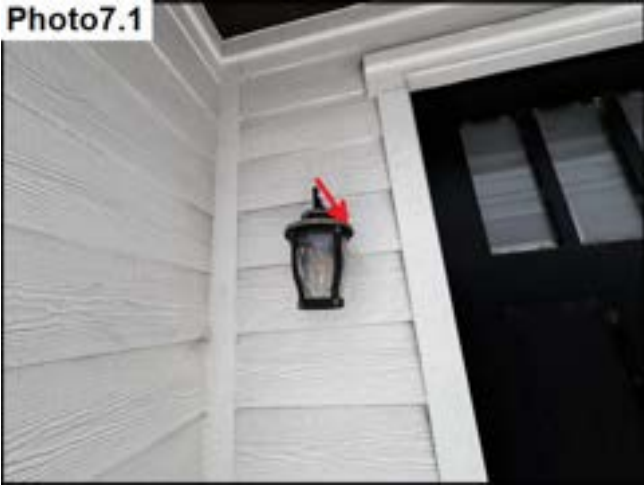
Photo7.1

Penetration Sealants / Seal

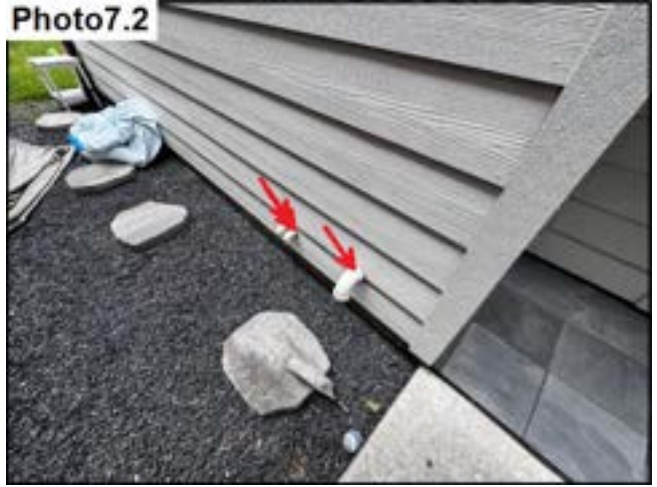
Photo7.2

Penetration Sealants / Seal

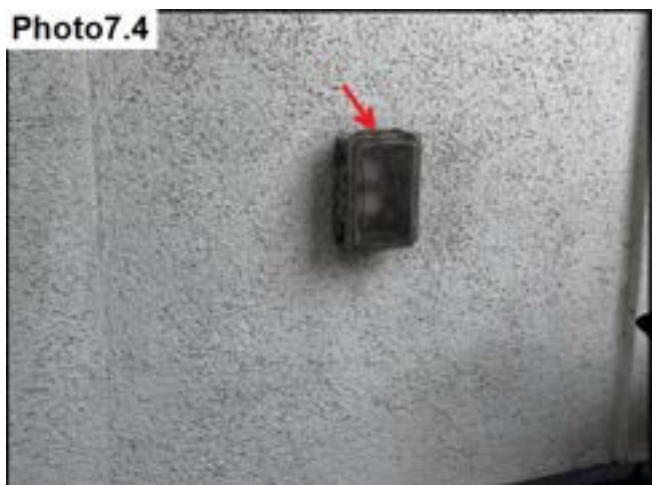
Photo7.4

Penetration Sealants / Seal

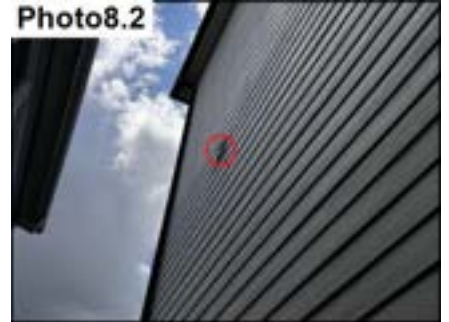
Photo8.2

Broken Vent / Replace and Seal

| Grid Location | Item Description | Moisture Readings | Substrate Condition | Observations |
|---|---|---|---|---|
| Red Circle | Vent | | | A broken vent is noted at this location. The inspector suggests to have a qualified contractor further assess, replace then seal as needed in an effort to prevent moisture intrusion. Please refer to photos #8.2, #8.3 and #8.4 for more detail. |

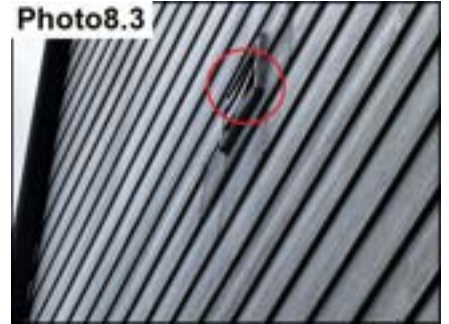
Photo8.3

Broken Vent / Replace and Seal

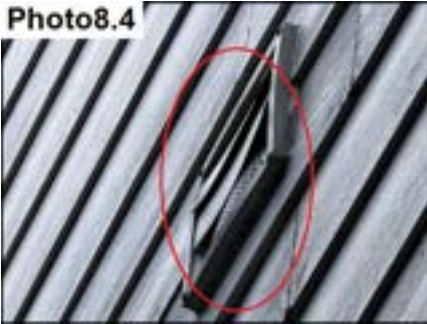
Photo8.4

Broken Vent / Replace and Seal

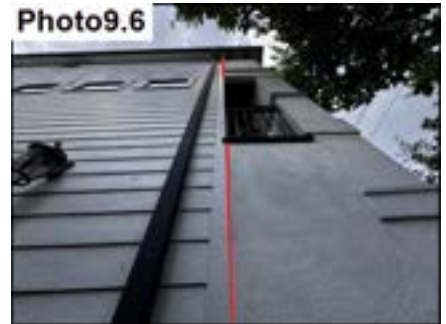
Photo9.6

Siding & Stucco Termination / Seal

| Grid Location | Item Description | Moisture Readings | Substrate Condition | Observations |
|---|---|---|---|---|
| Red Lines | Stucco Termination | | | Siding/stucco termination sealants are aged or separated at this location. The inspector suggests to have a qualified waterproofing contractor further assess and seal this area with a low modulus sealant in an effort to prevent moisture intrusion. These types of sealants are of high quality and compatible with stucco and other termination points. Please refer to photos #9.2, #9.3, #9.4, #9.5 and #9.6 for more detail. |

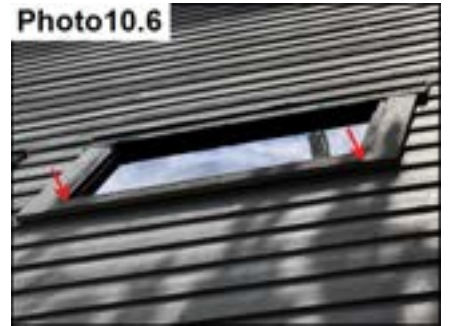
Photo10.6

Window Sealants / Seal

| Grid Location | Item Description | Moisture Readings | Substrate Condition | Observations |
|---|---|---|---|---|
| Red Arrows | Windows | | | The window sealants are aged or separated. The inspector suggests to have a qualified waterproofing contractor further assess and seal this area with a low modulus sealant in an effort to prevent moisture intrusion. These types of sealants are of high quality and compatible with stucco and other termination points. Please refer to photos #10.2, #10.3, #10.4, #10.5, #10.6, #11.1, #11.2, #11.3 and #11.4 for more detail. |

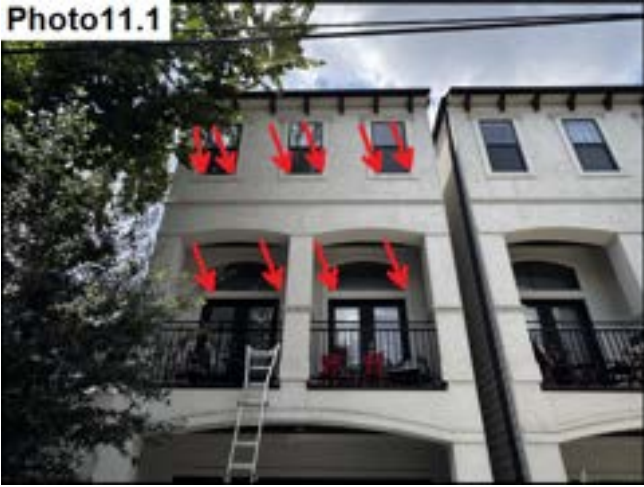
Photo11.1

Window Sealants / Seal

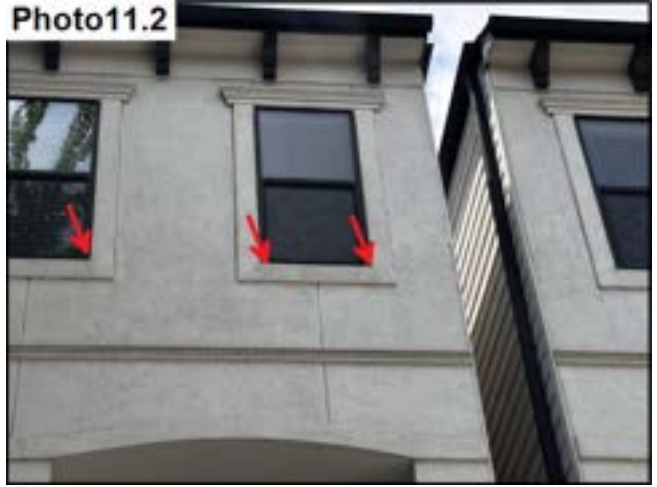
Photo11.2

Window Sealants / Seal

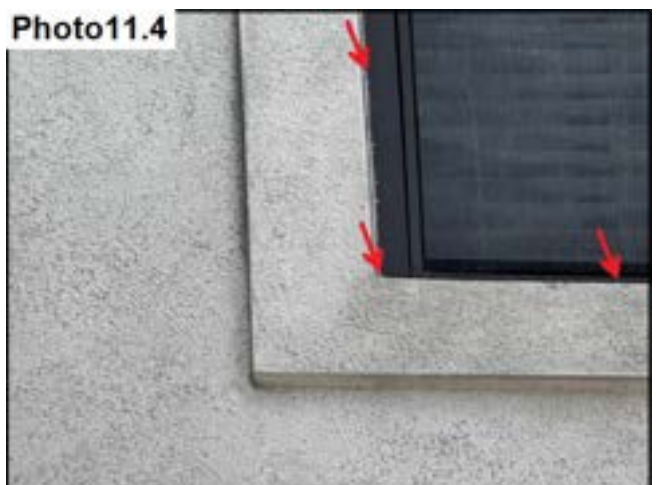
Photo11.4

Window Sealants / Seal

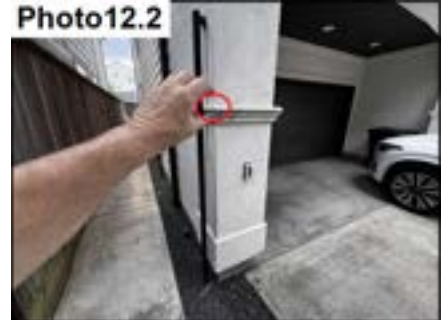
Photo12.2

Impact Damage / Repair

| Grid Location | Item Description | Moisture Readings | Substrate Condition | Observations |
|---|---|---|---|---|
| Red Circle | Impact Damage | | | Impact damage noted on foam accent with exposed mesh at this location. The inspector suggests to have a qualified waterproofing contractor further assess the extent of damage and repair as needed in an effort to prevent moisture intrusion. All impact damage was not necessarily identified in this report. Please refer to photos #12.2, #12.3 and #12.4 for more detail. |

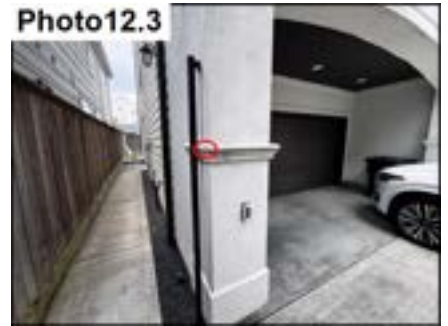
Photo12.3

Impact Damage / Repair

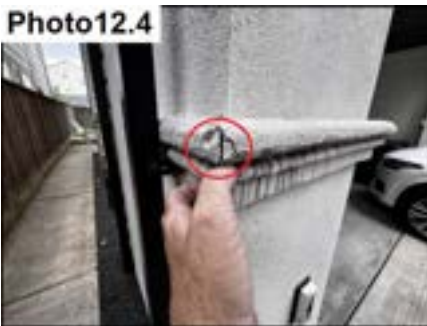
Photo12.4

Impact Damage / Repair

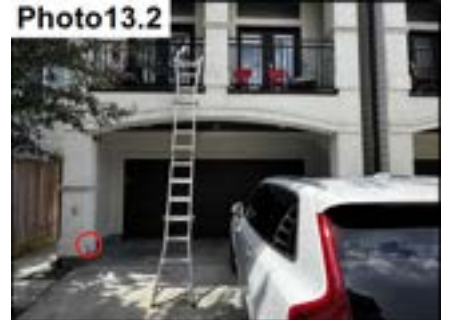
Photo13.2

Impact Damage / Repair (Aesthetic)

| Grid Location | Item Description | Moisture Readings | Substrate Condition | Observations |
|---|---|---|---|---|
| Red Circle | Impact Damage | | | Impact damage is noted at this location. The inspector suggests having a qualified waterproofing contractor further assess and repair this area as needed from an aesthetic concern. Please refer to photos #13.2, #13.3, #13.4, #13.5 and #13.6 for more detail. |

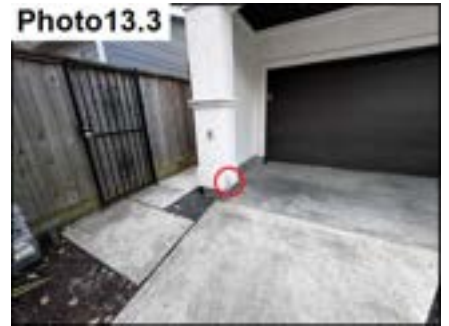
Photo13.3

Impact Damage / Repair (Aesthetic)

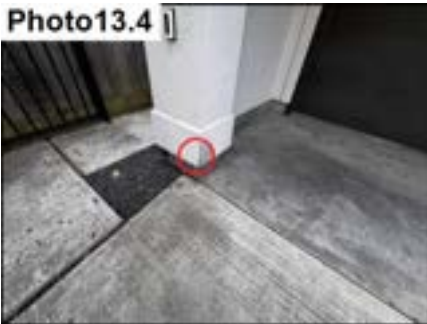
Photo13.4

Impact Damage / Repair (Aesthetic)

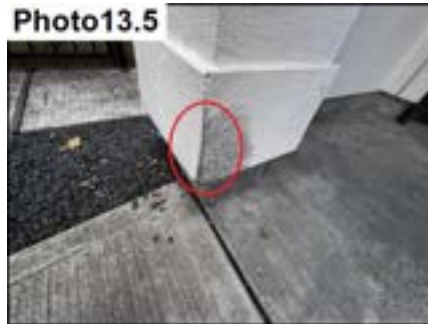
Photo13.5

Impact Damage / Repair (Aesthetic)

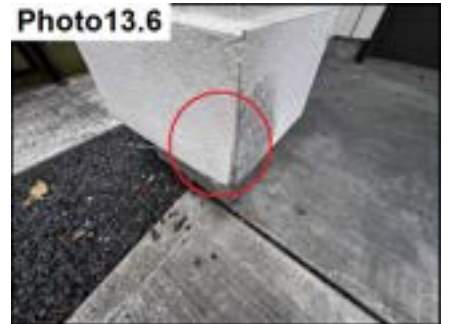
Photo13.6

Impact Damage / Repair (Aesthetic)

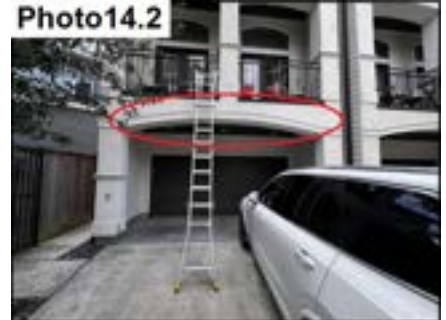
Photo14.2

Mildew & Runoff Stains / Clean  
(Aesthetic Concern)

| Grid Location | Item Description | Moisture Readings | Substrate Condition | Observations |
|---|---|---|---|---|
| Red Circles | Stains | | | Mildew and run off stains have been noted in this area. The inspector suggests to clean the area as needed from an aesthetic concern only. Please refer to photos #14.2, #14.3, #14.4, #14.5 and #14.6 for more detail. |

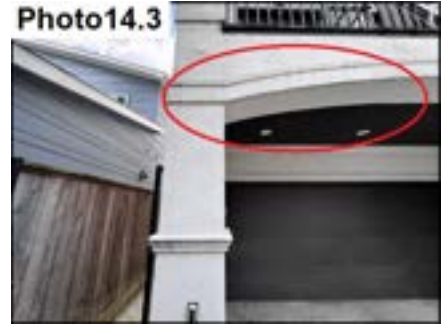
Photo14.3

Mildew & Runoff Stains / Clean  
(Aesthetic Concern)

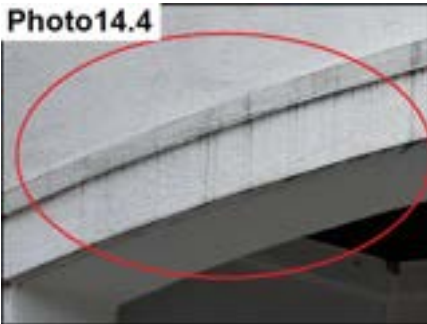
Photo14.4

Mildew & Runoff Stains / Clean  
(Aesthetic Concern)

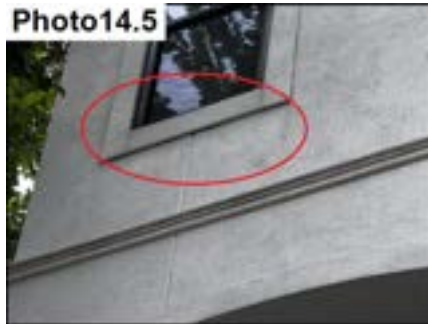
Photo14.5

Mildew & Runoff Stains / Clean  
(Aesthetic Concern)

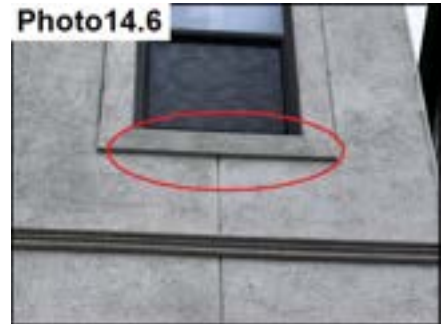
Photo14.6

Mildew & Runoff Stains / Clean  
(Aesthetic Concern)

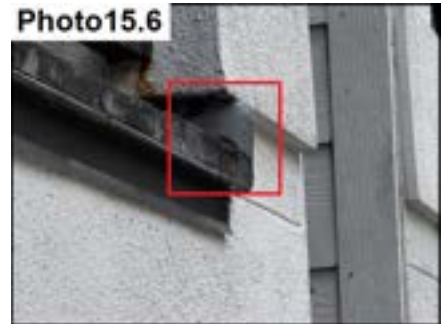
Photo15.6

Balcony Flashing Sealants / Seal

| Grid Location | Item Description | Moisture Readings | Substrate Condition | Observations |
|---|---|---|---|---|
| Red Boxes | Flashing | | | The balcony flashing sealants are aged at this location, allowing excess moisture into the system. The inspector suggests to have a qualified waterproofing contractor further assess and seal this area with a low modulus sealant in an effort to prevent moisture intrusion. These types of sealants are of high quality and compatible with stucco and other termination points. Please refer to photos #15.2, #15.3, #15.4, #15.5 and #15.6 for more detail. |

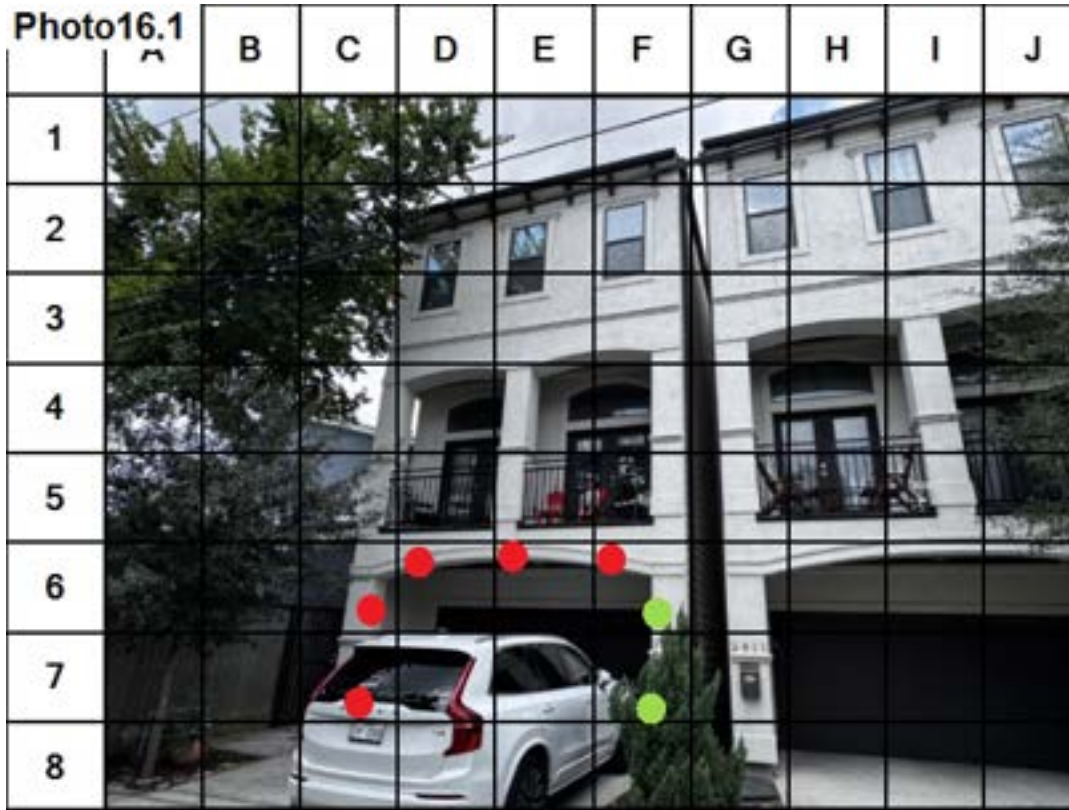
| Grid Location | Item Description | Moisture Readings | Substrate Condition | Observations |
|---|---|---|---|---|
| C7 | Left Corner Wall | 20% | Firm | A moisture probe was taken at left corner wall. An elevated moisture reading was noted with a firm substrate. |
| C6 | Left Corner Wall | 22% | Firm | A moisture probe was taken at left corner wall. An elevated moisture reading was noted with a firm substrate. |
| F7 | Right Corner Wall | 18% | Firm | A moisture probe was taken at right corner wall. The substrate was firm with no damage noted at this time. |
| F6 (green) | Right Corner Wall | 17% | Firm | A moisture probe was taken at right corner wall. The substrate was firm with no damage noted at this time. |
| D6 | Below Balcony | | None | A moisture probe was taken below the balcony. No substrate was noted at this time, modify as needed. |
| E6 | Below Balcony | | None | A moisture probe was taken below the balcony. No substrate was noted at this time, modify as needed. |
| F6 (red) | Below Balcony | | None | A moisture probe was taken below the balcony. No substrate was noted at this time, modify as needed. |

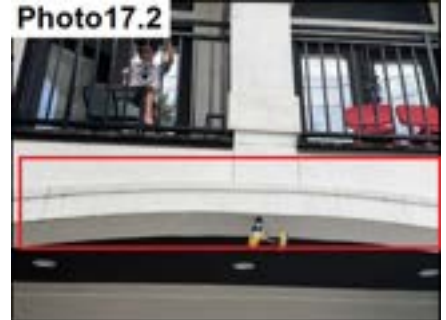
Photo17.2

Substrate Damage / Assess, Repair and Install Proper Relief

| Grid Location | Item Description | Moisture Readings | Substrate Condition | Observations |
|---|---|---|---|---|
| Red Box | Damage | | | Confirmed substrate and potential frame damage is noted at the bottom of the wall below the balcony. The inspector recommends having a qualified waterproofing contractor further assess the extent of damage, repair as needed and install a proper relief in an effort to prevent moisture intrusion. Please refer to photos #17.2, #17.3, #17.4, #17.5 and #17.6 for more detail. |

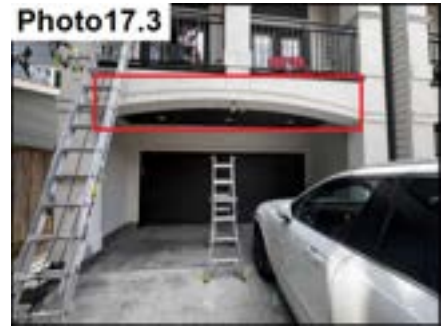
Photo17.3

Substrate Damage / Assess, Repair and Install Proper Relief

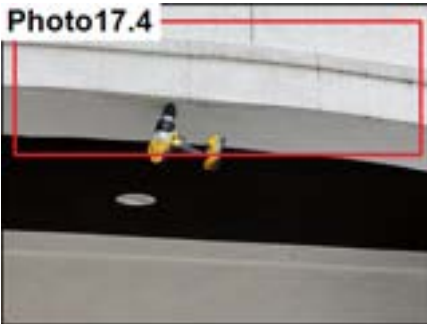
Photo17.4

Substrate Damage / Assess, Repair and Install Proper Relief

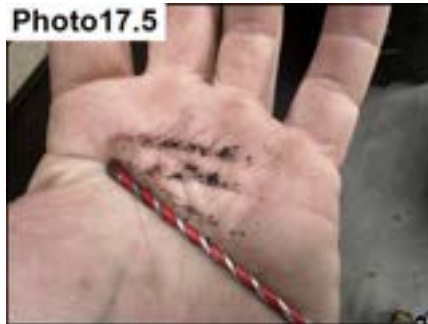
Photo17.5

Substrate Damage / Assess, Repair and Install Proper Relief

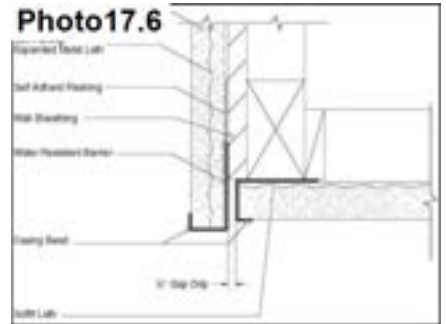
Photo17.6

Relief / Proper Detail

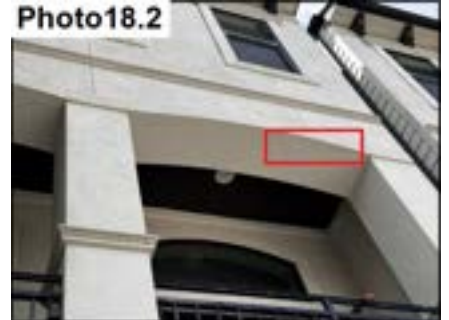
Photo18.2

Sizeable Crack Noted / Assess and Repair as Needed

| Grid Location | Item Description | Moisture Readings | Substrate Condition | Observations |
|---|---|---|---|---|
| Red Box | Cracks | | | Sizeable cracks are noted at this location. The inspector suggests to have a qualified waterproofing contractor further assess and properly repair these cracks to prevent moisture intrusion. All cracking was not necessarily identified in this report. Please refer to photos #18.2, #18.3, #18.4 and #18.5 for more detail. |

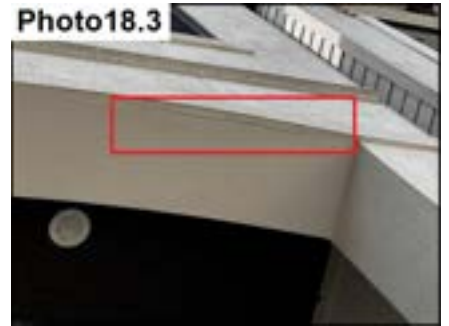
Photo18.3

Sizeable Crack Noted / Assess and Repair as Needed

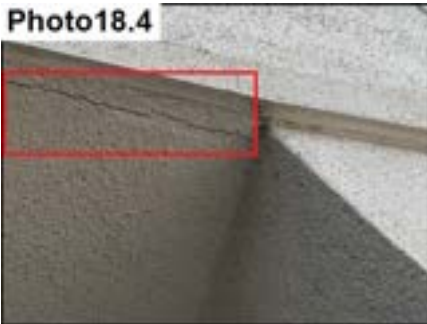
Photo18.4

Sizeable Crack Noted / Assess and Repair as Needed

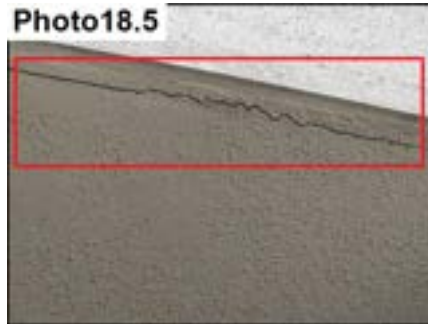
Photo18.5

Sizeable Crack Noted / Assess and Repair as Needed

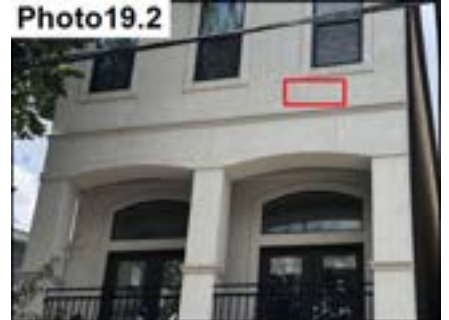
Photo19.2

Hairline Cracks / Paint (Aesthetic)

| Grid Location | Item Description | Moisture Readings | Substrate Condition | Observations |
|---|---|---|---|---|
| Red Box | Cracks | | | Hairline cracks are noted at this location. The inspector suggests to have a qualified waterproofing contractor paint for aesthetic concerns only. All cracking was not necessarily identified in this report. Please refer to photos #19.2, #19.3, #19.4, #19.5 and #19.6 for more detail. |

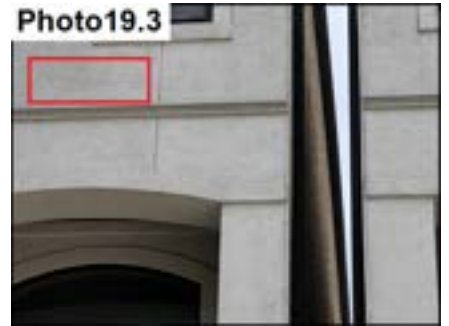
Photo19.3

Hairline Cracks / Paint (Aesthetic)

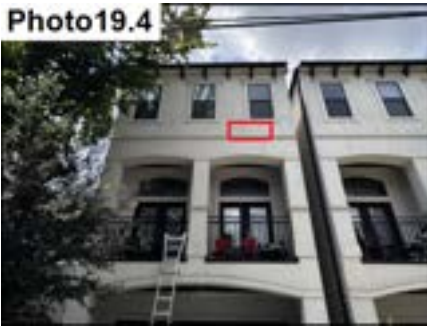
Photo19.4

Hairline Cracks / Paint (Aesthetic)

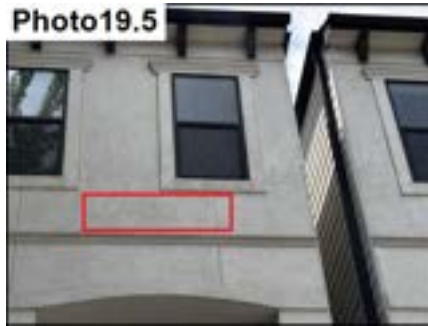
Photo19.5

Hairline Cracks / Paint (Aesthetic)

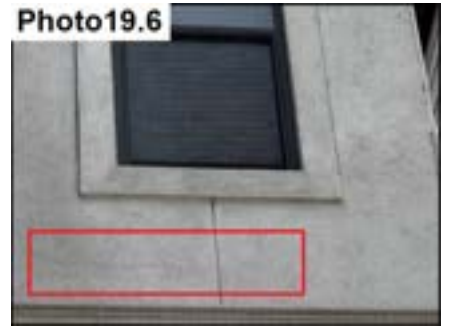
Photo19.6

Hairline Cracks / Paint (Aesthetic)

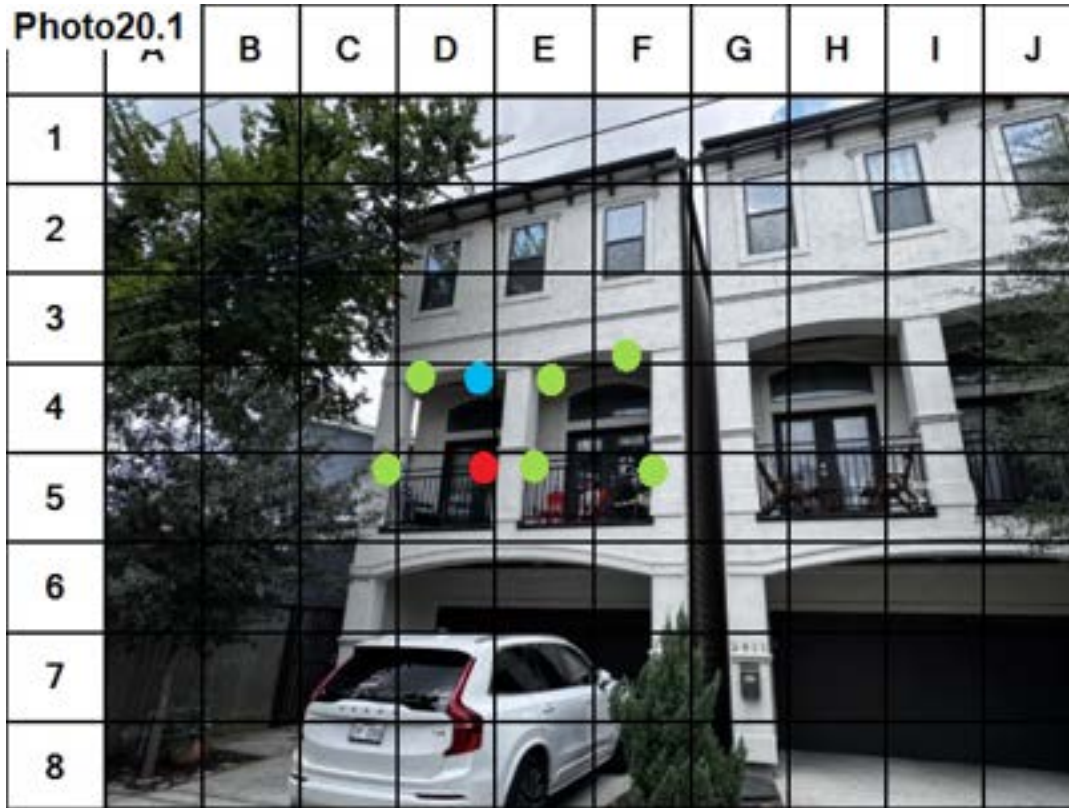
| Grid Location | | Moisture Readings | Substrate Condition | Observations |
|---|---|---|---|---|
| C5 | Column | 17% | Firm | A moisture probe was taken at column. The substrate was firm with no damage noted at this time. |
| D5 | Column | 20% | Firm | A moisture probe was taken at column. An elevated moisture reading was noted with a firm substrate. |
| E5 | Column | 18% | Firm | A moisture probe was taken at column. The substrate was firm with no damage noted at this time. |
| F5 | Right Wall | 15% | Firm | A moisture probe was taken at the right wall. The substrate was firm with no damage noted at this time. |
| D4 (green) | Bottom Wall | 17% | Firm | A moisture probe was taken at bottom wall. The substrate was firm with no damage noted at this time. |
| D4 (blue) | Bottom Wall | 15% | Firm | A moisture probe was taken at bottom wall. The substrate was firm with no damage noted at this time. |
| E4 | Bottom Wall | 16% | Firm | A moisture probe was taken at bottom wall. The substrate was firm with no damage noted at this time. |
| F3 | Bottom Wall | 17% | Firm | A moisture probe was taken at bottom wall. The substrate was firm with no damage noted at this time. |

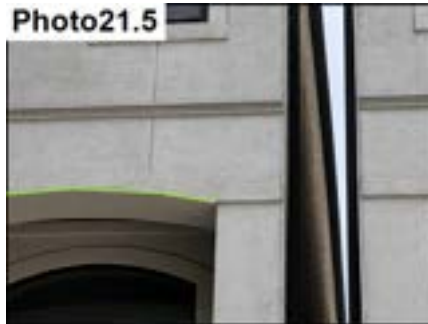
Photo21.5

- Although the bottom of the wall noted does not have a proper relief, this was a proper detail at the time of construction. Upon invasive testing at this location, the substrate was firm with low moisture readings. The inspector recommends no modification at this point in time but recommends to maintain all sealants above this location to prevent potential moisture intrusion. Please refer to photos #21.2, #21.3, #21.4 and #21.5 for more detail.

No Relief Present / No Modification but Maintain Sealants Above

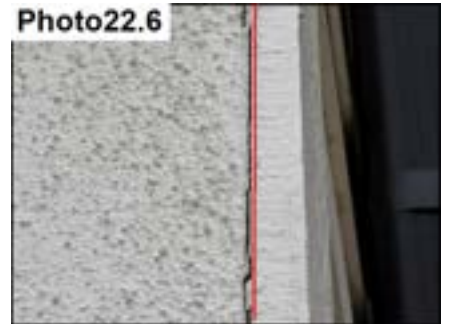
Photo22.6

- Siding/stucco termination sealants are aged or separated at this location. The inspector suggests to have a qualified waterproofing contractor further assess and seal this area with a low modulus sealant in an effort to prevent moisture intrusion. These types of sealants are of high quality and compatible with stucco and other termination points. Please refer to photos #22.2, #22.3, #22.4, #22.5 and #22.6 for more detail.

Siding & Stucco Termination / Seal

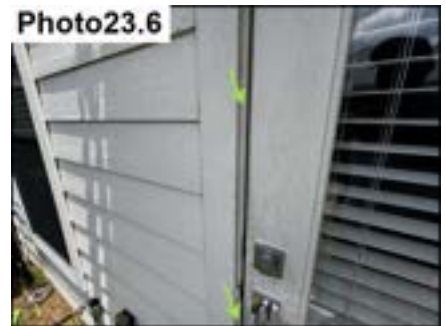
Photo23.6

- Door trim and miter sealants are present at this location. The inspector states that this is a positive detail and suggests maintaining these sealants in an effort to prevent moisture intrusion. Please refer to photos #23.2, #23.3, #23.4, #23.5 and #23.6 for more detail.

Door Trim and Miter Sealant /  
Maintain

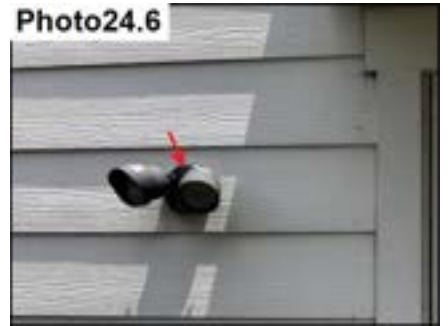
Photo24.6

- The penetration sealants are aged in this location. The inspector suggests to have a qualified waterproofing contractor seal this area in an effort to prevent moisture intrusion. Please refer to photos #24.2, #24.3, #24.4, #24.5 and #24.6 for more detail.

Penetration Sealants / Seal

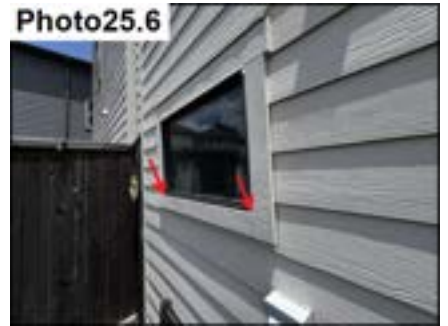
Photo25.6

- The window sealants are aged. The inspector suggests to have a qualified waterproofing contractor further assess and seal this area in an effort to prevent moisture intrusion. Please refer to photos #25.2, #25.3, #25.4, #25.5 and #25.6 for more detail.

Window Sealants / Seal

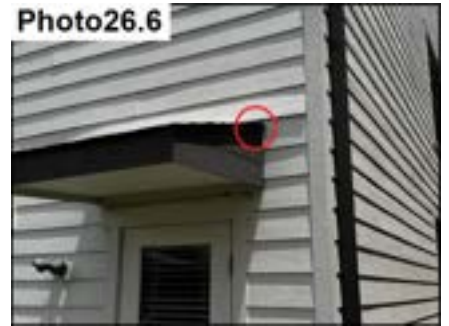
Photo26.6

- The roof diverter flashing sealants are aged at this location. The inspector suggests to have a qualified waterproofing contractor further assess and seal this area in an effort to prevent moisture intrusion. Please refer to photos #26.2, #26.3, #26.4, #26.5 and #26.6 for more detail.

Roof Diverter Flashing Sealants / Seal
