Subject: Pre-Repair Foundation Repair Evaluation  
Pier and Beam Foundation  
8800 Woodway Drive Unit 8, Houston, TX

#### LIMITED REPAIR PLAN

8800 WOODWAY DRIVE UNIT 8, HOUSTON

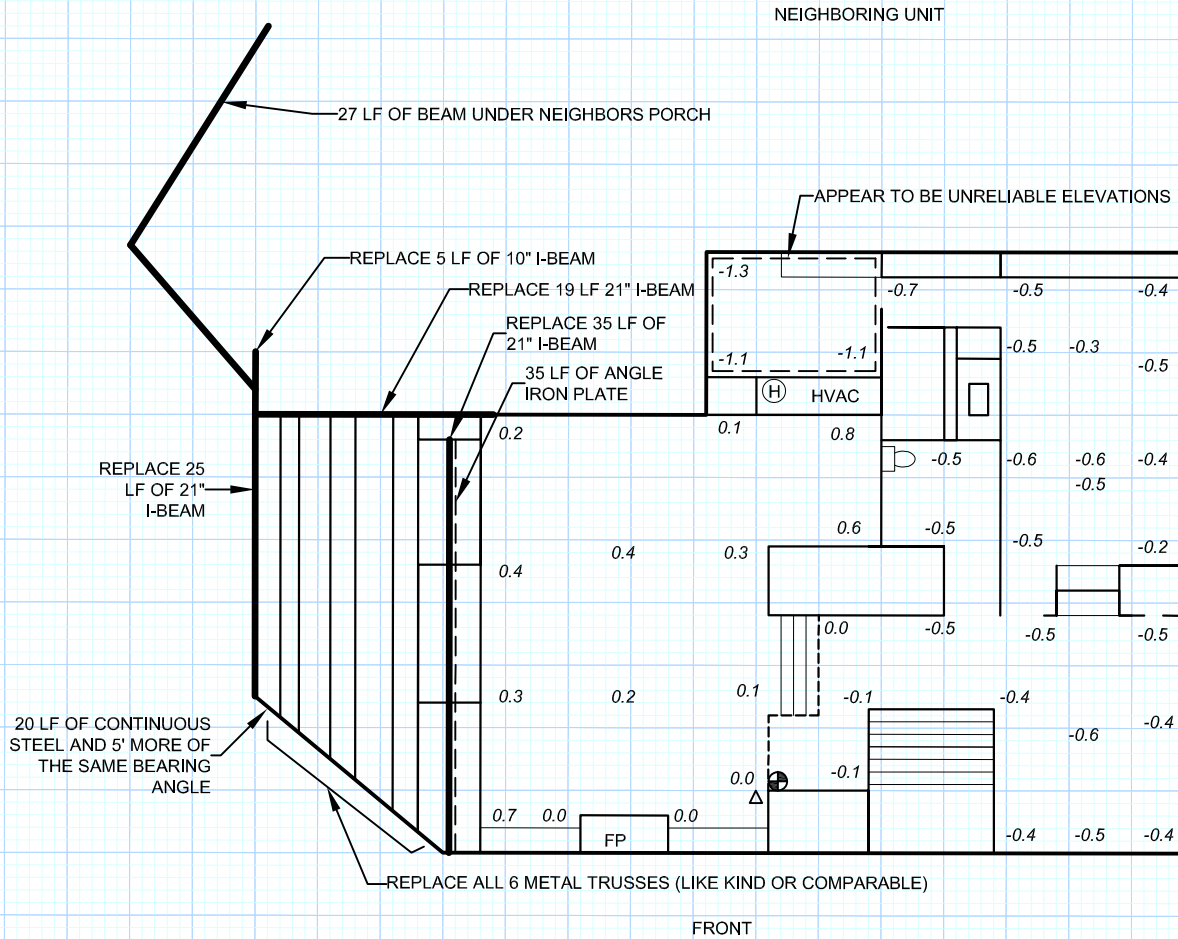
The elevations are generally level, with the exception of the utility room adjacent to the kitchen area. However, when compared to the elevations immediately on the opposite side of the wall, the lower elevations measured within the utility room appear to be unreliable. Therefore, all elevations within Unit 8 appear to be generally level.

The metal support system beneath the porch on the left side of the diagram is compromised by corrosion and rust and should be replaced. The compromised components recommended for replacement in kind consist of six metal truss systems totaling approximately 150 linear feet, approximately 70 linear feet of 21-inch-tall I-beam, approximately 5 linear feet of 10-inch I-beam, approximately 20 linear feet of continuous steel bearing angle along the front, and approximately 5 linear feet of steel bearing angle at the rear.

Rusted I-beams and trusses were observed. Based on our observations of the structure, the structure's physical damage and review of the elevation map, we believe the structure has experienced seasonal foundation movement over the life of the structure, resulting in differential movement of the pier and beam foundation.

Damage observations were notable on the back-left side of the structure and are correlated with floor elevation data.

- Replace six metal truss systems totaling approximately 150 linear feet.
- Replace approximately 70 LF of 21-inch-tall I-beam.
- Replace approximately 5 LF of 10-inch I-beam.
- Replace approximately 20 LF of continuous steel bearing angle along the front.
- Replace approximately 5 LF of steel bearing angle at the rear.

- REPLACE SIX METAL TRUSS SYSTEMS TOTALING APPROXIMATELY 150 LINEAR FEET.
- REPLACE APPROXIMATELY 70 LF OF 21-INCH-TALL I-BEAM.
- REPLACE APPROXIMATELY 5 LF OF 10-INCH I-BEAM.
- REPLACE APPROXIMATELY 20 LF OF CONTINUOUS STEEL BEARING ANGLE ALONG THE FRONT.
- REPLACE APPROXIMATELY 5 LF OF STEEL BEARING ANGLE AT THE REAR.
