# FULL HOUSE HOME INSPECTIONS L.L.C.

## PROPERTY INSPECTION REPORT

**Concerning: 3106 Mariner Island Dr. Texas City, TX 77568**

**2/10/2025**

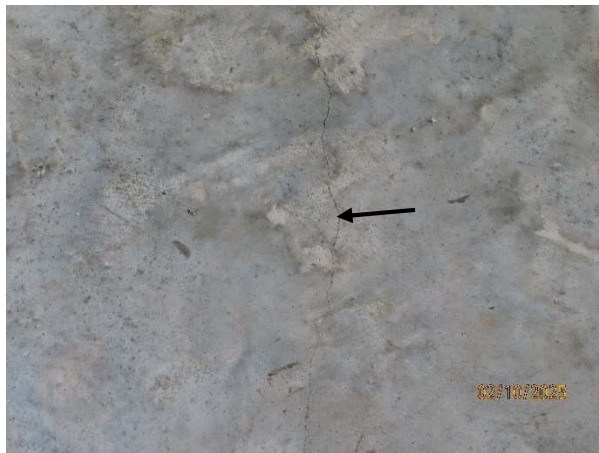
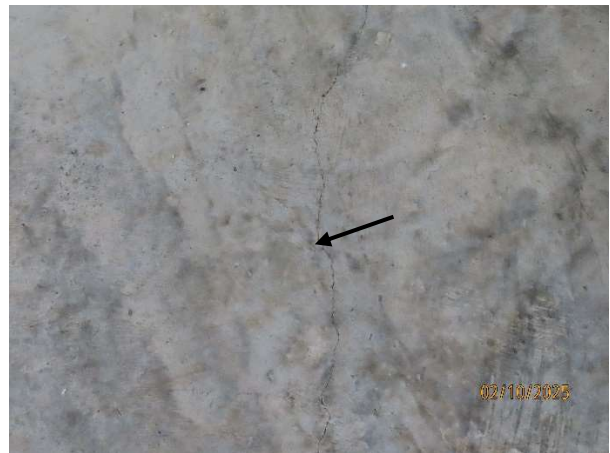
There are closed hairline cracks in the center of the garage floor portion of the structures slab. The cracks are not reflective of significantly excessive settlement at the time of the inspection. Recommend monitoring over time.

**Examples of the closed hairline cracks through the center of the garage floor portion of the slab**

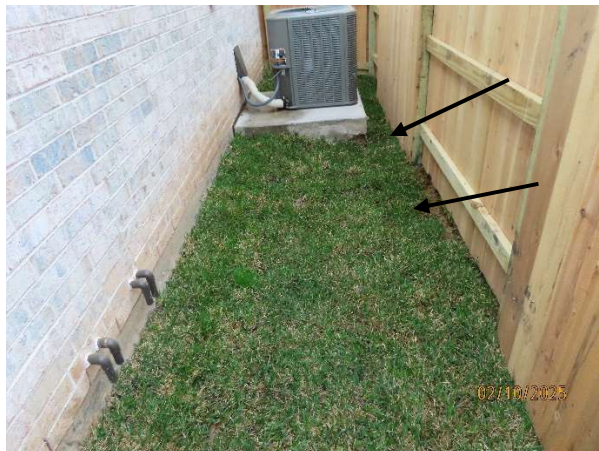
The north side of the structure has water collecting in the swale along the east and north sides of the a/c condenser pad. Recommend having this swale evaluated and adjusted by the builder.

**Water collecting the north side swale around the a/c condenser pad**

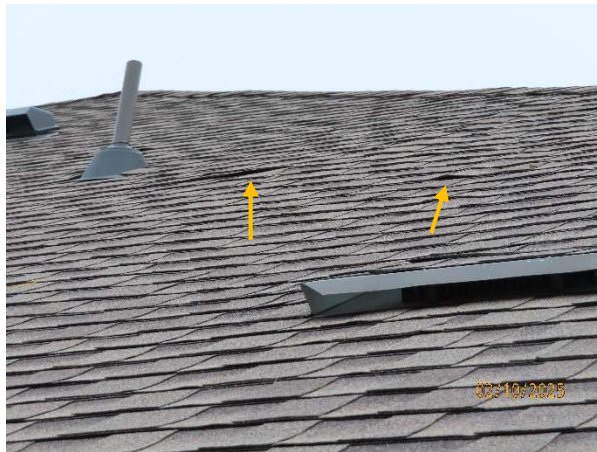
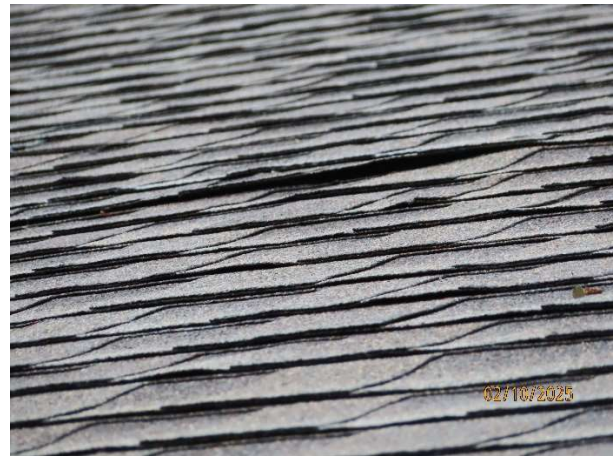
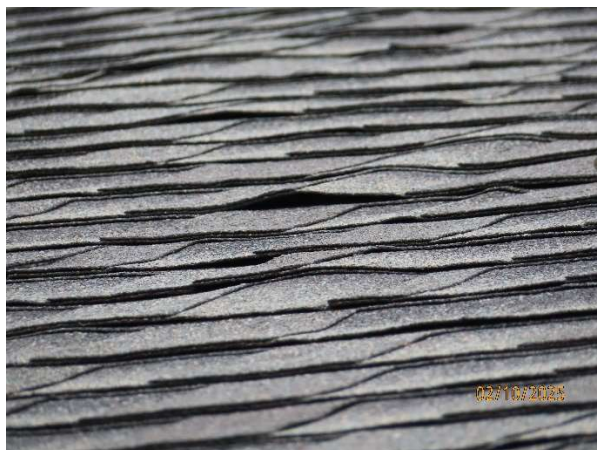
There are lifted shingles on the north sloping roof covering near the west end center. Lifted shingles are potential leak points and can be blown from the roof surface during heavy wind events. Recommend having the lifted shingles evaluated and repaired by the builder.

**Lifted shingles at the west end center of the north sloping roof covering**

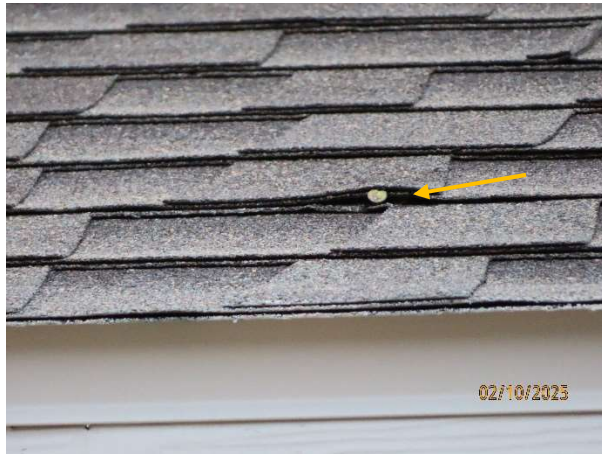
There is an exposed nail through a shingle at the center eave of the S/W corner south sloping roof covering (potential leak point). Recommend having the exposed nail evaluated and repaired by the builder.

Exposed nail through a shingle at the center eave of the S/W corner south sloping roof covering

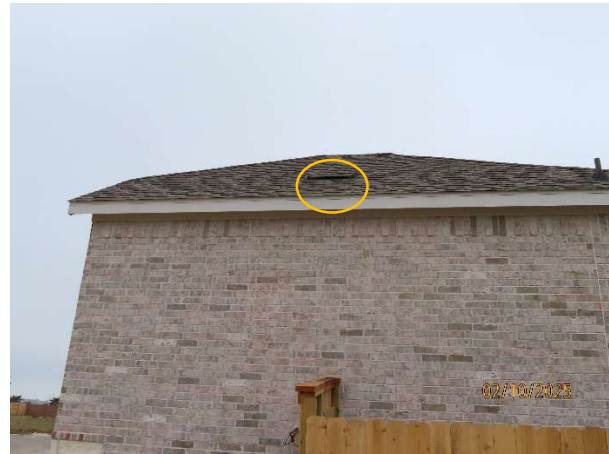
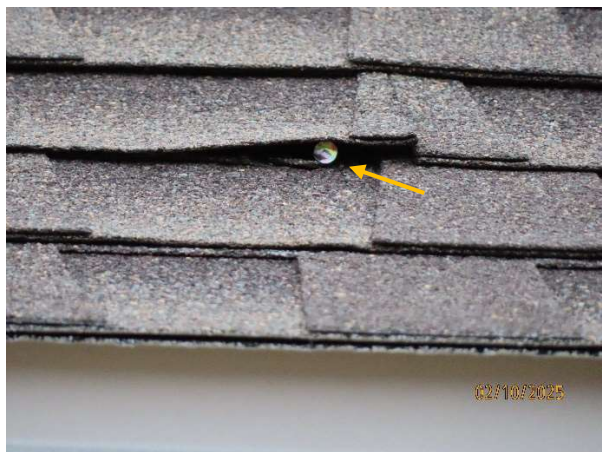
There is a nail lifting a shingle at the center east end eave of the south sloping roof covering (potential leak point). Recommend having the lifted shingle evaluated and repaired by a qualified roofing contractor.

Nail lifting a shingle at the center eave of the south sloping roof covering

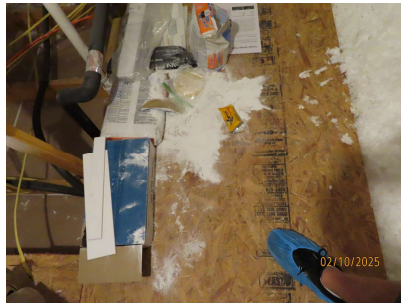
**Spilled bag of grout in the attic**

Recommend having the bag of spilled grout on the attic floor decking cleaned up by the builder.

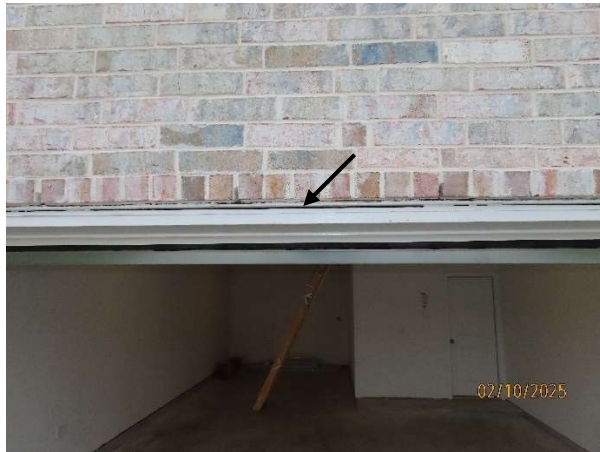
There is a gap in between the header board and steel lintel plate above the 16' garage entrance door. The gap does not reflect significantly excessive settlement at the time of the inspection. Recommend monitoring cover time.

**Gaps in between the header board and steel lintel plate along the top of the 16' garage door opening not reflective of significant settlement**

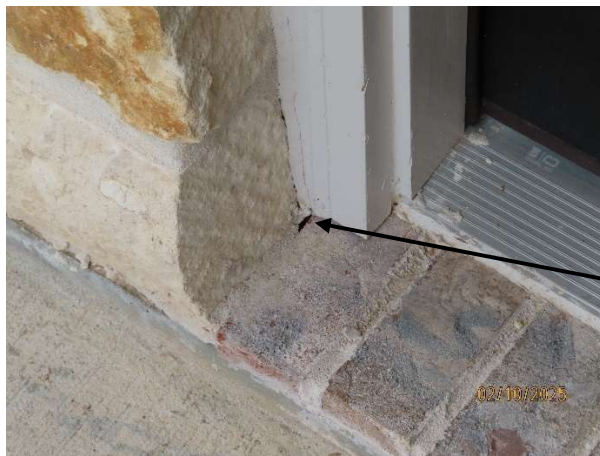
There is a small gap in to the brick veneer mortar at the bottom left side of the west entrance door opening. Recommend having the mortar gap sealed.

**Gap in to the brick veneer mortar at the bottom left side of the west entrance door opening**

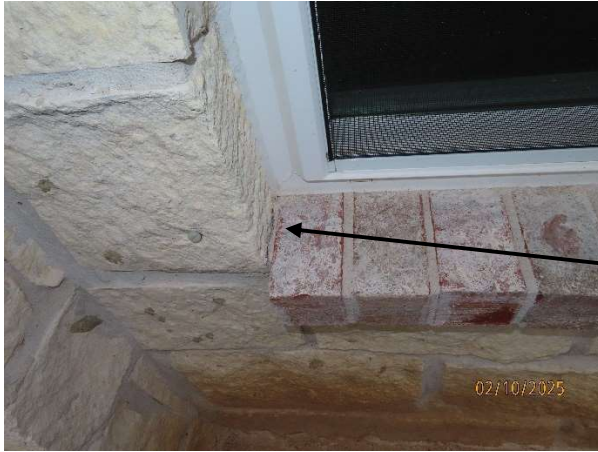
There is a gap into the brick veneer mortar at the left side of the west side S/W corner window ledge. Recommend having the gap in the mortar sealed.

**Gap in the brick veneer mortar  
at the left side of the west side  
S/W corner window**

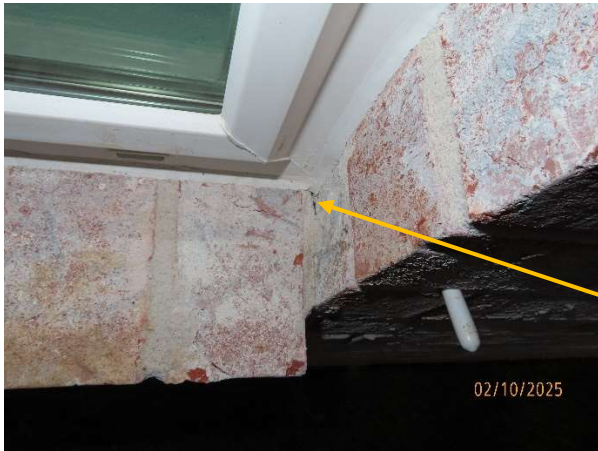
There is a gap into the mortar at the right side of the north side right window ledge. Recommend having the gap sealed.

**Gap in the mortar at the right  
side of the north side right  
window ledge**

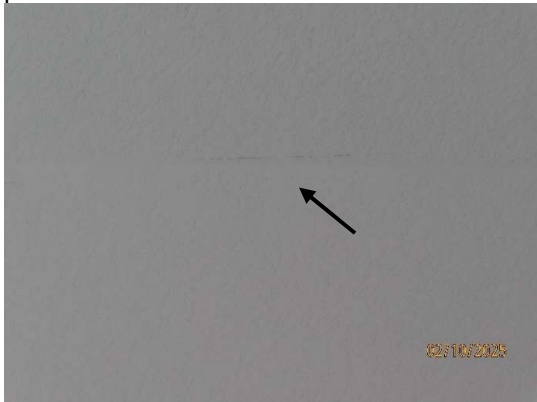
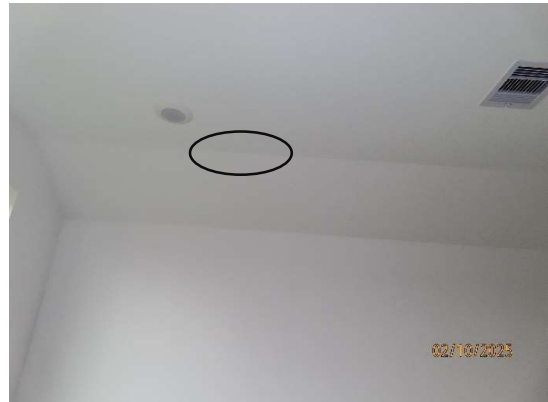
*Comments:* The drywall tape is starting to separate at the east end center of the master bedroom south end vaulted ceiling seam. Popped nail heads and separated seams are common defects along vaulted ceiling seams caused by minor normal settlement. The defects can usually be repaired with spackling and paint.

**Drywall seam starting to separate at the east end center of the master bedroom south end vaulted ceiling**

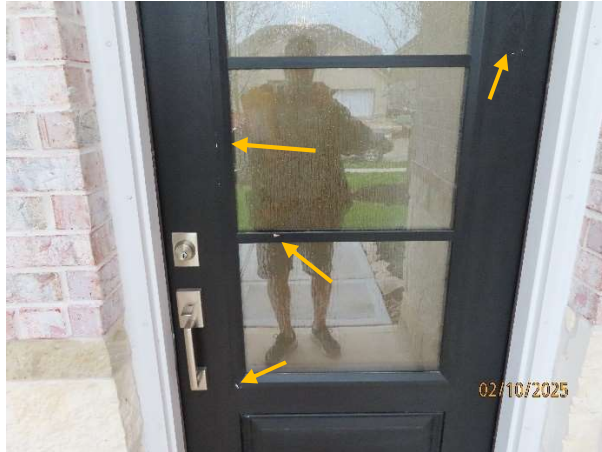
*Comments:* Paint is chipping and/or scratching off the outside of the west entrance door opening. Recommend having evaluated and repaired by the builder.

**Paint either chipped or scratched off the outside of the west entrance door**

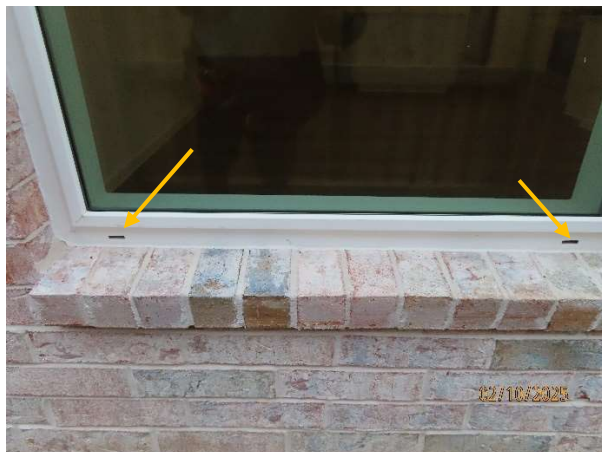
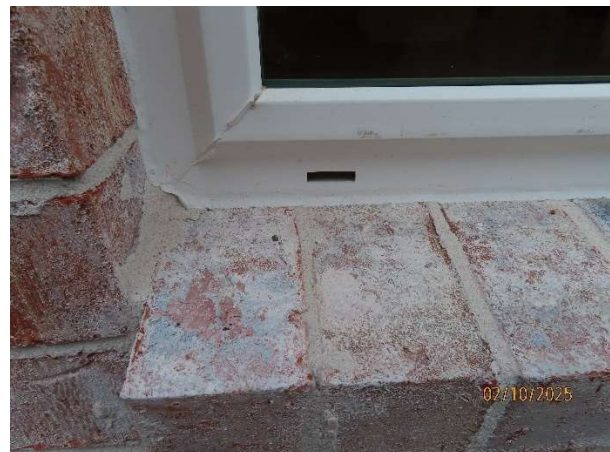
*Comments:* The weep hole flap covers are missing along the bottom of the north side center window. Recommend having evaluated and replaced by the builder.

**North side center window missing its weep hole flap covers**

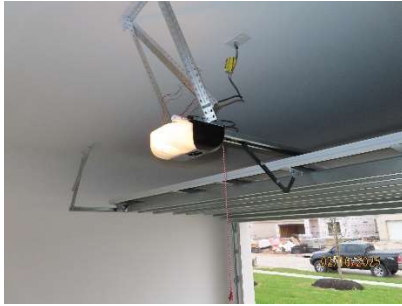
The doors reversing sensors are not working consistently. The door doesn't always reverse itself when the sensors plane is broken. Recommend having evaluated and repaired as necessary by the builder.

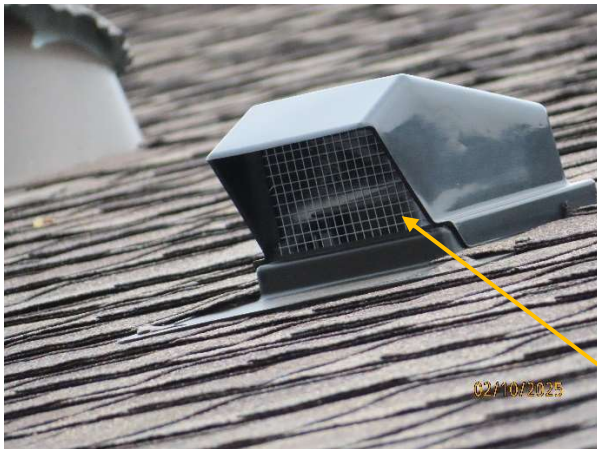
*Comments:* The dryer vent termination cover through the north sloping roof covering has a screen installed. The dryer vent termination cover should not be screened. This will cause the lint debris to collect at the termination and create fire hazards and leaks into the exhaust. Recommend having the screen removed.

**The dryer vent termination cover through the north sloping roof has a screen**
