# Home Inspection Report

3202 Mirro Drive, Manitowoc , WI 54220

Halverson Home Inspection LLC  
108 Eaton Court  
Valders , WI 54245  
920-905-5995  
th Alverson4@new.rr.com

073025-147

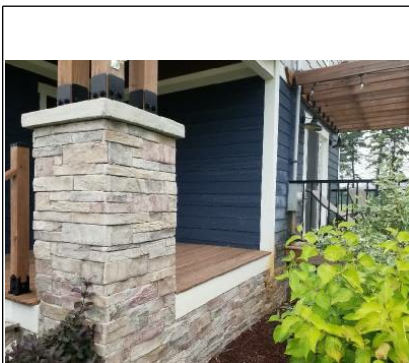
**Comments** Recommend installing railing on porch

Railings recommended

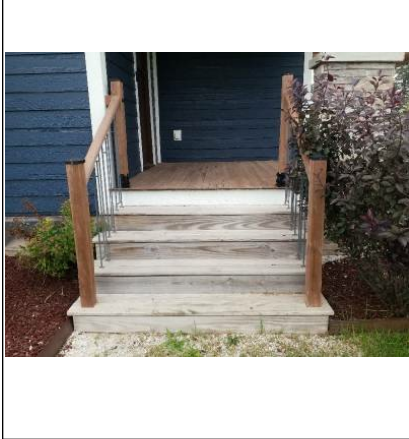
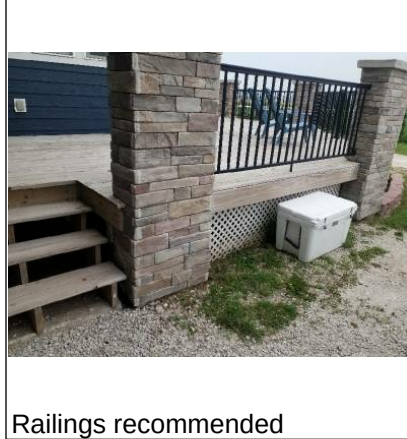
Recommend railing for steps - SAFETY CONCERN.

Railings recommended

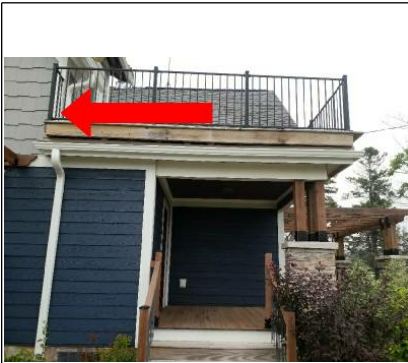
Rubber roof on balcony not visible. Evidence of leaking in house, recommend qualified contractor evaluate

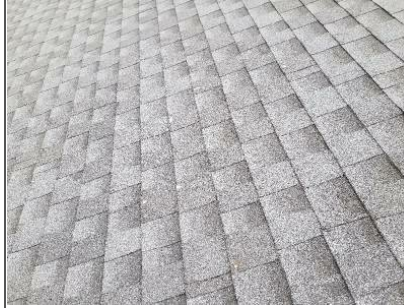
White spots are exposed nails,  
they have been caulked.  
Recommend monitoring

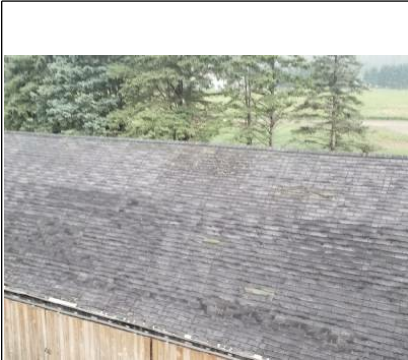
Roof on barn in need of  
replacement

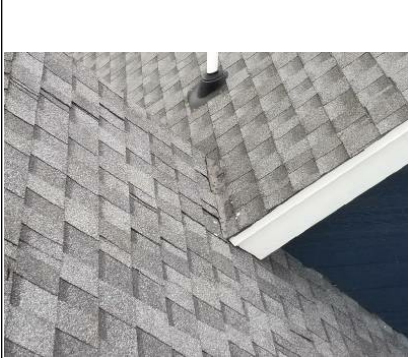
Potential problem area,  
recommend monitoring

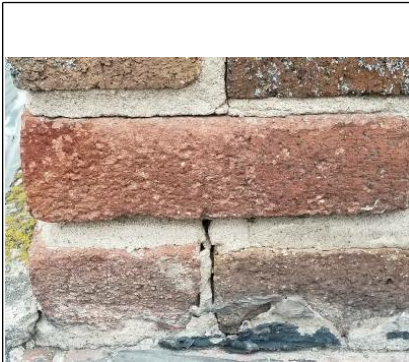
**Comments** Missing/loose mortar in the brick joints - recommend tuckpointing  
 Flashing has pulled away from the chimney - recommend repair  
 Missing/loose mortar in the brick joints - recommend tuckpointing

Tuckpointing maintenance recommended

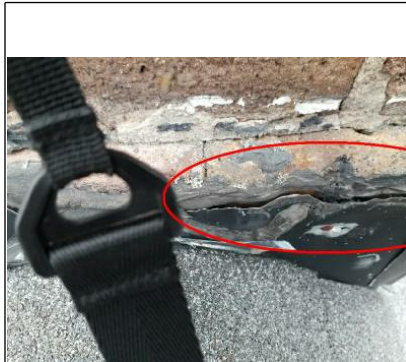
**Comments** Pulled away from chimney - recommend sealing.

Flashings. Loose, recommend qualified contractor evaluate and repair

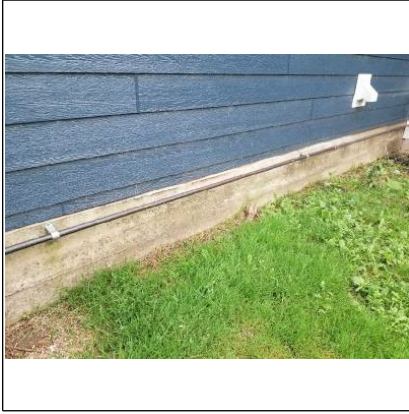
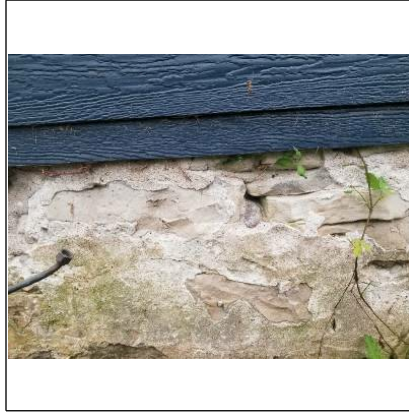
**Comments** Foundation (stem) wall contains typical cracks.

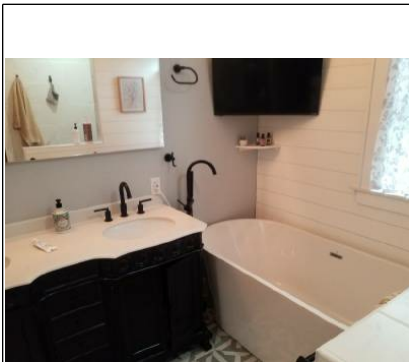
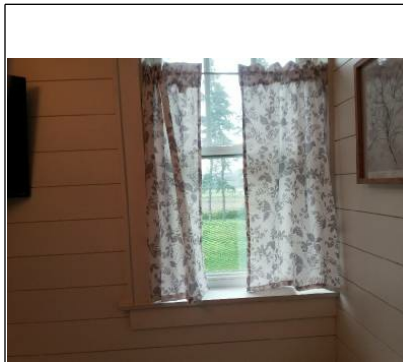
Window in tub area should be safety glass

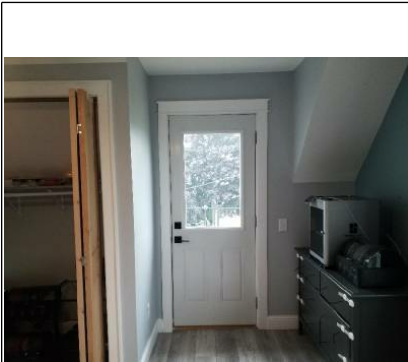
Unable to open door. Binding.  
Potential safety hazard

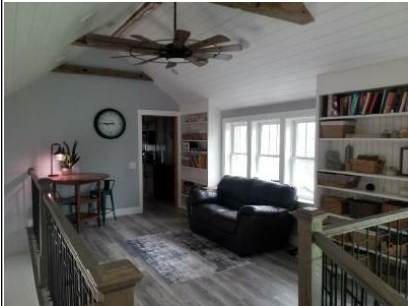
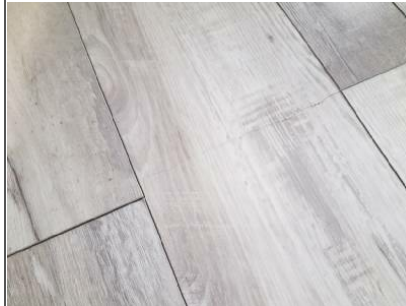
Floor is cracked

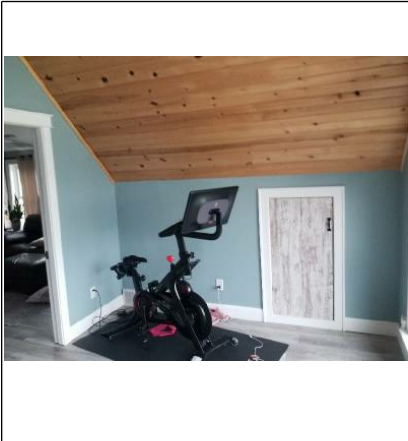
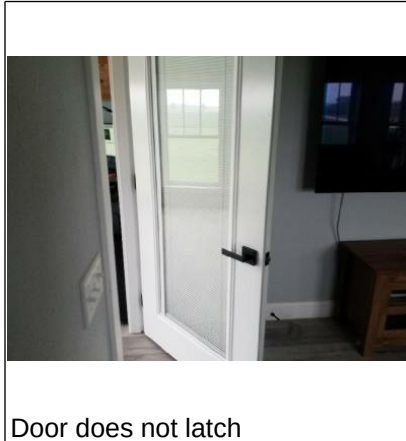
Door does not latch

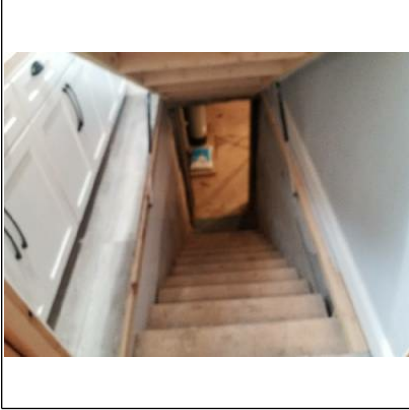
**Comments** Handrail missing, potential safety issue. Recommend Installing handrail

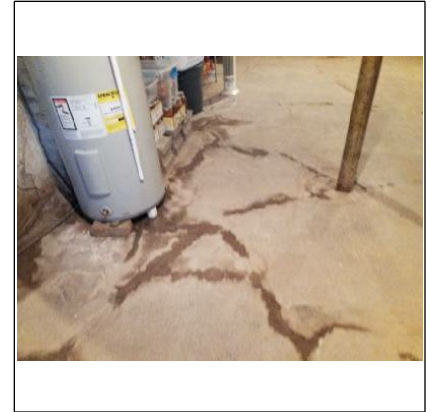
**Comments** Active seepage.  
Continual seepage is likely

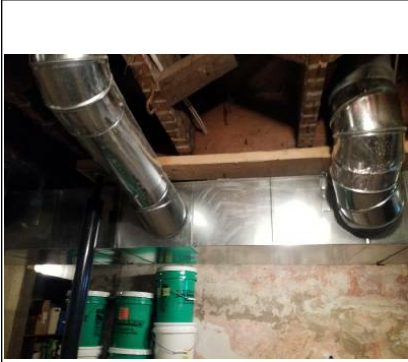
Additional supports have been added, recommend monitoring

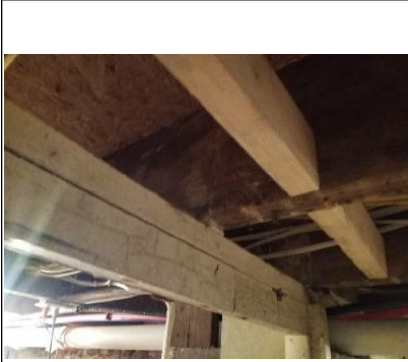
Joists improperly supported

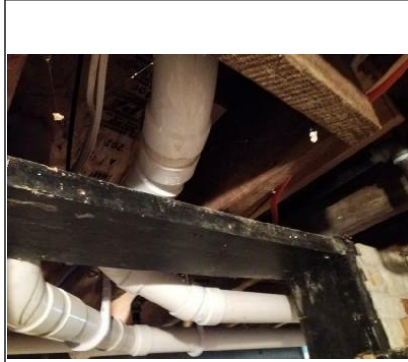
Joists improperly supported

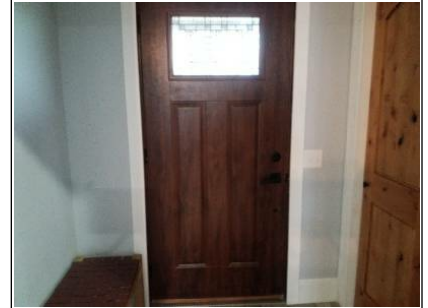
Unable to open door. Deadbolt malfunctioning. Safety Hazard

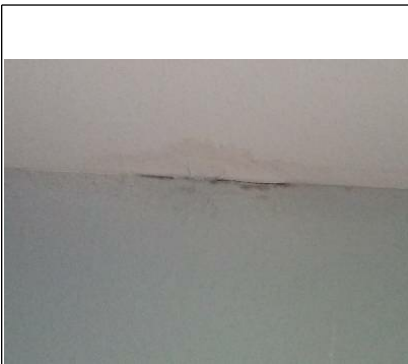
Moisture stains in entryway.

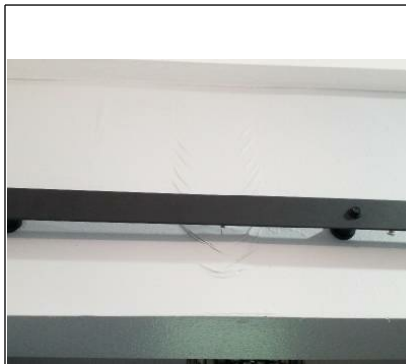
Moisture stains.
