## Peak Home Inspections

## Home Inspection Report

**850 E Ellsworth Ln**

Inspected on Tue, May 11 2021 at 2:00 PM

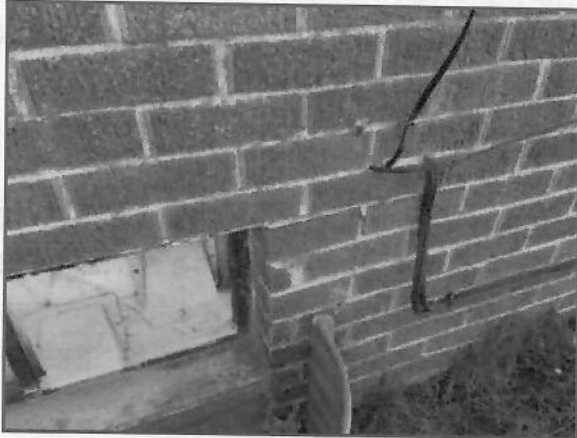
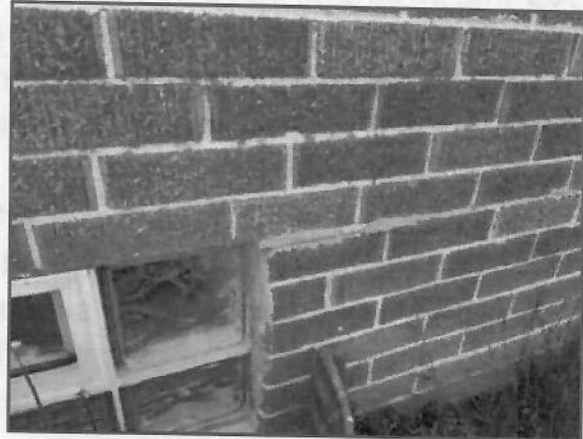
- 1) Multiple lintels above windows are rusting and causing cracking in the mortar. Recommend sealing the lintels and tuck pointing the affected mortar.

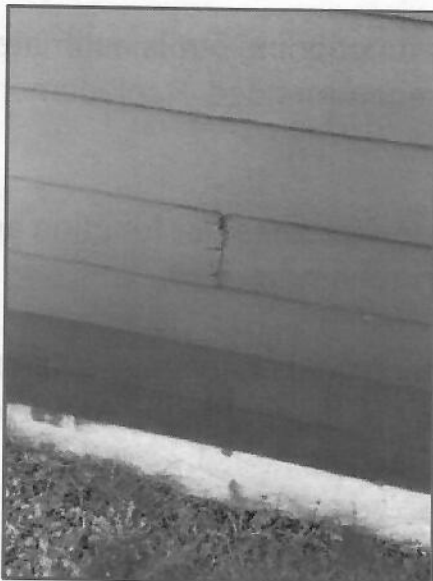
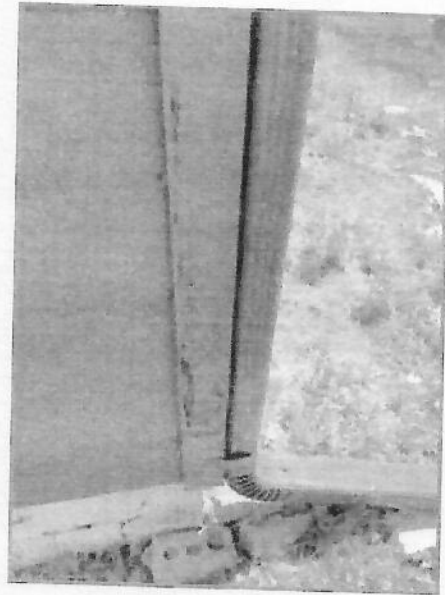
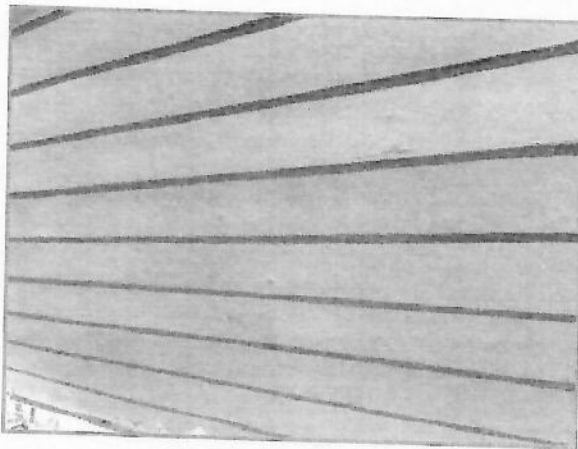
- 2) The siding and trim on the garage has wood rot. Recommend repair or replacement by a qualified contractor.

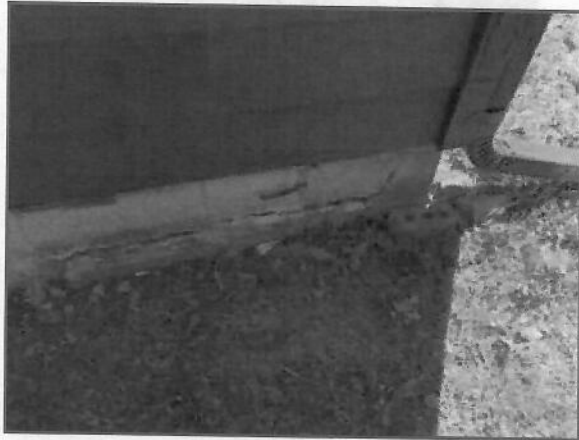
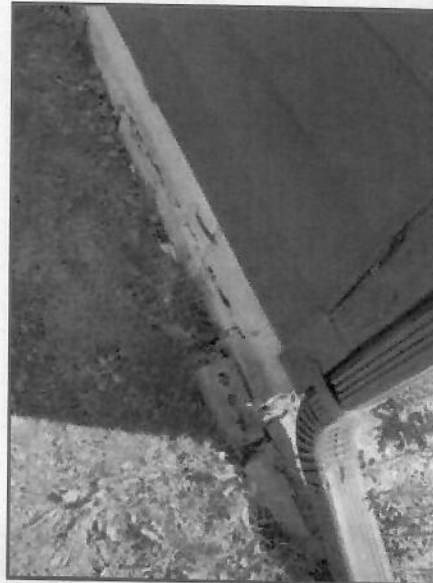
3) The block foundation on the back corner of the garage is damaged. Recommend repair or replacement by a qualified contractor.

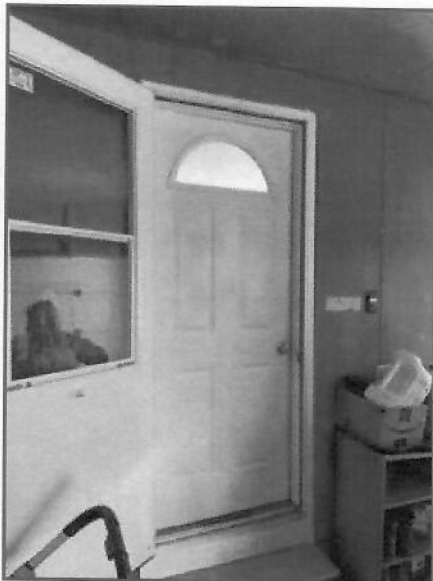
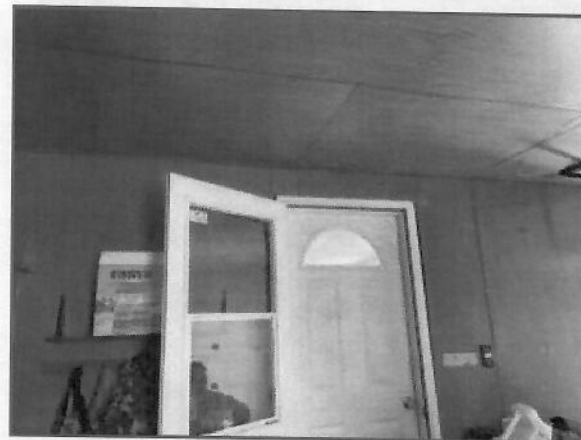
4) The firewall between the garage and living space is not complete. The drywall is not 5/8" and the door is not fire rated. Recommend repair or replacement by a qualified contractor.

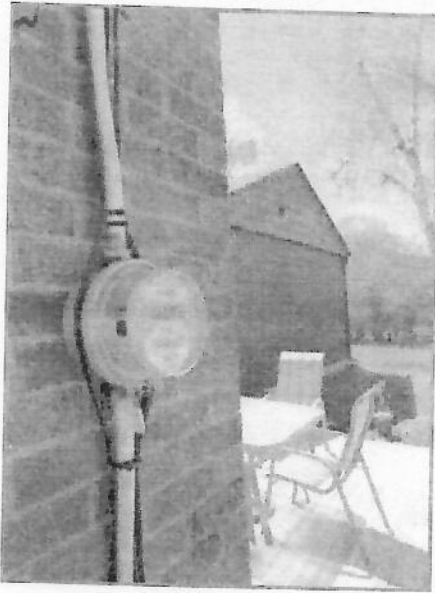
Figure 12-1

5) Circular meter socket present. Electricians, insurance company's, loan underwriters, and municipalities consider some circular meter sockets to be rated for only 60 amps and require updating to a square 100 amp meter socket to meet presents standards. Recommend a licensed electrician further evaluate and repair as needed.

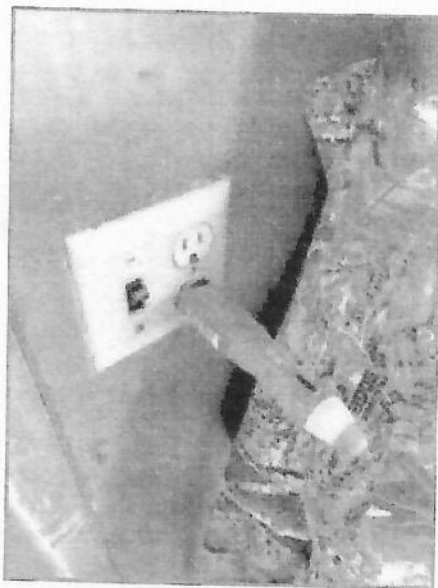
Figure 13-1

6) Outlet in the garage is not GFCI protected. Recommend repair or replacement by a licensed electrician.

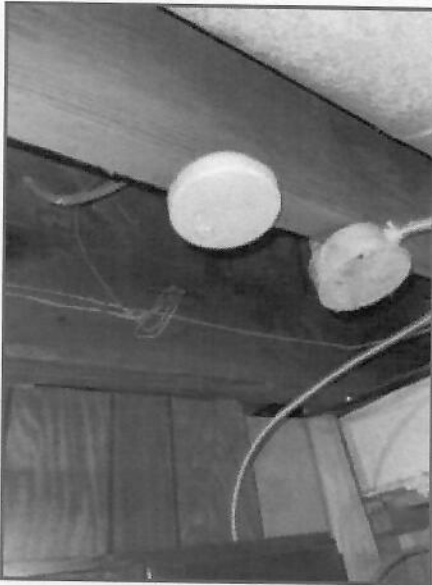
Figure 15-1

7) Missing or non functioning smoke and CO detectors. The National Fire Protection Association recommends homes should have smoke alarms installed inside every bedroom, outside each sleeping area and one on every level of the home including the basement. One CO detector is required on every level including the basement. Recommend installation of smoke and CO detectors where missing.

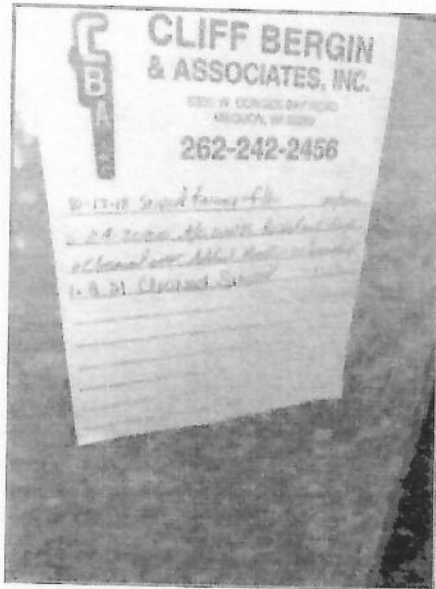
Figure 19-1

8) Refrigerant was added last year to the AC. Recommend a licensed HVAC contractor further evaluate and repair if needed.

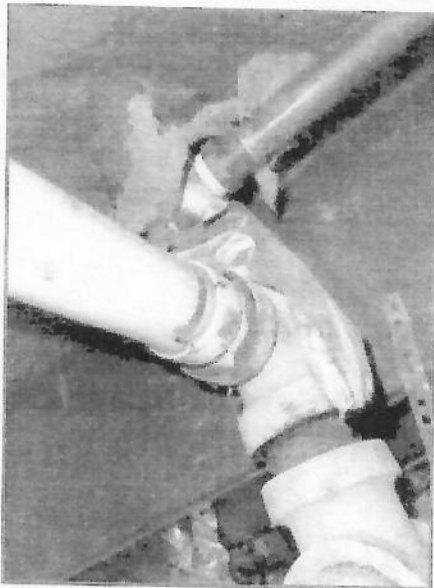
Figure 20-1

9) A dielectric union on a water supply pipe to the main bathroom is actively leaking. Recommend repair or replacement by a licensed plumber.

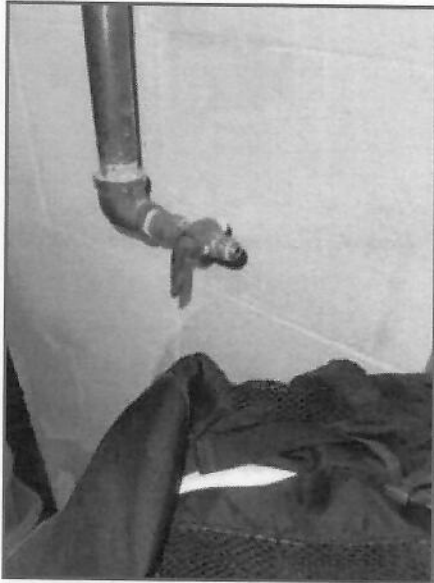
Figure 21-1

10) There is no cap on a gas line in the basement. Recommend repair or replacement by a licensed plumber.

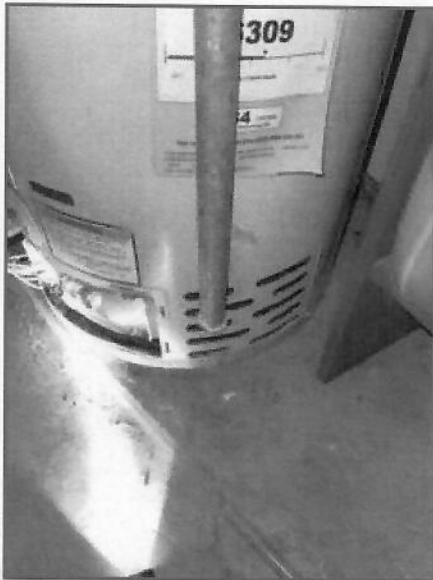
Figure 23-1

12) Temperature and pressure relief valve is leaking on the water heater. Recommend repair or replacement by a licensed plumber.

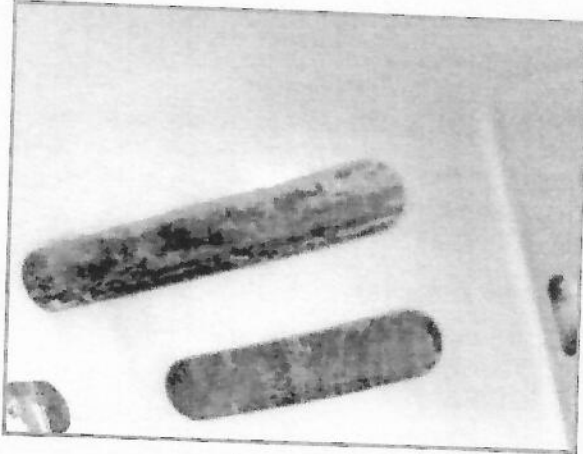
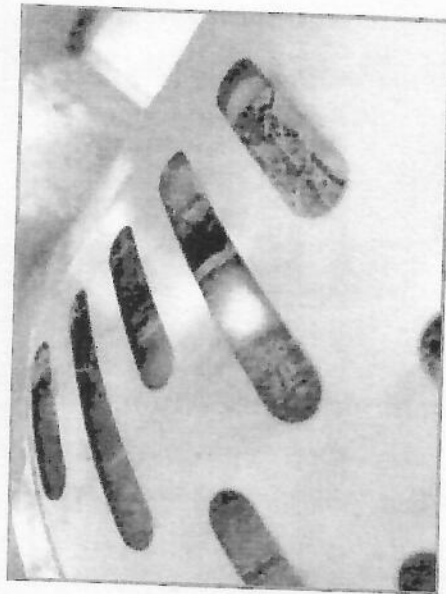
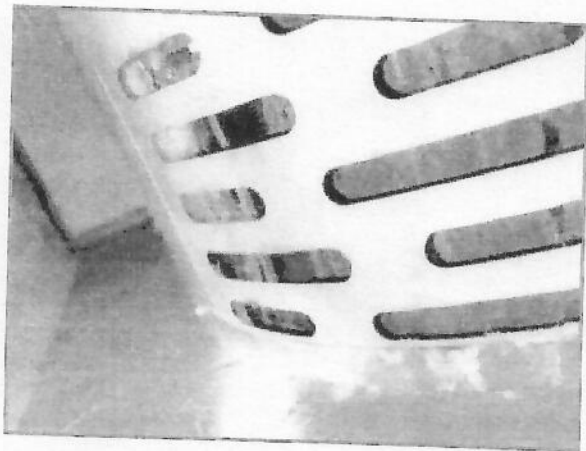
13) The water heater is heavily corroded and actively leaking. Recommend replacement by a licensed plumber.

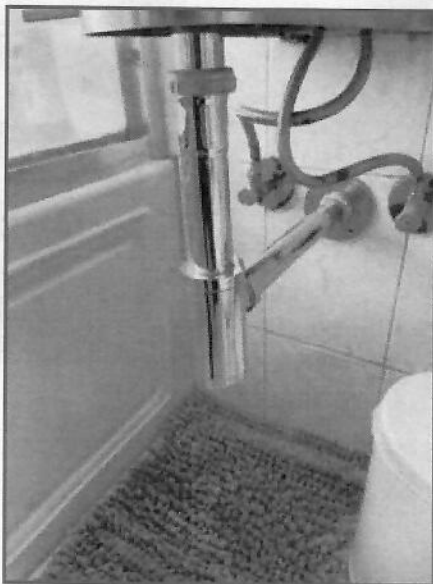
Figure 25-1

14) The bathroom sink has an bottle trap. Recommend replacement by a licensed plumber.

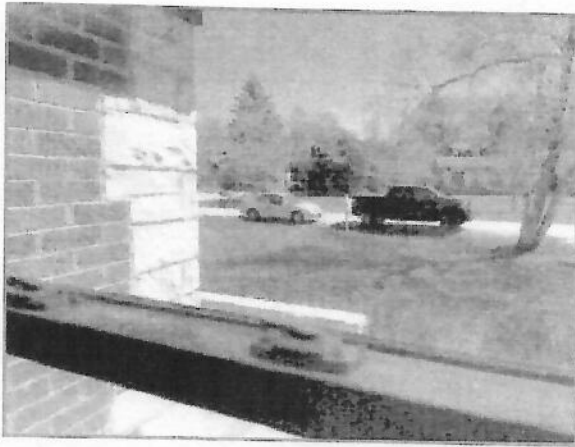
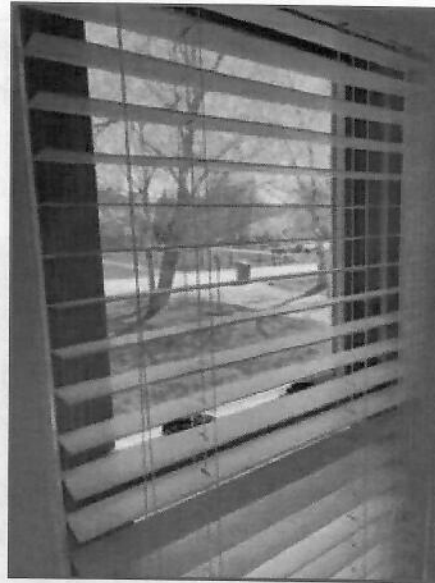
15) Two windows in vestibule, two windows in the living room, one window in the northeast bedroom and one window in the northwest bedroom have broken thermal seals and have allowed moisture between the panes of glass. Recommend repair or replacement by a qualified window contractor.

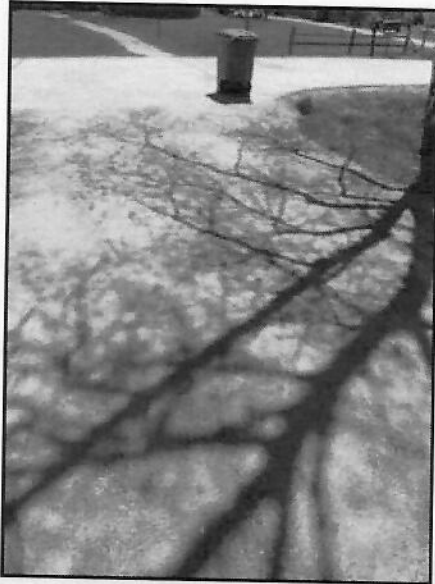
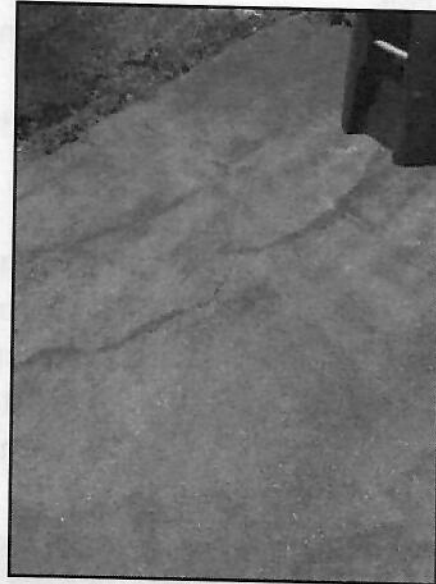
Recommend sealing the driveway to prevent wear.

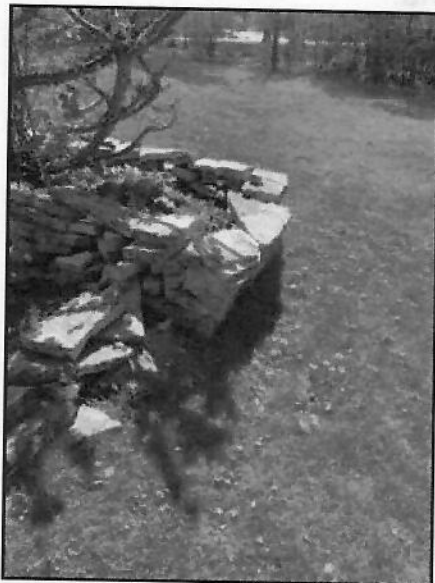
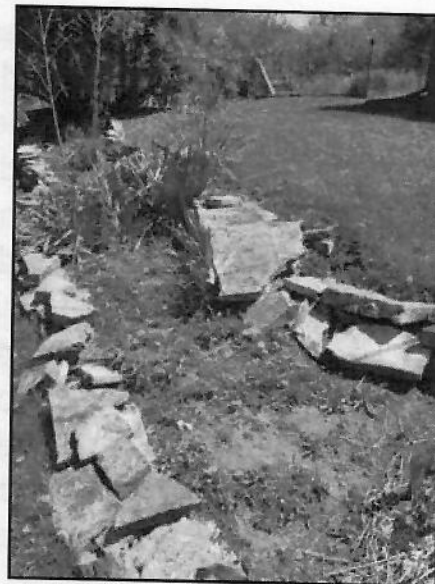
Part of the stone retaining wall is failing. Recommend repair or replacement by a qualified contractor.

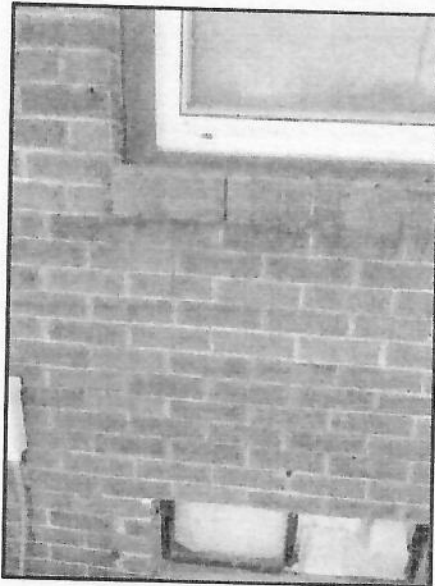
Figure 3-1

The sill on the back of the home is not properly sealed and has caused cracking in the brick siding. Recommend repair or replacement by a qualified contractor.

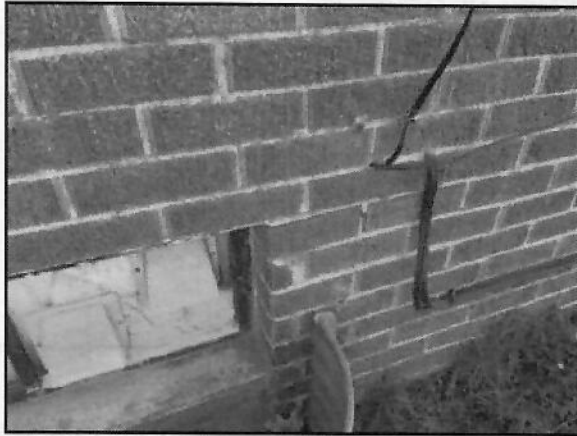
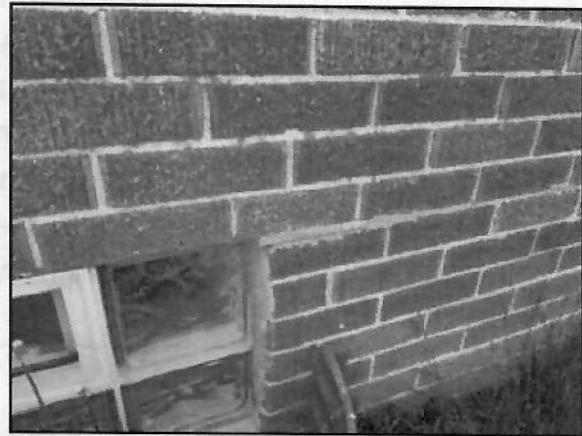
Multiple lintels above windows are rusting and causing cracking in the mortar. Recommend sealing the lintels and tuck pointing the affected mortar.

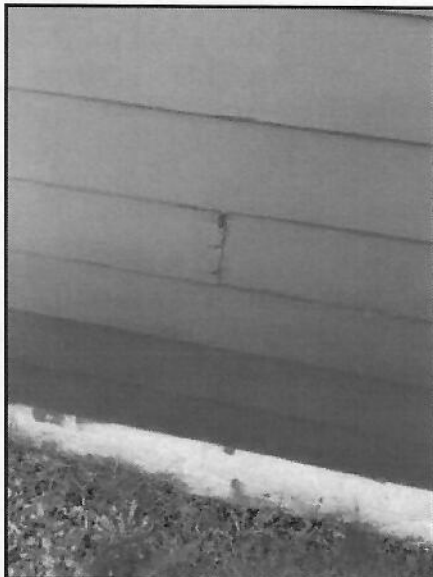
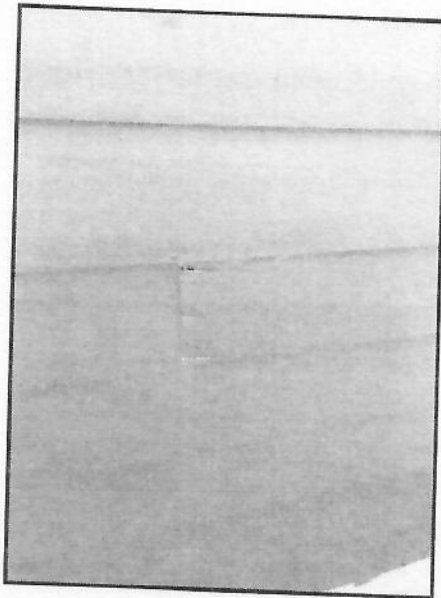
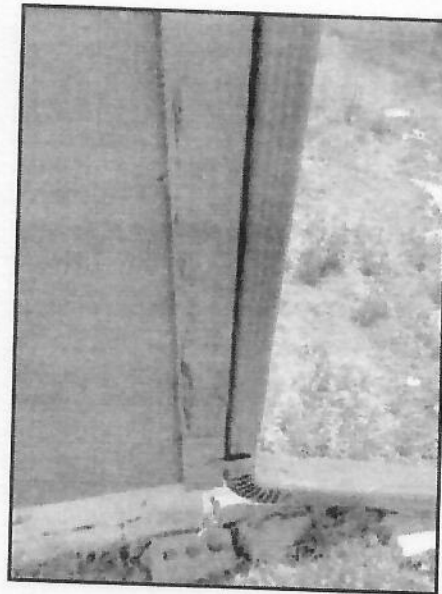
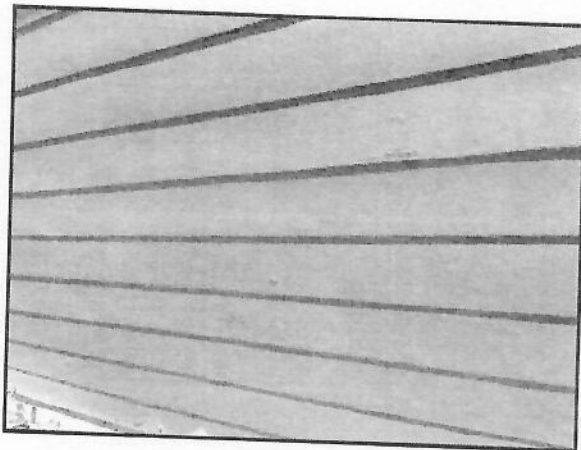
The siding and trim on the garage has wood rot. Recommend repair or replacement by a qualified contractor.

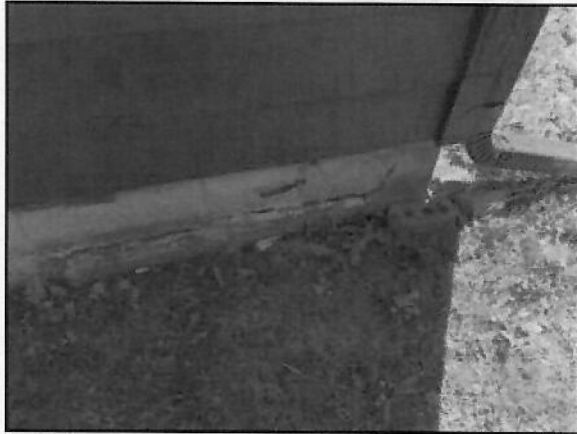
Figure 6-1

**Comment 6:**  
The block foundation on the back corner of the garage is damaged. Recommend repair or replacement by a qualified contractor.

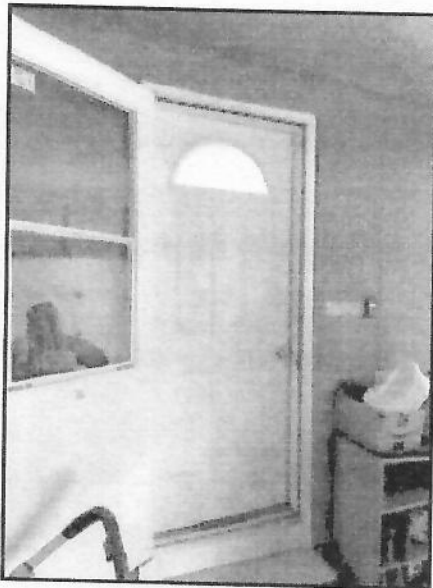
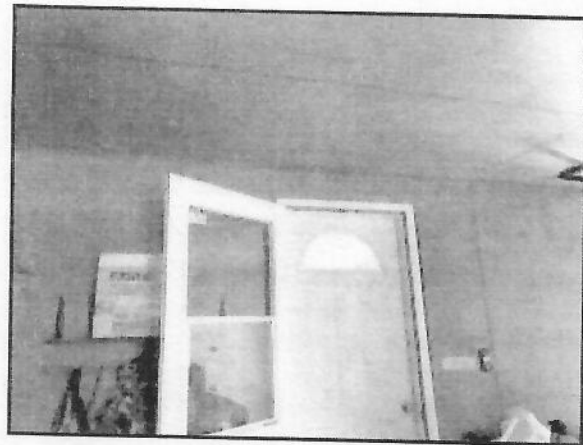
**Comment 7:**  
The firewall between the garage and living space is not complete. The drywall is not 5/8" and the door is not fire rated. Recommend repair or replacement by a qualified contractor.

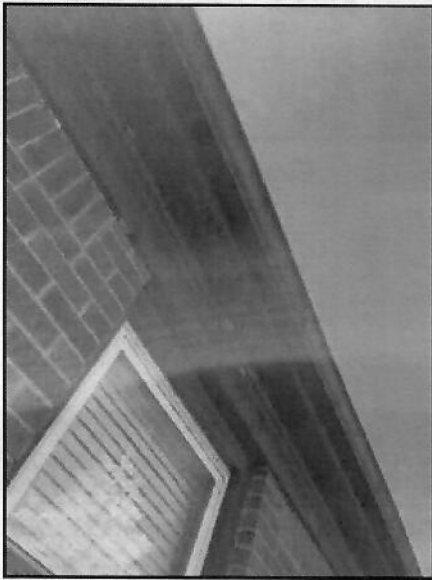
Figure 8-1

**i** **Comment 8:**  
There is peeling and missing paint on the fascia and soffit of the home. Recommend repair or replacement by a qualified contractor.

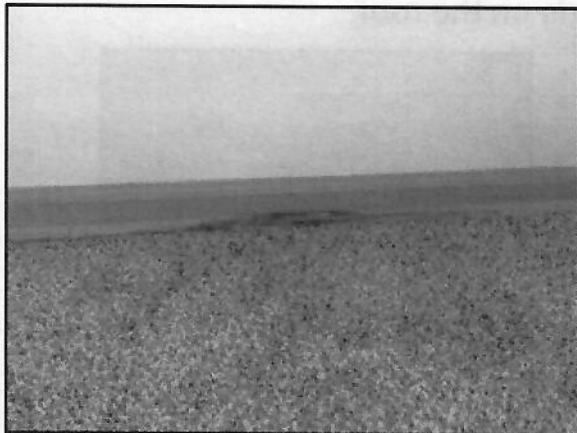
Figure 11-1

There were moisture stains in several areas of the basement. The stains were dry during time of inspection. Recommend correcting downspouts and grading then monitor for any further moisture.

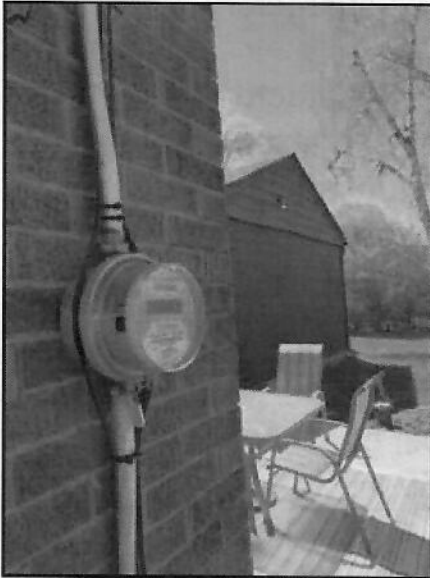
Figure 12-1

Circular meter socket present. Electricians, insurance company's, loan underwriters, and municipalities consider some circular meter sockets to be rated for only 60 amps and require updating to a square 100 amp meter socket to meet presents standards. Recommend a licensed electrician further evaluate and repair as needed.

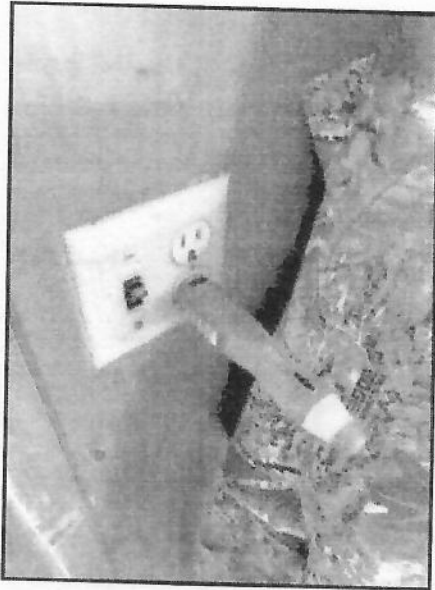
Figure 13-1

Outlet in the garage is not GFCI protected. Recommend repair or replacement by a licensed electrician.

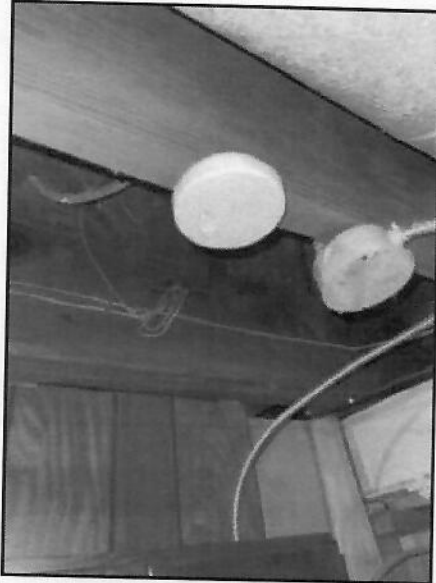
Figure 15-1

Missing or non functioning smoke and CO detectors. The National Fire Protection Association recommends homes should have smoke alarms installed inside every bedroom, outside each sleeping area and one on every level of the home including the basement. One CO detector is required on every level including the basement. Recommend installation of smoke and CO detectors where missing.

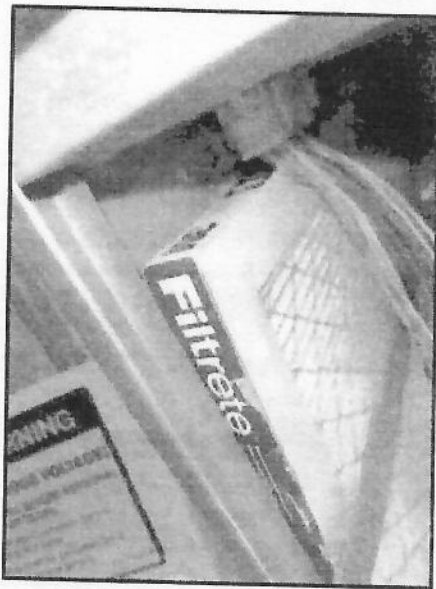
Figure 16-1

The furnace filter was installed backwards. Recommend repair or replacement.

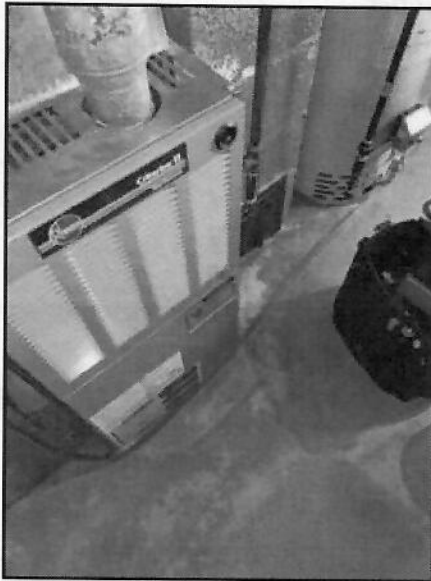
Figure 17-1

The furnace is near the end of its useful life due to age. Recommend budgeting for replacement in the near future.

Furnaces over 10 years old should be checked, cleaned and serviced yearly by a licensed contractor.

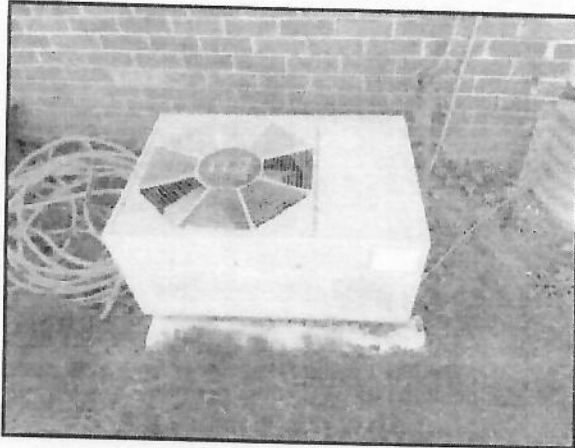
Figure 18-1

The air conditioning condensing unit is nearing the end of its useful life due to age. Recommend budgeting for replacement in the near future.

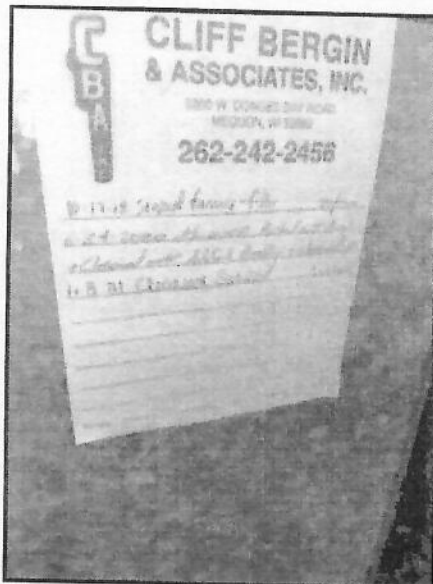
Figure 19-1

Refrigerant was added last year to the AC. Recommend a licensed HVAC contractor further evaluate and repair if needed.

Air conditioners over 10 years old and heat pumps over 5 years old should be checked, cleaned and serviced yearly by a licensed contractor.

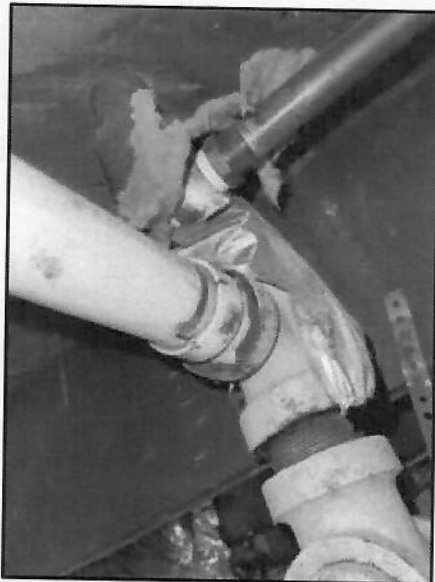
Figure 20-1

A dielectric union on a water supply pipe to the main bathroom is actively leaking. Recommend repair or replacement by a licensed plumber.

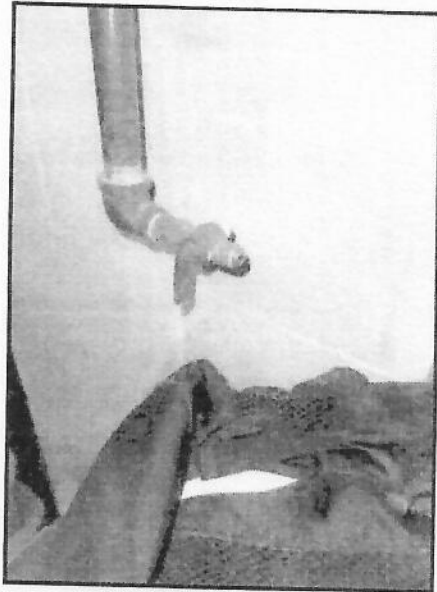
Figure 21-1

There is no cap on a gas line in the basement. Recommend repair or replacement by a licensed plumber.

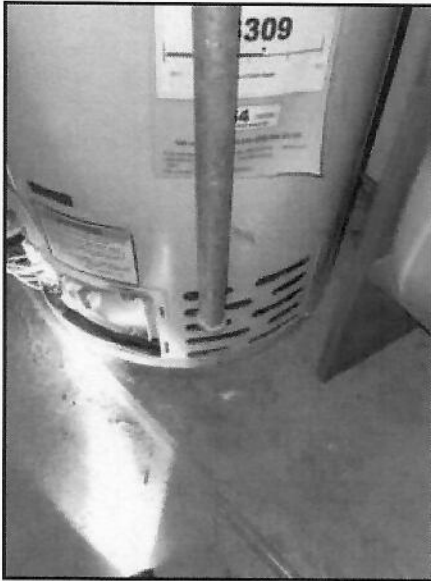
Figure 23-1

**Comment 23:**  
Temperature and pressure relief valve is leaking on the water heater. Recommend repair or replacement by a licensed plumber.

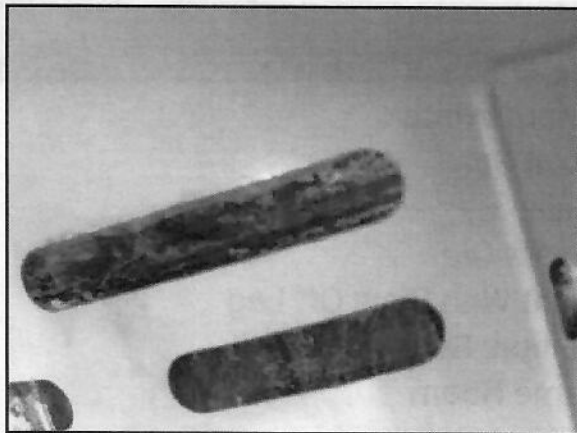
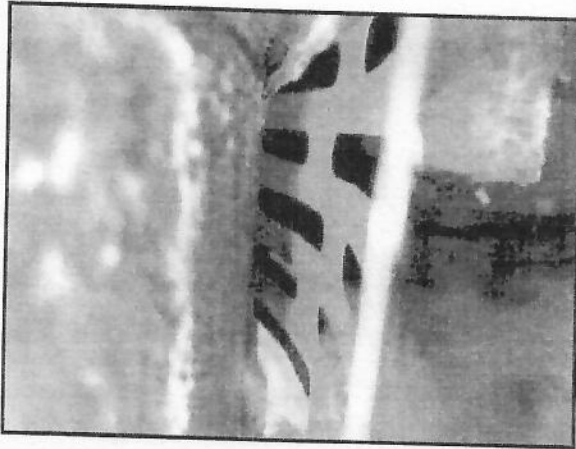
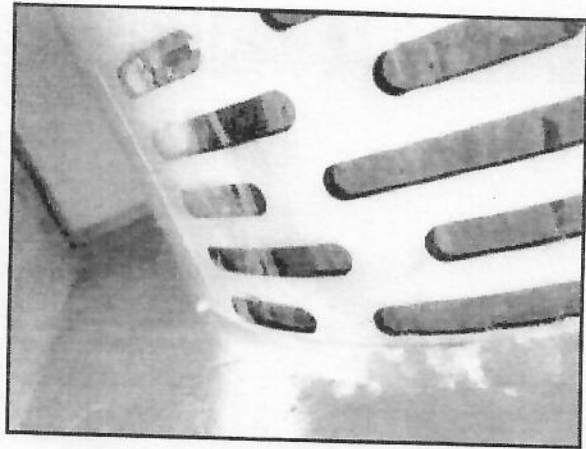
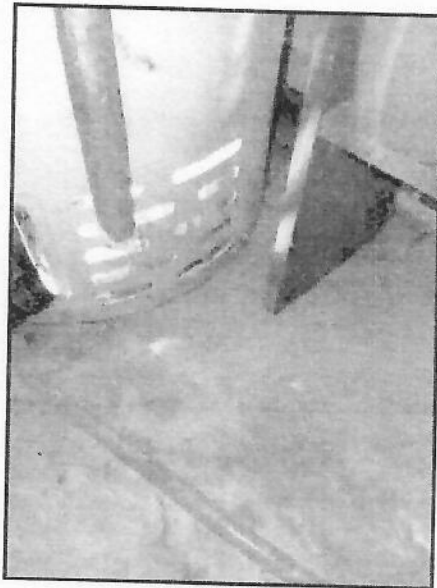
**Comment 24:**  
The water heater is heavily corroded and actively leaking. Recommend replacement by a licensed plumber.

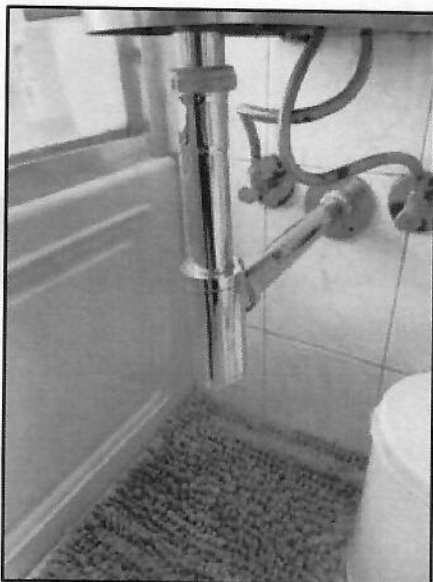
Figure 25-1

The bathroom sink has an bottle trap. Recommend replacement by a licensed plumber.

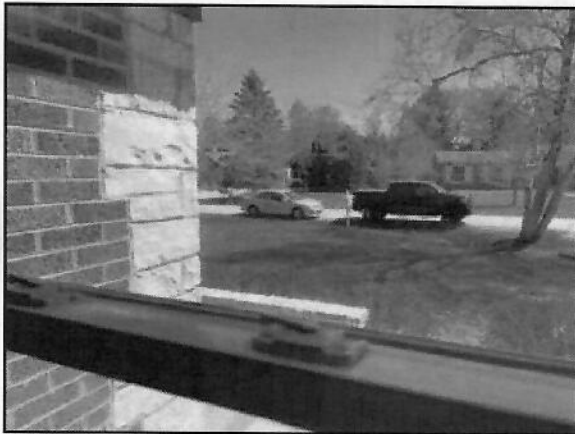
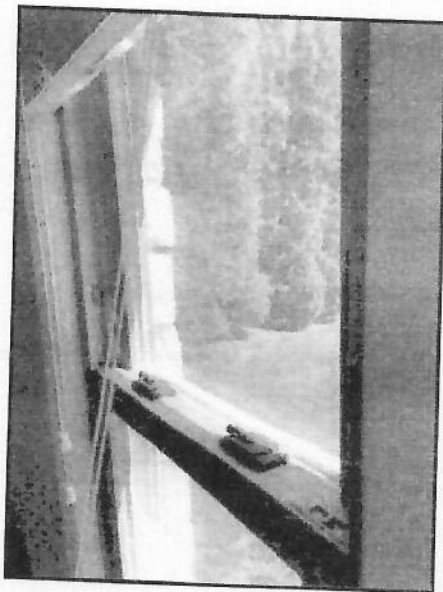
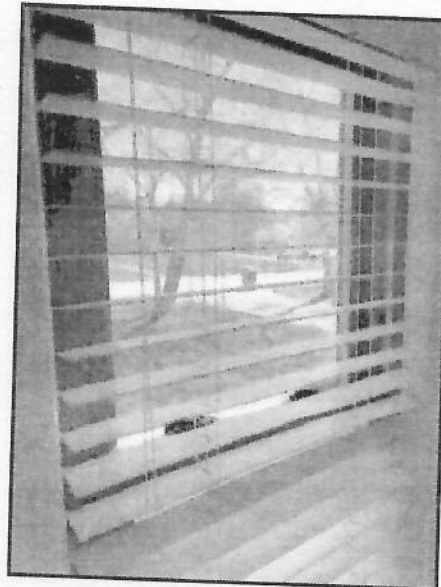
**Comment 26:**  
Two windows in vestibule, two windows in the living room, one window in the northeast bedroom and one window in the northwest bedroom have broken thermal seals and have allowed moisture between the panes of glass. Recommend repair or replacement by a qualified window contractor.

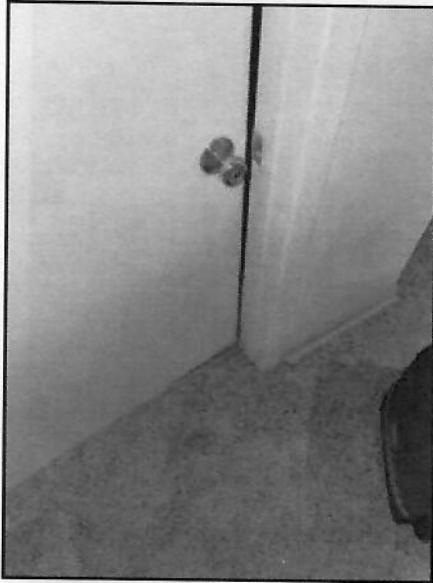
Figure 27-1

Basement door would not close. Recommend repair or replacement by a qualified contractor.
