**Peak Home Inspections**  
(414) 477-3775  
Peakhomeinspectionsmke.com

## Home Inspection Report

166 N 91st Pl  
Milwaukee, WI 53226

**Prepared For: Grace Schleevoigt**  
Inspected On Tue, Jun 23, 2026 at 9:00 AM

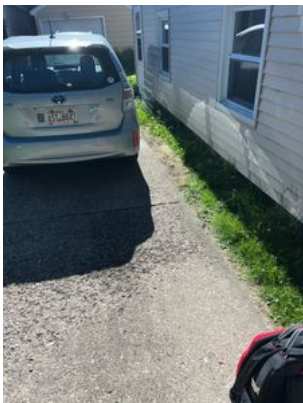
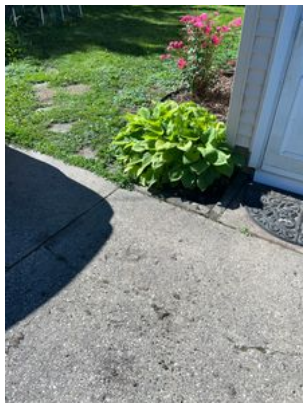
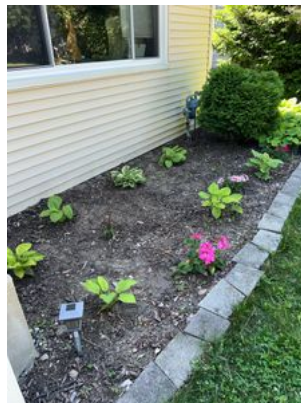
**Comment 1**  
**Maintenance**

The grading by parts of the home is negative (slopes toward the home). Recommend adding or removing dirt to create a positive grade. Recommended grade is an inch a foot for six feet sloping away from the home.

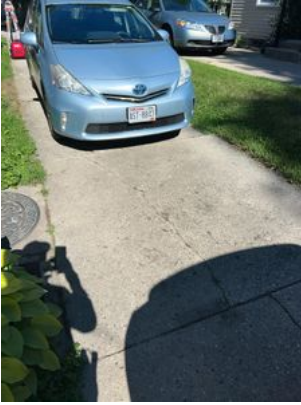
**Comment 2**

The pitch of the driveway is negative (slopes toward the home). Recommend repair or replacement by a qualified contractor.

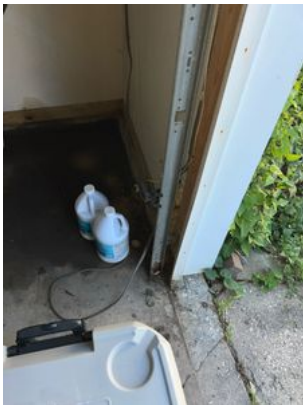
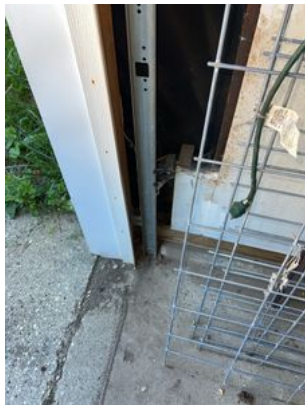
#### Comment 3

The garage light sensors are too high. The sensor have to be within six inches of the ground. Recommend repair or replacement by a qualified contractor.

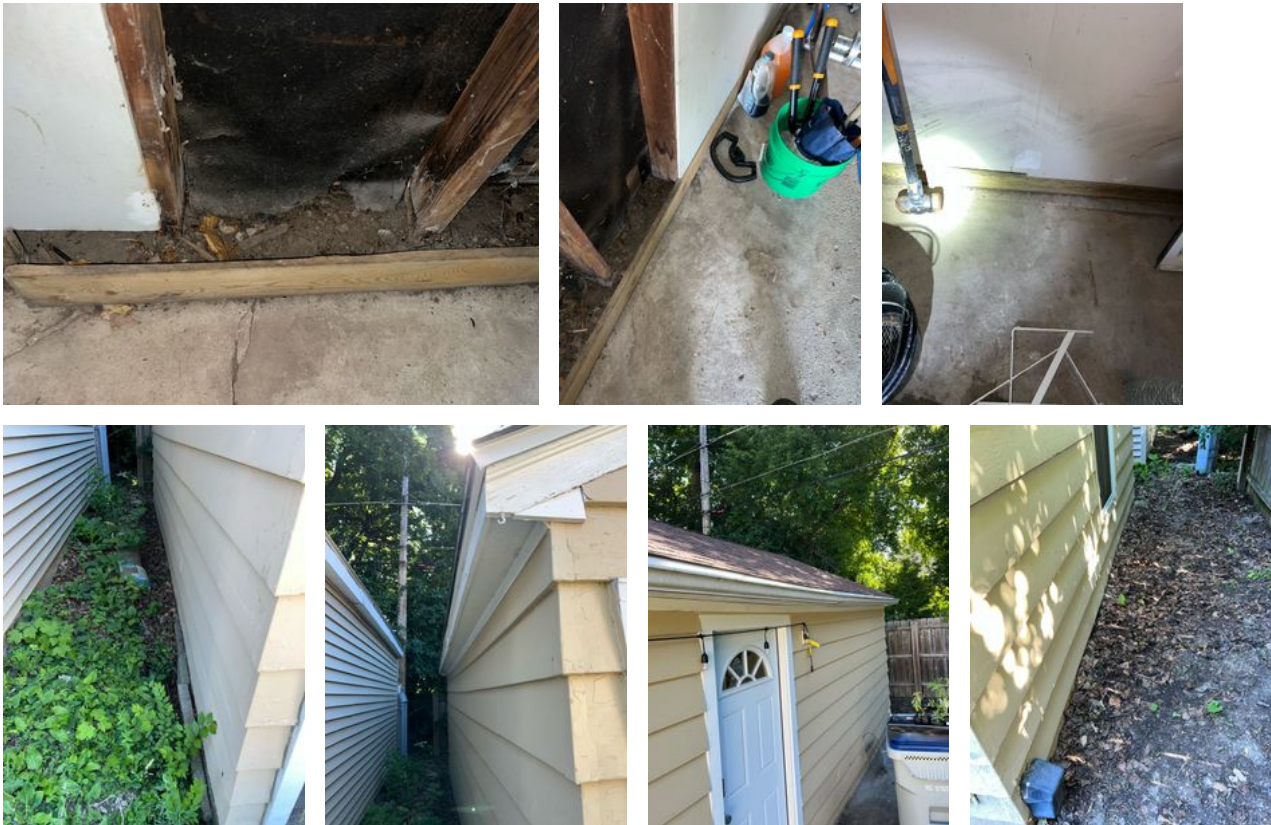
**Comment 4**

The lack and not properly functioning gutters on the garage and the high levels of the exterior dirt have caused deterioration to the sill plates and wall joist. Recommend repair or replacement by a qualified contractor.

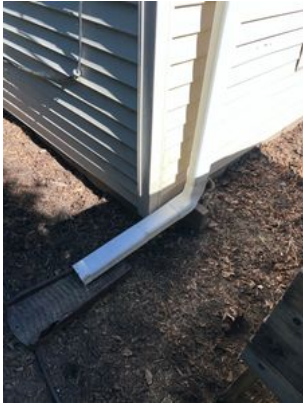
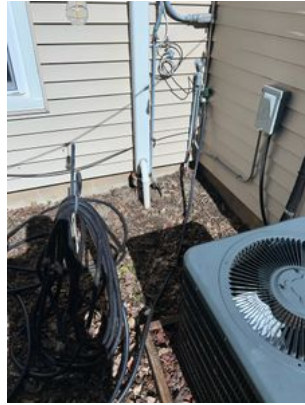
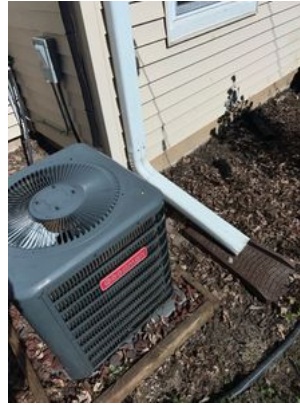
#### **Comment 5** **Maintenance**

Recommend extending all downspouts at least six feet away from the home.

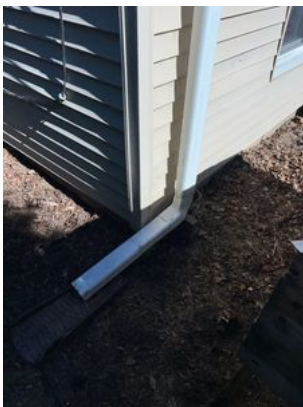
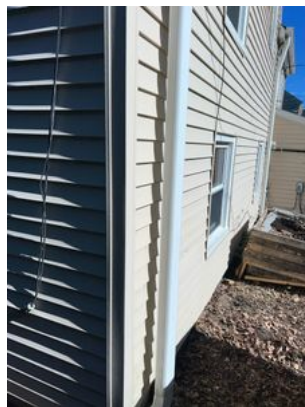
#### **Comment 6** **Maintenance**

Back gutter and extension is not properly secure. Recommend repair or replacement by a qualified contractor.

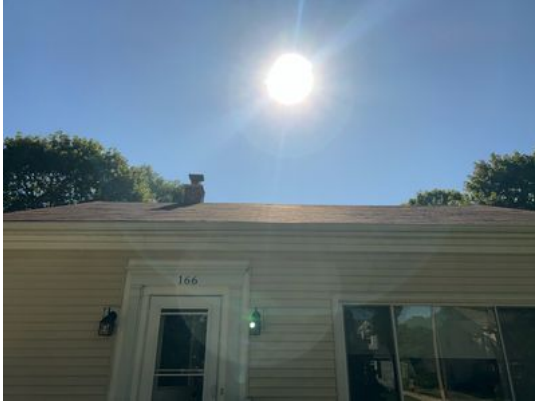
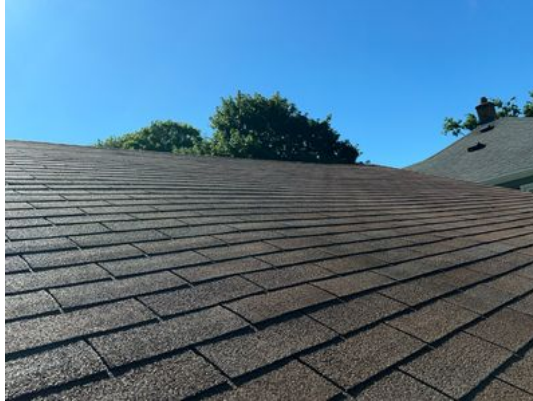
### **Comment 7** **Maintenance**

There are several shingles on the roof that are lifting. Recommend repair or replacement by a qualified contractor.

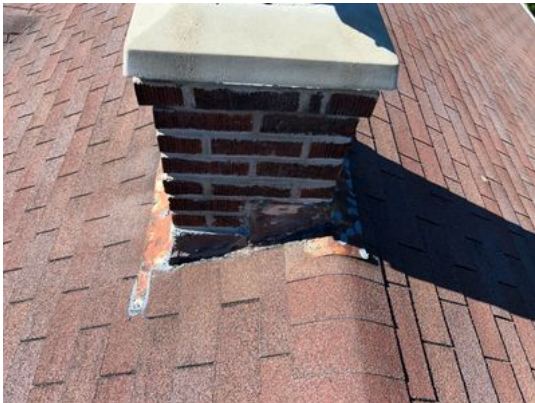
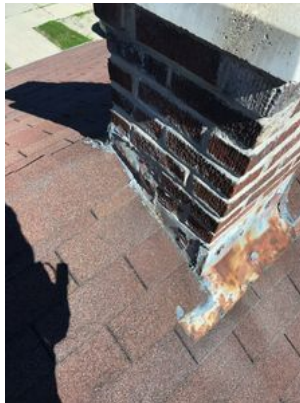
### **Comment 8** **Need Repair**

The chimney flashing was not properly installed. Recommend repair or replacement by a qualified contractor.

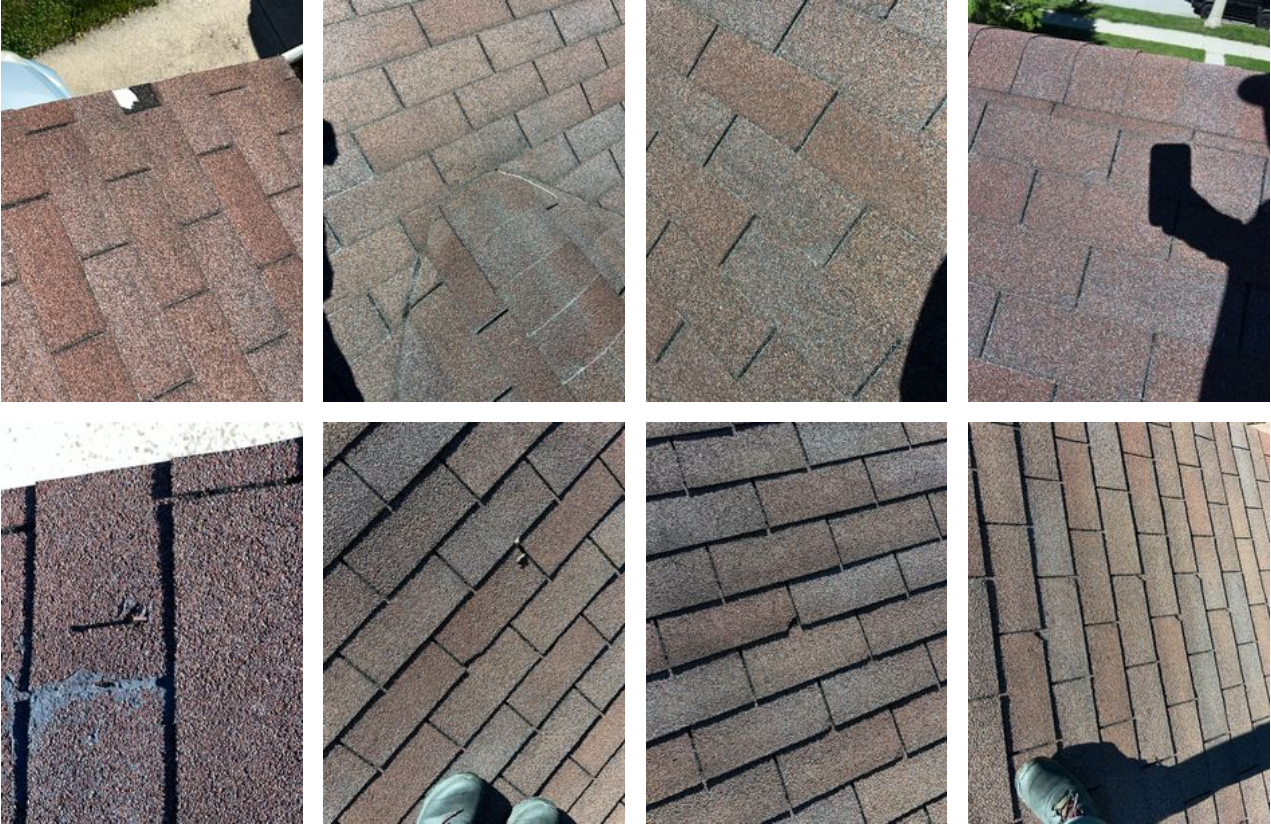
**Comment 9**  
**Need Repair**

There are several shingles throughout the roof that are damaged. Recommend repair or replacement by qualified roofing contractor.

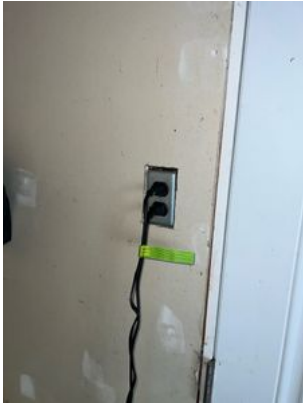
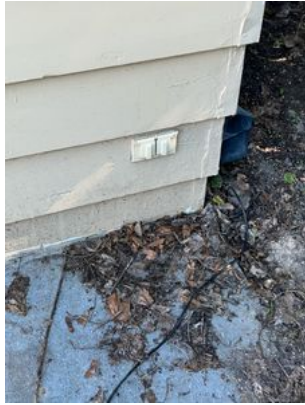
#### **Comment 10**

Interior and exterior outlet in the garage are not GFCI protected. Recommend repair or replaced by a licensed electrician.

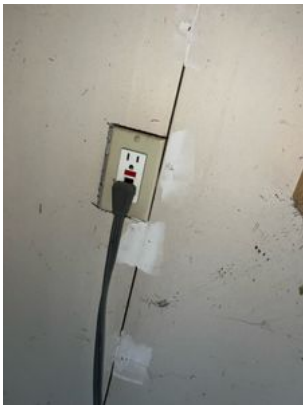
#### **Comment 11**

An outlet in the garage that is GFCI protected would not trip one tested. Recommend repair or replacement by a licensed electrician.

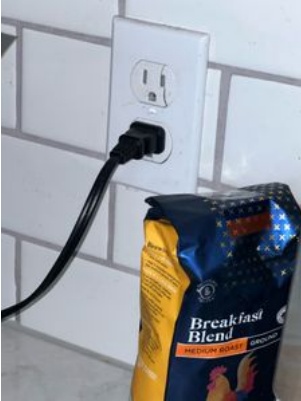
**Comment 12**

Outlet in the kitchen is cracked. Recommend repair or replacement by a licensed electrician.

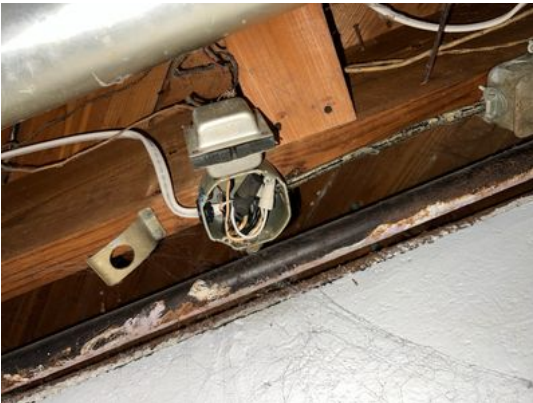
**Comment 13**

There is an open junction box in the basement. Recommend repair or replacement by a licensed electrician.

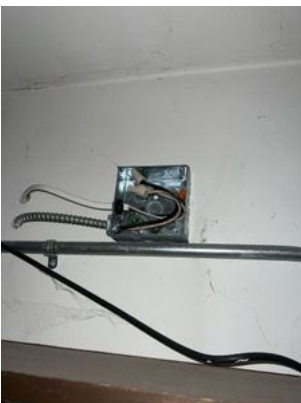
**Comment 14**

There is an open junction box in the lower level. Recommend repair or replacement by a licensed electrician.

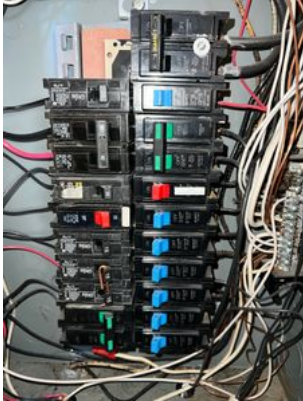
**Comment 15**

Several breakers in the main panel are the wrong type. Recommend repair or replacement by a licensed electrician.

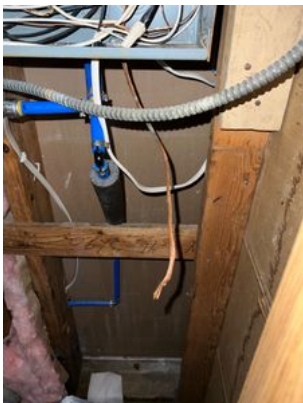
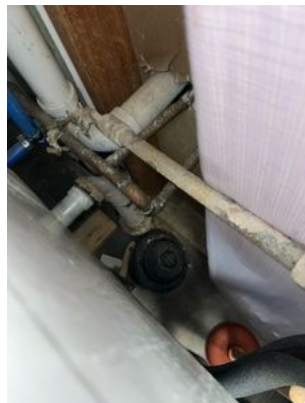
**Comment 16**

The ground wire for the plumbing does not appear to be properly connected. Recommend repair or replacement by a licensed electrician.

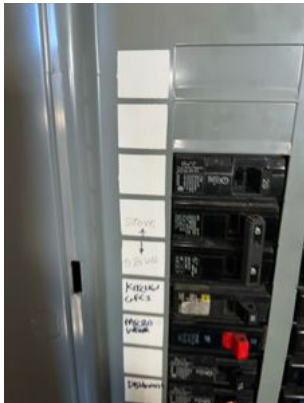
**Comment 17**

One breaker in the main panel is not properly labeled. Recommend repair by a qualified contractor.

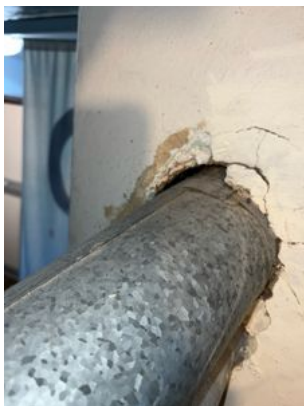
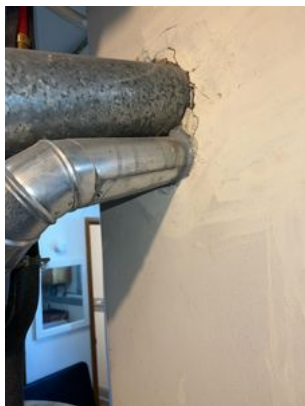
### Comment 19

The exhaust on the furnace and water heater are not properly sealed to the chimney. Recommend repair or replacement by a qualified contractor.

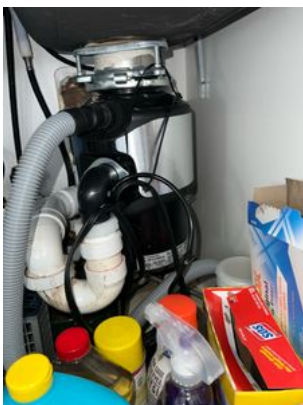
There is no air gap for the dishwasher. This could create cross contamination. Recommend repair or replacement by a licensed plumber.

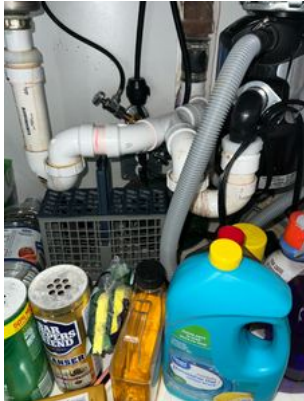
### Comment 21

The kitchen sink drain has evidence of leaking. Recommend repair or replacement by a licensed plumber.

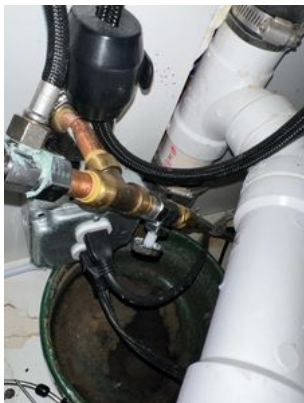
### Comment 22

There is no shock arrestor on the water supply to the dishwasher. Recommend repair or replacement by a licensed plumber.

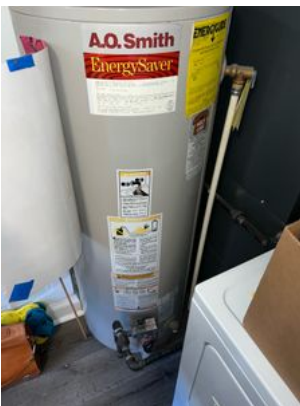
The water heater is nearing the end of its useful life due to age. Recommend budgeting for replacement in the near future.

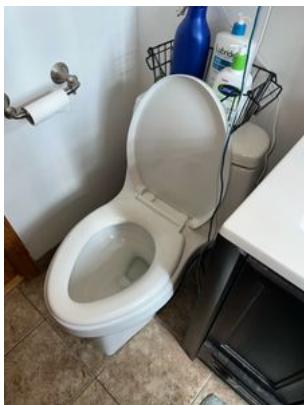
The toilet is loose. This can cause the wax ring to leak. Recommend repair or replacement by a licensed plumber.

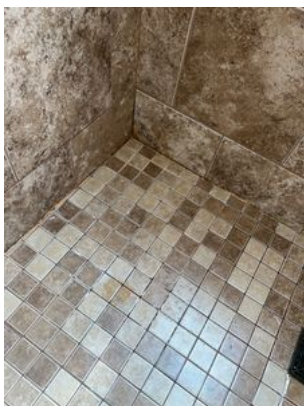
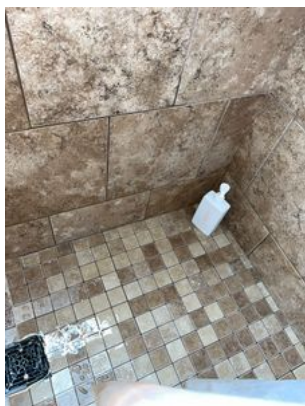
#### Comment 25

The bottom of the shower walls, where they meet the floor are no longer properly sealed. Recommend repair or replacement by a qualified contractor.

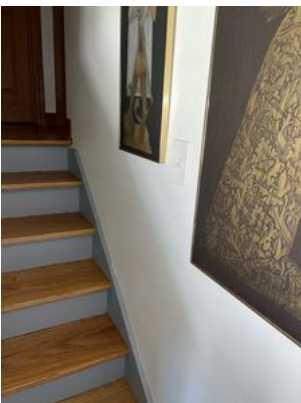
There is no handrail on the stairs to the second floor. Recommend repair or replacement by a qualified contractor.

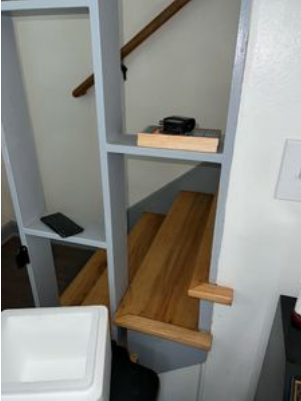
**Comment 27**

The balusters on the stair railing are spaced too far apart. Recommend repair or replacement by a qualified contractor.

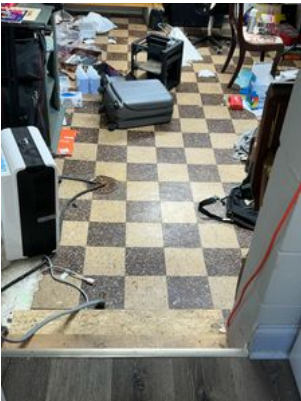
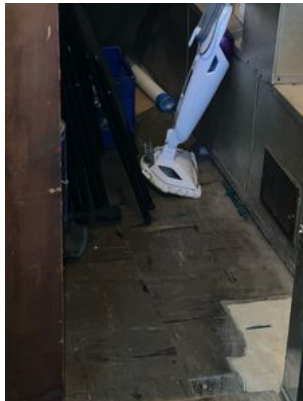
**Comment 28**

The flooring tiles in the basement are an asbestos like product . Recommend a licensed asbestos remediation contractor further evaluate and repair as needed.

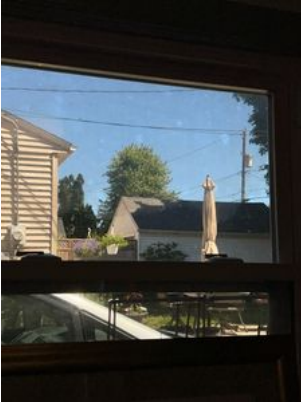
**Comment 29**

Window in the laundry room has a broken thermal seal and has allowed moisture between the panes of glass. Recommend repair or replacement by a qualified window contractor.
