Disclosure of Pre-Sale Inspection Report

2220 Stonecroft Dr.

# PROPERTY INSPECTION REPORT

**2220 Stonecroft Dr Grafton WI**  
**Inspection Prepared For: Tracy Prohuska**  
**Agent: Jaime Lubner - Compass**

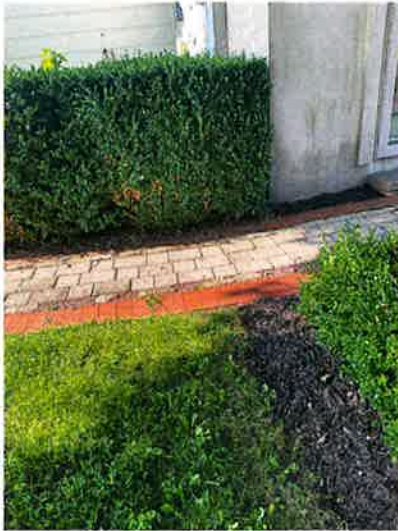
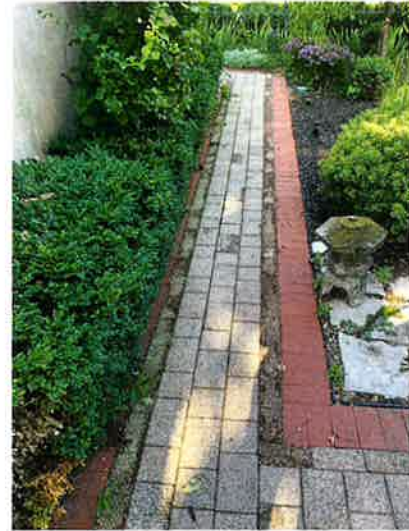
## 1. Service Walks

| Defects | | |
|---|---|---|
| Page 6 Item: 1 | Service Walks | • Brick deterioration and sloping toward the home at the sidewalk. Make repairs or replace as needed |

- Brick
- Marginal
- Brick deterioration and sloping toward the home at the sidewalk. Make repairs or replace as needed

Some brick deterioration and sloping toward the home at the sidewalk. Make repairs as needed

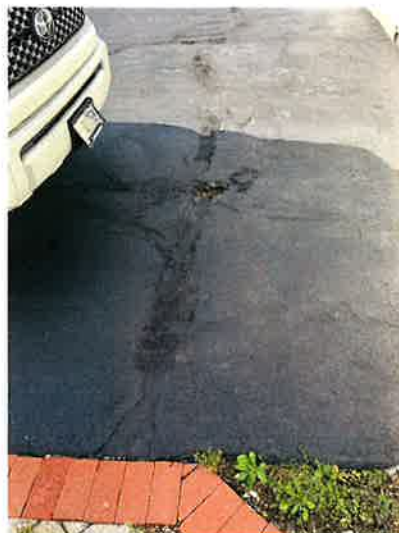
## 2. Driveway/Parking

| Page 6 Item: 2 | Driveway/Parking | • Small area of surface damage at the driveway. Repair |

- Asphalt
- Marginal
- Small area of surface damage at the driveway. Repair

Surface damage at the drive

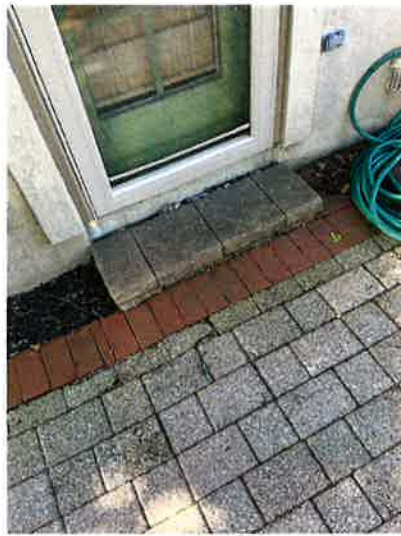
#### 4. Stoops/Steps

| Page 7 Item: 4 | Stoops/Steps | • Uneven risers at the entry step |

Uneven risers at the entry step

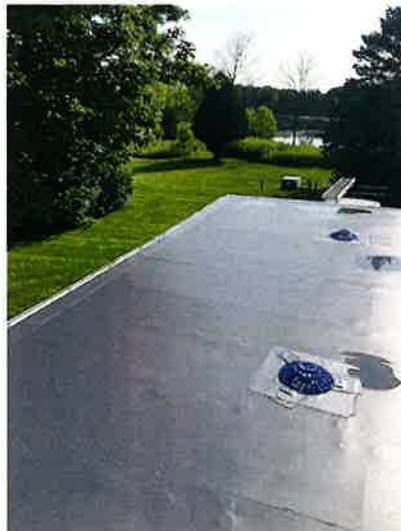
#### 6. Deck/Balcony

| Monitor | | |
|---|---|---|
| Page 7 Item: 6 | Deck/Balcony | <ul style="list-style-type: none"><li>• The decking appears to have been removed to complete the rubber roof. There is no decking or rail for safety. Recommend installation and blocking off the access door so no one can get onto the deck without a Rail.</li></ul> |

The decking appears to have been removed to complete the rubber roof. There is no decking or rail for safety. Recommend installation and blocking off the access door so no one can get onto the deck without a Rail

1. Pg. 7 of Report, item 6: 12x28 floating deck and railings (treated wood) <sup>has been</sup> ~~will be~~ installed prior to closing.

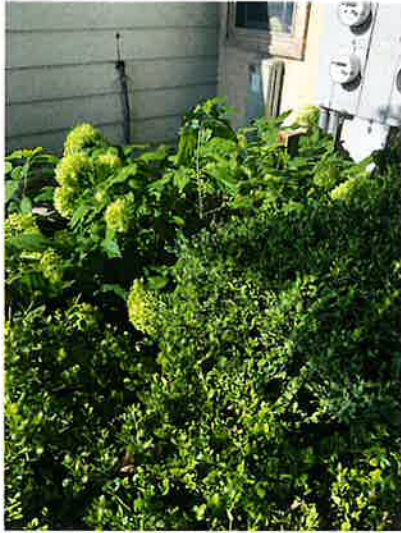
| Page 8 Item: 9 | Landscaping affecting foundation | • Low areas of grading next to the foundation - recommend using clay based soils to create a slope of 1" per foot in the first 6 to 10 feet away from the home. |

Low grade North

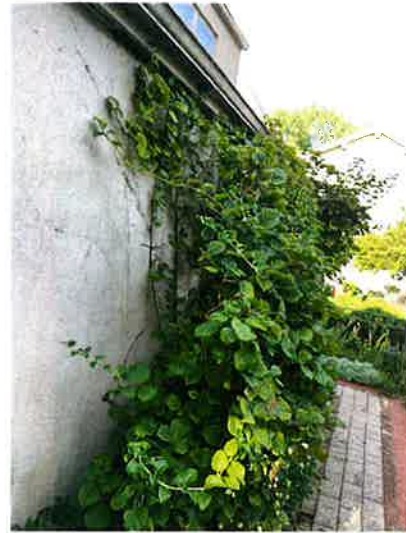
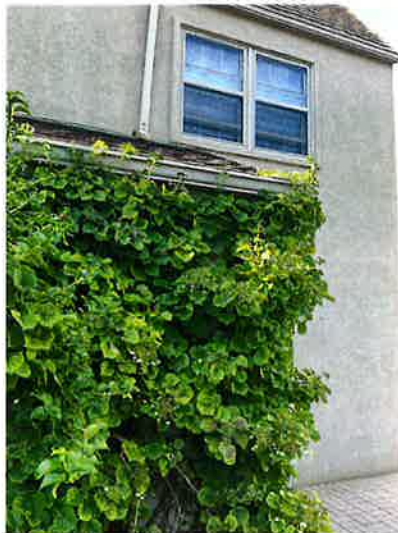
Recommend trimming and/or removal of vegetation away from home

9. Pg. 8, item 9: Trimmed vegetation away from home
10. Pg. 18, item 15: Trimmed growth away from the air conditioner
11. Pg. 24, item 1: Cleaned Dryer Vent

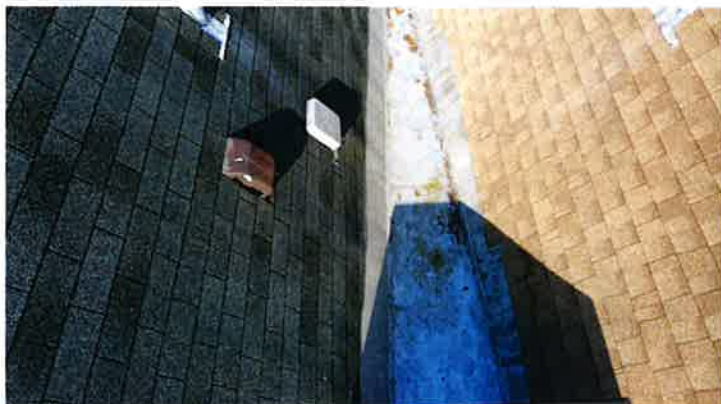
• Corroded galvanized pan [REDACTED] Lichen and algae. Some granule loss. The roof is older and approaching the end of its life. Budget be accordingly

Corrosion

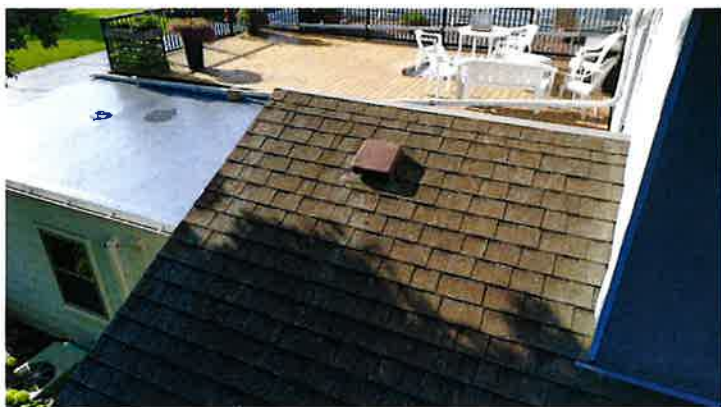
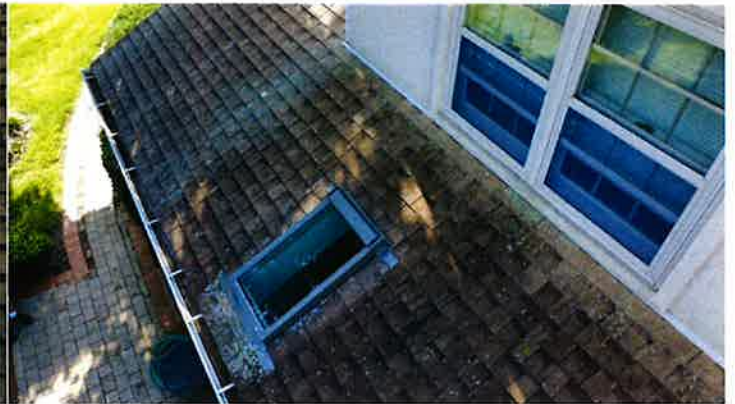
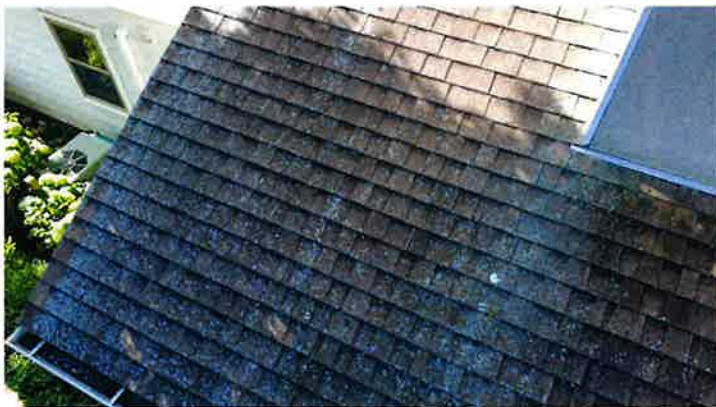
Lichen

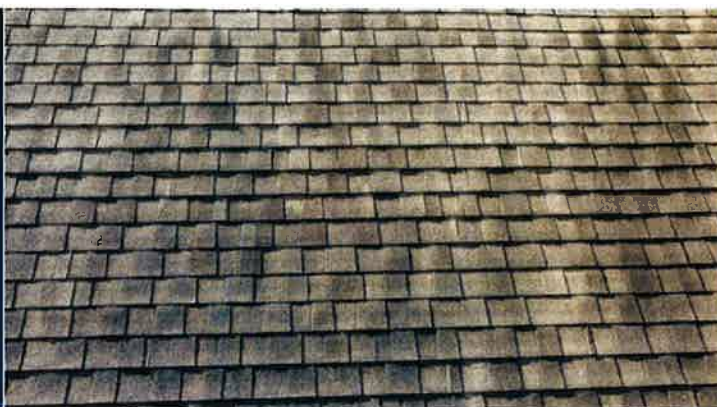
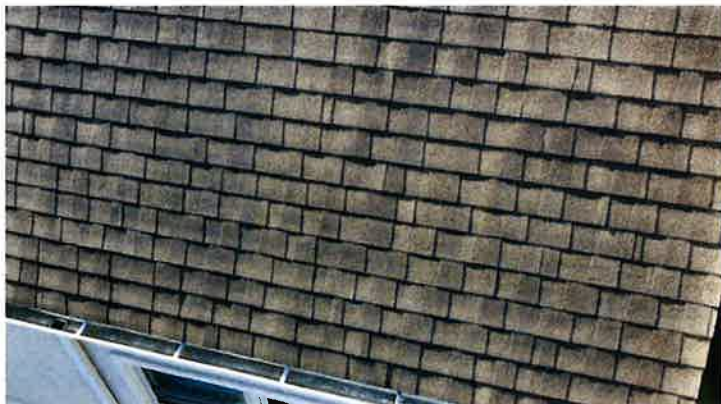
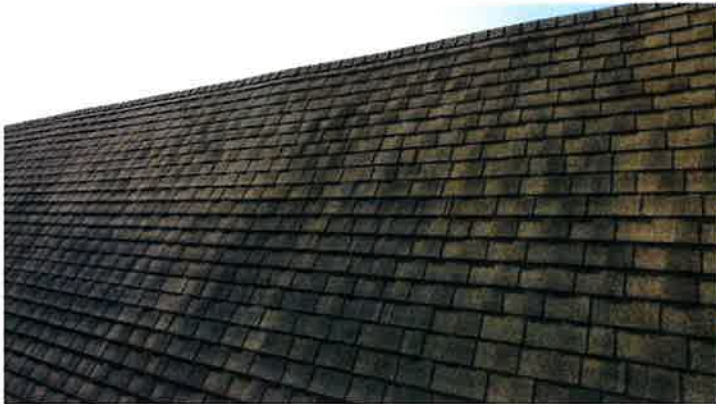
Algae

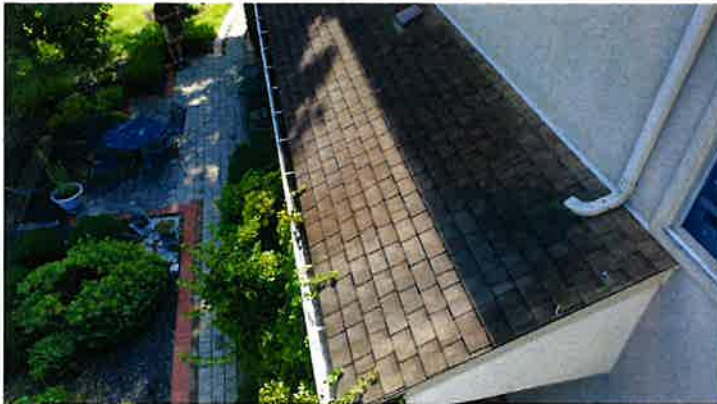
Remove ivy

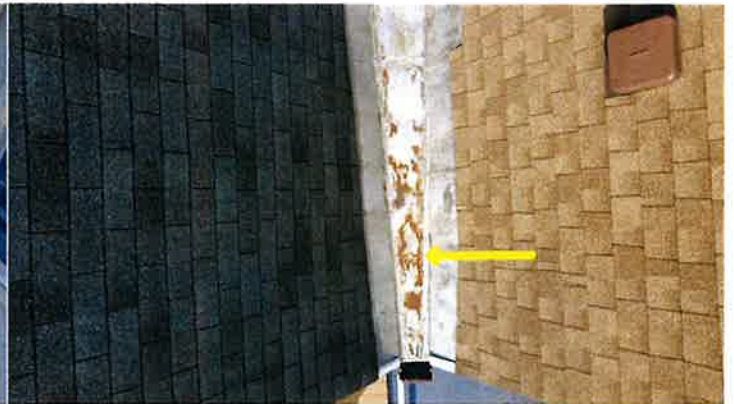
| Page 9 Item: 1 | General | <ul style="list-style-type: none"> <li>• Corroded galvanized pan <b>gutter</b>. Lichen and algae. Some granule loss. The roof is older and approaching the end of its life. Budget be accordingly.</li> </ul> |

Corroded galvanized pan valley

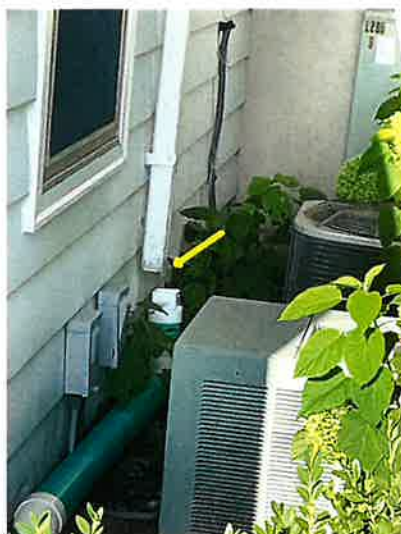
## 2. Gutters/Scuppers/Eavestrough

| Defects | | |
|---|---|---|
| Page 14 Item: 2 | Gutters/Scuppers/Eavestrough | • The downspout from the roof has become disconnected from the extension. Repair to keep water off the Foundation area |

The downspout from the roof has become disconnected from the extension. Repaired to keep water off the Foundation area

1. Pg. 14, item 2: Seller reconnected downspout and re-routed underground drains.
2. Pg. 14, item 3: Seller caulked/sealed holes (pictured on pg. 15)
3. Pg. 17, item 12: Seller installed new GFCI & replaced missing front door bell (west side)

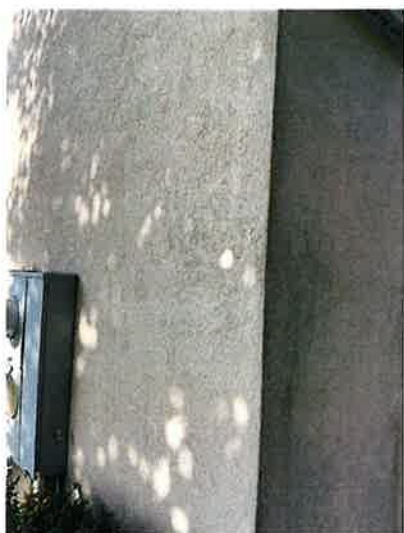
## 3. Siding

| Defects | | |
|---|---|---|
| Page 14 Item: 3 | Siding | • EIFS siding, trim requires a certified EIFS inspector to evaluate. There are areas that appear to need repair. Evaluate and repair as needed. |

EFS siding requires a certified EFS inspector to evaluate.

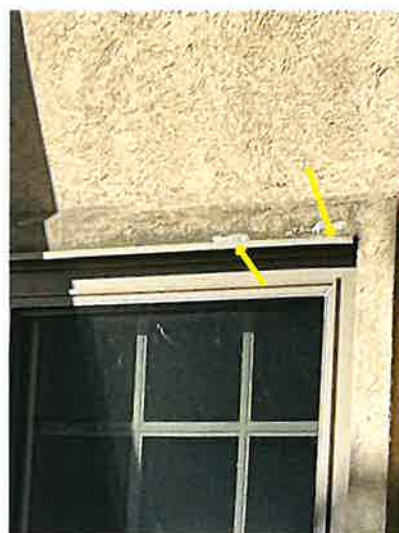
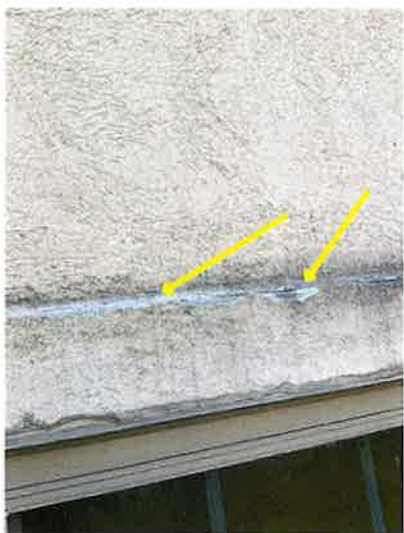
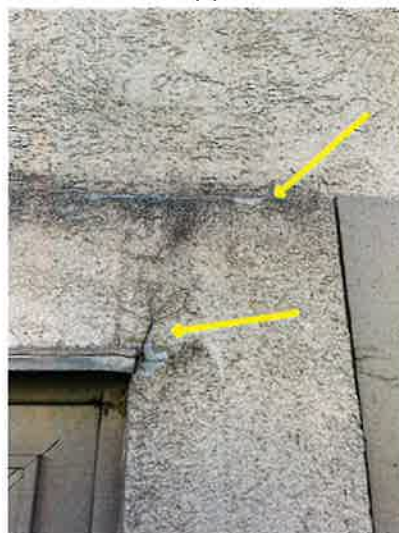
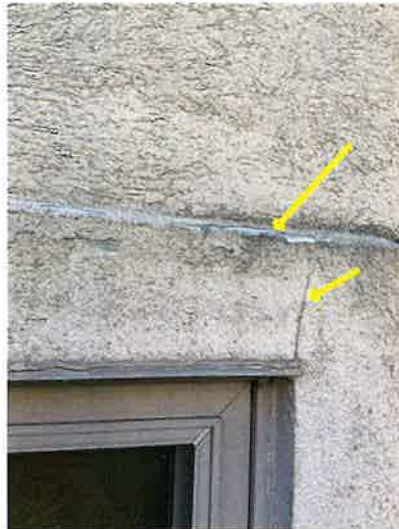
Surface damage

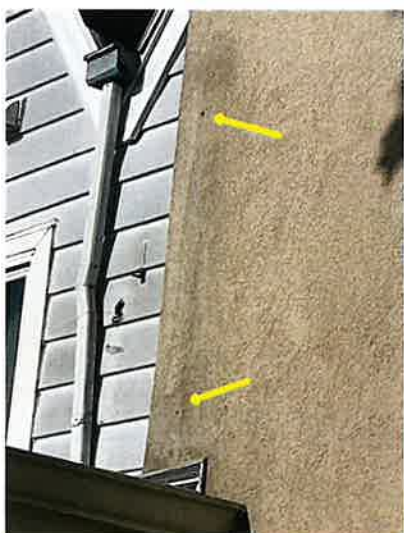
Holes

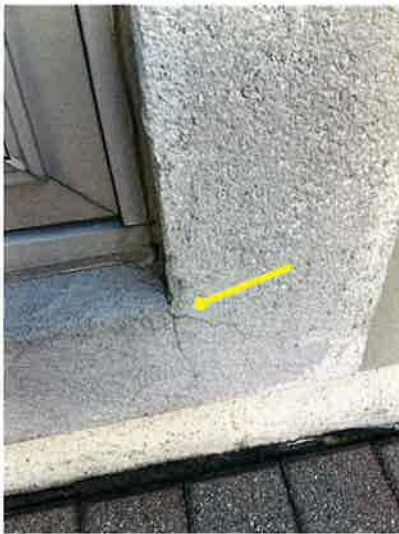
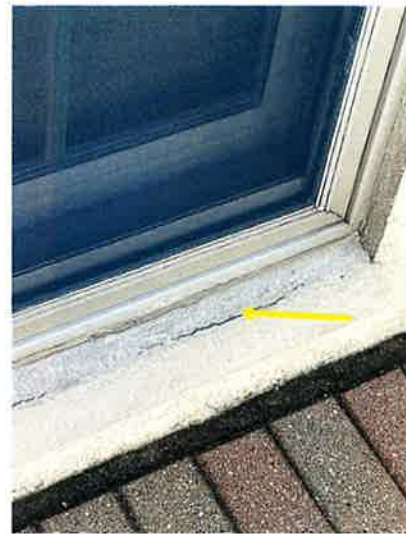
Cracks at trim

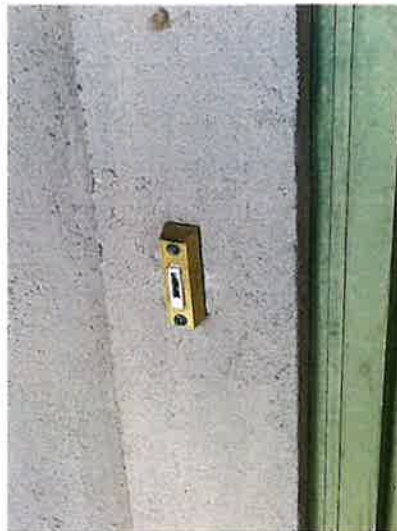
**12. Service Entry**

| Defects | | |
|---|---|---|
| Page 17 Item: 12 | Service Entry | • The exterior GFCI Outlets did not trip when tested. Check and replace the GFCI outlet if needed. Missing west doorbell. |

Missing door bell

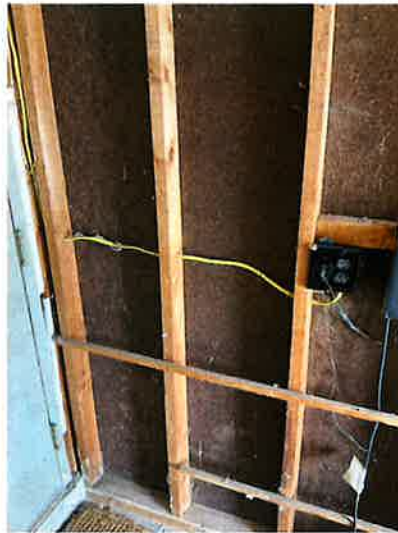
## 12. Electrical Receptacles

| Defects | | |
|---|---|---|
| Page 19 Item: 12 | Electrical Receptacles | • Handyman wiring in the garage to an outlet that isn't GFCI protected with unprotected horizontal wiring in the stud cavity. Have an electrician evaluate and repair |

Handyman wiring in the garage to an outlet that isn't GFCI protected with unprotected horizontal wiring in the stud cavity. Have an electrician evaluate and repair

4. Pg. 19, item 12: Seller installed new GFCI outlet and re-ran wiring along the side of studs/joist
5. Pg. 20, item 13: Seller added additional 2x8 sister boards at notching

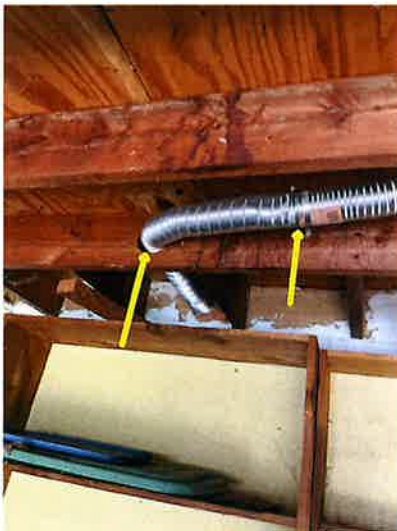
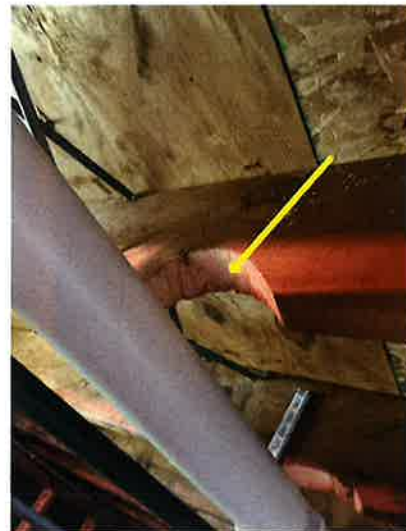
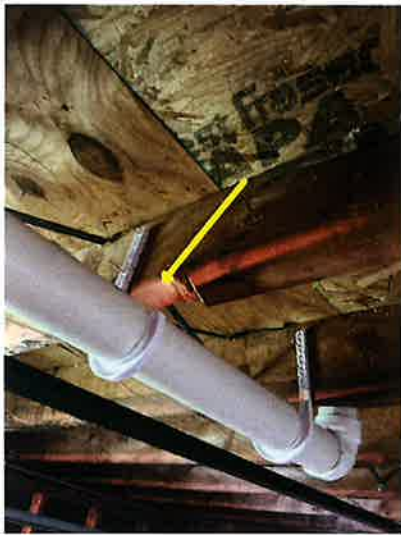
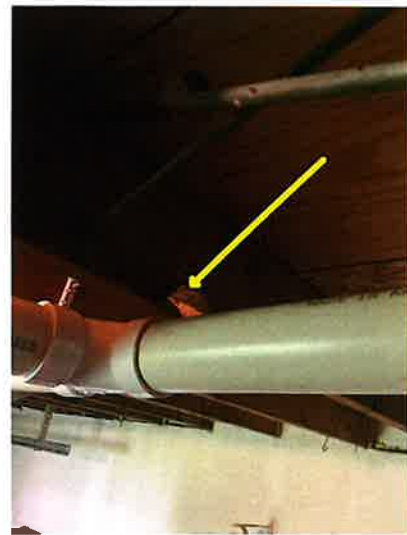
### 13. Fire Separation Walls & Ceiling

| Defects | | |
|---|---|---|
| Page 20 Item: 13 | Fire Separation Walls & Ceiling | • Excessive cutting, drilling or notching of the garage deck joists to install the roof drainage system and bath Piping need to be repaired. Have a carpenter evaluate further and make Joist repairs as needed for proper support |

Big hole for bath vent

Cut joist looks recent.

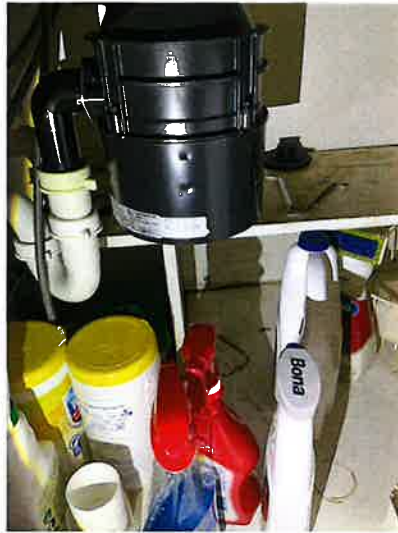
## 3. Kitchen Plumbing

There is moisture staining under the sink. Nothing leaked during testing of the faucet and drains

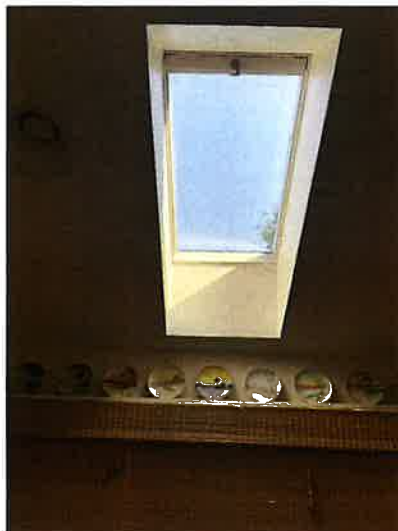
Skylight appears to be dirty rather than having defective seals. Clean the window

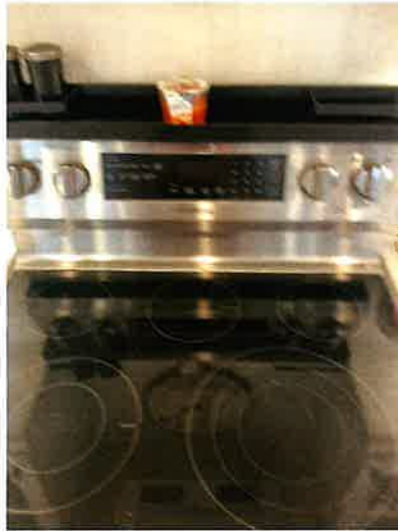
## 7. Kitchen Appliances

| Page 23 Item: 7 | Kitchen Appliances | <ul style="list-style-type: none"> <li>• The ice maker is off or out of operation. Verify operation and water line and make repairs if needed.</li> <li>• The range was not powered. Unable to test. Confirm operation</li> </ul> |

The range was not powered. Unable to test. Confirm operation

1. Pg. 23, item 7: Stove was unplugged at time of inspection. Stovetop and Oven currently operate property. Control board sometimes flashes.

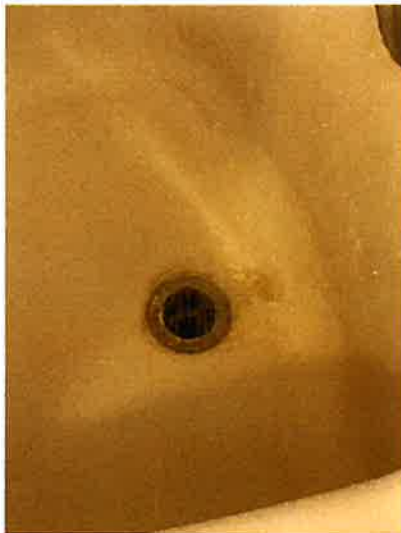
Missing tub stopper

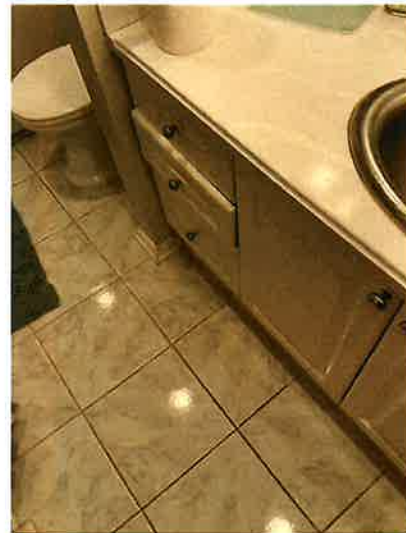
Repair the vanity cabinet drawer two close properly

12. Pg. 25, item 1: Seller caulked tub spout; repaired vanity cabinet drawer & fixed lock on pocket door
13. Pg. 39/40, item 1: Seller replaced furnace filter

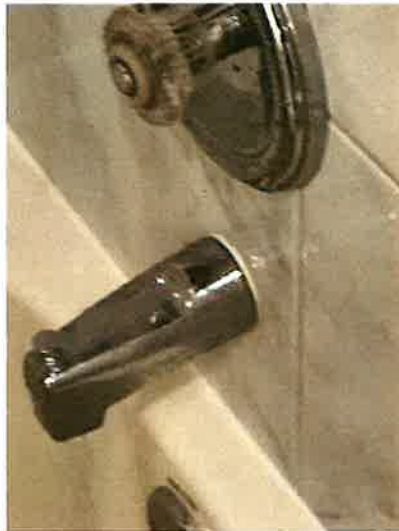
Caulk the tub spout.

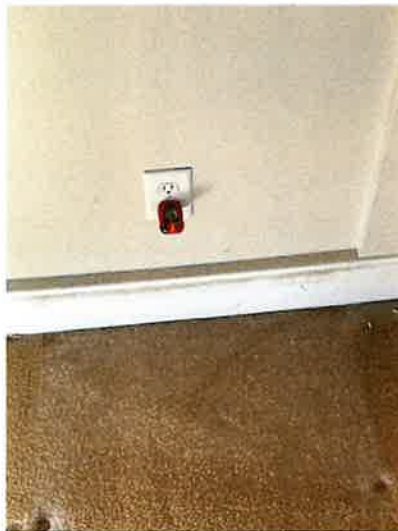
| Defects | | |
|---|---|---|
| Page 28 Item: 1 | Room | • Open ground outlet(s) |

Open ground outlet(s)

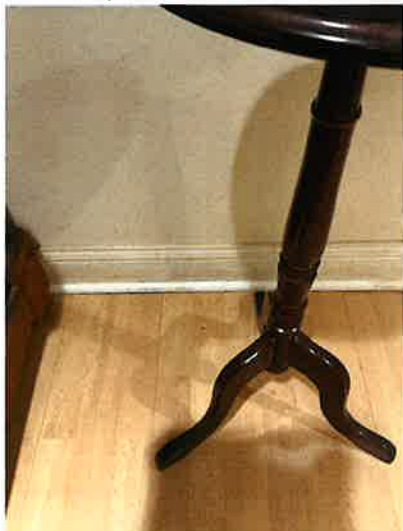
Some surface damage at the base molding. It could be scraped. There was not moisture when tested with the moisture tester

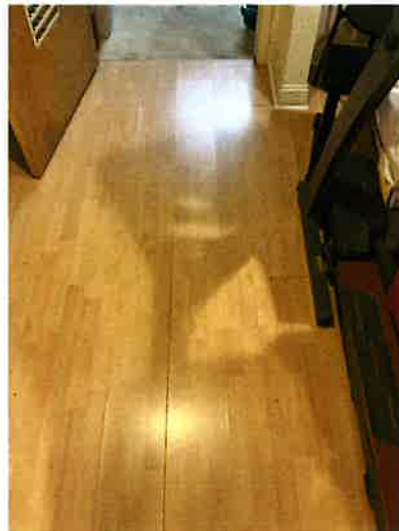
Some buckling

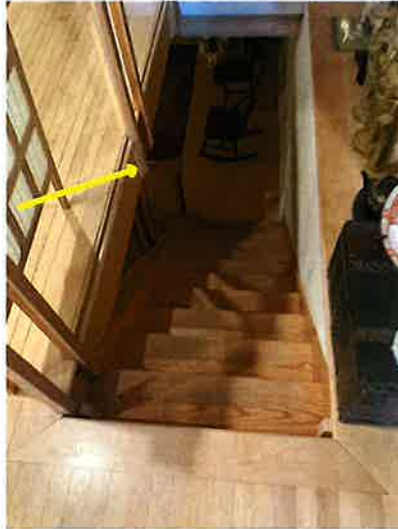
## 2. Stairs/Steps/Balconies

| Defects | | |
|---|---|---|
| Page 33 Item: 2 | Stairs/Steps/Balconies | • Handrail partially missing, potential safety issue. Recommend installing handrail for the full stair run. Stairs down to the basement |

Handrail partially missing, potential safety issue. Recommend installing handrail for the full stair run. Stairs down to the basement

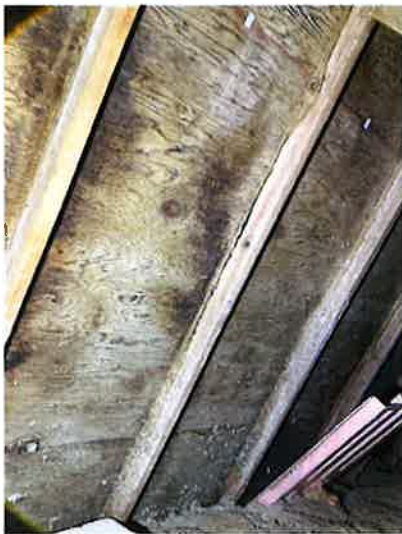
| Page 34 Item: 4 | Attic/Structure/Framing/Insulation | • Condensation staining in the attic is being remediated. Be sure the fans from below exhaust through the roof properly. They are not sealed through to the exterior. Improve insulation over the pull down along with adding a weatherstripping. The attic has soffit baffles but they don't appear to be soffit vents. Make roofing vent ventilation improve improvements. Check with contractors for planned repairs. |

- Condensation staining in the attic is being remediated. Be sure the fans from below exhaust through the roof properly. They are not sealed through to the exterior. Improve insulation over the pull down along with adding a weatherstripping. The attic has soffit baffles but they don't appear to be soffit vents. Make roofing vent ventilation improve improvements. Check with contractors for planned repairs.

Microbial growth/condensation stains

6. Pg. 23, item 7: Ice maker & water are functioning on refrigerator
7. Pg. 41, item 1: Seller installed cover on open junction box
8. Pg. 34, item 4: P&R addressed additional condensation staining in attic. See attached documentation.

P&R Cleaning completed mold remediation of the affected attic areas at address: [2220 Stonecroft Drive Grafton, WI 53024](#) on August 6, 2026. We sprayed the attic cavity with an antimicrobial treatment. After the antimicrobial spraying was completed, we then treated the affected areas with mold stain remover.

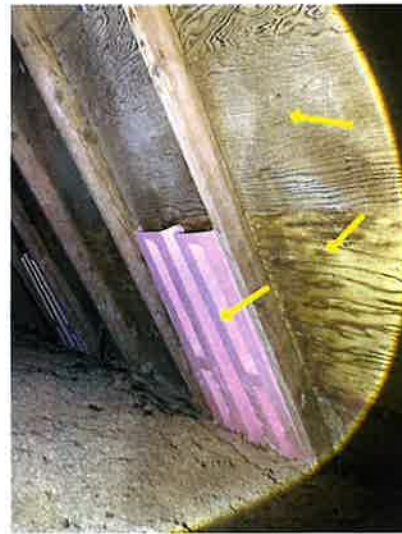
Baffles but no vents

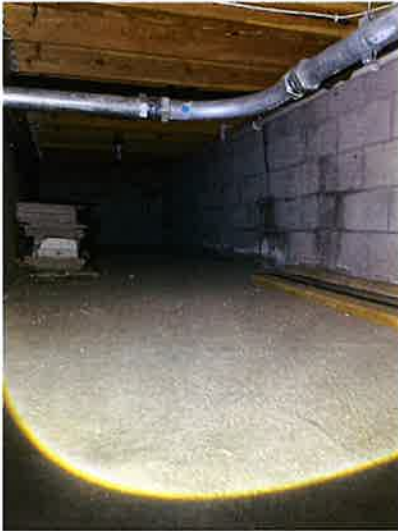
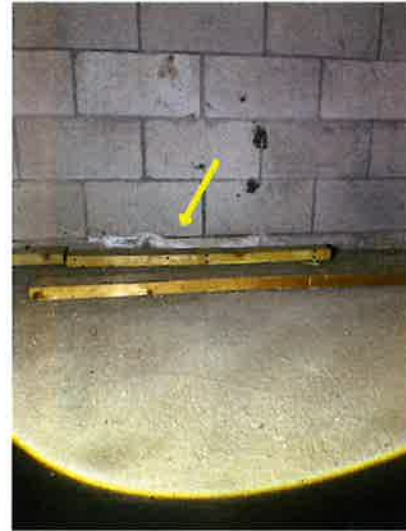
High moisture stains.

Low moisture stains

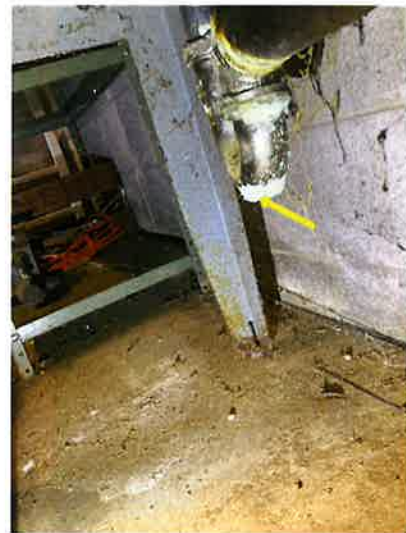
Corrosion noted. No moisture observed

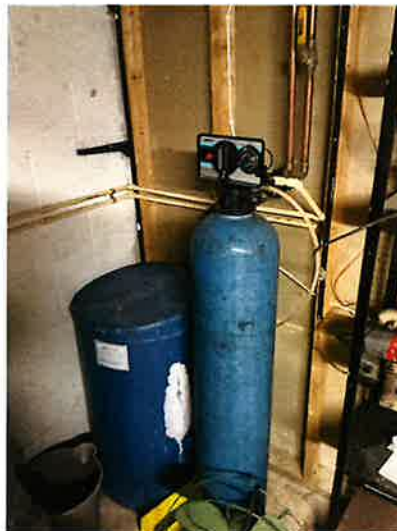
| Page 38 Item: 7 | Water softener | <ul style="list-style-type: none"> <li>• Sulphur smell in the water during testing. This could be due to while water sitting in pipes without use lately. Additionally the water softener appears to be older than 20 years. They can become any efficient and lose effectiveness after ages 15 to 20. Test for replacement. Test water for iron</li> </ul> |

Sulphur smell in the water during testing. This could be due to while water sitting in pipes without use lately. Additionally the water softener appears to be older than 20 years. They can become any efficient and lose effectiveness after ages 15 to 20. Test for replacement. Test water for iron

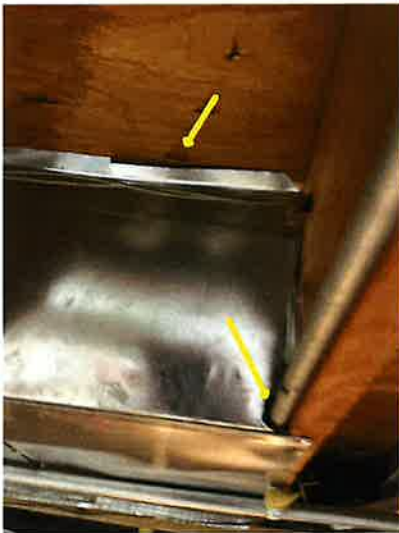
| Page 39 Item: 1 | Heating system | • Seal return air ducts where needed. |

Seal return air ducts where needed.

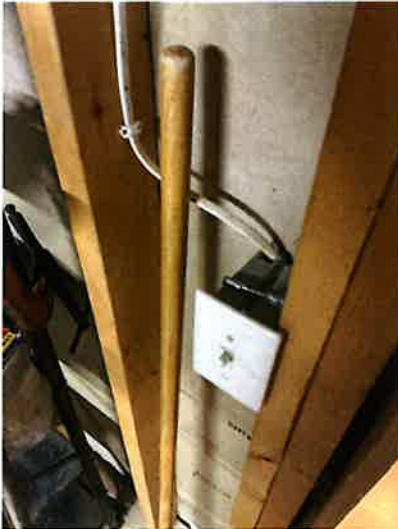
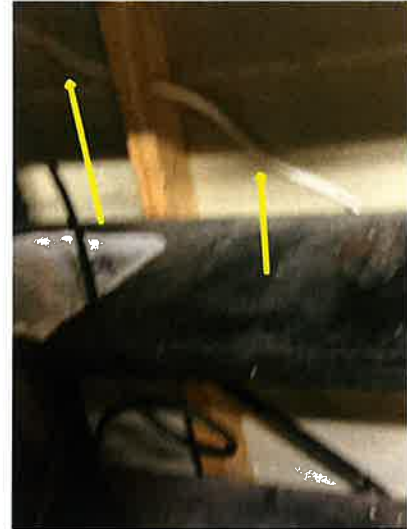
| Page 41 Item: 1 | Main panel | • Cover horizontal wiring at stud cavities |

Cover horizontal wiring and stud cavities

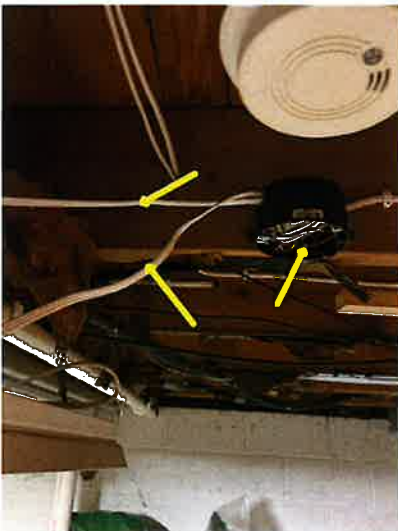
| Defects | | |
|---|---|---|
| Page 41 Item: 1 | Main panel | • Handyman wiring of basement lighting into an open junction box. Have an electrician evaluate and repair |

Handyman wiring of basement lighting into an open junction box. Have an electrician evaluate and repair
