## LANDMARK ON THE LAKE

Facade Critical Examination

1660 N. Prospect Avenue  
Milwaukee, WI 53202

November 18, 2024  
Project No. 237058

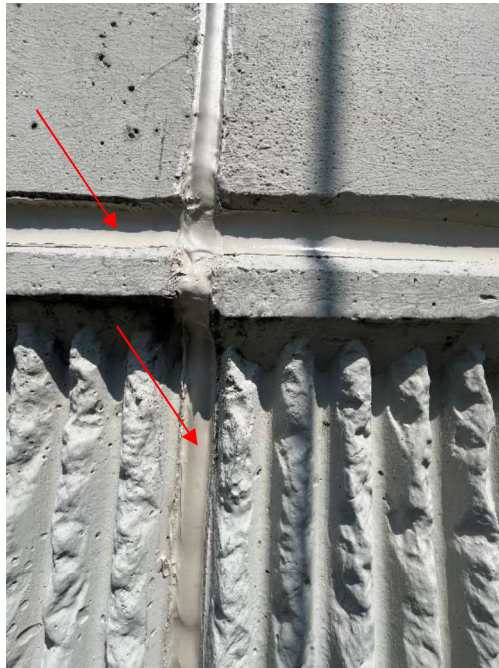
1- De-bonded sealant joint repairs- Sealant was removed and replaced with a new sealant

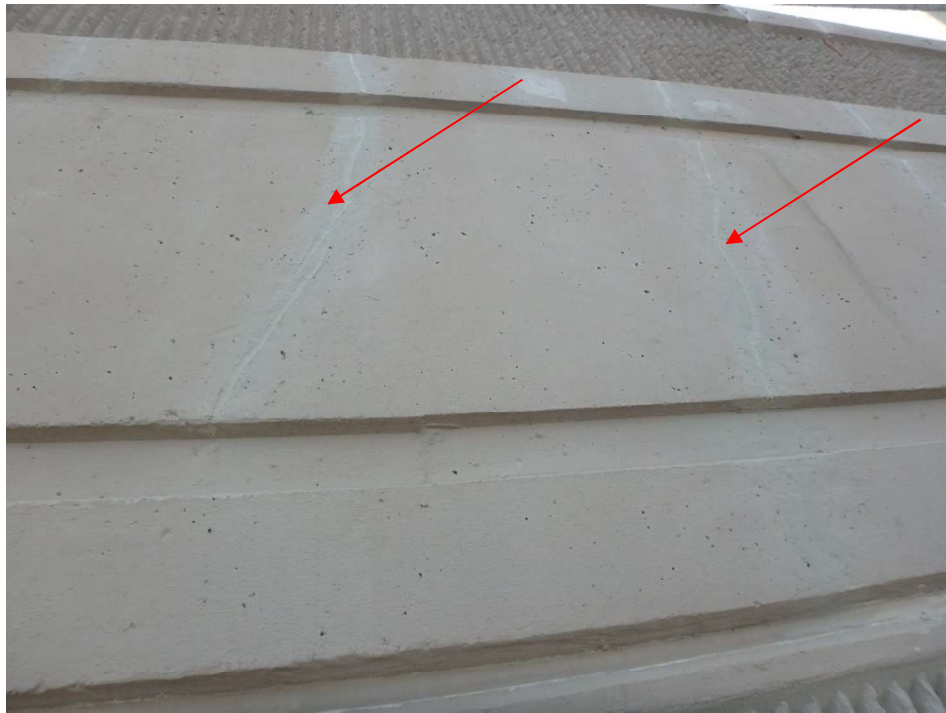
2- De-bonded sealant and hairline crack in concrete repairs - cracks were routed, and sealant replaced with a new sealant

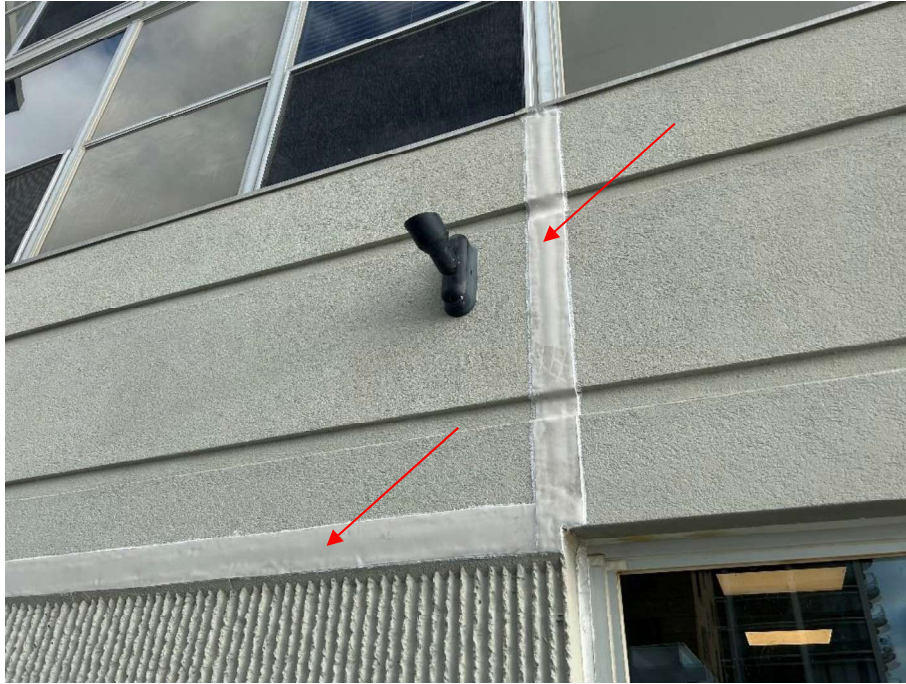
3- EIFS deteriorated sealant repairs - Deteriorated sealant was removed and replaced with new backer rod and sealant or silicon extrusions installed.

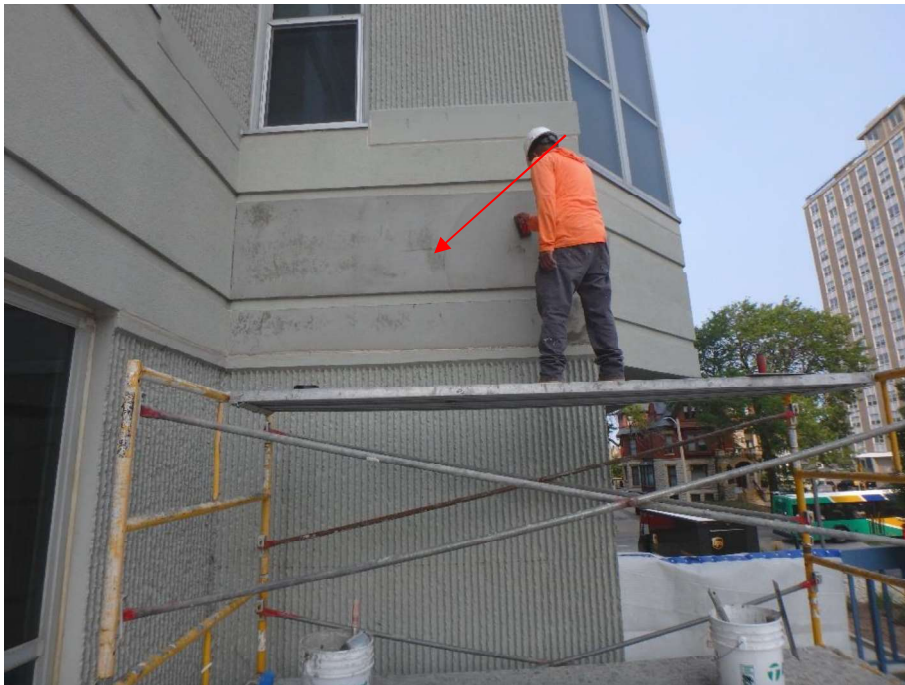
4- EIFS Repairs- Materials in the damaged areas were removed and replaced

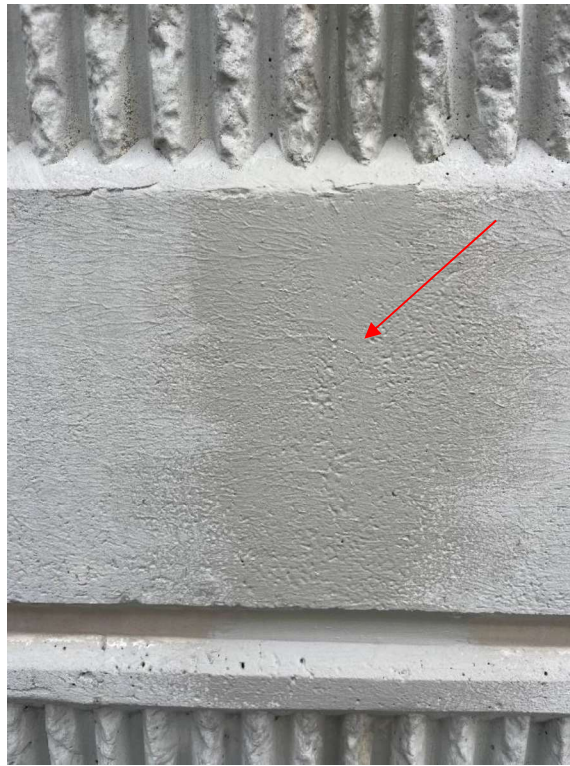
5A- Spalled concrete less than 1-1/2 inches deep repairs - the spalled concrete area was squared, and a concrete patch was installed.

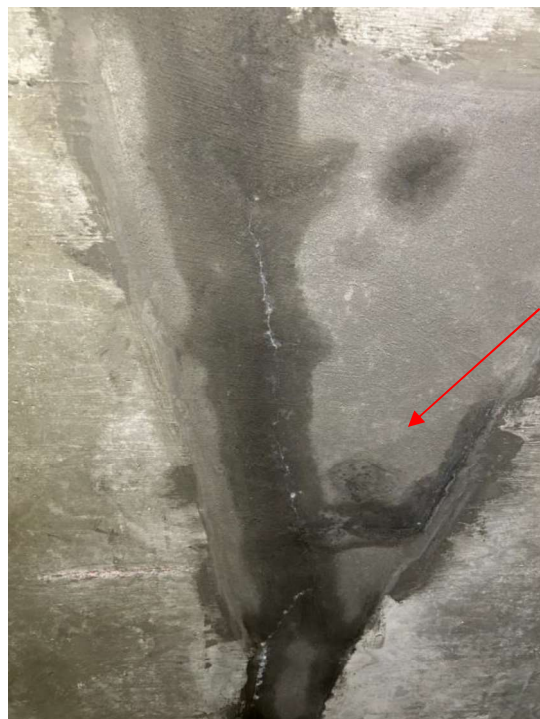
5B- Spalled concrete, more than 1-1/2 inches deep repairs - the spalled concrete area was investigated, existing steel was protected, concrete was squared, and a concrete patch was installed.

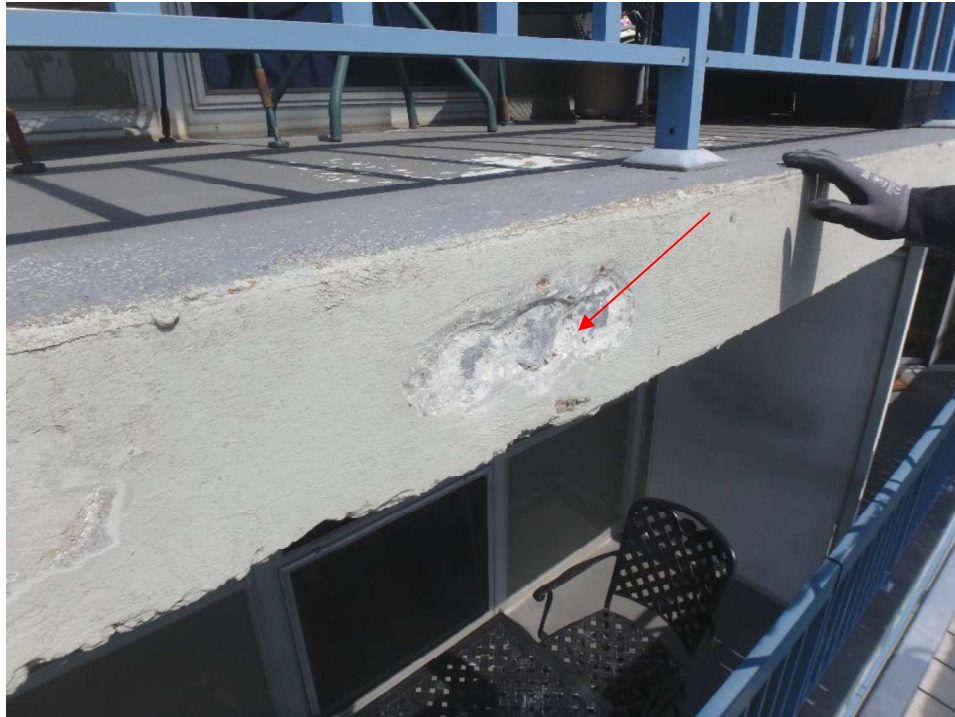
6- Concrete pocket repairs at post-tensioned concrete deck balconies- Unsound concrete was removed, PT-end protected and pocked sealed and painted

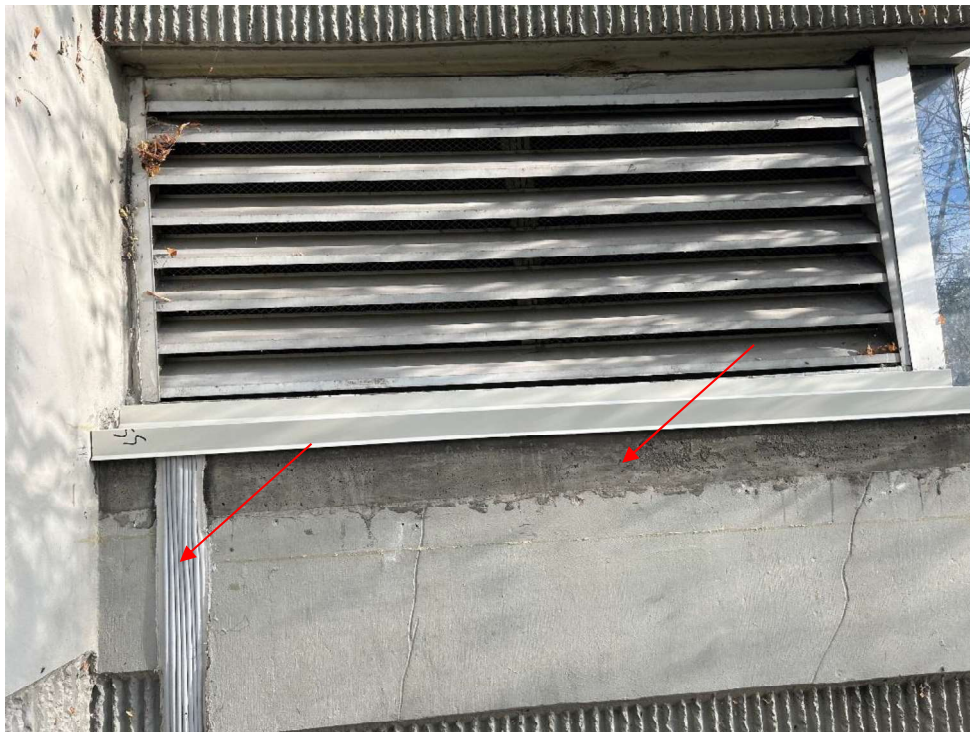
7- Façade Louver Sill Repair- The shifted louver sill was repaired and waterproofed

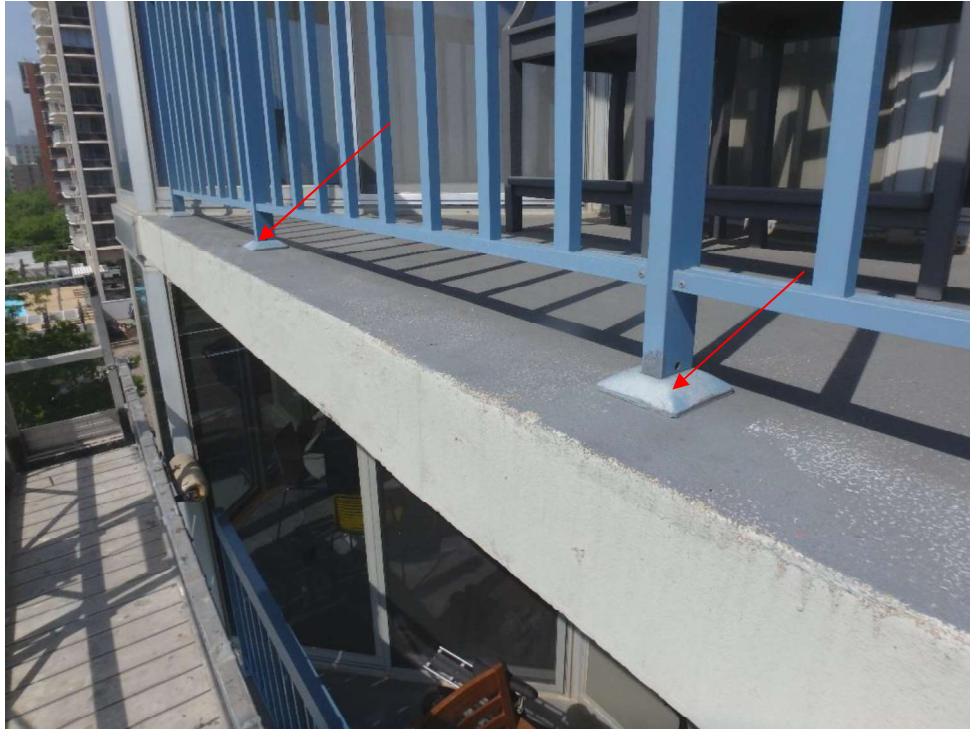
8- Spalled concrete at balcony rail footing- repairs completed by others in 2022.

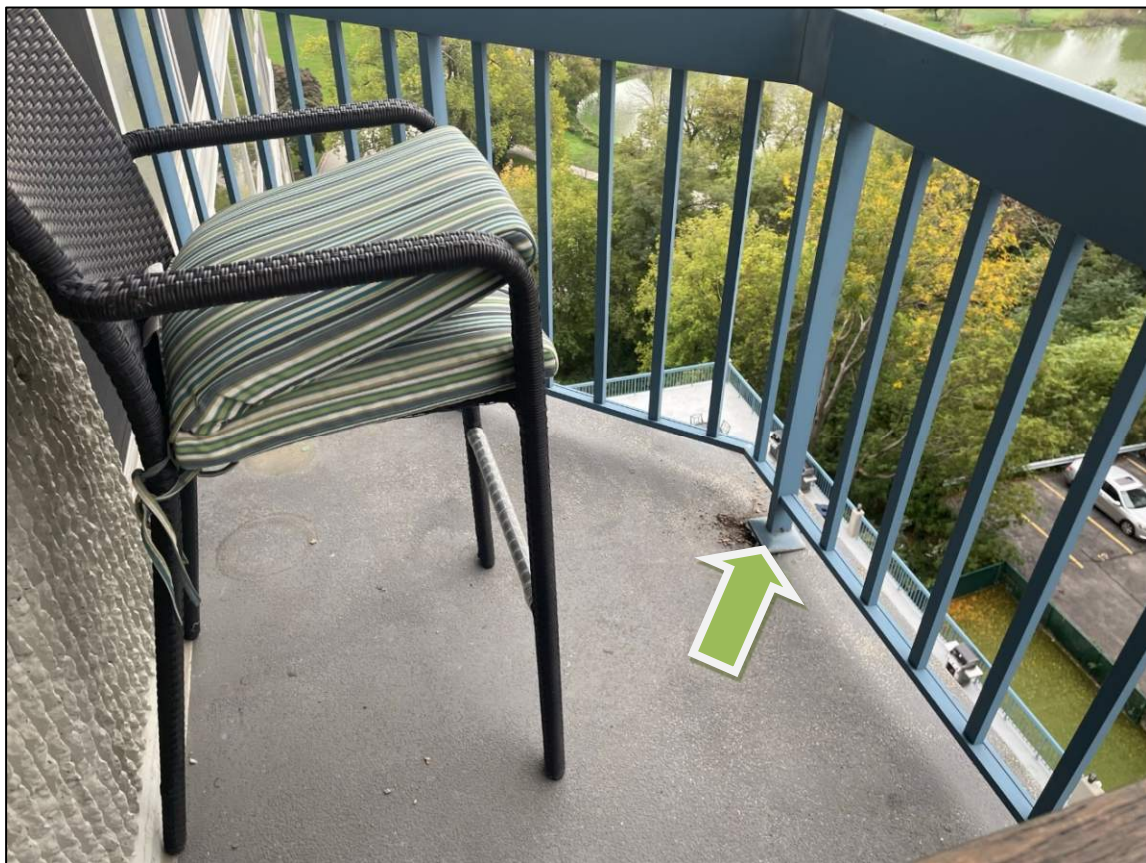
**Description:** The exterior concrete balcony slabs are covered with an epoxy and sand based waterproofing membrane, which is generally in good condition. The membrane at the railing post bases has failed in several locations. This has led to failure of the post connection to the concrete, which reduces the capacity of the railing system to restrain occupants from falling.

Photo A1-1: There are railing posts that are framing into the balcony slab that have failed as seen above.

**Recommendations:** Reassess all balconies for wear of the waterproofing membrane, the railing post connection to the concrete, repair the concrete around the post connection, and reapply a waterproofing membrane.

**Level of Urgency:** The railing posts should be repaired in Spring of 2022, once the weather is warm enough to pour the concrete / cement grout and apply the waterproofing membrane.

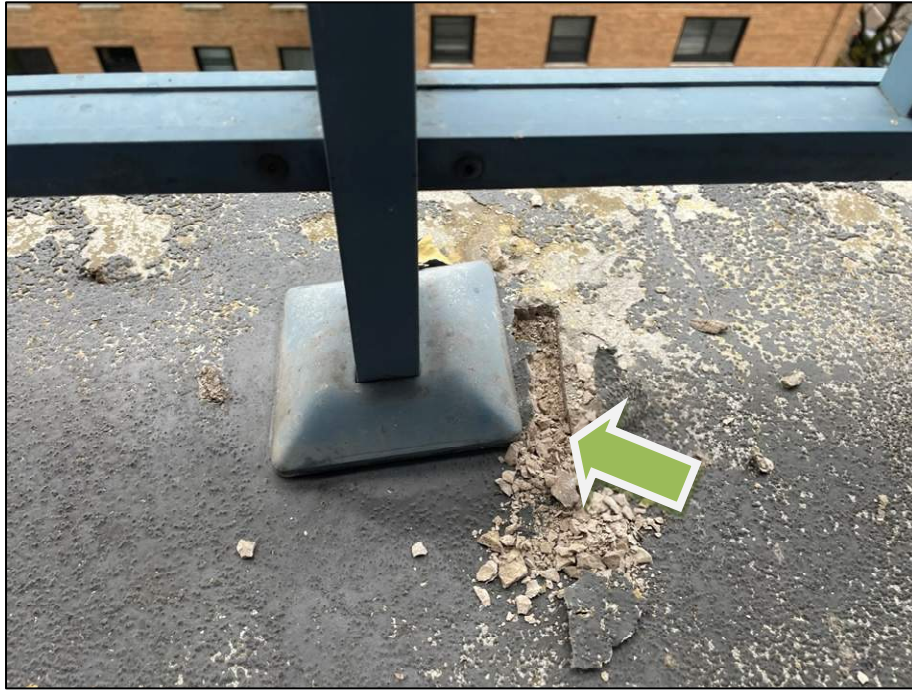
**Photo A1-2: Water had penetrated the post anchorage zone and the freeze-thaw cycle crushed the concrete into small chips. Both the concrete and membrane need to be removed and replaced.**

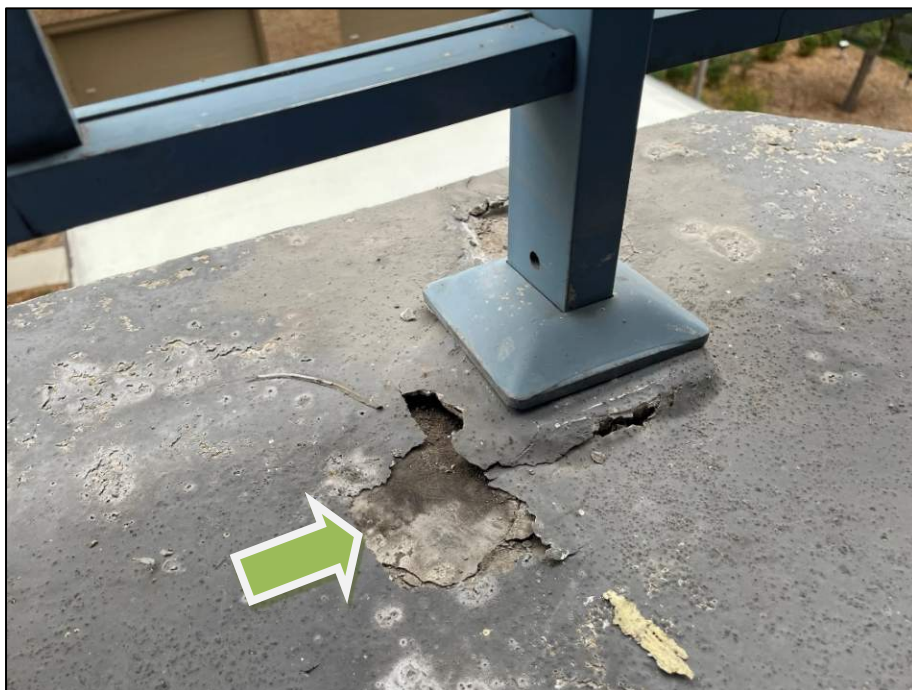
**Photo A1-3: In this case only the membrane has failed. Eventually the concrete will fail if the membrane is not replaced.**

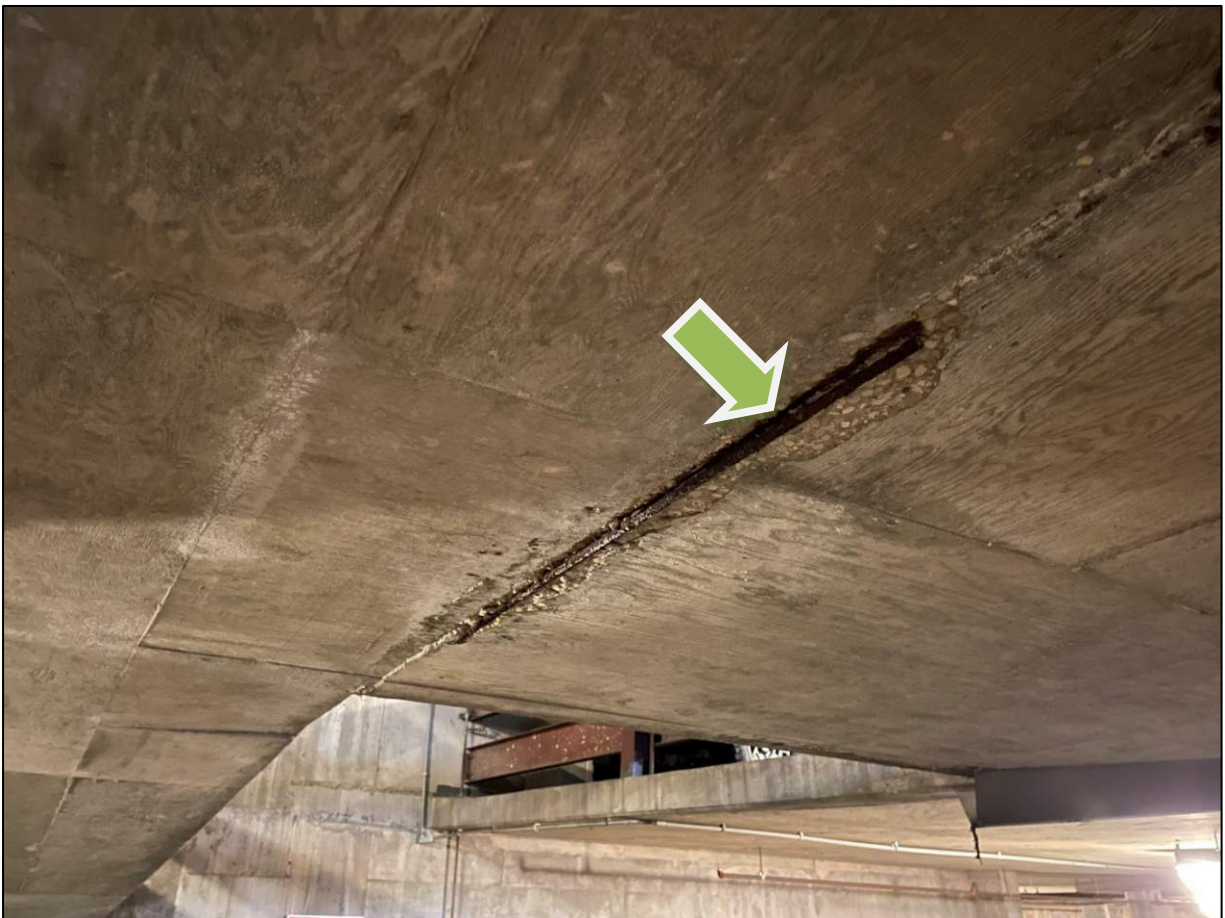
**Description:** Ambient moisture in the underground parking levels permeates through the porous concrete and slowly corrodes the rebar inside the concrete. Most of the rebars have adequate concrete cover to protect the rebar for the life of the structure. It appears some of the rebar was installed lower than what was recommended and has rusted. The expansion of the rust causes the concrete to spall.

**Photo A2-1: A rusted rebar is exposed within a concrete spall.**

**Recommendations:** Remove corrosion from rebar and coat steel with cold galvanizing in the form of zinc rich paint. Patch concrete spalls with repair mortar.

**Level of Urgency:** The post-tensioned tendons in the concrete do the heavy lifting to support the structure. The mild rebar reinforcing prevents cracks locally in the concrete. We recommend these spalls be repaired in the next year.

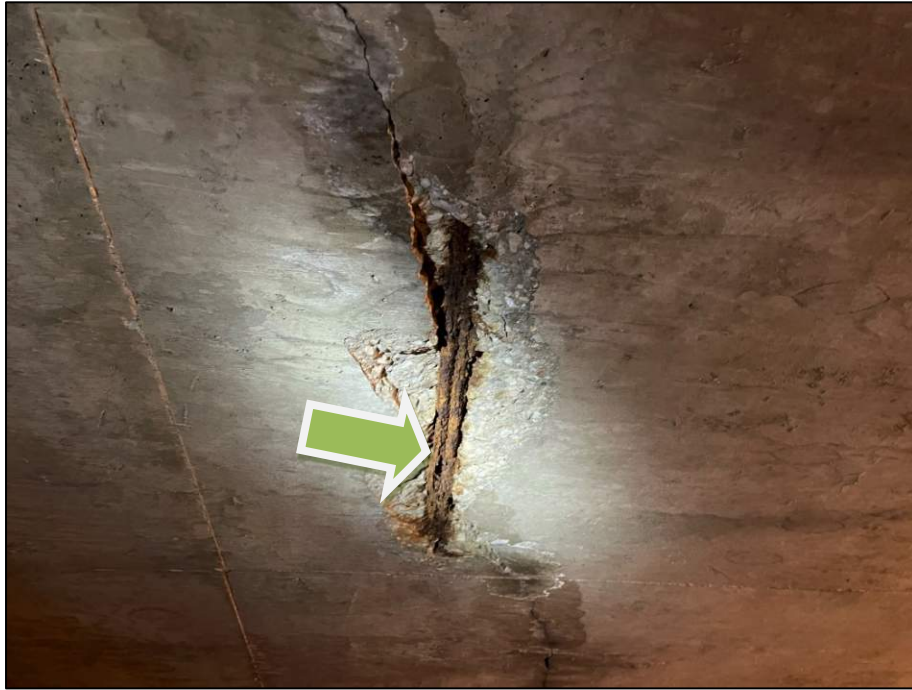
**Photo A2-2: The rebars shown within the spall are very low in the slab profile, which lead to their premature rusting.**

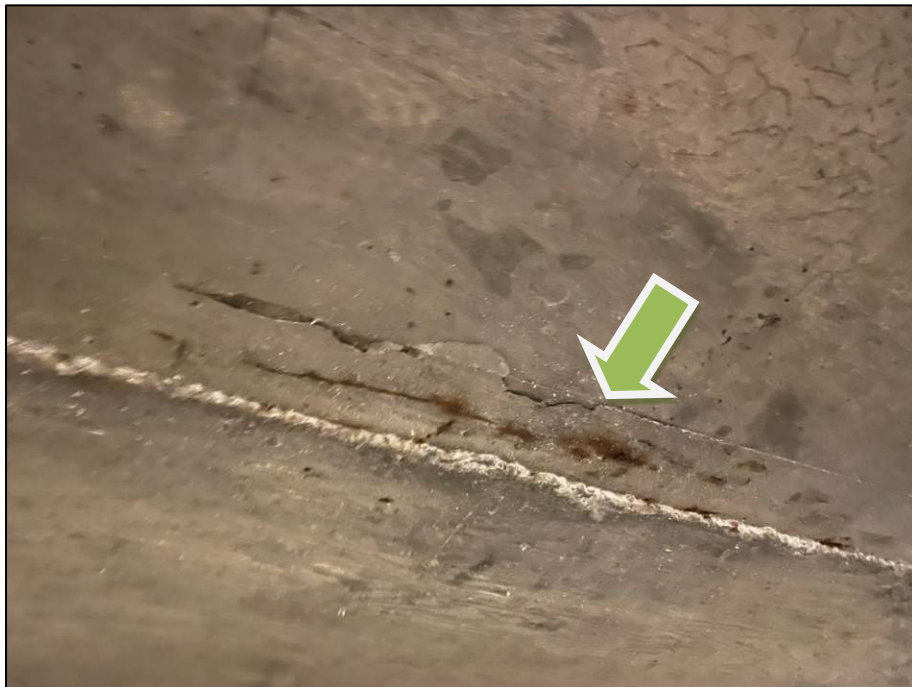
**Photo A2-3: This is an imminent spall. Loose concrete should be tapped with a hammer, and removed so it does not fall on a person or vehicle.**

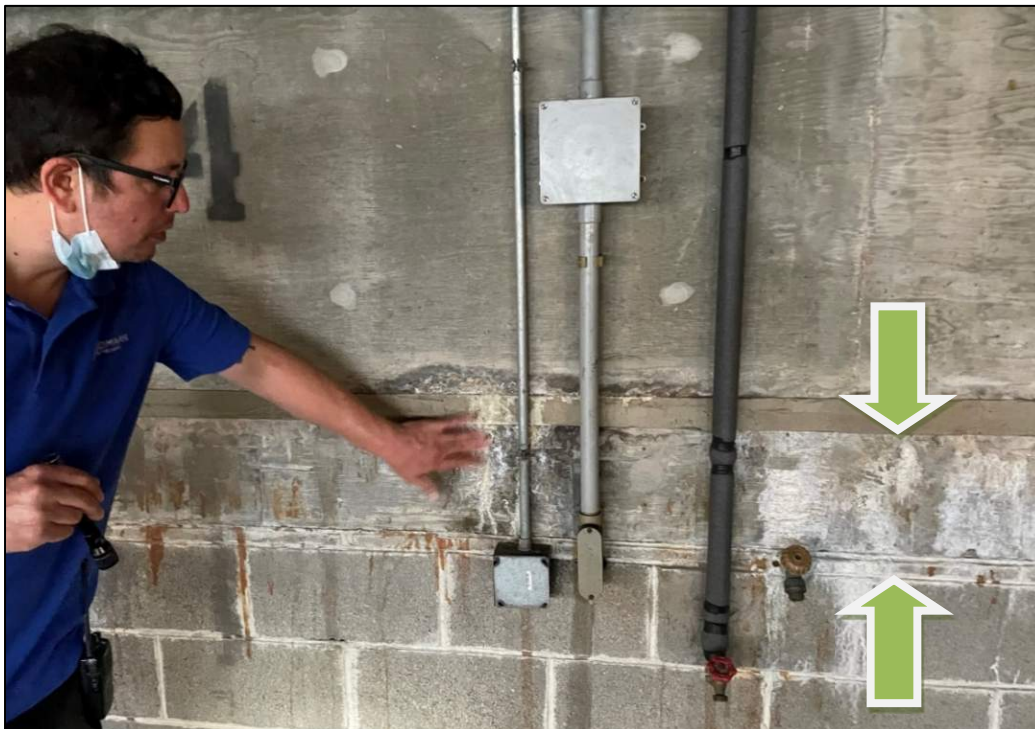
**Description:** The side walls of the recessed pool are post-tensioned beams that frame into columns. The slab itself is also post-tensioned with greased tendons encapsulated in plastic sleeves that support most of the load. There are mild reinforcing bars inside the slab that are corroding which is evident by the rust staining. The coating inside the pool has failed, which allows chlorinated water to leak through the slab to wall joint. Efflorescence is the white streaking coming from the joints, which is from evaporated salt and mineral deposits. It is harmless, but the occurrence is a sign that water is leaking through cracks, which can cause deterioration of the concrete and corrosion of the rebar steel.

Photo A3-1: Mineral deposits (efflorescence) and rust stains streak down sides of pool slab joint.

**Recommendations:** The best type of crack sealing is done on the “positive” side of the wall and slab, which in this case is inside the pool. The pool coating is scheduled to be replaced soon. When the coating is replaced, cracks should be injected with polyurethane from inside the pool.

**Level of Urgency:** When sounded, the concrete was solid and secure. The rate of deterioration is very slow, because the structure is heavily reinforced and consists of thick durable concrete. The pool coating replacement and crack repair should be done within the next three years.

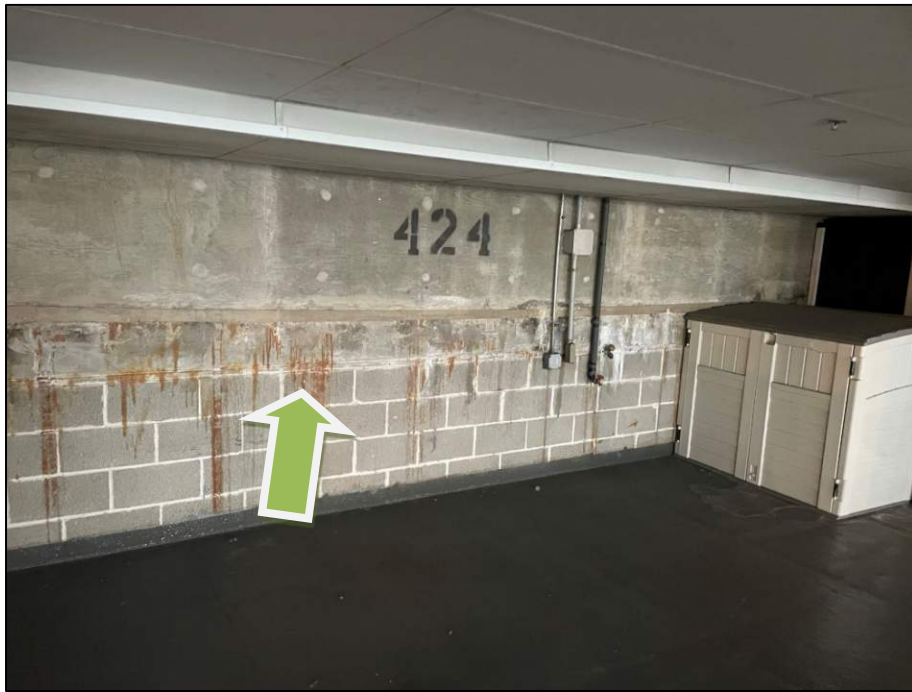
Photo A3-2: Efflorescence and rust staining coming from top and bottom of pool slab down the block wall.

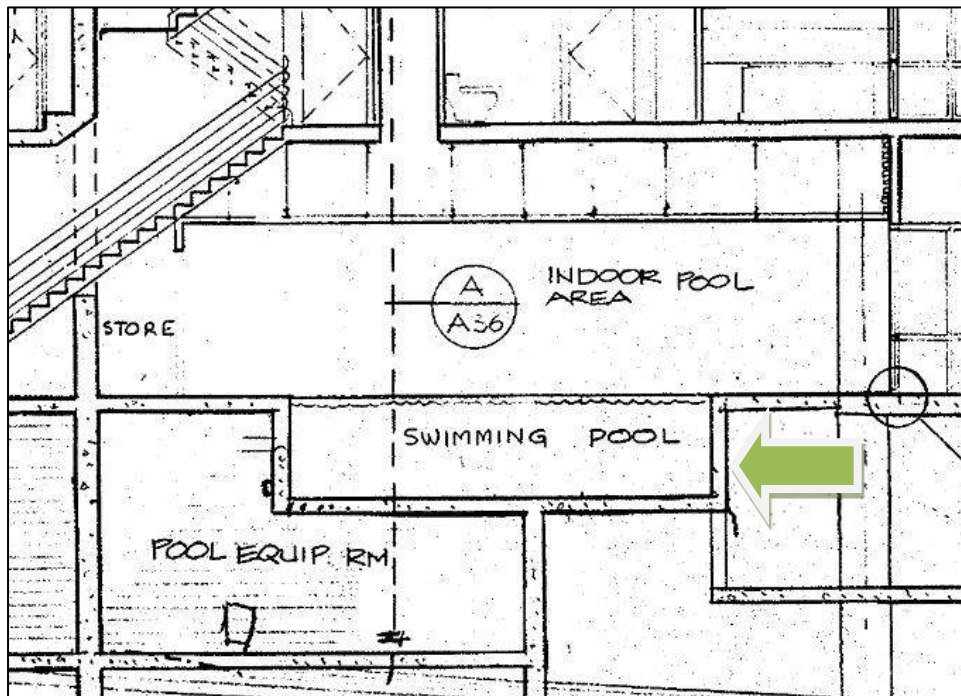
Photo A3-3: The top of the swimming pool is level in the Indoor Pool Room and is depressed into parking level 1 and the pool equipment room. The joint between the slab and wall is leaking.

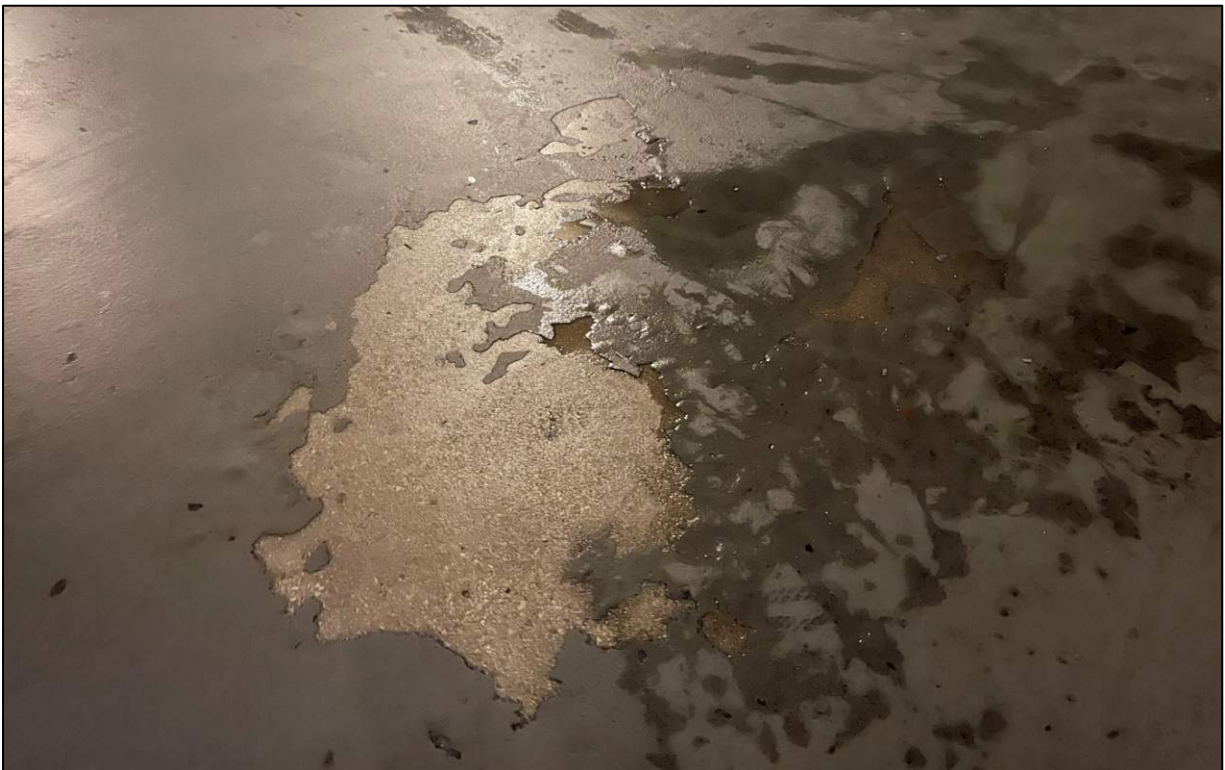
**Description:** A leak deposited water and formed a constant puddle near a heavily used turn. Turning tires rub on the traffic bearing membrane causing it to fail prematurely. A perennial water source seeped into a tear and caused the whole traffic bearing membrane to delaminate from the concrete substrate. Water can freeze here, causing a tripping hazard on the smooth concrete.

**Photo A4-1: A whole section of traffic bearing membrane is missing at a vehicle turning area. A water leak causes a puddle that will freeze in winter and cause a tripping hazard.**

**Recommendations:** The source of the water leak needs to be addressed first. A piece of mechanical equipment may need a secondary drain, but to prevent a reoccurring issue here, the source of the water needs to be removed.

**Level of Urgency:** We recommend the loose traffic bearing membrane be removed and the source of water be removed immediately. The secondary issue is to replace the traffic bearing membrane that protects the concrete from saltwater infiltration. It is recommended for the traffic bearing be replaced within 3 years, so this area has a similar lifespan as the rest of the parking surfaces.

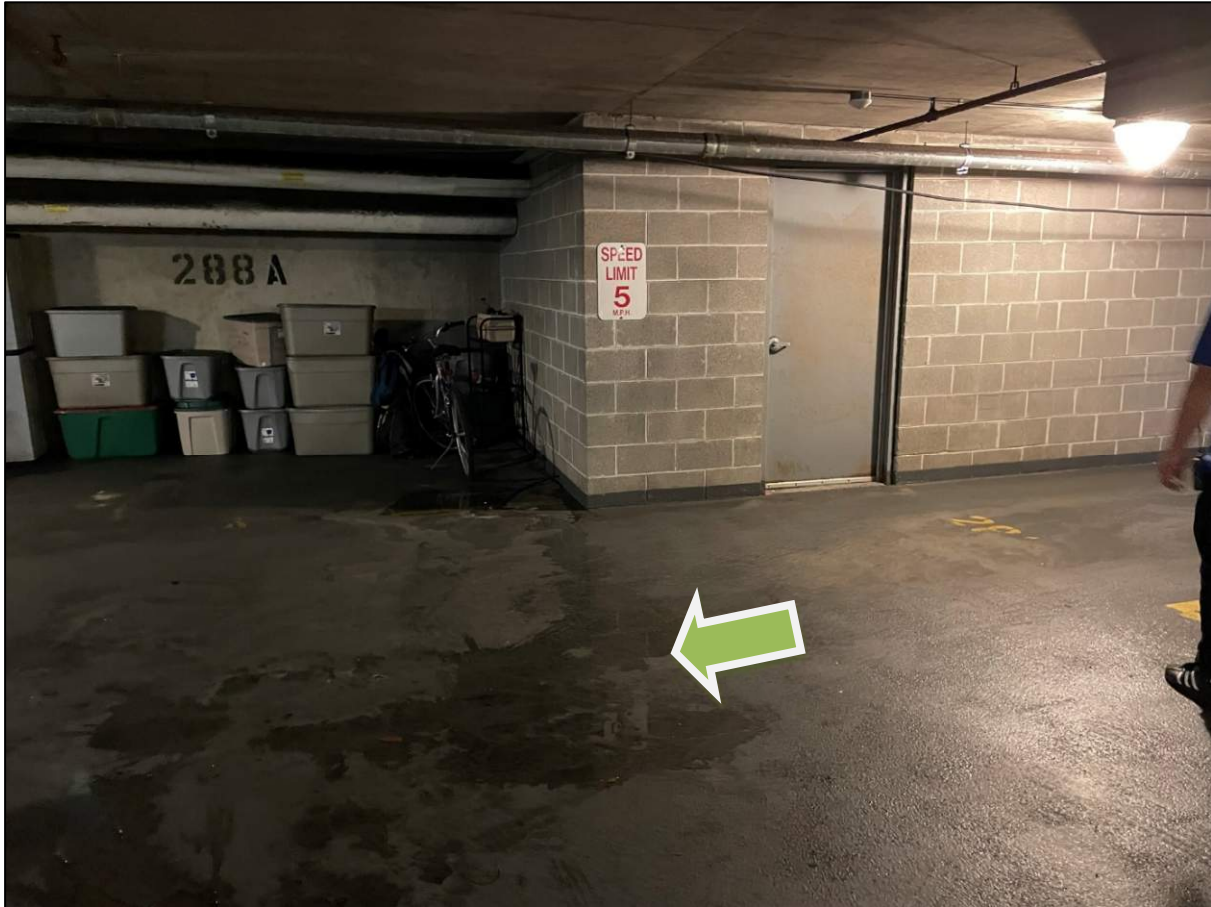
Photo A4-2: The failed traffic membrane and puddle is located between designated parking spaces 288A and 288.

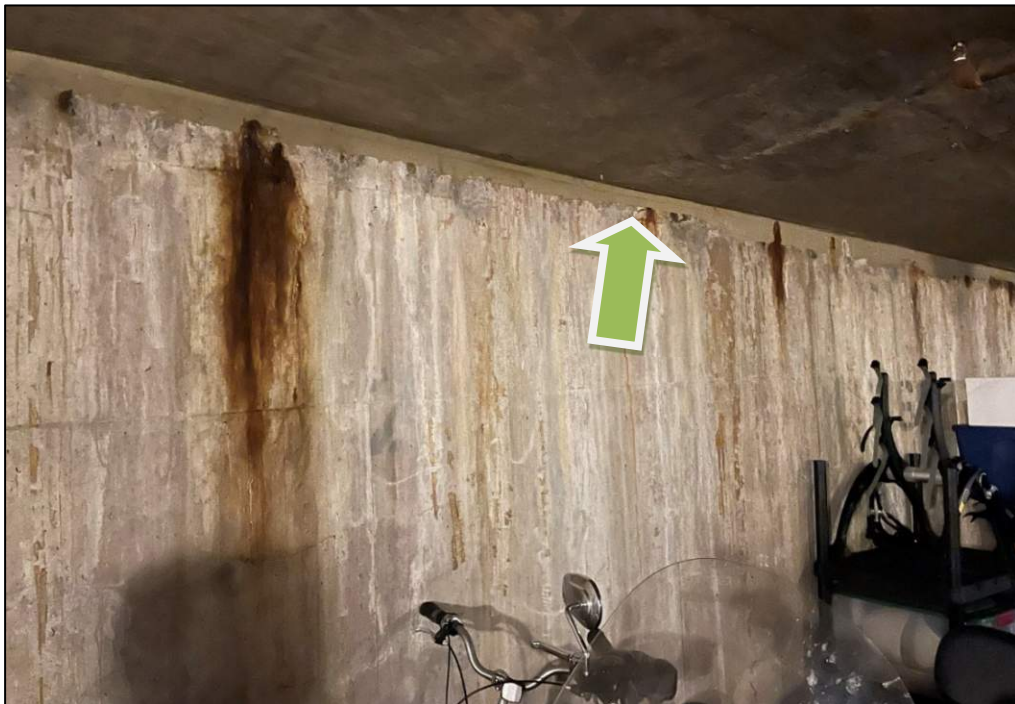
**Description:** During the original construction, the concrete floor was poured on top of the previously poured wall that created a permeable cold joint. The joint leaked water for many years. In 2013, GRAEF provided design input on waterproofing these joints by epoxy injection and coating the joint strip with sealant coating. This system has held up very well, but it is not maintenance free. This will be an ongoing issue unless a decision is made to excavated behind the wall and place a rubberized membrane on the soil side of the wall.

Photo B1-1: Small leaks have formed within the waterproofing joint at the top of wall.

**Recommendations:** The rust stains do not specifically represent current leaks. We recommend the current water leaks be injected with polyurethane, which swells and prevents water infiltration.

**Level of Urgency:** The leaks appear minor but will worsen and can deteriorate the concrete and corrode the steel reinforcing inside the concrete. We recommend the cracks be injected within three years.

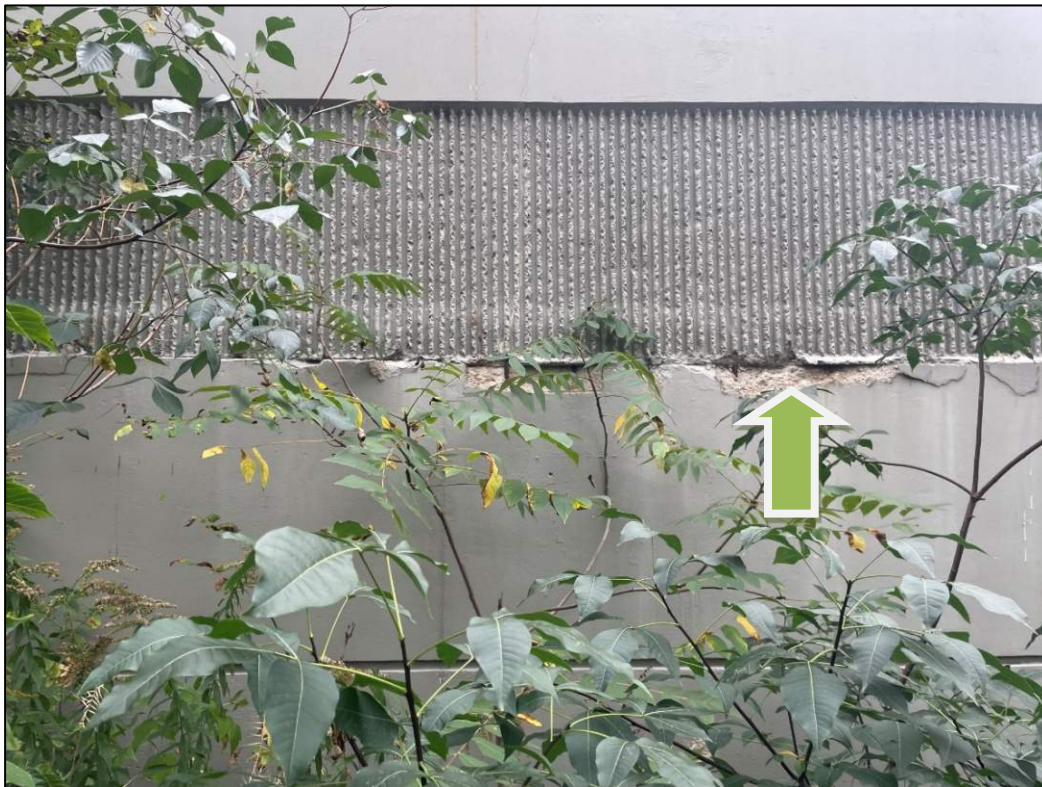
**Description:** Prior to the waterproofing membrane being replaced in the outdoor plaza patio deck a few years ago, water leaked through the base of the wall towards the outside wall face. This caused the concrete at the joint to deteriorate and the reinforcing steel inside the wall assembly to corrode.

**Photo B2-1: Large concrete spalls are at the cold joint between the parking wall and the parapet wall above.**

**Recommendations:** The source of the water from the patio has been addressed, so the exterior concrete repairs can now be completed. Loose concrete should be removed, exposed rebar be removed of rust and then coated with cold galvanizing, and the spalled area be patched solid with repair mortar.

**Level of Urgency:** The wall is substantial, and the interior wall leak has been addressed, however, exposed rebar will continue to corrode and cause more costly repairs later. We recommend they be repaired within the next three years.

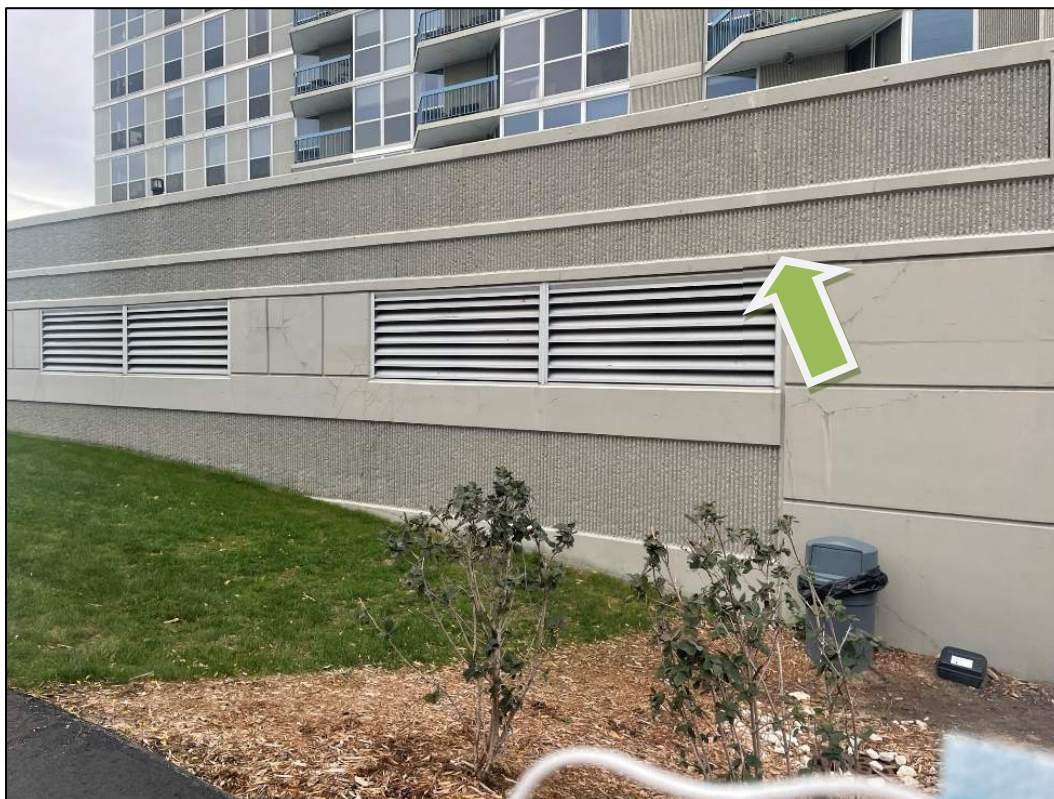
**Photo B2-2: Below the cold joint, there are concrete cracks that will lead to imminent spalls and should be injected.**

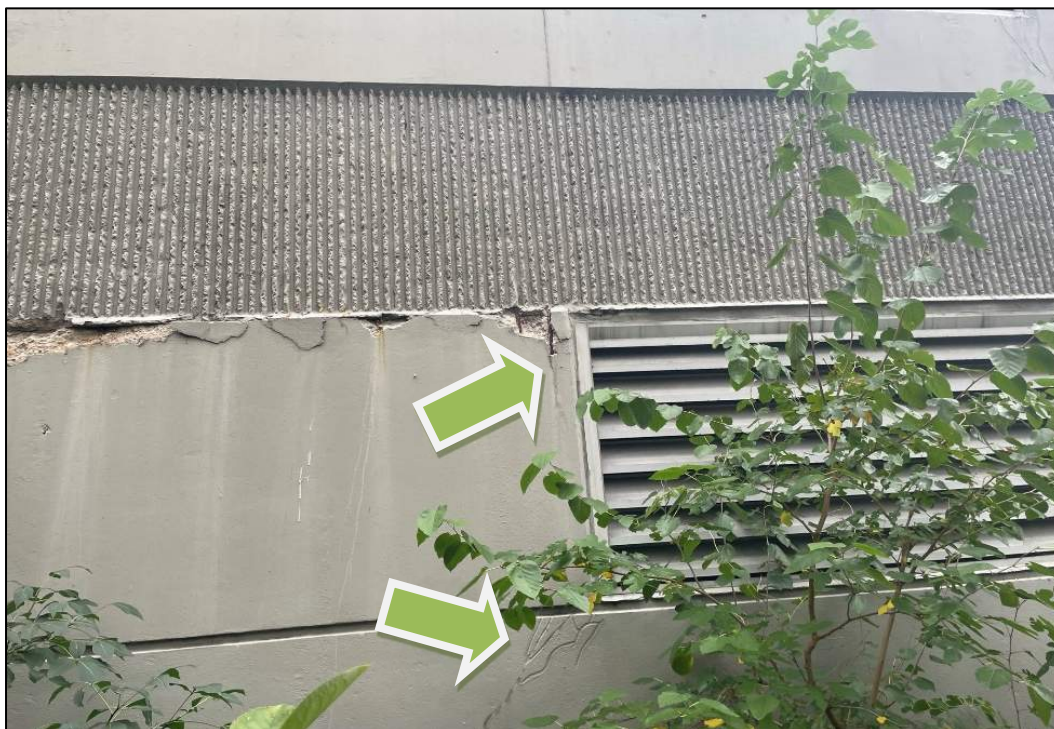
**Photo B2-3: Cracks and spalls continue along the cold joint and travel down the side of a vent louver.**

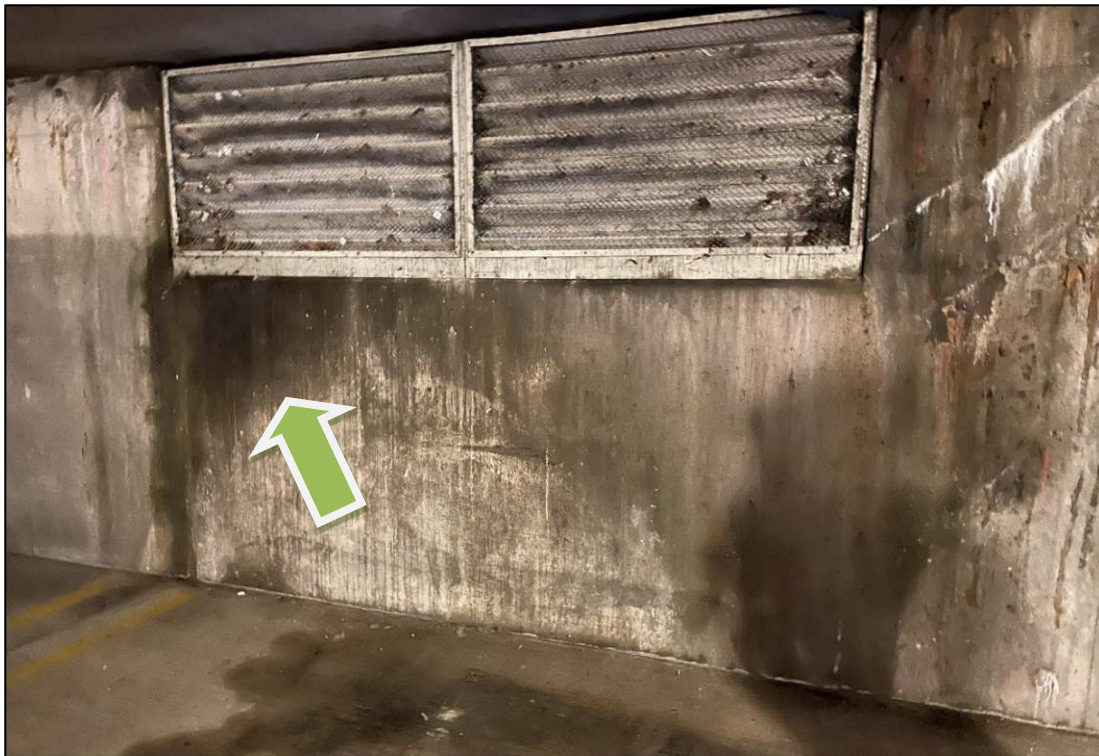
**Photo B3-1: Water is saturating the wall below the area well vent.**

**Recommendations:** Usually water that is trapped inside an area well has a drain for water to exit into a stormwater management system. It is unknown if the system here was not installed or is no longer working. The first step would be to remove debris at the bottom of the area well. If that does not solve the problem a drain could be installed inside the area well or a waterproofing membrane could be installed on the positive side of the wall.

**Level of Urgency:** Adjacent spalls to be addressed under report Condition A2 and adjacent cracks to be addressed under report item B1. We recommend the water issue be addressed at the area wells within five years.

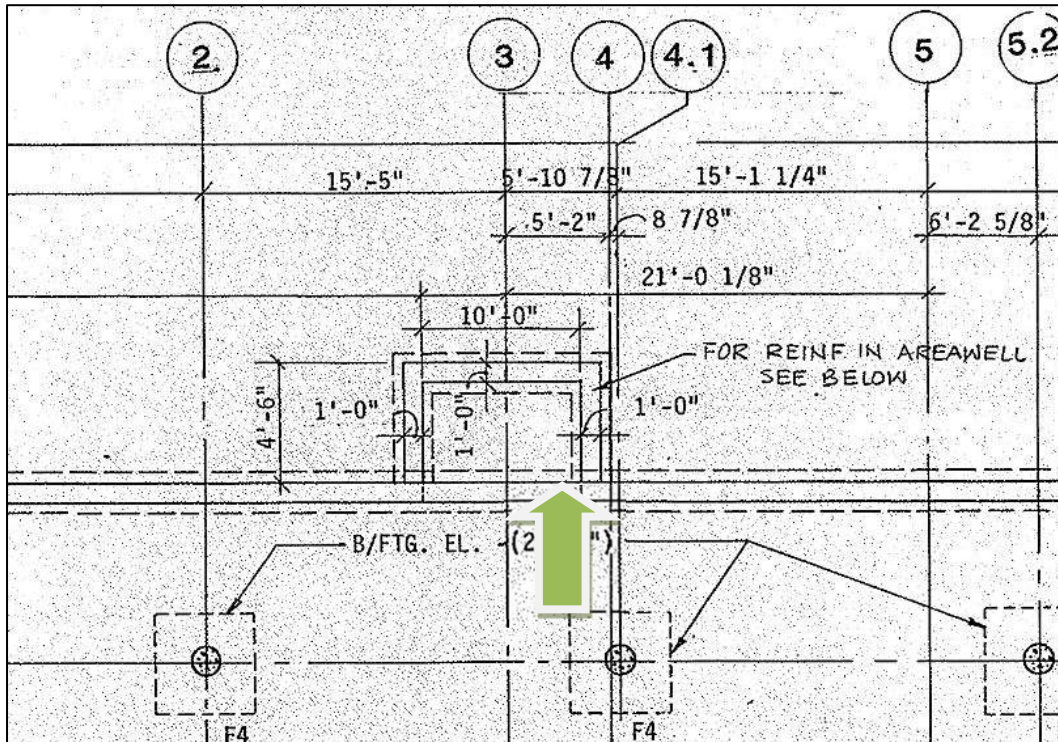
Photo B3-2: Area wells occur in the north and south foundation walls between grid lines 2 and 4.

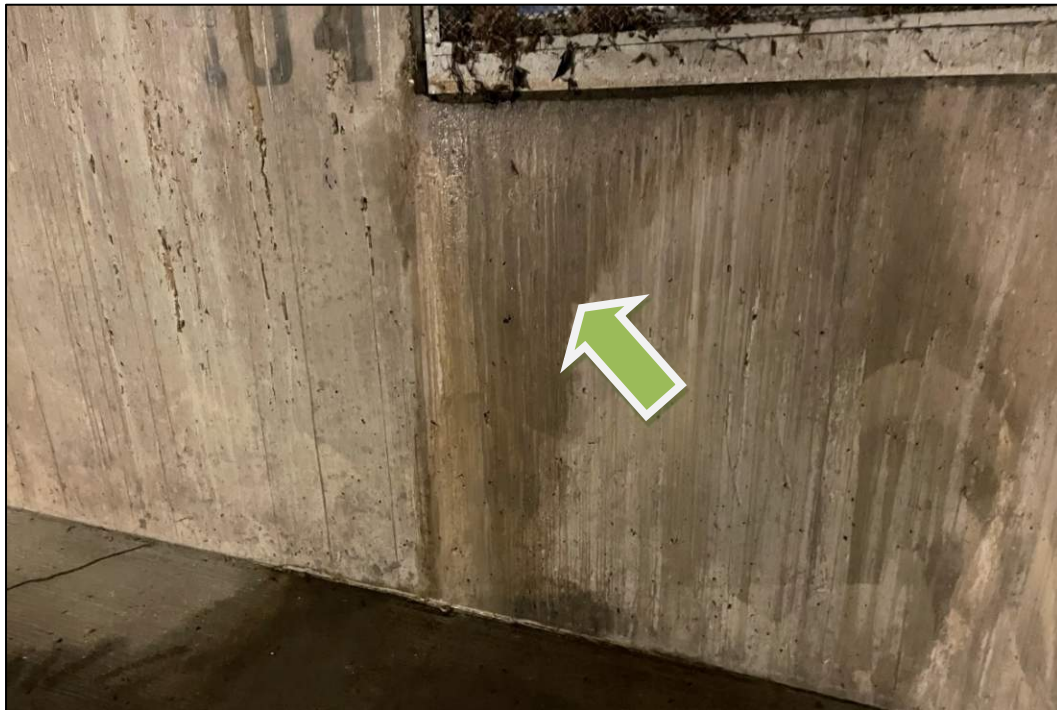
Photo B3-2: Water overflows inside the area well and leaks down the side of the wall. Debris inside the areas to be removed so the saturation problem can properly be identified.
