## LANDMARK ON THE LAKE

Facade Critical Examination

1660 N. Prospect Avenue  
Milwaukee, WI 53202

November 18, 2024  
Project No. 237058

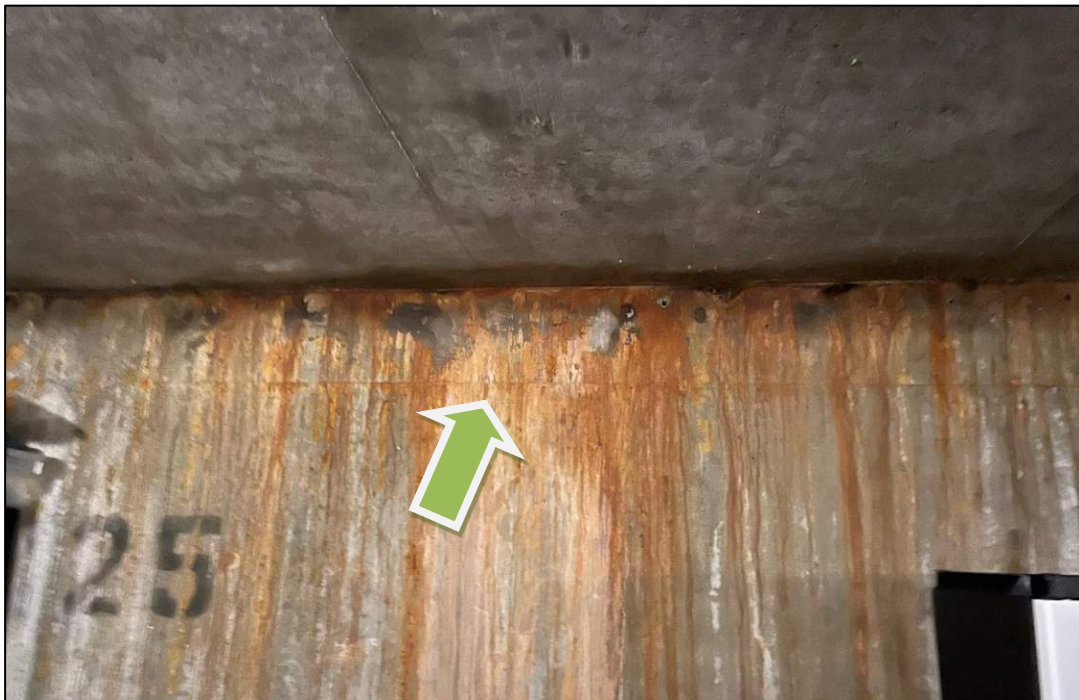
**Description:**                There are several rubbery adhesive streaks that cover the interior surface of the concrete foundation wall. The adhesive residue may have been used during construction or a previous repair project and was left in place. The soft glue-like surface has absorbed rust from water that leaked in through the slab and wall joint described in Condition B1. This is not a sign of damage to the wall and is just an aesthetic issue.

**Photo C1-1: Rust has stained the rubber adhesive on the side of the wall. The cold joint between the wall and the floor slab or previously repaired cracks could have stained the adhesive the rust color long ago.**

**Recommendations:**        The rubbery adhesive material can be removed by scrapping or possibly pressure washing the surface of the wall. The added benefit to removing the substance is that if a serious rust problem does arise, it would not be confused with this aesthetic issue.

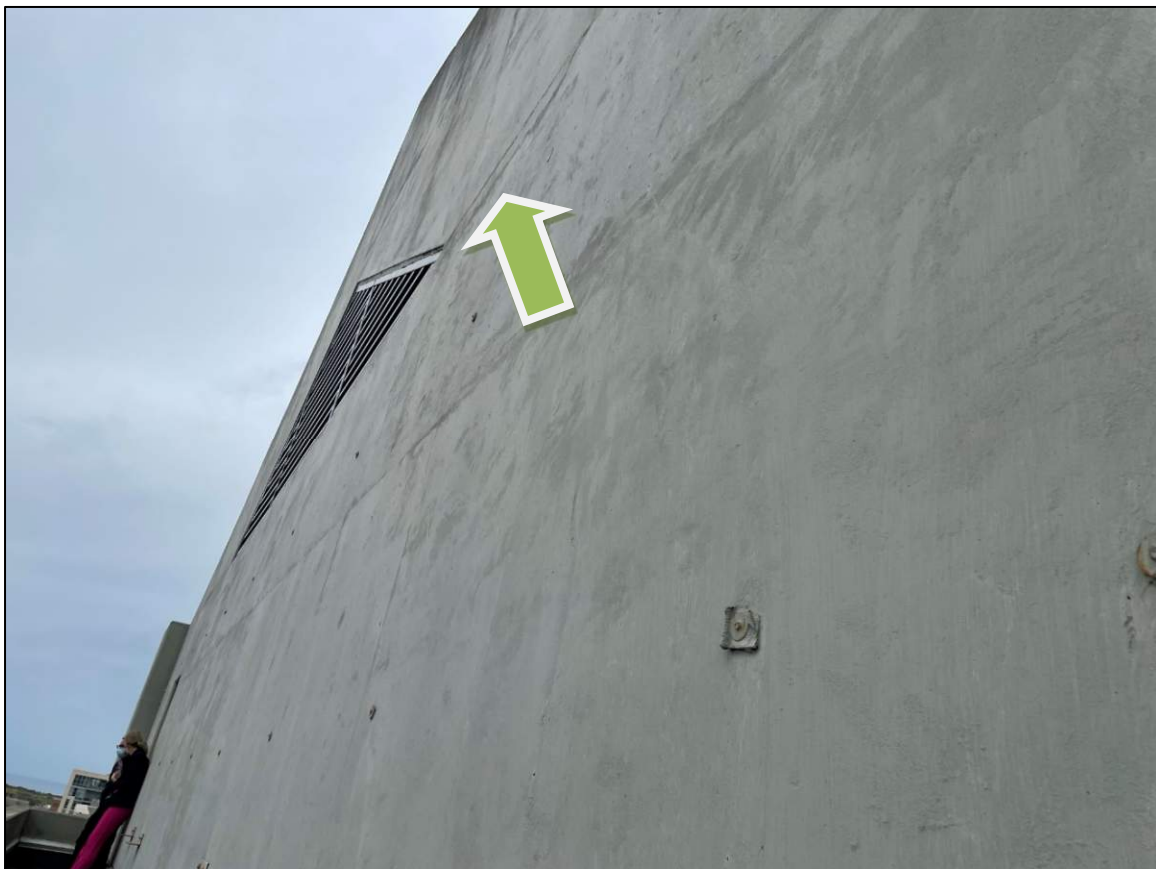
**Description:** Water has been reported to be found pooled along the bottom of this wall after a storm event with heavy rain and strong winds. Water could be coming in through this cold joint crack, or it could be coming in through the open louver and leaking through the mechanical ventilation duct connected to the louver.

**Photo C2-1: A horizontal crack follows a cold joint in the exterior wall and is aligned with a louver.**

**Recommendations:** Building maintenance person should investigate the area after a strong storm and determine the source of the water reported inside the mechanical penthouse. Additionally, if water is entering the mechanical ductwork, then a HVAC contractor should verify no damage is occurring to the interior mechanical equipment and that trapped water has a route to drain from the ventilation system.

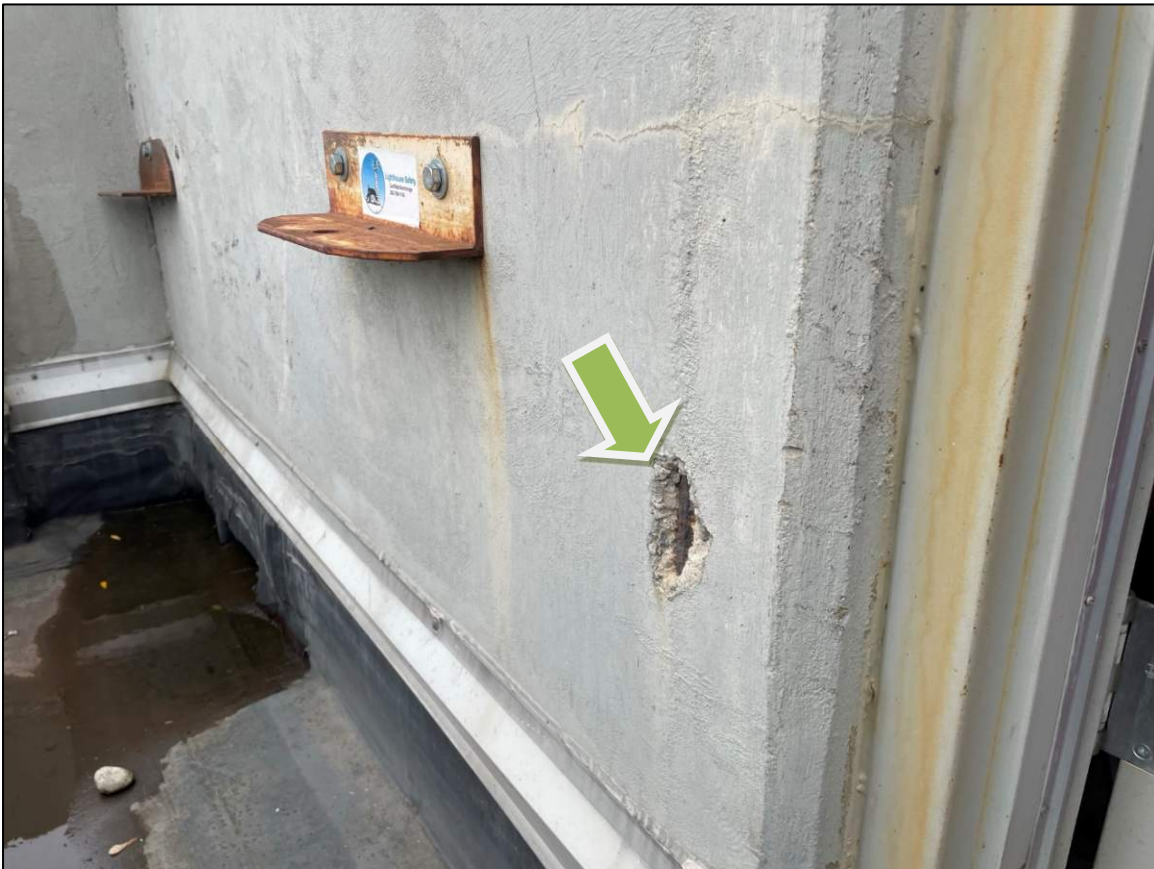
**Description:** A concrete spall on the exterior face of the wall has exposed a segment of rebar. The rebar is not overly corroded, and the only source of water is occasionally from rain. The concrete around the spall appeared solid and secure.

**Photo C3-1: A concrete spall on the south wall of the mechanical penthouse has an exposed rebar.**

**Recommendations:** The spall should be patched with repair mortar to prevent the damage from becoming worse.

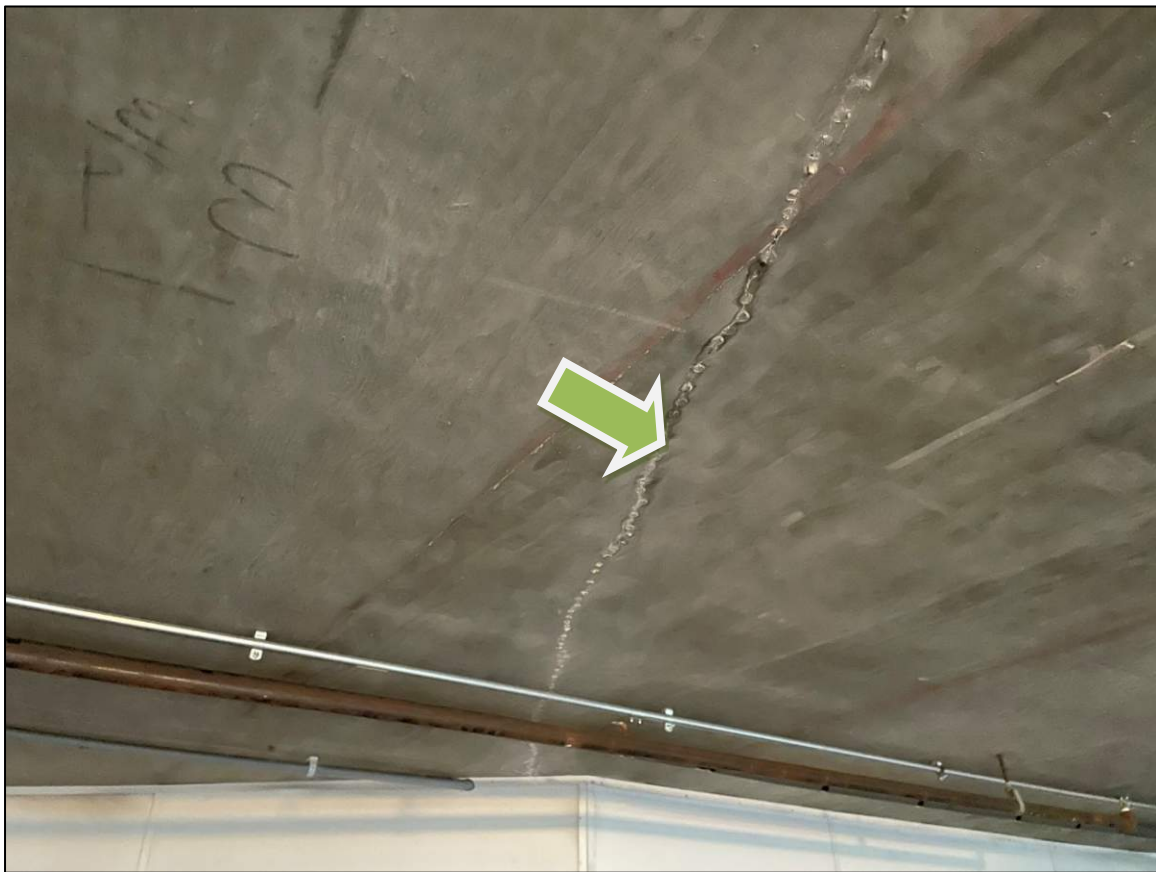
**Description:** It appears most of the horizontal cracks have been injected with epoxy previously and the traffic bearing membrane on the top surface is adequately preventing the cracks from receiving direct water. There are some cracks that have lengthened since they were injected, but do not appear to be leaking. Ambient moisture in the parking areas can infiltrate the cracked areas and cause the internal rebar to corrode.

**Photo C4-1: A crack on the bottom of the floor slab (ceiling) had been injected with epoxy and still has some of the damming material (to keep epoxy from spilling out) left in place.**

**Recommendations:** Monitor the condition of the cracks. Once the traffic bearing membrane above needs replacement, it is recommended for the cracks be injected at that time, which were not previously injected.
