# HOME INSPECTION REPORT

**5314 West Nokomis Road, Brown Deer, WI**

Date of Inspection: 6/30/2026 Time: 5:00 PM

Inspector: David Nason

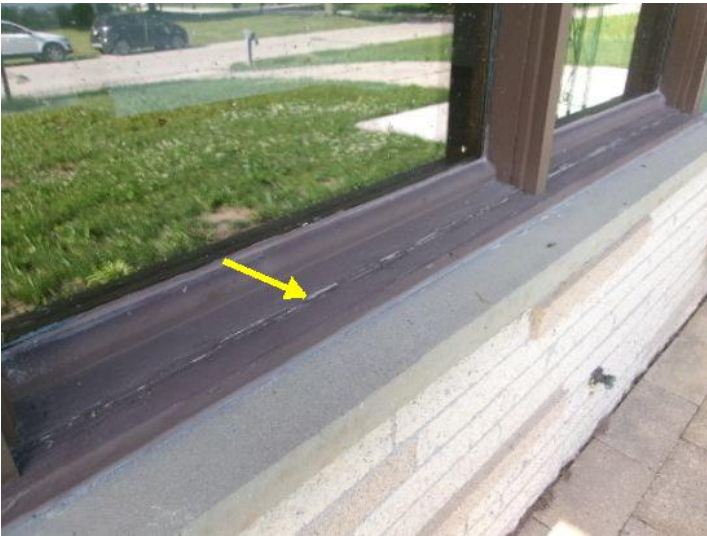
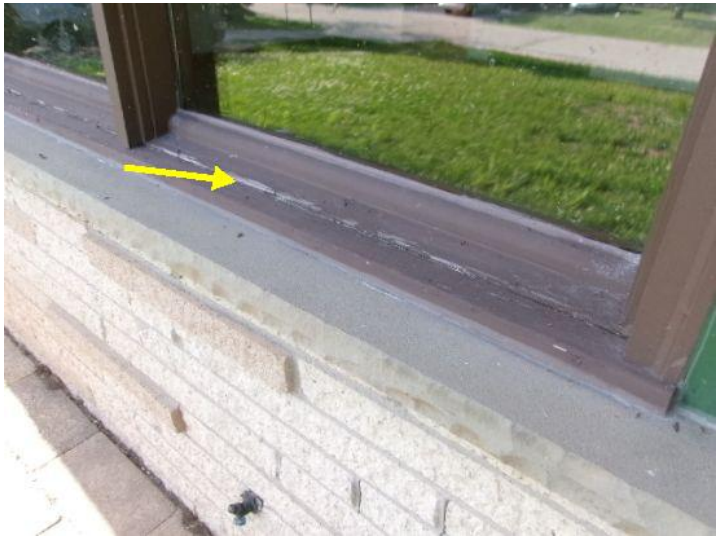
• **MAINTENANCE:** Cracking/peeling paint/caulk observed at the siding, trim, windows, and/or other surfaces; suggest scraping, caulking, priming, and painting as necessary.

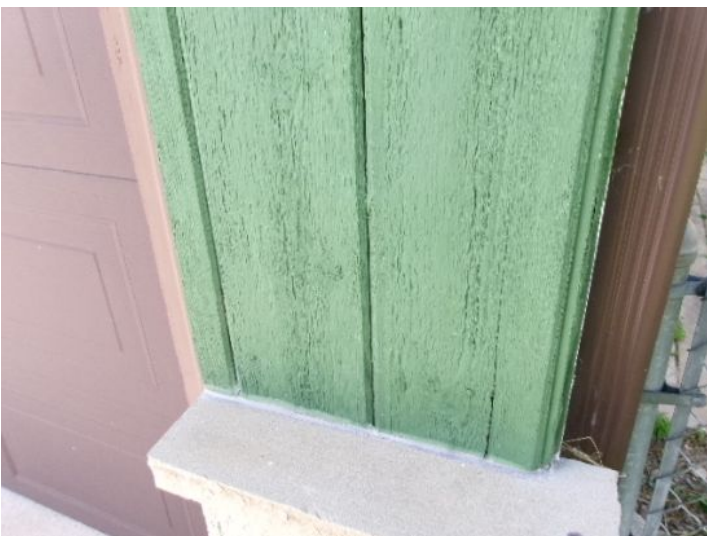
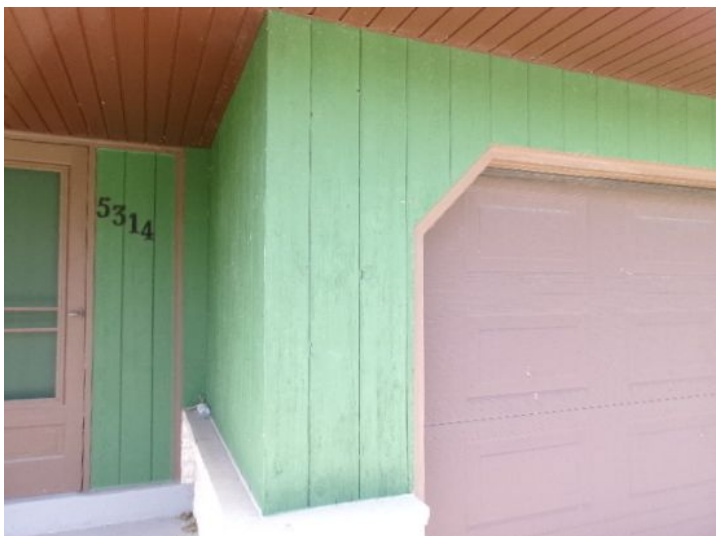
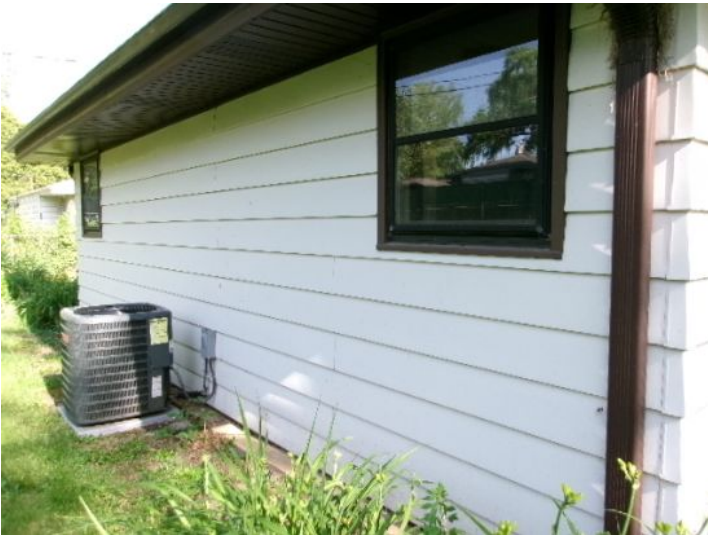
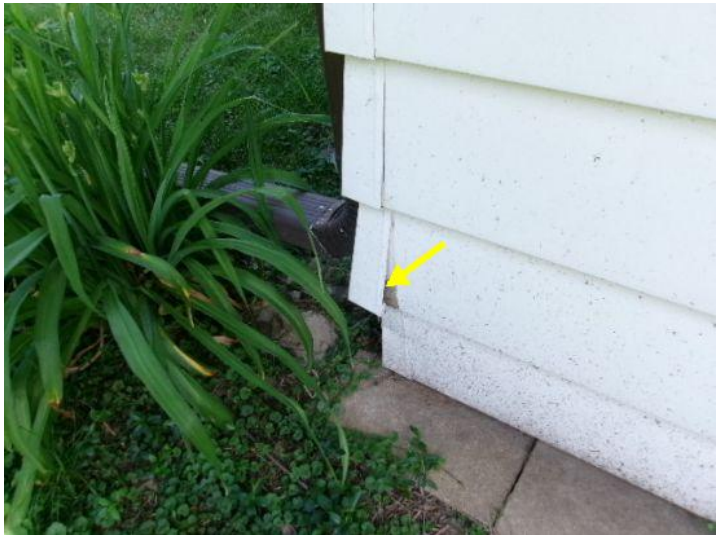
### 4. Siding & Trim

- No major concerns observed with the majority of the siding and trim.
- Weathering observed at the wood siding on the front elevation due to direct sun exposure. Caulk and paint as needed and have repairs made by a qualified siding contractor as necessary.
- Keep aluminum siding clean by washing with a mild detergent (or Jomax) and a garden hose - do not power wash the siding as this may force water behind the siding and cause damage.
- **REPAIR:** Corner pieces observed to be coming loose. Repair needed.

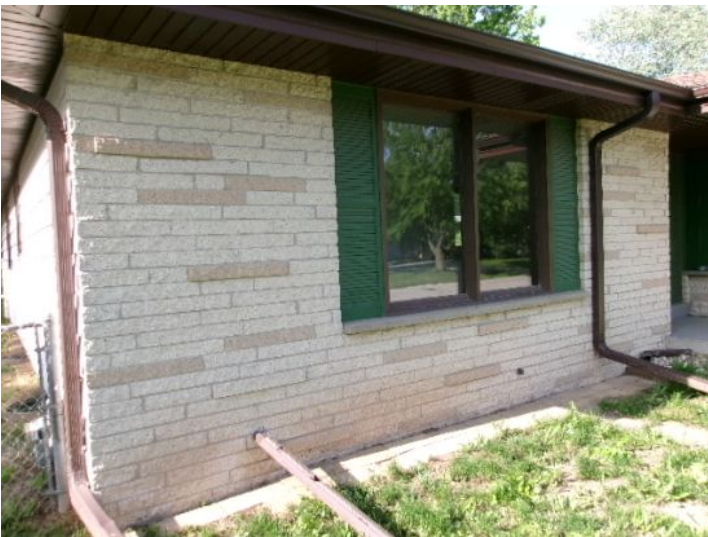
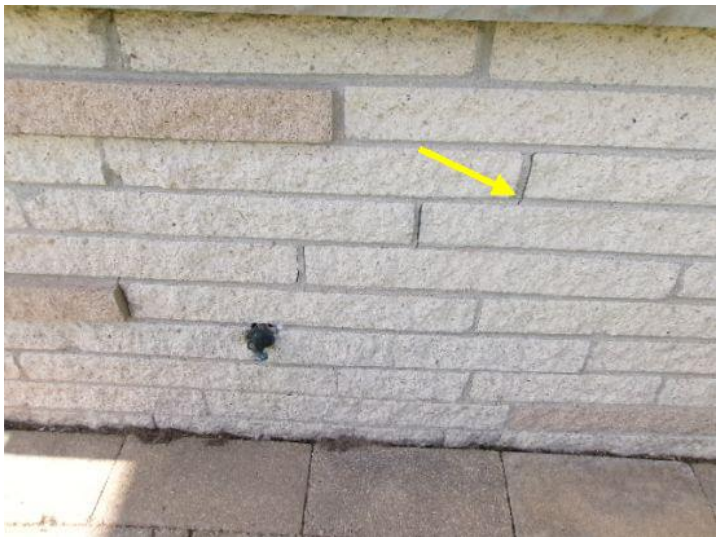
- **MAINTENANCE:** Brick veneer appeared to be in overall satisfactory condition on the home; no major concerns observed. Minor shrinkage cracking observed in the mortar in areas. Consult a qualified masonry restoration contractor for repairs as needed.

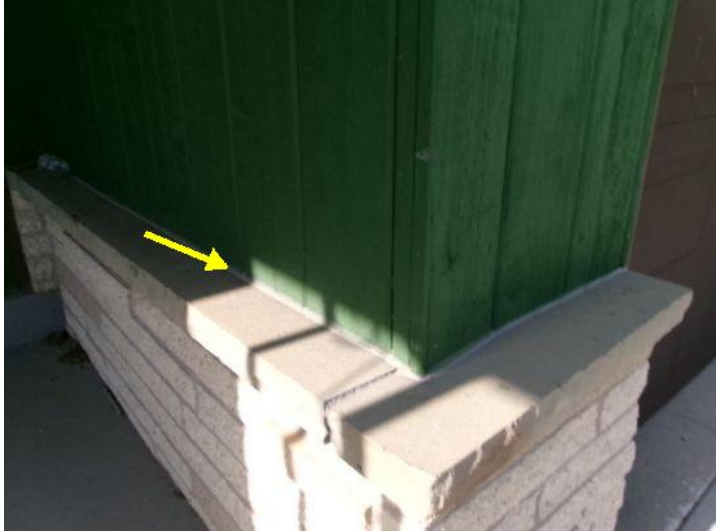
- Due to a hip style roof and windows and doors are under the overhangs, there is no need for flashing above the windows and doors.
- **MAINTENANCE:** The flashing from the siding to the stone sills at the front elevation is minimal and should extend at least 1" beyond the siding. The roof overhang is helping to keep moisture off the sills and no major concerns were observed. Maintain caulk as needed.

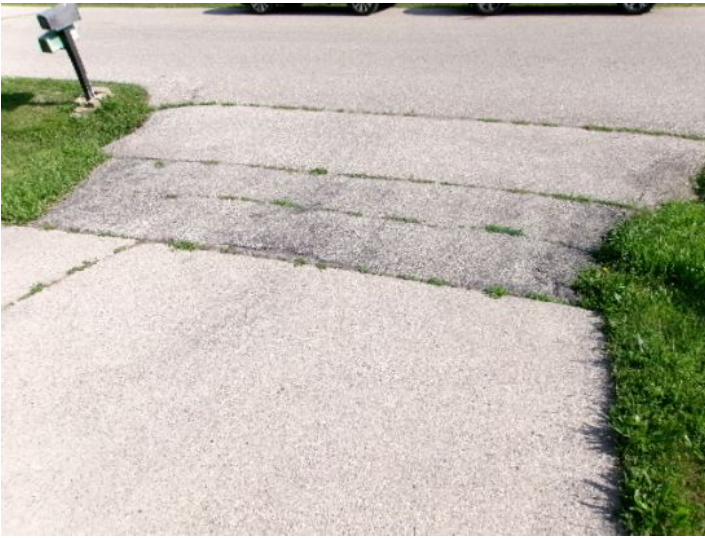
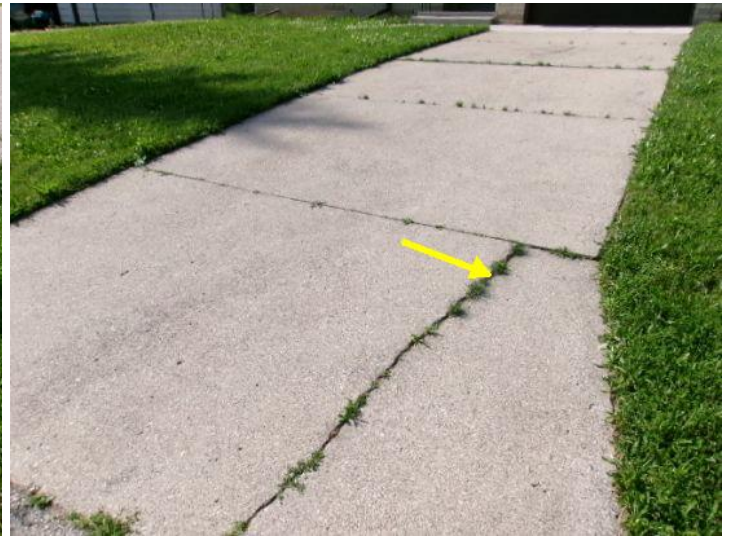
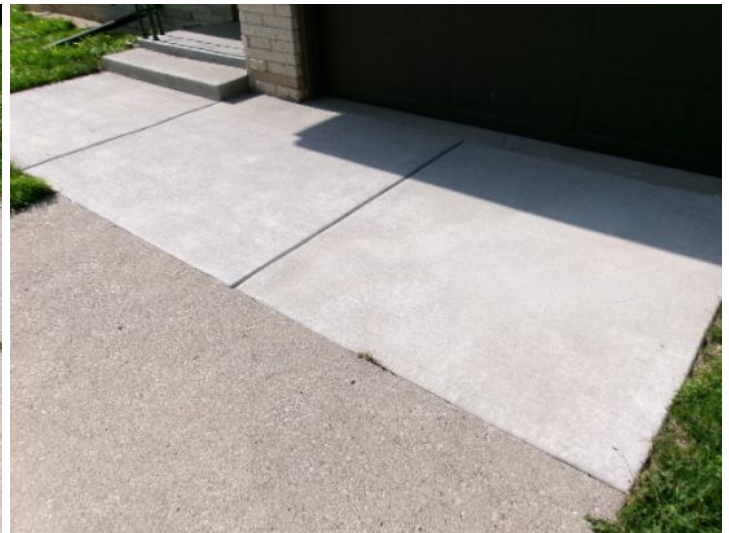
- Concrete section of the driveway near the garage appeared to be newer and observed to be in good condition.
- **REPAIR:** The concrete driveway appeared to be in overall satisfactory condition. Some joints are opening up possibly caused by water and gravity causing the concrete to slip downhill. Suggest sealing joints to prevent additional moisture intrusion. The large crack near the bottom of the driveway may be caused by a poor sub base in the area; repair or replacement needed.

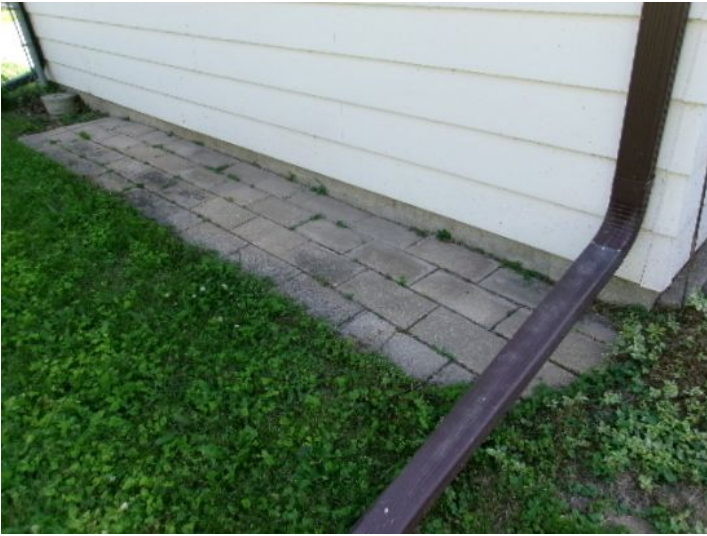
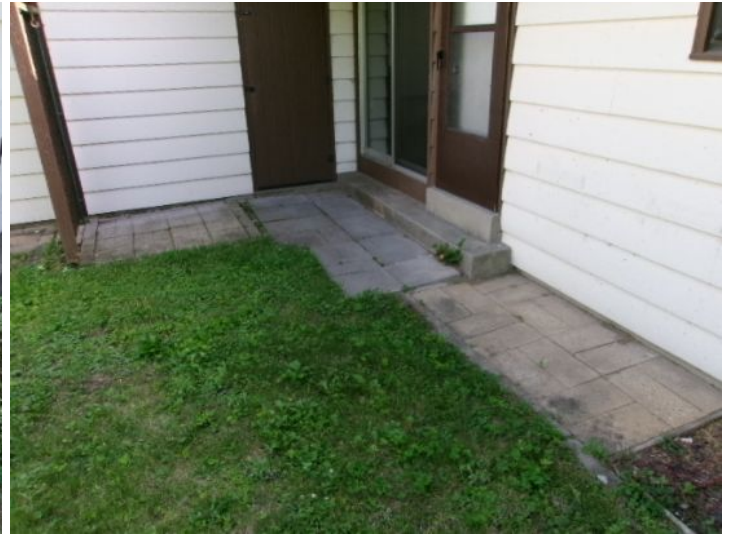
- **REPAIR:** The paver patio areas are beginning to settle and heave in areas causing potential trip hazards. Suggest making repairs as needed. Consult a qualified landscape contractor if needed.

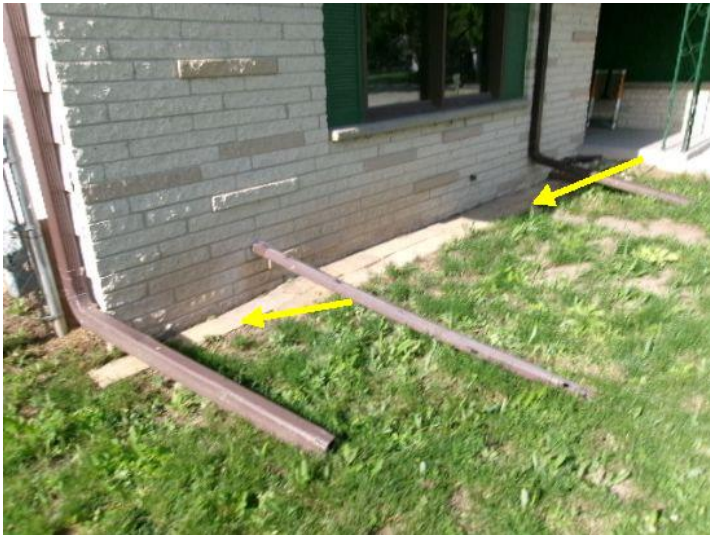
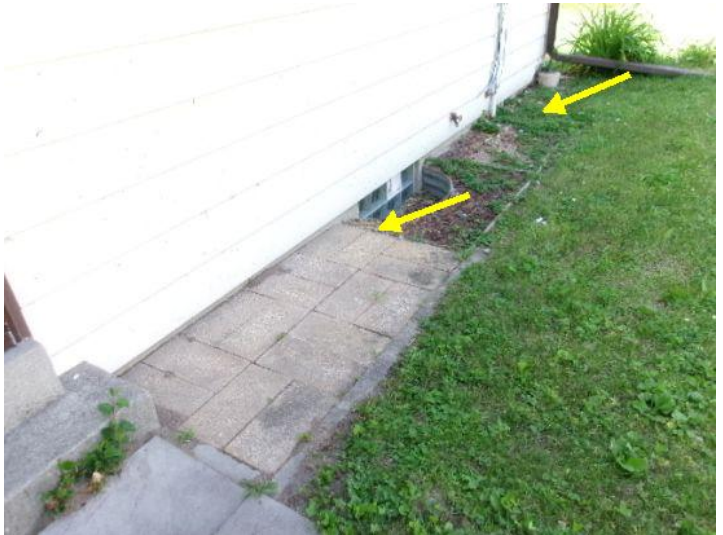
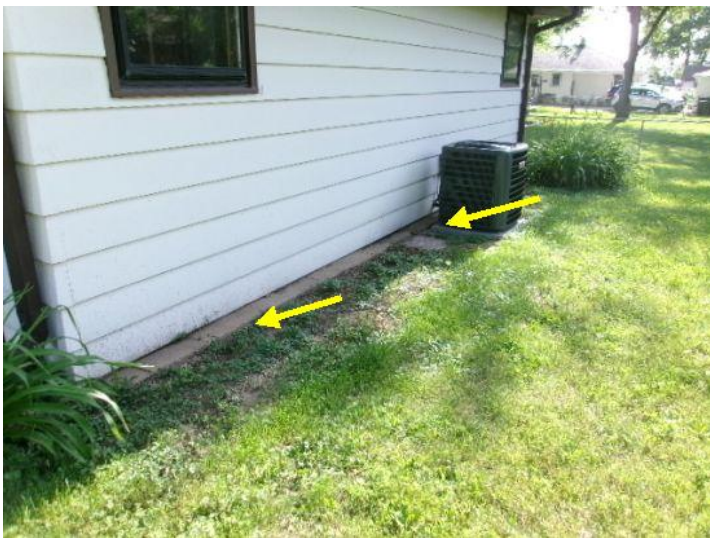
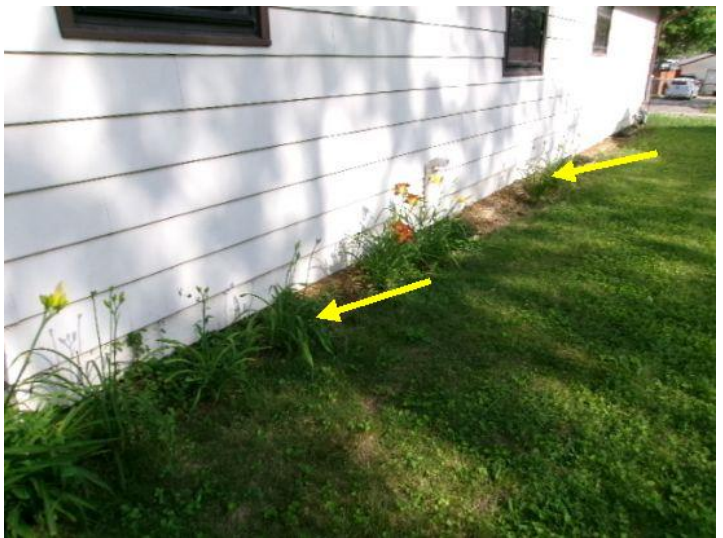
- **MAINTENANCE:** There are some low spots or flat areas along the foundation where the grade does not slope away. Recommend raking back mulch/rocks and adding or removing soil to create the proper slope away from the house to allow for effective drainage. Be careful not to raise the grade too high on the brick veneer to avoid allowing moisture intrusion into the wall behind and maintain at least 4" of space between the siding and the soil below to prevent potential siding damage or moisture intrusion.

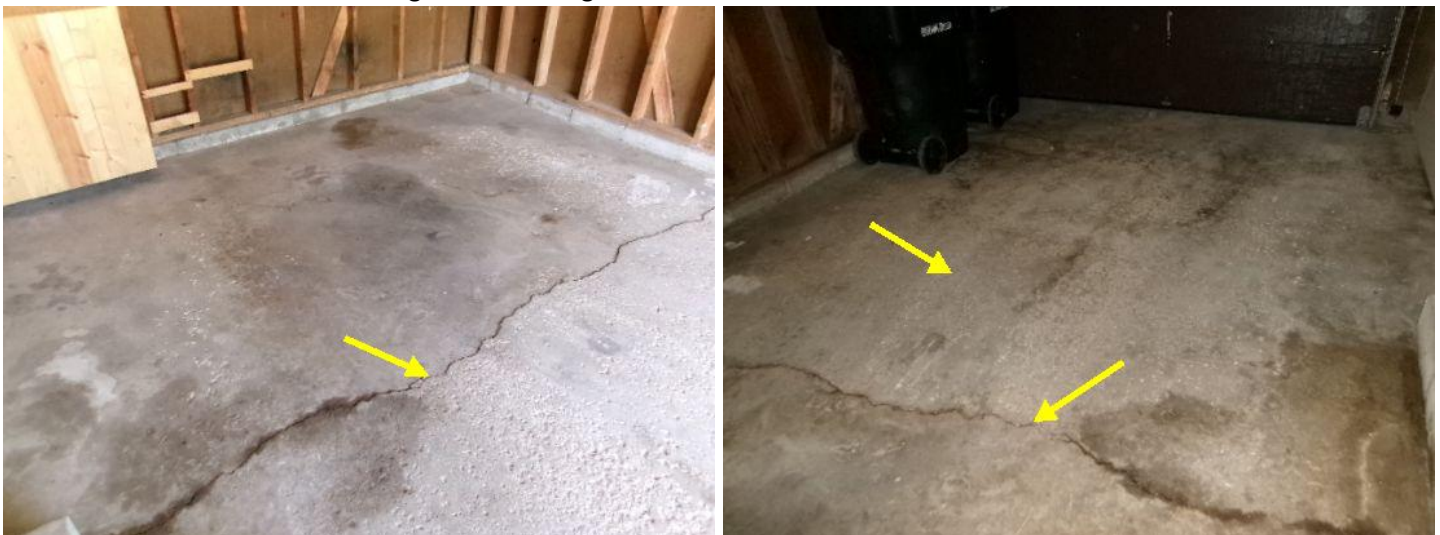
- Material: Concrete floor
- **IMPROVEMENT:** Common shrinkage cracks and surface pitting/spalling observed caused by road salt from cars. Cleaning and sealing with a concrete sealer will extend the life of the concrete.

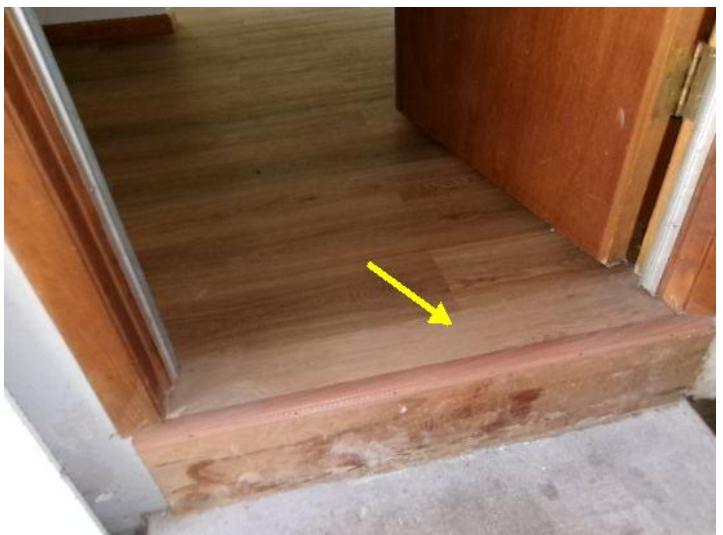
- **DEFECT:** The door between the garage and house is a solid core wood door however it is not a labeled fire rated door, there are gaps at the jamb, and the threshold was removed when the new flooring was installed. Fire doors are fundamental to the integrity of fire barriers which provide resistance to the spread of fire, smoke, and toxic gasses. Although a fire door may not have been required when the house was built, this door will not afford protection from fire, smoke, or combustion gases and is a safety hazard. Replacement needed, which will require some re-work of the flooring.

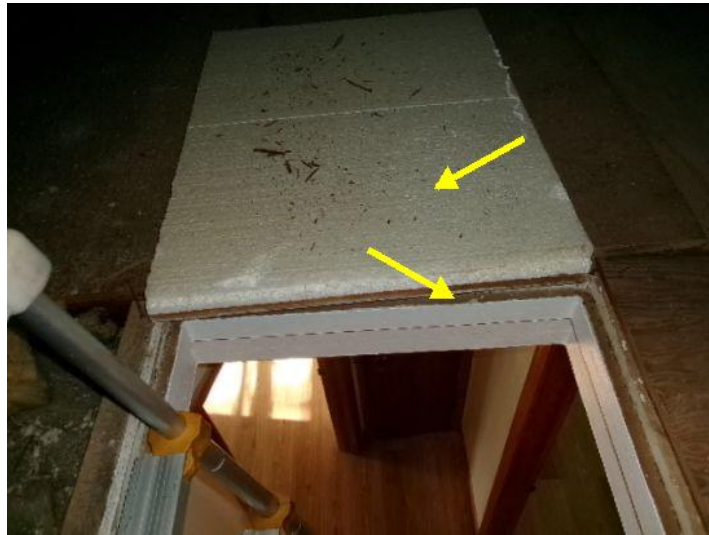
- **IMPROVEMENT:** Very little insulation observed on the access hatch and no weatherstripping around the opening, which is a significant source of heat loss and air leaking into the attic from the home; suggest adding insulation and weatherstripping to minimize heat loss.

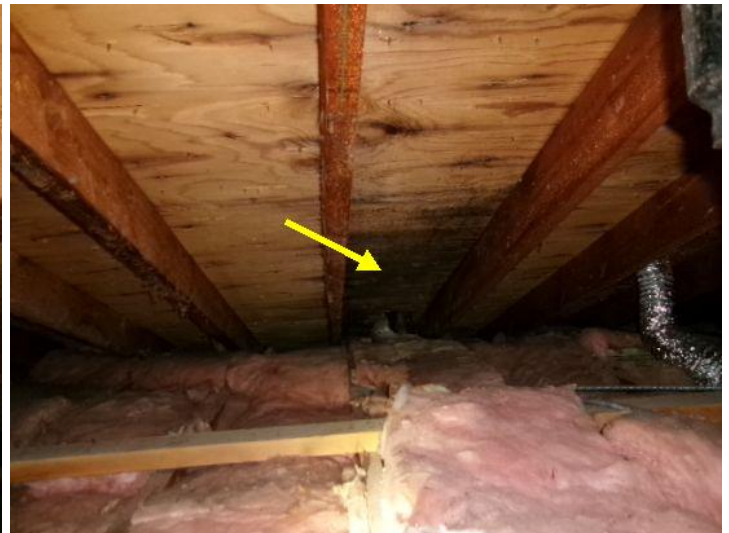
• **FURTHER EVALUATION:** Staining was observed on the roof sheathing on the north facing slope and above the bathroom that may be an organic growth likely caused by excessive condensation during cold weather months, due to air leaking into the attic from the home. Recommend further evaluation of the condition of the attic; proper cleaning of the structure may also be needed by a qualified professional contractor that specializes in this type of cleaning.

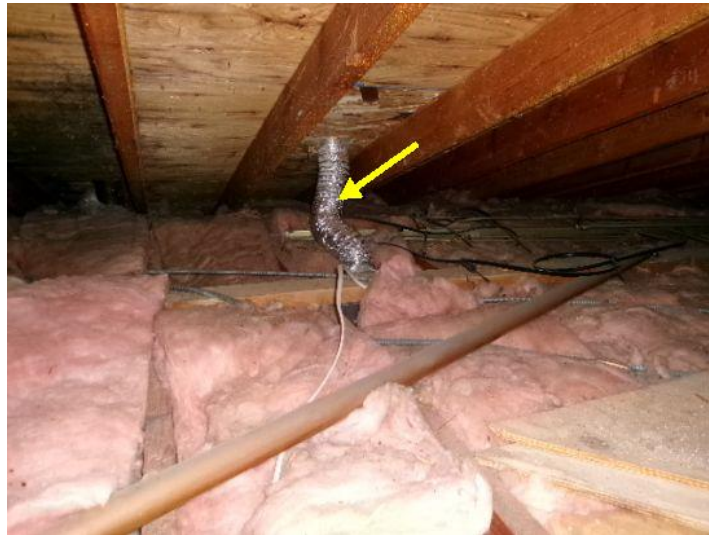
- **IMPROVEMENT:** The bathroom exhaust fan duct visible in the attic appeared to vent to the exterior properly, however recommend insulating the duct to improve venting and prevent possible condensation build up during cold months. The duct should also be mechanically fastened, with a hose clamp or zip tie, to the roof vent to prevent it from coming loose.

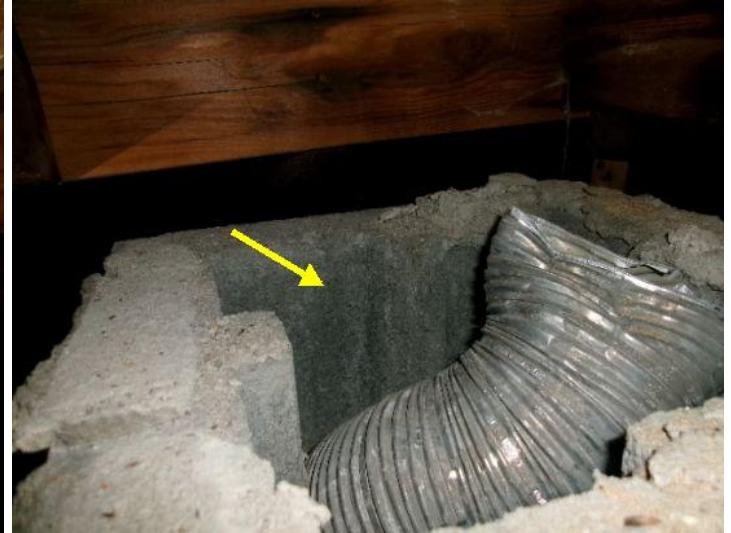
- The masonry chimney has been removed below the roof line and is no longer in use. Recommend sealing the flue to prevent warm air from the basement leaking into the attic.

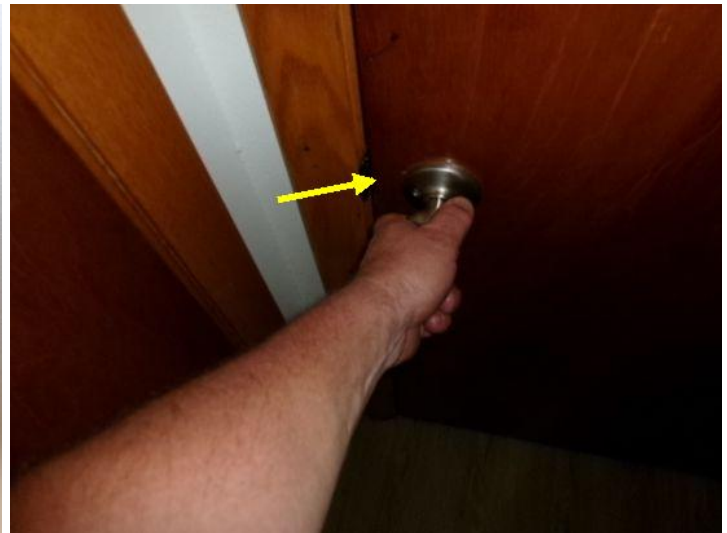
- Except as noted, a representative number of interior doors were opened and closed and appeared to be in satisfactory condition.
- **REPAIR:** The latches at a bedroom and bathroom door need adjustment to latch properly.

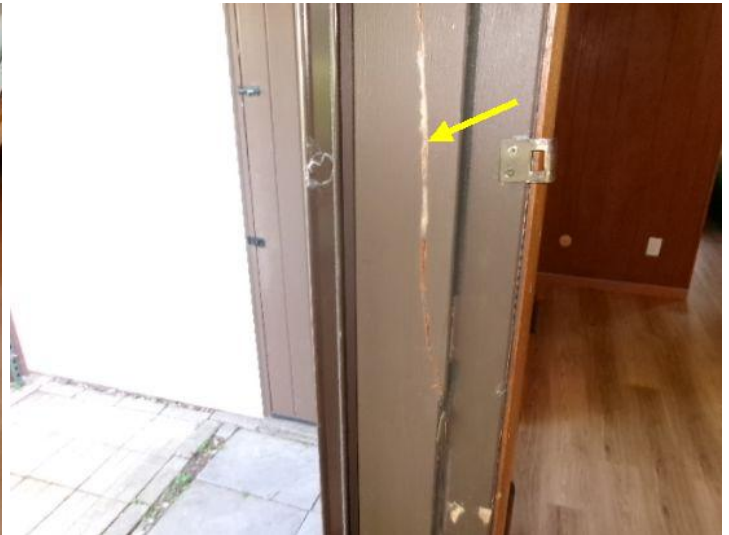
- Front entry door was functional and observed to be in satisfactory condition.
- **REPAIR:** Damage observed at the frame of the rear entry door apparently from a forced entry attempt. Repair/replacement needed.

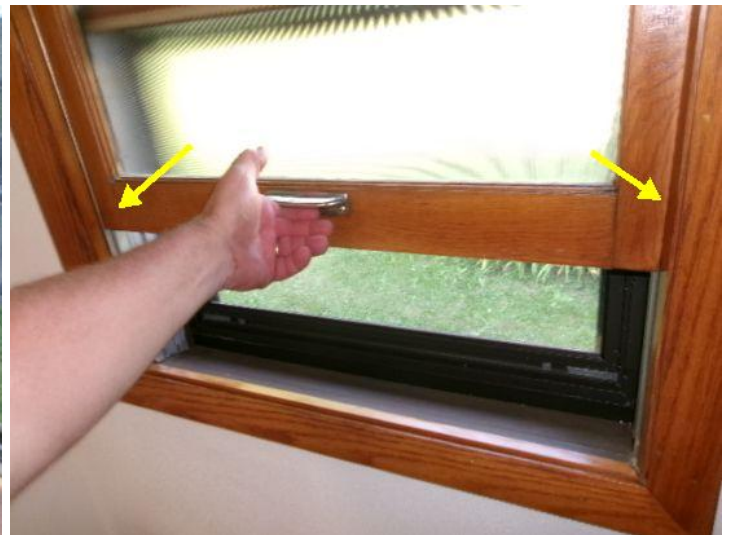
- Except as noted, a representative number of the windows were operated and appeared to be functional and in satisfactory condition.
- Operable windows need to be opened and cleaned regularly to extend their life and maintain proper operation.
- Locking all windows when not opened prevents air leakage or moisture intrusion, in winter and summer, by compressing the weatherstripping around the operable sash.
- **MAINTENANCE:** Failing finish observed at several wood window sash and sills due to age, moisture and/or sun exposure. Sand, stain, and varnish as needed; use an exterior spar varnish with UV protection for longer life.
- **REPAIR:** At least one window, in the bathroom, has balances that are broken which prevent the lower sash from staying up when opened. Repair needed.

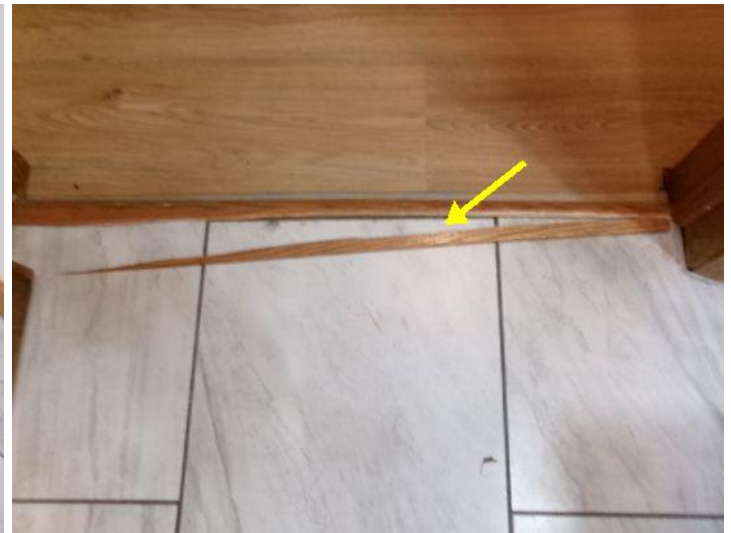
- Except as noted, floor observed to be functional and in satisfactory condition.
- Several cracked tiles observed in the bathroom floor; no major concerns observed. Suggest caulking or re-grouting as needed.
- **REPAIR:** Damaged wood transition observed at the hall/bathroom door opening. Repair needed.

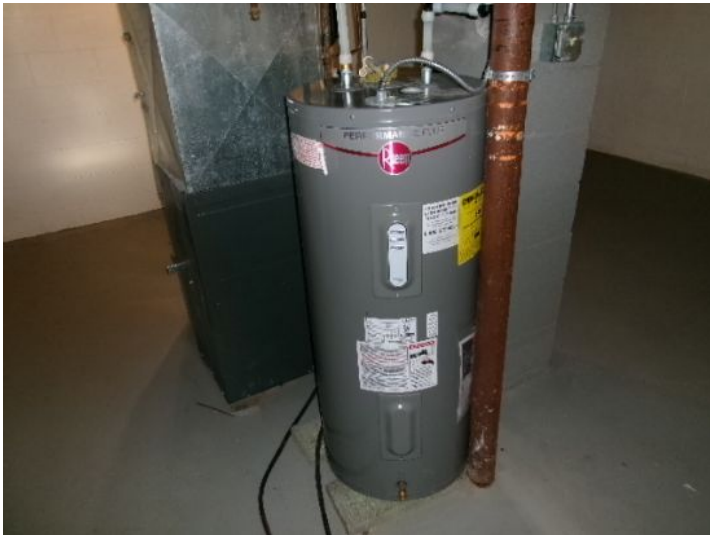
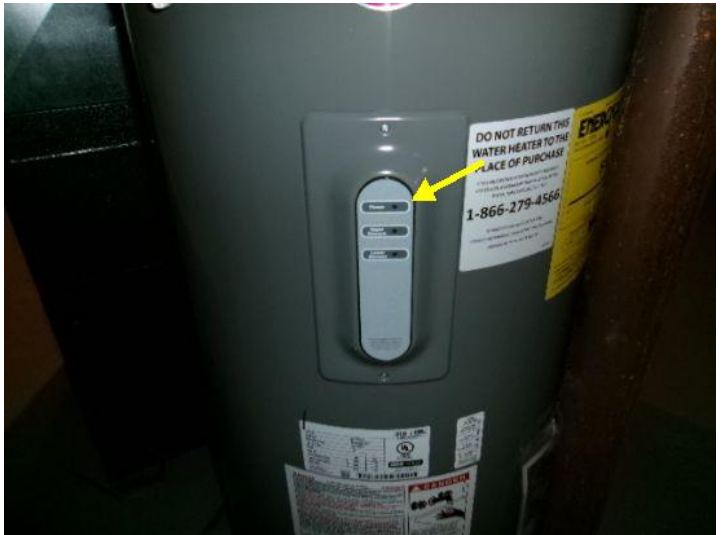
• **FURTHER EVALUATION:** The water heater was not functional - the installation appeared to be satisfactory and the circuit breaker in the panel was on, however the unit was not functioning. Recommend further evaluation by a plumbing contractor to determine any repair or correction needed.

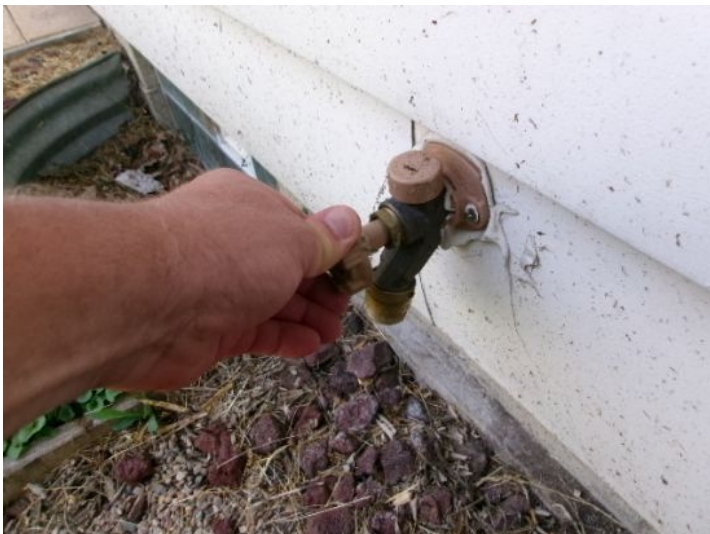
- Faucet on the rear elevation observed to be off at an interior shutoff valve; it is frost proof with a vacuum breaker present.
- **REPAIR:** The faucet on the front elevation is missing a handle and there is no vacuum breaker present. The interior piping had been cut and the new piping was not completed. Repair/replacement needed.

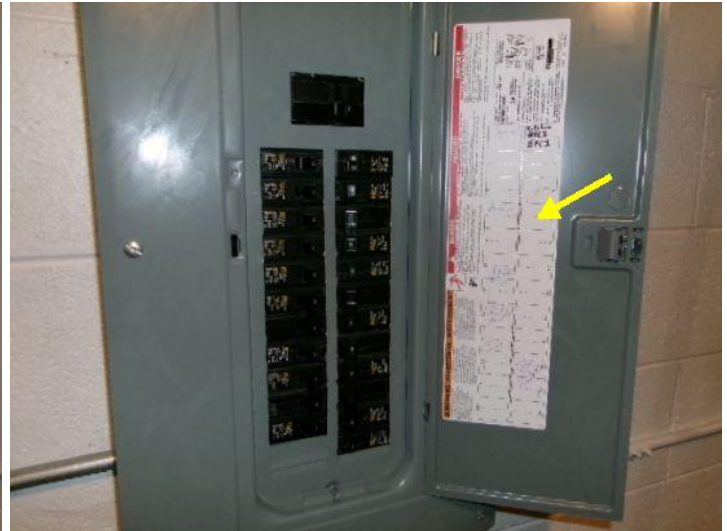
- No major system, safety, or function concerns observed in the main electrical panel.
- The main electrical panel appeared to be grounded and bonded, however the exterior grounding rod was not visible for inspection.
- **REPAIR:** The main panel is not labeled properly, which may indicate the panel was updated without a permit or final inspection. Recommend having the circuits properly labeled for safety in case of an emergency.

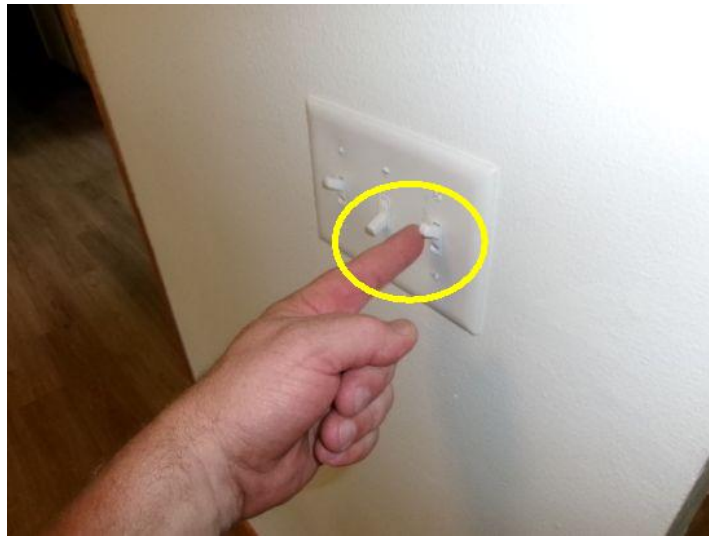
- A representative number of grounded receptacles and light fixtures throughout the main levels of the house were tested and appeared to be functional and operating correctly.
- **REPAIR:** A switch in the front hall did not operate any fixtures or receptacles; it may have previously controlled receptacles in the living room but was disabled when the receptacles were replaced. Repair needed when other electrical work is done.

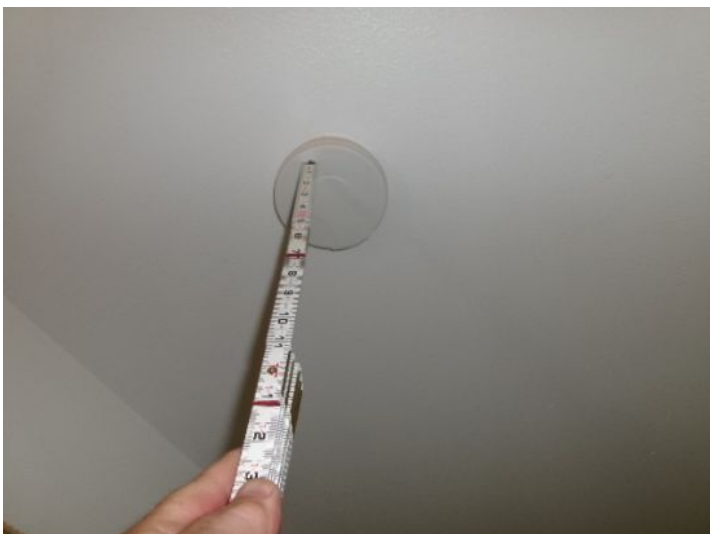
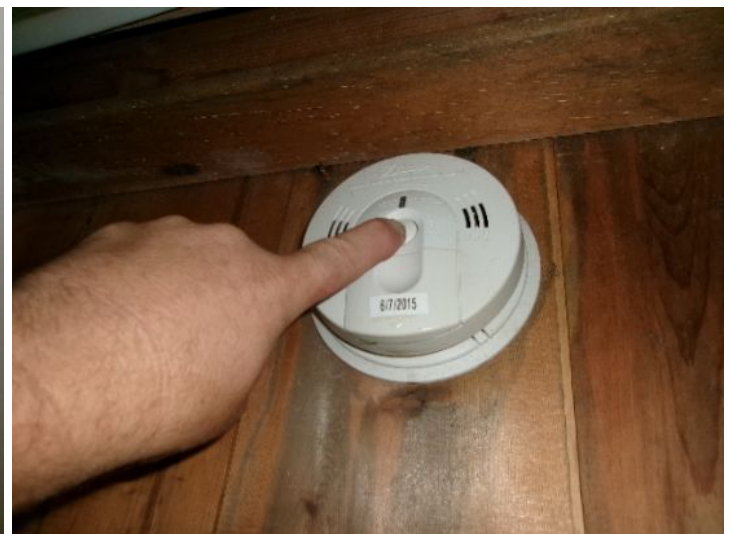
- Recommend installing a smoke detector in each bedroom to meet current safety standards.
- **DEFECT:** There were no operable smoke or carbon monoxide (CO) detectors on the main floor or in the basement. CO is colorless and odorless and thus impossible to detect without a proper electronic detector. Recommend putting a combination detector on each level of the home.

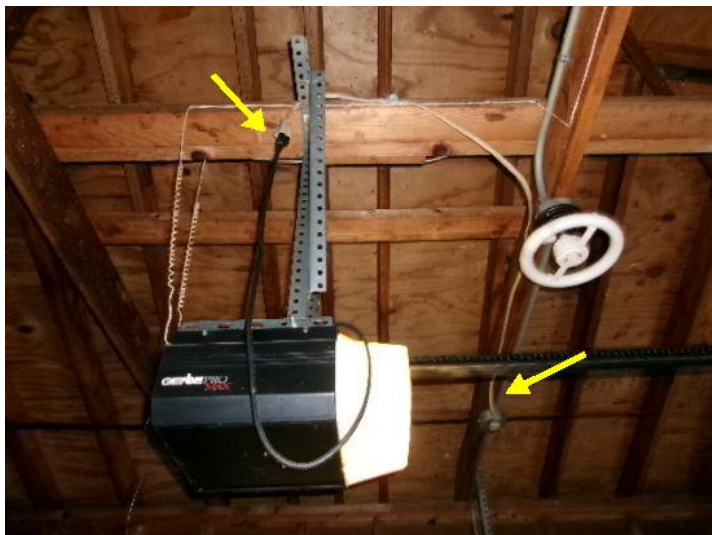
- **REPAIR:** The overhead door opener is plugged into an extension cord as permanent wiring. Installation of a receptacle near the opener needed.
- **DEFECT:** The original receptacle present is not a GFCI which is a safety hazard. Correction or replacement needed.

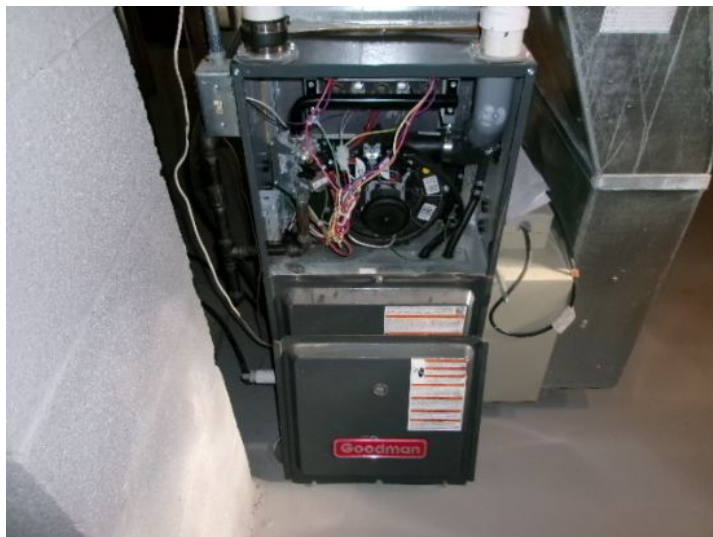
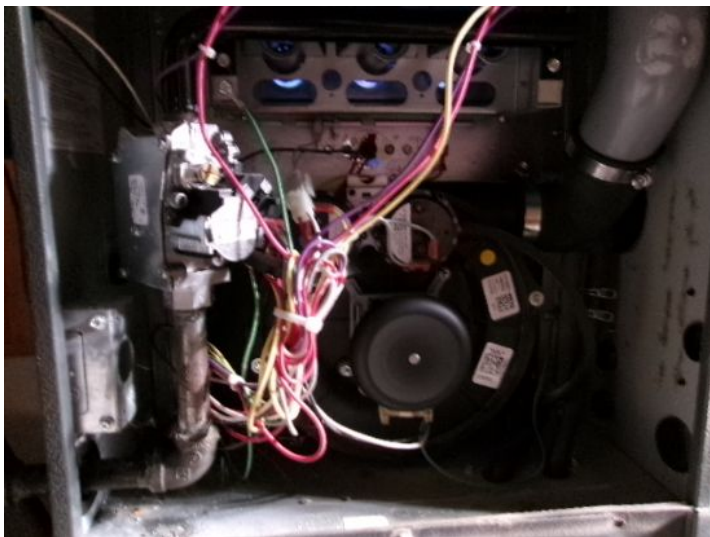
- **FURTHER EVALUATION:** Although no major concerns were observed with the furnace, it may not have been serviced since it was installed in 2024. The filter was damaged and filthy and the **A/C** was not functional. Due to the condition of the filter and air quality issues in the basement, the unit was shut down. Recommend further evaluation and service by a qualified HVAC technician to service/repair as needed.

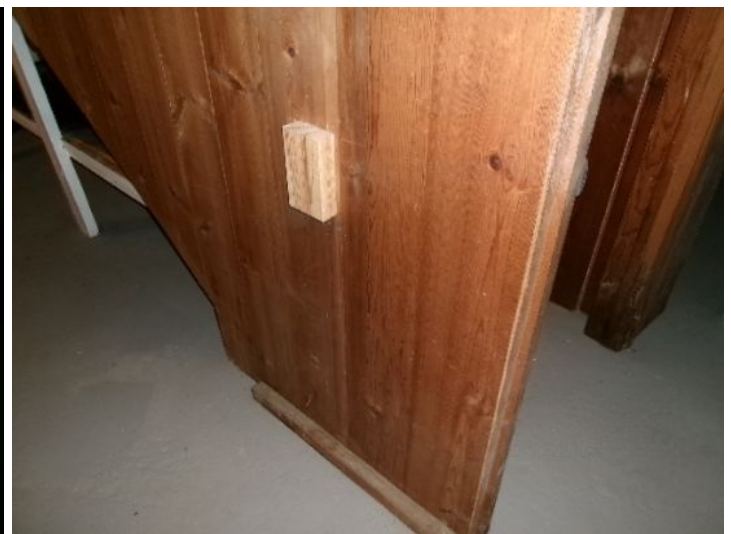
- None of the foundation walls were finished.
- **FURTHER EVALUATION:** Stains and possible organic growth were observed on the walls around the stair possibly caused or excessive humidity in the basement. Recommend further evaluation by a qualified contractor to clean and/or remove the damaged surfaces.

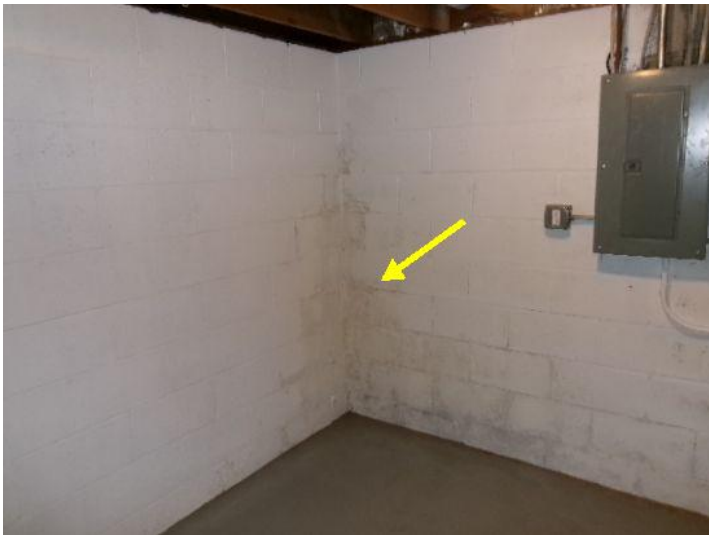
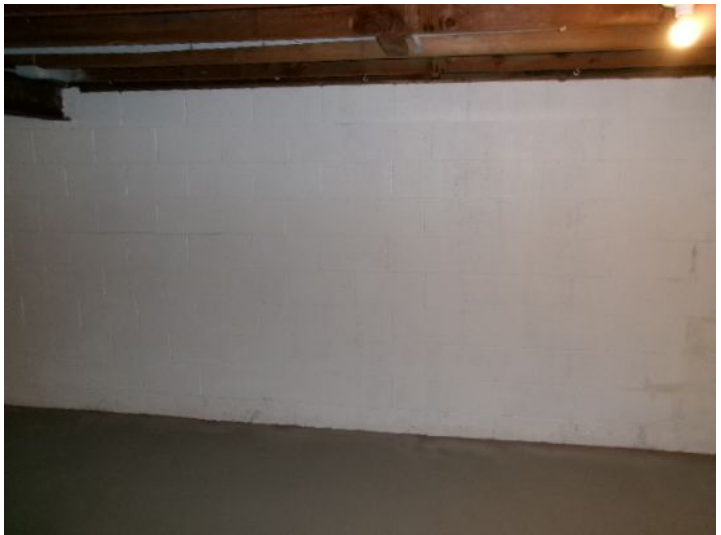
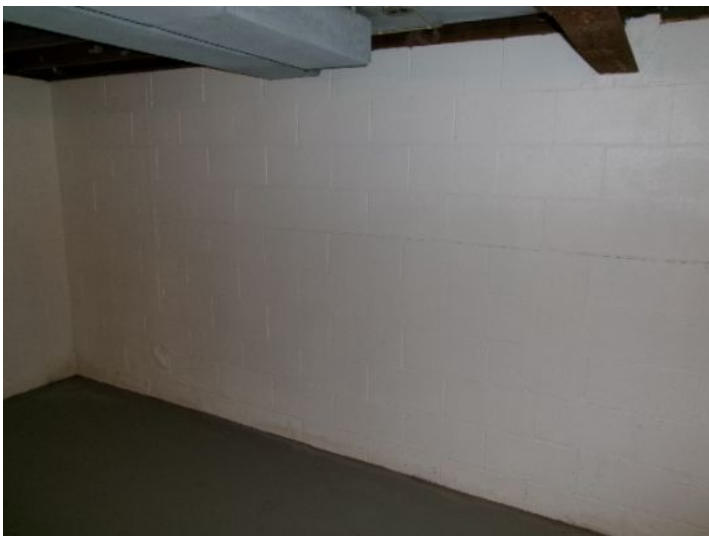
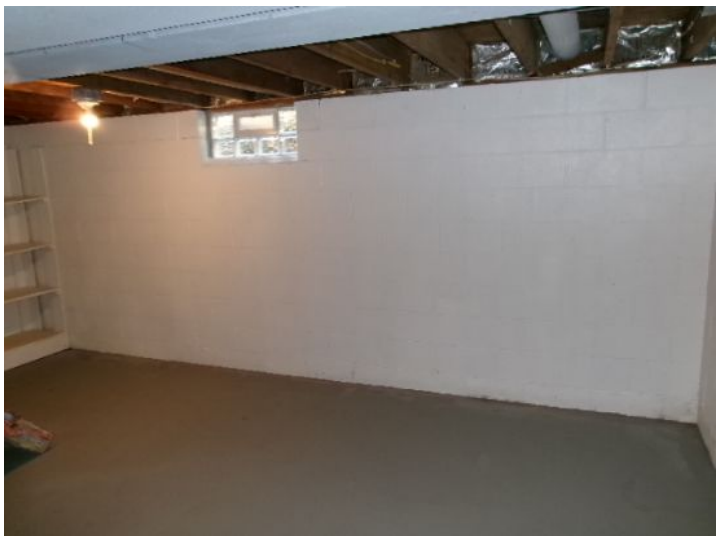
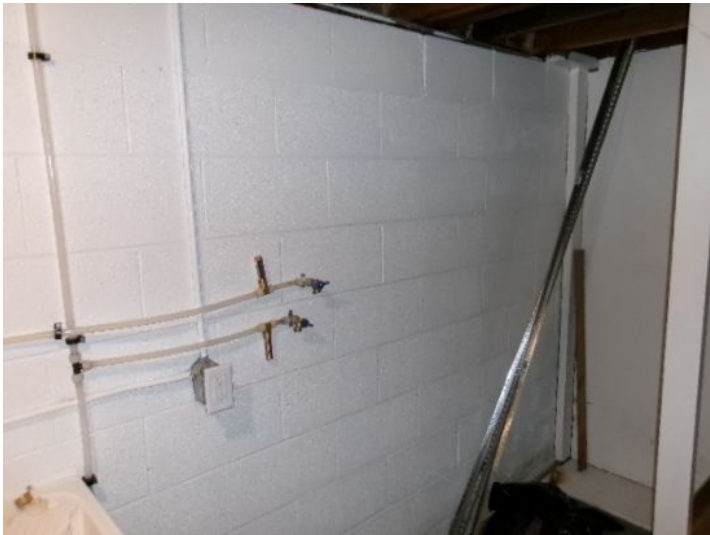
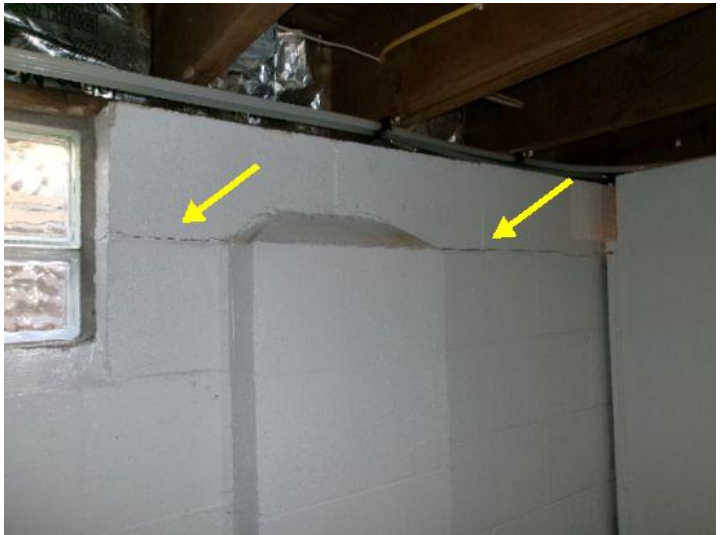
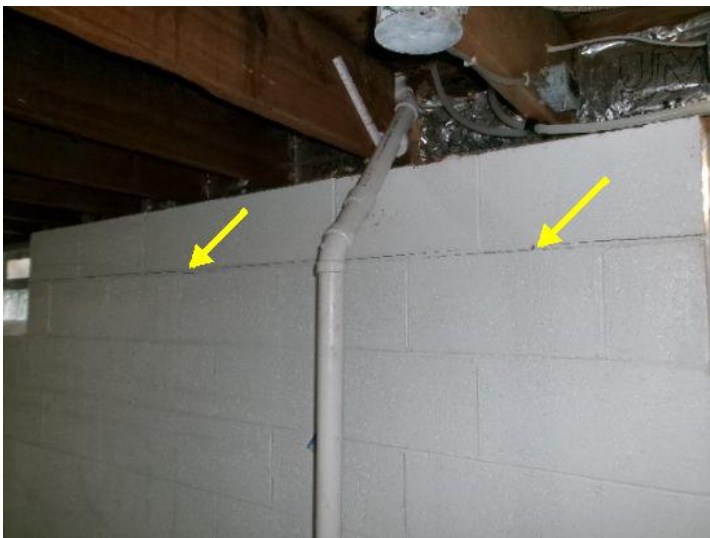
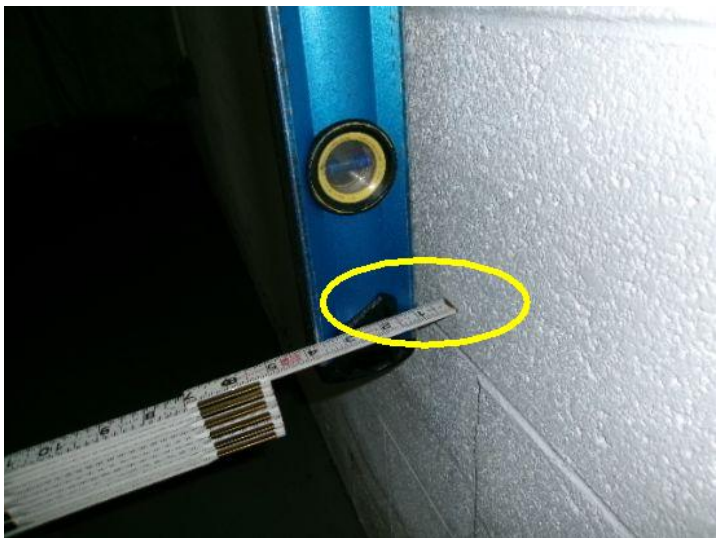
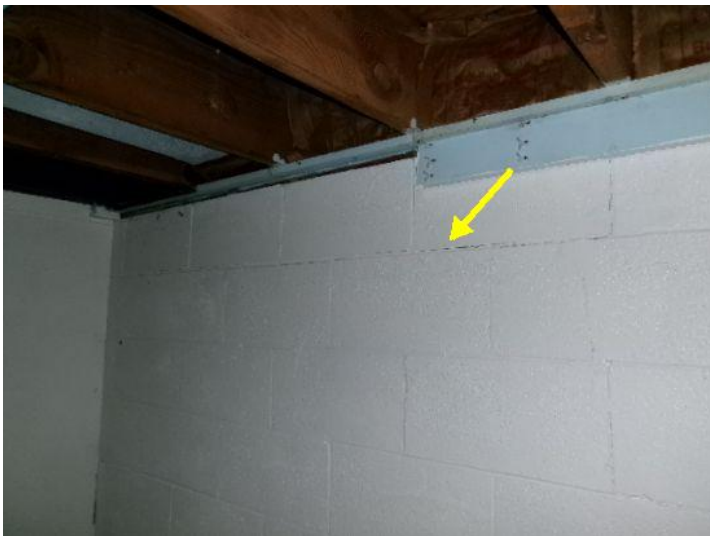
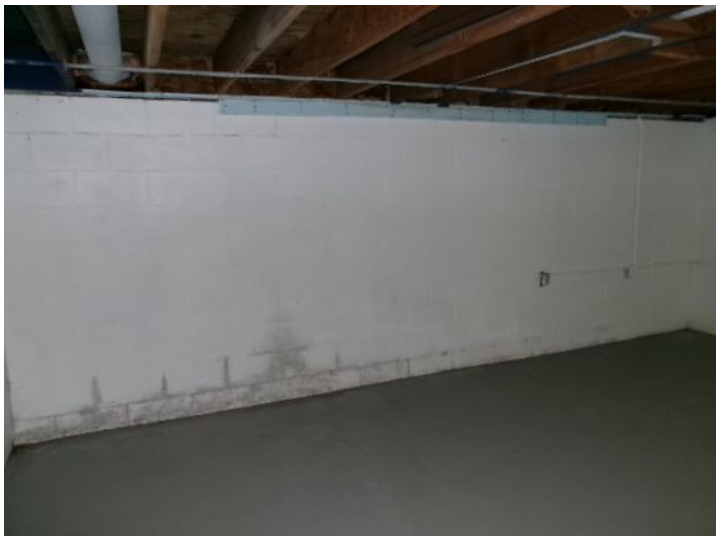
### 3. Foundation Walls

- **FURTHER EVALUATION:** The west foundation wall is bowing in approximately 3/4" in the center of the wall. Horizontal cracks near the top of the west and east walls were observed that are evidence of past or recent movement; other foundation walls are not completely plumb in areas. Recommend further evaluation and review of all the foundation walls by a qualified foundation consultant or foundation repair contractor to determine if repair and bracing is needed.

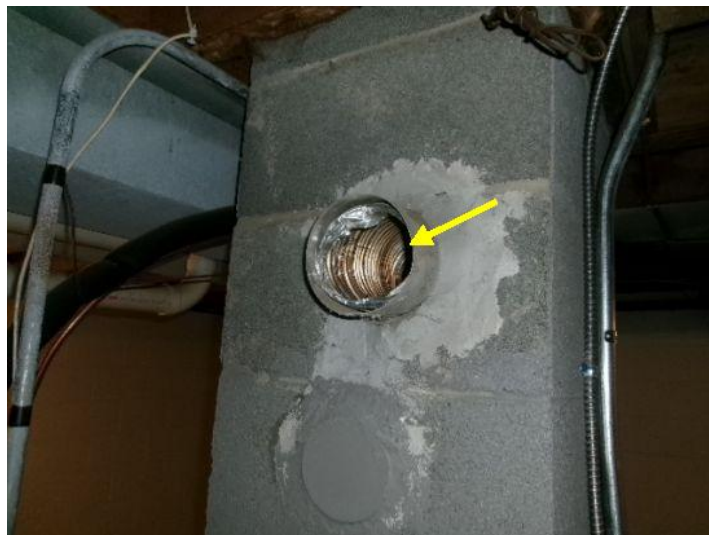
- **REPAIR:** Recommend sealing old openings and gaps in the chimney to prevent warm air from rising into the attic.

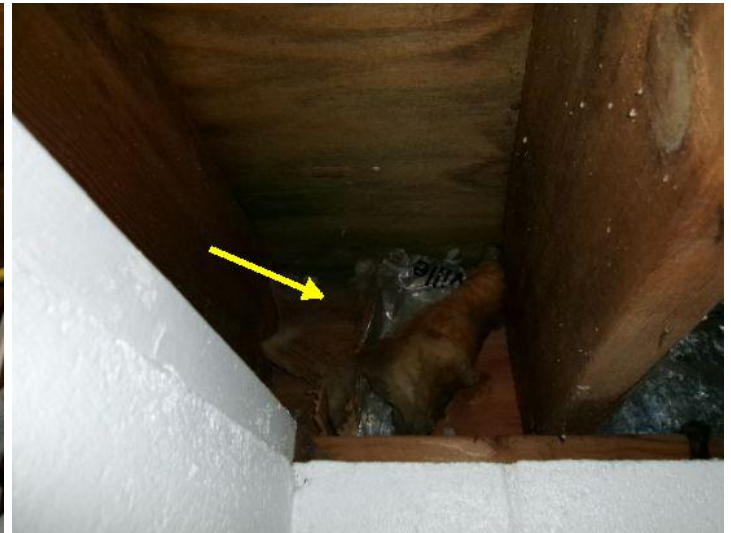
- **IMPROVEMENT:** Insulate gaps or holes and around penetrations in the box sills with expanding foam insulation to prevent cold air drafts or pest intrusion; replace missing or disturbed insulation.
