# HOME INSPECTION REPORT

**5314 West Nokomis Road, Brown Deer, WI**

Date of Inspection: 6/30/2026 Time: 5:00 PM

Inspector: David Nason

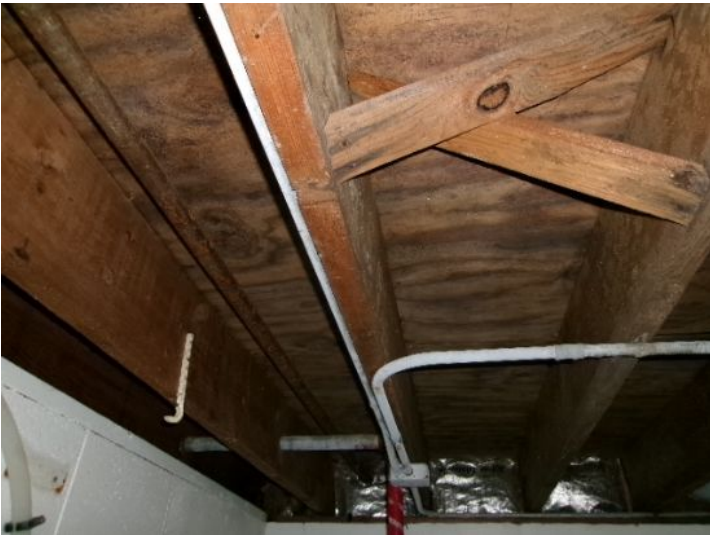
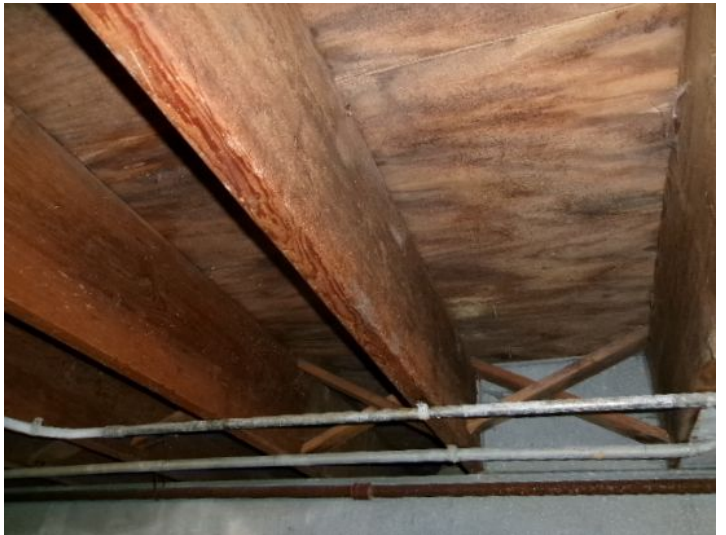
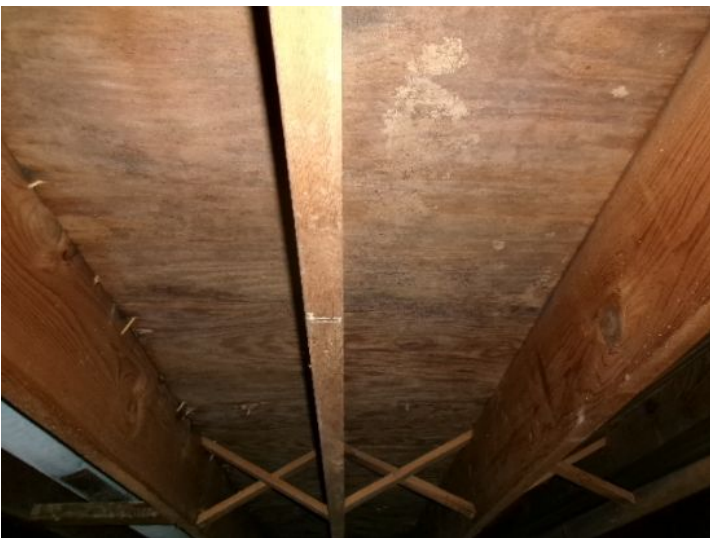
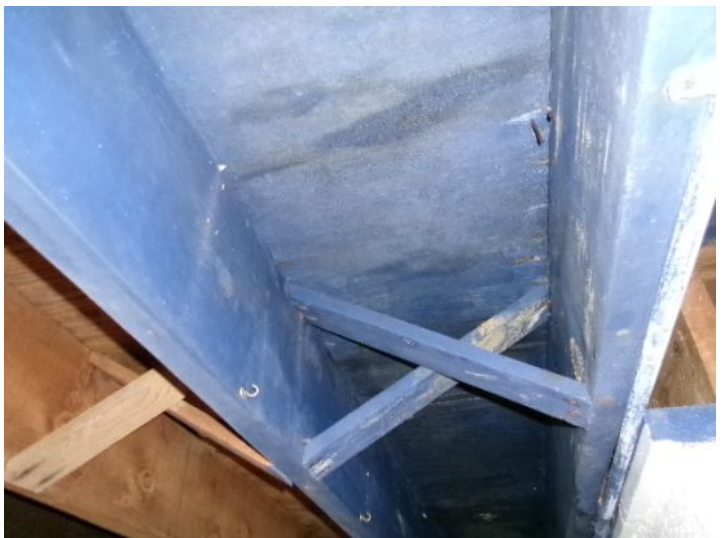
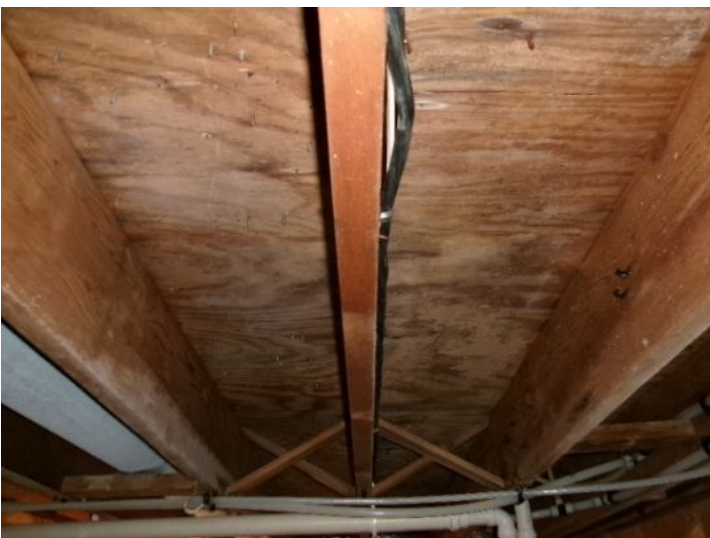
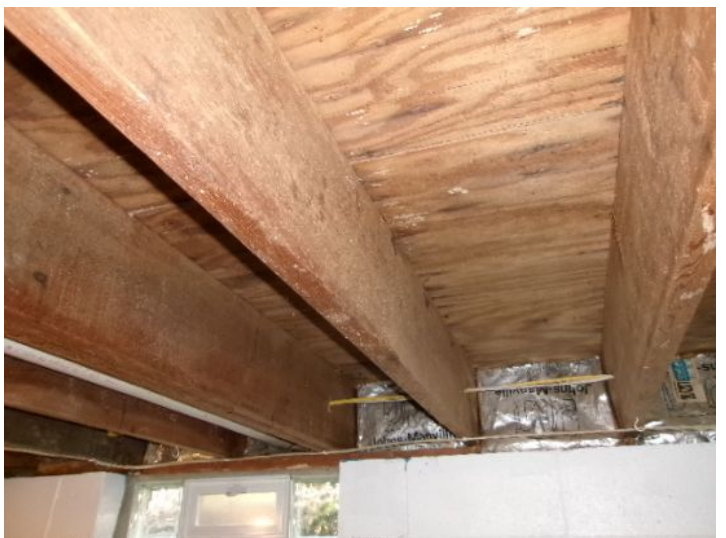
- SUBFLOOR
- Plywood sheathing
- JOISTS/FRAMING
- Dimensional lumber wood Joists
- **FURTHER EVALUATION:** An organic growth was observed on the entire sub-floor and floor joist system that may have been caused by excessive moisture and humidity in the basement. Recommend further evaluation and cleaning by a qualified contractor trained in this type of cleaning.
