# REPORT SUMMARY

5314 West Nokomis Road

Brown Deer, WI, 53223

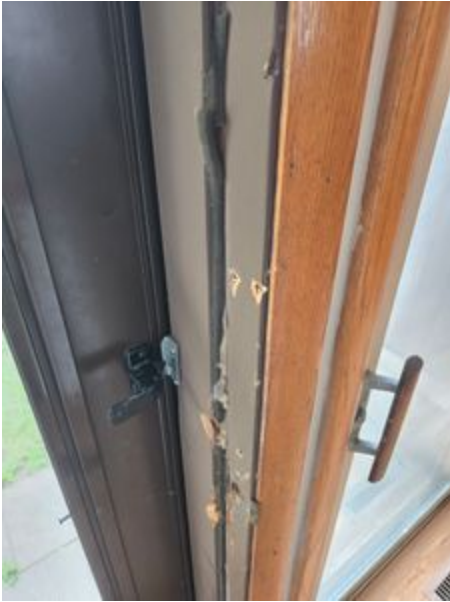
### 2.1 · DAMAGED WEATHERSTRIP

The weatherstripping at this location is damaged or deteriorated, which may allow air and moisture infiltration. Repair or replacement is recommended to improve energy efficiency and protect against water intrusion.

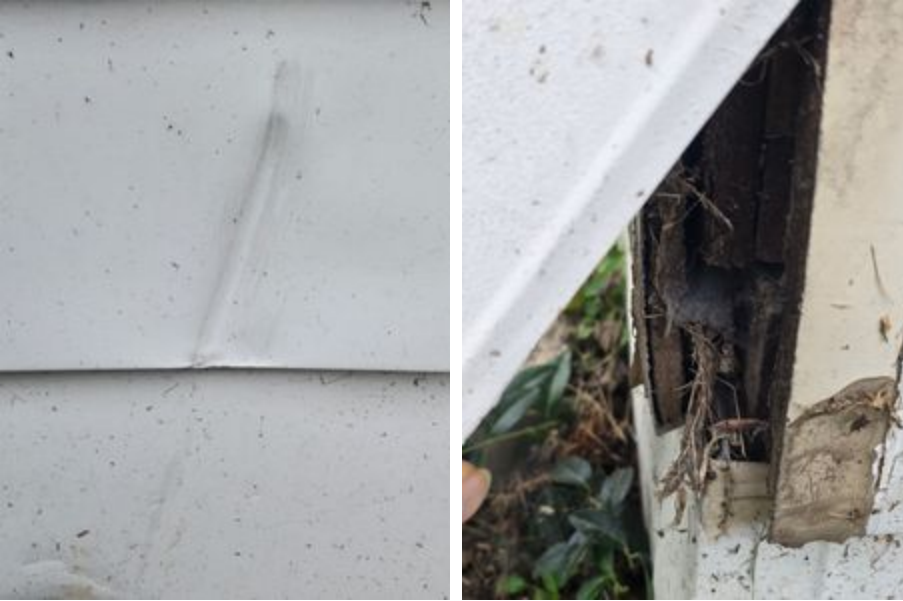
### 2.2 · DAMAGE

Impact damage was observed to the exterior siding, and the damaged area exposed deteriorated wood sheathing behind the siding. The opening in the exterior wall covering may allow moisture intrusion and pest entry, which can contribute to additional concealed deterioration if left uncorrected. Recommend further evaluation and any necessary repairs by a qualified contractor.

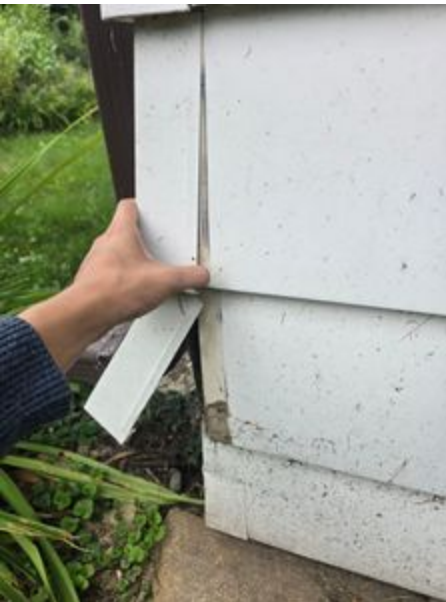
### 2.3 · LOOSE TRIM

The exterior siding trim was observed to be loose and not fully secured to the adjacent wall surface, which may allow moisture intrusion behind the exterior cladding and contribute to deterioration of underlying materials. Recommend further evaluation and any necessary repairs by a qualified contractor.

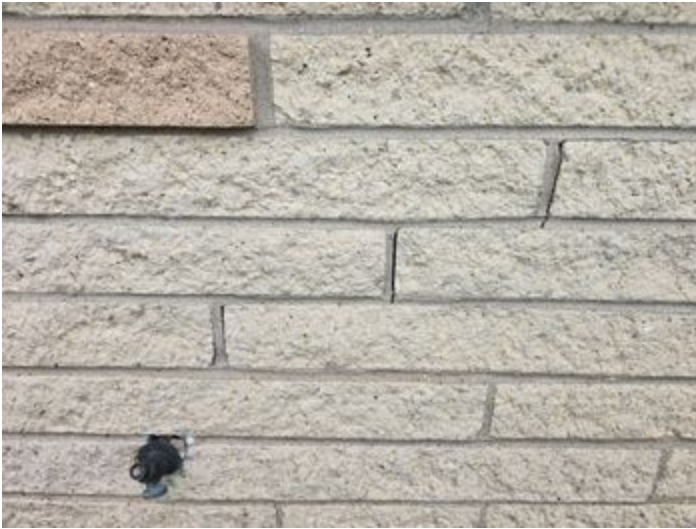
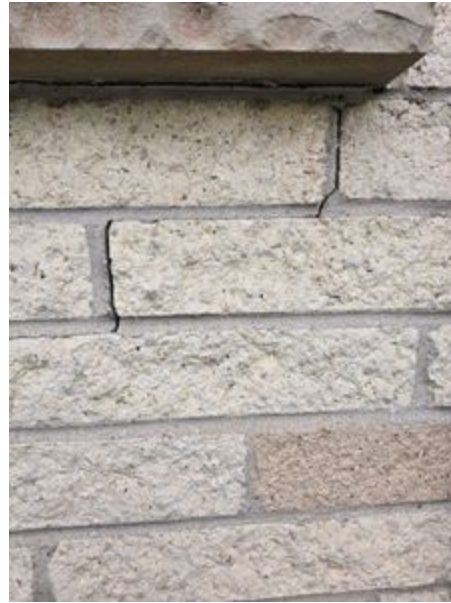
## 2.4 · MORTAR DETERIORATION

Mortar deterioration and separation were observed at the brick veneer. Gaps were present between the brick veneer and adjacent siding trim, which may allow moisture intrusion. Recommend further evaluation and any necessary repairs by a qualified masonry contractor.

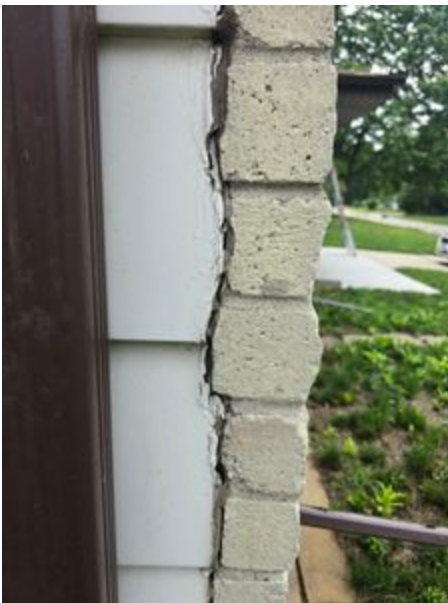
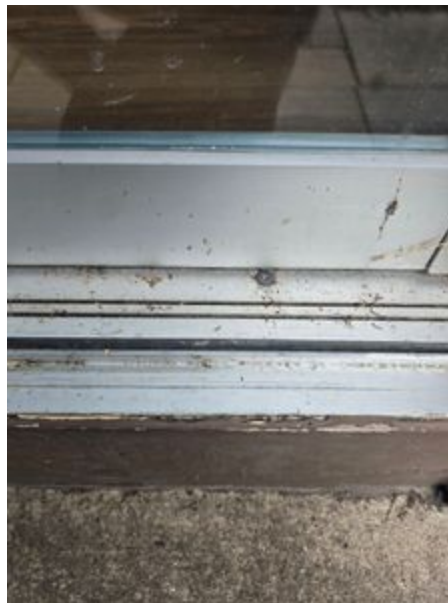
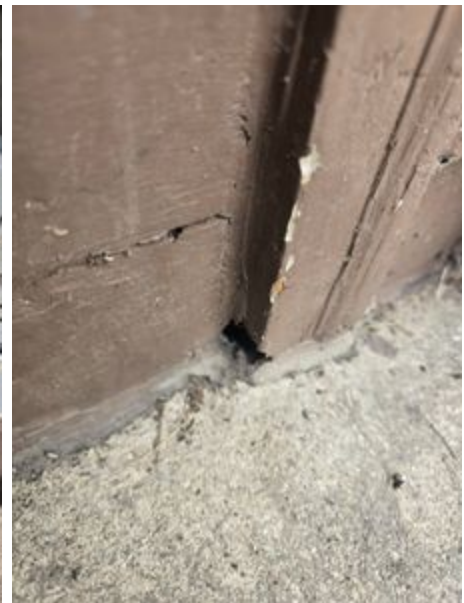
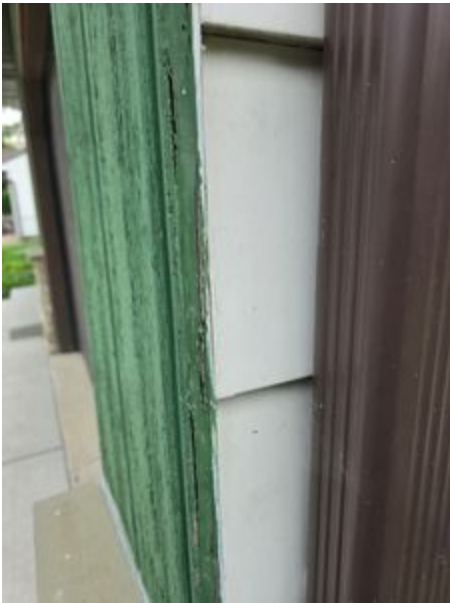
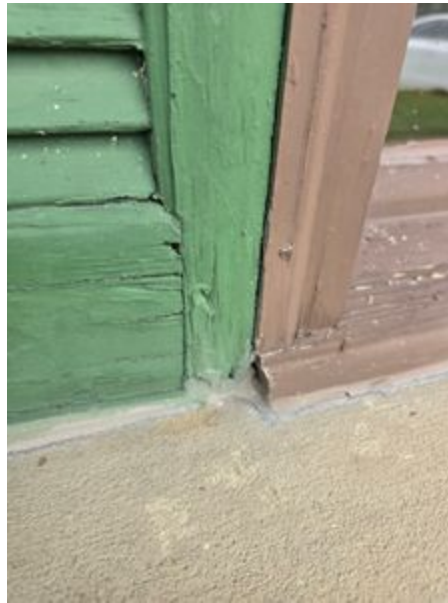
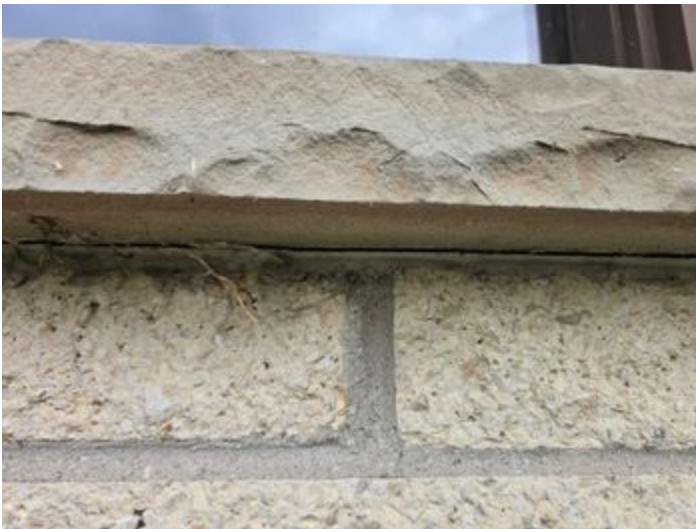
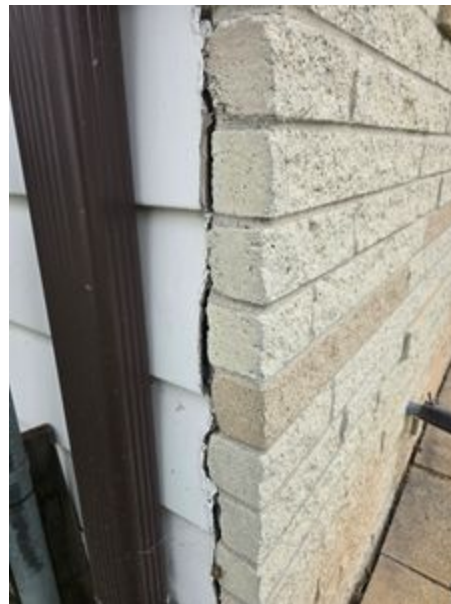
## 2.5 · CAULKING DEFECTS

Caulking in several areas is failing/missing. Cracked or separated caulking can allow moisture intrusion and reduce the home's weather protection. Recommend evaluation and correction by a qualified siding contractor.

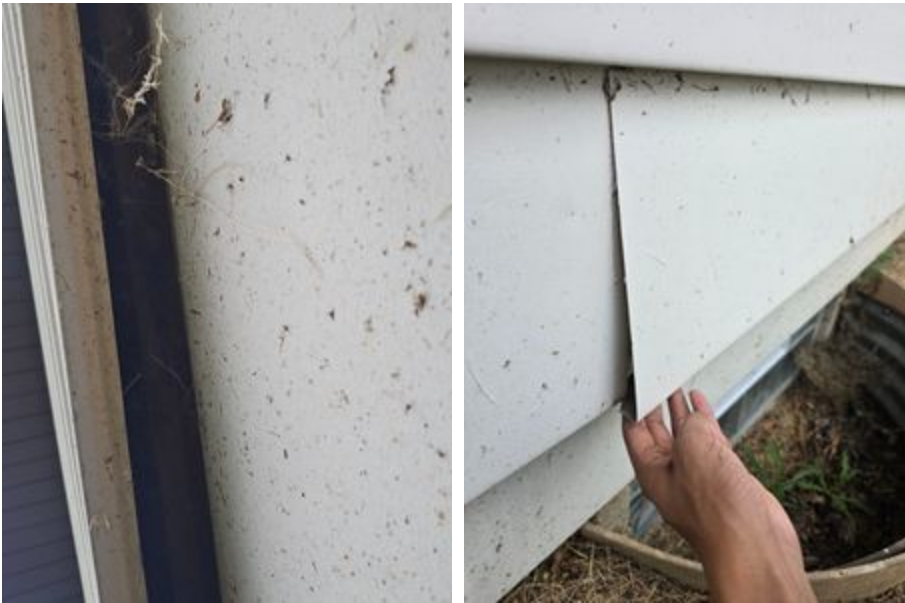
## 2.6 · LOOSE BOARDS

One or more siding boards were loose, which could result in moisture intrusion. Recommend a qualified siding contractor secure and fasten.

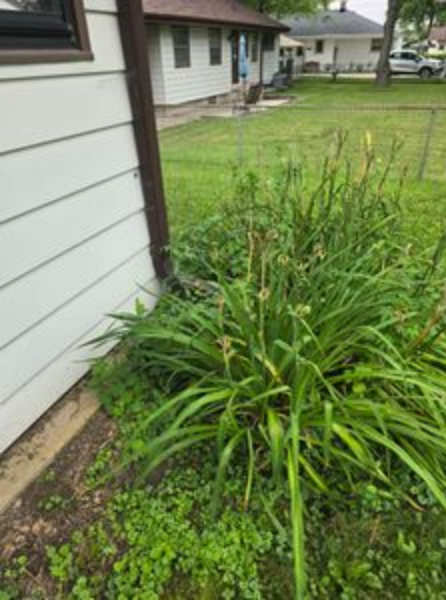
### 2.7 · VEGETATION

Vegetation was observed touching or in close proximity to the house. This condition can retain moisture against siding, roofing, or other building materials, which may contribute to damage, deterioration, or conducive conditions for pests. Vegetation in contact with the home may also obstruct proper inspection and maintenance. Recommend trimming or removing vegetation so that it remains well-clear of the structure.

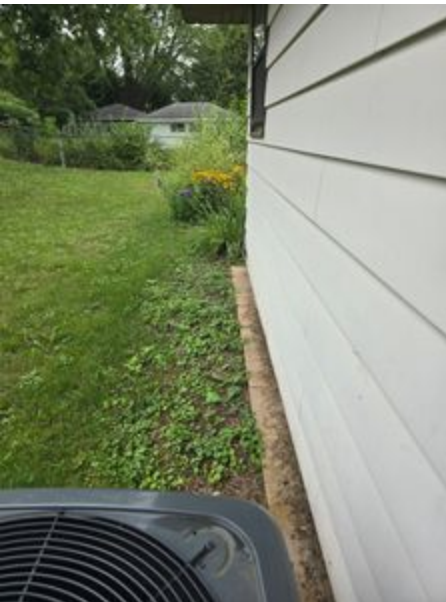
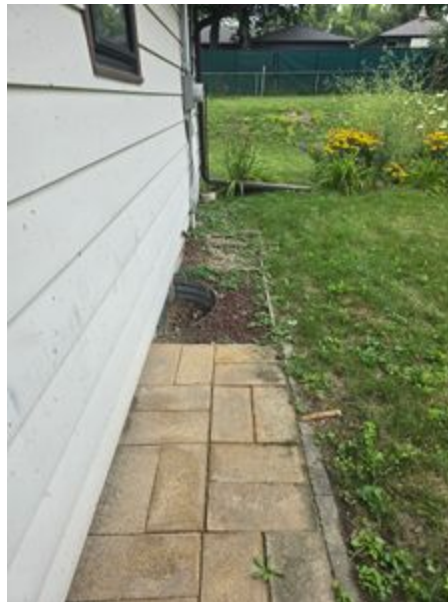
### 2.8 · NEGATIVE GRADING

Grading is sloping towards the garage in some areas. This could lead to water intrusion and foundation issues. Recommend qualified landscaper or foundation contractor regrade so water flows away from home.

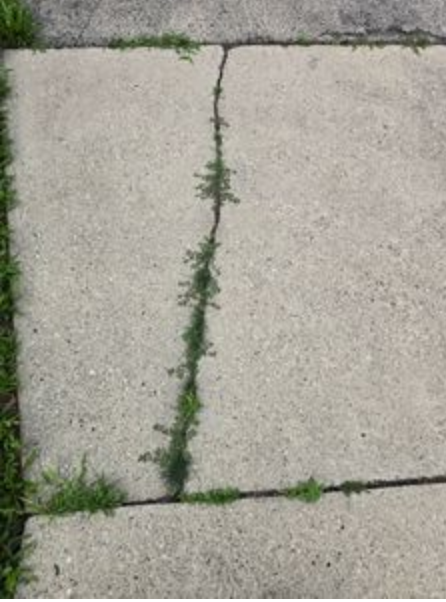
### 2.9 · DRIVEWAY CRACKING - MINOR

Minor cosmetic cracks observed, which may indicate movement in the soil. Recommend monitor and/or have concrete contractor patch/seal.

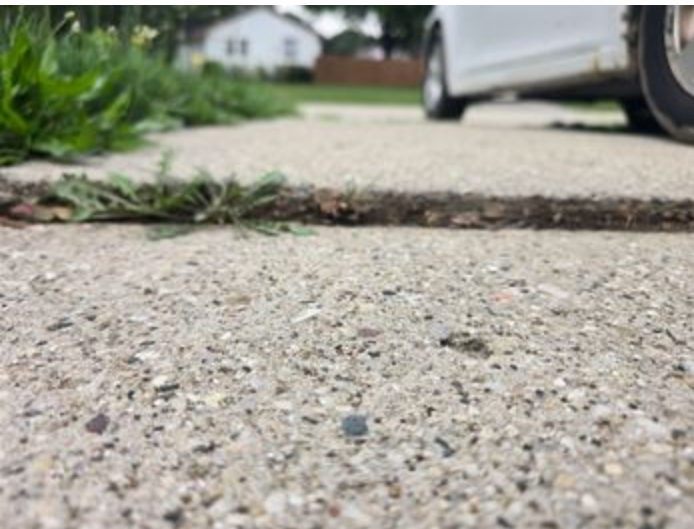
### 2.10 · DRIVEWAY TRIP HAZARD

Trip hazards observed. Patch or repair recommended.

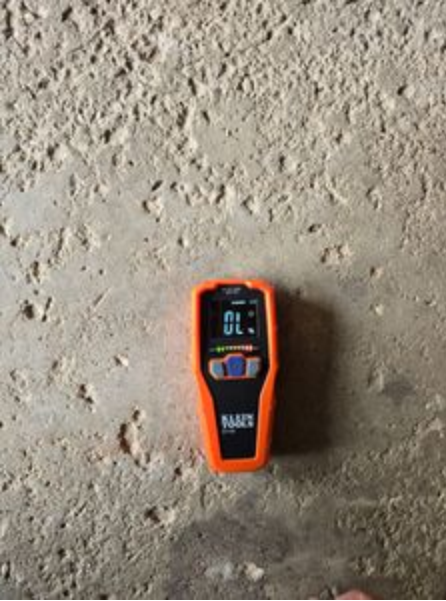
### 3.1 · HIGH MOISTURE LEVELS

Elevated moisture levels were observed at the garage floor surface. This condition may contribute to surface deterioration and can affect materials stored in contact with the floor. Recommend further evaluation and any necessary corrective measures by a qualified contractor.

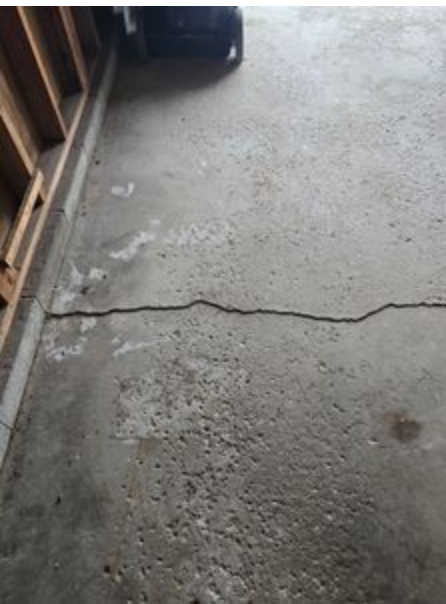
### 3.2 · EFFLORESCENCE

Efflorescence is a white, crystalline deposit of salts that are left behind when moisture was present. Recommend scrubbing with a mild detergent.

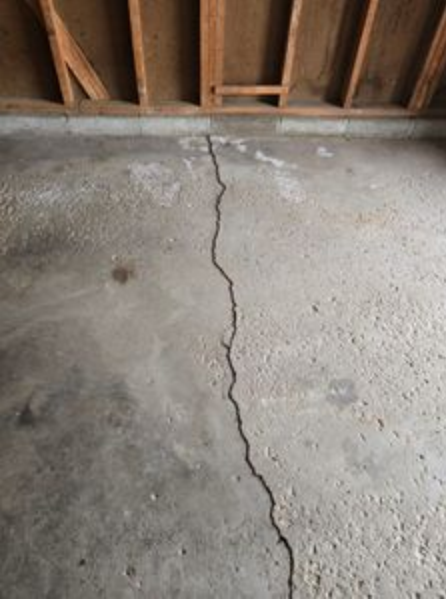
### 3.3 · SETTLING

Garage floor shows signs of settling in the soil beneath the slab. Recommend a structural engineer evaluate for potential repairs.

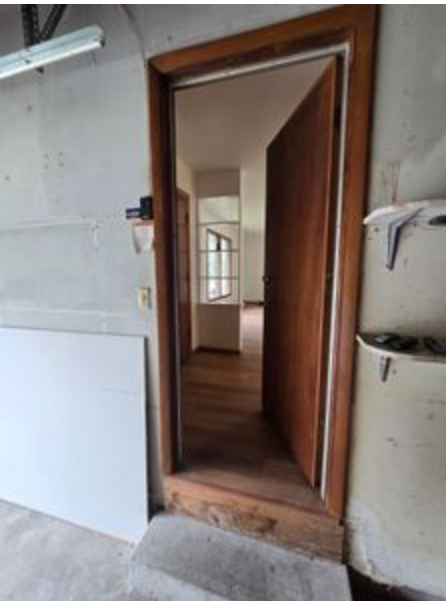
### 3.4 · NOT SELF-CLOSING

Door from garage to home should have self-closing hinges to help prevent spread of a fire to living space. Recommend a qualified contractor install self-closing hinges.

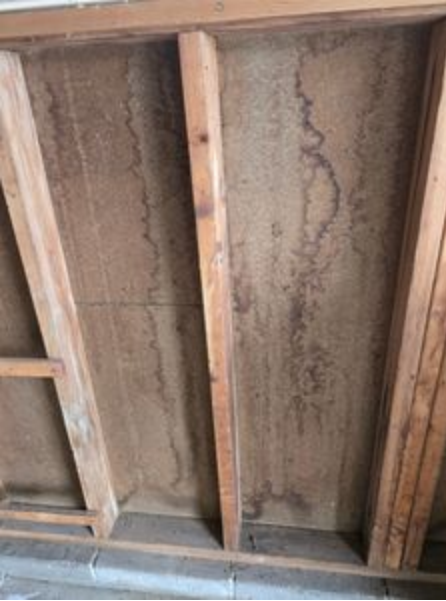
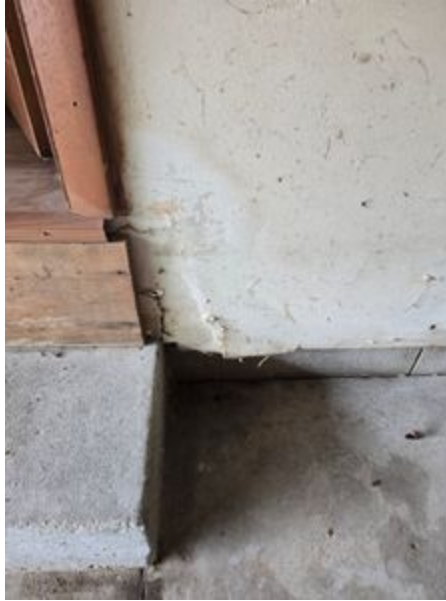
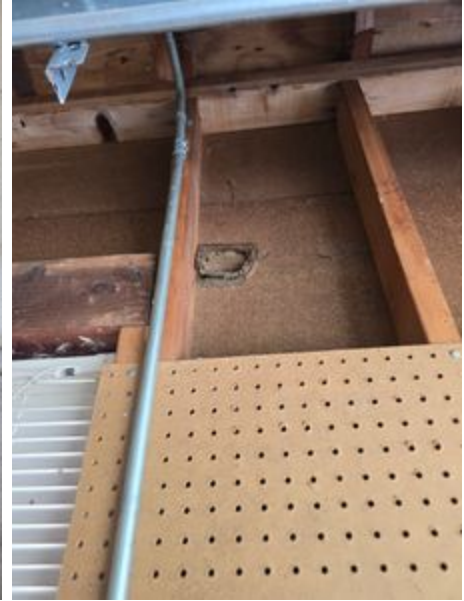
### 3.5 · MOISTURE DAMAGE

Moisture-related damage was observed on the garage wall finishes, including visible deterioration and staining consistent with prior or ongoing moisture exposure. The source and extent of the moisture intrusion could not be determined during this visual inspection. Recommend further evaluation to determine the source of the moisture and any necessary repairs by a qualified contractor.

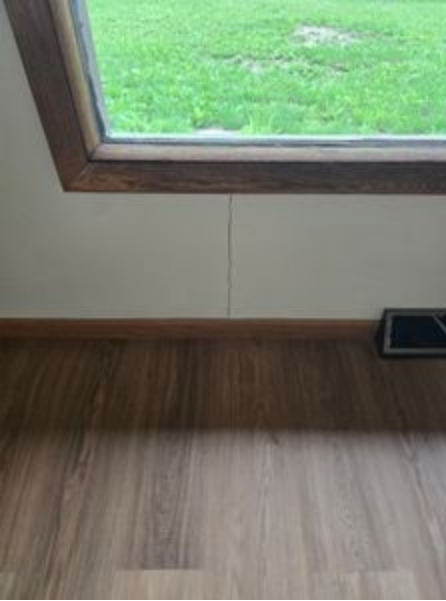
### 5.1 · MINOR CORNER CRACKS

Minor cracks at the corners of doors and windows in walls. Appeared to be the result of long-term settling. Some settling is not unusual in a home of this age and these cracks are not a structural concern.

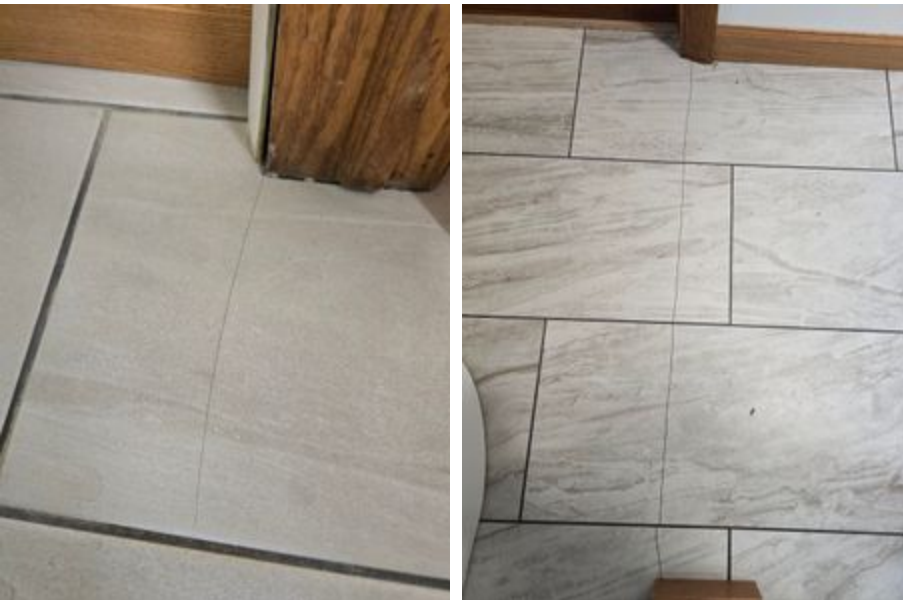
### 5.4 · TILES CRACKED

A few tiles were observed to be cracked. A contractor is recommended to repair.

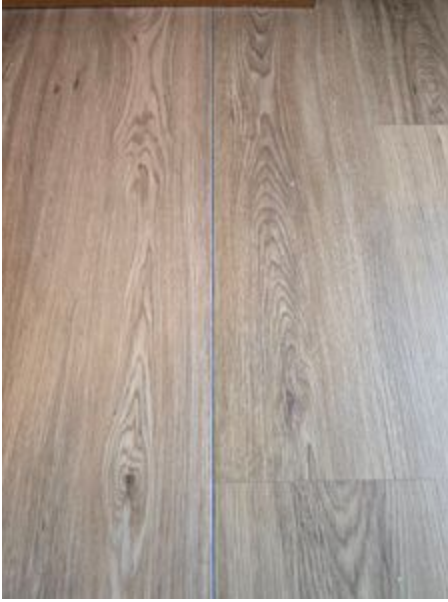
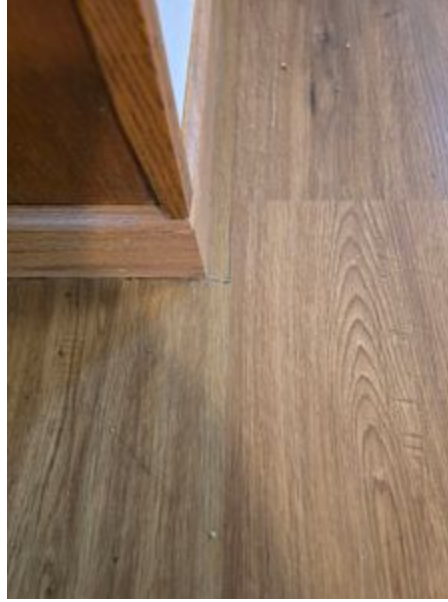
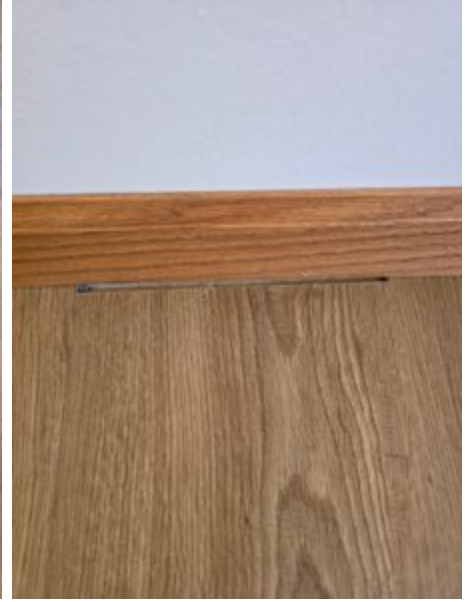
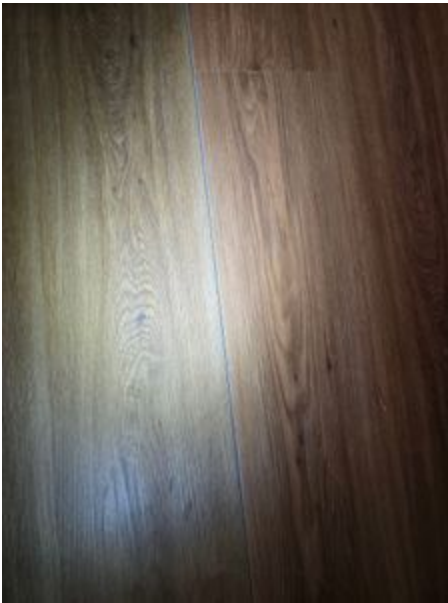
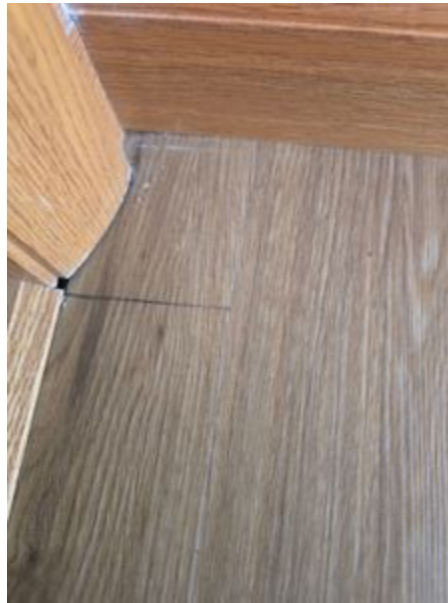
## 5.5 · GAPS

The floor covering at the time of inspection exhibited a visible gap between adjacent planks. Gaps between flooring materials may allow debris and moisture to collect within the joints and may indicate movement or installation-related issues. This is a defect. Recommend further evaluation and any necessary repairs by a qualified contractor.

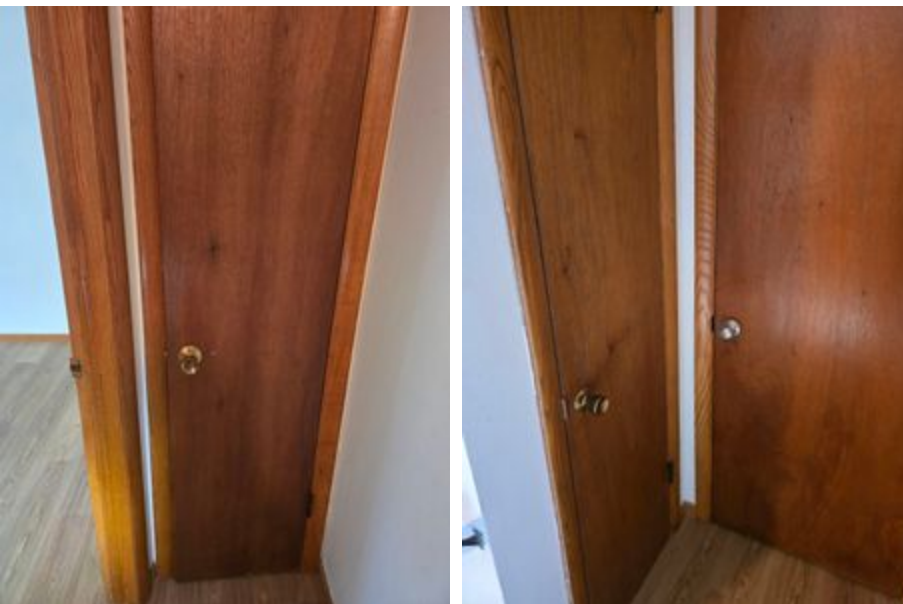
### 5.7 · DOOR DOESN'T LATCH

A door did not latch properly. Recommend handyman repair latch and/or strike plate.

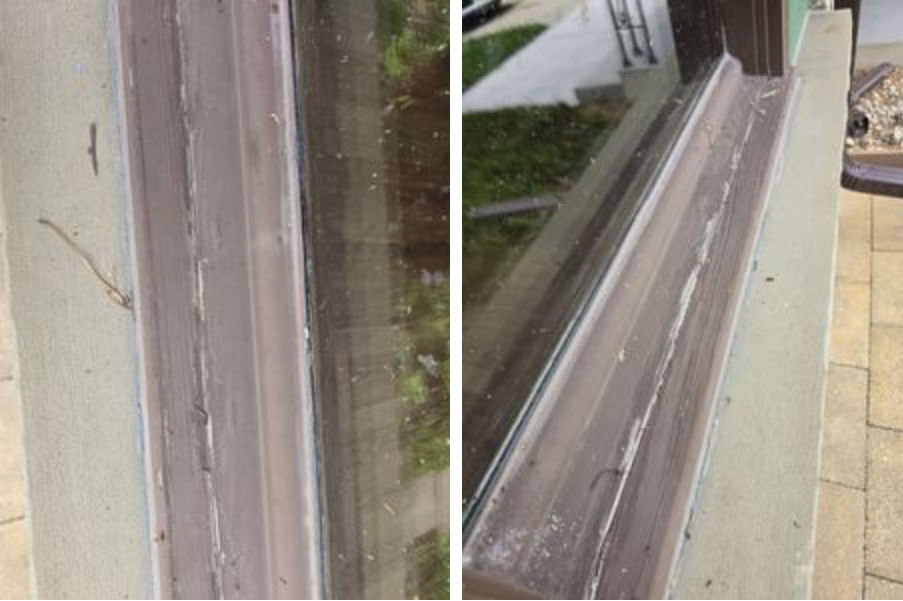
### 5.8 · WINDOW FRAME DETERIORATION

Deterioration and rot were observed at the lower window frame/sill area. The wood appears damaged and compromised, which may allow moisture intrusion. Recommend repair or replacement by a qualified contractor.

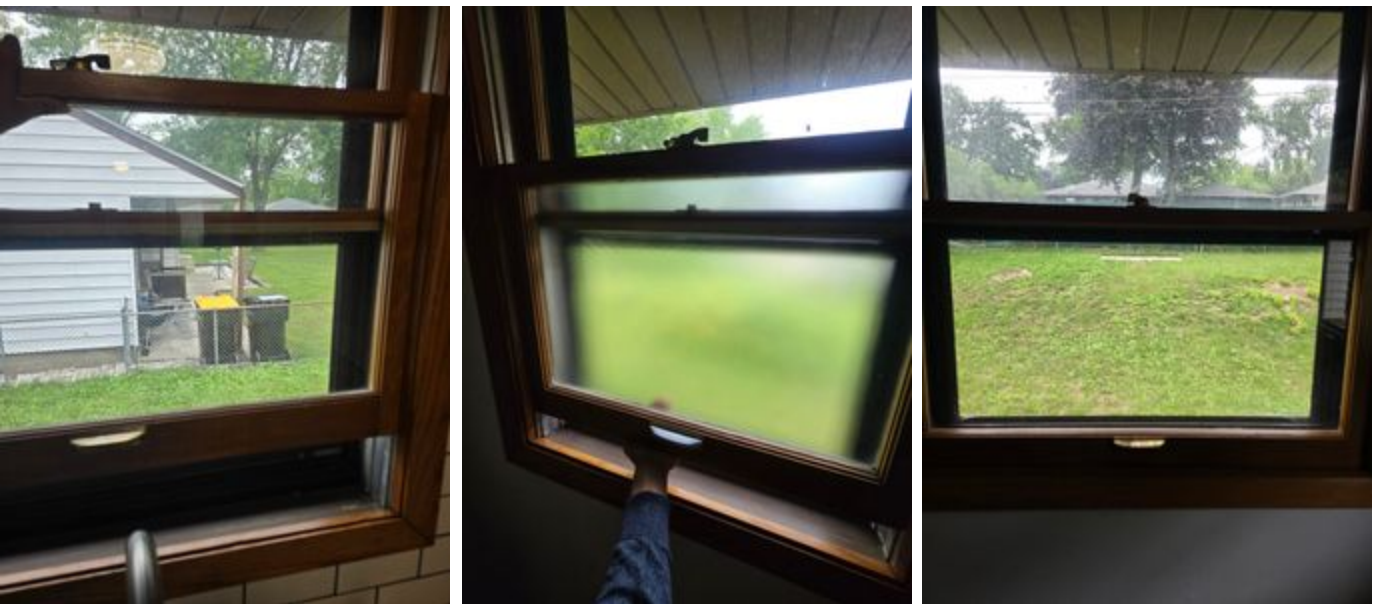
### 5.9 · WINDOW SASH FAIL

The window sash did not remain in the open position when operated and was observed to fall or slide down, indicating a defect in the sash balance or support mechanism. This condition may limit proper use of the window and could present a safety concern during operation. Recommend further evaluation and any necessary repairs by a qualified contractor.

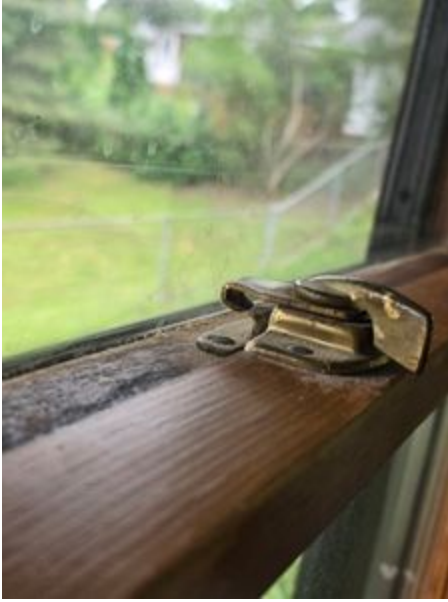
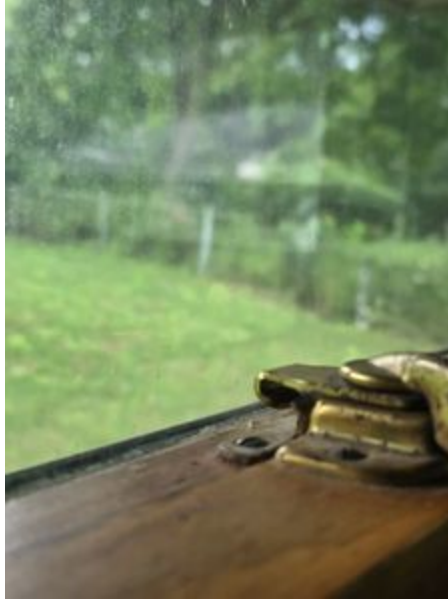
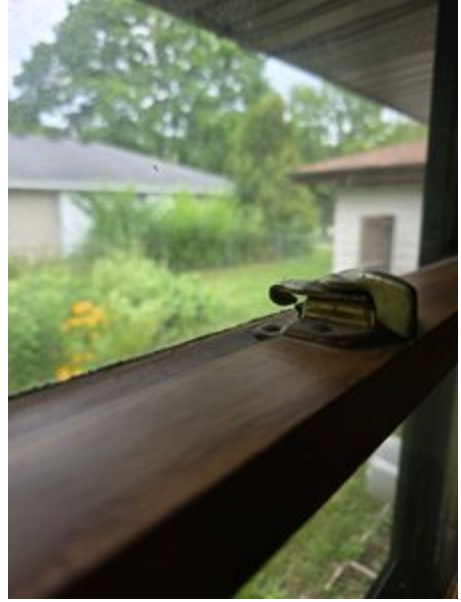
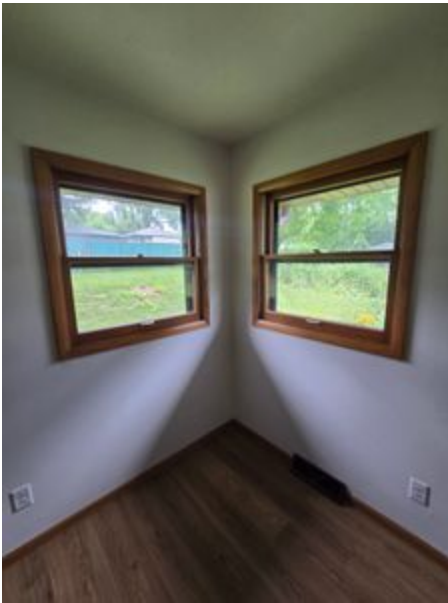
## 5.10 · WINDOW DOESN'T LOCK

Multiple windows were found that do not lock properly. This is a safety and security concern. Recommend repair by a qualified handyman.

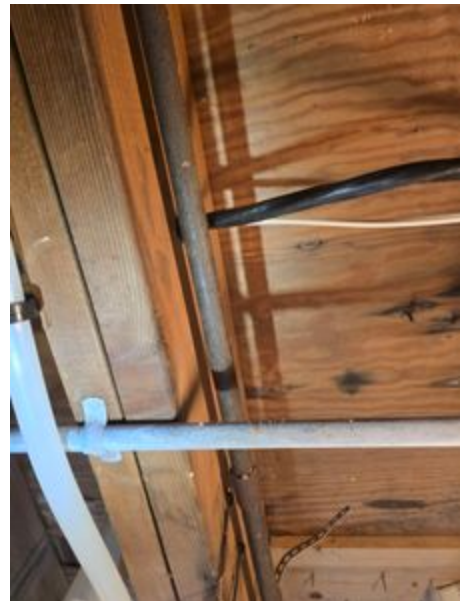
### 6.2 · CORROSION

Gas pipes were corroded. This can lead to gas leaks. Recommend contacting local utility company for evaluation and repair.

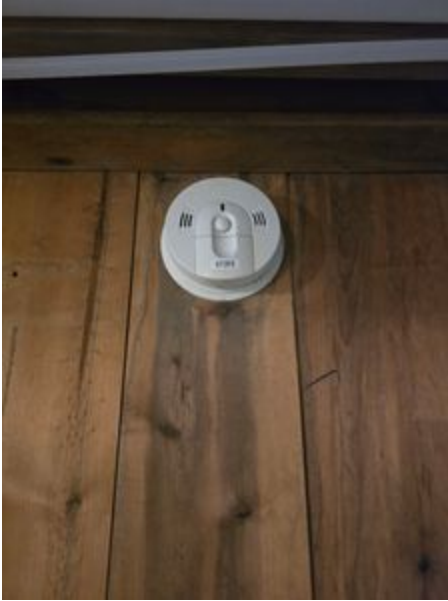
### 7.1 · DEFECTIVE

Carbon monoxide detector is connected, but not functioning properly. Recommend replacement.

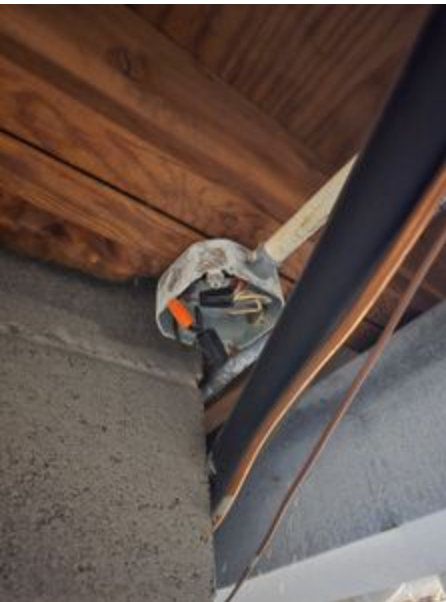
### 7.3 · EXPOSED ELECTRIC JUNCTION BOX

An open electrical junction box with exposed wiring splices was observed. The junction box was missing its required cover, leaving the wiring connections accessible to accidental contact and physical damage. Recommend further evaluation and any necessary repairs by a qualified electrical contractor.

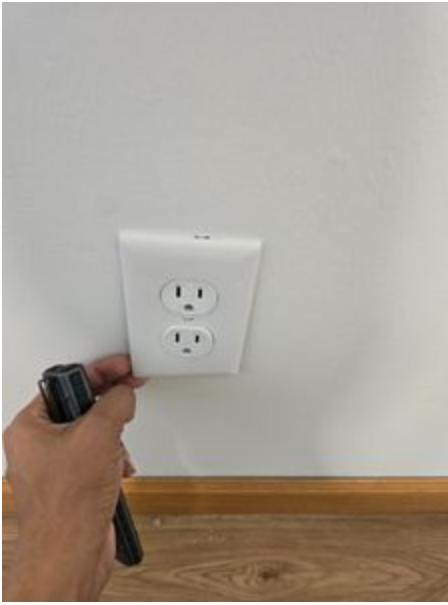
## 7.4 · DAMAGED RECEPTACLE

An electrical receptacle was observed to be damaged. Damaged receptacles can pose a risk of electric shock, arcing, or fire and may prevent proper operation of connected devices. Recommend evaluation and replacement by a licensed electrician to restore safe and functional operation.

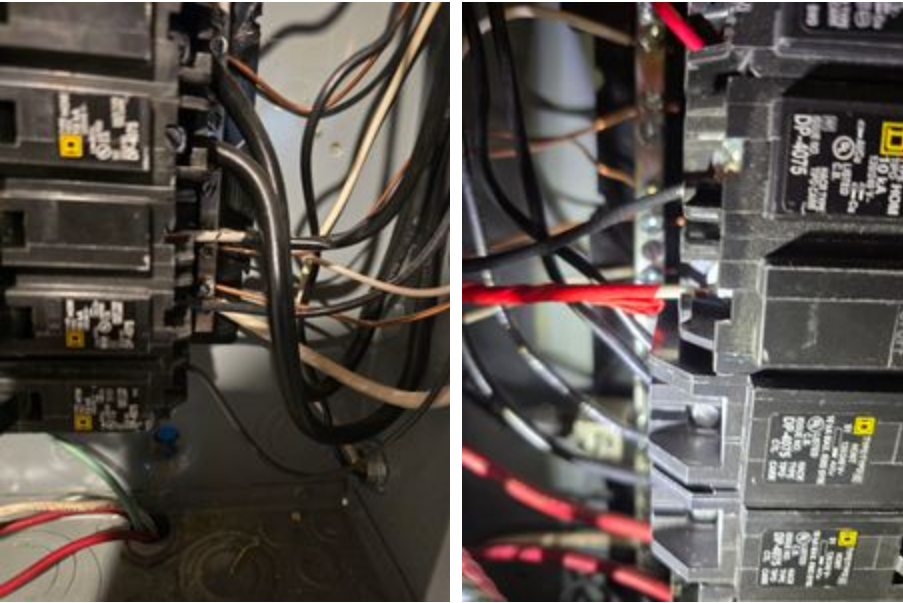
**MAIN & SUBPANELS, SERVICE & GROUNDING, MAIN OVERCURRENT DEVICE****7.5 · MISSING NEUTRAL CONDUCTOR**

A neutral conductor was observed to be missing in the service panel. This condition may result in improper operation of electrical circuits and potential safety hazards. This is a defect. Recommend evaluation and correction by a qualified electrician.

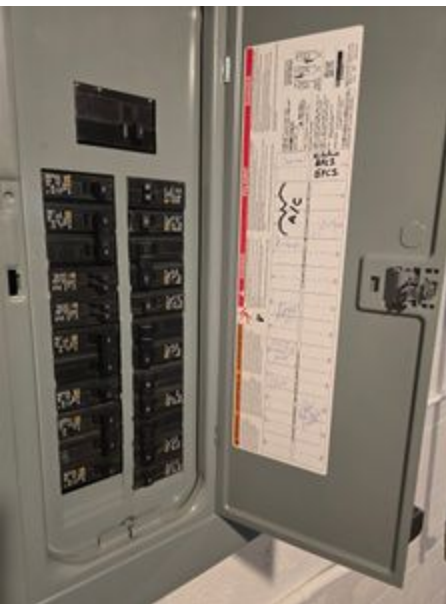
**7.6 · MISSING LABELS ON PANEL**

At the time of inspection, panel was missing labeling. Recommend a qualified electrician or person identify and map out locations.

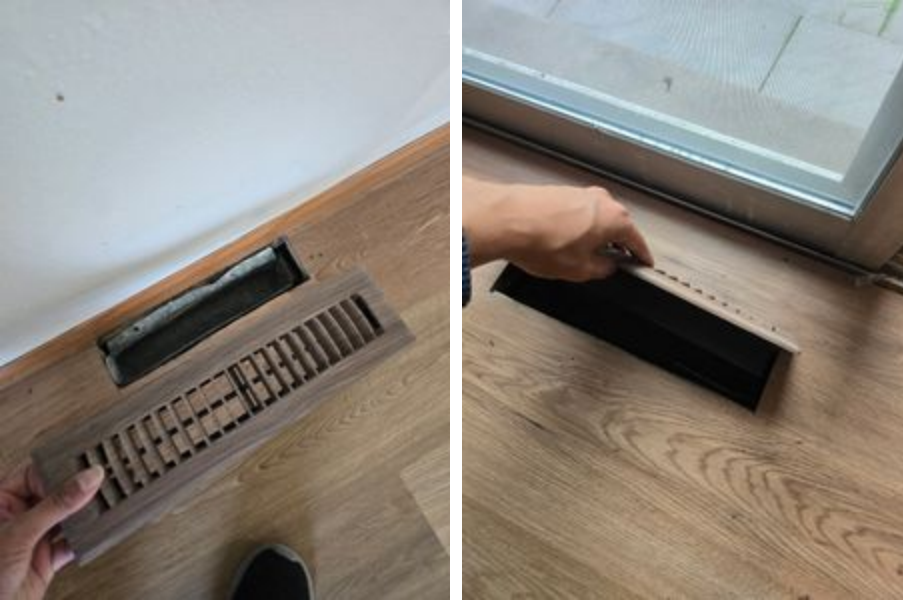
### 9.1 · UNSECURED AIR GRILLES

One or more HVAC air supply/return grilles were observed to be unsecured and were not firmly attached to the surrounding surface. Loose grilles may become displaced during normal use and can reduce the intended protection of the duct opening. Recommend further evaluation and any necessary repairs by a qualified HVAC contractor.

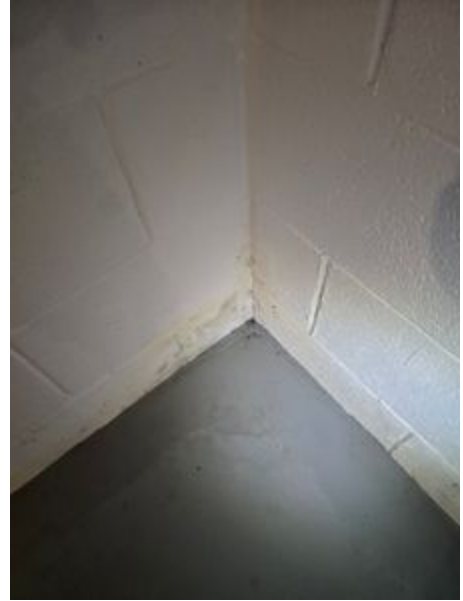
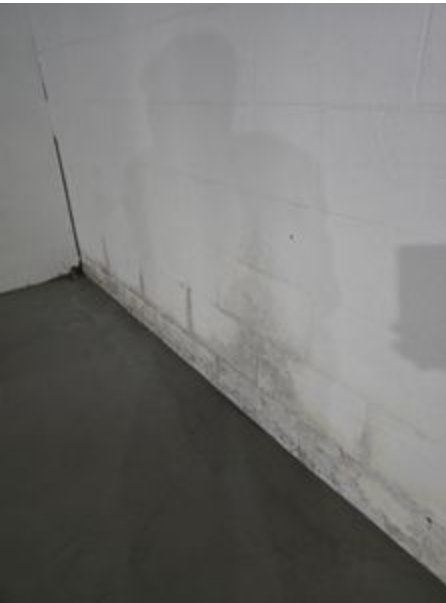
### 10.1 · SUSPECTED ORGANIC GROWTH

Dark and yellow, organic-appearing staining consistent with suspected microbial growth was observed on basement surfaces at the time of inspection; the substance was not tested or confirmed, and its composition was unknown. This condition may be associated with elevated moisture conditions and can contribute to deterioration of building materials. Recommend further evaluation and any necessary remediation by a qualified mold or environmental specialist.

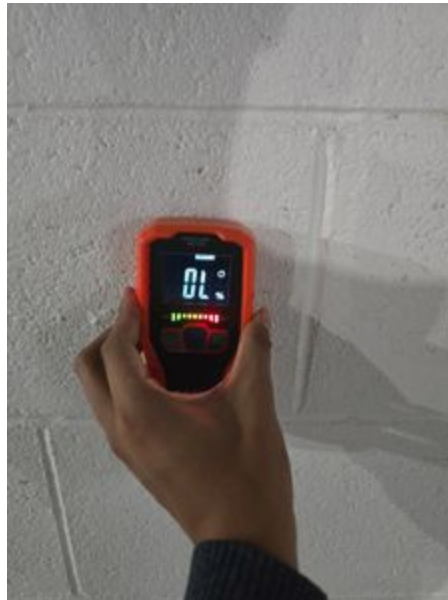
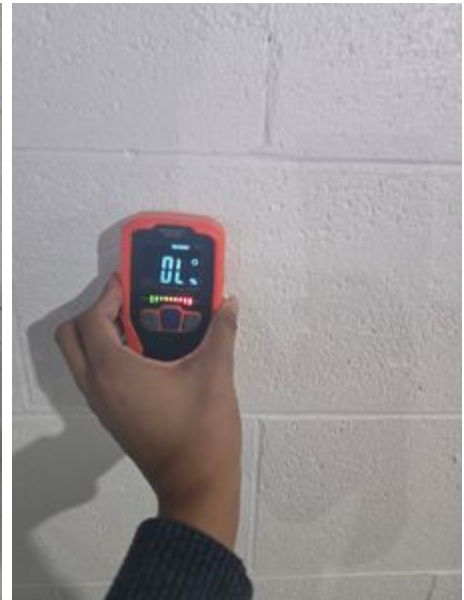
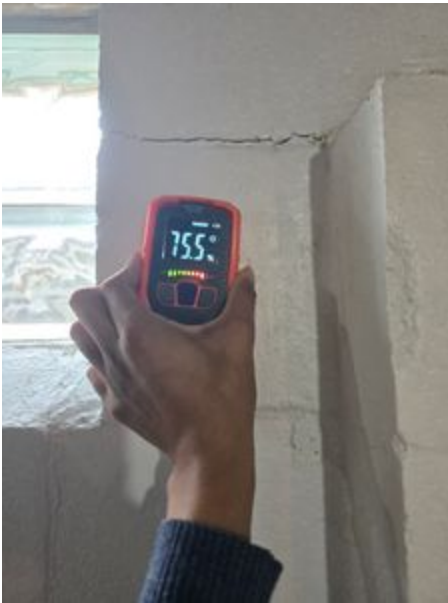
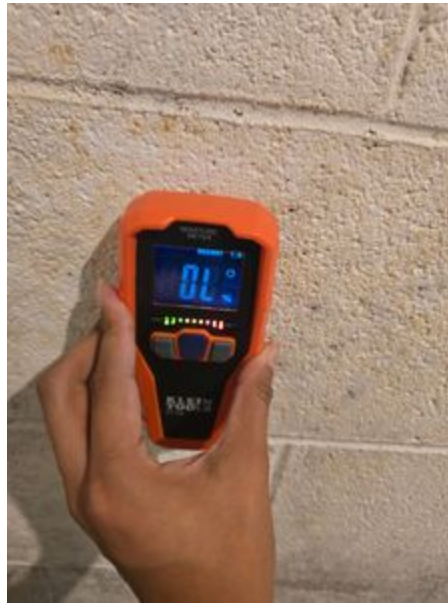
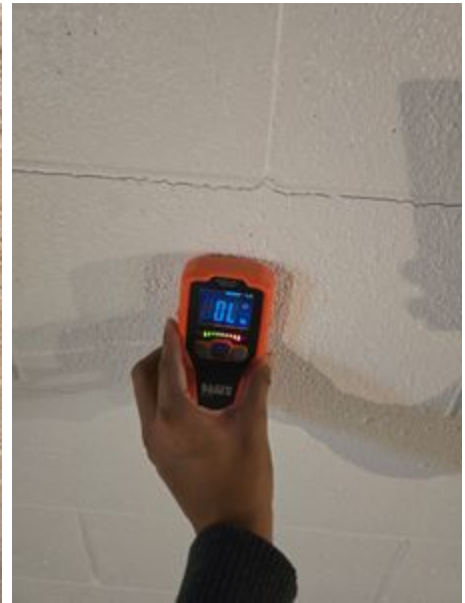
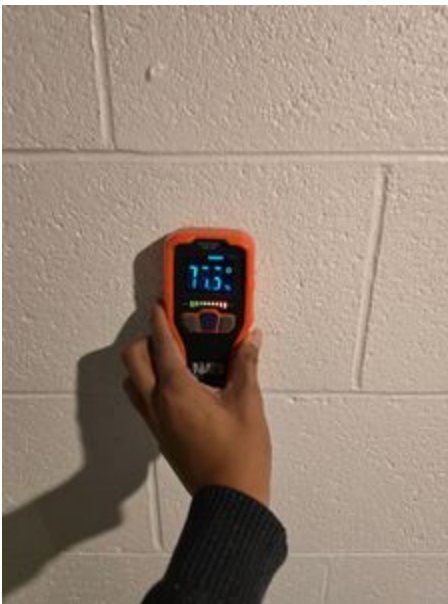
## 10.2 · HIGH MOISTURE LEVELS

High levels of moisture were noted in the basement foundation wall. Recommend monitoring and finding source of moisture intrusion to prevent damage to structure.

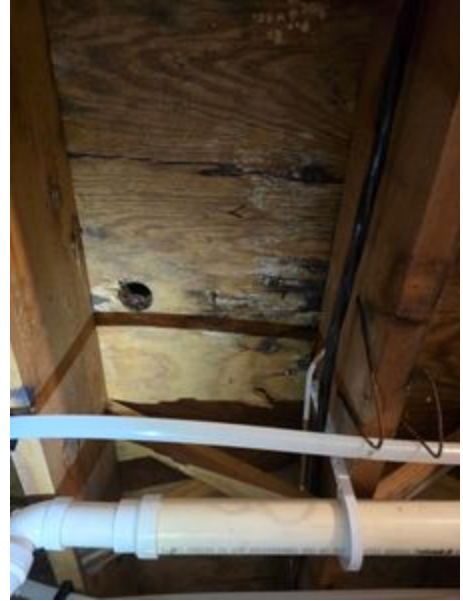
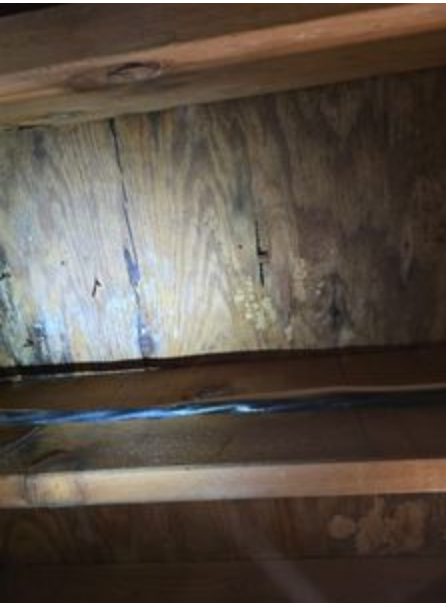
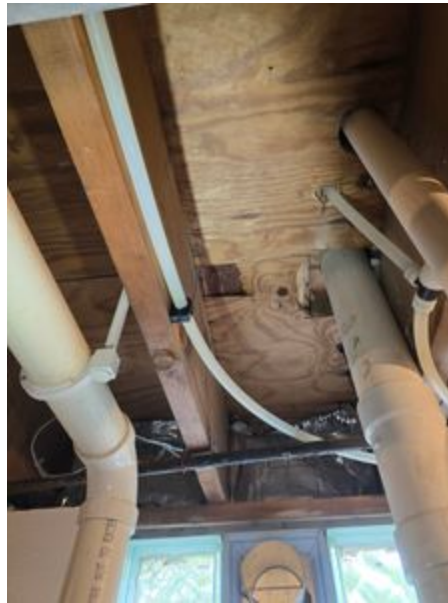
### 10.3 · WOOD ROT

Wood deterioration and rot were observed at the floor framing and underside of the subfloor. The affected wood exhibited dark staining and visible deterioration consistent with prolonged moisture exposure. Recommend further evaluation and any necessary repairs by a qualified flooring contractor or carpenter.

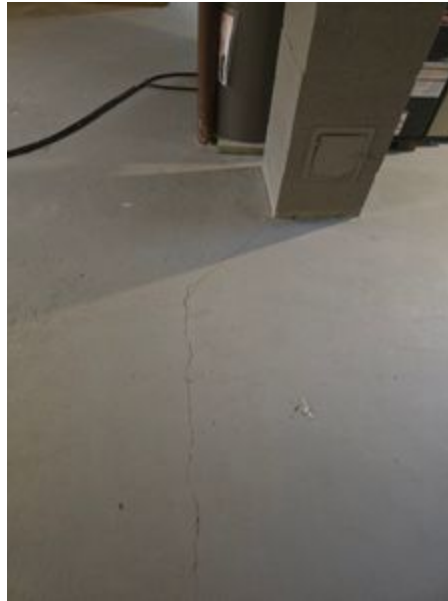
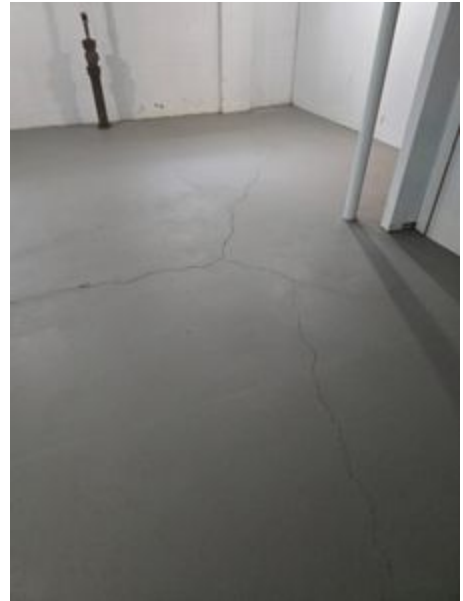
#### 10.4 · MINOR CRACKING

The concrete foundation floor exhibited minor cracking consistent with typical shrinkage. No displacement was observed at the time of inspection.

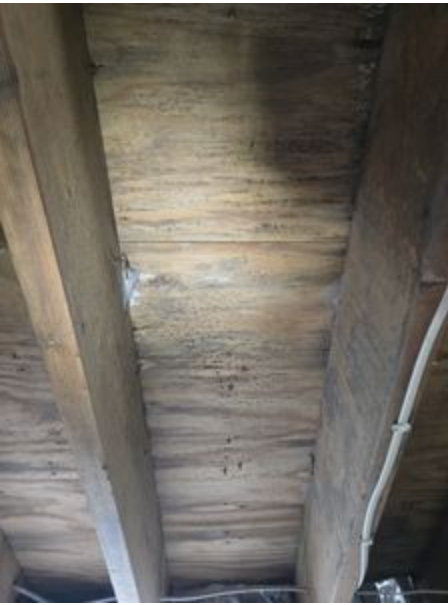
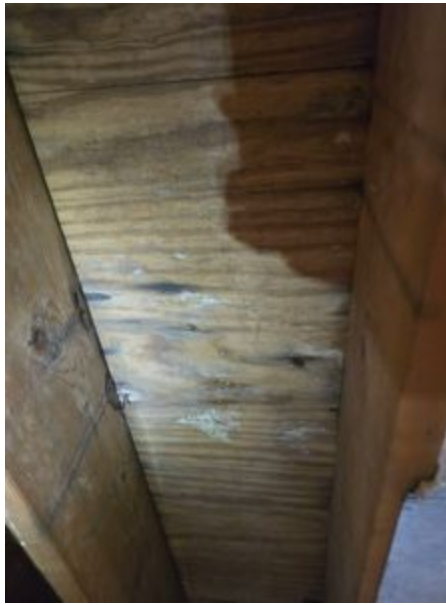
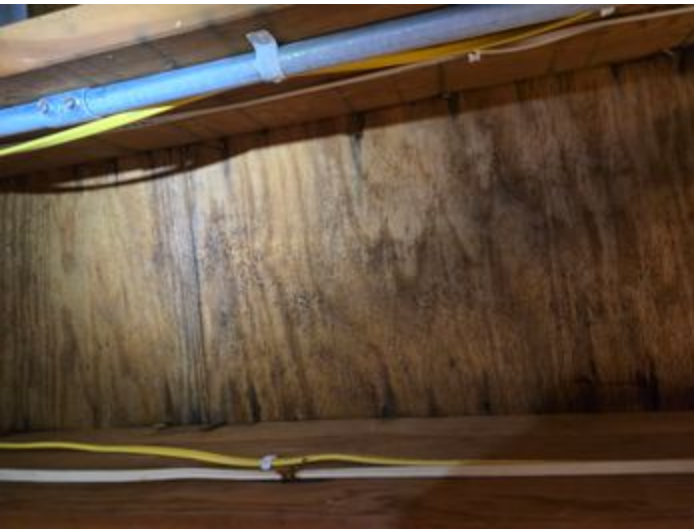
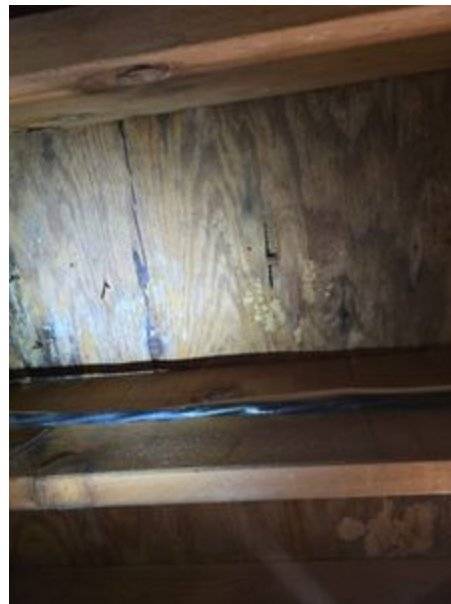
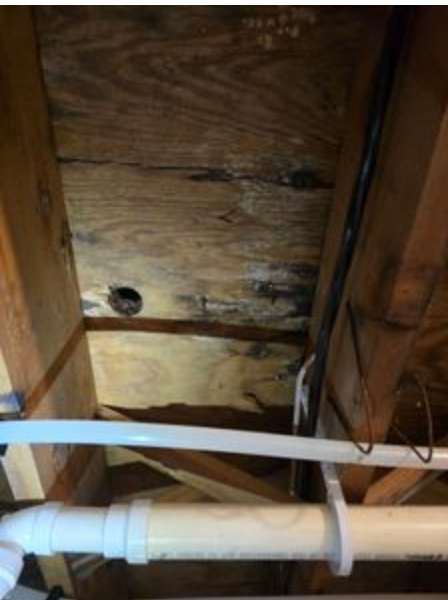
#### 10.5 · SUSPECTED ORGANIC GROWTH

Suspected organic microbial growth was observed on the underside of the subfloor in the crawl space/basement area. The visible discoloration was consistent with possible microbial growth; however, the

material was not tested and its composition could not be determined during this visual home inspection. Conditions conducive to microbial growth may be associated with elevated moisture levels. Recommend further evaluation by a qualified mold assessment or remediation contractor and any necessary corrective measures as determined appropriate.
