# REPORT SUMMARY

5314 West Nokomis Road

Brown Deer, WI, 53223

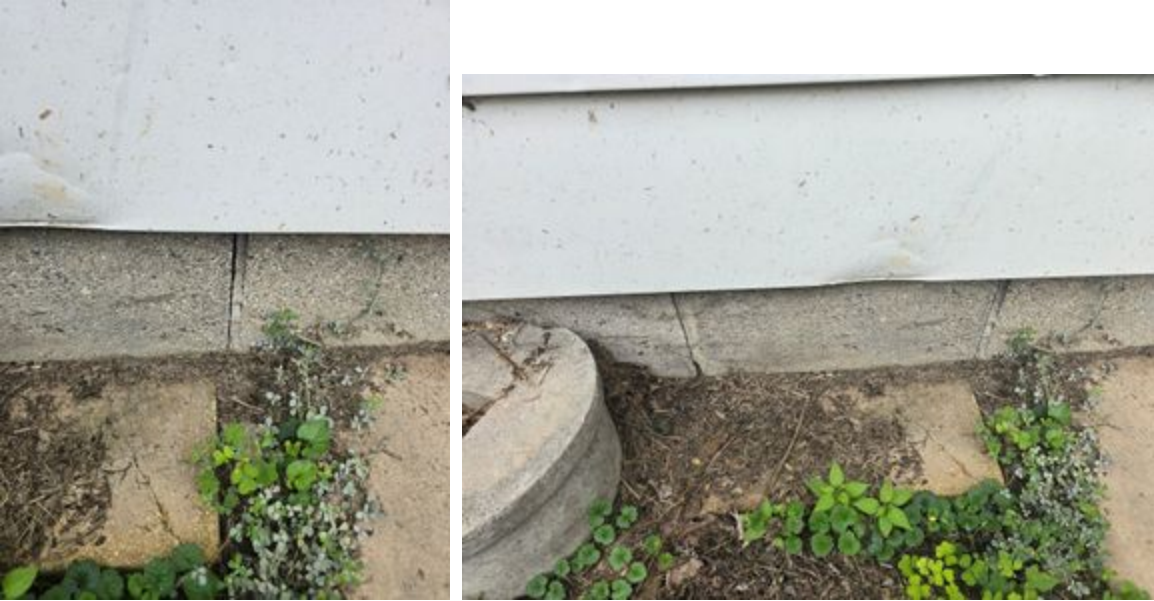
### 10.6 · EXTERIOR FOUNDATION CRACKING

Cracking was observed at the exterior foundation. The cracking may allow moisture intrusion and could indicate possible movement within the foundation system. Recommend further evaluation and any necessary repairs by a qualified foundation contractor.

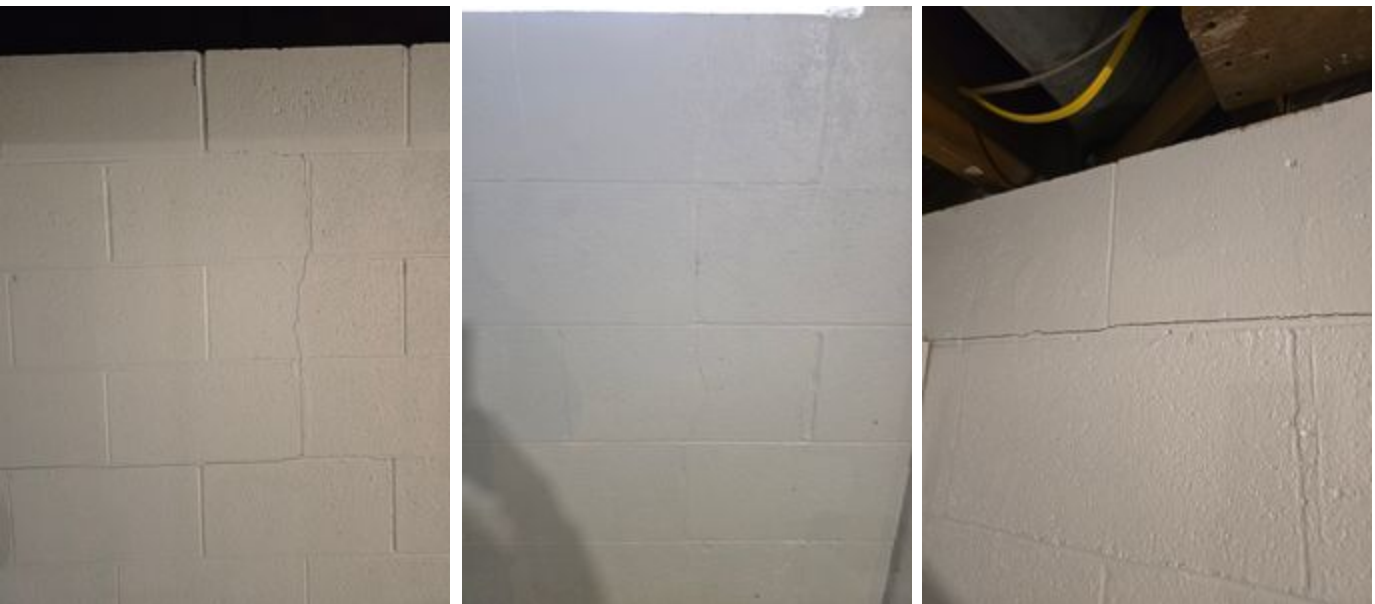
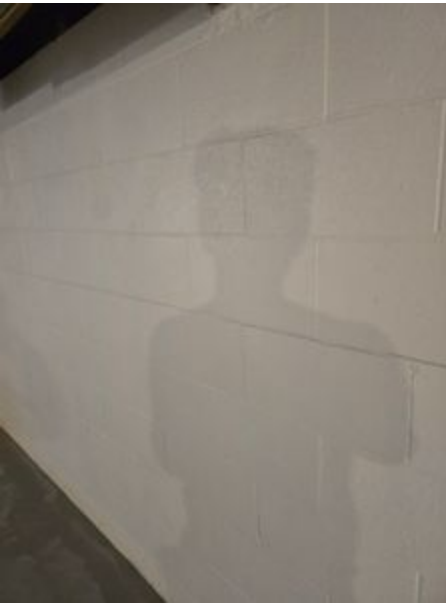
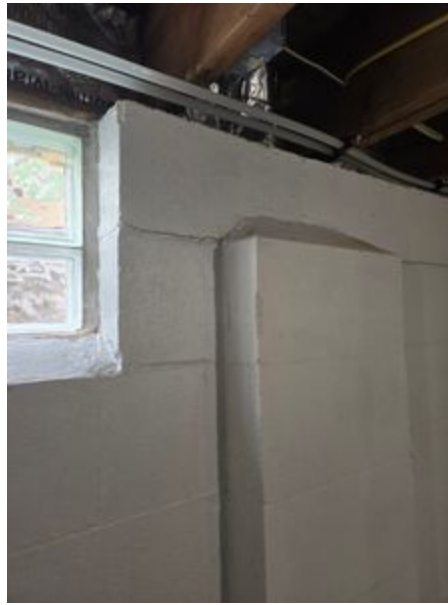
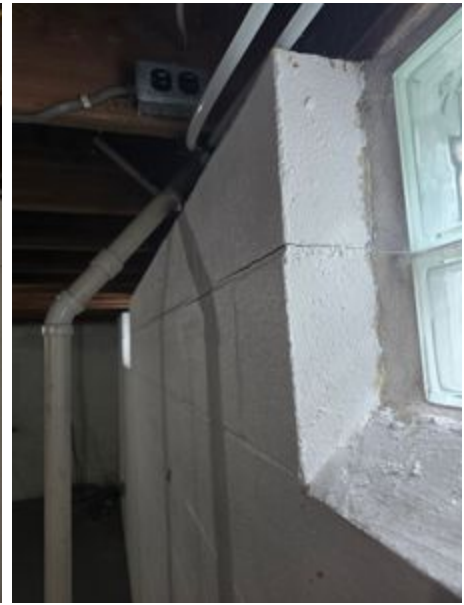
### 10.7 · FOUNDATION CRACKS - MAJOR

Multiple horizontal and vertical cracks were observed in the painted concrete masonry unit (CMU) foundation walls. The cracking extended through mortar joints and individual masonry units in several locations, including around a window opening, and was consistent with possible foundation movement. The extent and pattern of the cracking warranted further evaluation to determine its significance and any necessary corrective measures. Recommend further evaluation and any necessary repairs by a qualified foundation contractor or structural engineer.

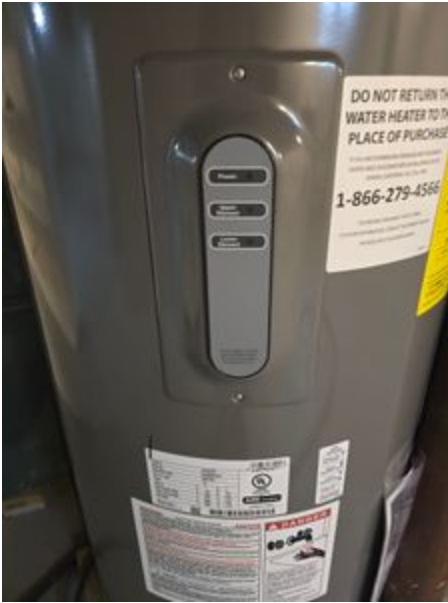
## 6.3 · LIMITATION

The water heater was observed to be turned off at the time of inspection; therefore, it was not operated or fully evaluated. Performance and proper operation could not be determined.
