# INSPECTION REPORT

For the Property at:  
**N6604 MINE RD**  
IRON RIDGE, WI 53035

RE: Report No. 2349  
N6604 Mine Rd  
Iron Ridge, WI  
53035

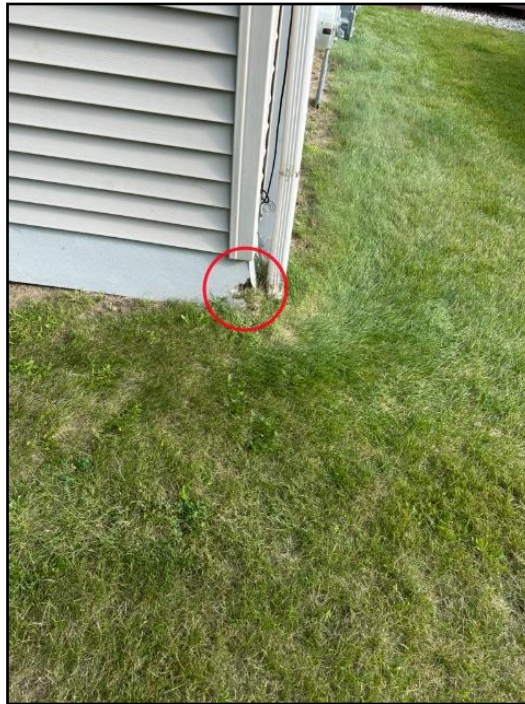
## WALLS \ Vent (fan, clothes dryer, etc.)

**Condition:** • Cover damaged

**Task:** Repair or replace

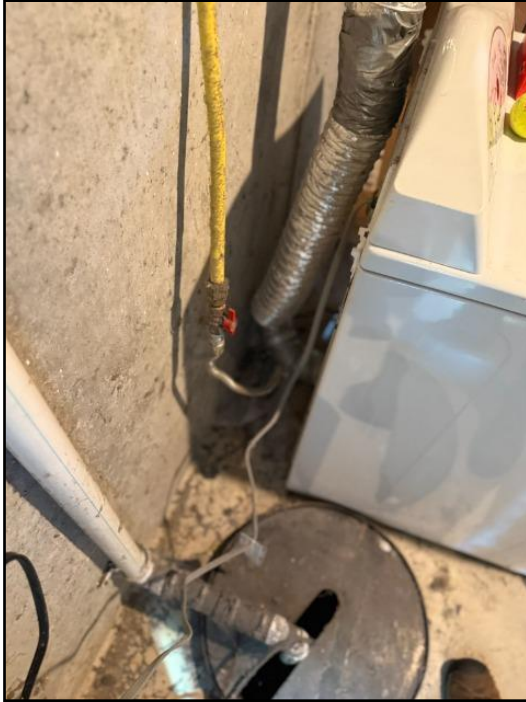
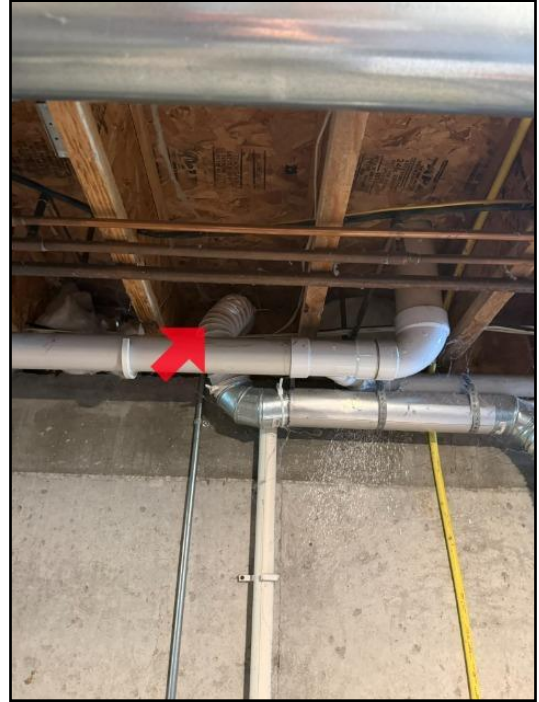
**Condition:** • Suggest using rigid pipe for dryer venting to exterior.

Lint in basement suggest loose or damaged vent pipe as well.

**Task:** Improve

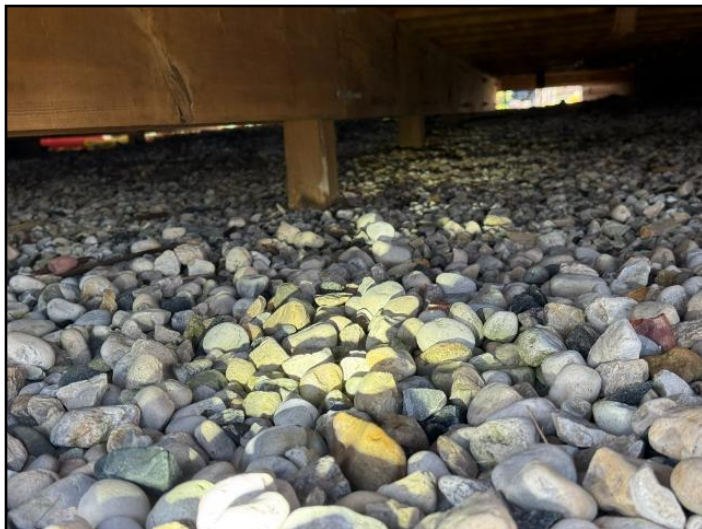
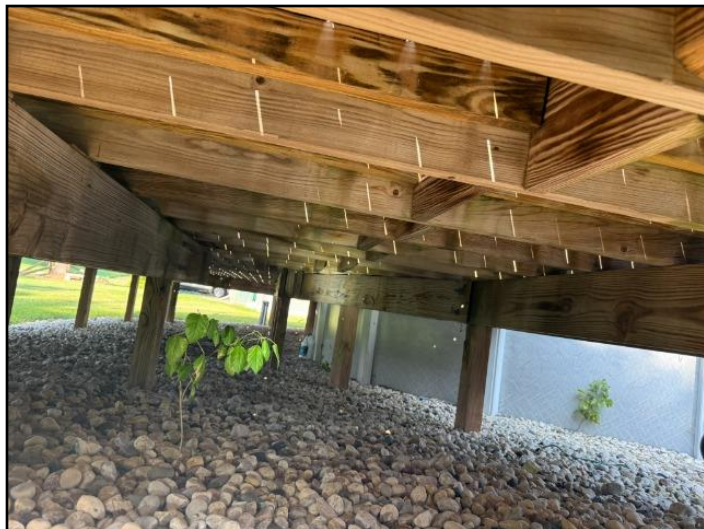
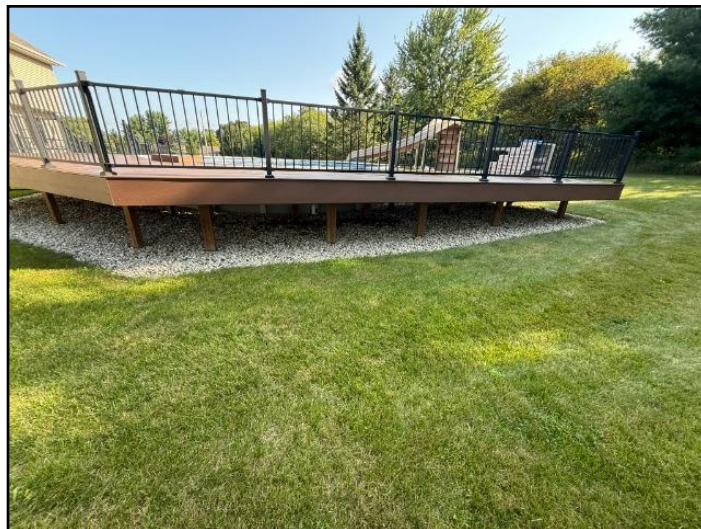
## PORCHES, DECKS, STAIRS, PATIOS AND BALCONIES \ Columns / Posts

**Condition:** • [Wood/soil contact](#)

All deck posts are set below ground level. This will likely reduce life expectancy. Monitor and replace as necessary.

**Implication(s):** Weakened structure | Chance of movement | Rot | Insect damage

**Task:** DEFECT, Monitor

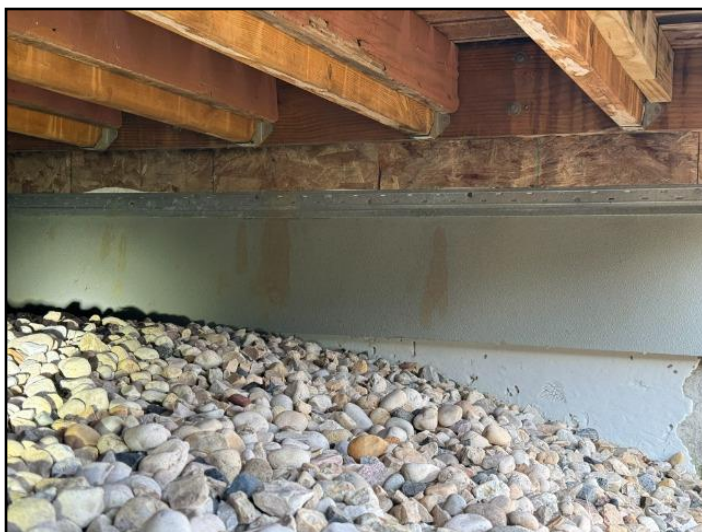
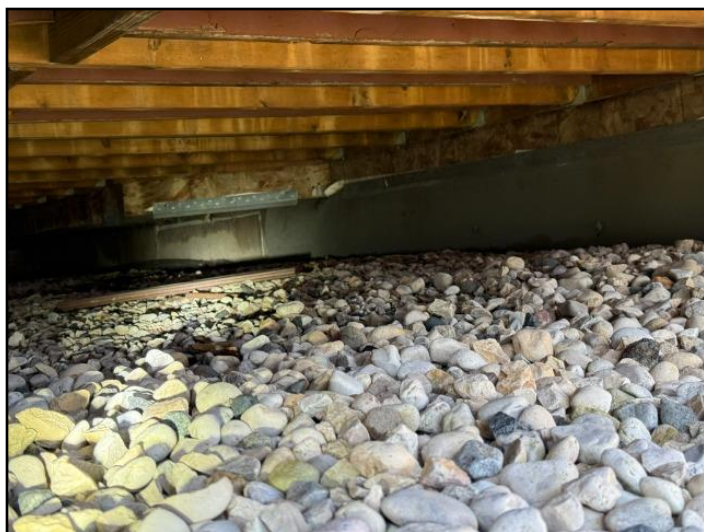
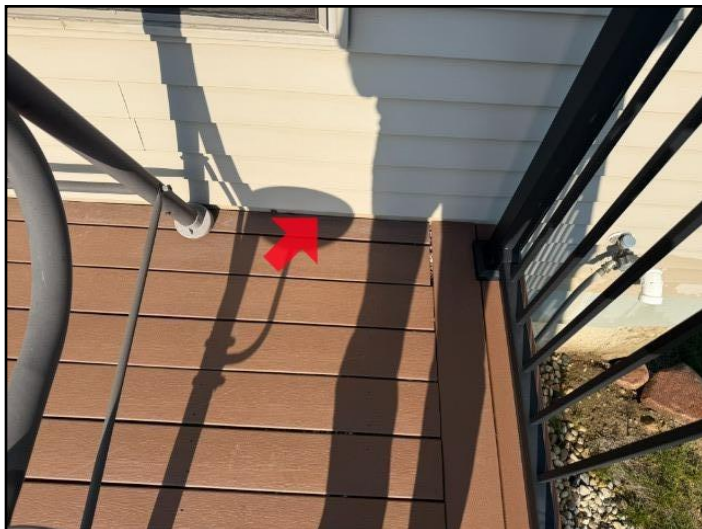
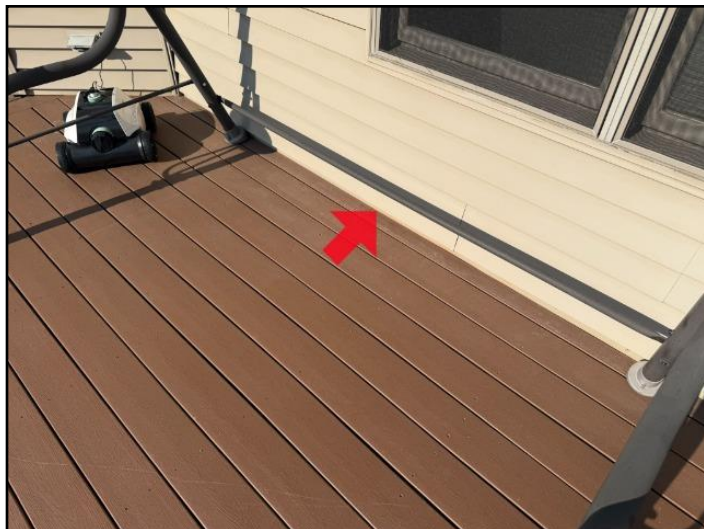
## **PORCHES, DECKS, STAIRS, PATIOS AND BALCONIES \ Joists**

**Condition:** • [Ledgerboard problems](#)

Ledger board appears to be missing proper flashing and protectant weather wrap.

**Task:** DEFECT, Repair

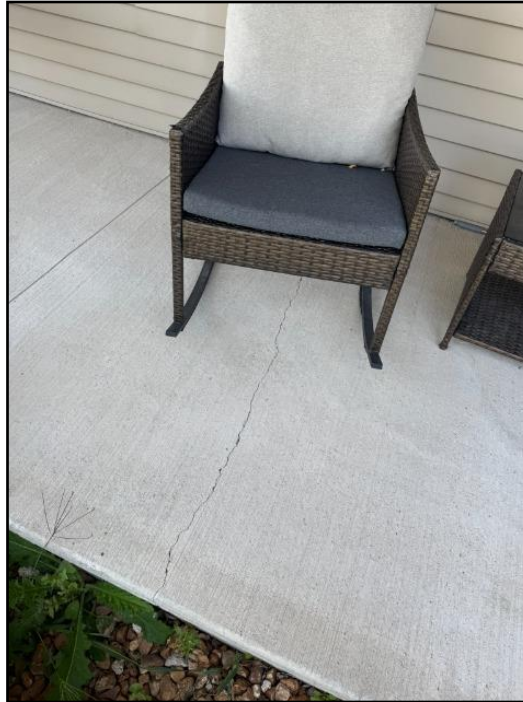
## PORCHES, DECKS, STAIRS, PATIOS AND BALCONIES \ Floors

**Condition:** • [Concrete cracked](#)

**Implication(s):** Chance of damage to structure | Material deterioration | Trip or fall hazard

**Task:** Repair or replace

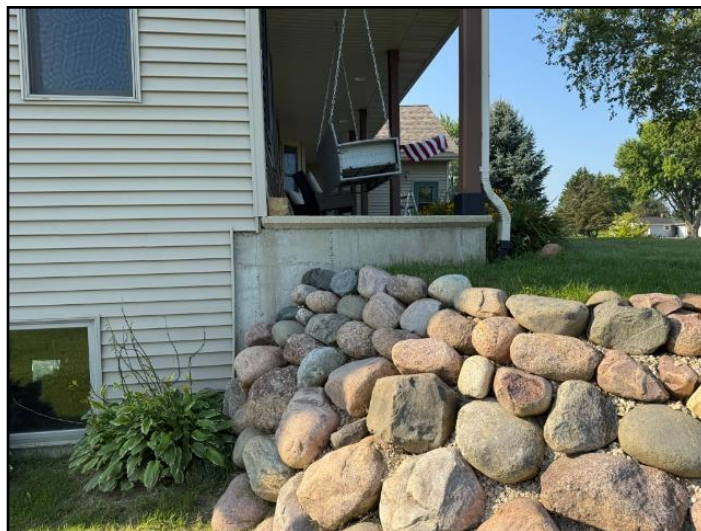
**Condition:** • [Missing](#)

Stairways with 4 or more steps require a proper handrail.

**Implication(s):** Fall hazard

**Task:** DEFECT, Safety item

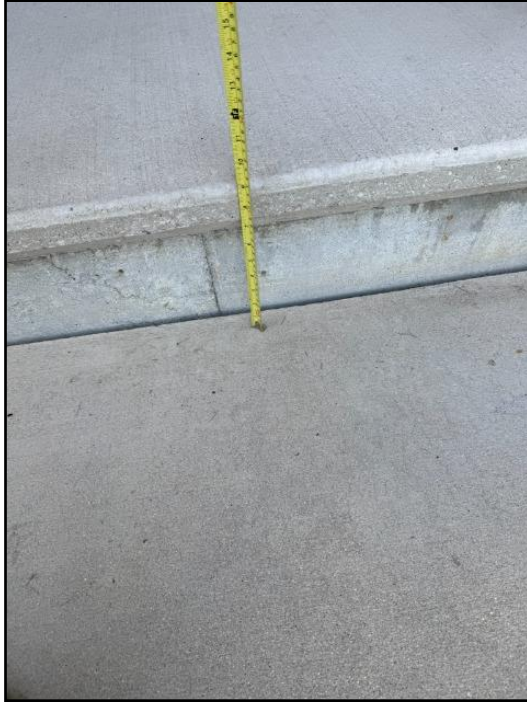
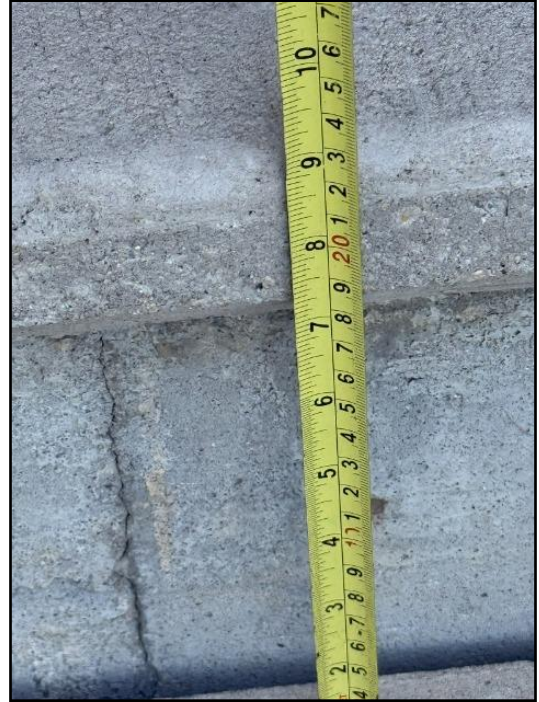
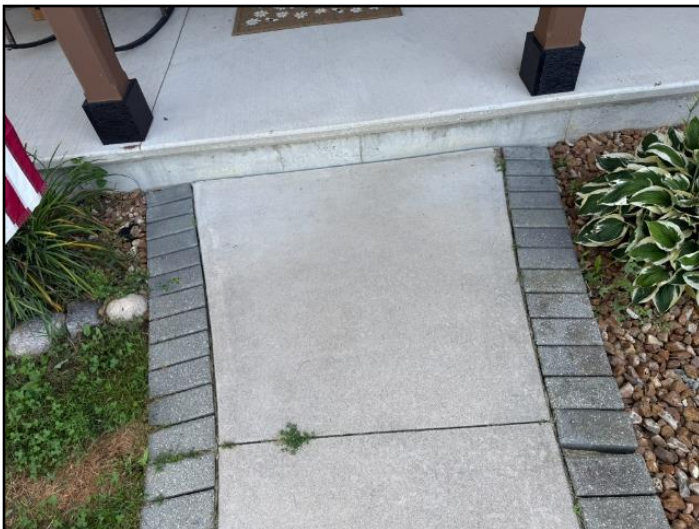
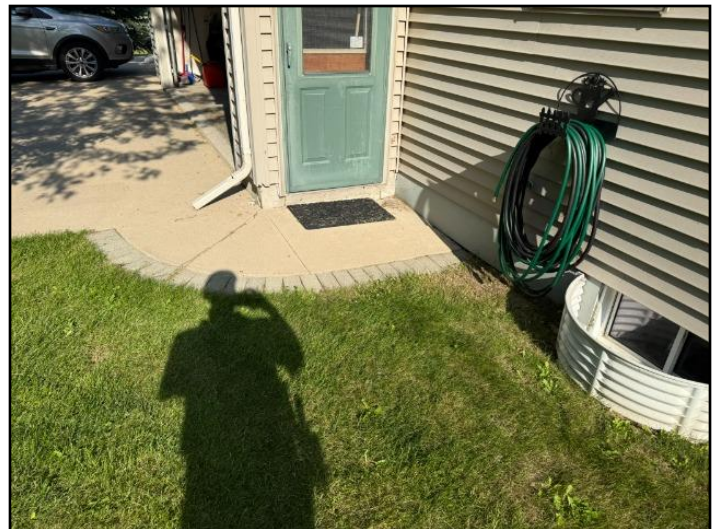
## LANDSCAPING \ Driveway

**Condition:** • [Uneven \(trip hazard\)](#)

Driveway has settled at garage openings causing a trip hazard into garage.

**Task:** DEFECT, Safety item

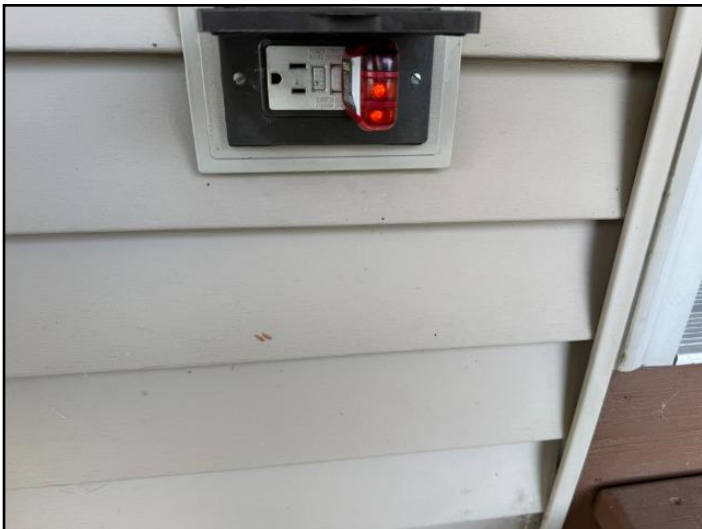
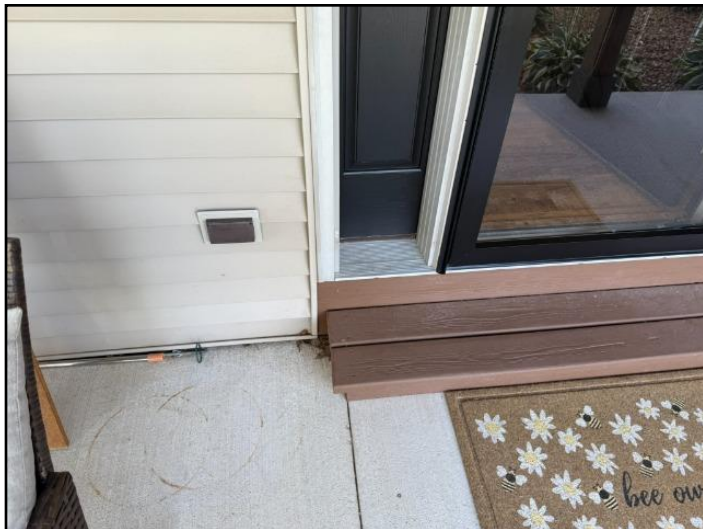
## DISTRIBUTION SYSTEM \ Cover plates

**Condition:** • For junction box is missing

**Task:** DEFECT, Contact a licensed professional for repair/replacement.
