# FOUNDATION INSPECTION REPORT

| Inspection Address: 5235 Briarwood Circle, Caledonia, WI | | |

FOUNDATION  
DOCUMENTATION  
PLAN

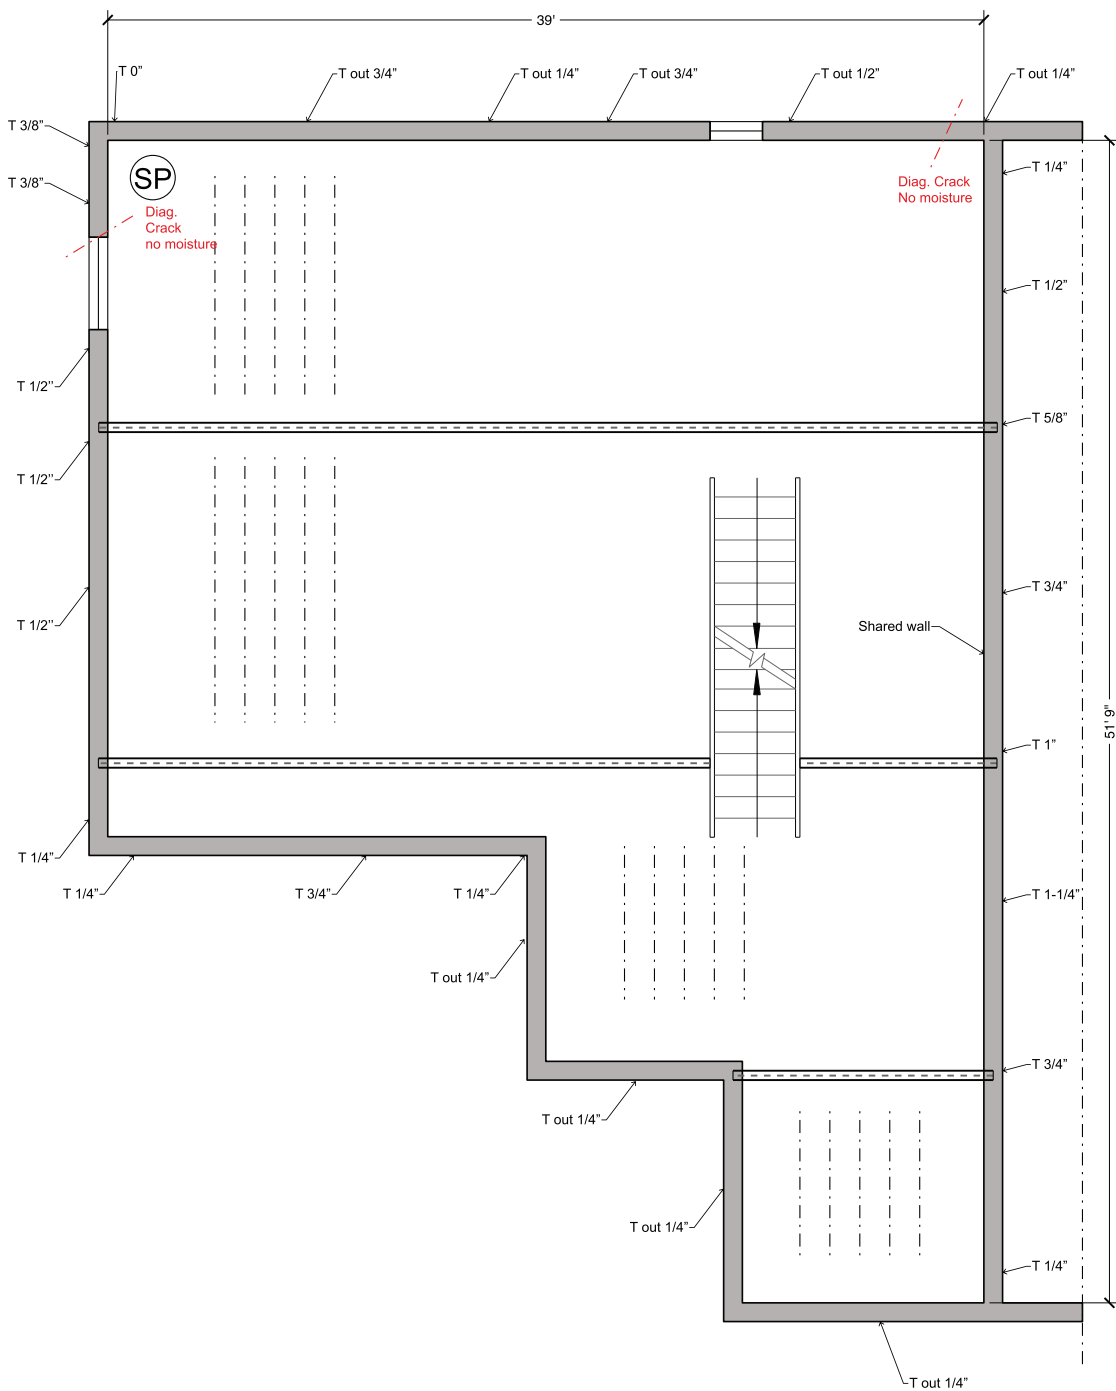
# S1.0

The basement foundation was visually inspected and found to have two hairline cracks less than 3/16" wide with no discoloration in the southwest and southeast corner. In my opinion, these cracks are the result of normal concrete shrinkage or temperature change.

The north foundation wall sections are tipped out roughly 1/4" with the east section tipped in roughly 3/4". The east wall is consistently tipped in 1/2". The south wall is consistently tipped out 1/2"-1". The west wall was found to have the most out-of-plumb measurements of tipped in 1" to 1-1/4". However, the west wall is an interior wall and is not retaining soils. CONTINUE...

At this time, there are no signs of structural instability or indications that the foundation was incorrectly constructed. The foundation wall hairline cracks and out-of-tolerances are normal for poured concrete construction. Basement foundation walls should be monitored and re-evaluated if wall cracks are found to develop over 3/16" in width. The attached foundation wall survey measurements should be used as a baseline for future evaluation.

| North Wall | Out 1/4" / in 3/4" | Active? | No | | |
| South Wall | Tipped out 3/4" | Active? | No | | |
| West Wall | Tipped 1-1/4" | Active? | No, interior wall | | |
| East Wall | 1/2" | Active? | No | | |
| Moisture present? | No | Water stains or discoloration? | No | | |

Notes: Check sump pump height. Should be below drain tile inlets.
