**Tri-State Home Inspections LLC**  
4235 Fairway St  
La Crosse WI 54601  
563-380-2515  
tristate.org@gmail.com

**Report:** 7742-hawkins **Address:** N2067 County Rd F

## **Confidential Inspection Report**

**N2067 County Rd F**  
**La Crosse, WI 54601**

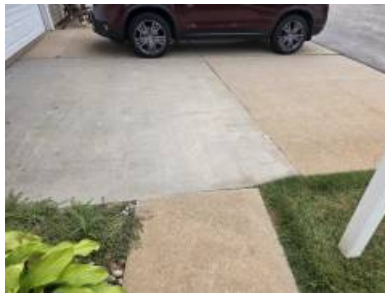
**Walks:**

☐ ☒ ☐ ☐ Sidewalk type: Concrete  
 • Surface raised/settled.

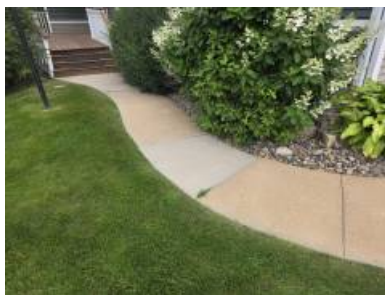
**Patio:**

☐ ☒ ☐ ☐ Patio type: Concrete  
 • Surface raised/settled  
 • Cracks (1/4-inch or less) were visible in the concrete. Cracks exceeding 1/4- inch should be filled and the surface sealed with an appropriate material as needed to avoid continued damage to the driveway surface from freezing moisture.  
 • I recommend sealing with concrete around the deck post to prevent further erosion and damage.

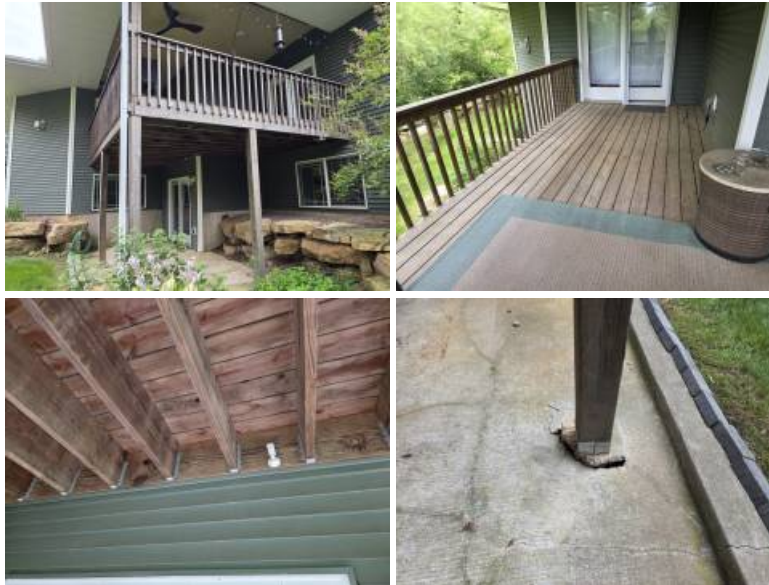
☐ ☐ ☐ ☐ Maintain deck surface to prevent deterioration.

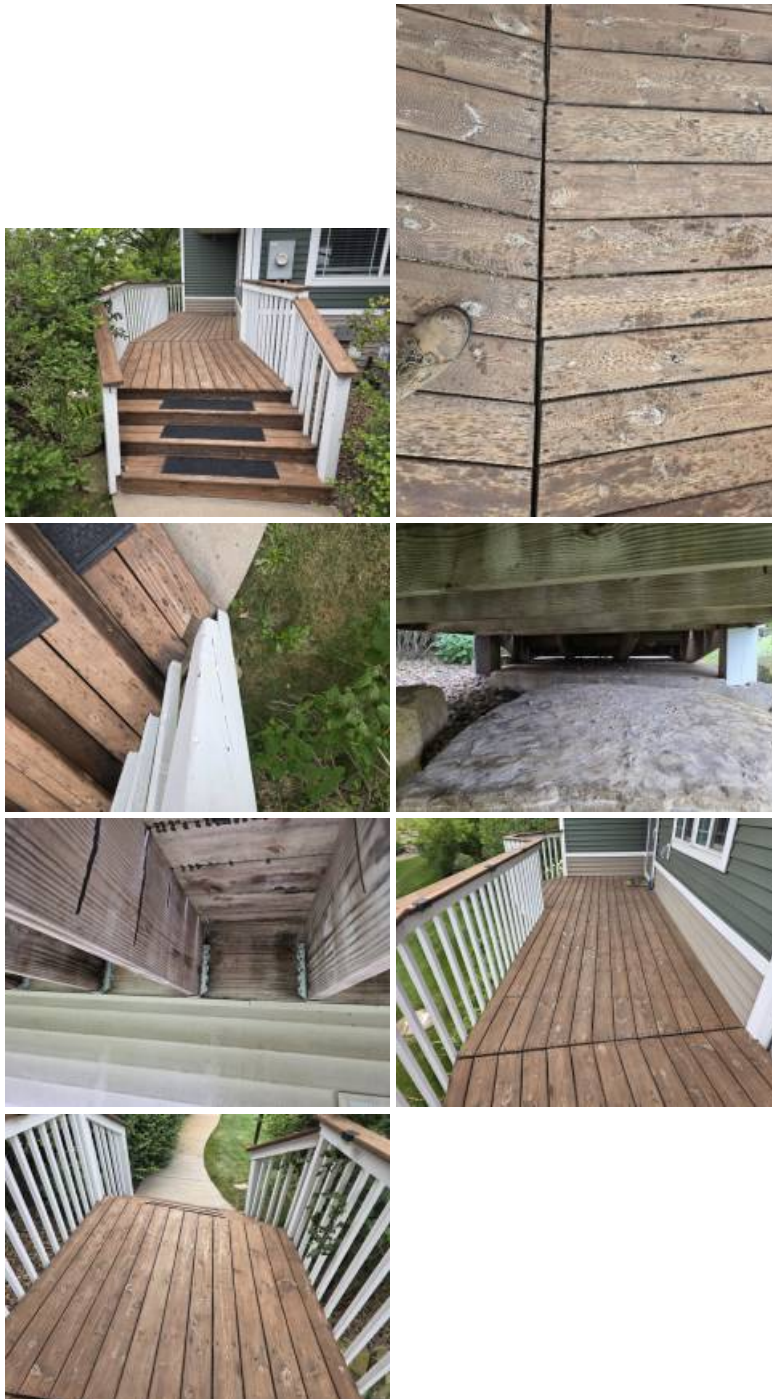
## Deck:

Deterioration noted to deck surface, Maintain deck surface to prevent deterioration

Improper conditions viewed, The girder is improperly relying on the sheer strength of wood screws. The girders should bear directly on posts. No lag bolts visible. The deck ledger board is nailed or screwed to the house or is covered and not visible. Recommend installing lag screws to securely attach ledger board to house if they have not been used.

Recommend installing lag screws to securely attach ledger board to house if they have not been used.

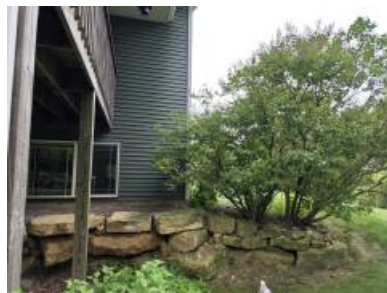
## Landscaping:

☐ ☒ ☐ ☐ Some trees and/or shrubs on the site need to be trimmed.

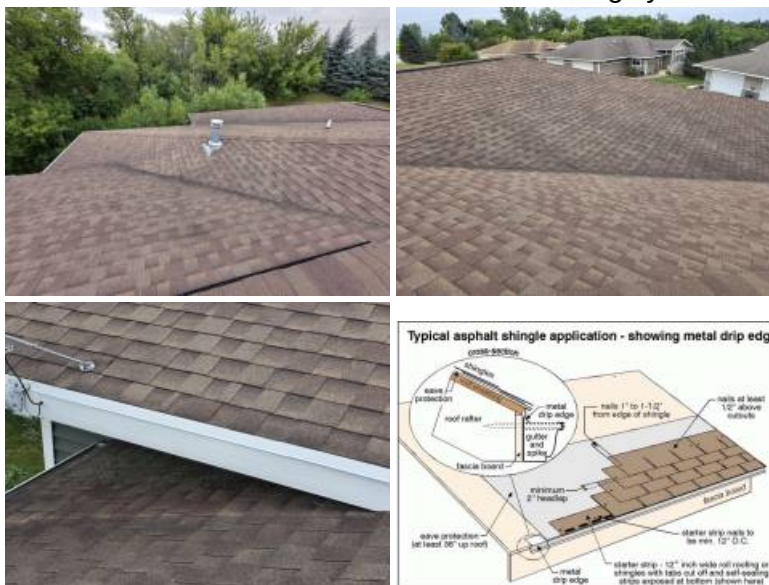
- ☐ ☐ ☐ ☐ The roof covering has some moss like growth in areas which can damage the roof. It can anchor into the surface and remove the granules that protect the material, it can grow into the spaces between shingles, causing shingles to lift and leak and lastly, moss retains more water that can seep into roofing material and supporting structures. It can also make the roof slippery when wet leading to possible fall/injury. Therefore I recommend treating and have qualified specialist repair any shingles found to be damaged once moss is removed.

One effective method of cleaning algae and moss from a roof is with a 50:50 mix of laundry strength liquid chlorine bleach and water. Apply with a sprayer and allow the solution to dwell on the roof surface for 15 to 20 minutes, and then rinse thoroughly with low pressure water.

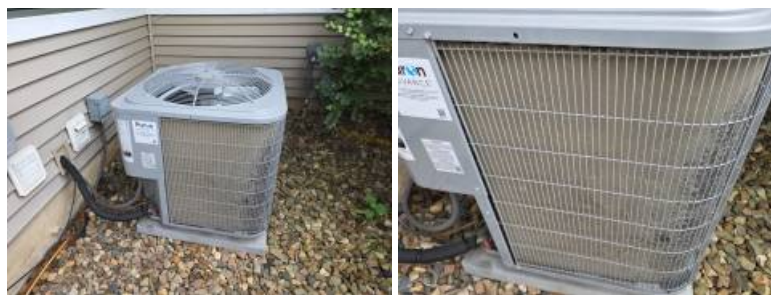
The clothes dryer vents correctly to the exterior; however, it empties at a location that causes the air conditioning condenser cabinet to collect the lint. This reduces the efficiency of the air conditioning system, and it could result in system failure.

[The exterior condenser needs to be cleaned.](#)

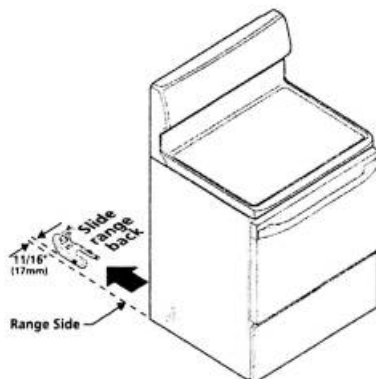
Stove has not been secured as required by manufacturer's installation instructions. A tip-over hazard exists for small children. Stove should be properly secured. Information on anti tip devices

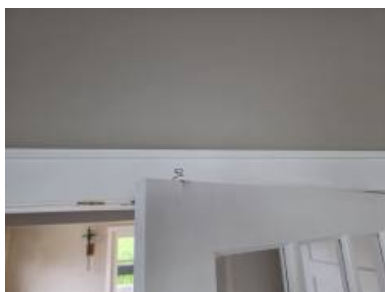
### Den:

Damage viewed.

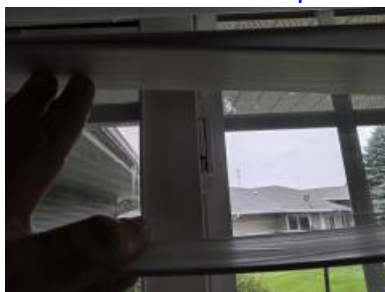
### Den:

At least one window or associated hardware in this room needs repair. Locking hardware needs repair or replacement.

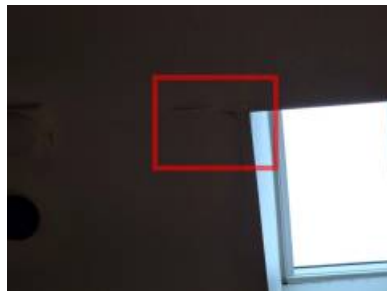
### Kitchen Interior:

There is a condition in the ceiling that needs attention.

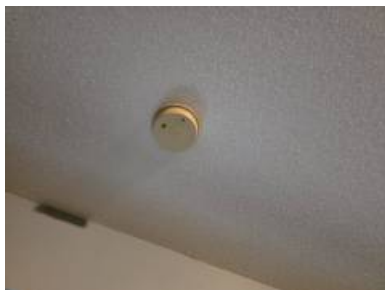
**General:** ☐ ☐ ☒ ☐ Wisconsin law requires every home; owner occupied, rentals, and residential buildings to be protected by smoke and CO detectors. Owner must install at least one smoke and CO detector on each floor level of each unit, including the basement and any finished attic. Carbon monoxide detectors are required to be located in the immediate vicinity of any sleeping rooms, if the home has a fuel burning appliance.

Smoke detector appeared to be outdated. Recommend replacement of unit with required type of device, such as a combination smoke and CO detector, and tested for functionality as appropriate prior to occupancy.
